## West Babine Fish Passage Restoration Project – Williams Creek 34.5km Nilkitkwa FSR

### Project Completion Abstract - *Fish Salvage Component*

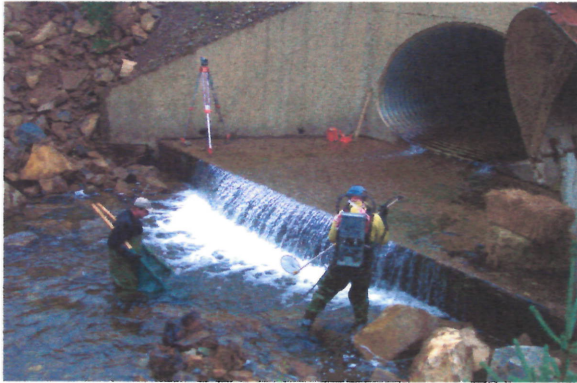
Fig.1 Second fish salvage pass - at the outlet pool utilizing an electroshocker and pole seine.

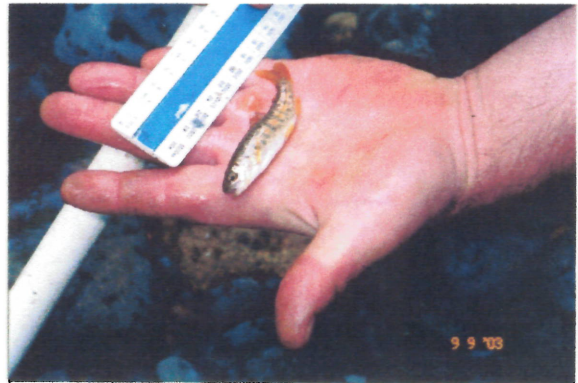
Fig.4 78cm RB captured u/s of culvert during upstream baseline sampling.

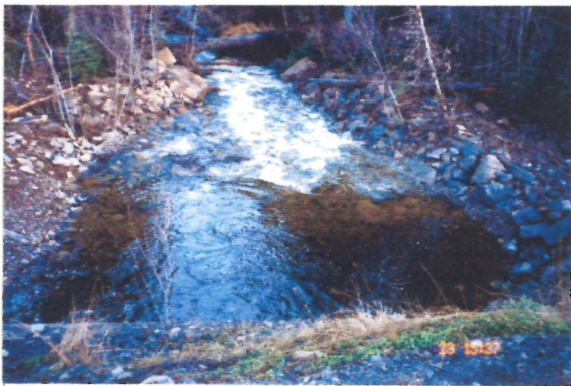
Backwatering of the culvert has completely eliminated the outlet drop, reduced the water gradient to 0% for approximately 1/2 to 2/3 of the lower culvert length and has reduced the water velocities considerably within the same 1/2 to 2/3 of the culvert. The restoration work has undoubtedly facilitated both adult and juvenile fish passage through the culvert, making it easier to access the good quality fish habitat upstream of the crossing site. All three species were captured both upstream and downstream of the pre-restoration work culvert. Given the pre-restoration conditions of the site, it is unlikely that many juvenile rainbows and coho could successfully migrate upstream through the culvert. A more reasonable explanation is that adult RB and CO likely spawn upstream, being more able to successfully navigate the culvert. The downstream face of the completed rock weir/riffle structure now has a relatively steep slope with shallow, fast flowing water and no holding sites. It may be worth considering the placement of some large boulders into the weir face to provide resting and holding areas for fish, if not for this project, at least for future projects.

Fig.2 Weir/riffle structure approx. 1.5mo after construction.

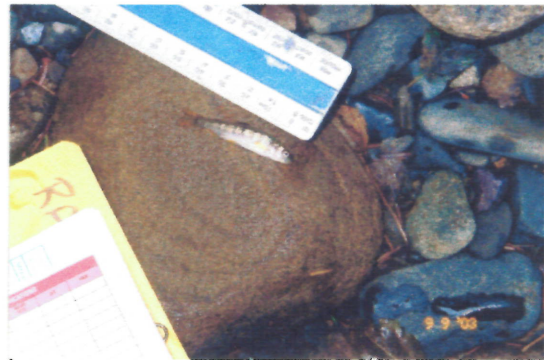
Fig.5 47cm CO captured u/s of culvert during upstream baseline sampling.

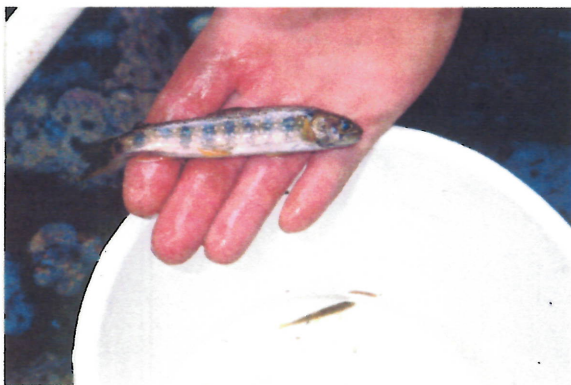
Fig.3 110cm DV/BT captured u/s of culvert during upstream baseline sampling.

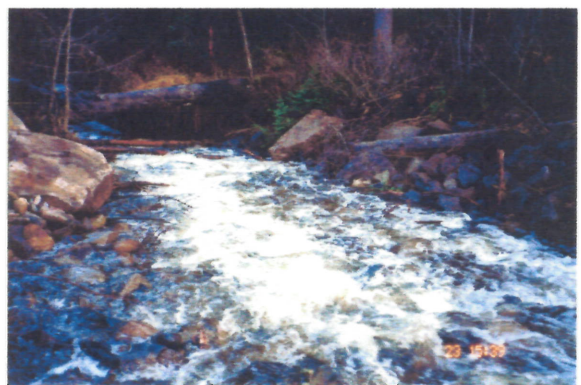
Fig.6 Closer view of face of weir/riffle structure approx. 1.5mo after construction. (Some large boulders in this riffle would provide resting and holding areas for fish).
