West Babine Fish Passage Restoration Project – Culvert removal at 9km on the 413 Rd

Project Completion Abstract - *Fish Salvage Component*

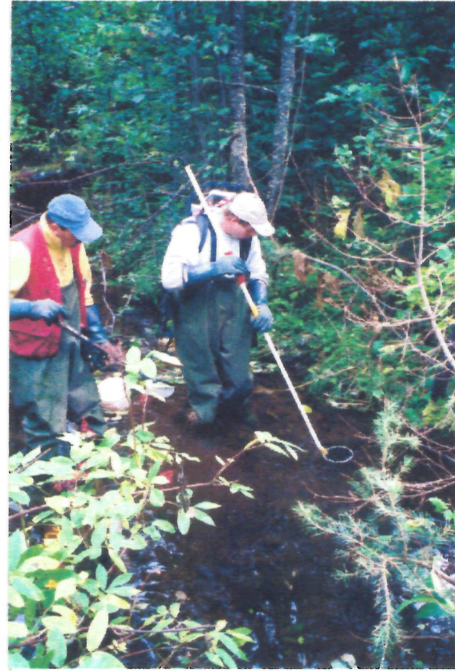
Fig.1 Fish salvage using a Smith-Root 12B POW backpack electroshocker.

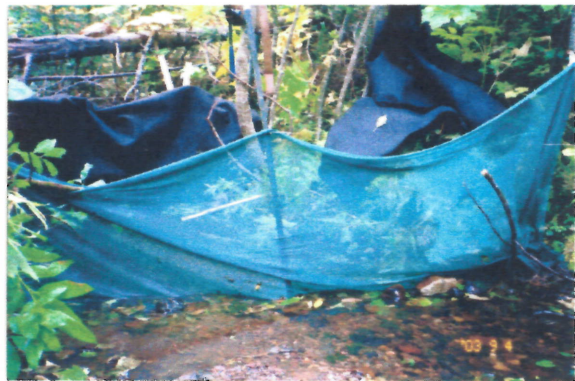
Fig.2 Isolation net at downstream end of work site.

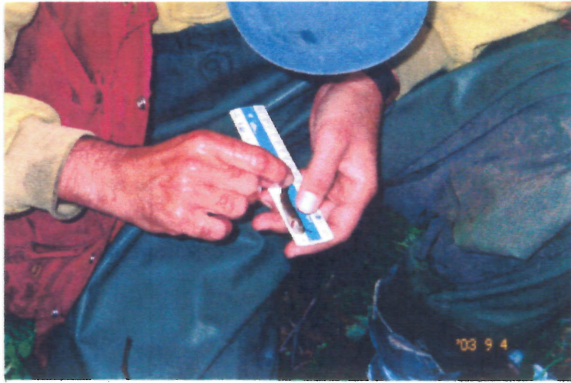
Fig.3 Measuring captured RB parr.

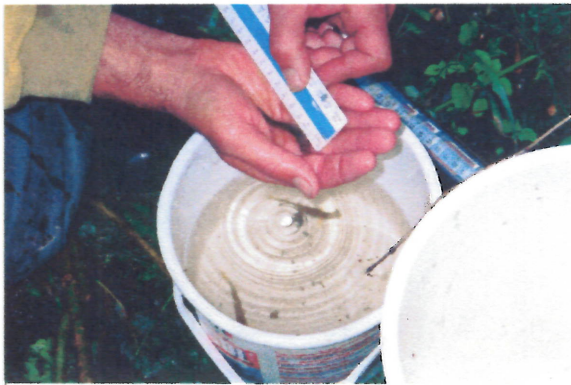
Fig.4 Processing RB parr captured during fish salvage operations.
