West Babine Fish Passage Restoration Project – Heal Creek 40.5km Nilkitkwa FSR

Project Completion Abstract - *Fish Salvage Component*

Heal Creek is located within the West Babine watershed. It passes under the Nilkitkwa FSR at ~40.5km (UTM 09 E6649768 N6123028), approximately 0.75km upstream of its confluence with Babine Lake. Heal Creek is a third order watershed that flows eastward into Babine Lake approximately 2 kilometres south of the outlet of Babine Lake.

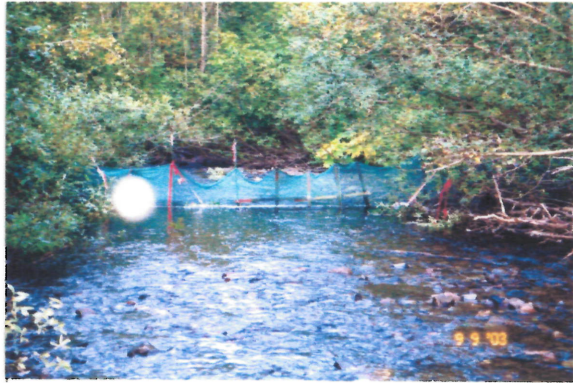
Fig.1 Downstream isolation net shortly after it was erected.

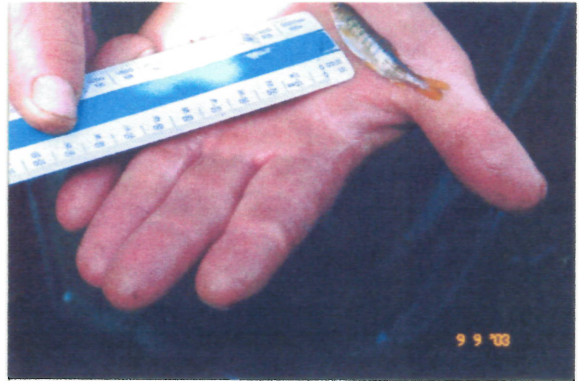
Fig.4 Coho parr captured during upstream baseline sampling.

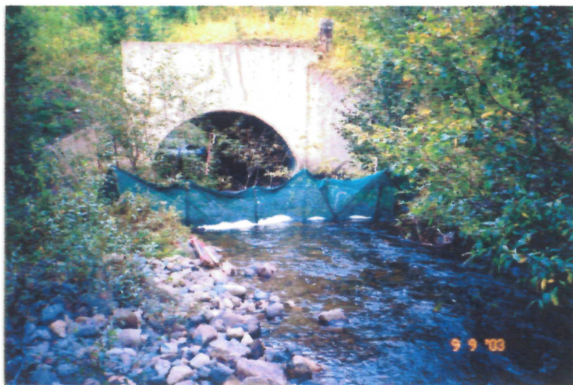
Fig.2 Upstream isolation net shortly after it was erected.

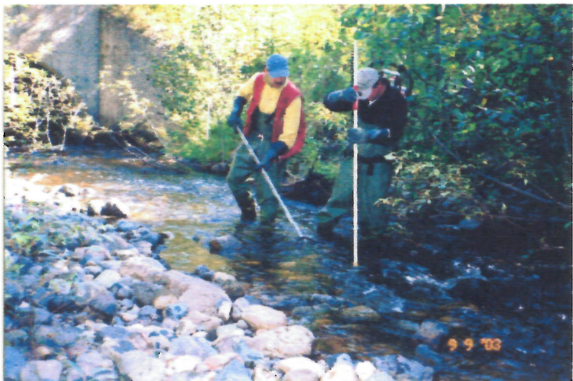
Fig.3 Upstream baseline sampling using a Smith-Root 12B POW backpack electroshocker and dipnet.

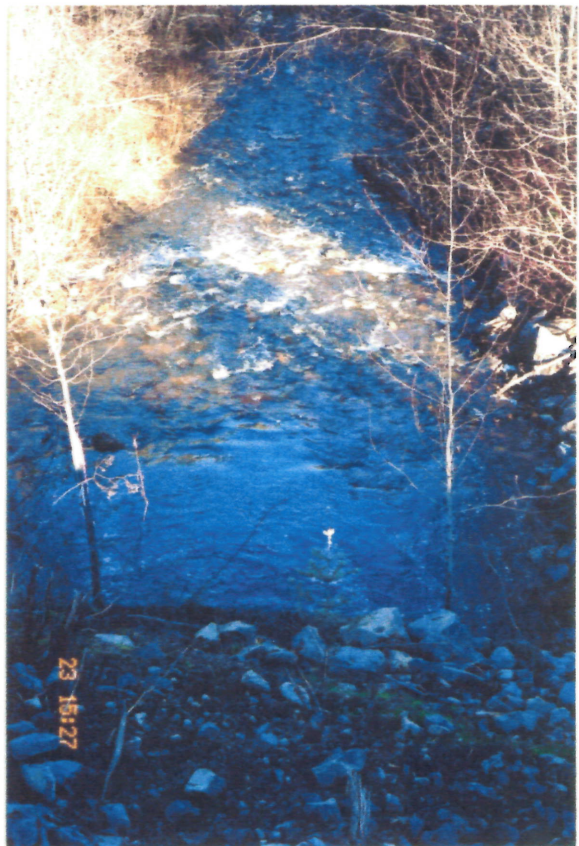
Backwatering of the culvert has reduced the water gradient to 0% for approximately 2/3 of the lower culvert length and has considerably reduced the water velocities within the same 2/3 of the culvert. The restoration work has undoubtedly facilitated both adult and juvenile fish passage through the culvert, making it easier to access the good quality fish habitat upstream of the crossing site. DV/BT and CO were captured both upstream and downstream of the pre-restoration work culvert. No CH were captured upstream of the site and no RB were captured downstream of the site, however the number and size of the samples conducted are likely too small to attach any real significance to these observations. Also, some juveniles with extremely good fitness were likely able to overcome the velocity barrier and successfully migrate upstream through the culvert.

Fig.5 Weir/riffle structure approx. 1.5mo after construction.

It is recommended that the site be visited after the spring and fall freshets in 2004 to ensure that the structure is functioning as designed.
