***Gitanyow Fisheries
Authority***

**The 2006 Kitwanga River Fish
Passage-Culvert Inspection and the
Stream Crossing Quality Index
Project**

**Submitted to: B.C. Ministry of Forests
Smithers, B.C.**

April 10, 2007

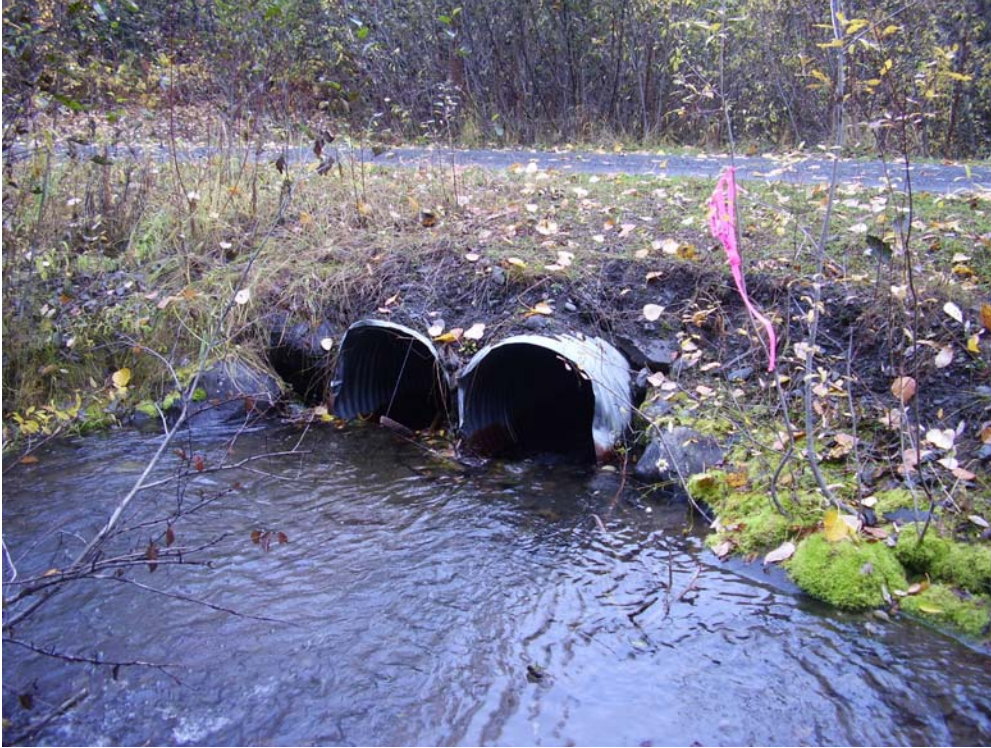
This twin culvert crossing was considered a partial barrier due to the excessive water velocity inside the culvert. The culvert slope was considered steep (3 percent) creating high water velocity (1.57 meters/sec). The water velocity exceeded the swimming capability of juvenile salmonids. A deep scour pool below the culvert provided good fish habitat. The Q100 culvert diameter was calculated to be 1600 millimeters for a round culvert, which is the same as the combined diameters of the two culverts currently in place (800 millimeters each). The fill depth above the culvert was 0.5 meters.

Photo 1: Site 3 looking downstream at culvert inlet – velocity barrier to juvenile salmonids.

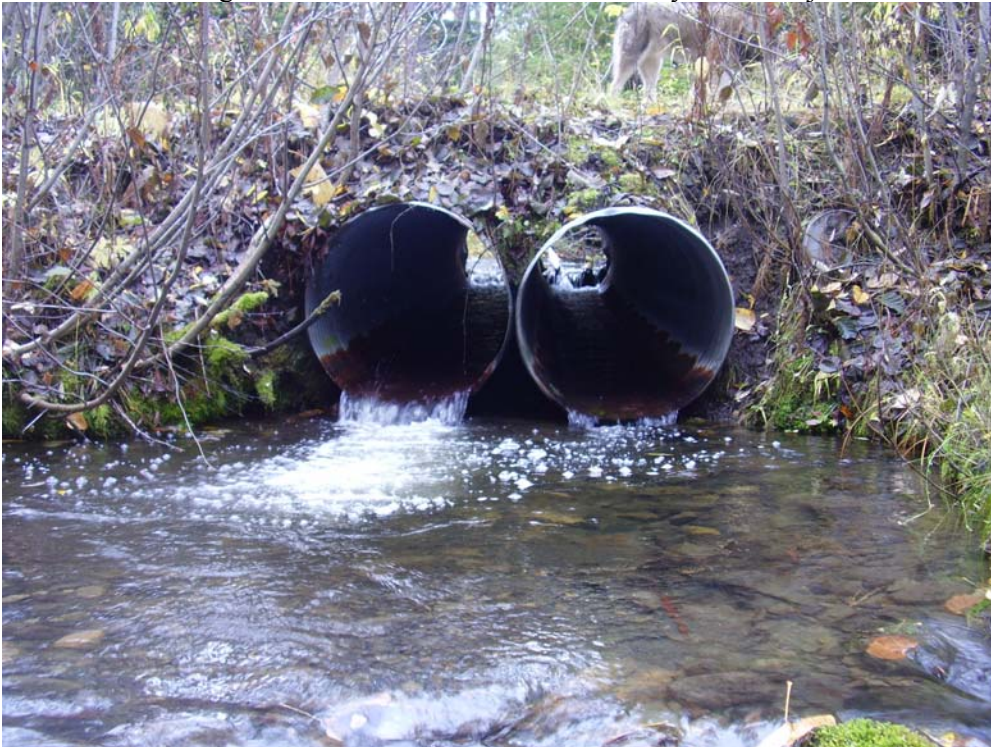
Photo 2: Site 3 looking upstream at culvert outlet – velocity barrier to juvenile salmonids.

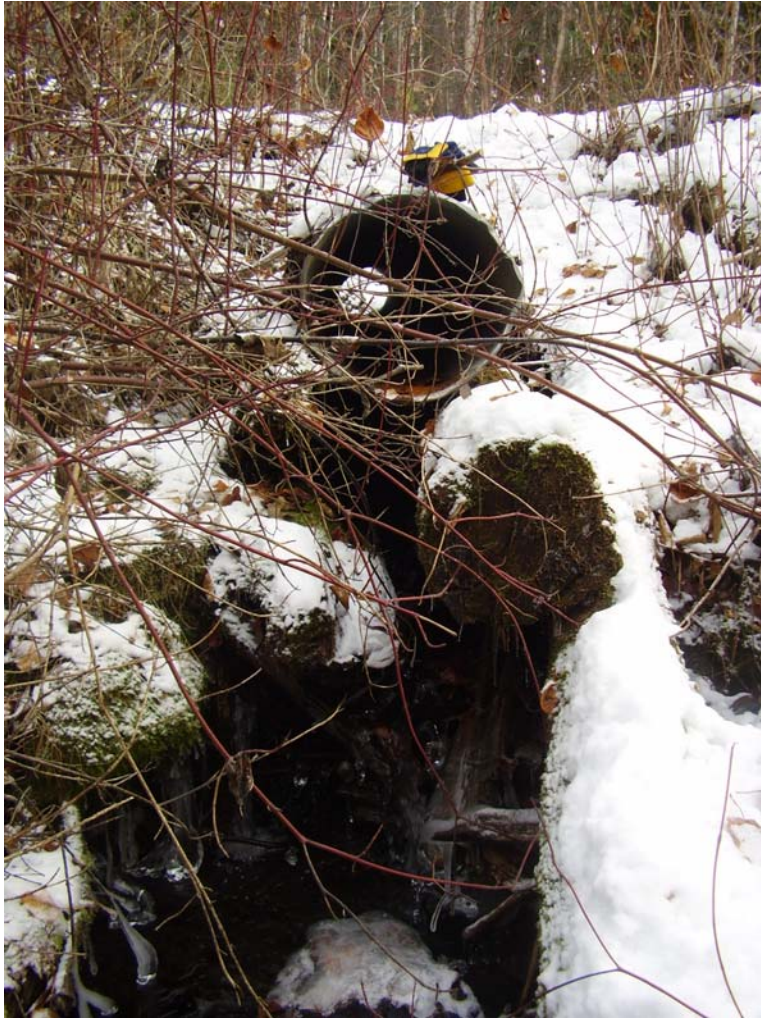
This crossing was considered a full barrier due an absence of water in the culvert (water was flowing under culvert through log corduroy) and a suspended culvert outlet. The culvert slope was considered steep (5 percent), and would likely create excessive water velocity if it actually contained water. The culvert outlet drop was unsuitable for fish passage (71 centimeter drop / 11 centimeter outfall pool). The Q100 culvert diameter was calculated to be 1200 millimeters for a round culvert, which is twice the size of the 600-millimeter diameter culvert currently in place. The fill depth above the culvert was 0.75 meters.

Photo 3: Site 14 looking at dry suspended culvert and water flow through log corduroy below – barrier to all fish.

The 25-Mile FSR is a low-use road that has a culvert crossing deemed as a full barrier to fish (Site 14). Currently, the unnamed stream flows underneath the culvert through the roadbed. Beyond this crossing, flagging tape labeled “X-DITCH” is affixed to trees at regular intervals along the road, however there was no cross ditches in place at the time of the survey. Deactivation of this road was obviously planned but not completed. GFA recommends deactivating this road by removing the culvert at Site 14, and completing the cross ditching already staked out.

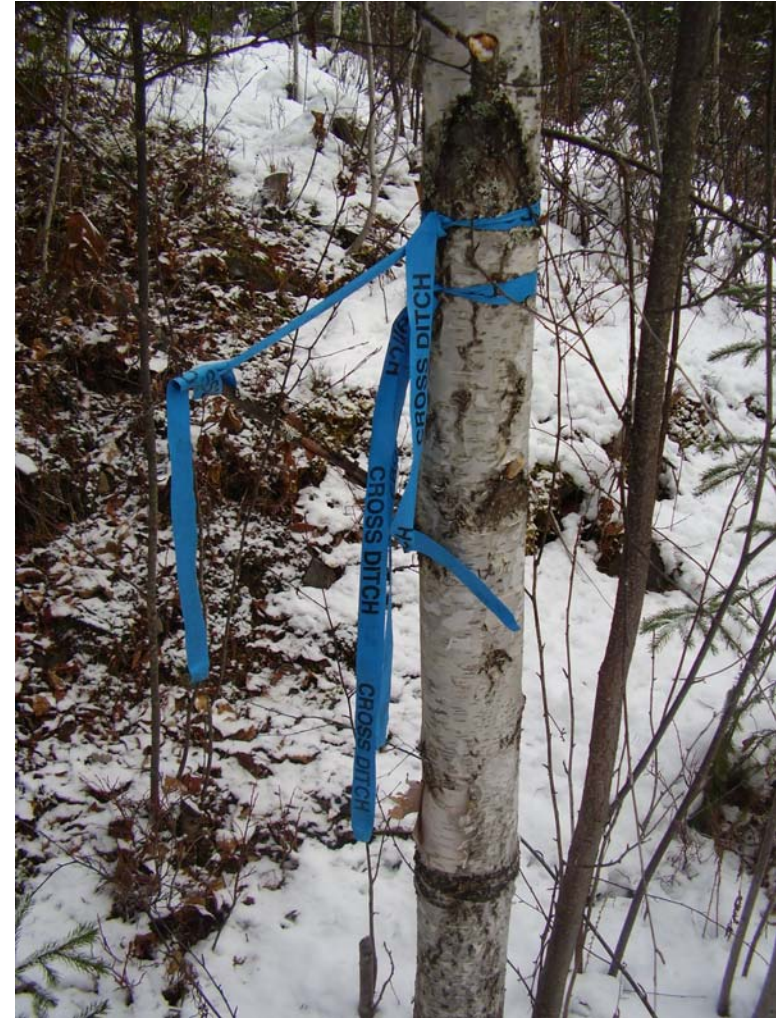
Photo 4: Site 14 looking at cross ditch flagging. Road was scheduled for deactivation but had not been carried out.

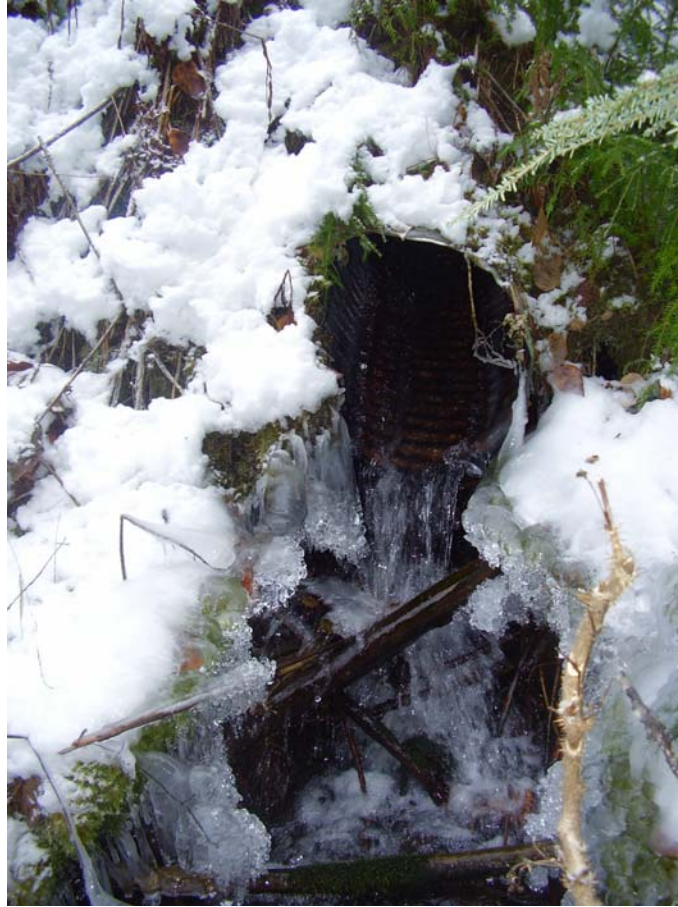
This crossing was considered a full barrier due to the excessive water velocity inside the culvert and an excessive outflow drop. The culvert slope was steep (9 percent), creating a water velocity of 1.16 meters/second over an 8-meter distance, which exceeded the swimming capability of most juvenile salmonids. Also, the culvert outlet drop was unacceptable for fish passage (40 centimeter drop / 14 centimeter outfall pool). The Q100 culvert diameter was calculated to be 1200 millimeters for a round culvert, which is twice the size of the 600-millimeter diameter culvert currently in place. The fill depth above the culvert was 1.5 meters.

Photo 5: Site 15 looking at suspended outlet – barrier to all fish (24-Mile FSR Km 0.4).

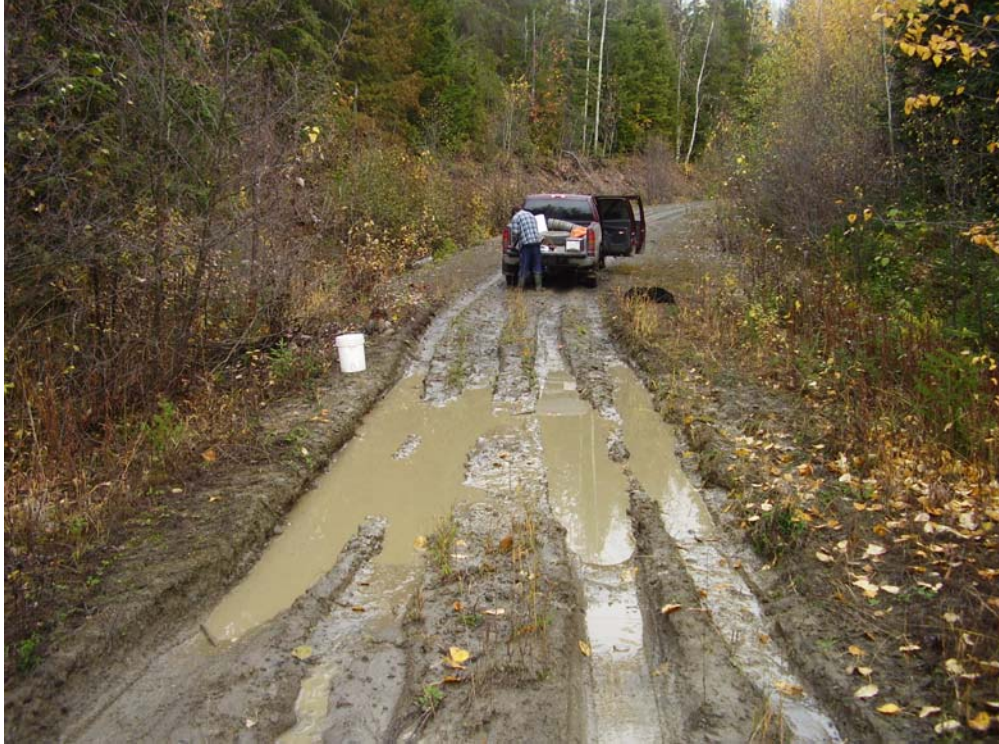
Photo 6: Site 21 looking at left road. SCQI = 6.2 (very high ranking).

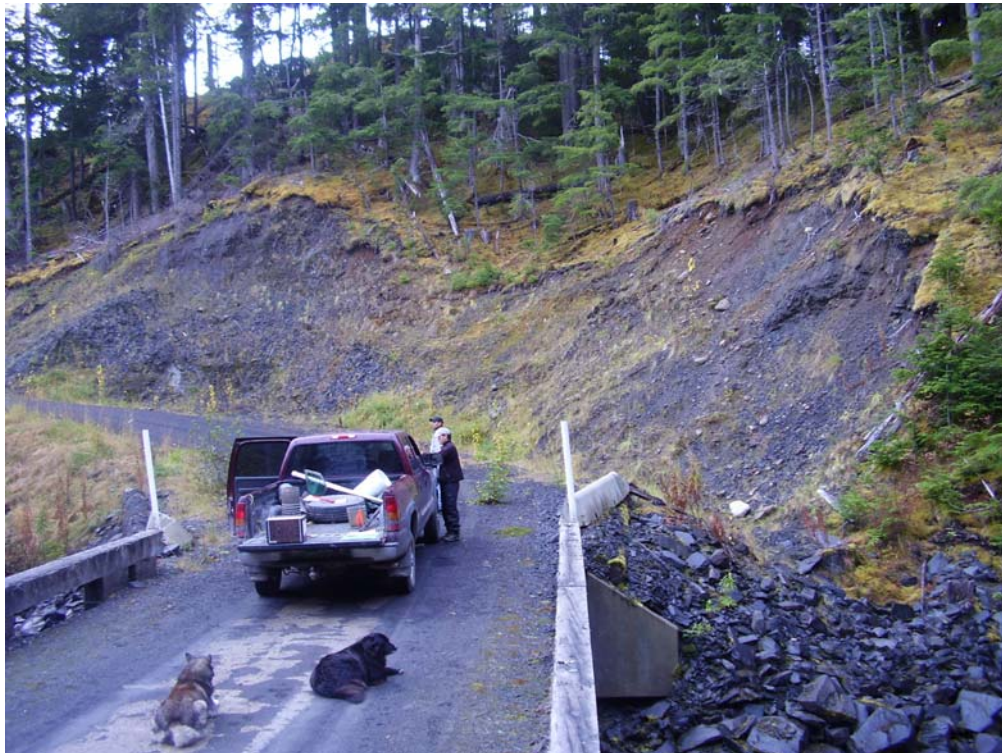
Photo 7: Site 1 looking at large exposed cut bank on right back ditch. SCQI = 1.8 (very high ranking).

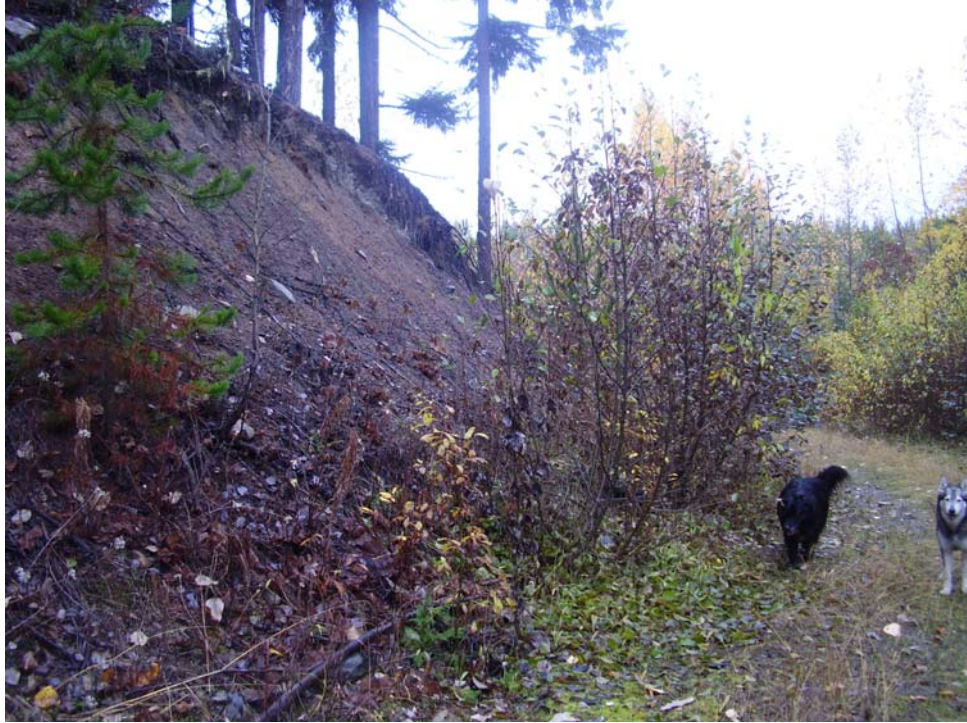
Photo 8: Site 23 looking at exposed cut bank on right back ditch.

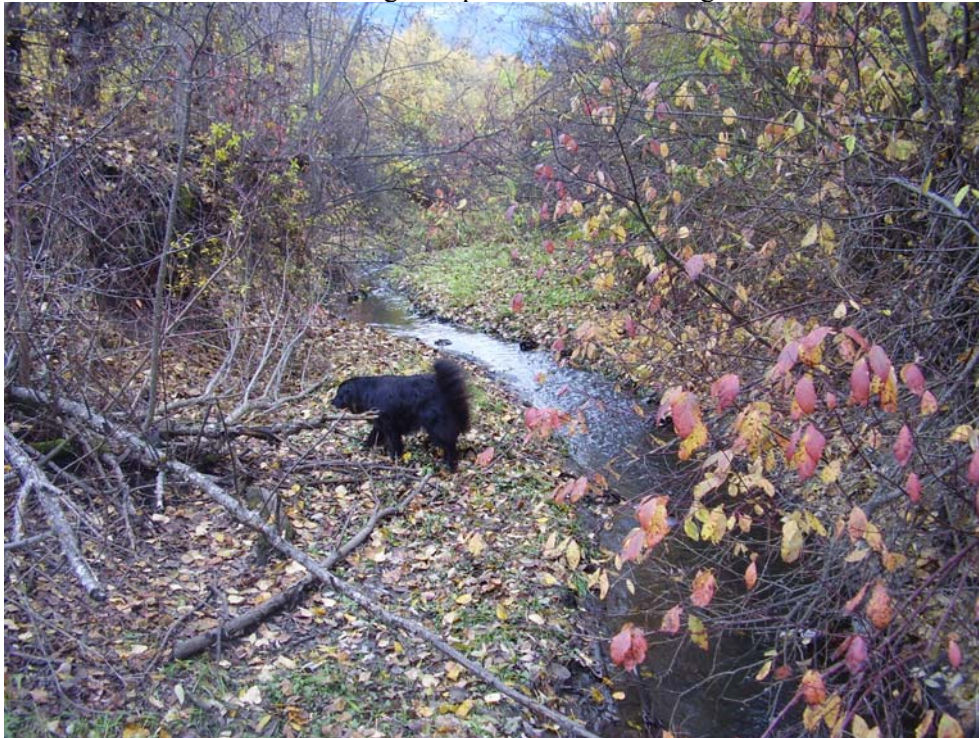
Photo 9: Site 10 looking at stream flowing along right back ditch.

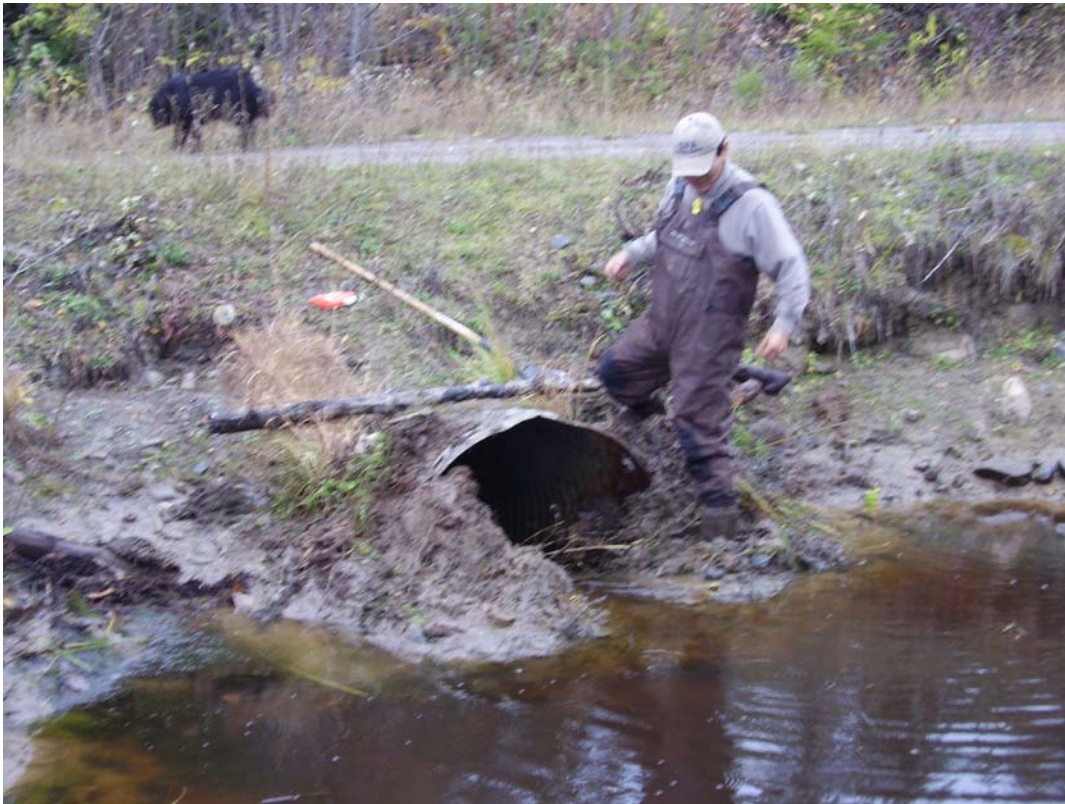
Photo 10: GFA technician cleaning culvert intake that was plugged by beavers at Site 20 (Canoe Creek FSR – Km 2.4).

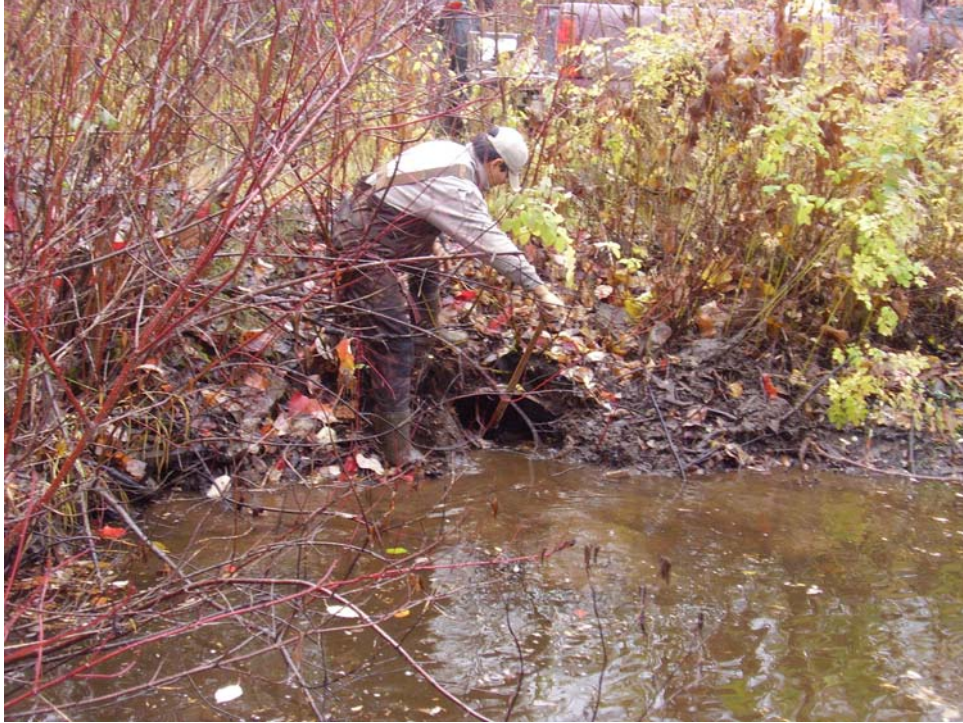
Photo 11: GFA technician clearing culvert intake that was plugged by beavers at Site 22 (Canoe Creek FSR – Km 2.4).

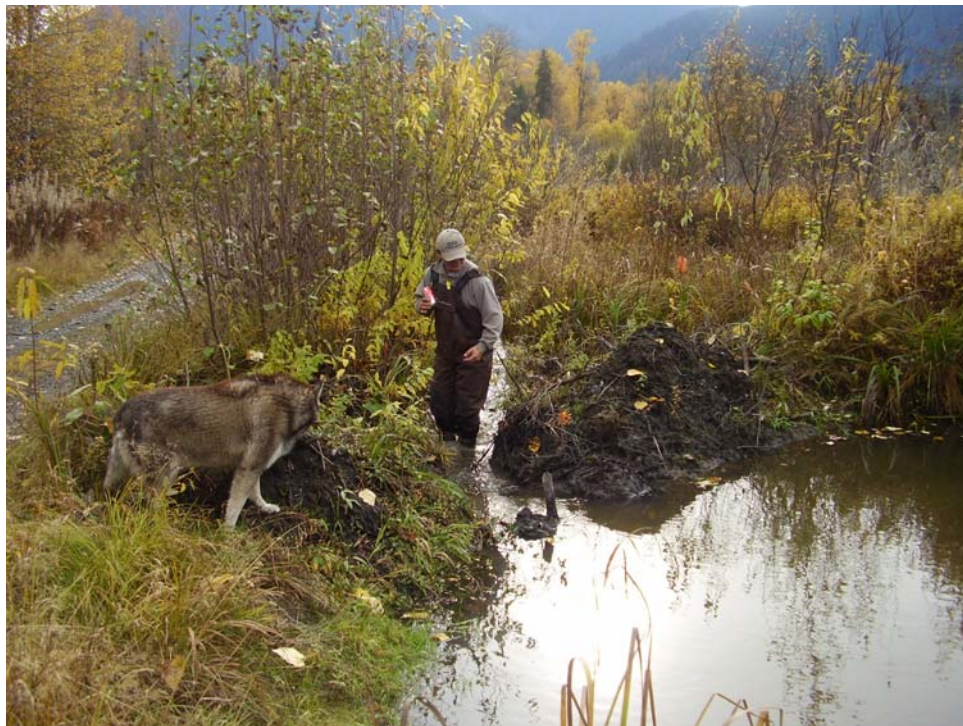
Photo 12: GFA technician clearing back-ditch that was dammed by beavers at Site 9 (Kitwancool FSR – Km 1.8)
