**Suskwa Watershed
Restoration Program
1996
Fisheries and Riparian
Field Assesments and Prescriptions**

**Prepared by M. Jacobs
for Suskwa Restoration Society**

**Suskwa Watershed Restoration Program 1996
Fisheries and Riparian Impacts
Level II**

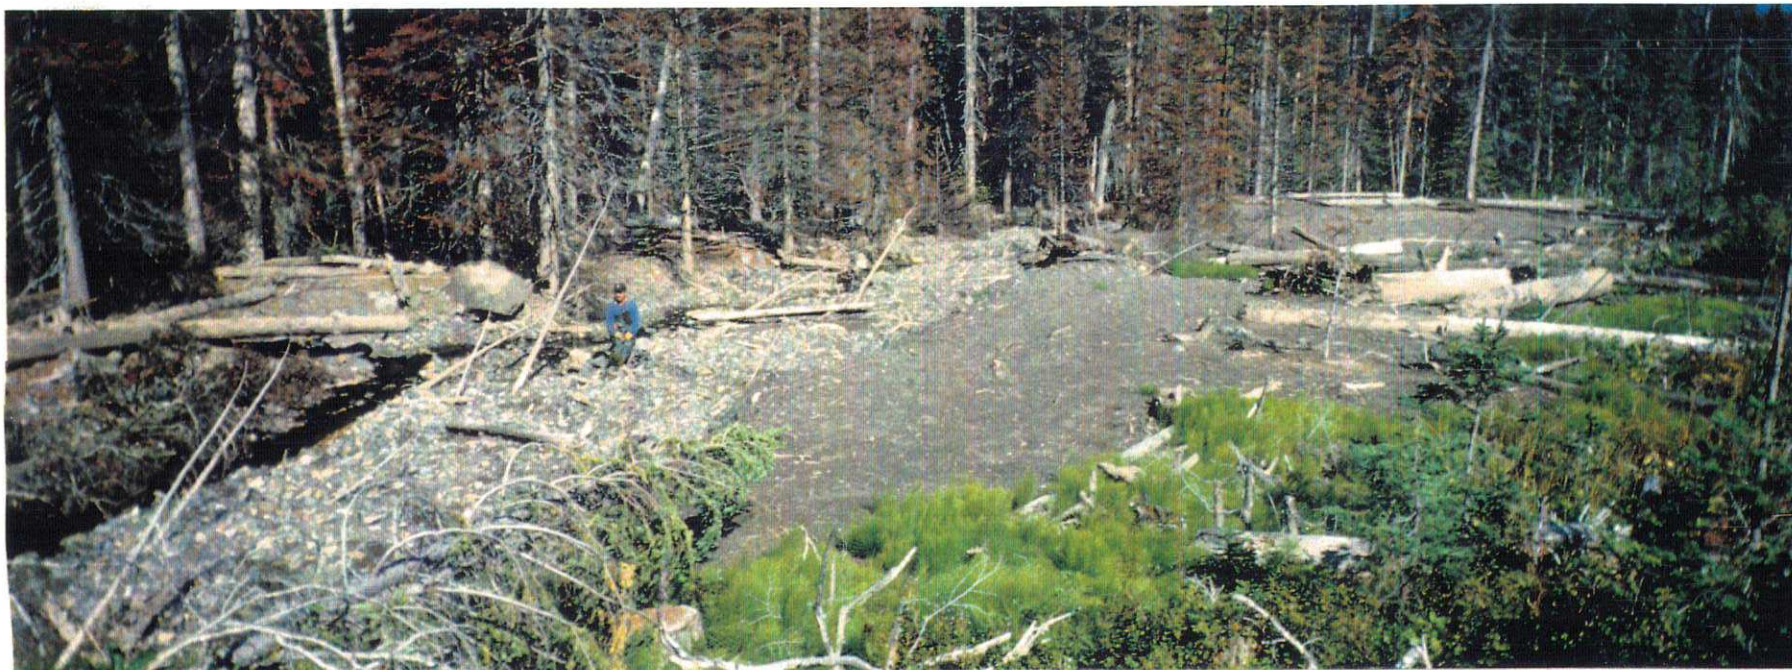
Photo 1 - Debris torrent through block 93m016-029 (northwest corner) from natural diversion of trib. 46-700-50-30-35 on Goat Mountain. Diversion of flows to this area has led to ditchblock failures at crossings along the Kuelsh FSR (downstream).

Prescription: The debris torrented area through Block 93M016-029 requires mixed fill-planting (for channel stability) for 464 meters on the blocks western boundary. Planting of willow, cottonwood and pine is recommended. Planting of the aggraded area should be attempted. Block 93M016-028 will require further assessment in 1997.

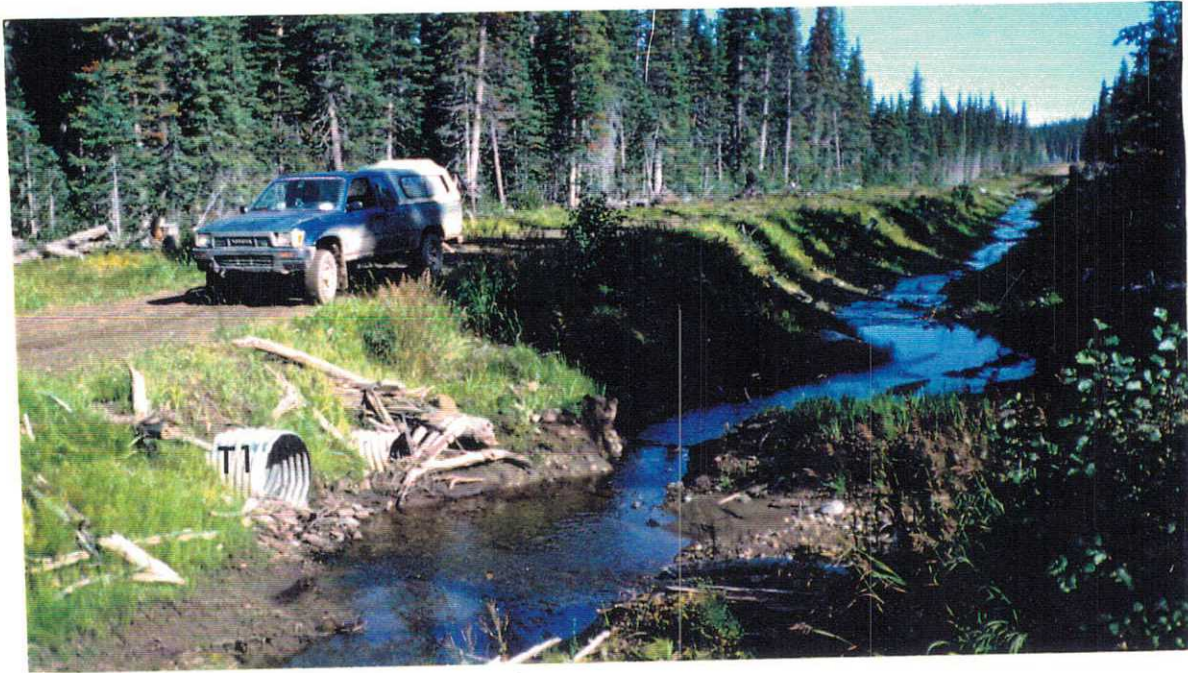
Impact Description: This tributary has been de-watered downstream of the Kuelsh FSR due to a failed ditchblock. This stream now drains through a culvert 136 meters east its original channel (photos 2 and 3) at the spur road branch to Block 93M016-029. These flows spread out over aggraded materials, through the forest with no established channel. T1 also has sustained damage at the entrance to Block 93M016-029. Multiple blockages of the stream channel with logging debris and loss of riparian vegetation has occurred for 100m of stream (photo 4).

Photo 2. (top)
Failed ditch block at trib. 1 to Wan
Lake. Flows continue east to next
culvert. Cutthroat fry (o+) were found
throughout this ditchline.

Prescription: This drainage should be returned to its original channel after a fry-salvage, of the newer aggraded channel, downstream of the Kuelsh road crossing. This will involve the replacement of the existing culvert at 42.6 km. This site should be electro-shocked in August after trout fry have emerged and before fall spawning occurs. All four of the small blockages upstream of this crossing can be removed with hand tools within one day.

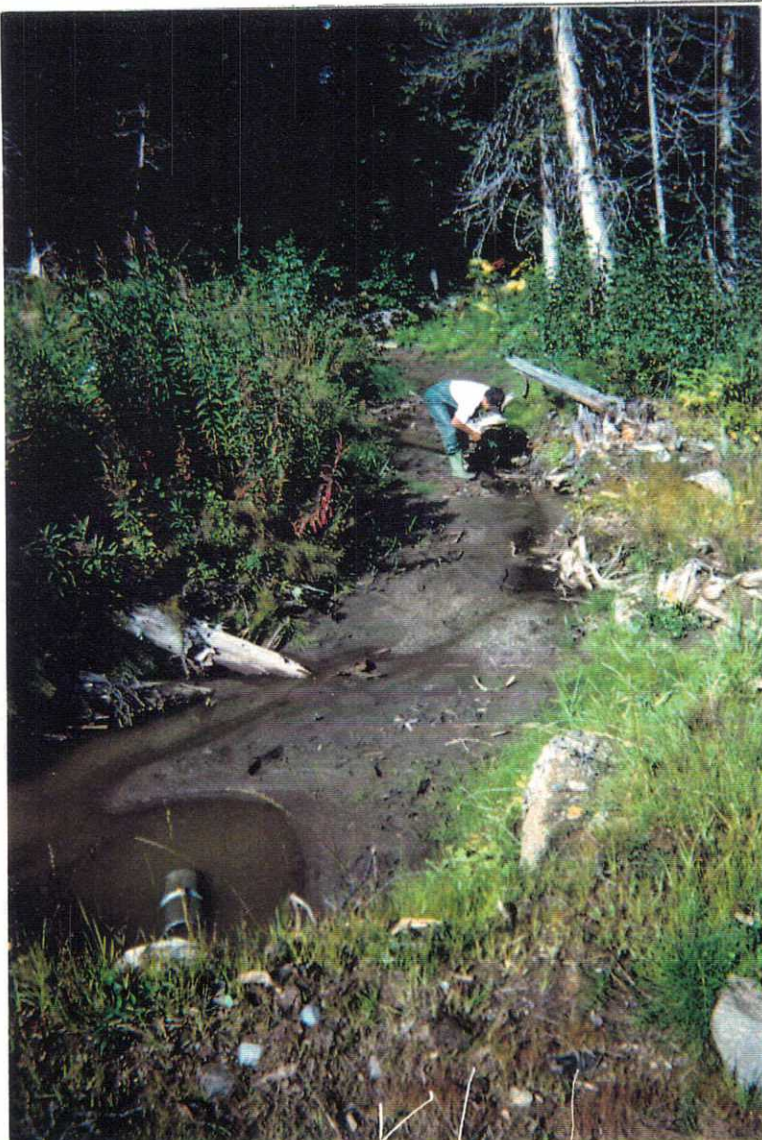
Photo 3. (left) Dewatered channel,
below Kuelsh FSR (43.1 km) of Trib
1 to Wan Lake.
Dolly varden were stranded in the
pools of this picture.
Sept. 10/96

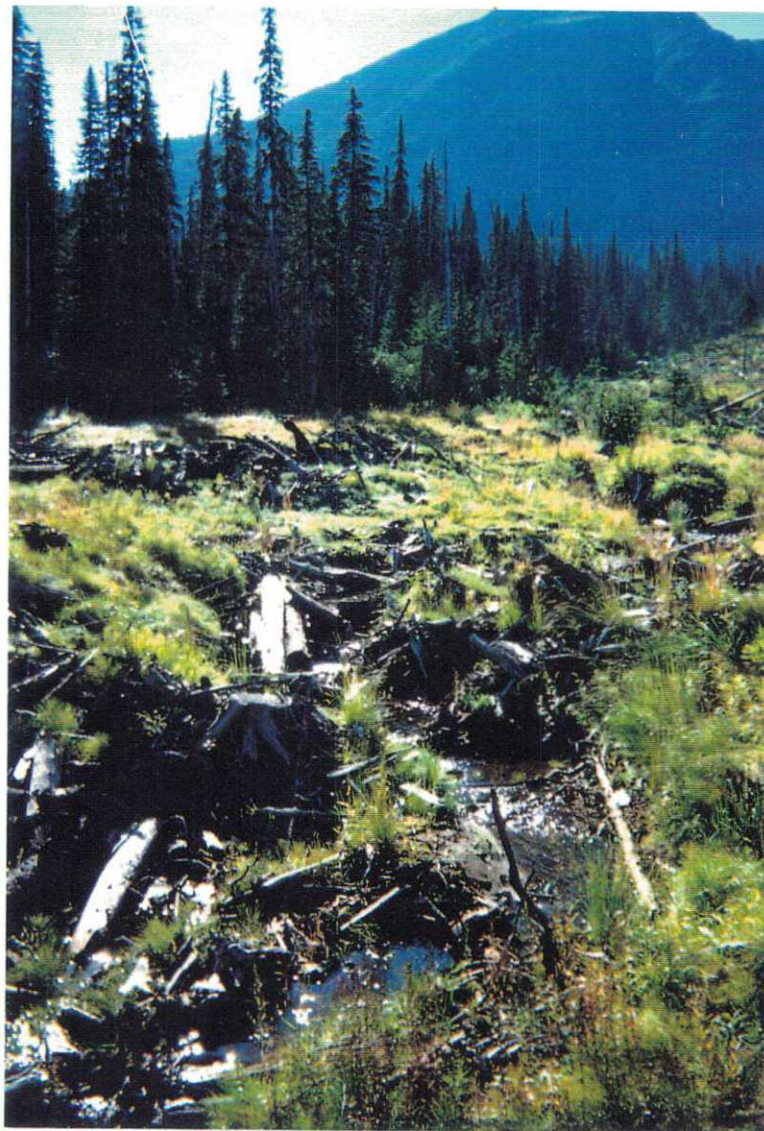
Photo 4. Trib.1 to Wan Lake at entrance to block 93m016-029. Removal of logging debris and streamside vegetation required over 100 meters.

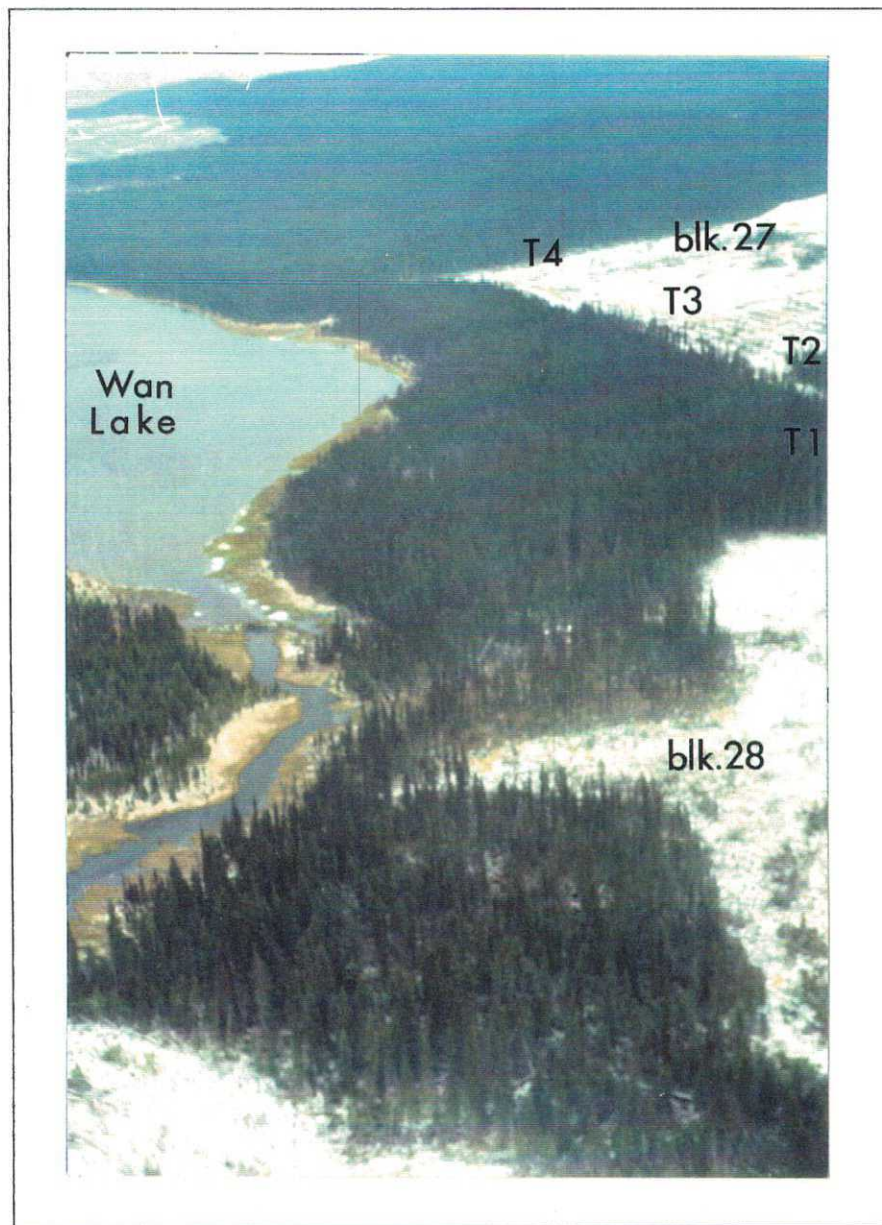
Photo 5. Wan Lake and the tributaries. Additional water from Goat Mountain diversion also traverses block 28 and (0+) cutthroat trout were dip-netted in spur road ditchlines.

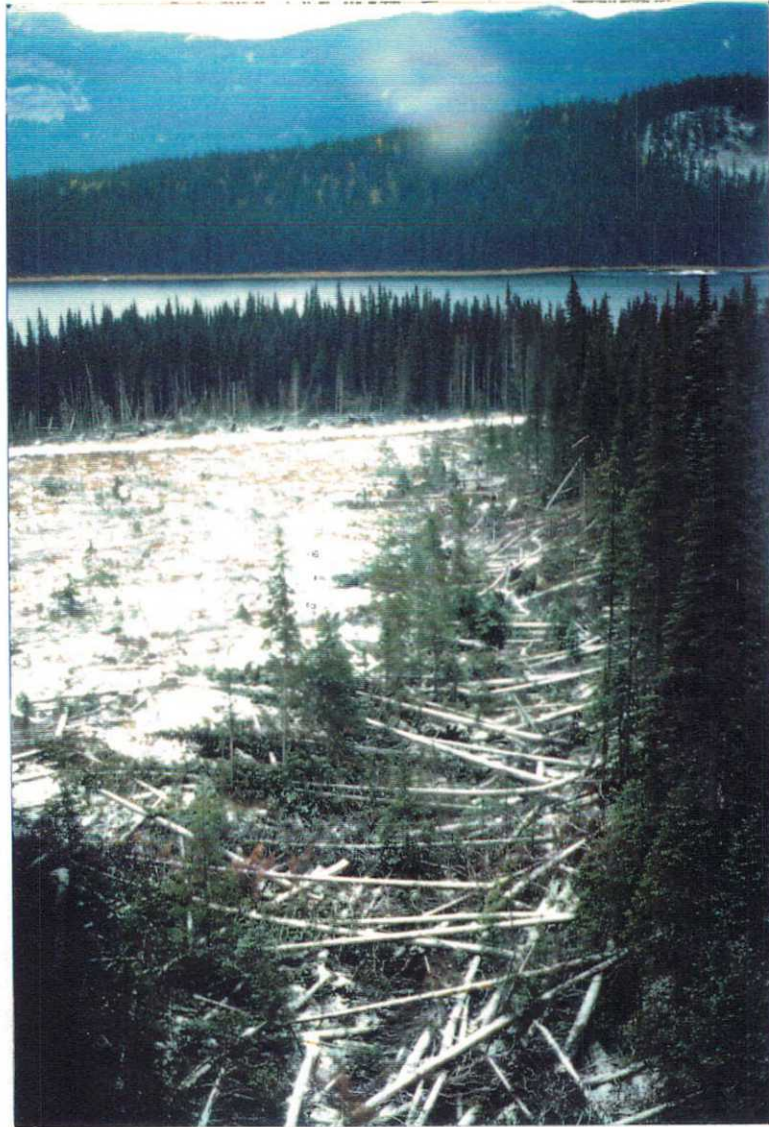
Photo 6. Trib 4. to Wan Lake in Block 93 m016-027 (under fallen logs)
Ongoing forest harvesting, during October 1996, and subsequent removal of timber
(winter 1996/97) will require reassessment of this tributary for fish/forestry impacts in 1997.

Prescription: Re-assessment of this tributary will be required in 1997 to establish prescriptions for revegetation and assess fish and fish habitat impacts. Removal of trees, felled over and into the stream, is scheduled for winter 1996/97. The culvert at the Kuelsh road crossing should be replaced to restore access to this stream. The grading of the southern ditchline would improve access upstream of this road crossing as well.

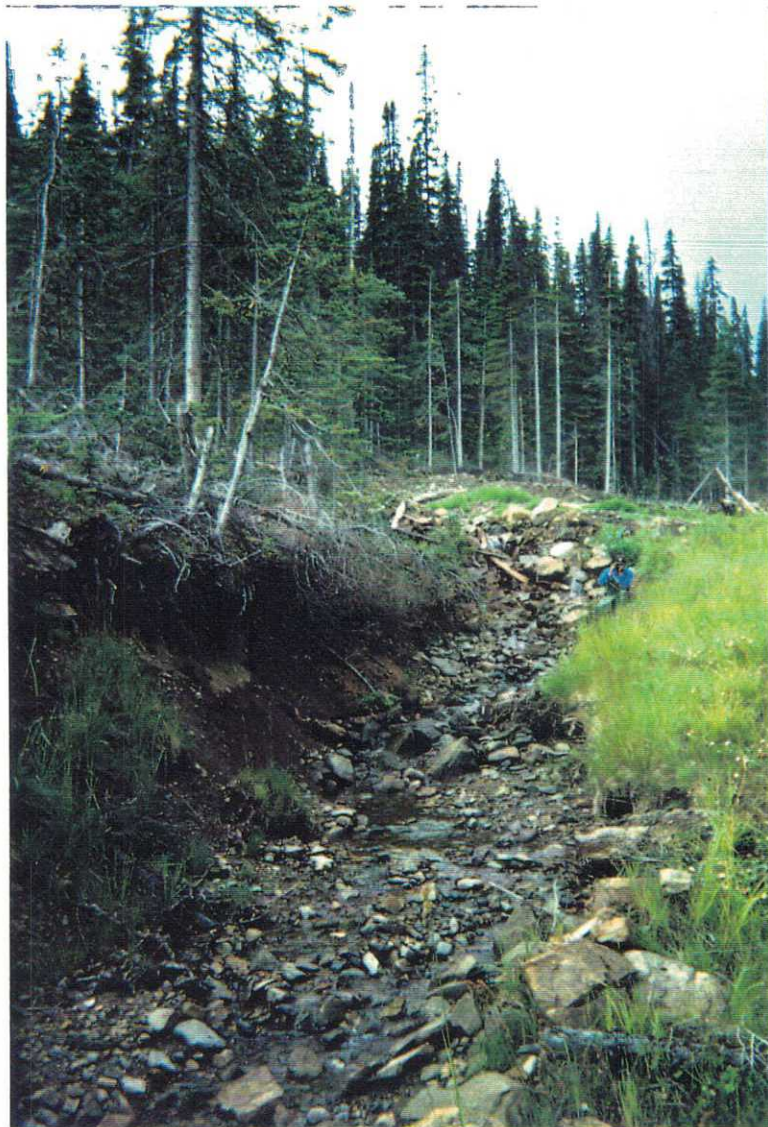
Photo 7. Trib. 46-700-50-30-110 at entrance to block 93m005-004 (24.4 km Blunt FSR)
Road grade materials block access upstream of the spur road (center).
Improper culvert placement dewatered the stream channel downstream of this point.
Cutthroat trout (0+, 1+ and adults) were dip-netted in this isolated 60 meters of stream..

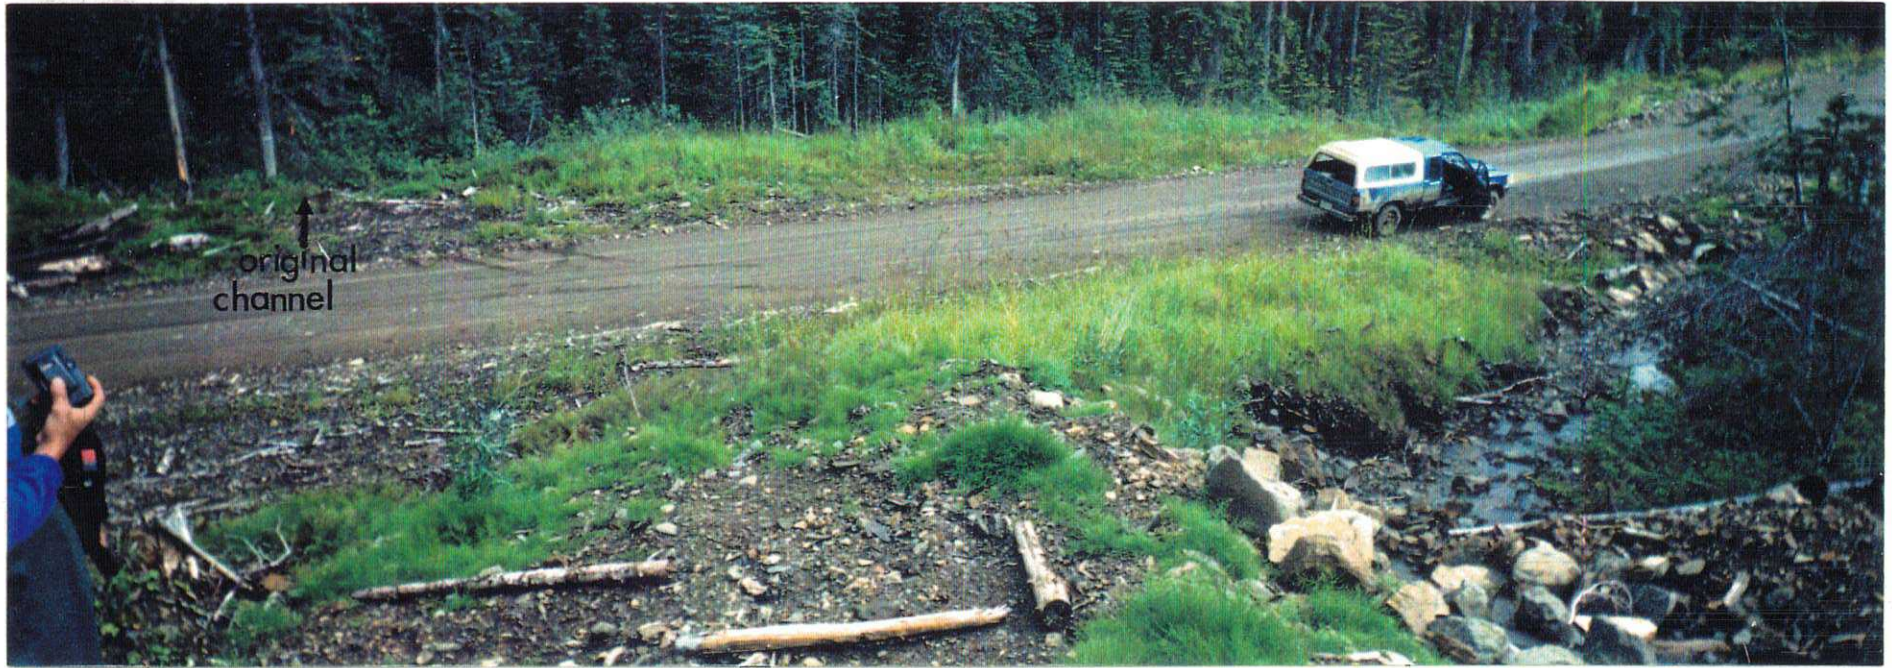
Photo 8. Trib 46-700-50-30-110 from spur road obstruction(lower right) in block 93M005-004 (24.4 km Blunt FSR). This diverted streams original channel splays out over aggraded road materials (upper right). A significant amount of wetland area was dewatered as a result of this diversion. Cutthroat trout (0+, 1+, and adults) were dipnetted in this isolated section of stream. Adult cutthroat were found residing inside the culvert in this photo.

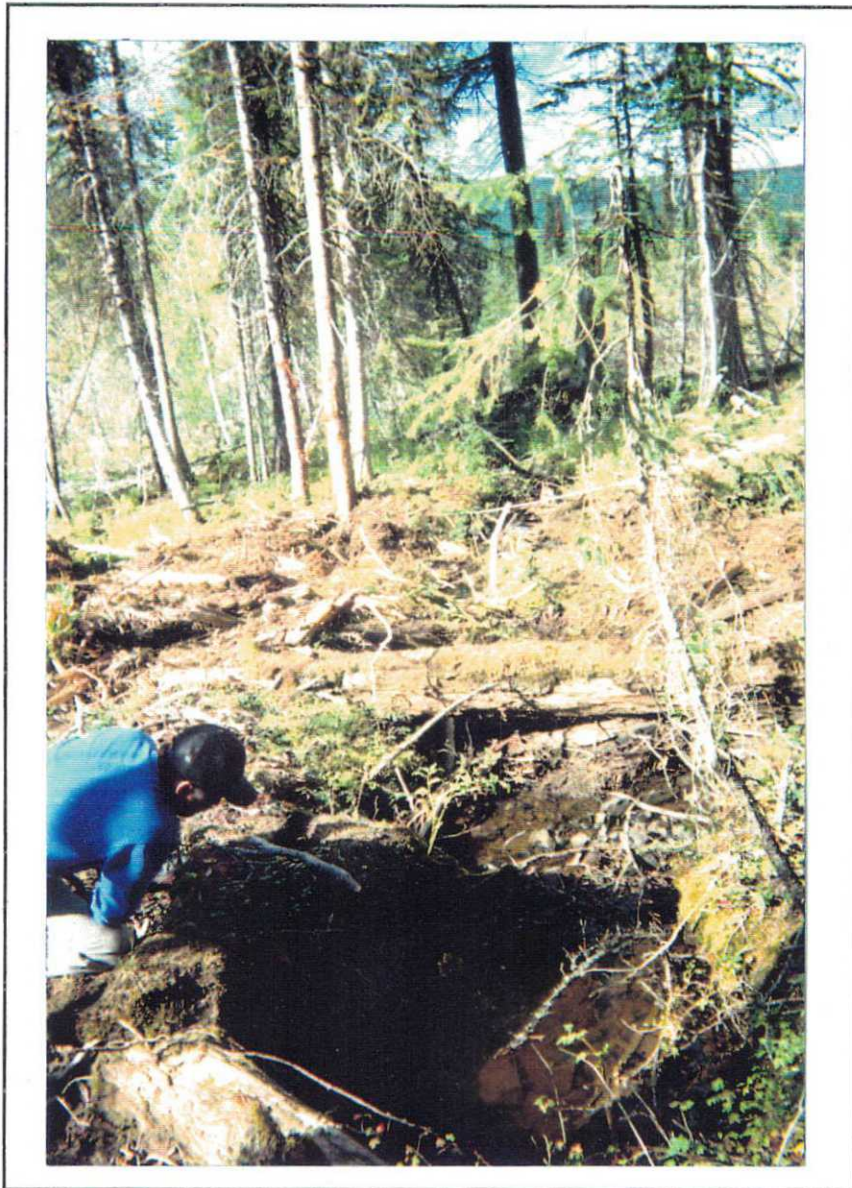
Impact Description: This stream has been logged to and through despite efforts to establish a riparian buffer within Block -020 (photo 9.) Sedimentation from forest harvesting and road development on this stream, was aerially photographed Oct 18, 1995 (see "level 1" Mosaic Blunt #8.) Multiple blockages of logging debris obstruct this stream beginning 161m downstream of the Blunt 2000 Rd. Loss of streamside vegetation and mechanical disturbance has reduced channel stability and exposed this stream for 388 meters.

Photo 9. Trib. 46-700-50-30-55 in block 93M015-020 (30.4 km Blunt FSR). Skid trail through creek (at center) and multiple blockages of logging debris. Logging contractor fell trees inside a flagged riparian management zone. Coho juveniles (0+ and 1+) were gee-trapped downstream at beaver pond complex.

Prescription: Removal of small blockages beginning 161m below Blunt 2000 Rd. crossing. This may be accomplished with hand tools and a small crew in one day. Streamside mixed fill-planting is recommended for 388 meters through Block -020 for channel stability and to fulfil riparian functions.

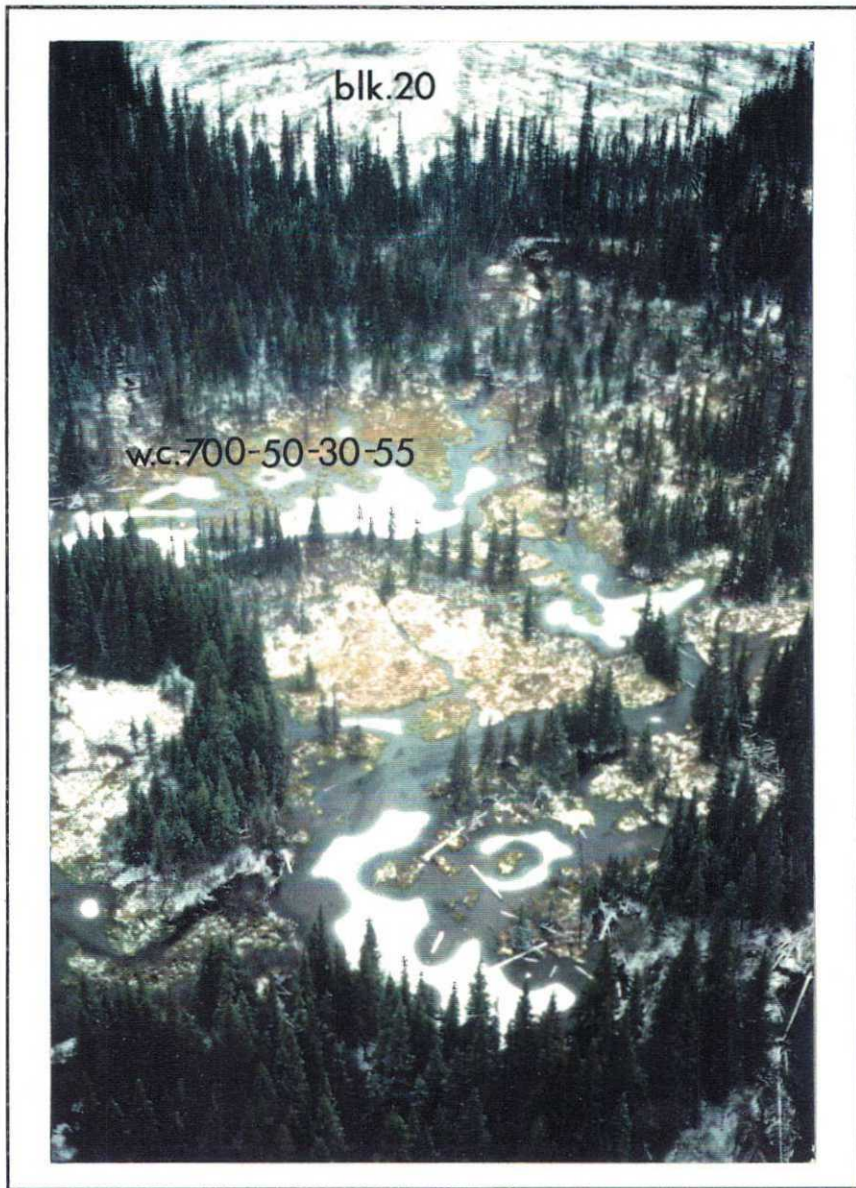
Photo 10. Trib. 46-700-50-30-55 beaver pond complex and block 93M015-020. Coho juveniles(0+ and 1+) were found rearing here. These ponds join Blunt Creek at the upper end of Reach 5. Sedimentation of these ponds, through blk.20 development was aerially photographed for the "level 1" report in mosaic - Blunt #8 Oct., 1995.

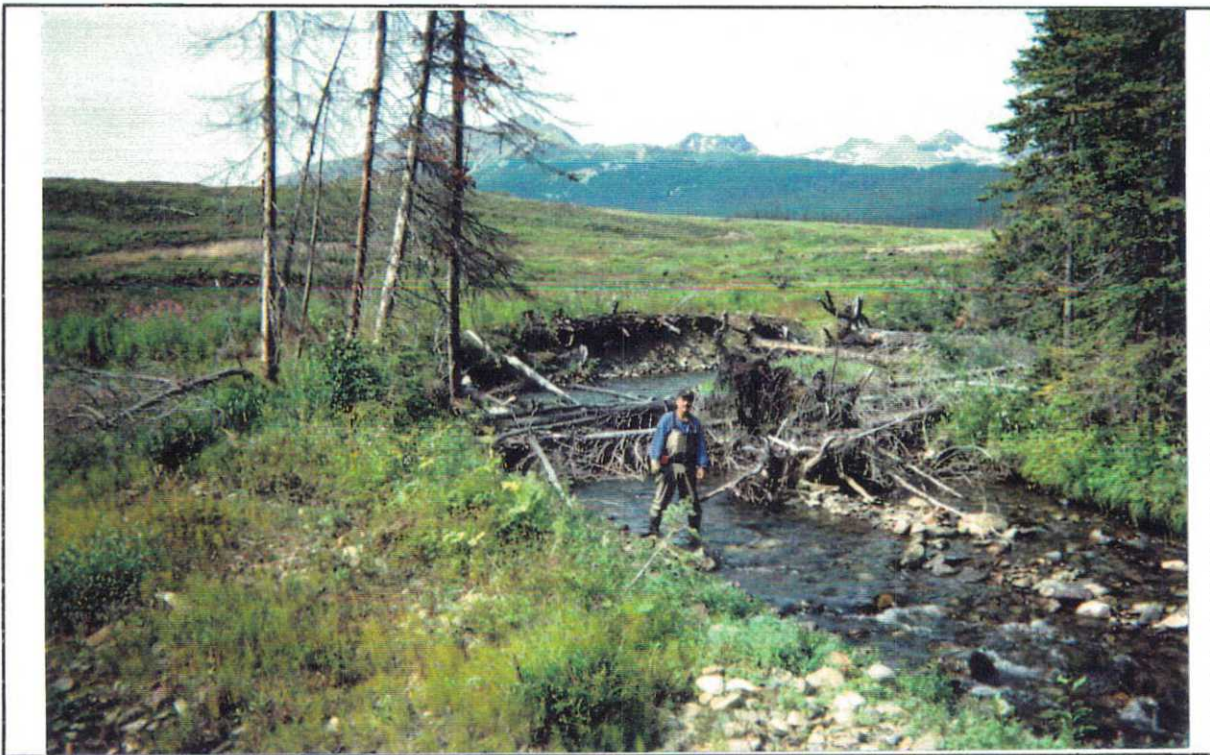
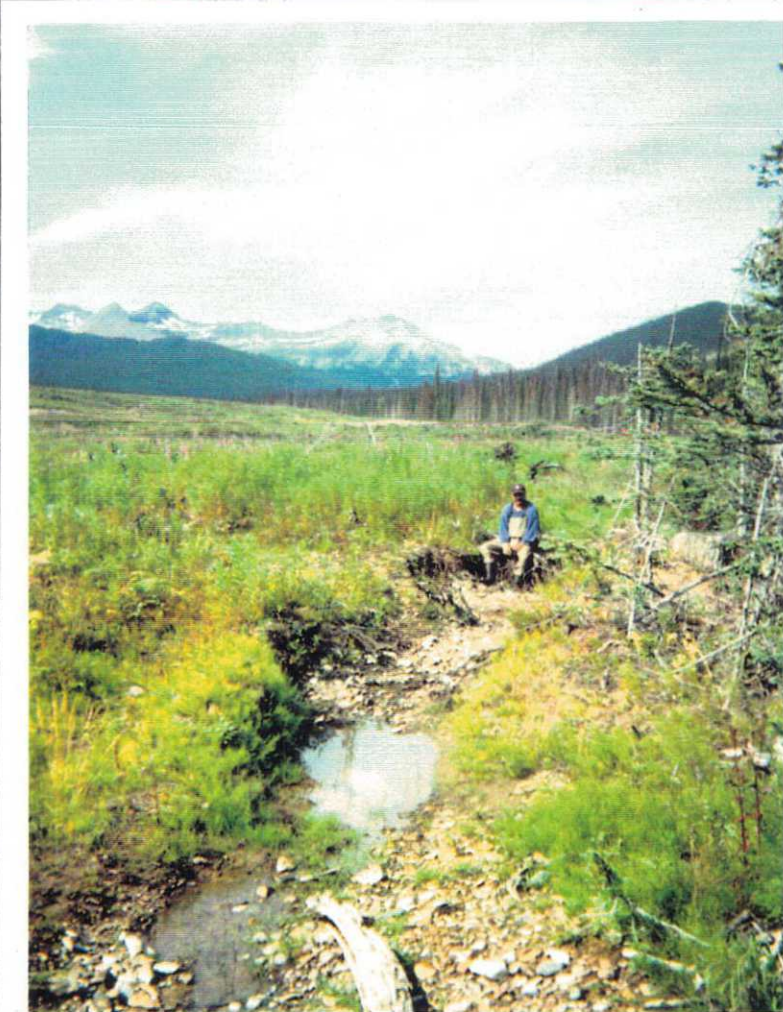
Impact Description: Two channel diversions have occurred as a result of improper bridge placement, and a debris jam of harvested material located 357 meters downstream of the road crossing. The bridge site has channelled flows into Block -002, and an estimated 350 cubic meters of till has been deposited downstream. A debris jam and subsequent sediment wedge seasonally forces flows onto the blocks fireguard (photo 12) 357 meters downstream of the 2500 road bridge. Another potential diversion exists at a similar debris jam 259 meters downstream of the FSR. Loss of streamside vegetation for 1600 meters, along Block -002, continues to enhance erosion of organic and inorganic materials along the streams western banks. The infilling of pools is apparent on this aggraded channel, especially downstream of the FSR crossing.

Photos 11 and 12
Trib. 700-50-30-115-010(top) and
block 93M015-002. Actively
eroding logged flood plain needs
streamside vegetation. Debris jams
seasonal flows onto fire guard (left)
in block 93M015-002 357 meters
below the road crossing (21km Blunt
2500 FSR). Channel avulsion at
crossing needs stability. Numerous
Dollyvarden were gee-trapped above
and below the road crossing.

Prescription: The disassembly of two debris jams located 259m and 357m downstream of the Blunt 2500 road bridge will help retain flows in their original channel. This could be accomplished with hand tools and a small crew in several days. Streamside mixed fill-planting of willow, spruce, and pine is recommended for 1600 meters of stream bank along Block -002. This is important if channel stability and riparian components are to be restored at this heavily impacted site.

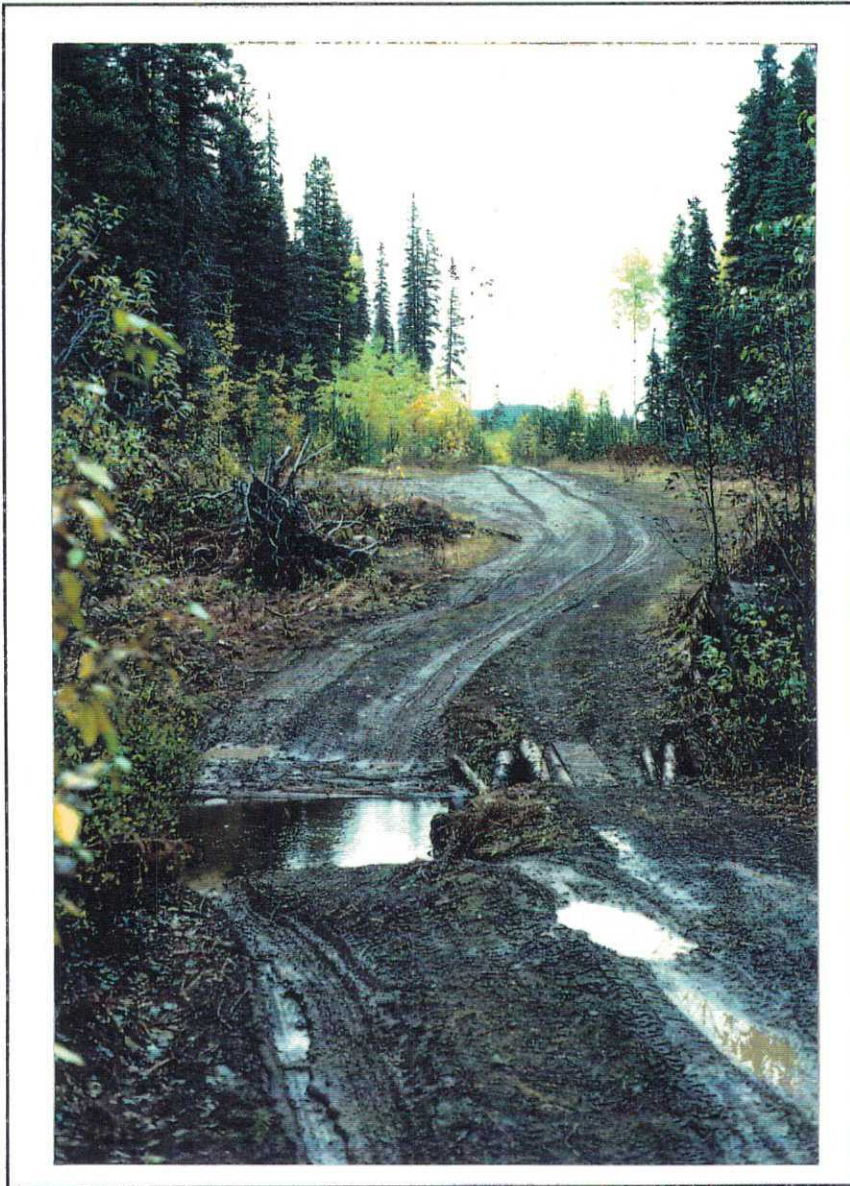
Photo 13. Unnamed tributary to Camp Lake at entrance to block 93M205 x 2. Unarmoured ford contributes sediment to Camp Lake and stream. Cutthroat trout spawned at this crossing in 1990 when access was limited to pedestrian traffic (footbridge) only.

Fish/Habitat Assessment: This stream, unmentioned in the "level 1" report, represents the bulk of flows into Camp Lake and is utilized by cutthroat trout for spawning and rearing. Cutthroat were observed spawning, at this road crossing (photo 13) in 1990, prior to the fording of this stream. The ford recently replaced a small foot bridge that limited vehicle access to this area. Detailed habitat information on this tributary was not acquired during the 1996 field season.

Prescription: An effort should be made to exclude vehicle traffic from this stream as the existing ford lies on top of a known spawning site for cutthroat trout. A wooden box culvert or permanent vehicle barrier (ie: boulders) should be placed at this crossing. Further assessment of this stream should be conducted through Block 93M026-003 in 1997 to determine possible logging related impacts upstream of Camp Lake and this crossing.

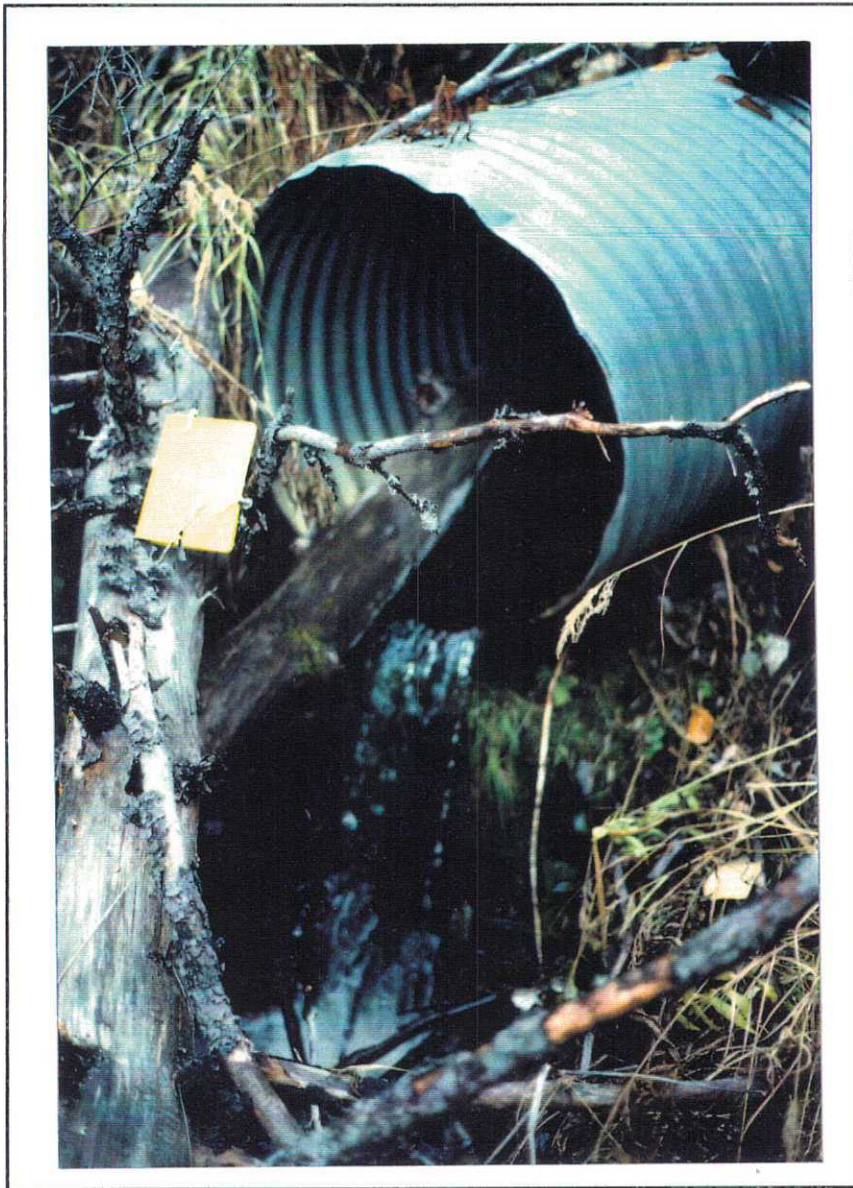
Impact Description: Two metal culverts (on spur D in Block -005 and in Block -006) present obstruction to fish migration. The lower crossing (photo 14) plunges 1 meter, at its outlet, to a marginal jump pool. The upper crossing (Block -006) is plugged with debris and has a .75 meter drop onto rocks. A failed corduroy crossing also exists 70m upstream of the upper crossing in Block 93M026-006.

Photo 14. Trib. 46-700-50-14-15 lower spur road crossing (obstruction). One adult cutthroat trout was gee-trapped upstream of this site. This spur road is scheduled for de-activation and the culvert is to be removed.

Prescription: The upper and lower spur road culverts should be removed in Blocks -005 and -006. Stream blockages, including the corduroy crossing in Block -006, are easily accessed via existing roads. Subsequent mixed fill-planting of these sites and exposed portions of this stream for 3362 meters is recommended for future LWD, channel stability and associated riparian functions.

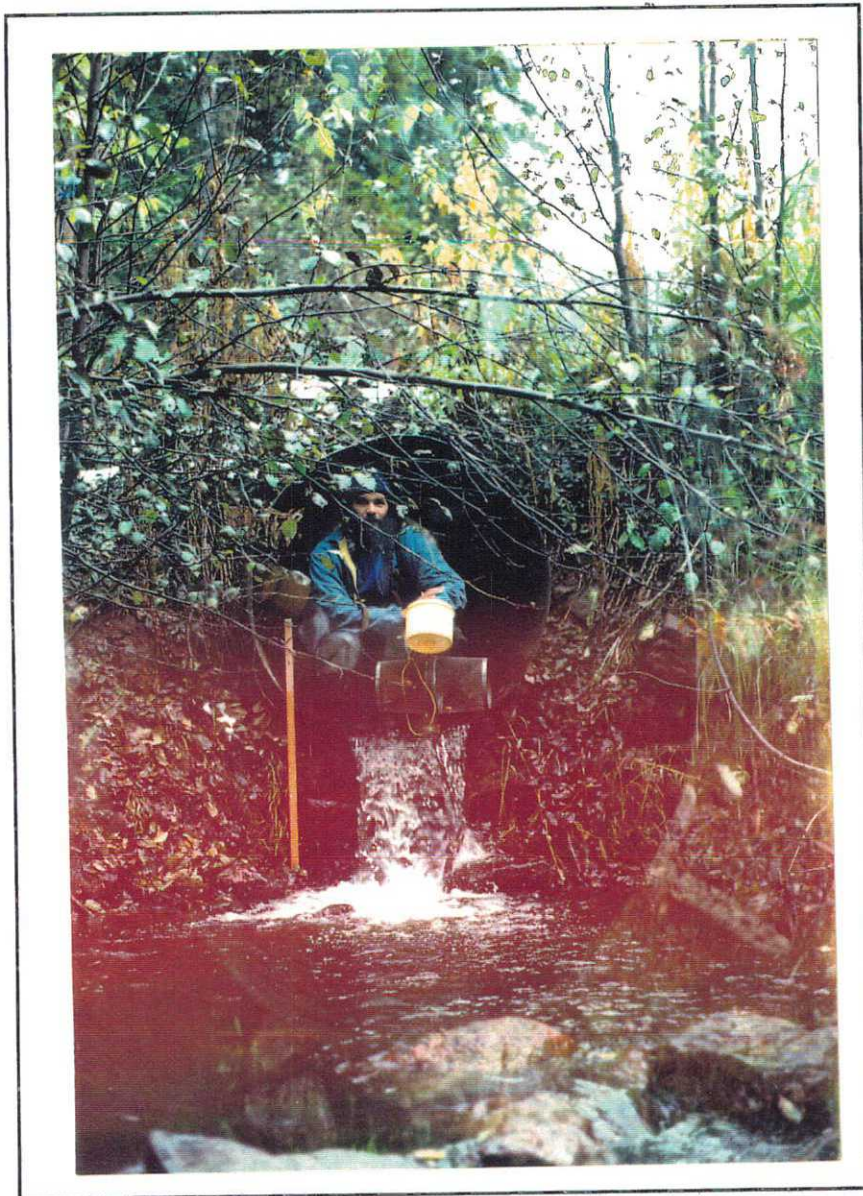
Impact Description: This 900mm metal pipe culvert (photo 15), at 49.3 km Upper Fulton FSR, obstructs fish passage upstream. No fish were found above this crossing, when gee-trapped, in 1995.

Photo 15. Trib 700-050-20-60 (49.3 km) Upper Fulton FSR. Culvert obstructs fish passage. Gravid dolly varden were gee-trapped up to this crossing, but not above. Fall/1995.

Prescription: Replacement of existing culvert to ensure access for resident fish. This should be done in August, only after trout fry have emerged and before char commence spawning.

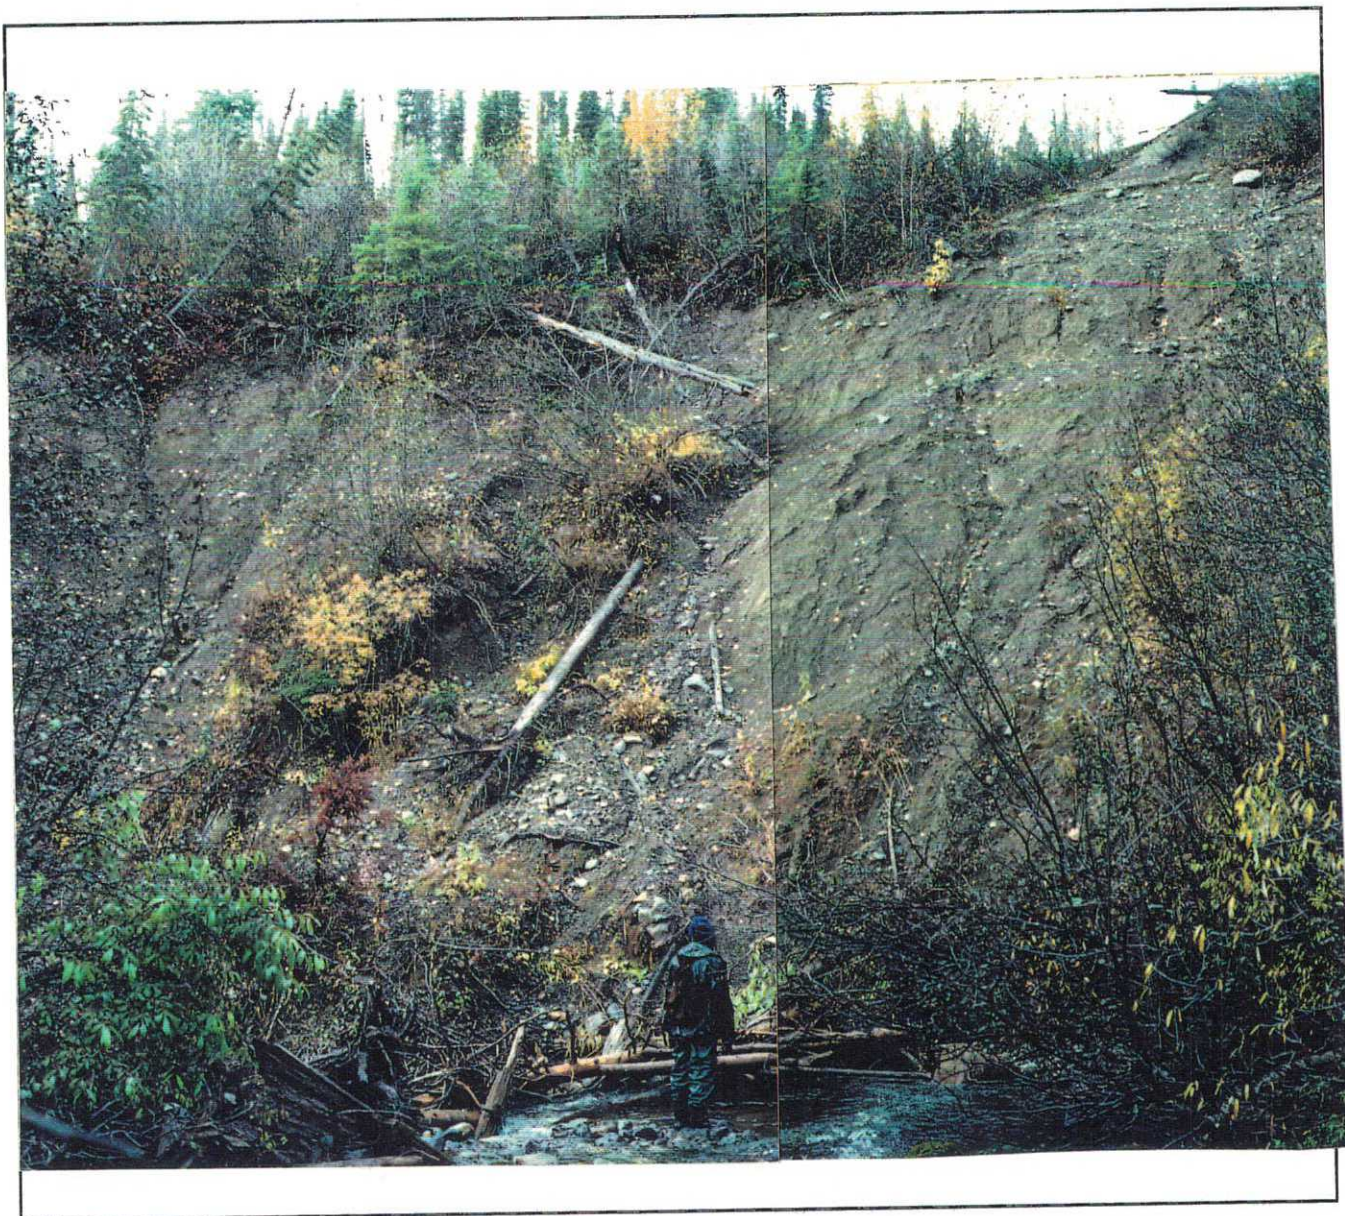
Impact Description: The ford at the Upper Fulton FSR crossing is contributing fine sediment to the stream channel, especially during fall hunting season when vehicle traffic is heavy in this area. Portions of this stream have been brushed of initial shrub cover and lack stabilizing vegetation. Subsequent downstream movement of bedload has resulted from bank erosion and there has been a loss of riparian components through a total of 998 meters of cutblock. A valley wall failure off of Block 93M026-031 at the Maish/Paask confluence (photo 16) is enhanced by the lack of stabilizing vegetation along the terrace edge.

Photo 16. Failure to Maish Creek at Passk Creek confluence from block 93M026-31. Planting of terrace edge is recommended for 50 meters.

Prescription: Road crossing required. An abandoned metal bridge deck located 20 meters SW of the crossing may suffice if structurally sound. Streamside mixed fill-planting for channel stability and riparian functions is recommended from the FSR

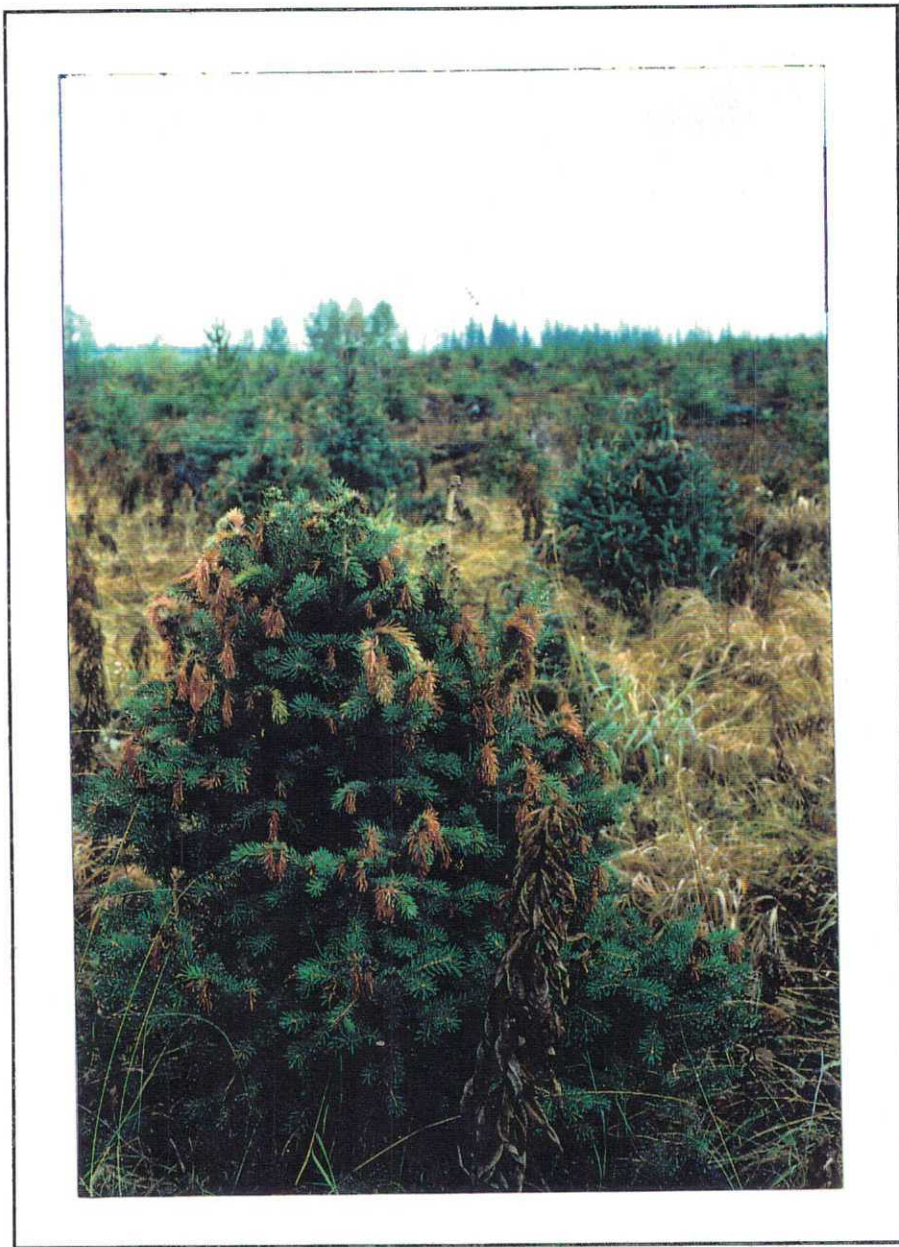
Photo 17. Stunted spruce trees common along reach 6 of Harold Price Creek in block 93M016-016. Planting of lodgepole pine for future LWD is recommended.

Prescription: Mixed fill-planting for 6 km along the SW bank and 1.5 km along the NW bank. Pine is recommended over spruce with willow and cottonwood. LWD placement is possible here if logs are angled downstream. However, access to each 6 is limited within Block -016.

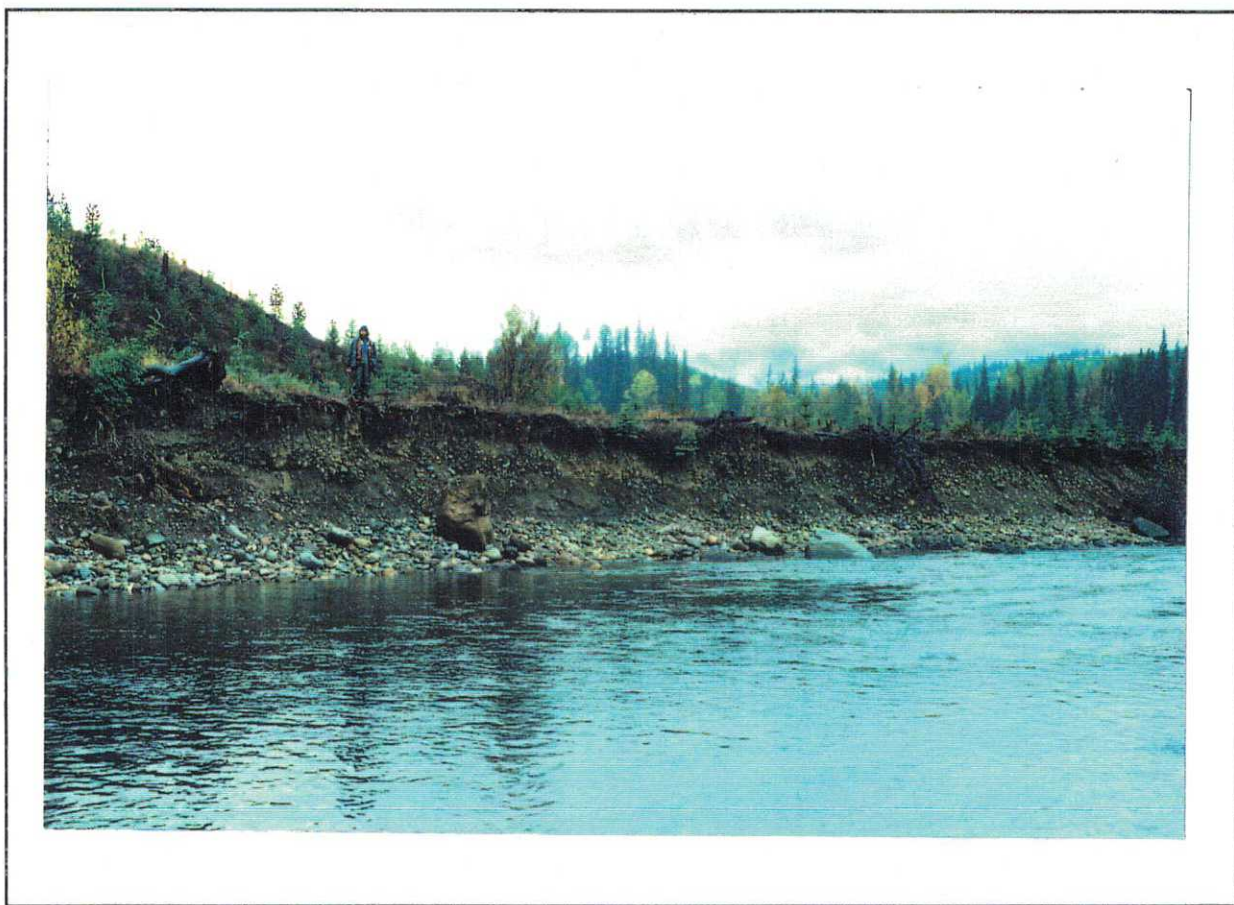
Photo 18. Reach 6a of the Harold Price Creek and block 93M016-016. This area sprayed with "Vision" in 1990, lacks streamside vegetation crucial to bank stability and riparian attributes.

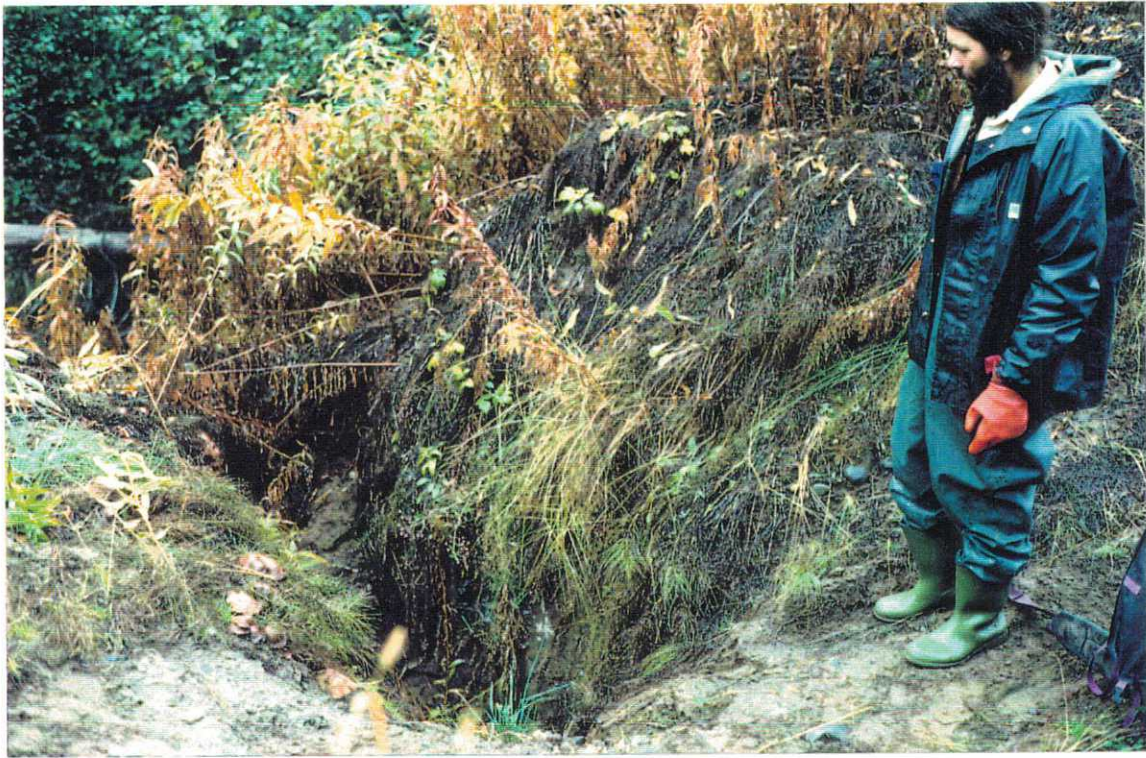
Photo 19. Trib. 46-700-50-40 (H.P. east main FSR). This wooden box culvert and road grade materials have collapsed into the stream. Cutthroat fry (0+) were dipnetted up to this crossing. This road is scheduled for de-activation in 1997.

Prescription: Removal of this failed culvert is necessary to restore access upstream. Road access to this culvert must be made from the Upper Fulton FSR at the 38.1 km branch. The Harold Price East Main has been de-activated and an excavator will have to be "walked" to sites north of Luhk Creek. This includes excavation at tribs W.C. 46-700-50-40 and an adequate forested stream buffer along this trib requires no streamside planting. This crossing is scheduled for semi-permanent de-activation within the Roads, Hillslope and Gullies "Level 2" report. (SRS 1996)
