**Suskwa Watershed
Restoration Program
1996
Fisheries and Riparian
Field Assesments and Prescriptions**

**Prepared by M. Jacobs
for Suskwa Restoration Society**

**Suskwa Watershed Restoration Program 1996
Fisheries and Riparian Impacts
Level II**

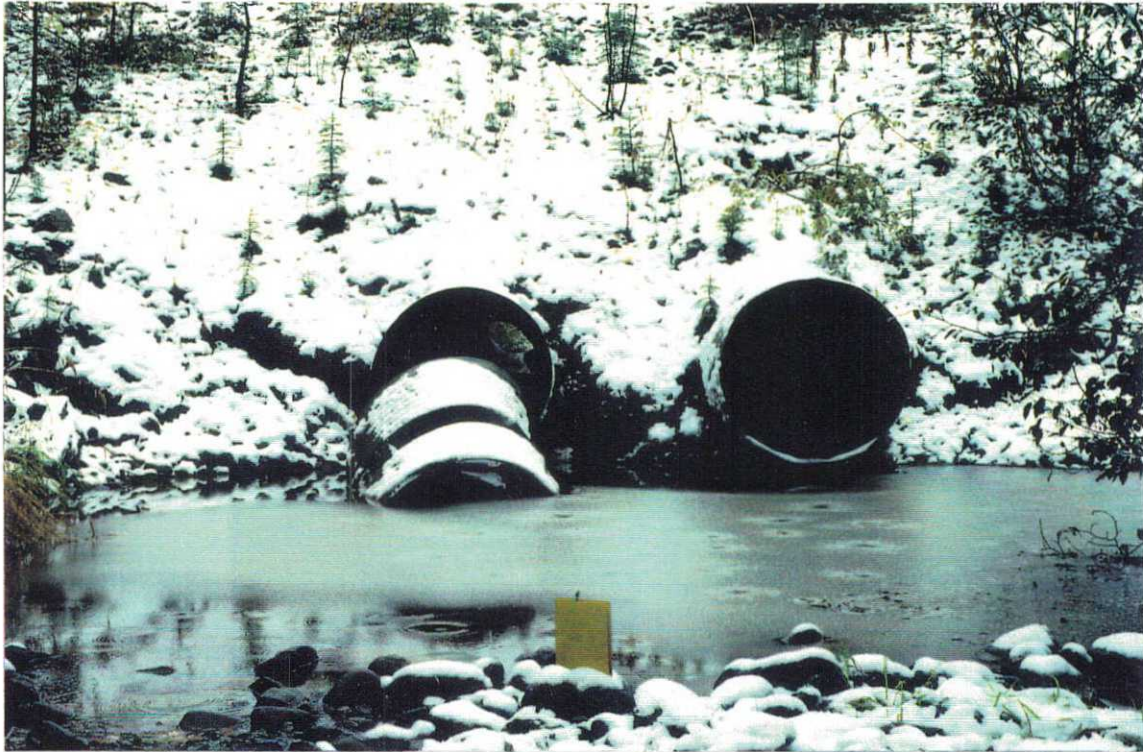
Photo 20. Howal Creek crossing at 32.2 km Upper Fulton FSR. Unravalled culvert needs trimming. Cutthroat trout were gee-trapped above and below this crossing. Riparian vegetation is needed upstream and downstream of crossing in blocks 93M016-034 and -035.

Prescription: The unravelling culvert (32.2 km Upper Fulton FSR) should be trimmed with a welding torch to prevent further degradation of this passable culvert. The debris jam, 96 meters below this crossing, may be removed with hand tools and a small crew. Channel diversions to the fireguard, are limited within the existing floodplain. Some difficulty would be had trying to reinstate flows back to the original channel without heavy equipment, and subsequent site damage. Therefore, it is recommended that this area be stabilized by planting, and the new channels left as they are. A total of 1033m of mixed fill-planting (in Blocks 93M016-034 and -035) is recommended using willow, cottonwood, spruce and pine to help stabilize the stream channel and restore riparian components.

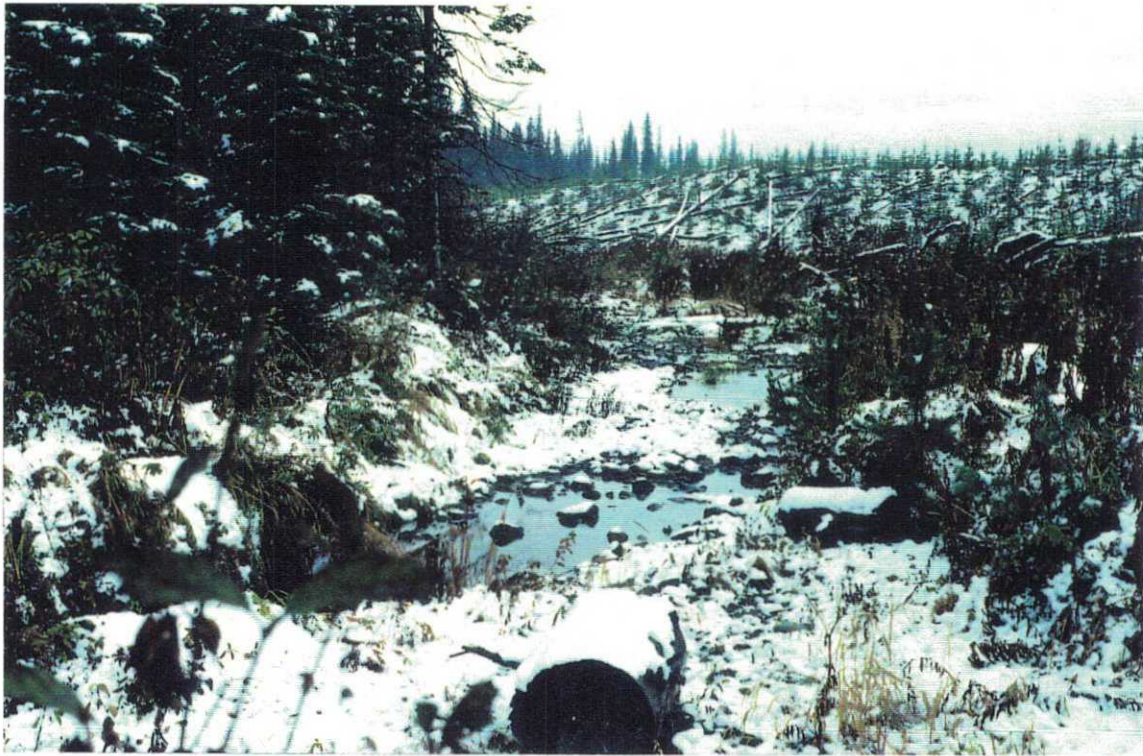
Photo 21. Howal Creek and block 93M016-035. Stream has been diverted to fire guard in this photo (original channel in forested area at left). Planting of this block boundry for channel retention is recommended for 565 meters.

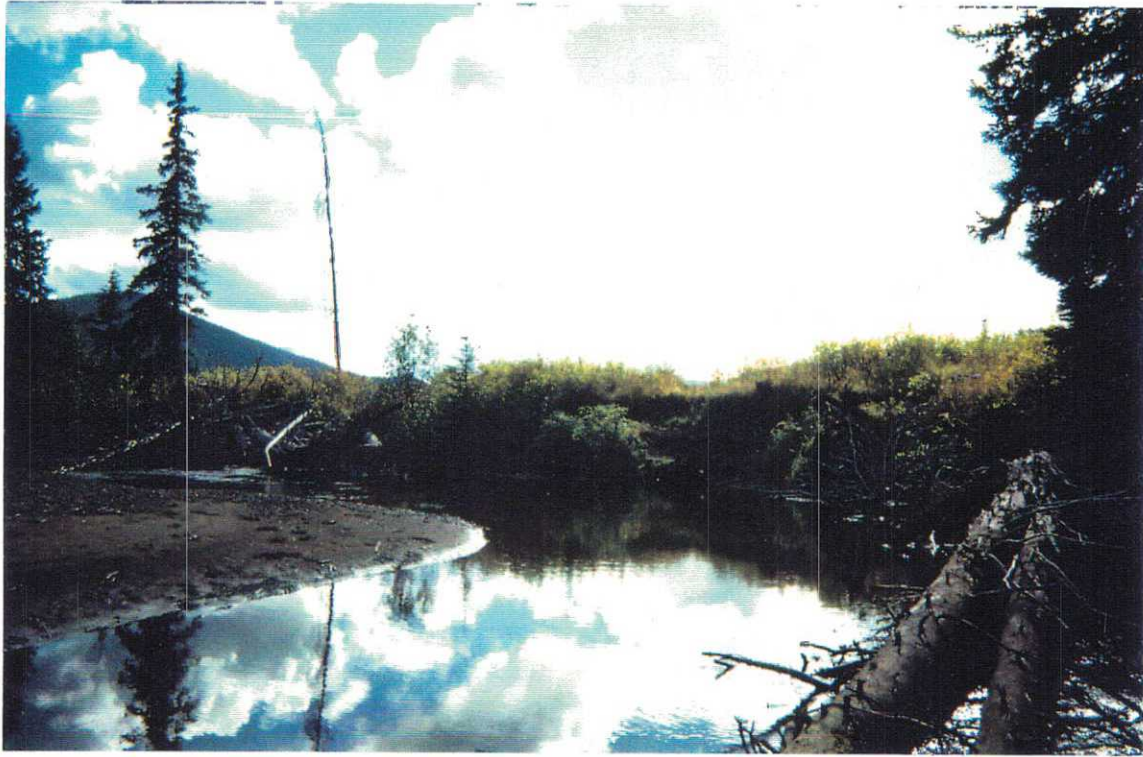
Photo 22. Harold Price Creek (reach 8) and block 93M017-019. Streamside vegetation is needed for bank stability and riparian functions for 1223 meters.

Prescription: Remedial work should concentrate on stabilizing banks within Blocks 93M017-019 and 93M007-101 by establishing riparian vegetation. Mixed fill-planting of willow, cottonwood, spruce and pine is recommended for 1223m along Block 93M017-019. Block 93M007-101 is described in reach 9 of the H.P.

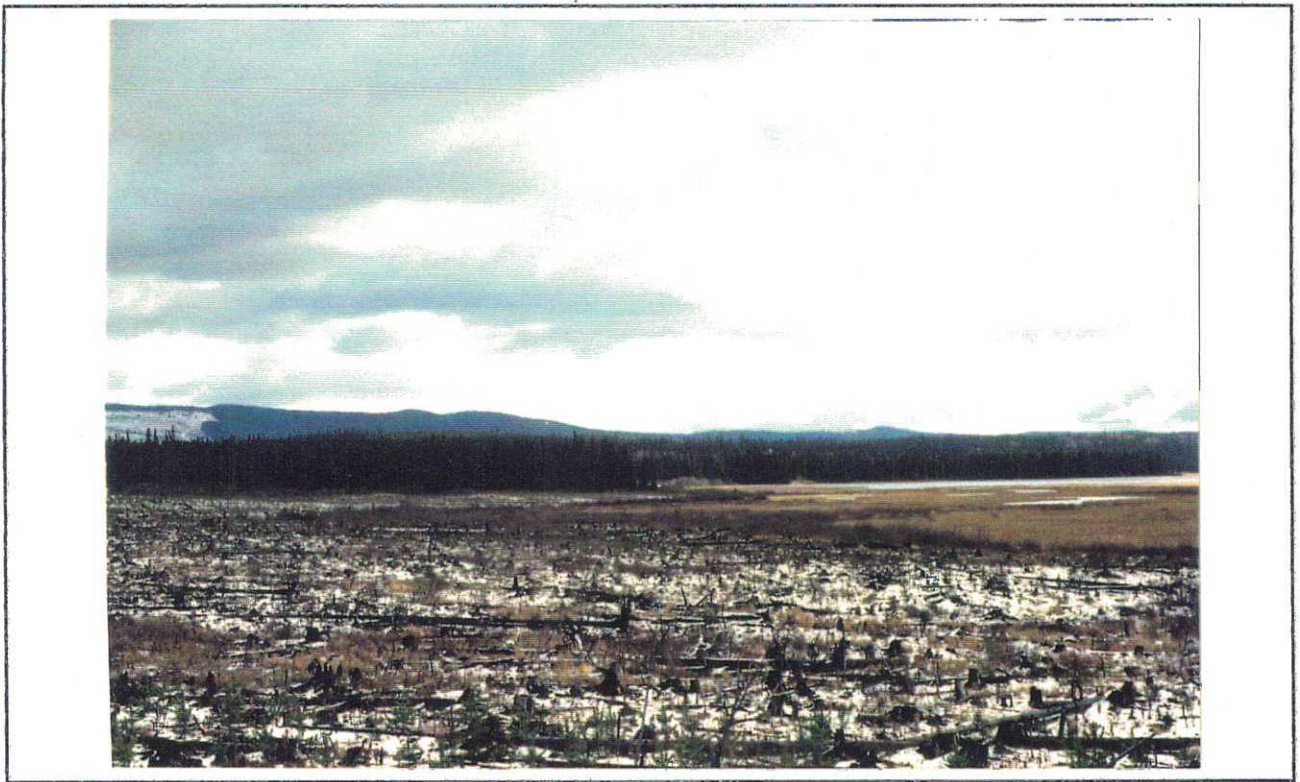
Photo 23. Blocks 93m107-018/-034 and-024 at Torkelson Creek. Riparian vegetation needed along wetlands for 1365 meters.

Prescription: The debris jam described in "impacts, should be cleared to restore access and may easily be accomplished with hand tools and a small crew. Mixed fill-planting along this streams border with Block 93M017-007 is recommended for 1043m to help maintain the original stream channel and re-establish riparian functions.

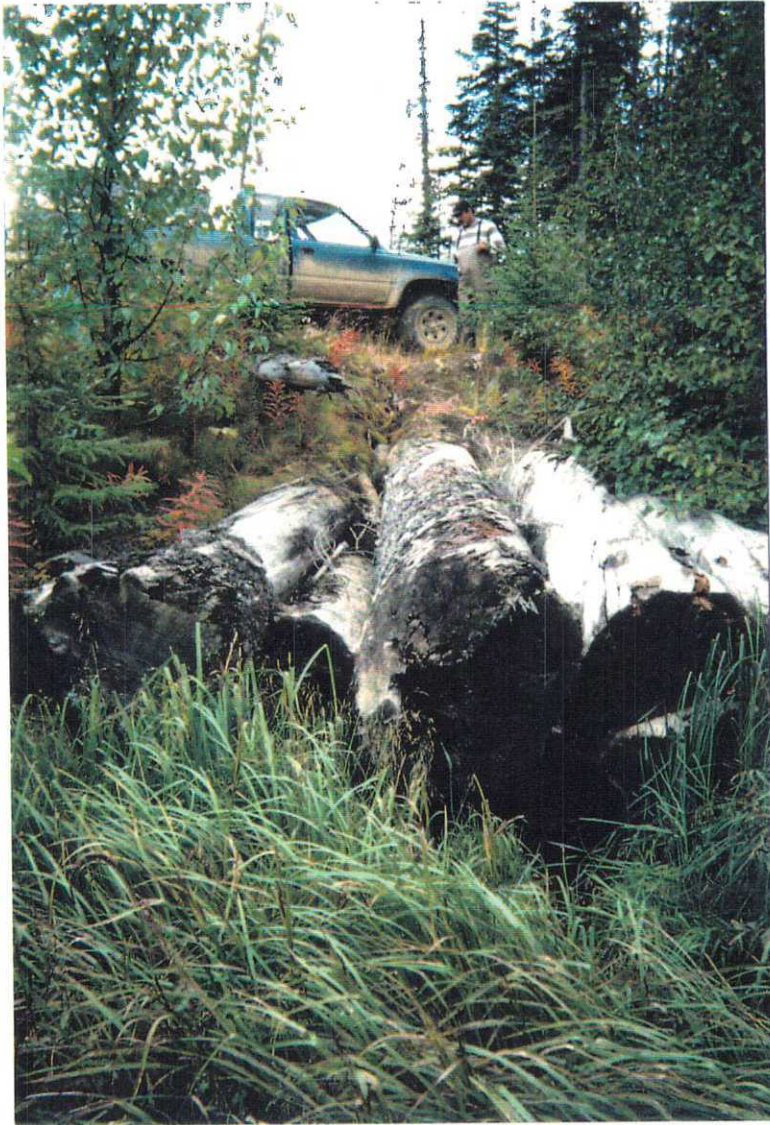
Photos 24 and 25. Trib.
46-700-50-115-010 obstructed by two
coursuroy crossings in blocks
93m017-016 (top) and -24 (bottom).
These roads were prescribed for
deactivation in 1997. (R. Hand G.
"Level 2" prescriptions).

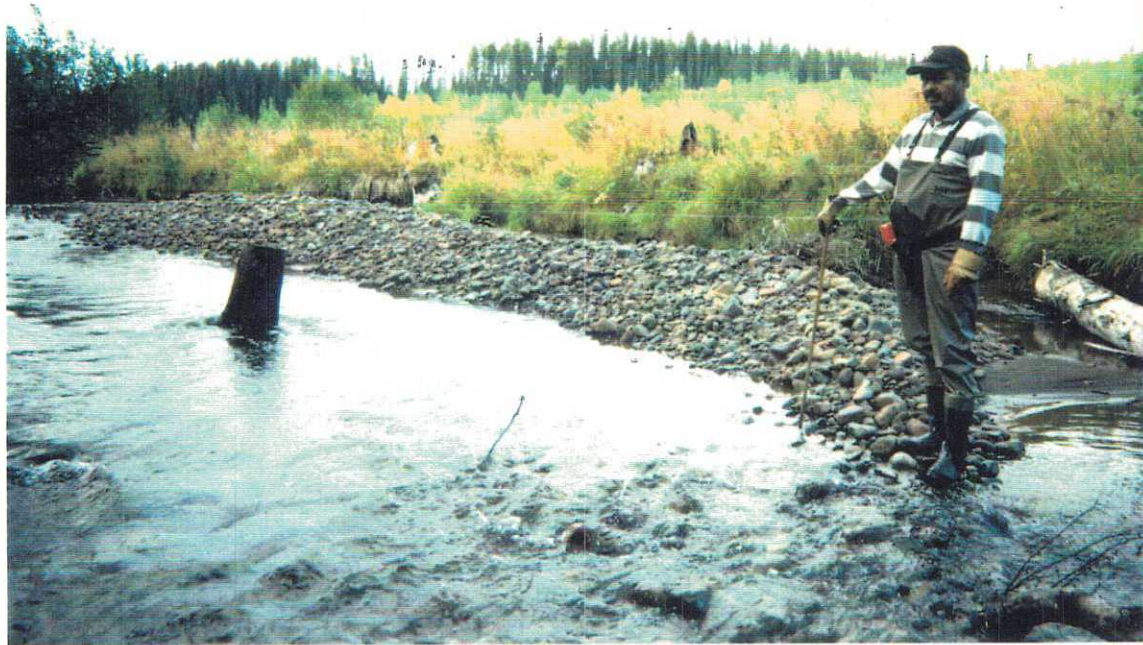
Photo 26. Harold Price Creek (reach 9) and block 93m006-001. Planting for bank stability and riparian functions needed for 1654 meters.

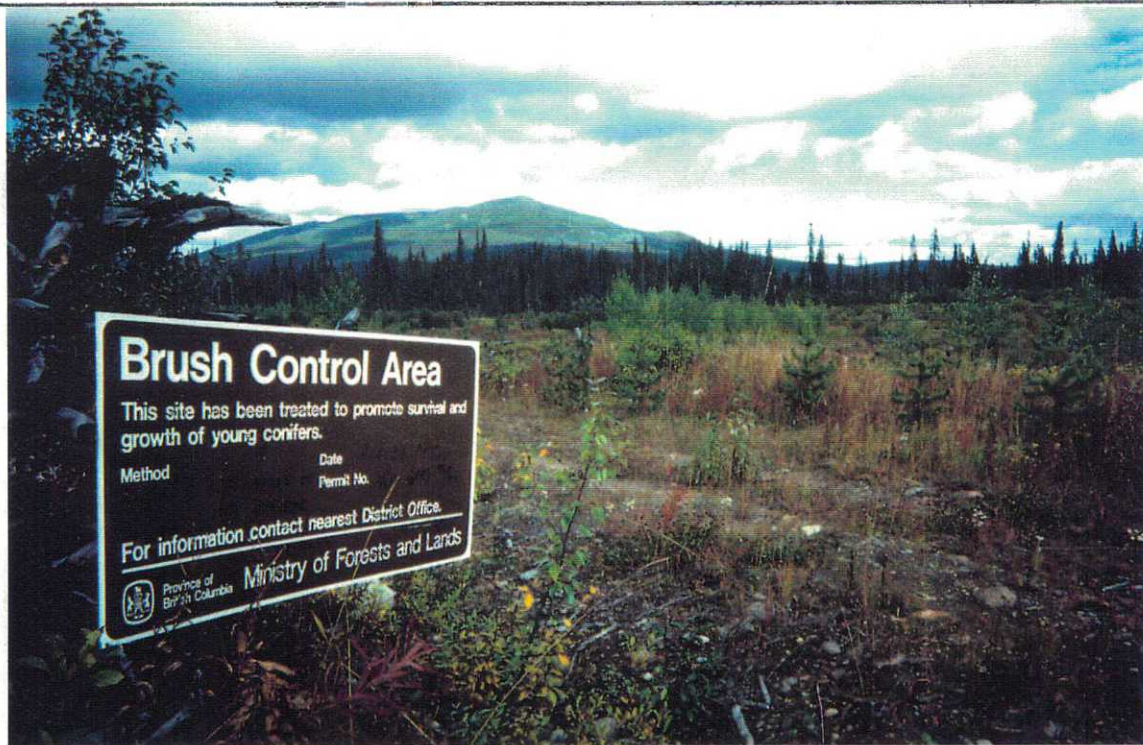
Photo 27. Block 93m006-001 stand tending operations may contribute to loss of riparian vegetation. This block was aerially sprayed with "Vision" August 1995.

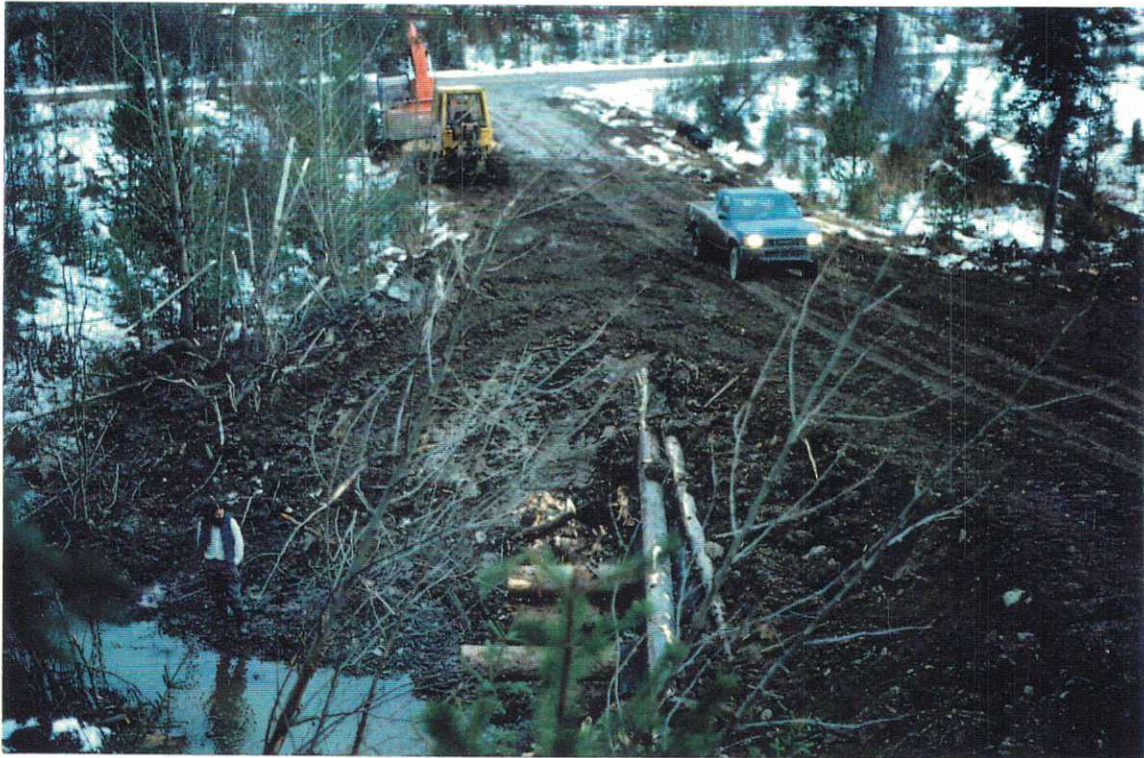
Impact Description: The metal pipe culvert, which was passable when assessed September 28, 1996, was replaced with a wooden box culvert October 22, 1996 (photo 28), by Repap, Smithers operations. Significant amounts of fine sediment was delivered downstream. An effort should be made, in the future, to replace crossings

Photo 28. Trib. 46-700-50-120 (branch 27.6 km Upper Fulton FSR) This crossing was replaced Oct.22/96. Dolly varden and cutthroat trout were gee-trapped here in Sept./96. This crossing requires hydroseeding and streamside planting. Block 93M006-006-007 and -010 requires streamside fill-planting along this tributary for 2055 meters. Future instream works should be conducted in August (after trout fry emerge and prior to fall spawning).

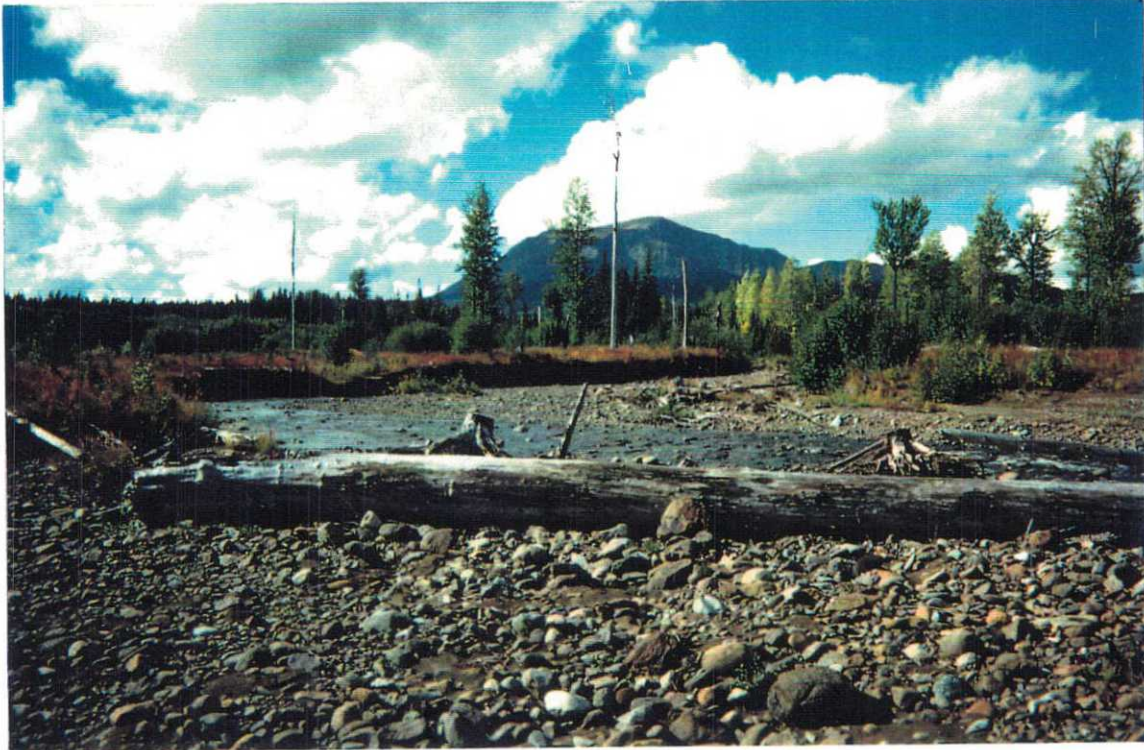
Photo 29. Reach 10 of Harold Price Creek and block 93M006-012. Extensive bank erosion requires stabilizing vegetation throughout reach 10 for 3769 meters. Planting of gravel bars and dry channels also recommended.

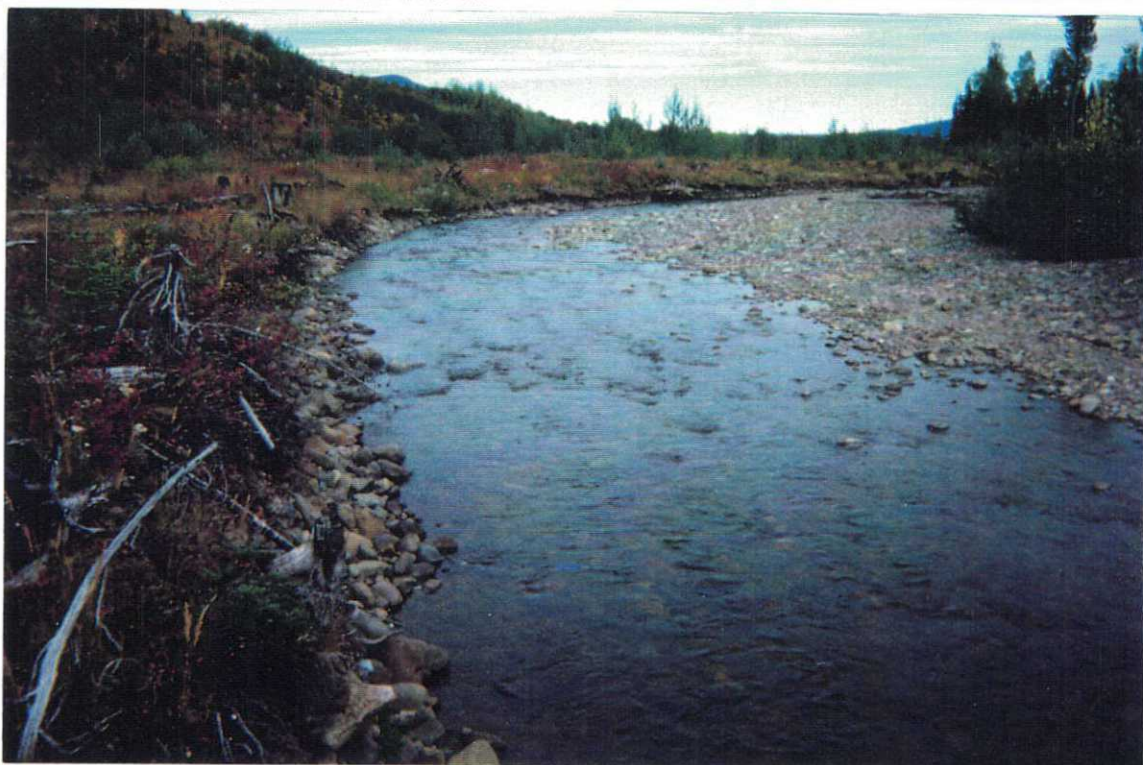
Fish/Habitat Assessment: This reach, though not identified in the Level 1 report as impacted, exhibits logging related impacts similar to those in reach 10 (photo 30.)

Photo 30. Reach 11 of Harold Price Creek (block 93M006-004) Streamside vegetation is needed for 925 meters of reach 11. Bank erosion contributes to site loss and downstream movement of sediments, bedload, and organic debris.

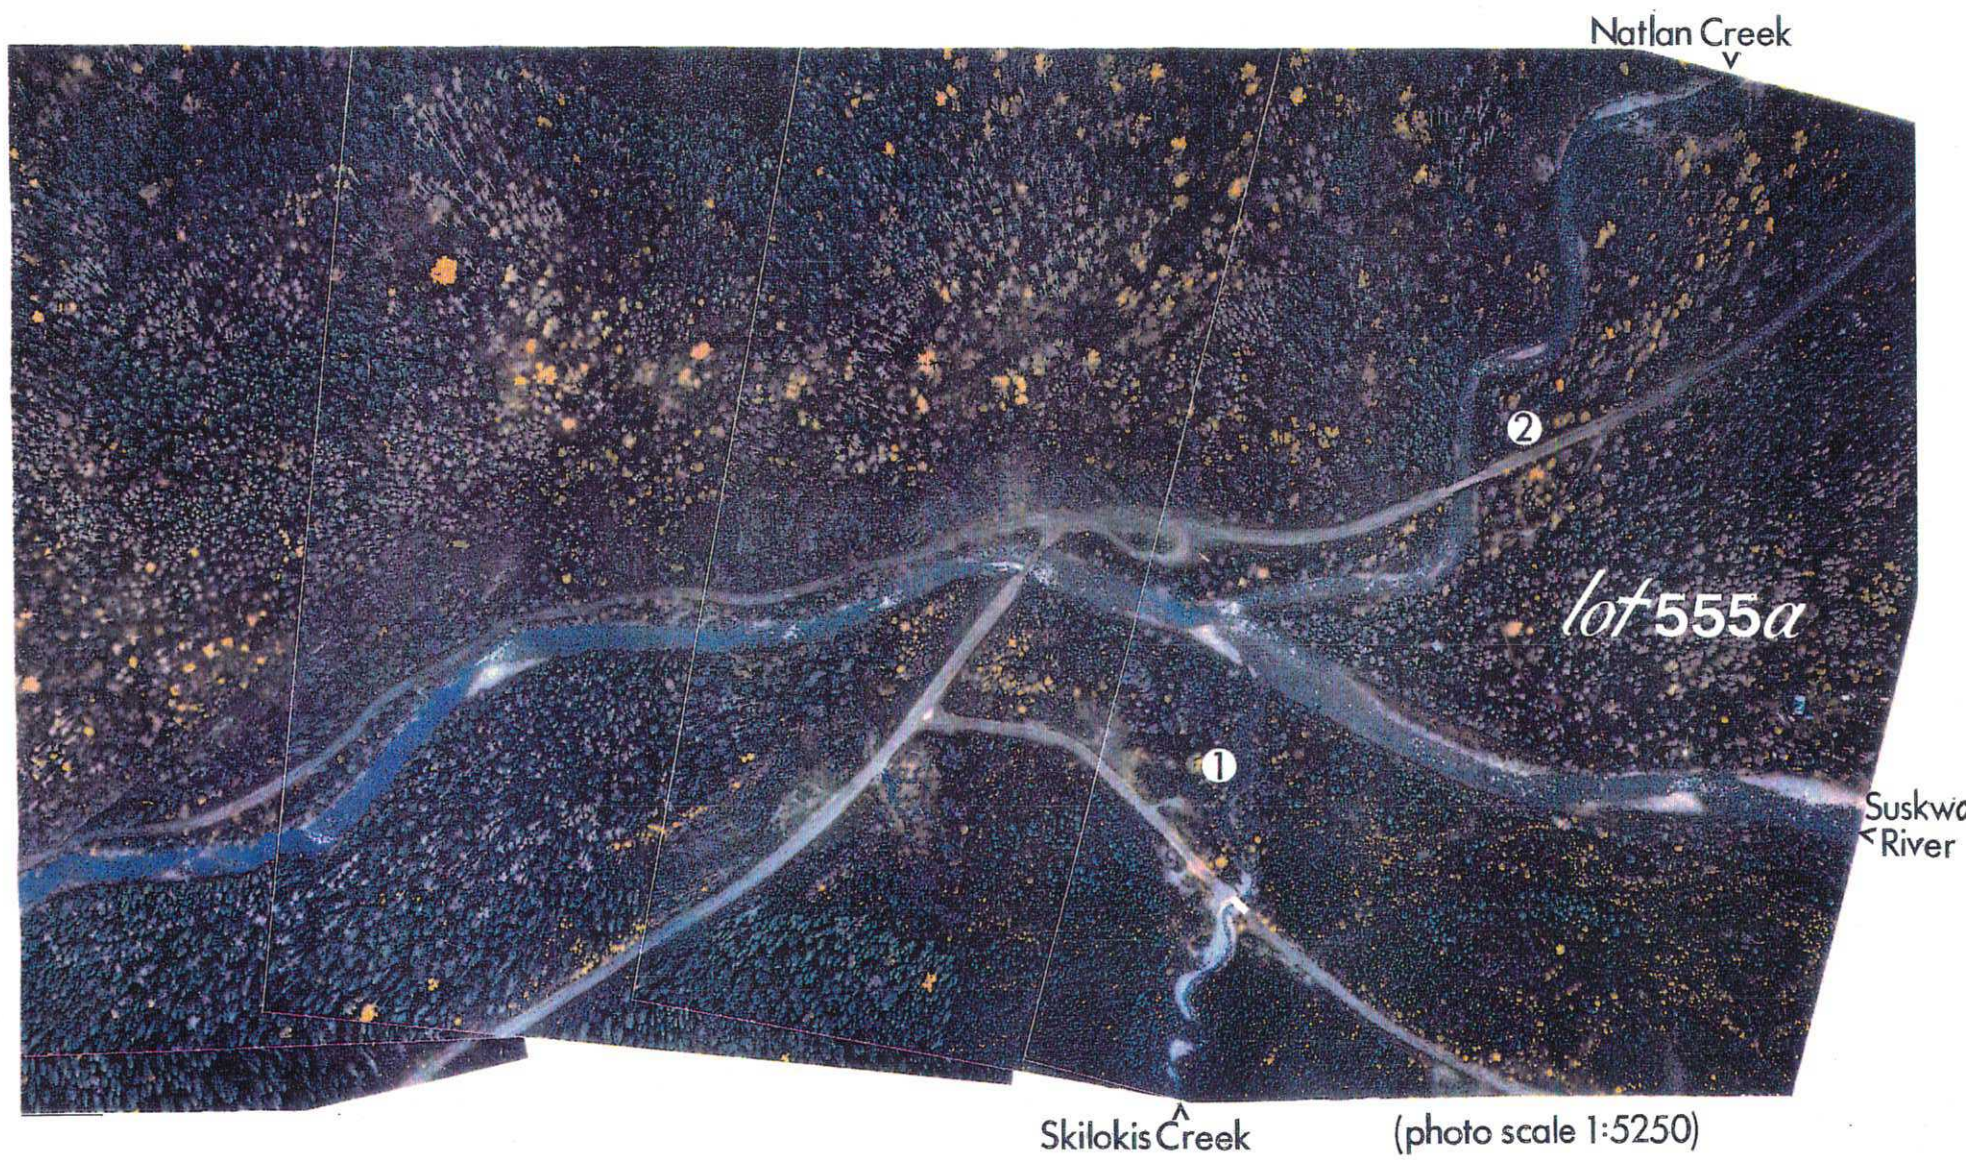
Photo.31 SkilokisCreek rehab.site(1) and lot555a groundwater channel(2).

Prescription: An excellent opportunity exists downstream of the bridge crossing to place LWD for cover, and pool creation. Two old skid roads access the stream 60m downstream of the road crossing, and will help limit disturbance by heavy equipment in log placement (photo 31). At the time of assessment, two large logs (50cm+

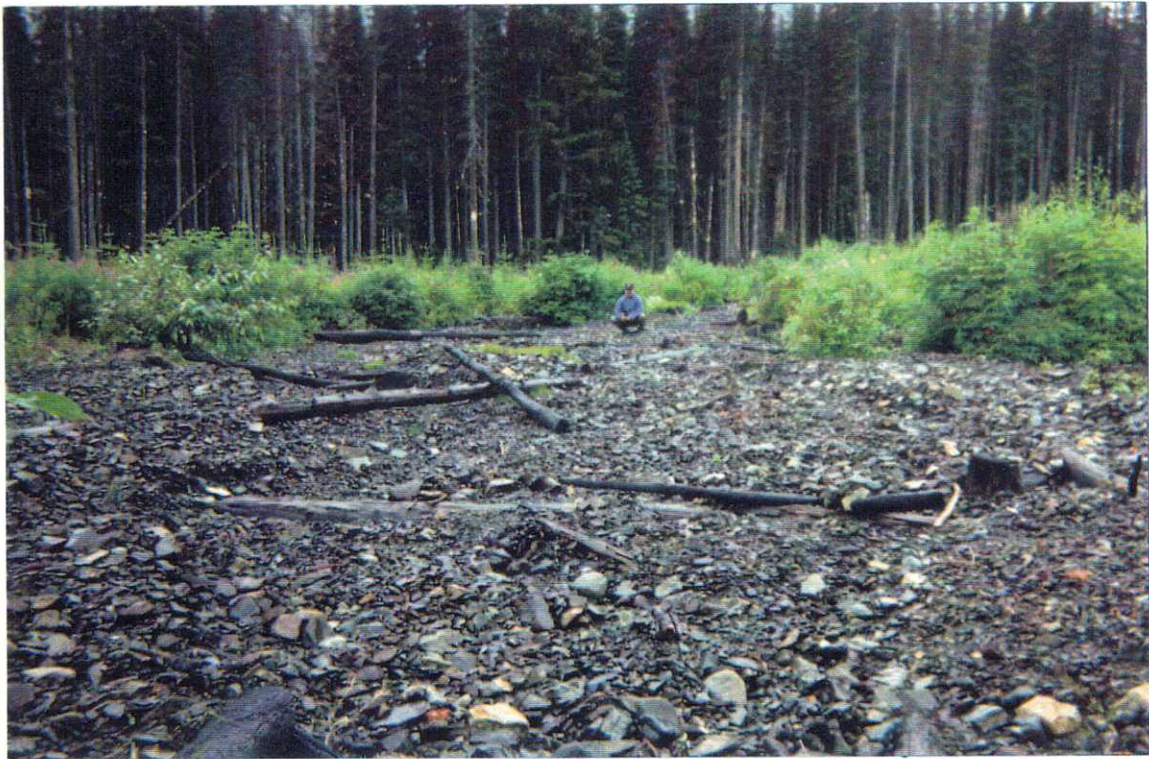
Photo 32. Trib. 46-700-84 in block 93M035-004. A debris torrent begins in block 93M035-001 and diverts flows to block -004 and -010 downstream. No fish were found on this upland bench, however, a courduroy crossing in block -004 should be removed to limit site loss via flooding.

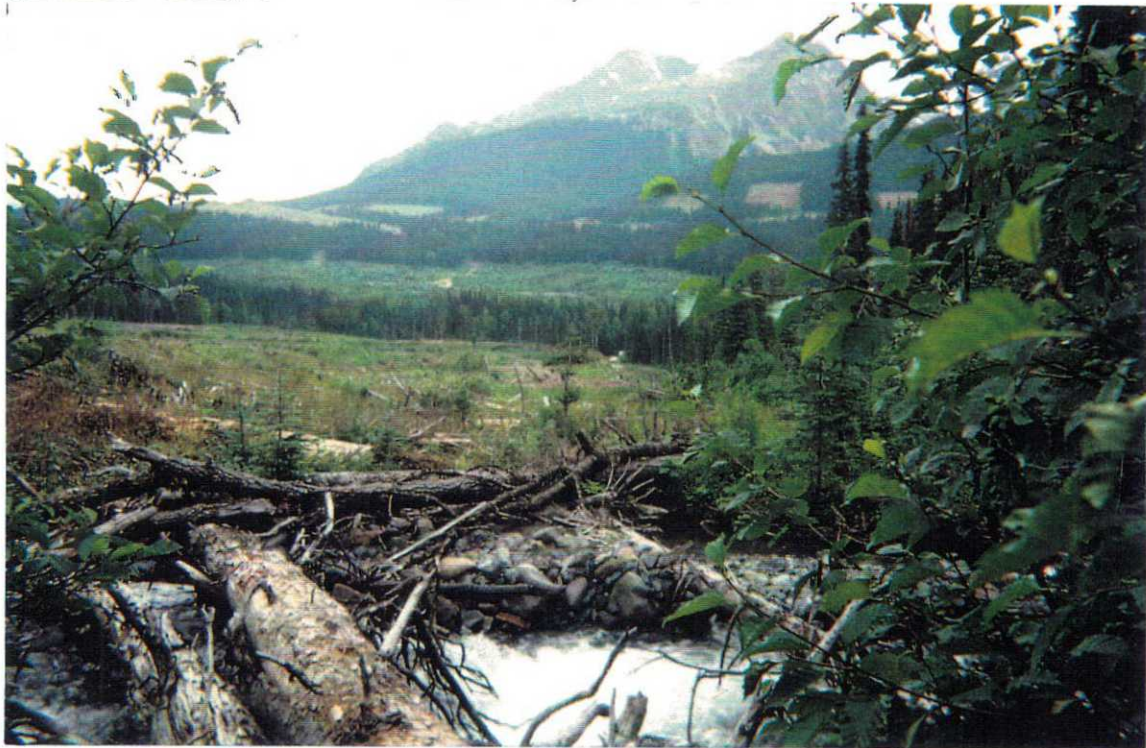
Impact Description: A debris jam, 423m upstream of the bridge site, is channelling flows towards Block 93M035-015. A potential channel diversion exists here. Lack of streamside vegetation, unstable banks and a shallow drainage adjacent to the creek has left this stream vulnerable to de-watering below this debris jam (see photo 33.) Bank erosion along Block -015 contributes bedload to the existing channel and deposits of fine sediment were noted at small backwaters. The bridge crossing, though passable, contributes road grade materials (eroding at its west bank abutment) to the stream channel.

Photo 33. Trib 46-700-140 in block 93M035-015. This site (423 meters) above the Grizzly FSR bridge is vulnerable to channel diversion into block -015. Removal of a debris jam and log deflectors may retain this stream channel until streamside vegetation is established. Numerous bulltrout juveniles were gee-trapped at the road crossing.

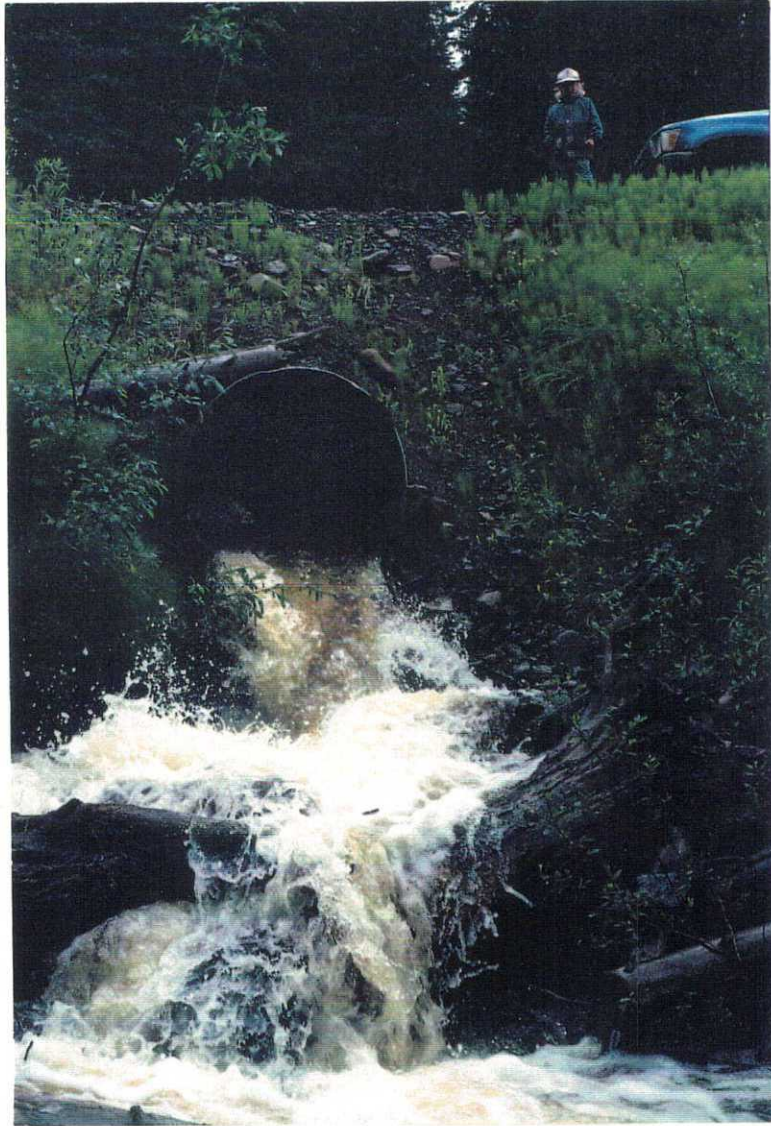
Photo 34. Trib 46-700-144 .5 km Grizzly FSR) This impassable culvert should be replaced to restore access upstream. Dolly varden were gee-trapped up to this crossing, but not above.

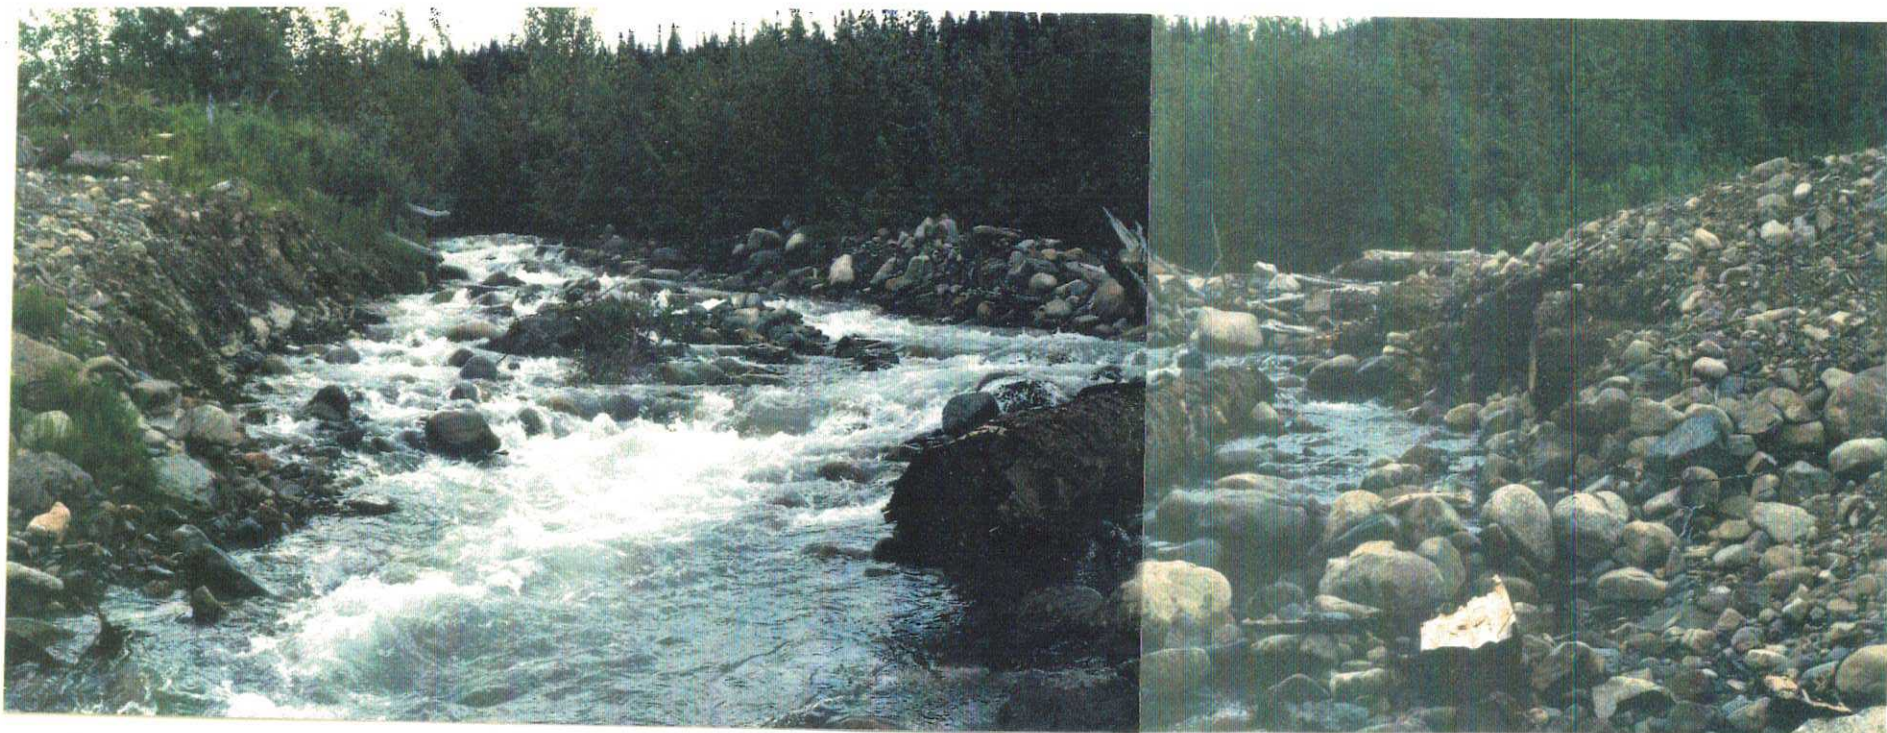
Photo 35. Trib. 46-700-137 in block 93M035-016. Deactivation of the Netazul FSR left bridge stringers and road grade materials instream. Cross-ditches have been in-filled (see photo 36). Mixed species fill-planting is recommended through block -016 especially downstream of this crossing.

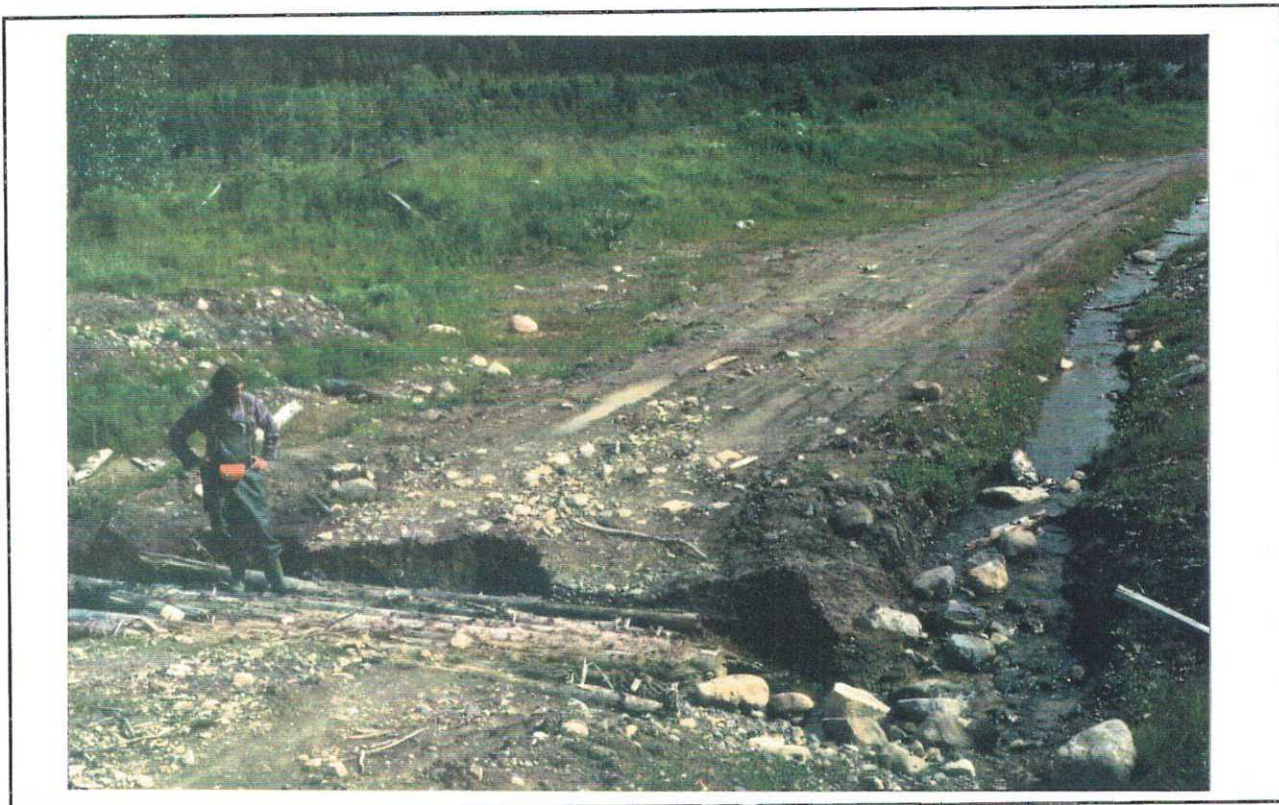
Photo 36. Blocked cross-ditches eroding along the (deactivated) Netazul FSR. Assessment of cross-ditches along this road should be made in 1997. Water in this picture joins trib. 46-700-137 in block 93M035-016.

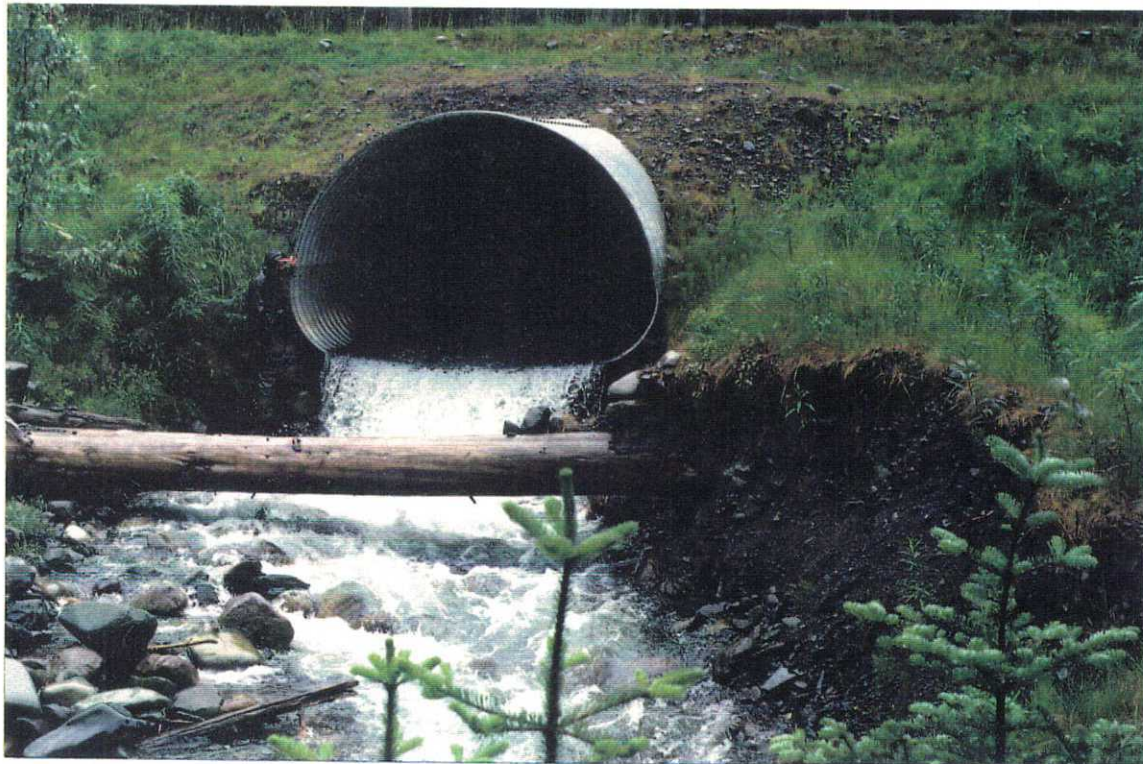
Photo 37. Trib. 46-700-30-130 (34 km Suskwa FSR) . This culvert requires a jump pool to ensure access upstream. Dolly varden were gee-trapped up to this crossing. Pull back of road grade materials is recommended for southeast stream bank. (at right)

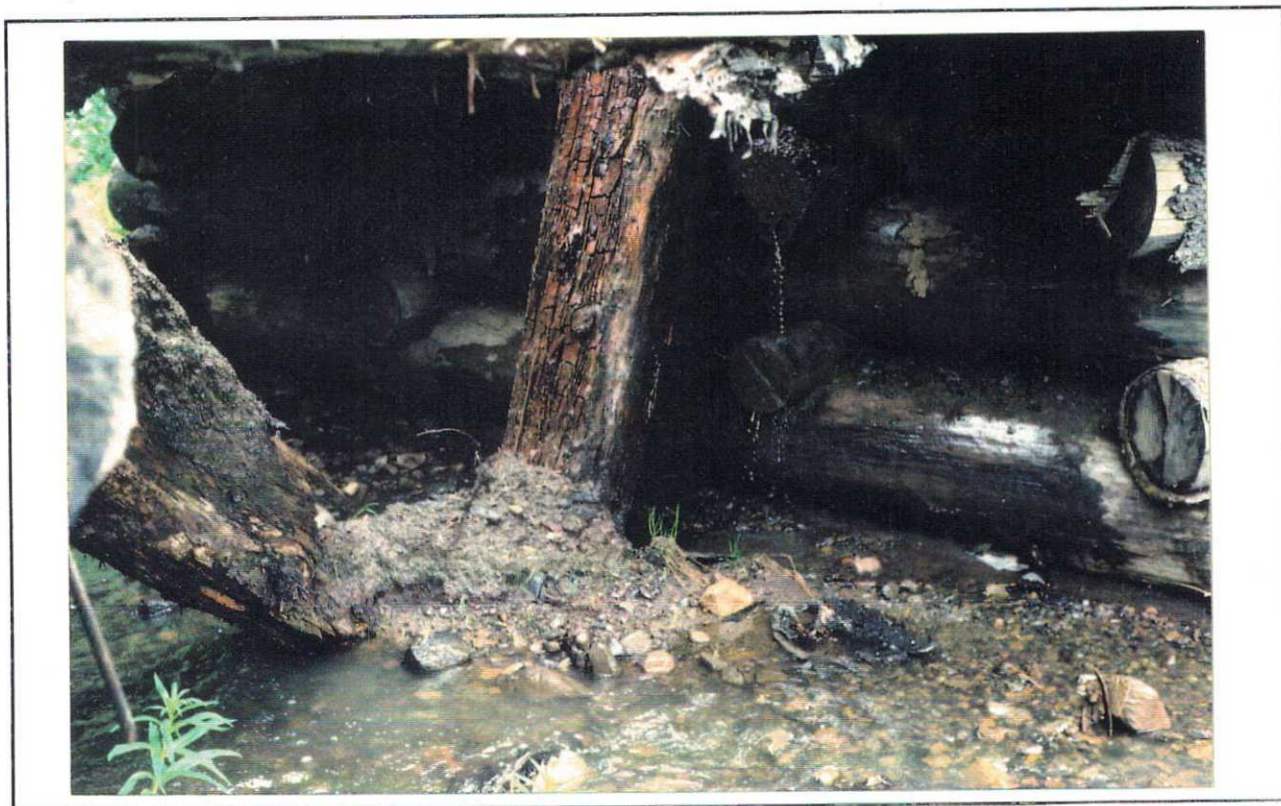
Photo 38. Trib 46-700-30-144 at branch 6b-37km Suskwa FSR. Failure of bridge delivering fine and coarse sediment to Natlan Creek. Bridge site was prescribed for deactivation during 1997. (R.H. and G. "Level 2" prescriptions)

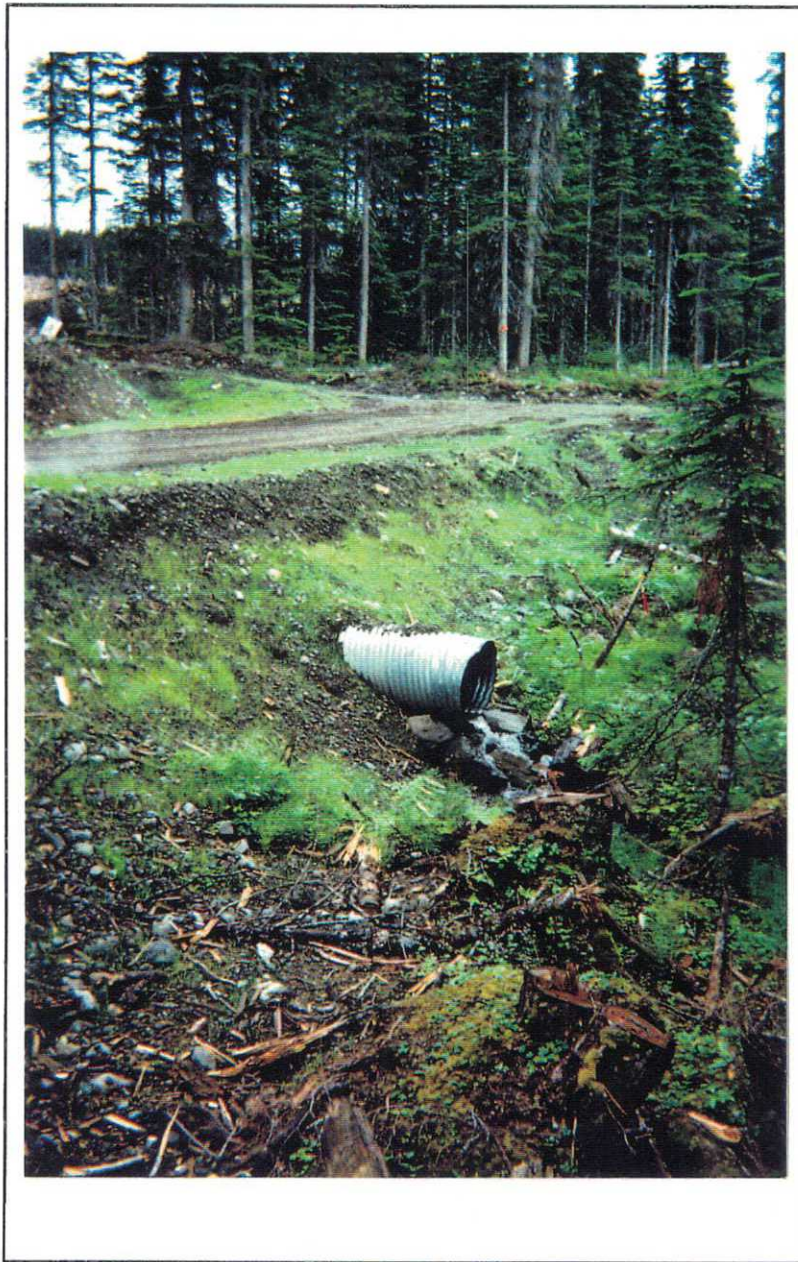
Photo 39. Unnamed trib. to Iltzul Creek (presently impassable).

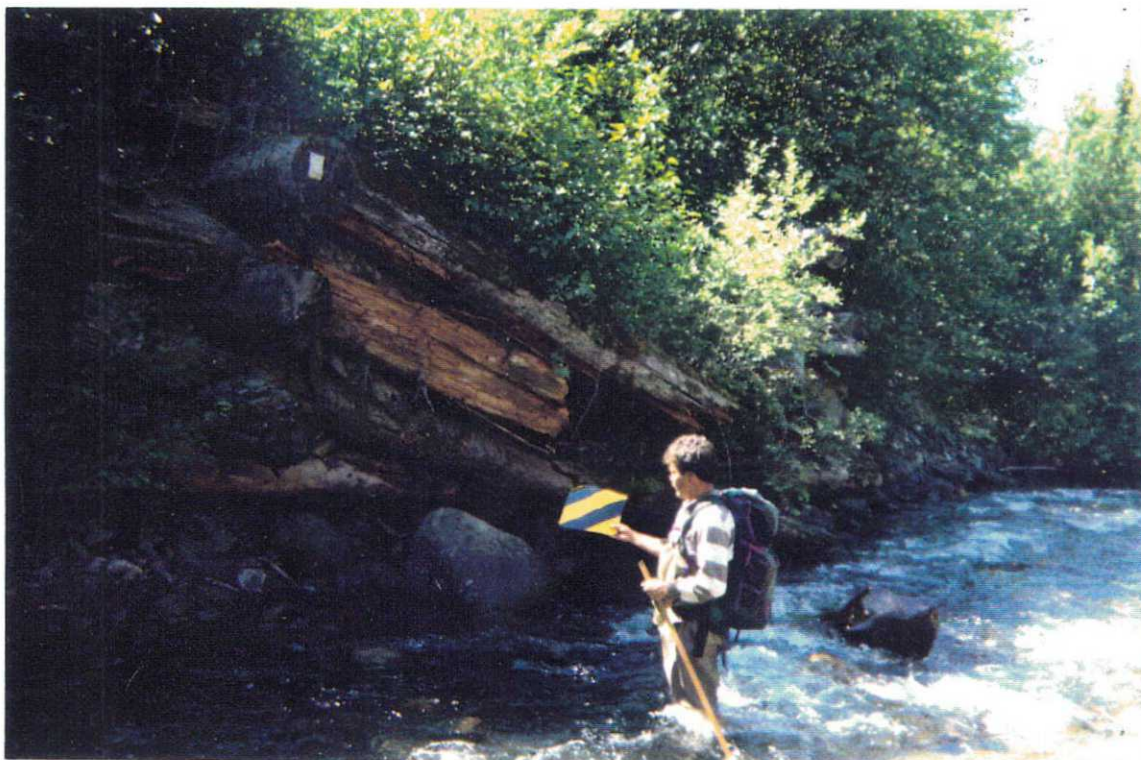
Photo 40. Old Bridge abutment failing into Denison Creek (reach 1) at 22.2 km Suskwa FSR. Bridge materials are contributing to debris jams downstream.
