Final Report #NF-2008-H-9

Bulkley/Kispiox River Agricultural Stream Restoration Seed Funding

SECTION 9 APPLICATION

PRESCRIPTIONS FOR SITES ON: Maxan Creek

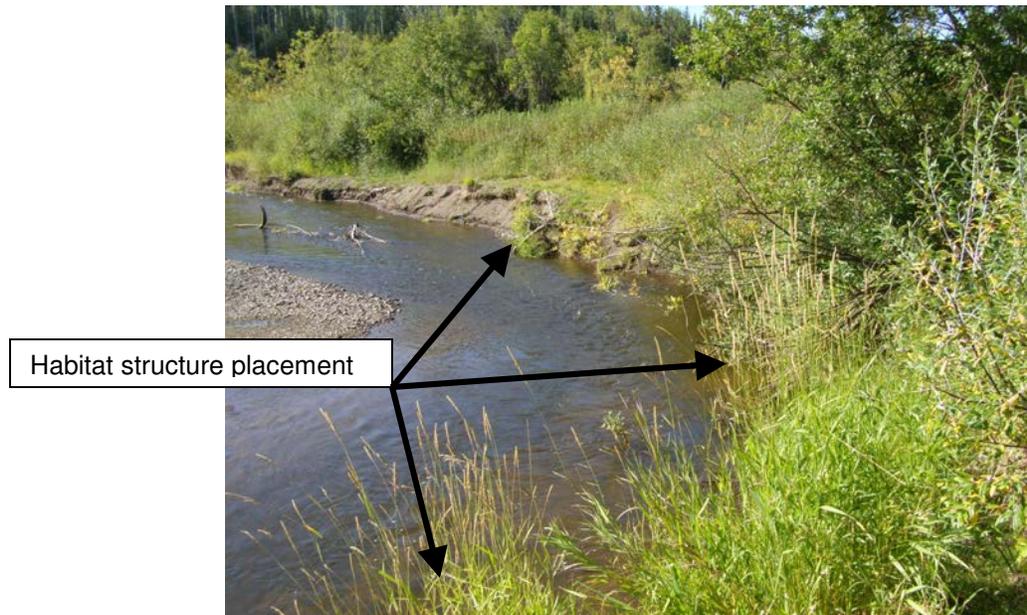
- Channel morphology: Riffle-Pool
- Disturbance Level: Partially Aggraded to Severely Aggraded
- Limited riparian corridor along migrating creek bank
- Undercutting occurring along 1.2 meter cut bank
- Limited woody debris and over all bank integrity has allowed scouring and potential for further bank migration along 100% of corridor

Looking up stream, riparian corridor on left side of photo shows exposed bank.

- Placement of 3 habitat recruitment structures along exposed cut bank

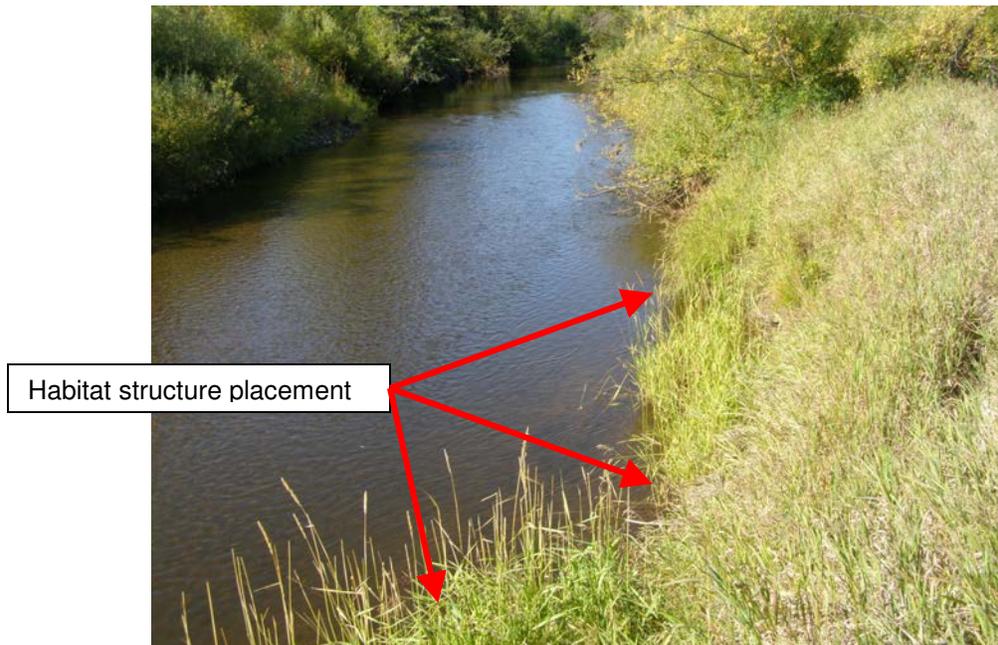
- Channel morphology: Run
- Disturbance Level: moderately degraded
- Undercutting occurring along 2.0 meter cut bank due to channel depth
- Limited woody debris and over all bank integrity has allowed scouring and potential for further bank migration along 100% of corridor

Looking upstream from lower end of site. Channel has degraded or deepened and bank has slumped. Small structures would reduce migration and increase habitat values.

- Placement of 3 habitat recruitment structures along north bank

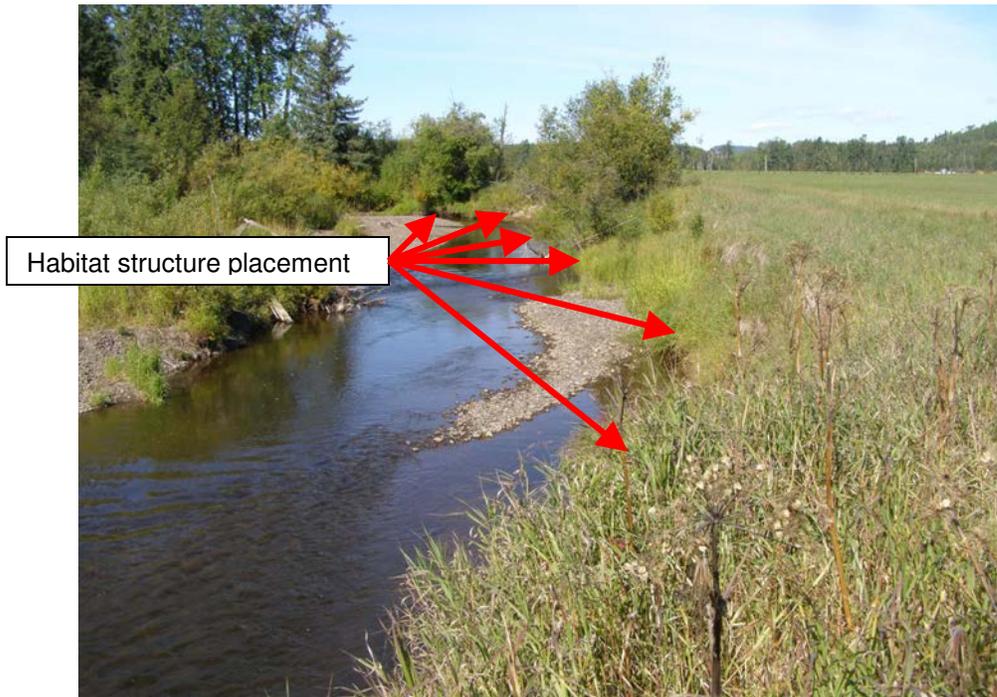
Looking upstream from bottom end of site. Bedload has limited pooling while bank has limited stability.

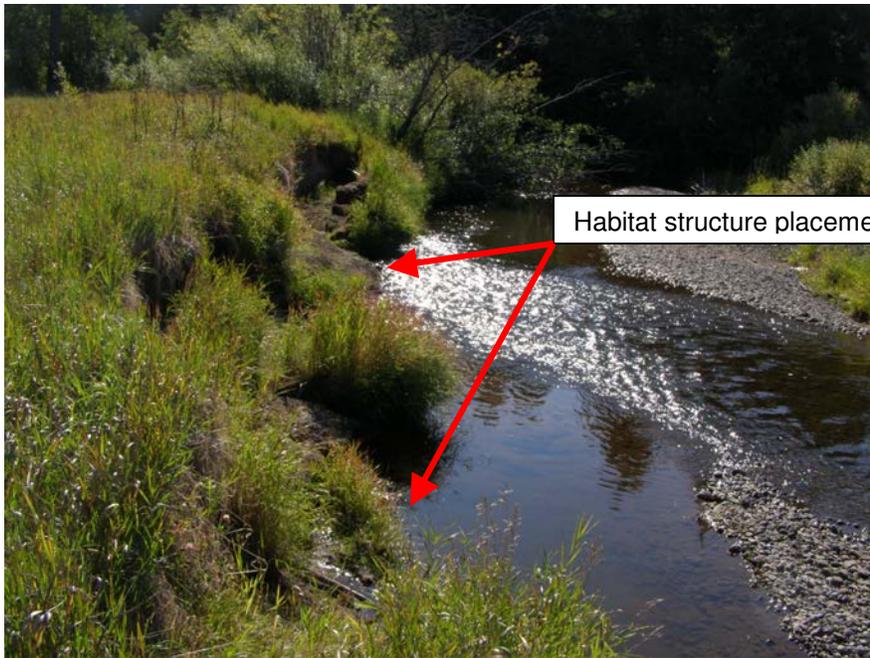
Looking downstream at lower end of site at slumping bank due to undercutting .

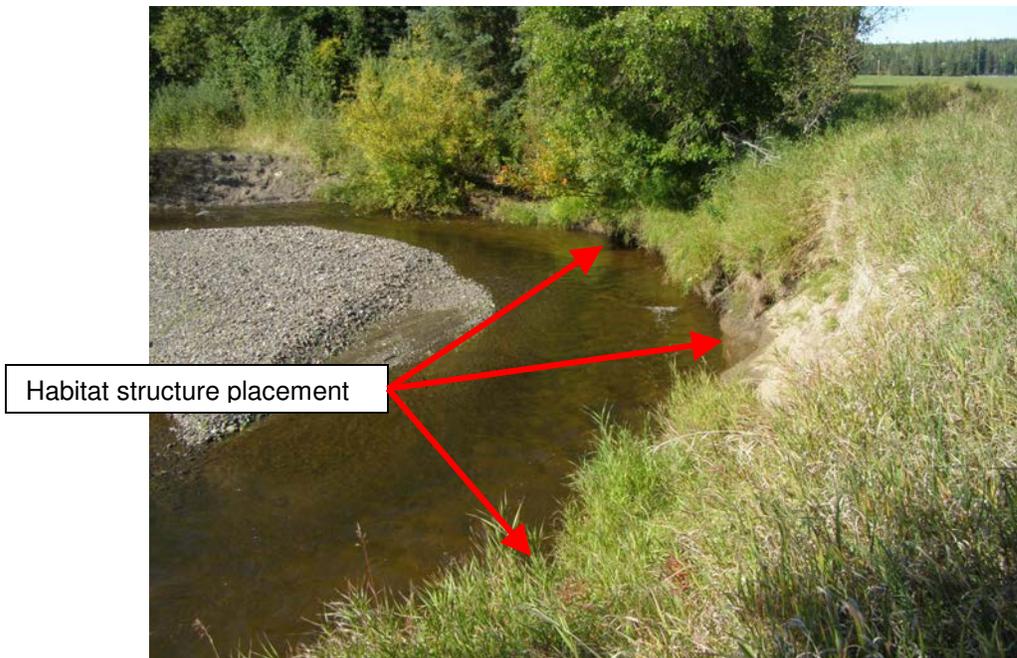
Looking up stream at exposed cut bank along top end of site. Recent bank migration has seen channel widen out leaving a point bar developing on inside bend of channel. Habitat structures would protect bank while increasing habitat values. Alterations would promote pooling and point bar removal through positive hydrologic influence during next springs freshet.

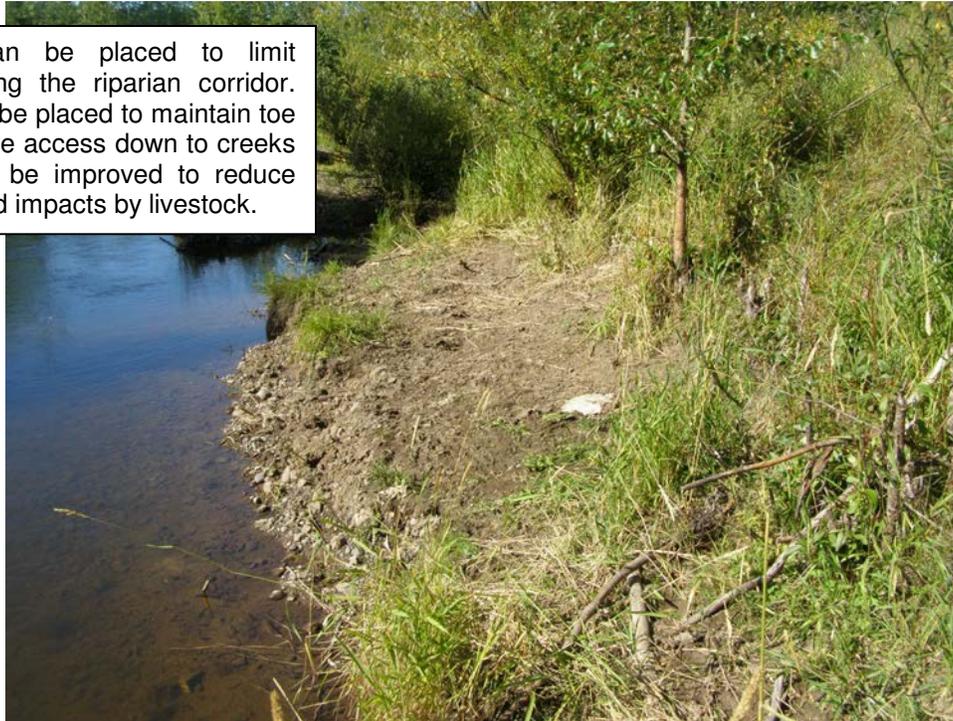
Looking upstream at current watering point utilized by livestock and wildlife.

Material can be placed to limit access along the riparian corridor. Rock could be placed to maintain toe of bank while access down to creeks edge could be improved to reduce mingling and impacts by livestock.

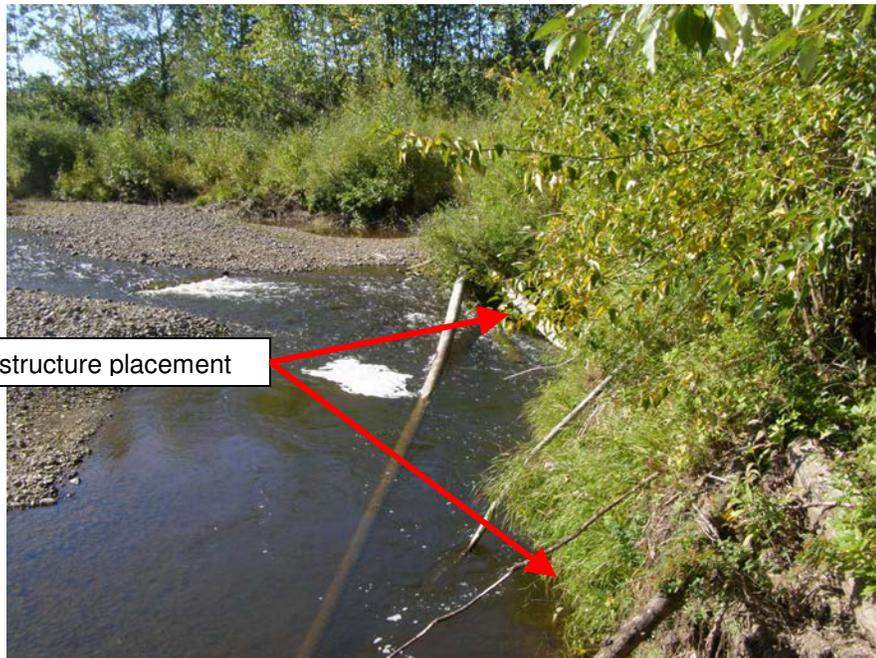
Looking upstream at undercut bank. Habitat structures would enhance stability and habitat values.

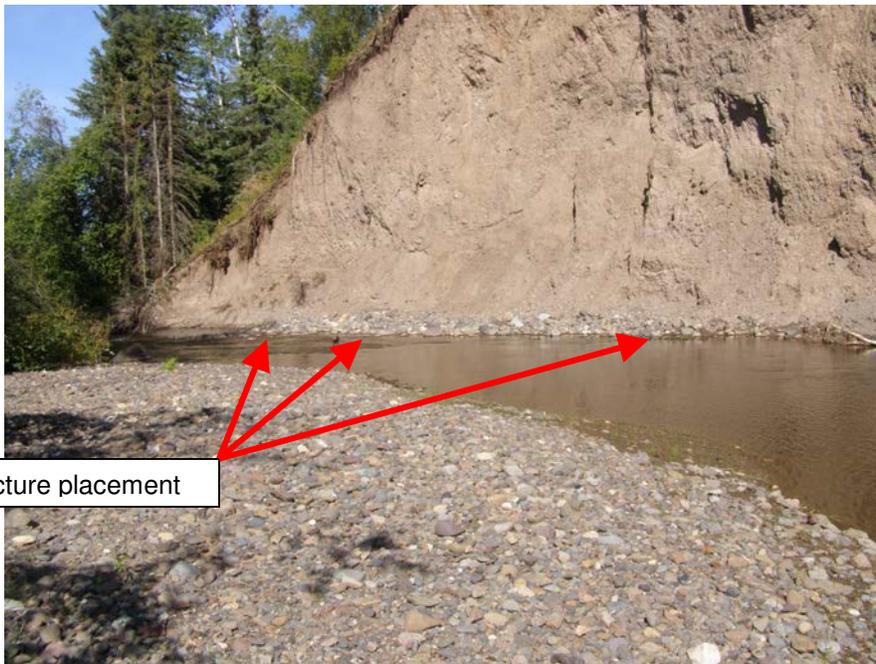
Habitat structure placement

Looking down stream at lower end of undercut bank. Habitat structures would enhance stability and habitat values.

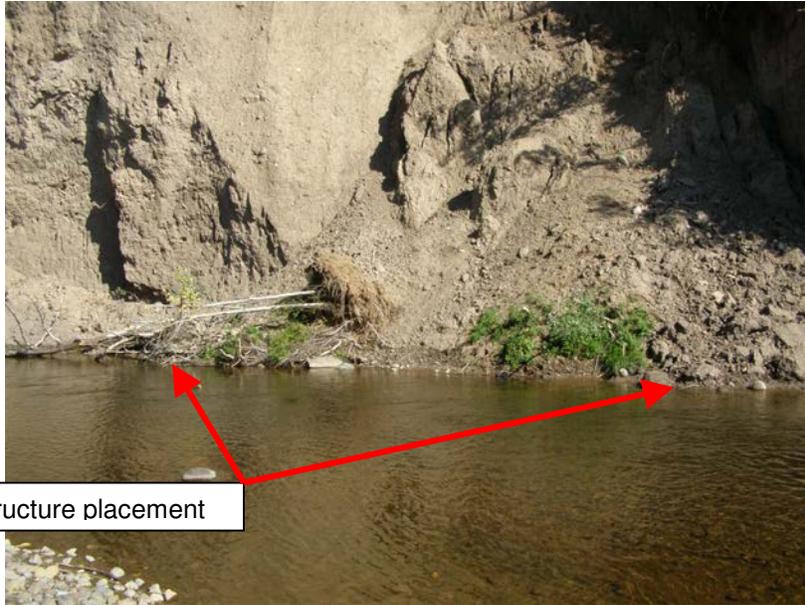
Habitat structure placement

Looking across at midpoint of cut bank. Habitat structures would enhance stability and habitat values. Bank would still slump but base of bank would not migrate back allowing for reduced bedload sourcing.

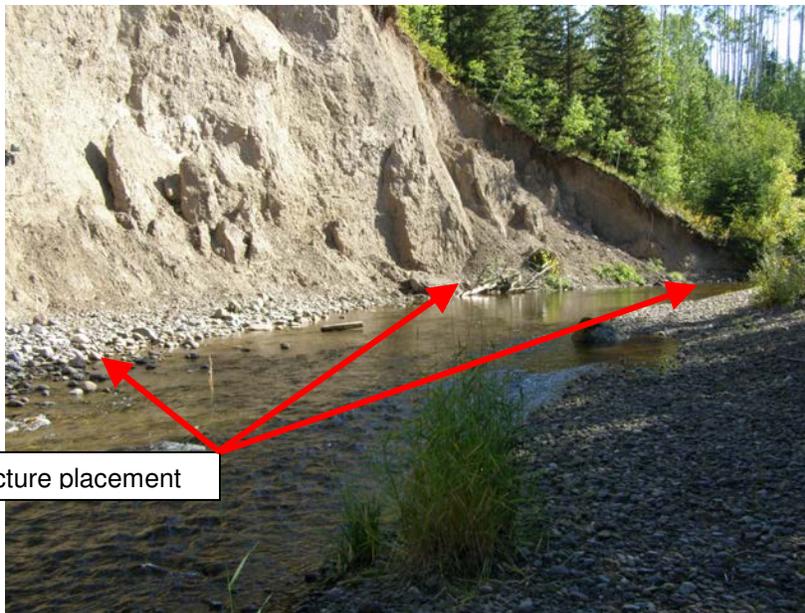
Habitat structure placement

Looking upstream at top end of undercut bank.

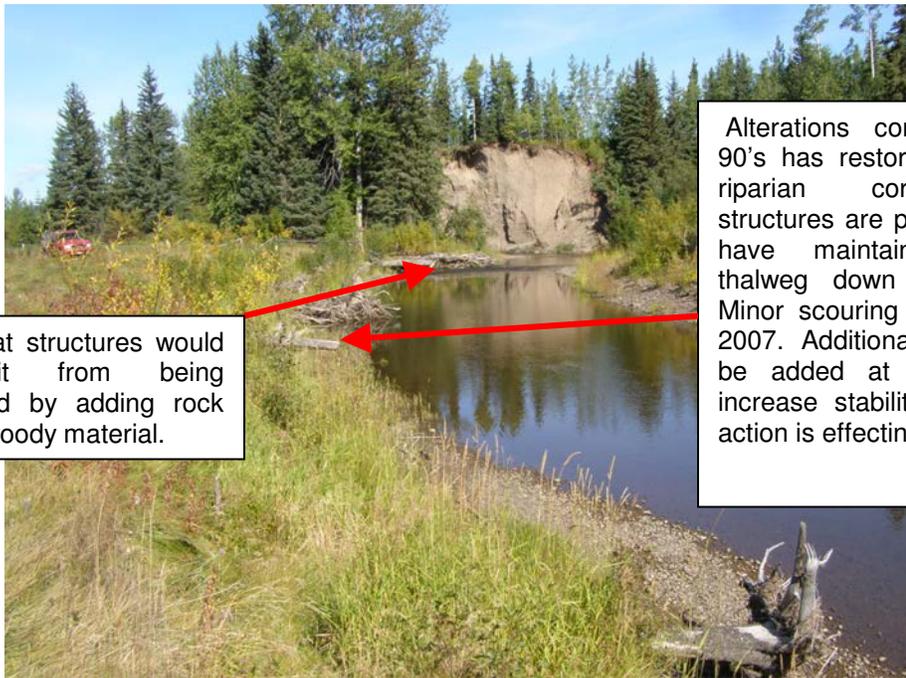
Habitat structures would benefit from being altered by adding rock and woody material.

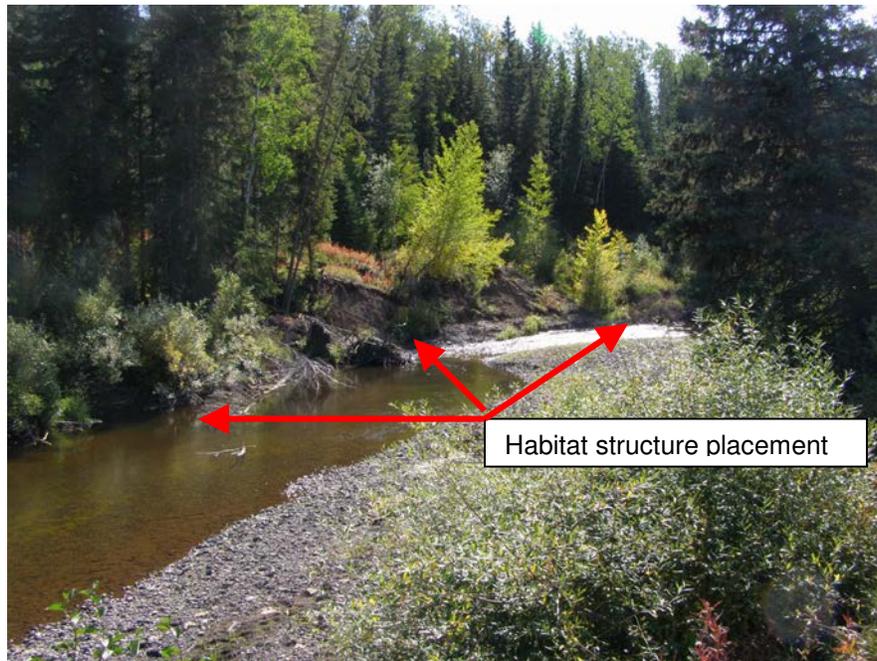
Looking upstream at undercut bank. Habitat structures would enhance stability and habitat values.

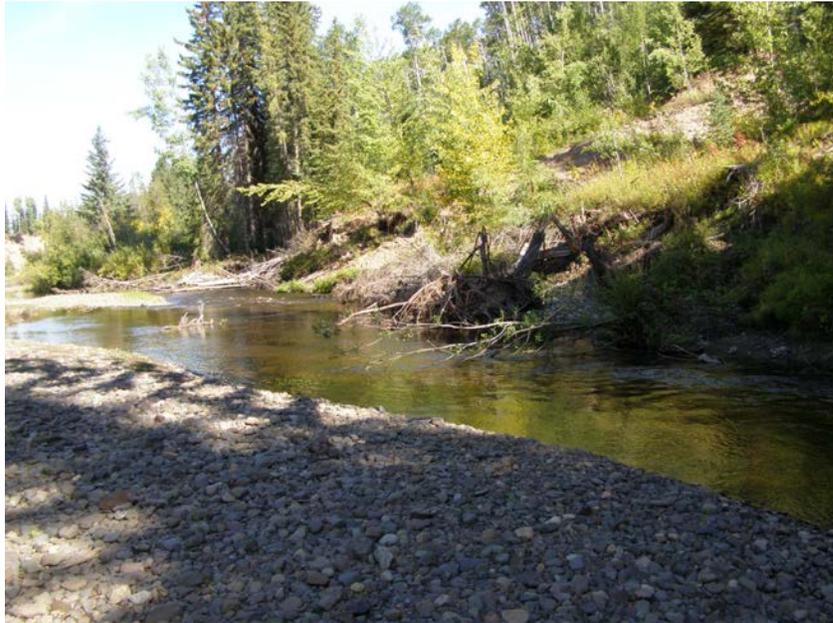
Looking down stream at undercut bank and toppled trees. Habitat structures would enhance stability and habitat values by moving energy away from bank. Slump runs 15 meters back.

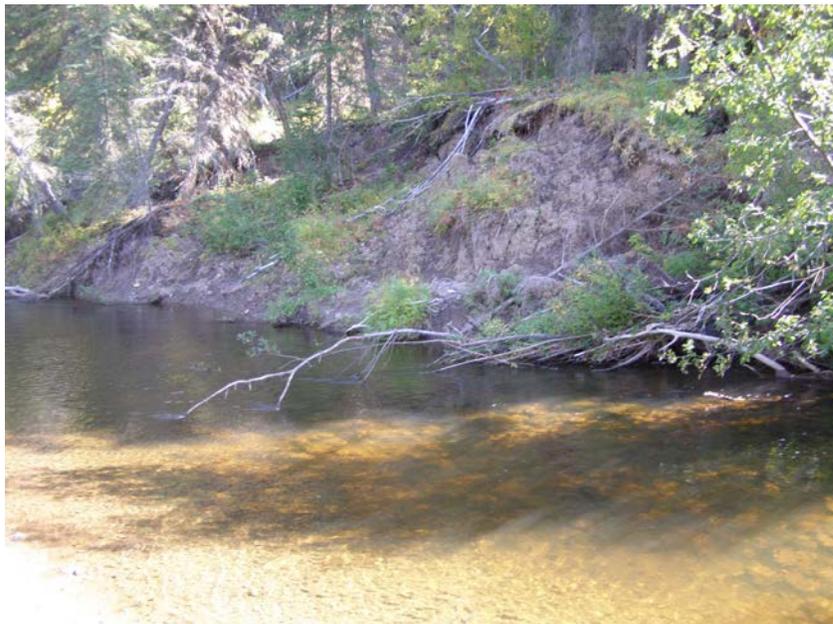
Looking downstream at undercut bank near top of site. Habitat structures would enhance stability and habitat values.

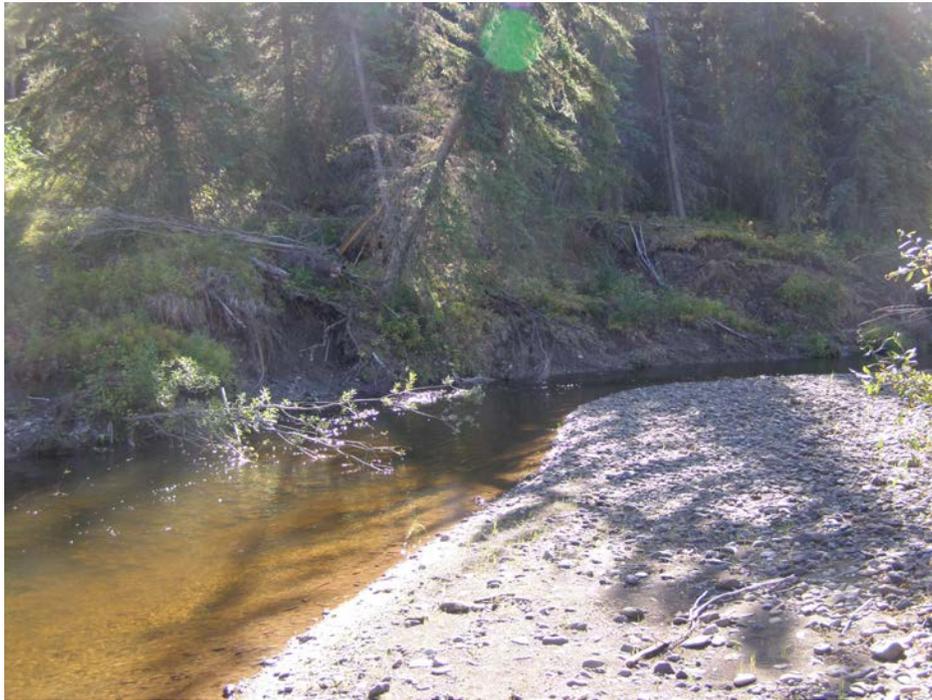
Looking up stream at undercut bank near top of site. Habitat structures would enhance stability and habitat values. Slumping of bank runs the entire 140 meters of site, note angle of trees along top of bank.

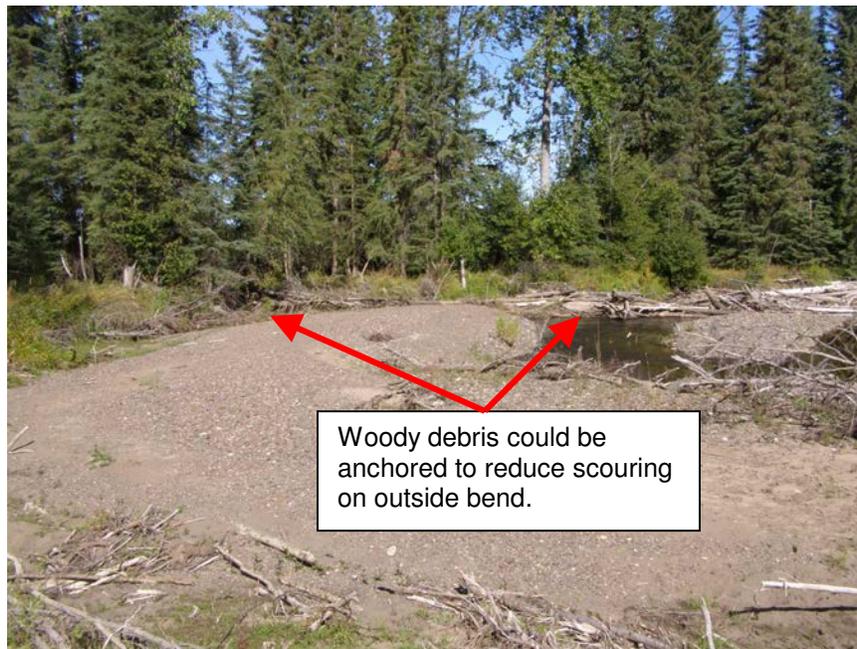
Looking down stream at undercut bank. Habitat structures utilizing woody debris already distributed along corner would enhance stability and habitat values.

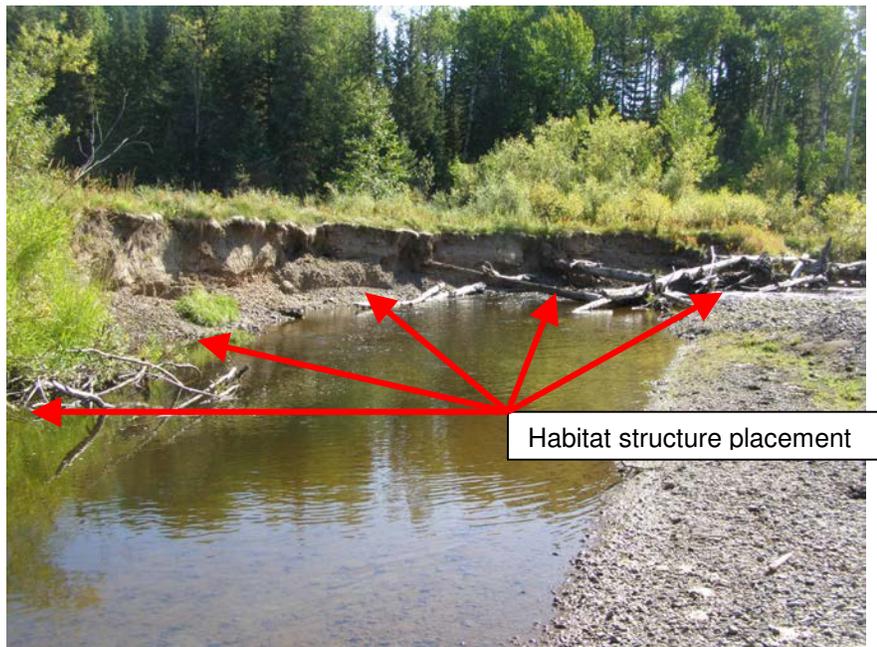
Looking upstream at undercut bank. Habitat structures placed in mid 90's have been undercut during the 2007 freshet and have started to fail.

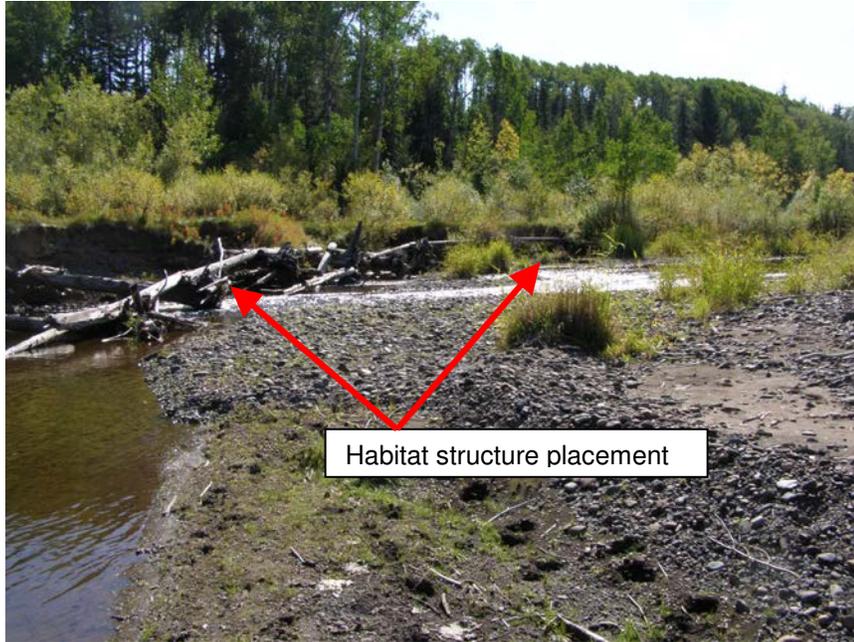
Looking upstream at undercut bank along top end of site.

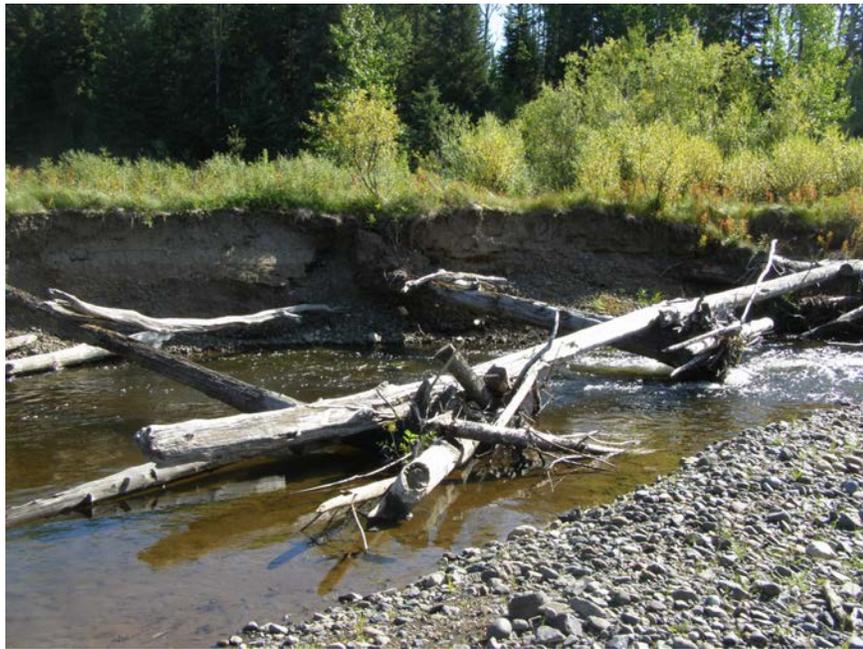
Looking across stream at undercut bank. Habitat structures still provide influence but extreme flows have down cut channel.

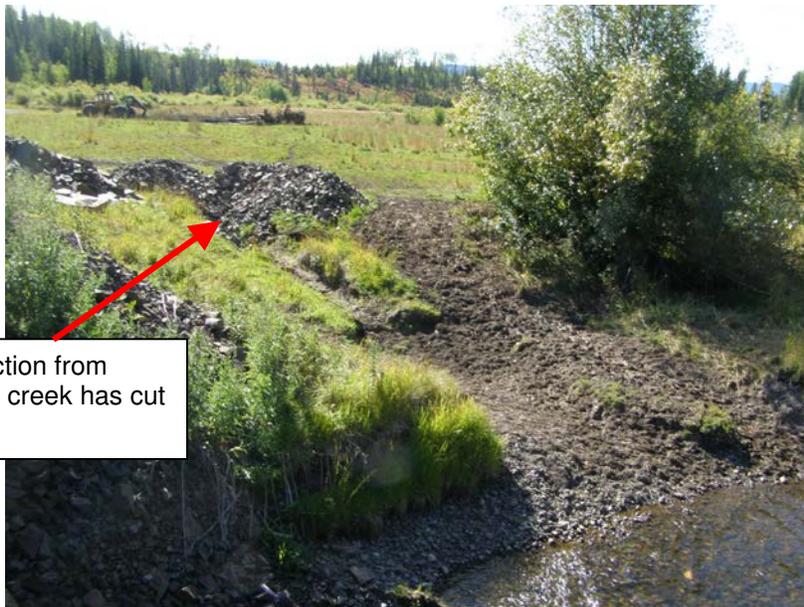
Backcutting action from small seasonal creek has cut ditch

Looking at access on south side of creek. Crush rock to be placed to reduce scouring and erosion during high flows along creeks edge.

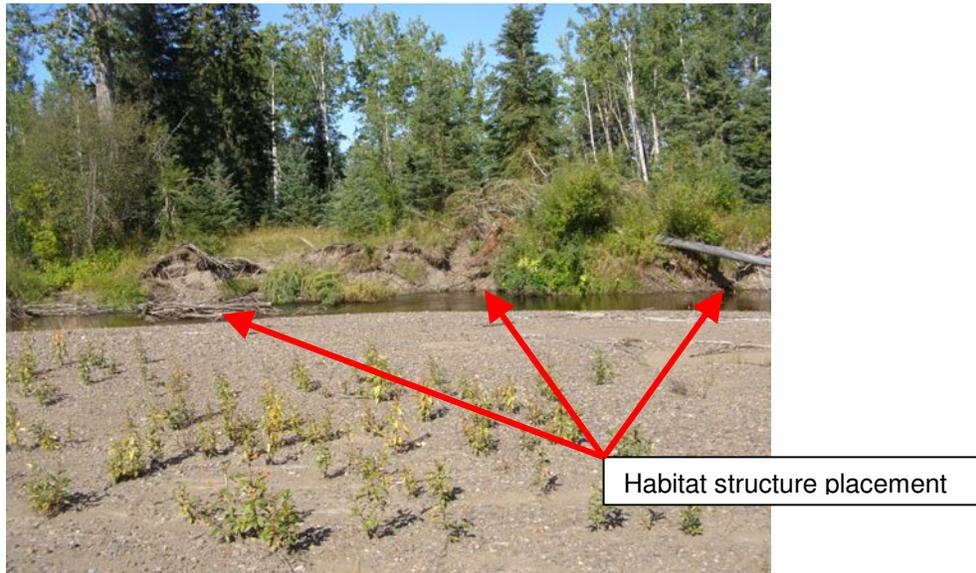
Looking across at cutbank that has migrated back on top end of site. Note cottonwood trees newly established on gravel bar.

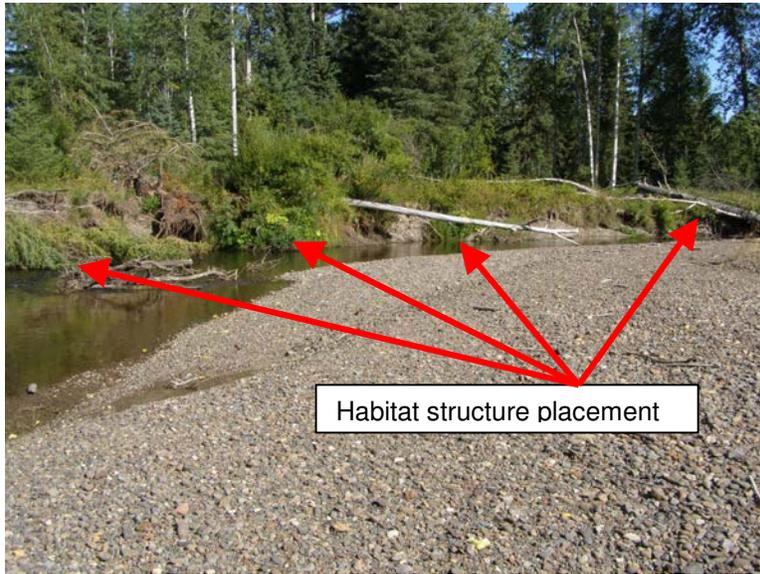
Looking downstream at lower end of site. Creek has migrated over into corner 10 meters

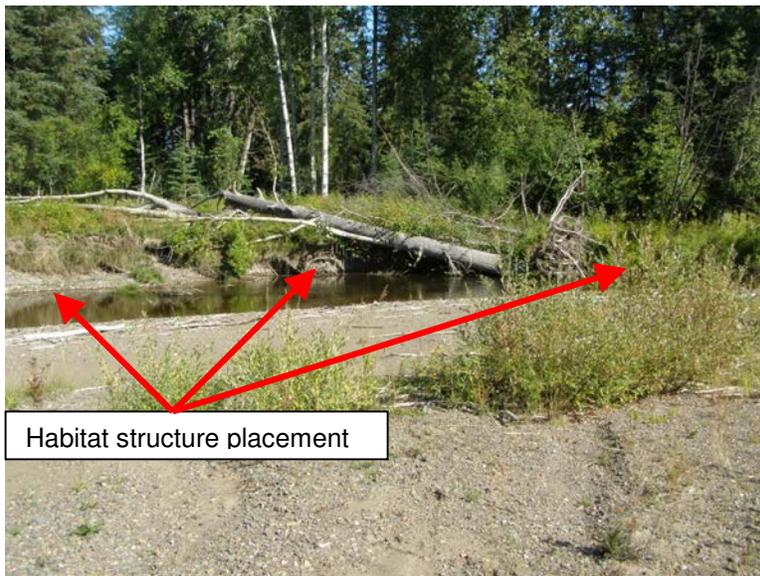
Looking downstream at large cottonwood toppled at lower end of site.

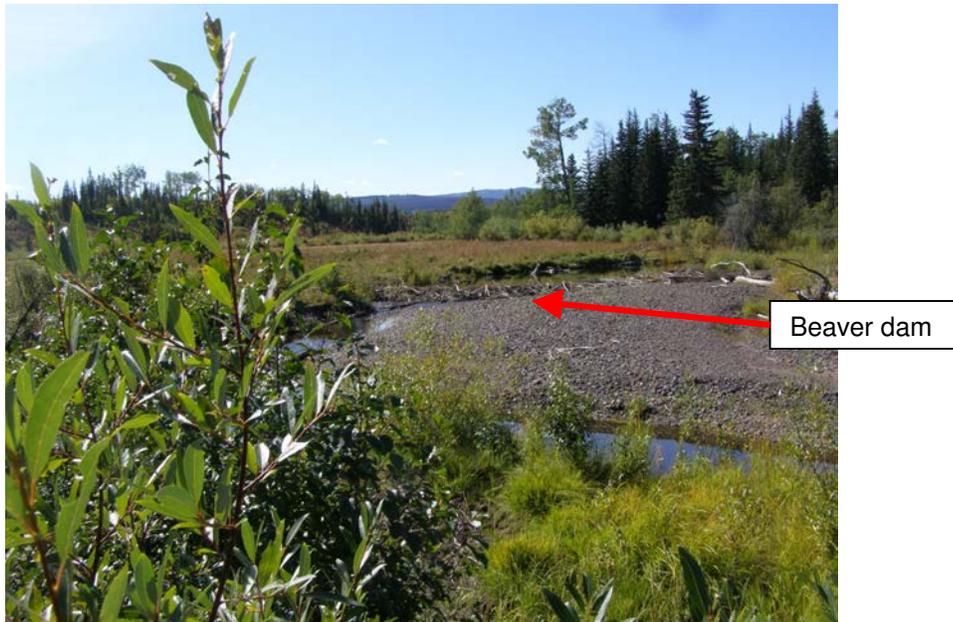
Looking at channel heavily aggraded by channel migration upstream. Beaver dam will be washed out during next freshet.

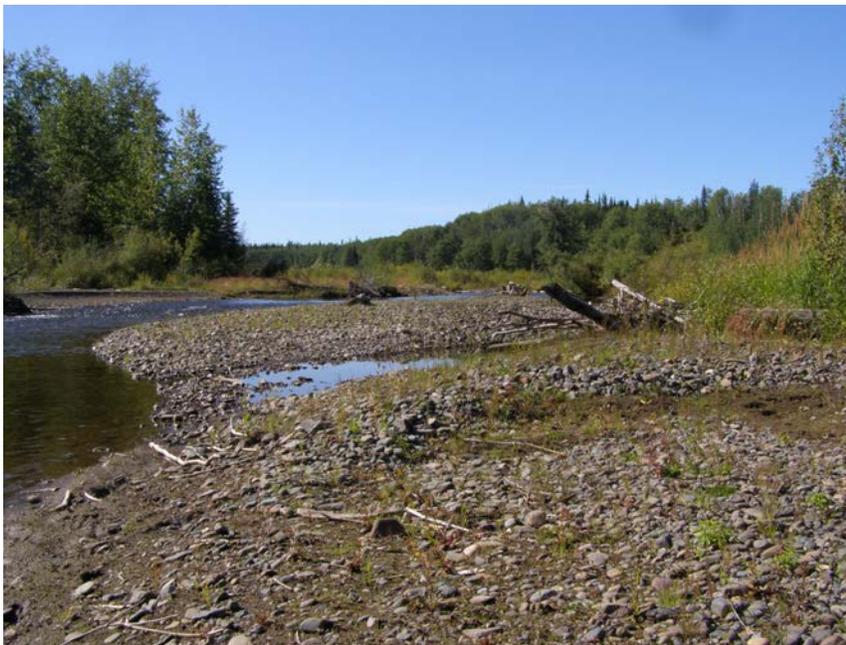
Looking upstream. Bedload accumulation has widened out flow pattern. Low gradient has channel braided with a portion flowing out across pasture downstream

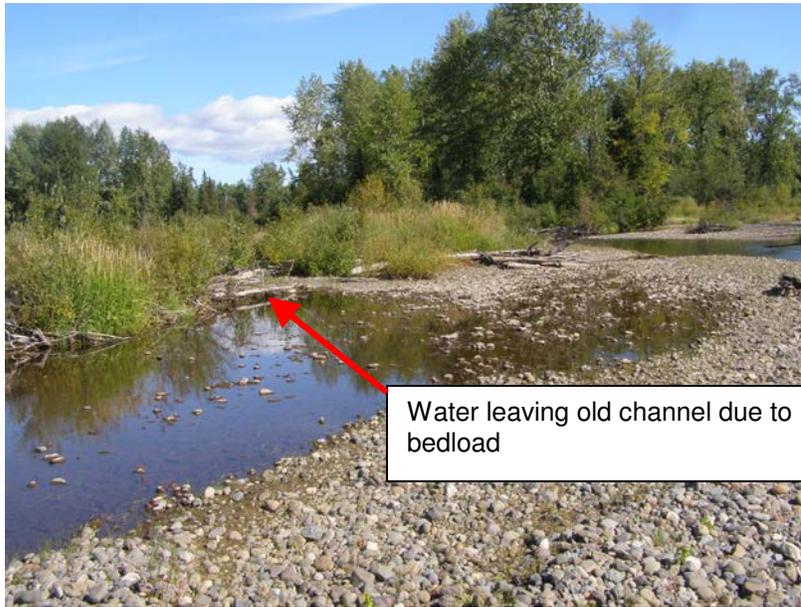
Water leaving old channel due to bedload

Mid channel bar has forced flow pattern to braid

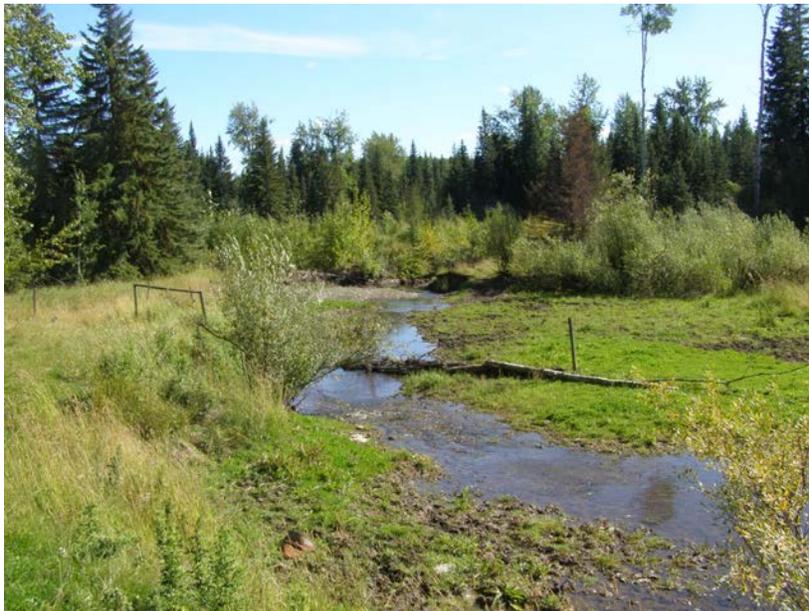
Channel avulsion upstream due to bedload accumulation has creek flowing through pasture.

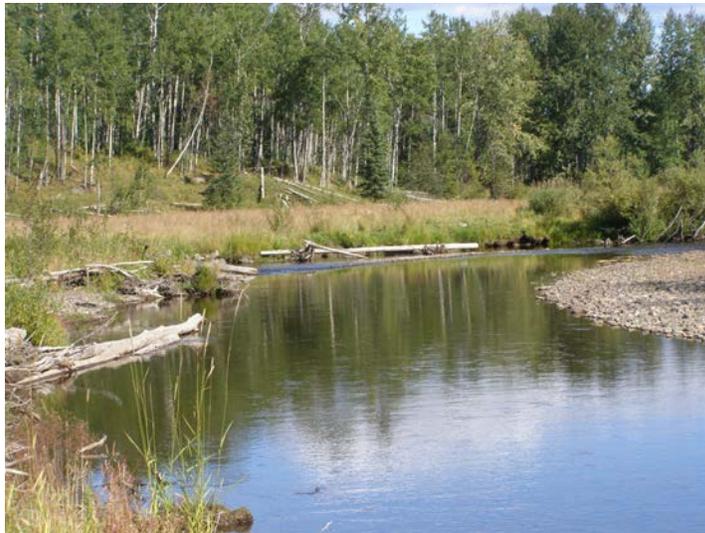
Old restoration works could be upgraded to increase influence.

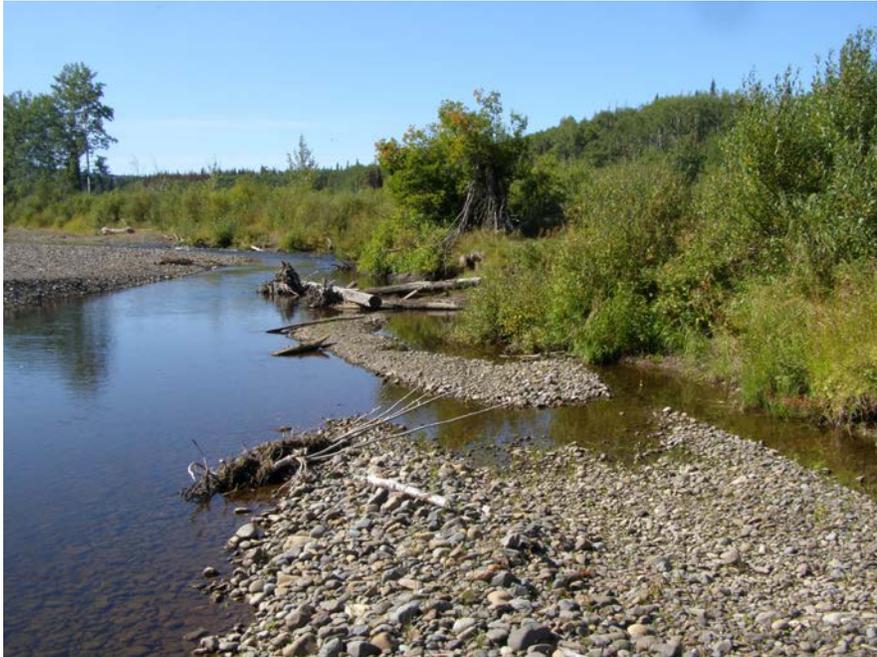
Old restoration works require upgrades along 120 meter section. Channel pattern movement due to bedload has undercut some structures that were constructed of only wood.

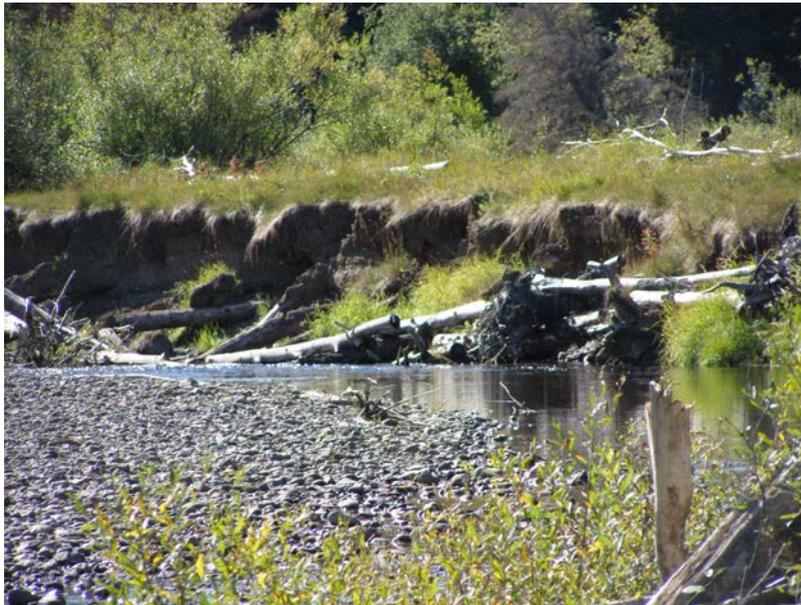
Old restoration works along pasture is failing due to undercutting along toe of bank. Upgrades would see habitat structures push thalweg to center of stream and reduce erosion while creating instream habitat values.

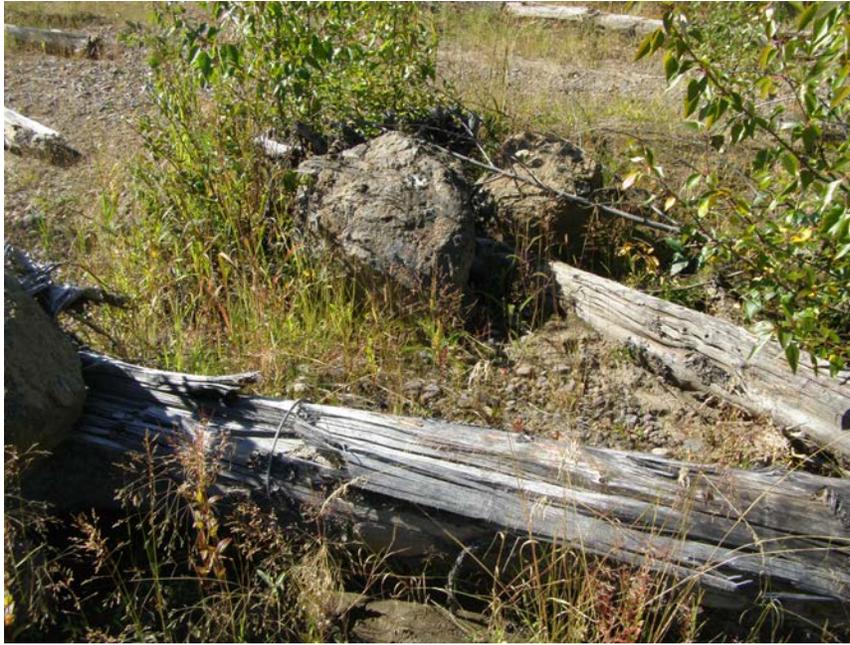
Old restoration works to stabilize gravel bars has worked well as silt has accumulated and vegetation established
