**Fish Passage - Culvert Inspections  
where  
Yellowhead Highway 16 and Singlehurst Road  
cross  
Singlehurst (Swede) Creek**

**March 2006**

**Fish Passage - Culvert Inspections where  
Yellowhead Highway 16 and Singlehurst Road cross Singlehurst Creek  
(Watershed Code 400-232100)**

**Contract 356CS0561**

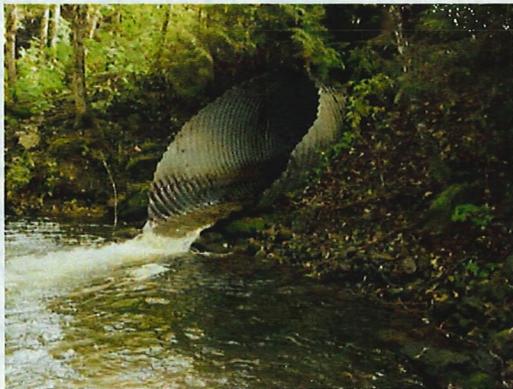
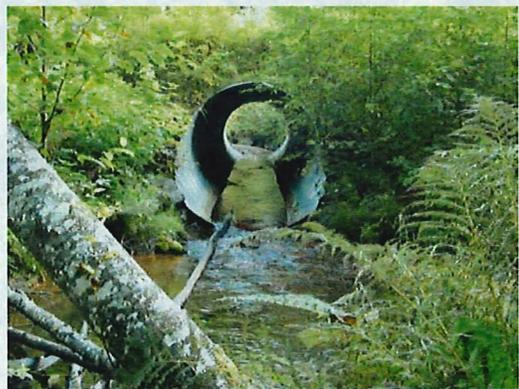
Yellowhead Highway 16 Culvert and broken down fish ladder

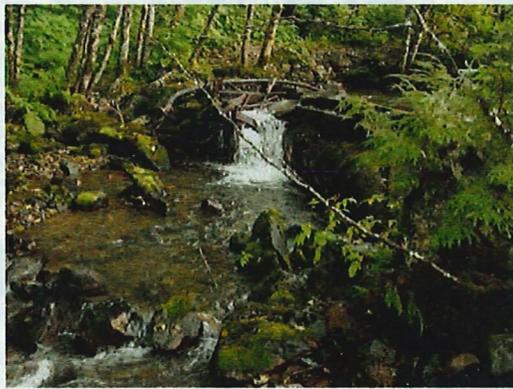
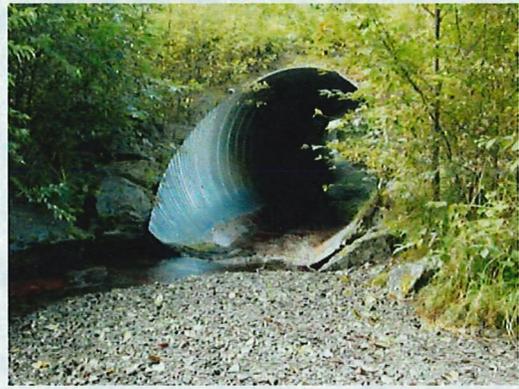
Singlehurst Road Culvert

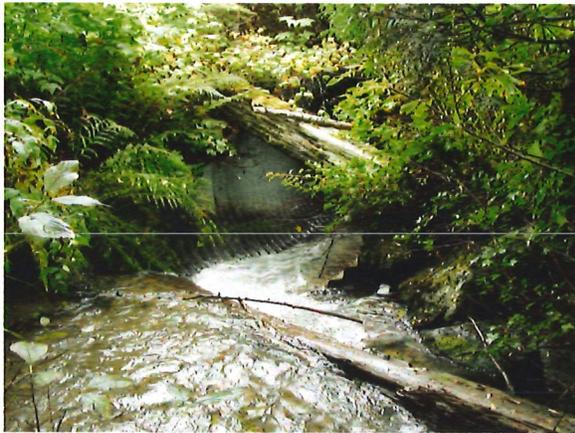
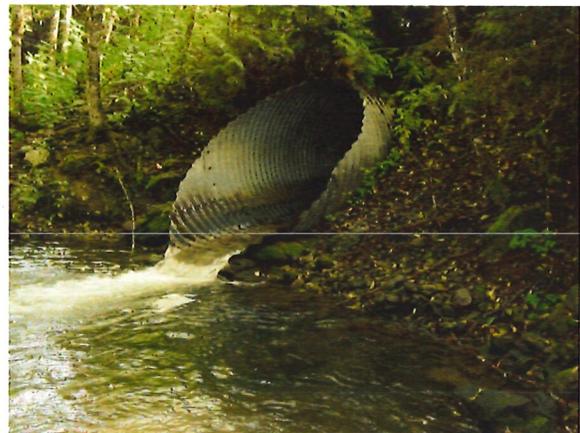
A detailed culvert assessment, including the completion of the Fish Passage - Culvert Inspection form (FPCI form), as outlined by Parker (2000) was conducted on August 23<sup>rd</sup>, 2005 where Highway 16 crosses Singlehurst Creek. The Highway 16 crossing of Singlehurst Creek consists of a 2000 mm diameter culvert that has a gradient of 2.5%, is not baffled or embedded, and had an outfall drop of 12.5 cm (Figure 2). The physical characteristics and the conditions at this location during the site assessment are summarized in table 5. Similar to previous assessments (Rabnett and Williams 2004), the Singlehurst Creek culvert at Highway 16 was noted to be a partial barrier to fish passage. Based on culvert area/diameter relationships in the FPCI procedures, the existing culvert is significantly undersized and is not suitable for considering installation of baffles or backwatering. The recommended size of culvert based on estimated volumes for 100 year flood events for the culvert at Highway 16 would be either 3050 mm round or 3890 x 2690 elliptical if embedded 20%.

**Figure 2.** Downstream view of culvert inlet (left) and upstream view of culvert outlet (right) where Highway 16 crosses Singlehurst Creek.

The long-term objective toward completely restoring fish passage for all species and life stages where Highway 16 crosses Singlehurst Creek will require the eventual replacement of the existing, undersized culvert with an open bottom or well embedded structure that will not restrict natural stream dynamics. The relatively high fish habitat value and fisheries priority score upstream of this culvert make planning and budgeting for the eventual replacement of this structure worth considering. In the interim, some short-term options have been considered to maintain the present level of fish passage since the culvert has withstood past flood events and coho synoptic surveys have indicated that habitat upstream of the culvert has remained productive while the weir downstream of the crossing has been functional.

Although the existing culvert has withstood past flood events, a 3000 mm diameter culvert is recommended based on the FPCI  $Q_{100}$  for Singlehurst Creek even without accounting for fish passage (Parker 2000). Due to the apparently undersized structure at this location, the existing 2000 mm diameter culvert is suspected to be vulnerable to washing out during unusually high flood events, which could have drastic impacts on fish and valuable spawning habitat downstream of this crossing. The installation of baffles at the culvert may assist in reducing water velocity through the existing culvert, but will also reduce the discharge capacity of this structure. Due to the concerns related to engineering restrictions at the existing crossing, no short-term options for restoring juvenile fish passage have been proposed.

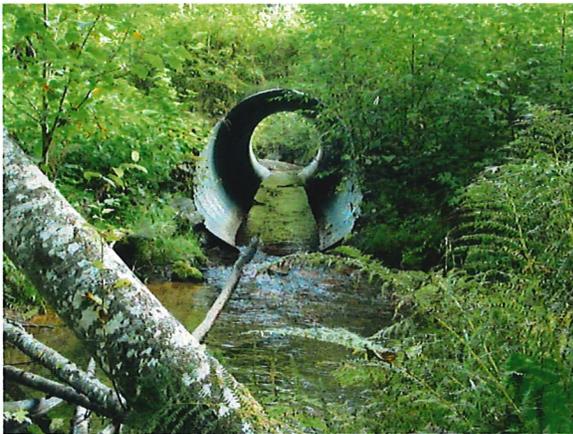
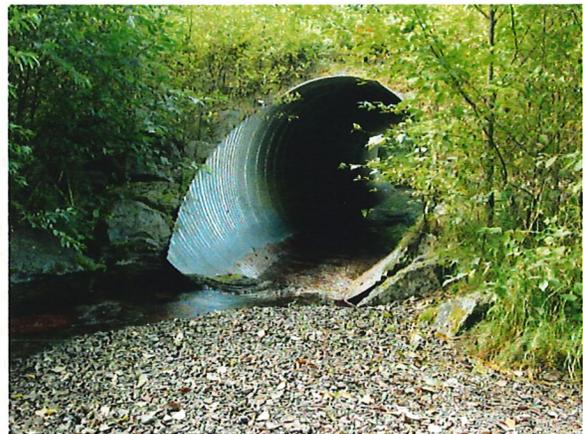
In addition to the culvert assessment at Highway 16, a detailed culvert assessment, including the completion of the Fish Passage - Culvert Inspection form (FPCI form) was conducted on August 23<sup>rd</sup>, 2005 at the Singlehurst Road crossing of Singlehurst Creek. The Singlehurst Road structure was not included in culvert inspections of road crossings along Highway 16 conducted in 2004 (Rabnett and Williams 2004), but was assessed in 2005 to provide a more complete assessment of potential culvert obstructions on Singlehurst Creek. The Singlehurst Road crossing of Singlehurst Creek consists of 3000 mm diameter culvert that has an average gradient of 0.75%, and is not baffled or embedded (Figure 3). The physical characteristics and the conditions at this location during the site assessment are summarized in table 6. Some of the flow at the Singlehurst Road culvert on Singlehurst Creek appears to drain under rather than through the culvert. The existing culvert appears suitable for modifications to facilitate juvenile fish passage because the recommended size of culvert based on estimated volumes for 100 year flood events would be either 3050 mm round or 3890 x 2690 elliptical if embedded 20%.

**Figure 3.** Upstream view of culvert outlet (left) and downstream view of culvert inlet (right) where Singlehurst Road crosses Singlehurst Creek.

m/s) exceeded the prolonged swimming ability for the juvenile life stages of most species in the system, flow was deemed passable along the shallower edges of wetted area through this culvert (Section 3.2, Figure 3). Overall, this culvert is likely passable for most species and life stages, but the higher velocity flow at the inlet to this culvert (1.2 m/s), where the half-pipe portion appeared to be lifting, likely impedes juvenile fish passage at some flows (Section 3.2, Figure 3). Notably, the culvert water depth (26 cm) was below the recommended minimum depth for adult anadromous fish (30 cm), but was above the minimum recommended depth for resident trout (15 cm) (Votapka 1991 as in Parker 2000) and did not appear to effect either adult or juvenile fish migration during the low summer flows at the time of survey. One pair of pink salmon was observed approximately 200 metres upstream of this crossing and this implies that the adults of all species documented in the system are also able to migrate through the culvert since pink salmon are reported to have the weakest swimming abilities (Table 2). This culvert stream crossing was considered to be a partial barrier to fish passage due to it not being embedded or baffled, and because the lifting half-pipe portion of the culvert at the inlet appears to impede juvenile migration at some flows.

The long-term objective toward completely restoring fish passage for all species and life stages where Singlehurst Road crosses Singlehurst Creek will require the eventual replacement of the existing culvert with an open bottom or well embedded structure or the use of baffles and weirs that will prevent flow from scouring under the culvert and improve fish passage for juvenile life stages. The presence of some good fish habitat and the assignment of a moderate fisheries priority score upstream of this culvert make planning and budgeting for the eventual improvement of fish passage at this structure worth considering.

The immediate replacement of the existing culvert with an open bottomed structure is not recommended since the structure appears to be large enough to handle significant flood events based on the FPCI  $Q_{100}$  taken at this location. However, in order to restore juvenile fish migration at all flows and to prevent the creek from scouring under the existing culvert, it is recommended that some restoration of fish passage be conducted in conjunction with future culvert repairs. Plans for culvert repairs or significant maintenance projects at this location should include designs for bank stabilization upstream of the road to confine flow more directly into the culvert opening, in conjunction with sufficient backwatering and weir construction downstream of the culvert to allow the culvert to be 20% embedded with a relatively low gradient. A series of natural rock weirs constructed downstream of this culvert should be designed to ensure minimal maintenance and to make water depths through the culvert greater than 30 cm during low summer flows. In the interim, it is suggested that the culvert at Singlehurst Road should be regularly monitored due to the evidence of flow under a lifting portion of the culvert inlet that could increase the priority for work at Singlehurst Road or may result in a significant impact on fish and fish habitat downstream.

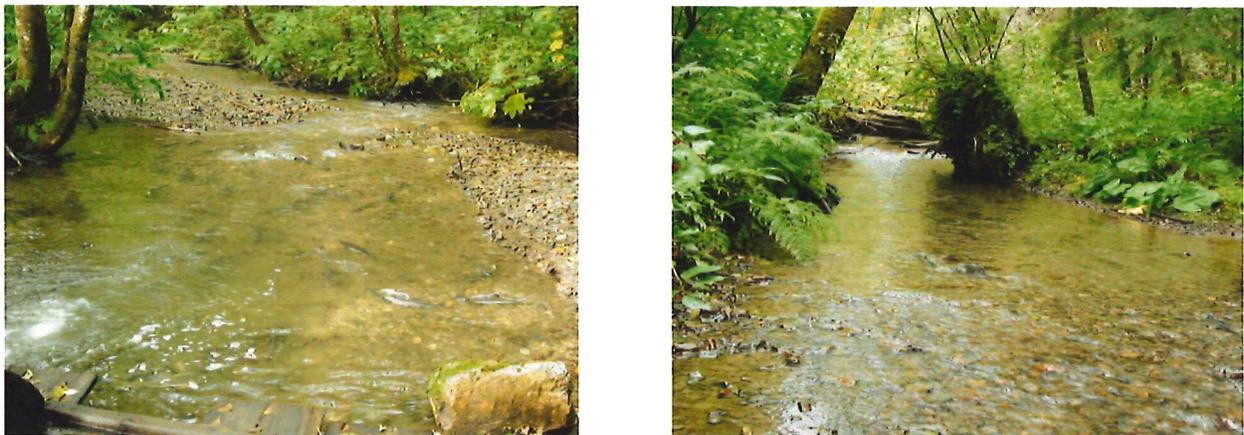
**Figure 4.** Downstream view from culvert outlet where pink salmon are congregated and spawning (left) and upstream view approximately 80 metres upstream of culvert (right) where Highway 16 crosses Singlehurst Creek.

Approximately 200 pink salmon were observed in the 200 metre section of stream surveyed immediately downstream of the culvert. The stream channel was significantly influenced by the log weir structures for approximately 50 metres downstream of the culvert so channel measurements started ~80 metres downstream of the culvert. Excellent spawning and good potential rearing habitat was observed throughout the entire section surveyed.

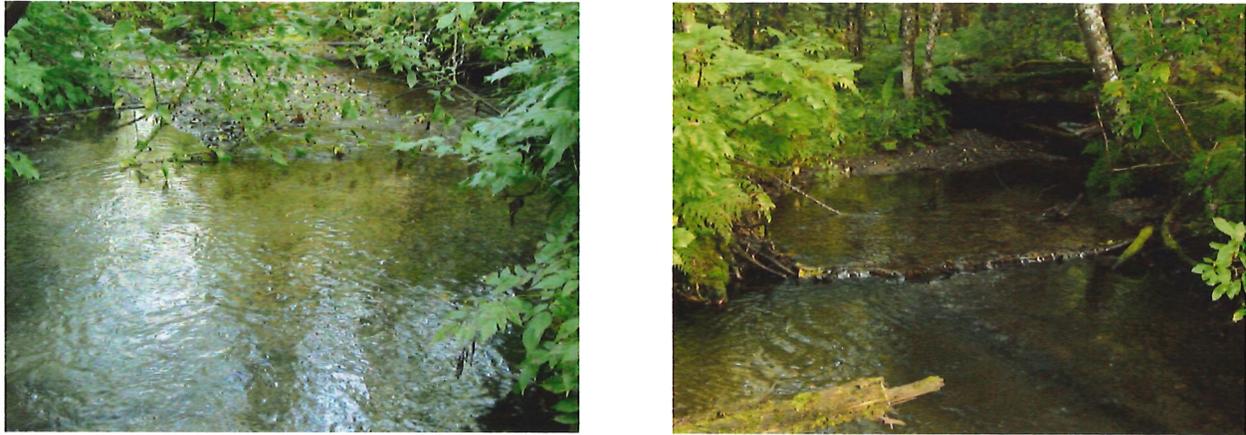
**Figure 5.** Downstream view (left) and upstream view (right) of Singlehurst Creek from Singlehurst Road.

Heavy deposits of fine sediments were observed downstream of the culvert, but numerous deep pools and glides with cutbanks, overhanging vegetation and functioning large woody debris appeared to provide excellent rearing habitat. Very limited potential spawning habitat was observed for 200 metres downstream of the culvert and only five pink salmon were observed holding in the 200 metre section surveyed.

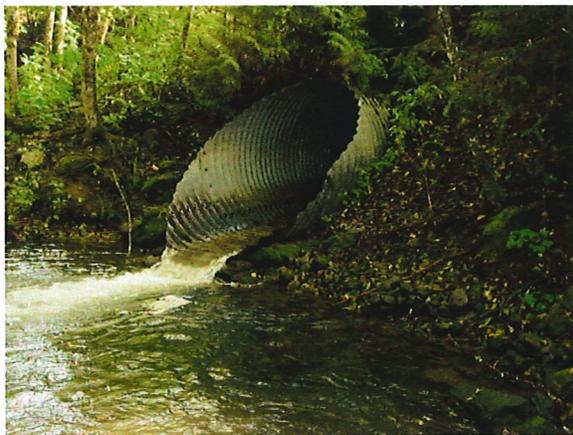
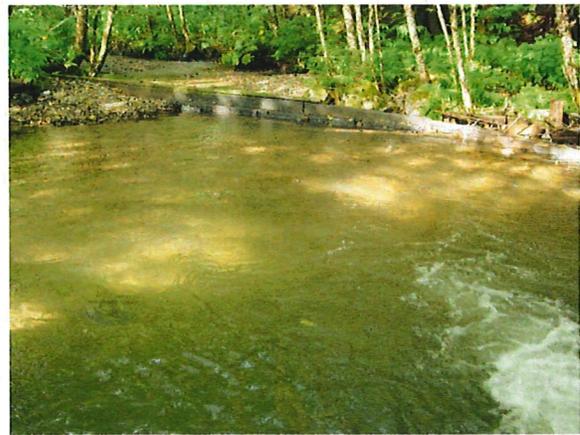
Prior to 1978, the drop from the culvert outlet located where Highway 16 crosses Singlehurst Creek was approximately 1.7 metres and was a full barrier to fish passage (Rabnett and Williams 2004). In 1978, Fisheries and Oceans Canada (FOC) installed two log weirs downstream of the culvert (Figures 6 and 7) in order to restore fish passage (Southgate 1978 as in Rabnett and Williams 2003, Hancock *et al* 1983 as in Rabnett and Williams 2004). An approximately 2 metre wide, 10 metre long side channel was added on river left, with boulder step pool morphology in conjunction with a wood fish ladder parallel to the log weir to aid in fish passage past the weir (Figure 7). Since the placement of this weir, the culvert has been reported to be a partial barrier to fish passage, and a significant obstruction to fish passage for some life stages (Rabnett and Williams 2004). This site was visited on August 23<sup>rd</sup> 2005, to re-assess the conditions and severity of obstruction to fish migration of the culvert and weir located where Highway 16 crosses Singlehurst Creek.

At the time of survey, the length and size, shallow water depth, and moderate water velocity in this culvert appeared to significantly impede fish migration. The outfall drop at the Highway 16 culvert (12.5 cm) did not form an obstruction to fish migration due to an approximately 1.4 metre deep pool at the outlet that was created by the backwatering effect of the log weir that was installed by FOC in 1978. Culvert slope (2.5%) exceeds the maximum recommended culvert slope of un-baffled culverts greater than 24 m in length (0.5%) (Parker 2000) and water velocity at the Highway 16 culvert (2.15 m/s) exceeds the burst and prolonged swimming abilities reported for all juvenile salmonids that utilize Singlehurst Creek for rearing habitat. In addition, water velocity in this culvert is in the upper range of the prolonged swimming abilities reported for adult chum and pink salmon in the literature (table 2). Water depth in the culvert (32 cm) was also near the minimum recommended water level in culverts requiring adult salmonid passage (30 cm, Parker 2000) at the time of survey. Pink salmon were observed struggling to swim the entire length of this culvert at the time of survey, and the few that were accidentally chased downstream into the culvert inlet were washed all the way downstream to the outlet.

**Figure 6.** Upstream view of approximately 12.5 cm drop from culvert outlet (left) and downstream view of deep pool and top of first weir downstream of the culvert outlet where Highway 16 crosses Singlehurst Creek.

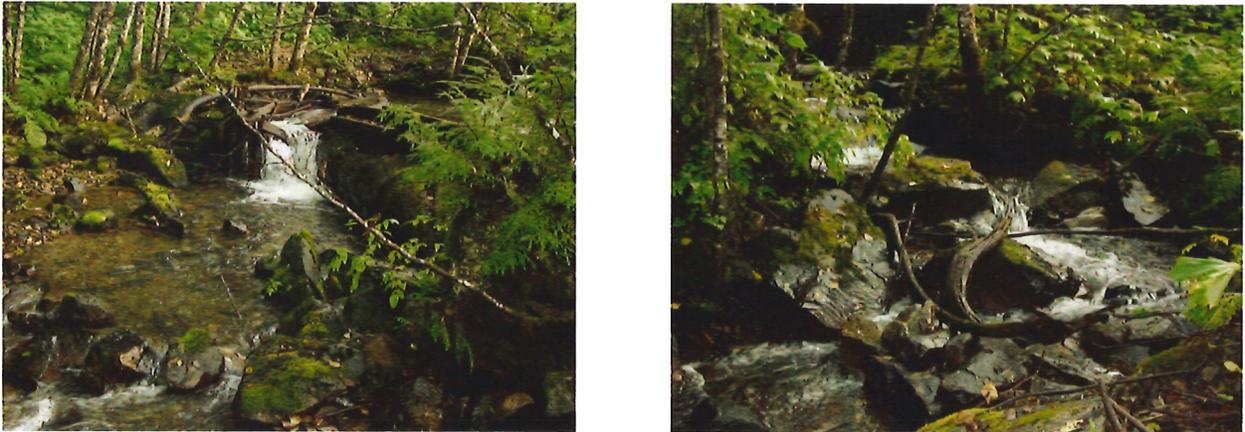
**Figure 7.** Upstream view of log weir structure with broken wood fish ladder (left) and 12% gradient, boulder side channel beside the log weir (right) in Singlehurst Creek at outlet from the Highway 16 culvert.

The log weir structures located immediately downstream of the culvert are in need of restoration efforts if replacement of this culvert is not planned for in the immediate future. The effective culvert drop is expected to increase and may form an additional obstruction if the deteriorating log structure at the culvert outlet is not upgraded or replaced. The lower weir was embedded in the stream bed and was hardly visible at the time of survey. The upper weir was located approximately 8 metres downstream from the culvert outlet and creates an approximately 1.4 metre drop into a very shallow pool that is filled with gravel and cobble. Pink salmon were observed attempting to jump this barrier without success. Remnants of the wooden fish ladder that was originally placed parallel to the log weir was not functional at the time of survey (Figure 7). The side channel on river left of the upper weir that was constructed with boulder step pools was also degraded and appeared to be significantly impeding fish passage at the time of survey (Figure 7). The presence of approximately 80 fish immediately downstream of the weir and only a few fish in the pool above the upper weir at the time survey suggests that the weirs below this culvert were a significant obstruction to pink salmon migration with the flow conditions at the time of survey.

The culvert located where Highway 16 crosses Singlehurst Creek was obstructing juvenile fish passage due to velocity barriers, and a combination of the culvert and failing weir structures appeared to obstruct adult fish migration at some flows. This crossing was confirmed not to be a full barrier to fish passage, as indicated by the presence of pink salmon spawning upstream of the crossing. Since adult pink salmon are known to have relatively poor jumping and swimming abilities (Tables 1 and 2), adults of all salmonid species documented to use Singlehurst Creek are likely able to migrate upstream through the existing structure. However, fish passage at the Highway 16 crossing may be further jeopardized if the failing log weir structure is not repaired or replaced.

The primary objective in the short term should be to restore, maintain, and possibly improve adult fish migration through the existing culvert and to prepare to mitigate any potentially disastrous flood events. Presently, the log weir downstream of Highway 16 has significantly deteriorated, and this crossing will soon return to being a full barrier to fish passage. The existing, but failing log structure that was constructed to reduce the effective height of the culvert outfall, still provides some backwatering up to the culvert outlet, but is in need of repair. The lumber portions of the weir appeared unstable, the wooden fish ladder up to the culvert pool has collapsed, and boulders used to construct the step pool morphology in the side channel have been displaced. In conjunction with increasing the height of the upper weir by about 20 cm, a new fish ladder should be constructed parallel to the log weir, and the step pools in the side channel around the weir should be restored. Consideration should also be given to the construction of a short series of smaller weirs upstream of the culvert in order to lower the presently elevated channel and reduce water velocity at the culvert inlet.

In summary, it is recommended that planning and budgeting occur for the eventual replacement of the somewhat undersized culvert located where Highway 16 crosses Singlehurst Creek, and immediate attention be given toward restoring and maintaining the deteriorating fish weir to ensure that fish passage
