# Reconnaissance (1:20,000) Fish and Fish Habitat Inventory in the Morice River Watershed

**TRITON**

Environmental Consultants Ltd.

Project Name Morice River Fish Inventory - 1999

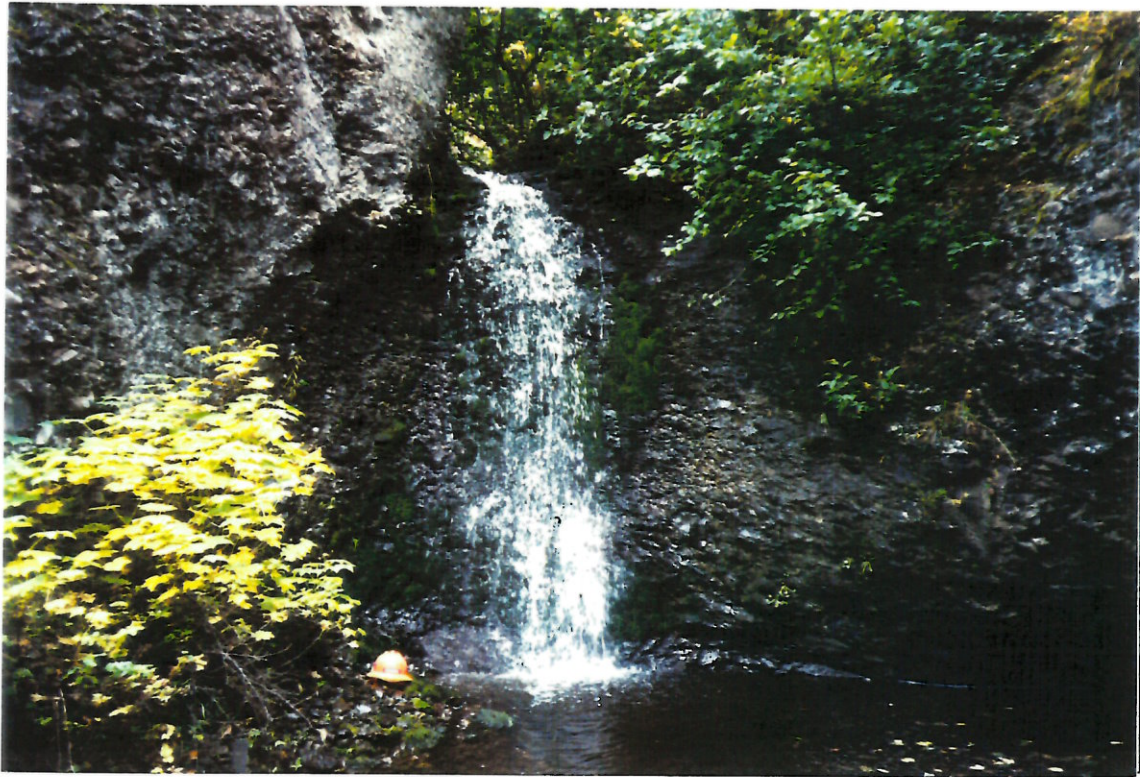
Photo #: 24 - 1

Site 249, upstream view of 3 m falls adjacent to corner of cutblock.

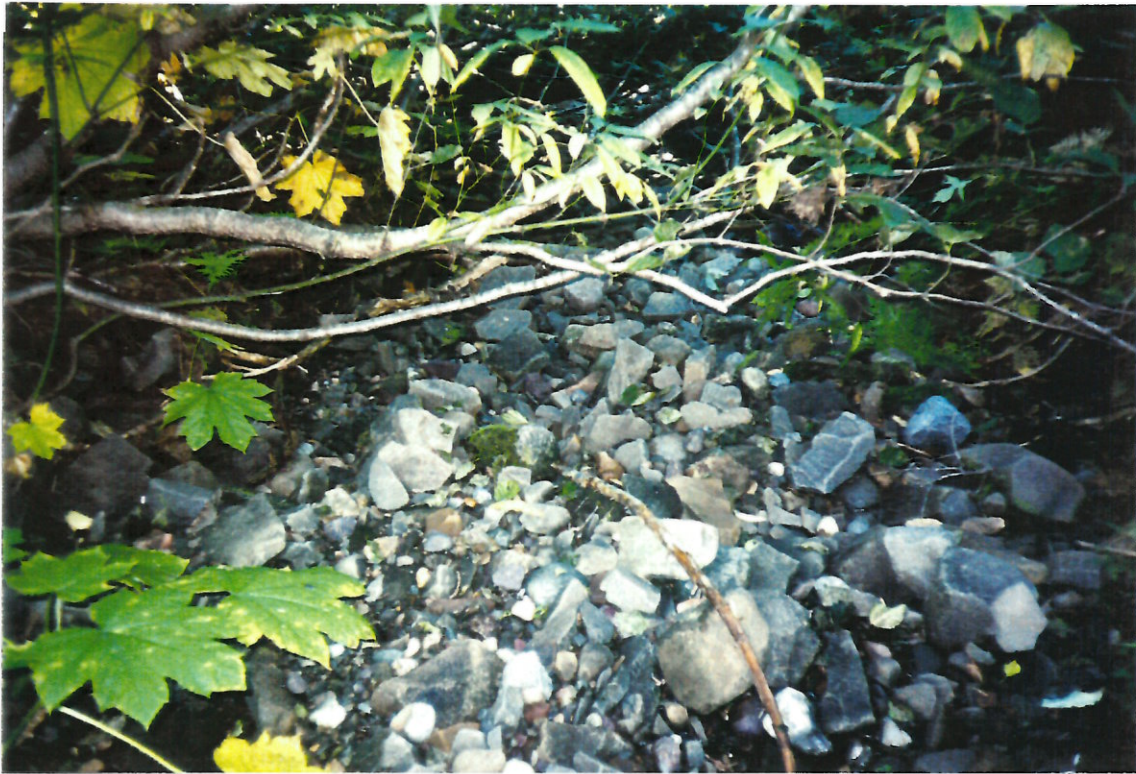
| Form | Section | Comments |
|---|---|---|
| SITE | CHANNEL | Substrate size will create numerous cascades, combined with flashy nature would prevent access |

Photo #: 24 - 14  
Site 254, downstream view of dry cobble/boulder field, impassable to fish.

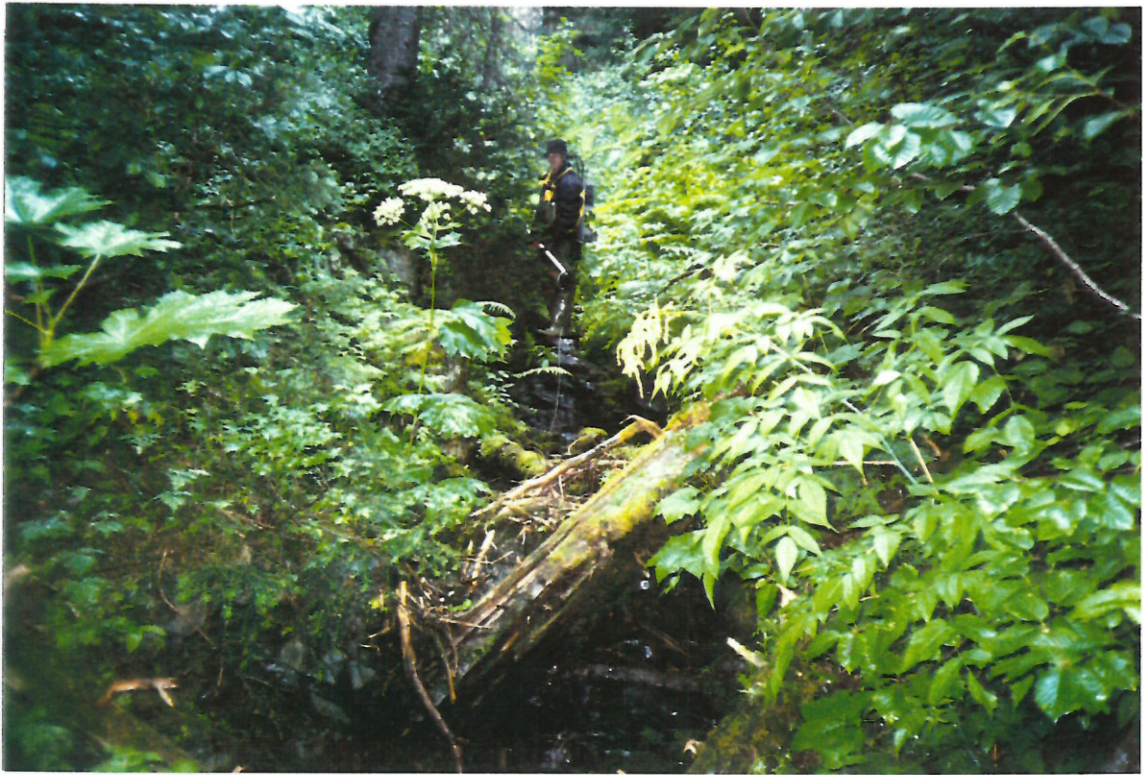
Photo #: 1 - 19  
Site 307, looking upstream at falls, 1.9m.

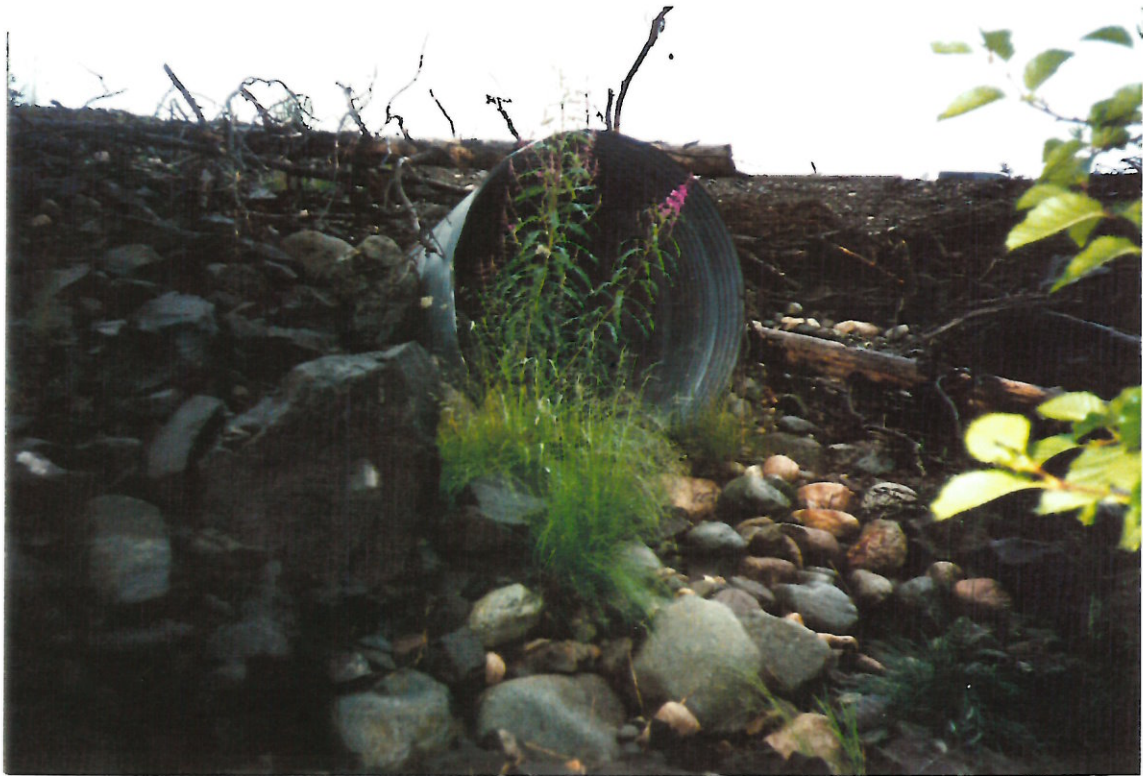
Photo #: 2 - 4  
Site 311, looking upstream at culvert perched 2m CV (1.4m).

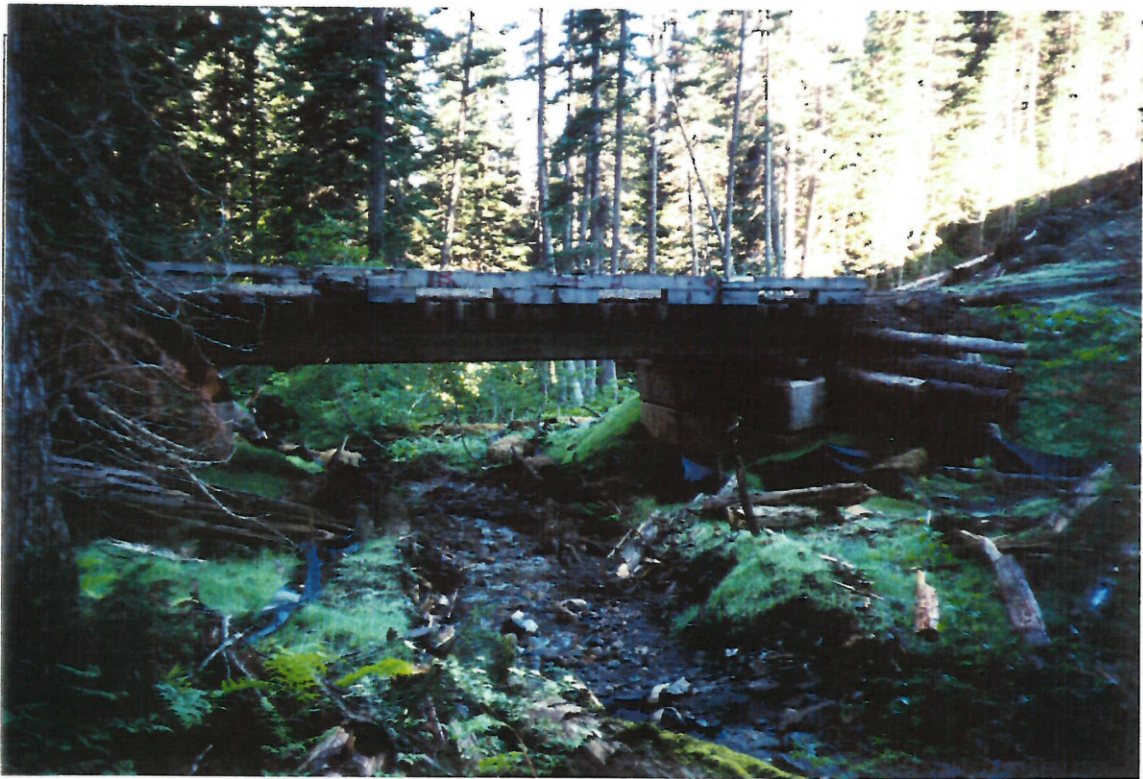
Photo #: 2 - 24  
Site 318, looking downstream at bridge in poor shape - erosion.

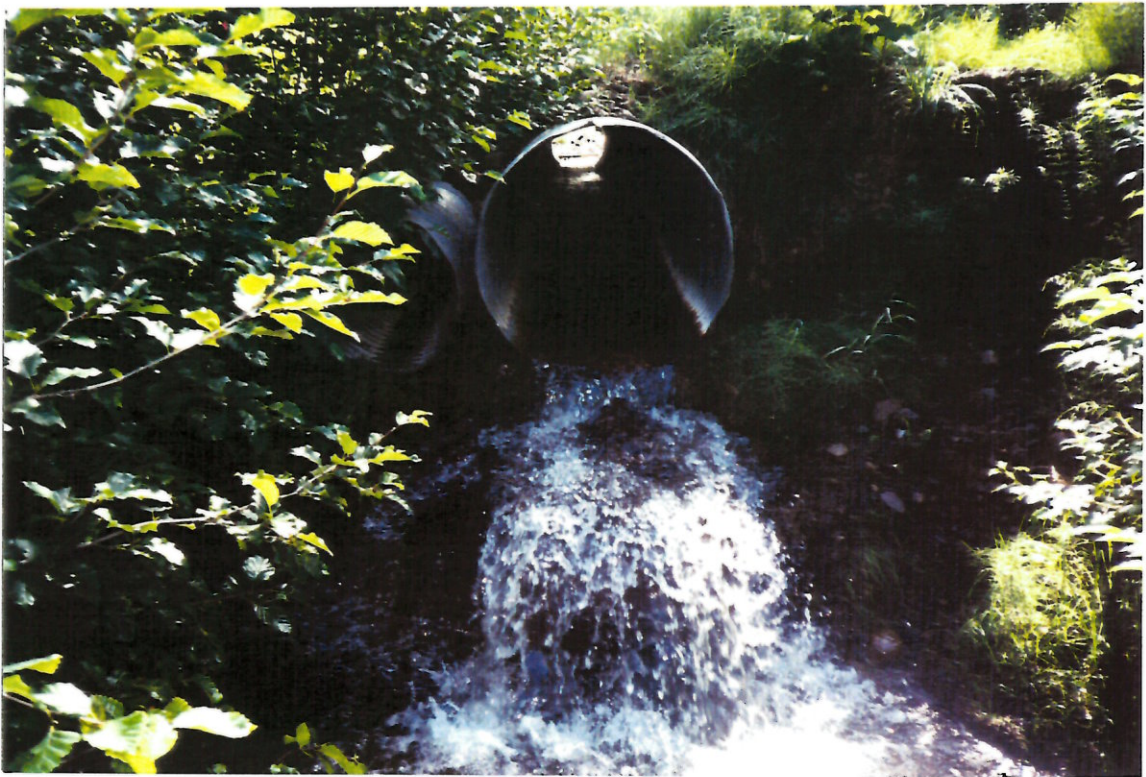
Photo #: 2 - 30  
Site 319, looking upstream at barrier to u/s fish migration (1m CV).
