Level I Detailed Field Assessment of Aquatic and Riparian Habitat for Coldwater Creek in the Lakelse River Watershed

Prepared for Ministry of Environment

BioLith Scientific Consultants Inc.

March 31, 1999

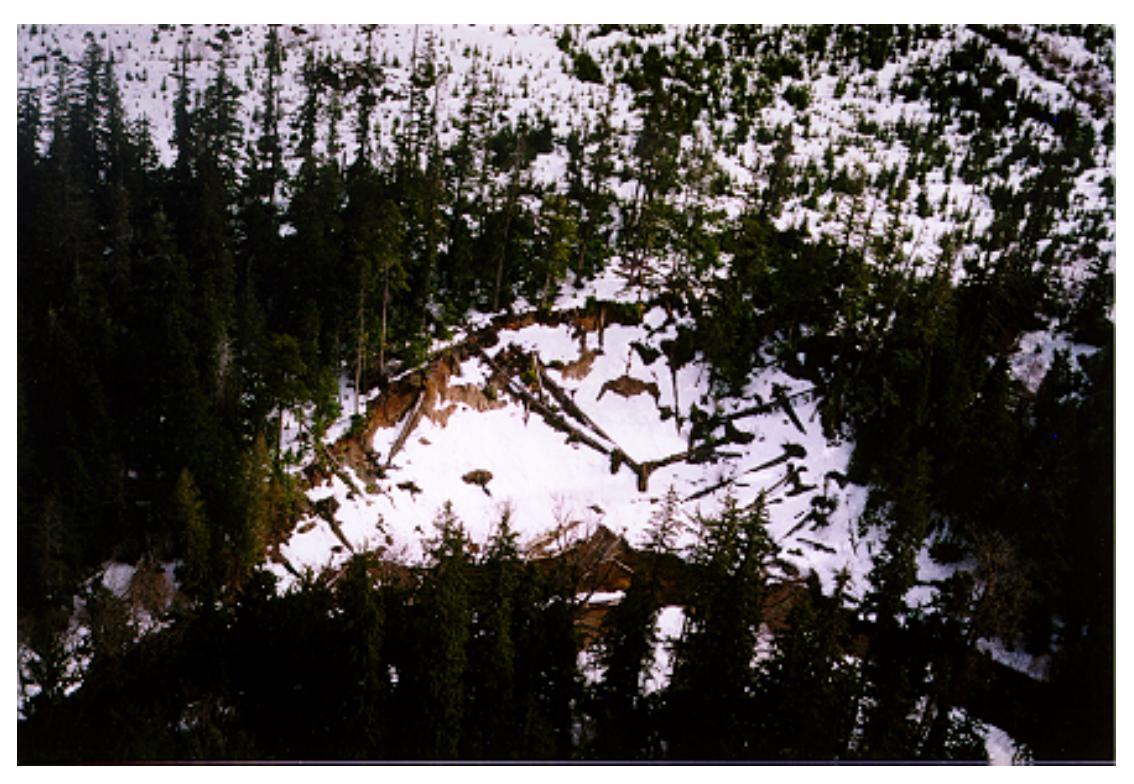
• There was significant bank erosion at a number of sites throughout the reach.

Photo 1. Looking east at a large eroding bank that was breaching through the buffer strip into the cut block.

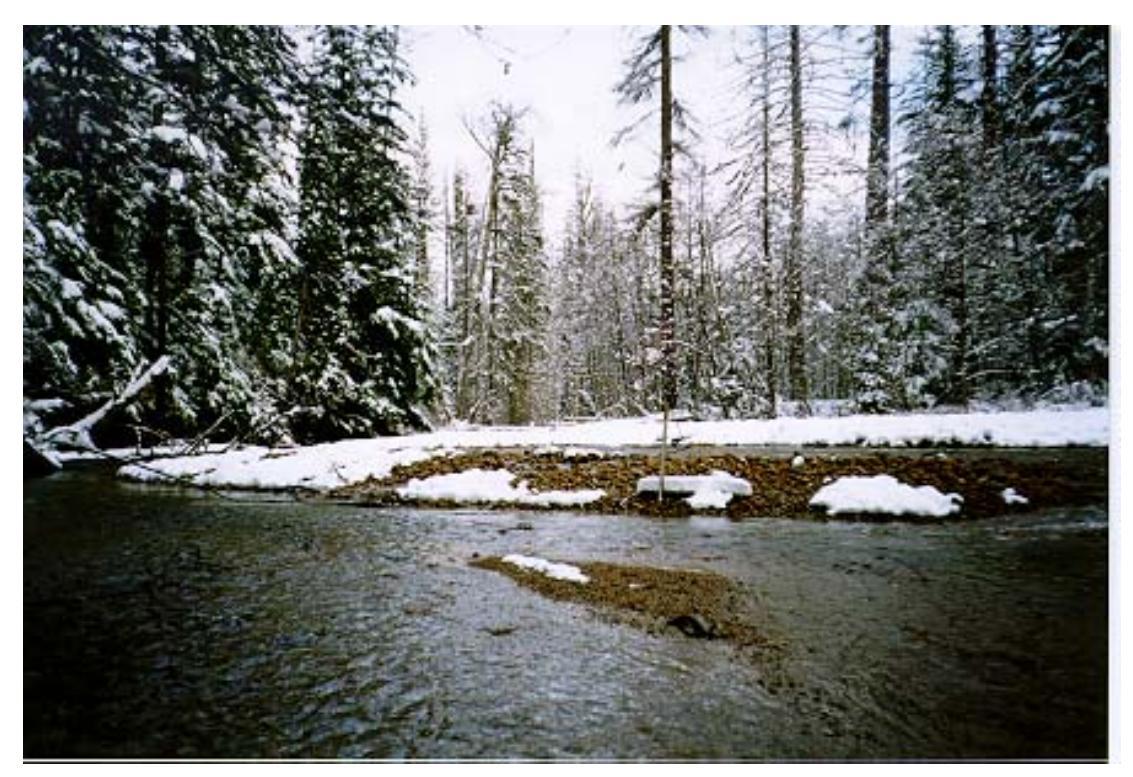
• There was an excess of bedload sediment moving through Reach 1 and, in some places of deposition, aggrading the channel.

Photo 2. Looking northwest downstream at Coldwater Creek junction from Johnstone Creek. Note the elevated bar in Coldwater Creek.

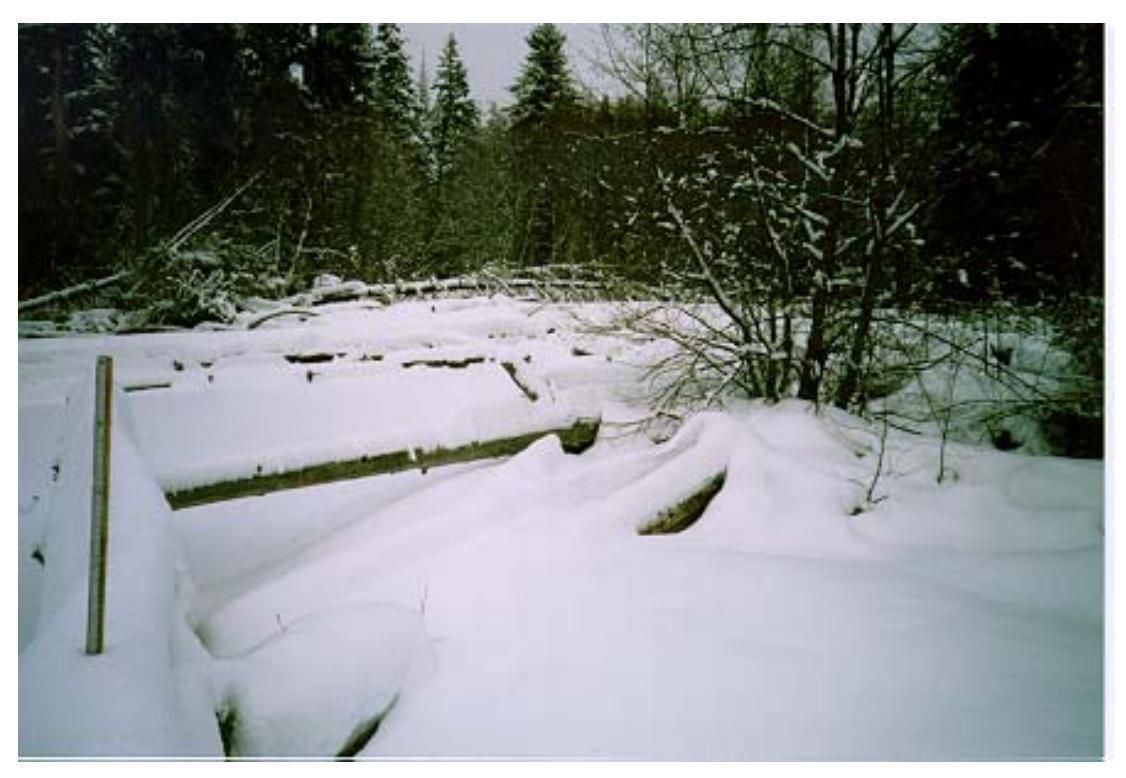
There were some large log jams, especially in the upper part of the reach. These were likely increasing the channel instability downstream but contributed to creating good fish habitat at the jams.

Photo 3. Looking north downstream at logjam and main Coldwater channel at 702 meters below the second bridge site.

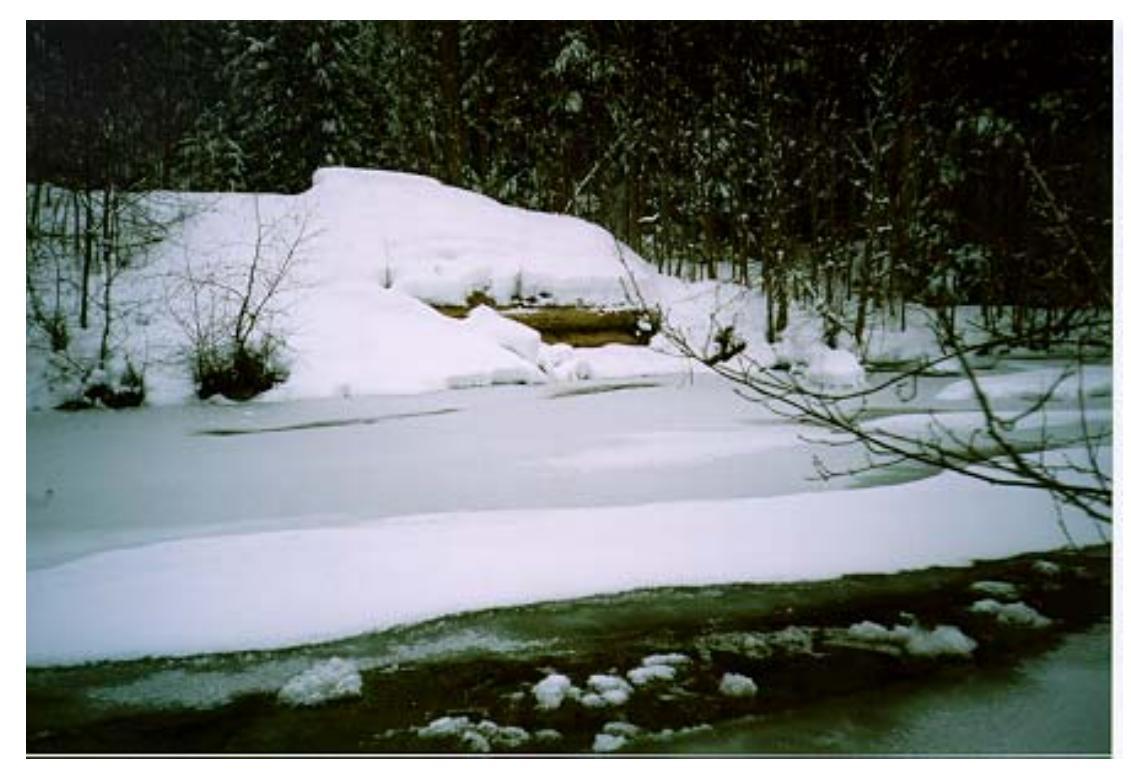
Two former bridge sites were considered unstable.

Photo 4. Looking east at bridge cribbing at second bridge site over the Coldwater.

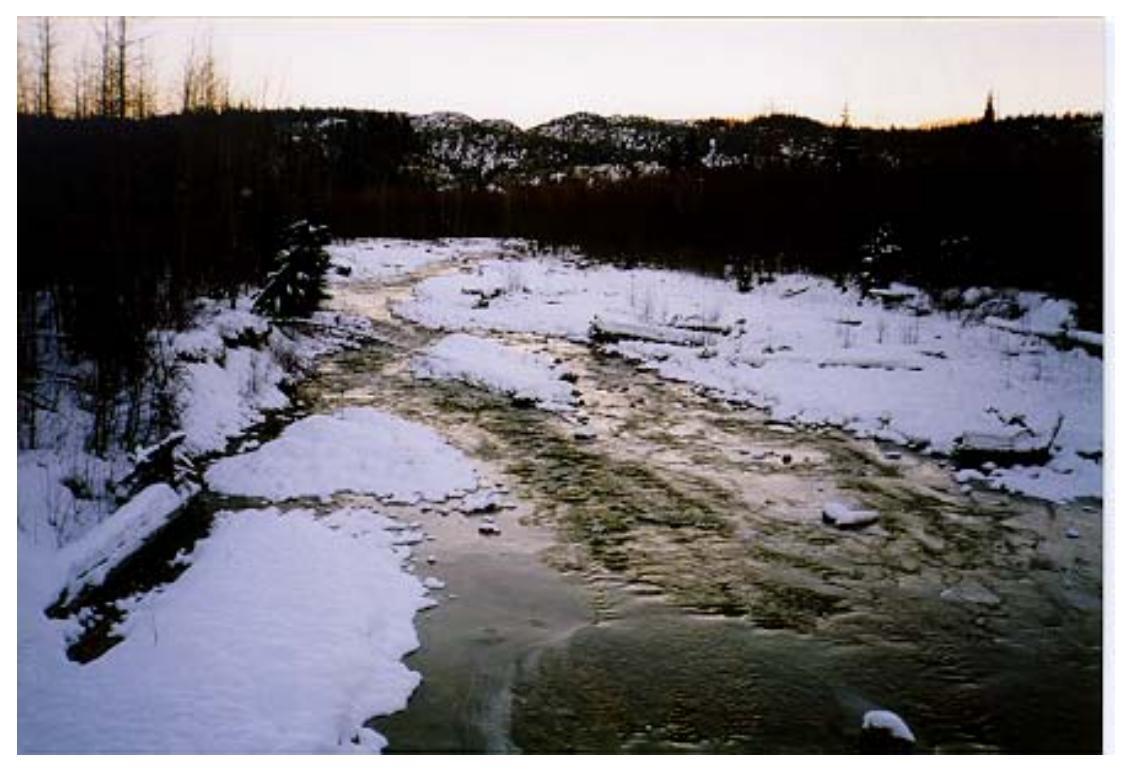
- The channel in Reach 2 was very unstable.
- There was an excessive amount of bedload sediment in the channel and deposited in elevated bars.
- There was a general lack of cover for fish.
- The denuded bars were up to 90 m wide.

Photo 5. Looking downstream from the Lakelse FSR bridge over Coldwater Creek. Note the widely eroded channel.

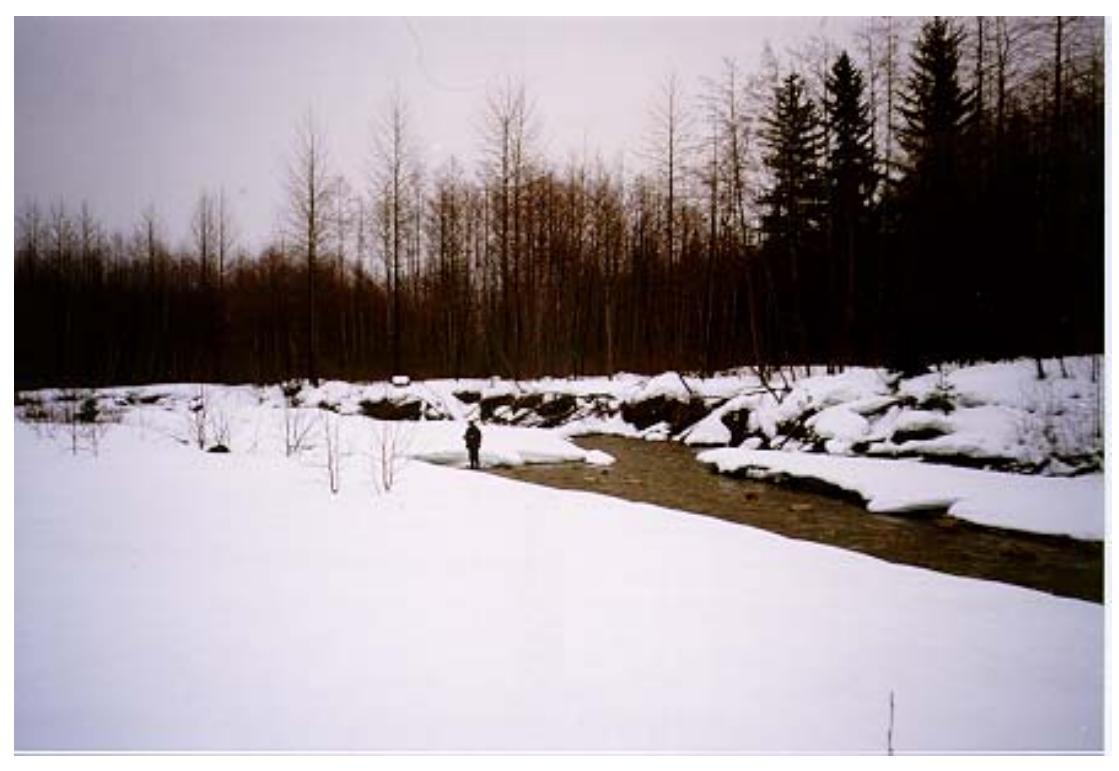
- LWD in the reach was perched on the elevated bars and was non-functional.
- The riparian area had been logged to both banks below the main bridge.
- There was significant bank erosion throughout this reach.

Photo 6. Looking downstream and SE from approximately 200 m d/s from the main bridge. This photo shows the extend of erosion in this area, where the denuded floodplain was >80 m wide.

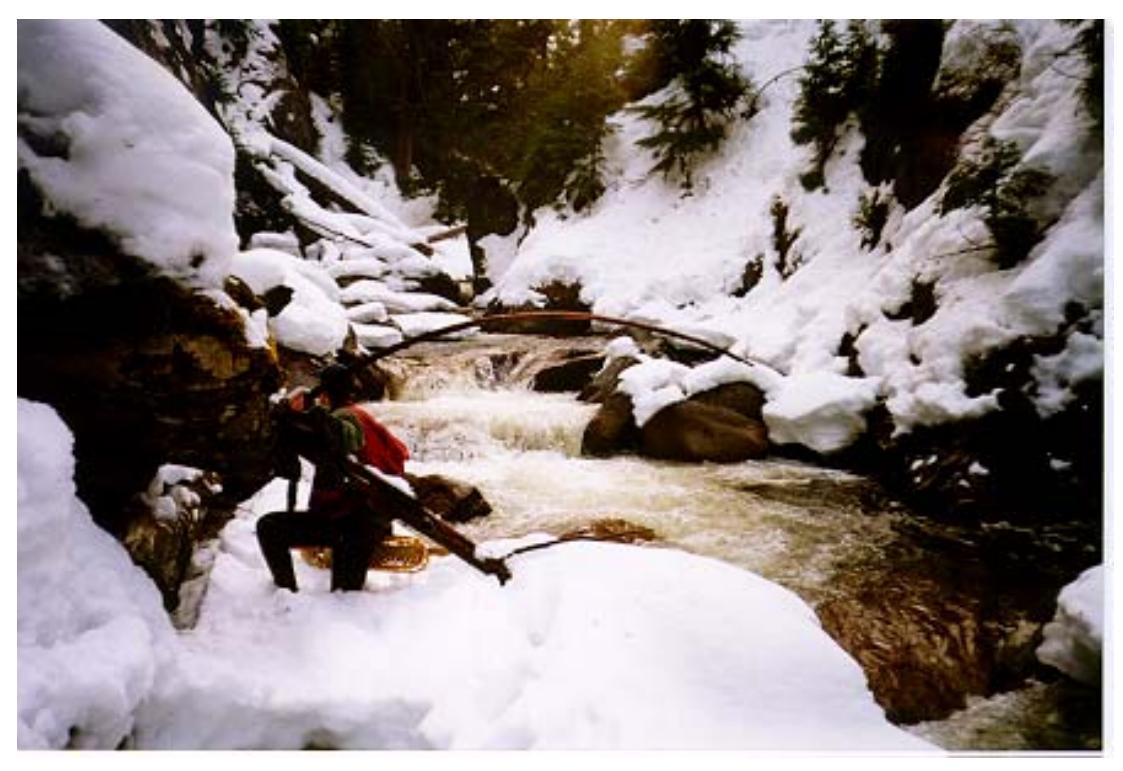
Photo 7. Looking west upstream in Coldwater Creek canyon above main FSR bridge.

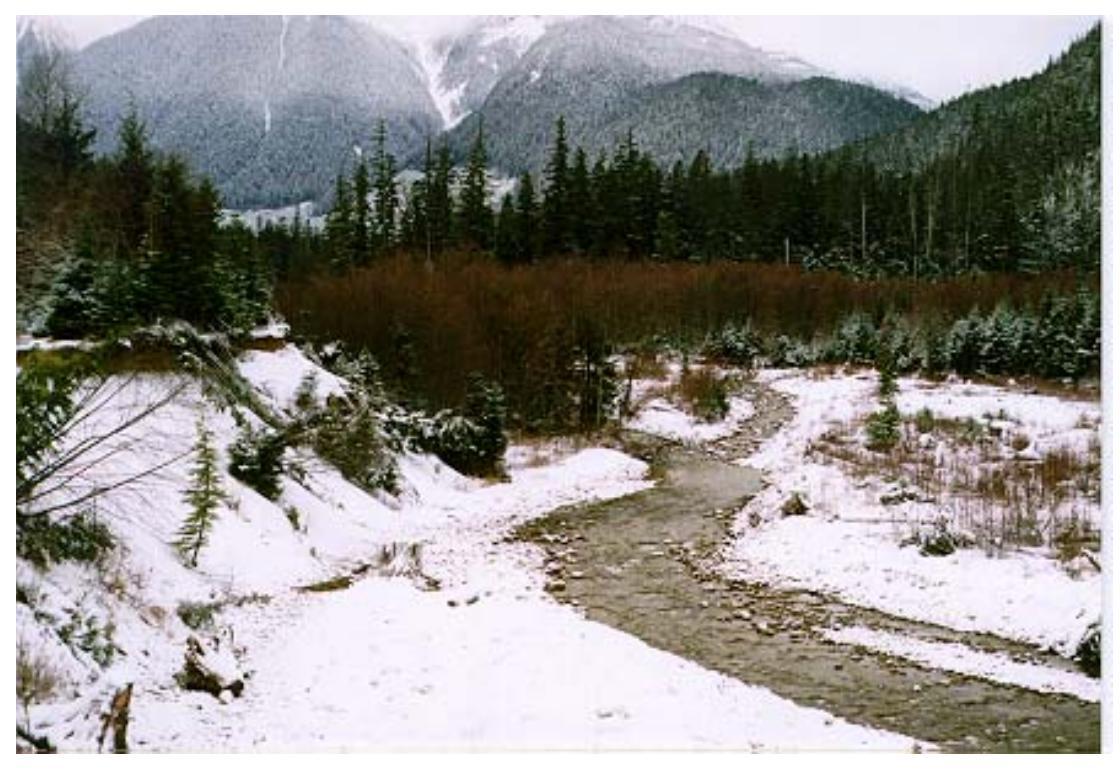
- The channel was very unstable.
- There was a general lack of LWD.
- There was a lack of cover for fish.
- There was a lack of habitat variety.
- There was extensive bank erosion.
- There was a lack of large conifers in the majority of the riparian area.
- Existing riparian vegetation was being eroded.
- The FSR on the south side was eroded into the stream channel and was a danger to the public.

Photo 8. Looking west from the easterly edge of eroded road at the largest site of bank erosion in the watershed.

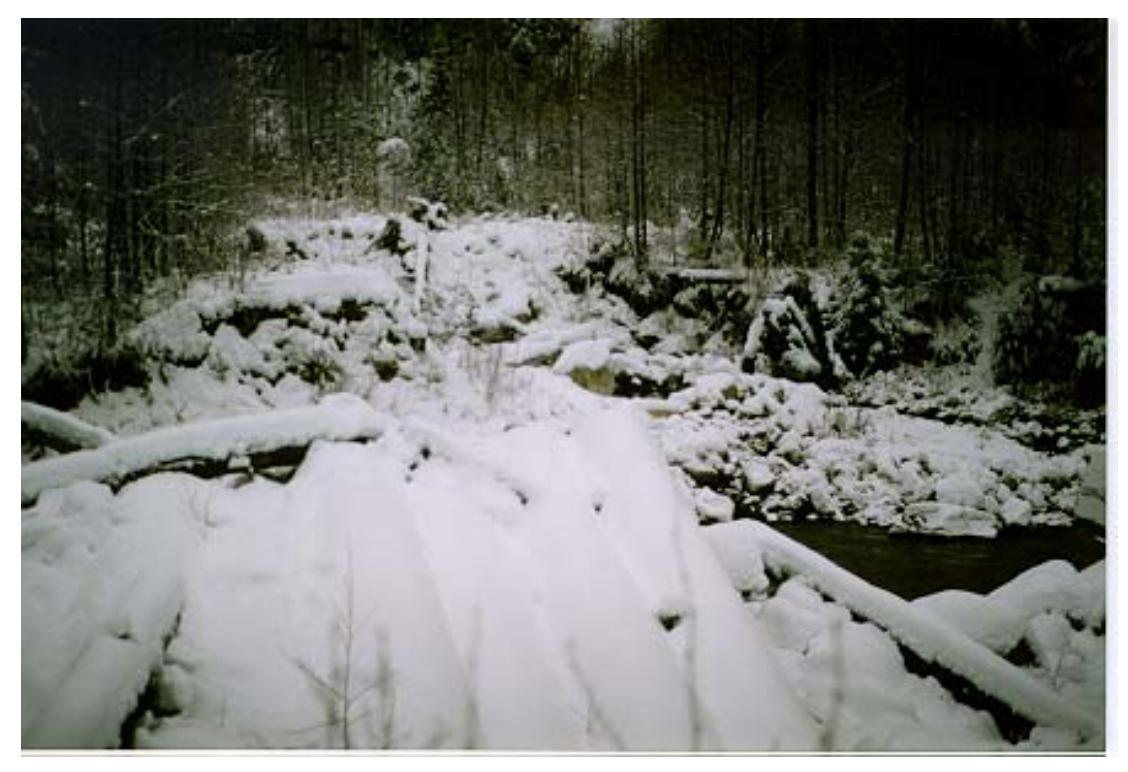
- The channel was unstable.
- The channel was denuded over a wide area.
- There was significant bank erosion.
- The original stream would likely have contained more functional LWD in the wetted channel than was observed during this study.
- There was a collapsed bridge crossing on the Coldwater FSR.

Photo 9. Looking northwest from the southern side of the uppermost road crossing on Coldwater Creek.

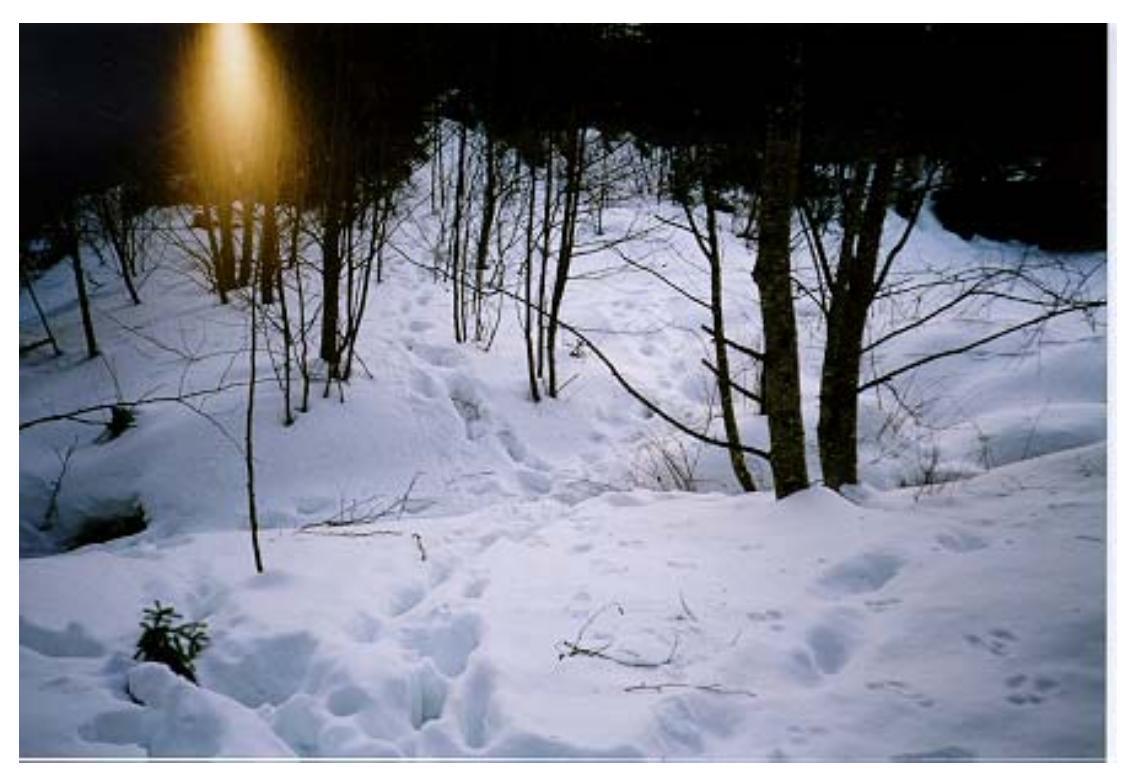
- A road crossing in the headwaters of the mainstem may have eroded, contributing excess sediment into the system.
- The same road crossing may also offer a partial barrier to migration of fish.

Remove metal culvert and permanently de-activate the crossing with pull back of banks and planting of locally available cuttings from deciduous trees. This work should be done with a bobcat and/or by hand to minimize damage to the regenerating trees. Access to this site was gained on foot from the Middle Silvertip Road. Although not observed by the field crew, the aerial photomosaic suggests there were a number of old roads leading to this area from the east side. The road may also be an extension of the road system that approached from the north. Any fish in the area should be salvaged before construction work begins and stop nets should be used above and below the site.

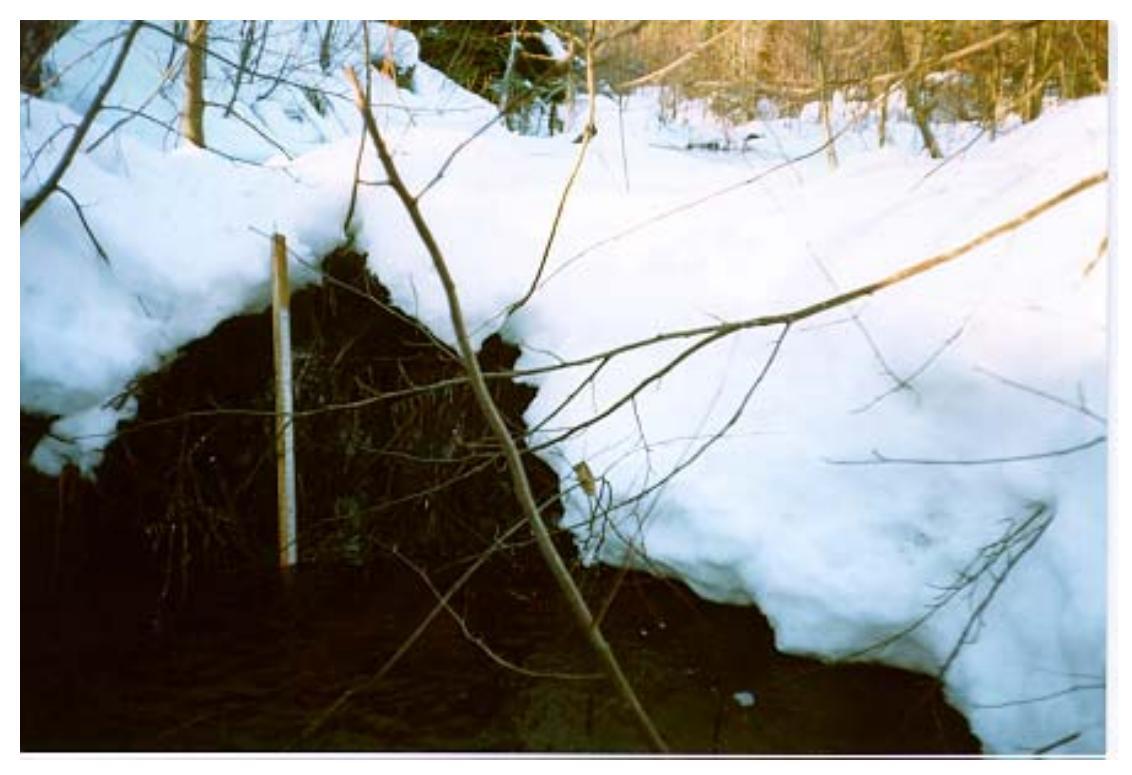
- The crossing on the Upper Silvertip Road was eroded.
- The riparian area in the upper watershed had been logged.

Photo 11. A view of the beaver dam associated with the eroding road on Trib 720C.

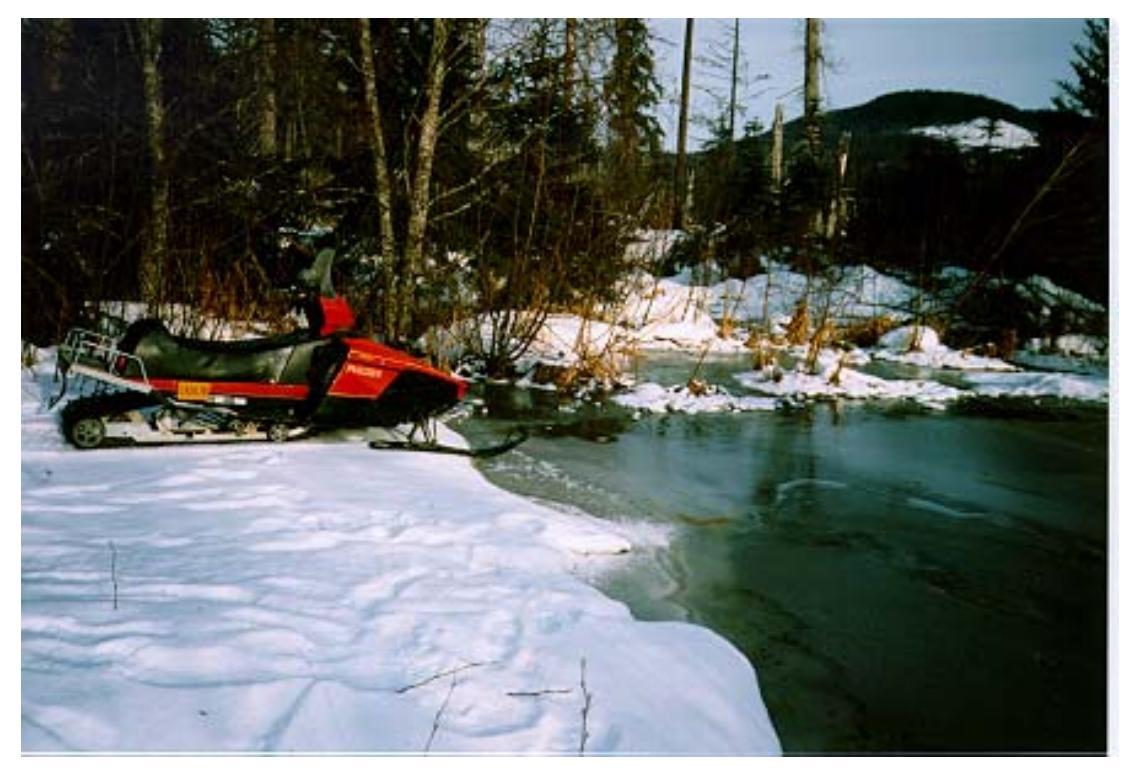
- Logging had occurred along most of the stream but a buffer strip of old growth trees were left along the majority of the stream's length.
- The Lakelse FSR crossed the creek in two shallow fords at approximately 14 km. These fords were frequently used by vehicles.

Photo 12. Looking downstream at the most westerly of the two shallow fords on the lower part of Middle Creek.

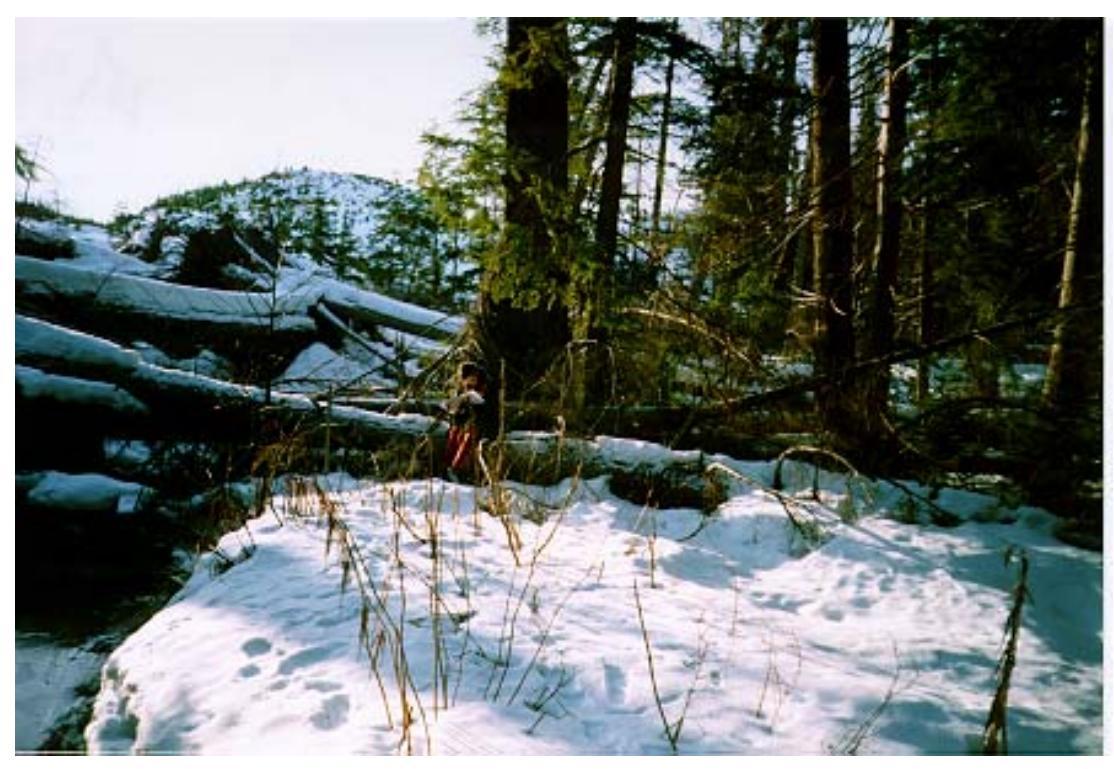
• A recently cut block in the middle section of the stream on the southeast side encroached on the stream.

Photo 13. Looking south upstream at Middle Creek in old growth section upstream of the road crossing . Note the logging close to the east bank and the resulting windfalls.

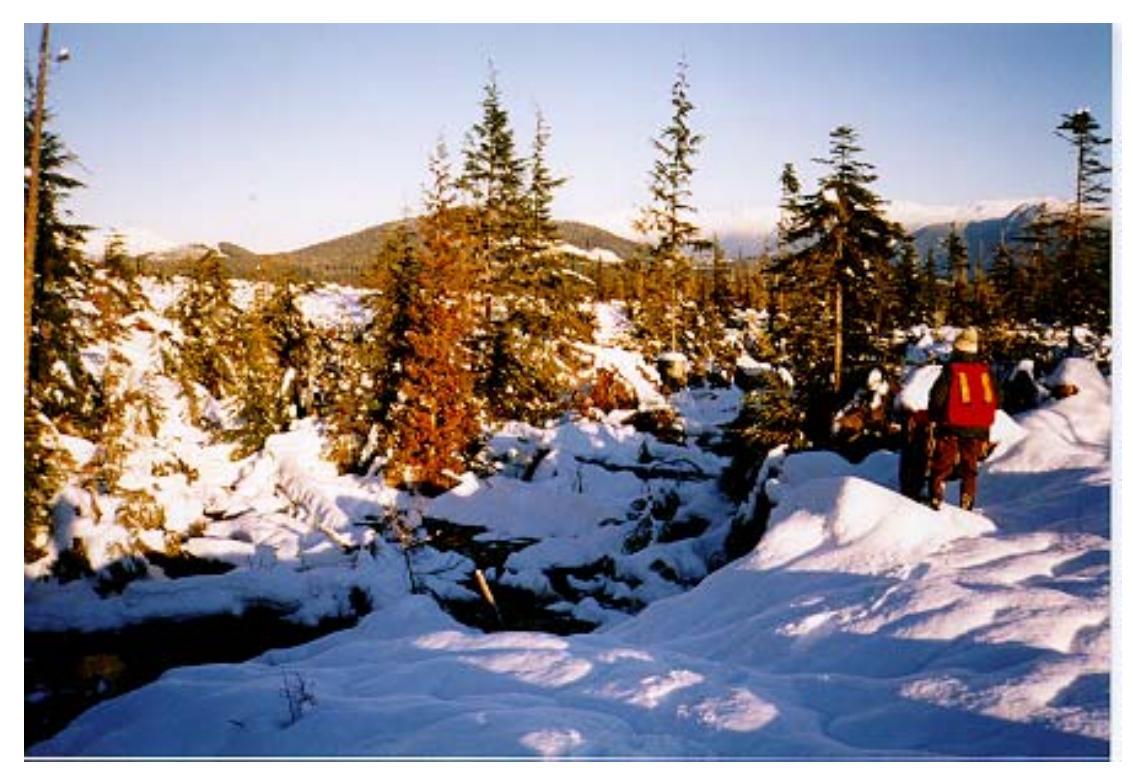
• Recent logging had occurred within the stream channel's gully along the 400 m below the Boot Creek Road.

Photo 14. Looking northeast at the area that was logged into the stream's gully.

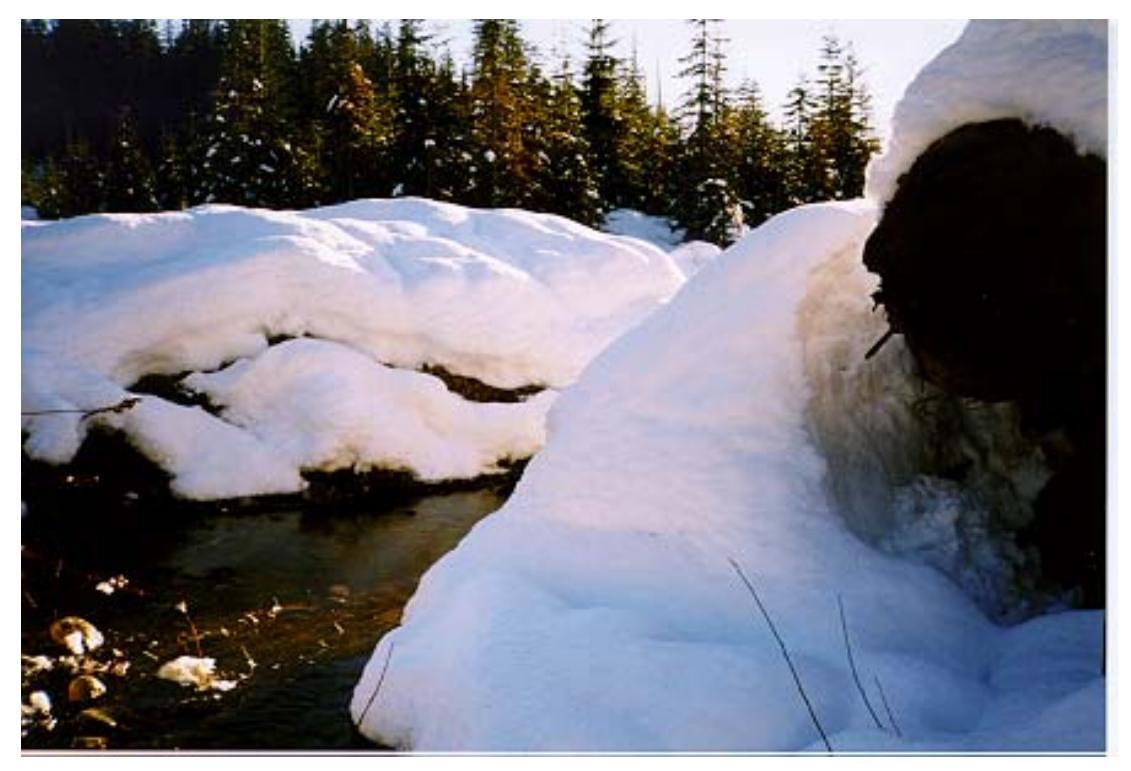
The Boot Creek Road crossing of the stream had eroded through, contributing fine road bed material to the stream. This breach in the road blocked vehicular traffic.

Photo 15. Looking upstream at the Boot Creek Road crossing of Middle Creek. Note the depth of the eroded channel through the road bed.

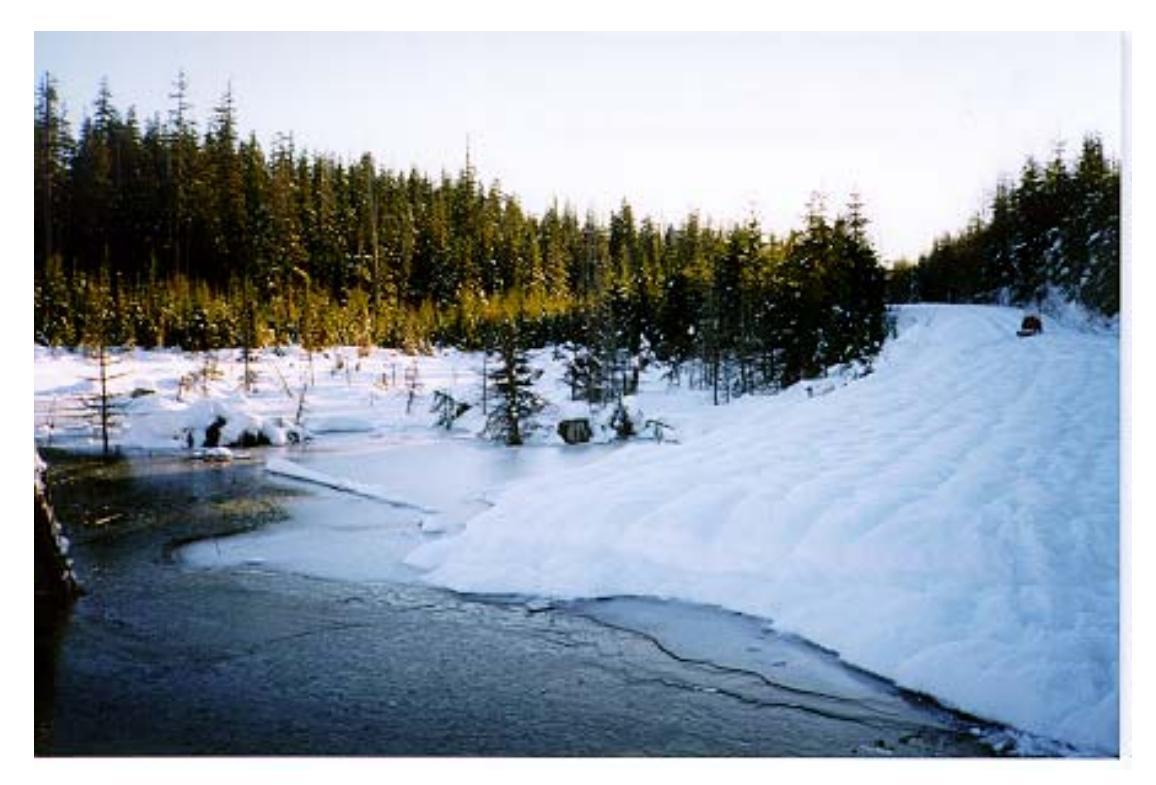
• The Lakelse FSR crossing of the stream at 11.5 km was a shallow ford that was used frequently by vehicles.

Photo 16. Looking south across the shallow ford where the Lakelse FSR crosses Middle Creek.

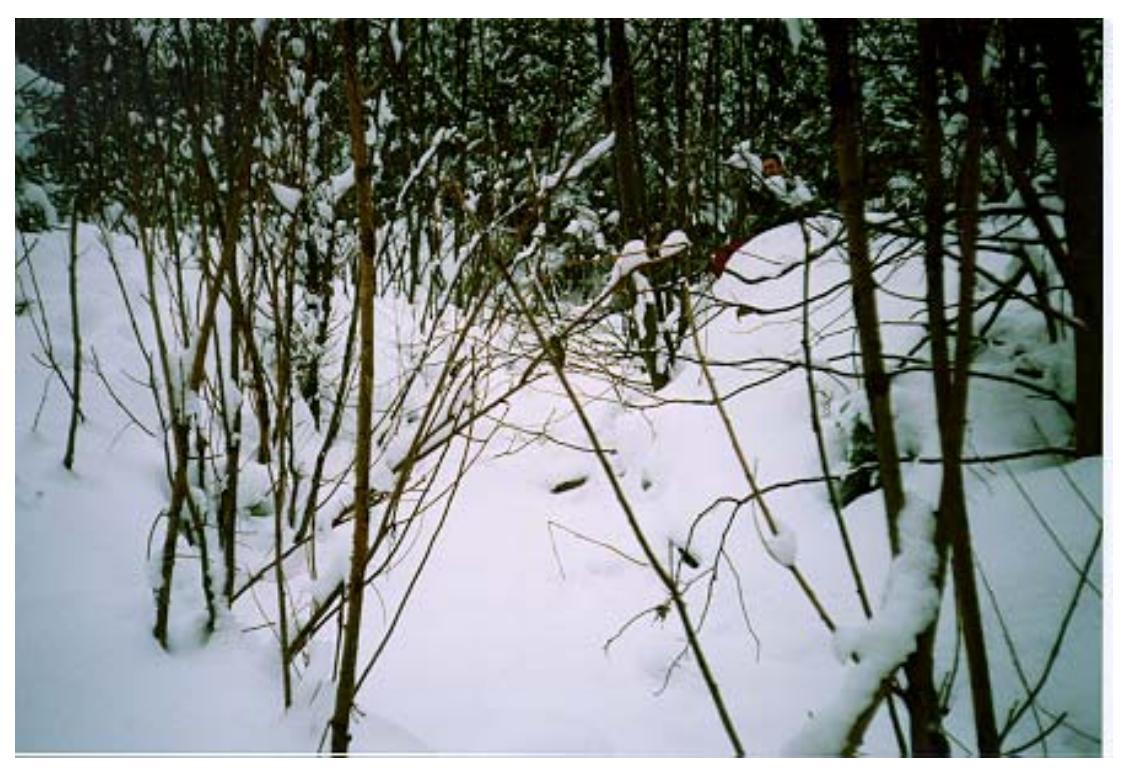
- The riparian area had been logged to both banks, however, the area had re-grown a young forest of alder with a conifer understorey.
- Although the road crossing could not be seen under the snow, the site was generally well populated with an overstorey of alder and an understorey of young conifers. Although the stream had been altered at this point by road construction, it was considered to have reached a stable equilibrium.

Photo 17. Looking southeast upstream at the road crossing of tributary 10, 175 meters above the Coldwater junction.

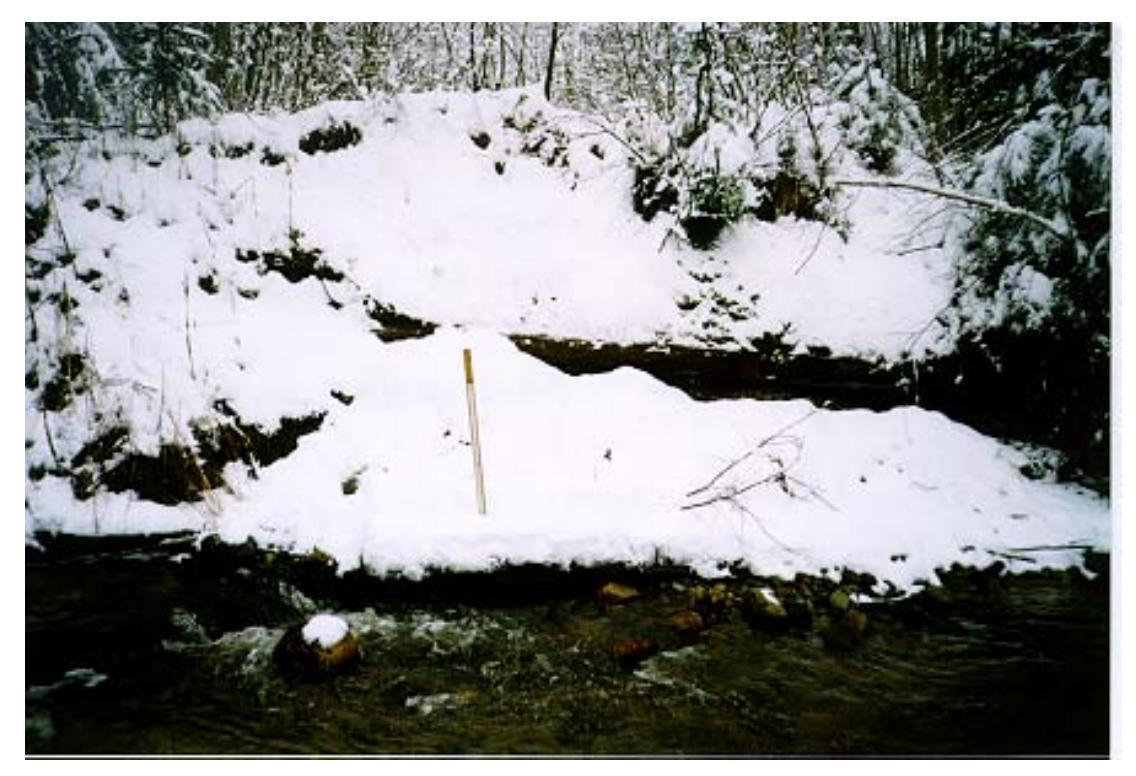
Impact Descriptions The lower road crossing was eroded.

Photo 18. Looking east across the eroded road crossing on lower Johnstone Creek.

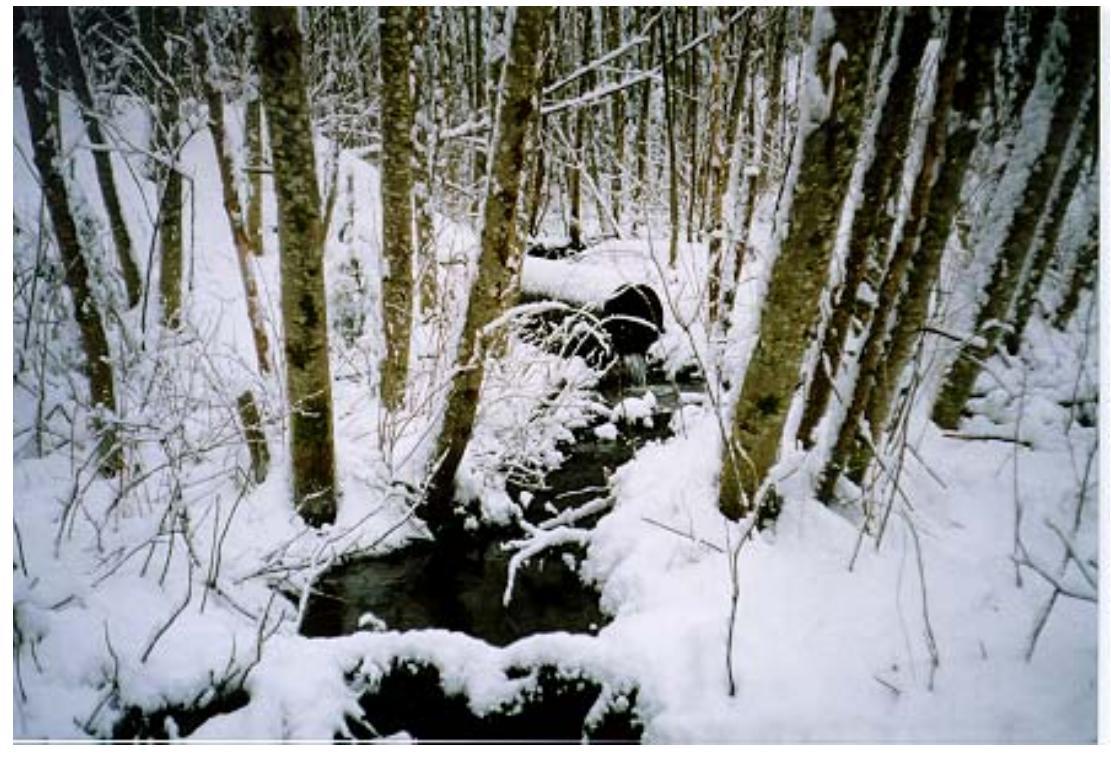
There was a dysfunctional metal culvert above the FSR bridge.

Photo 19. Looking at the eroded culvert above the FSR bridge on Johnstone Creek.

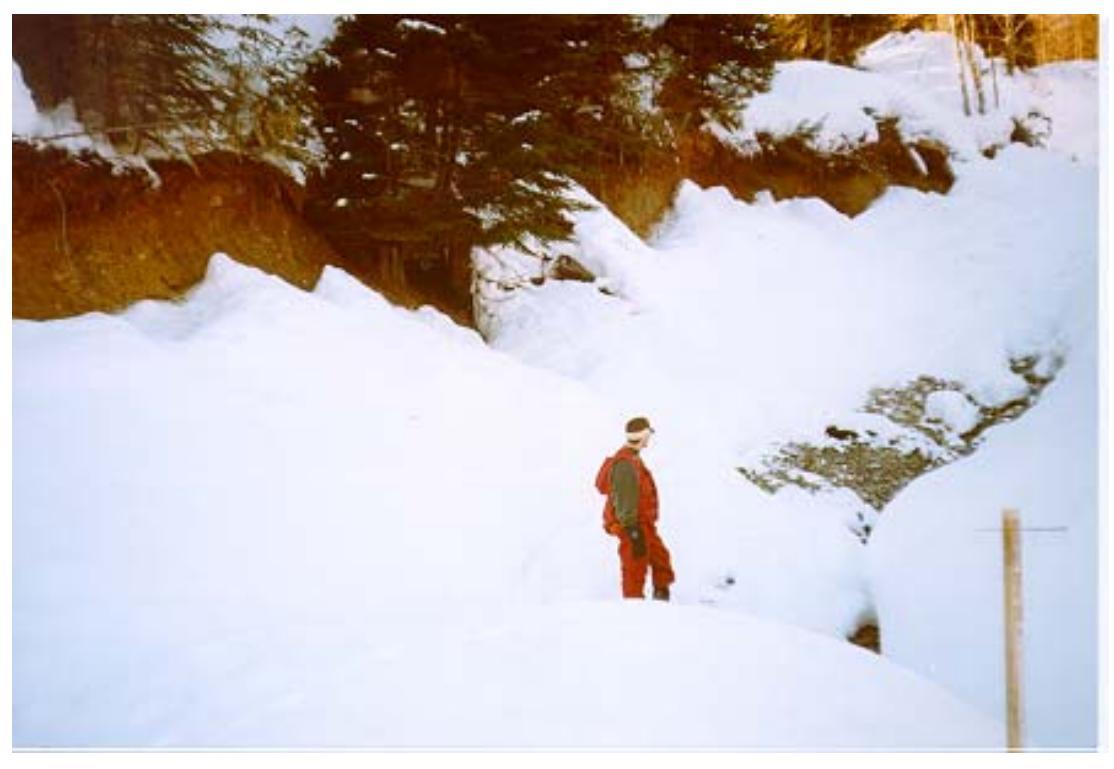
The section above the Middle Johnstone Creek Road crossing and between the stream and the road was eroded into the stream and the riparian area in this vicinity was in poor condition.

Photo 20. Looking up the Middle Johnstone Creek Road approximately 500 m from its lower crossing. Note the erosion on the inside bank. This erosion was coupled to the stream below.

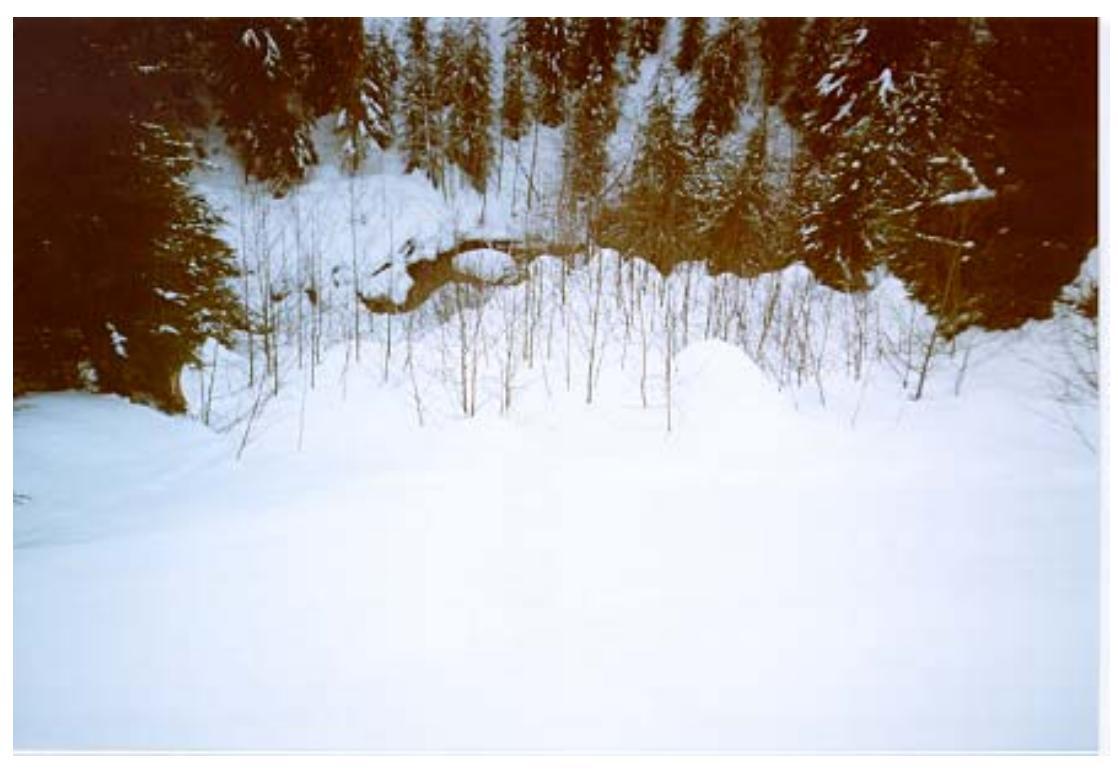
The slide on the eastern side of the stream from the Upper Johnstone Creek Road may have contributed excess sediment into the stream. The road below this point had water drainage problems.

Photo 21. Looking down the slide on the Upper Johnstone Creek Road.

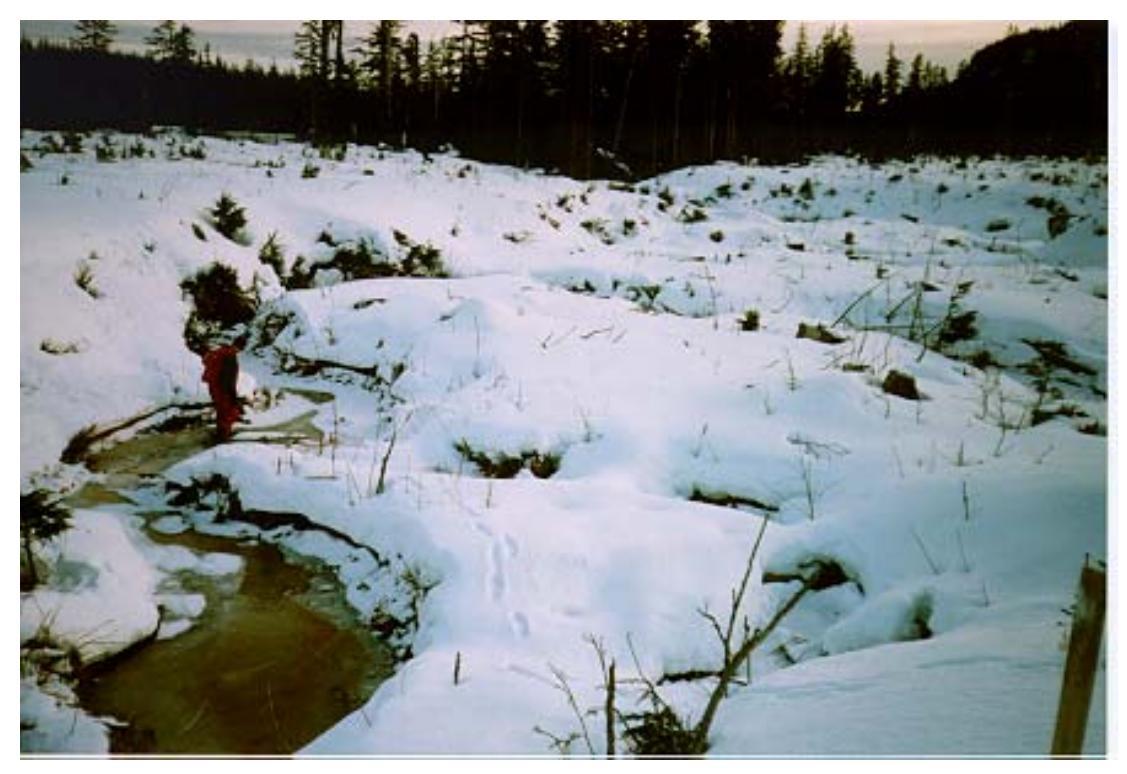
The riparian area, upstream from a point approximately 300 m above the mouth, had been logged to both banks of the stream. The stream in this area featured minor, incipient bank erosion, little cover or LWD and no potential for recruitment of LWD for at least a century.

Photo 22. Looking south and downstream on Trib 710B.

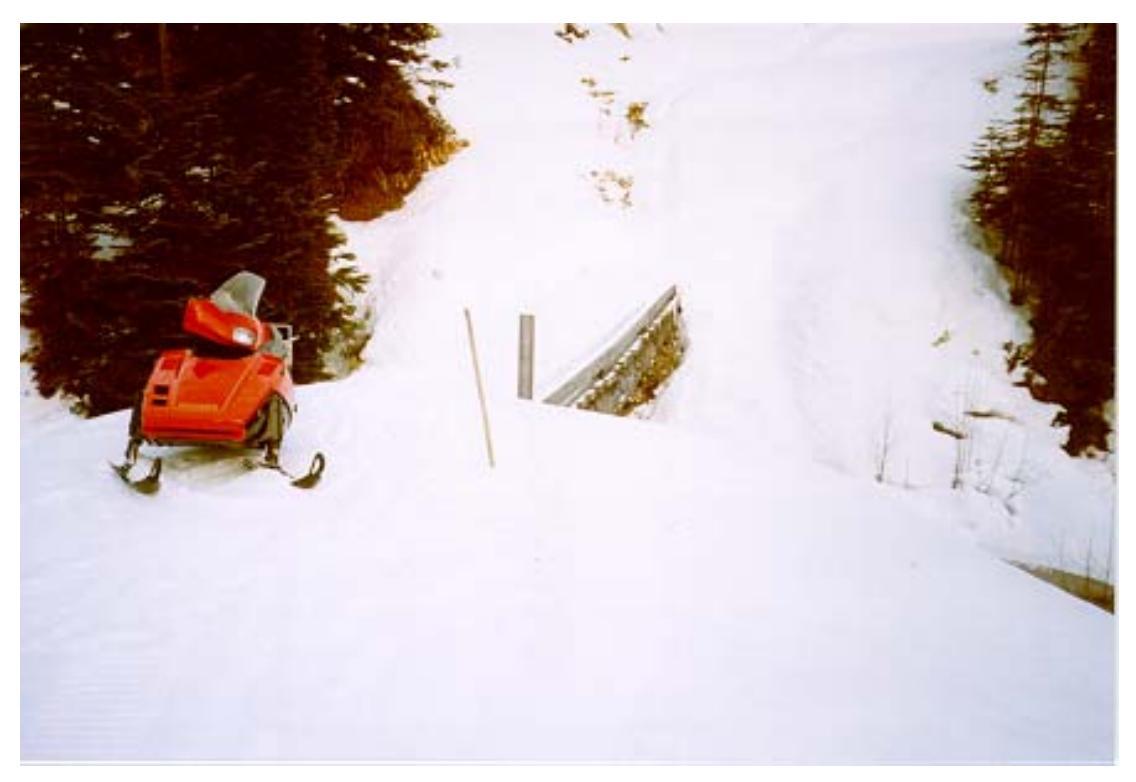
• The road crossing, located approximately 200 m above the mouth, was eroded.

Photo 23. Looking upstream on Trib 710C and across the lower eroded crossing.

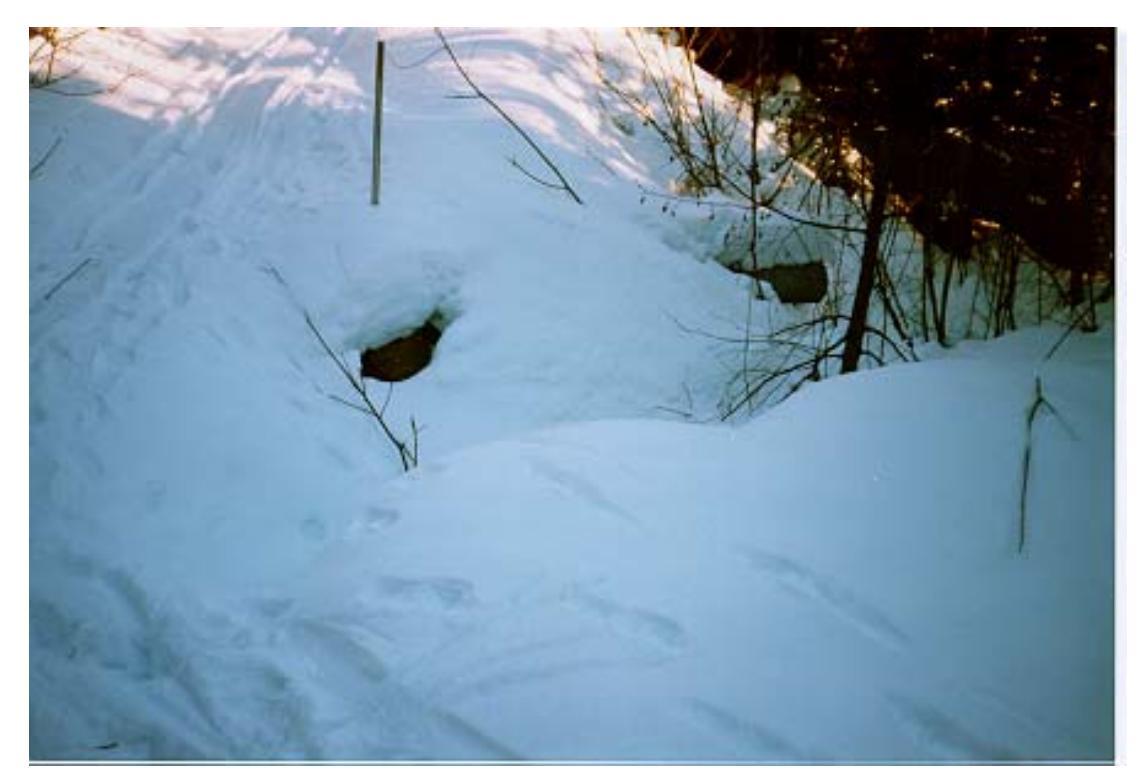
• The road crossings on the Middle Johnstone Creek Road were eroded.

Photo 24. Looking north at one of the eroded upper crossings of Trib 710C on the Middle Johnstone Creek Road approximately 283 meters from the Lakelse Main FSR. Note the abandoned culvert and the bank erosion.
