Level I Detailed Field Assessment of Aquatic and Riparian Habitat for Coldwater Creek in the Lakelse River Watershed

Prepared for Ministry of Environment

BioLith Scientific Consultants Inc.

March 31, 1999

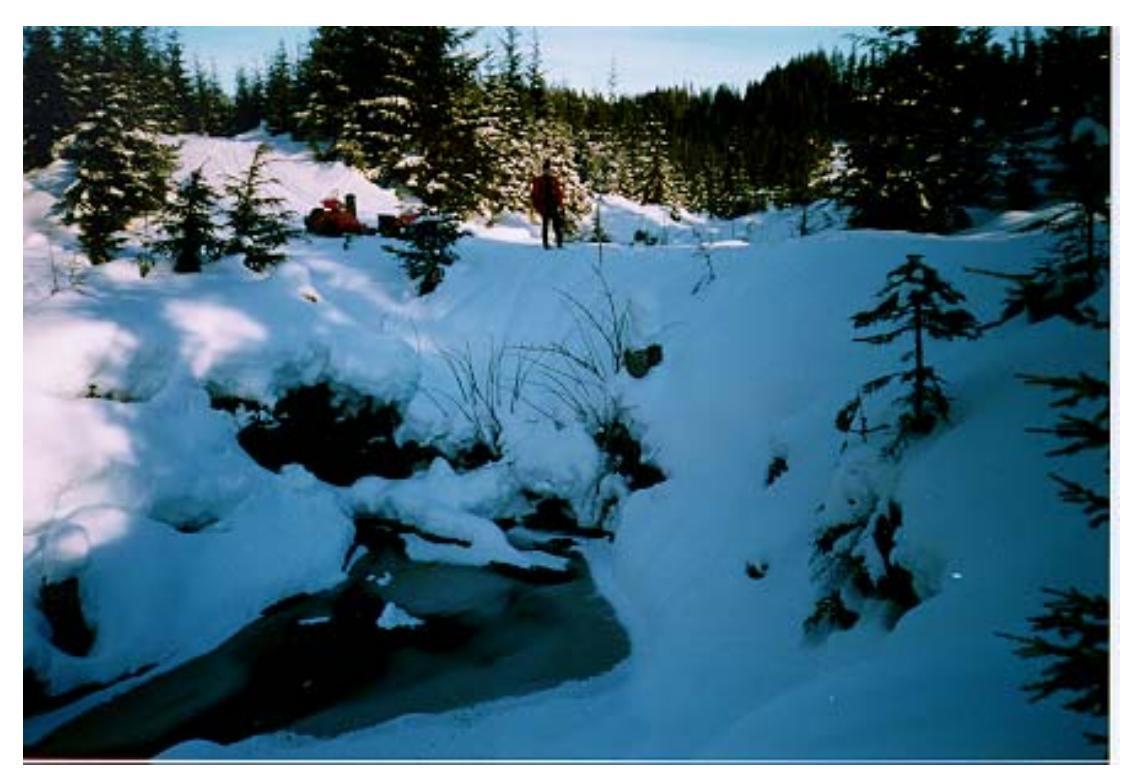
- The riparian area had been logged to the banks of the stream.
- The road crossing was eroded.

Photo 27.. Looking northeast and downstream on Trib 710G. The Upper Johnstone Creek Road is in the foreground.

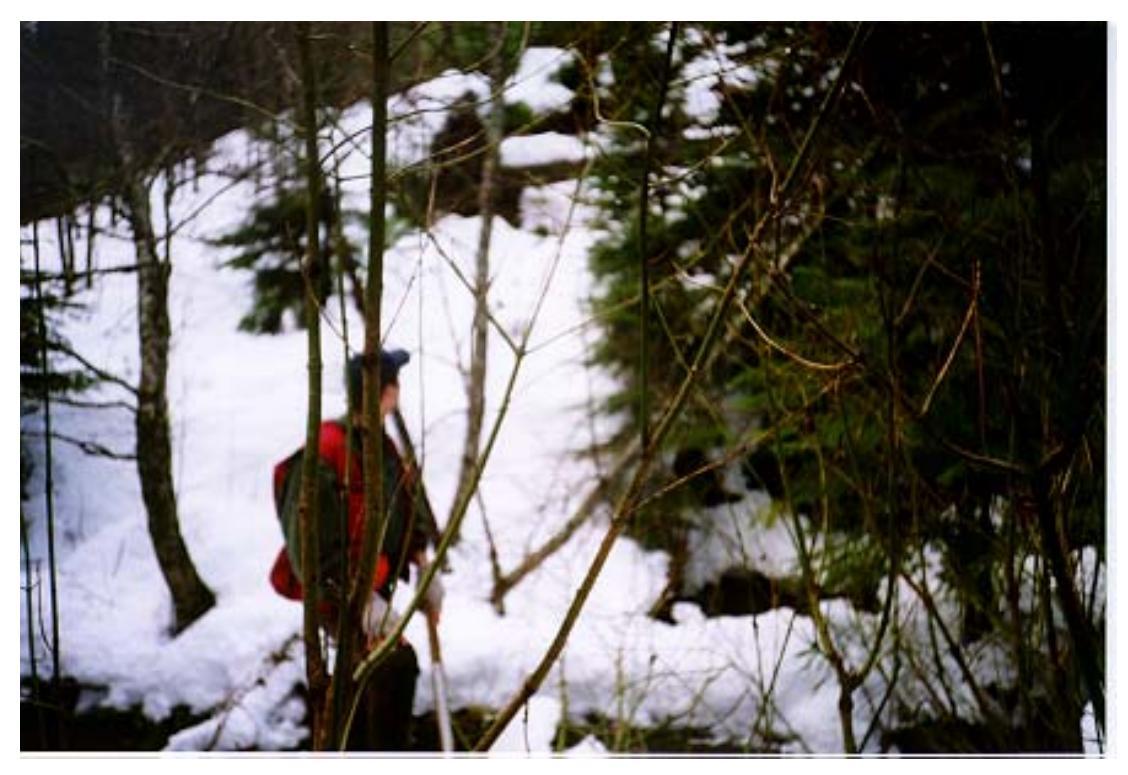
A bank was eroding on Trib 700B at approximately 36 m above the Lakelse FSR.

Photo 28. Looking south at bank erosion on tributary 700B 38 meters above main FSR.

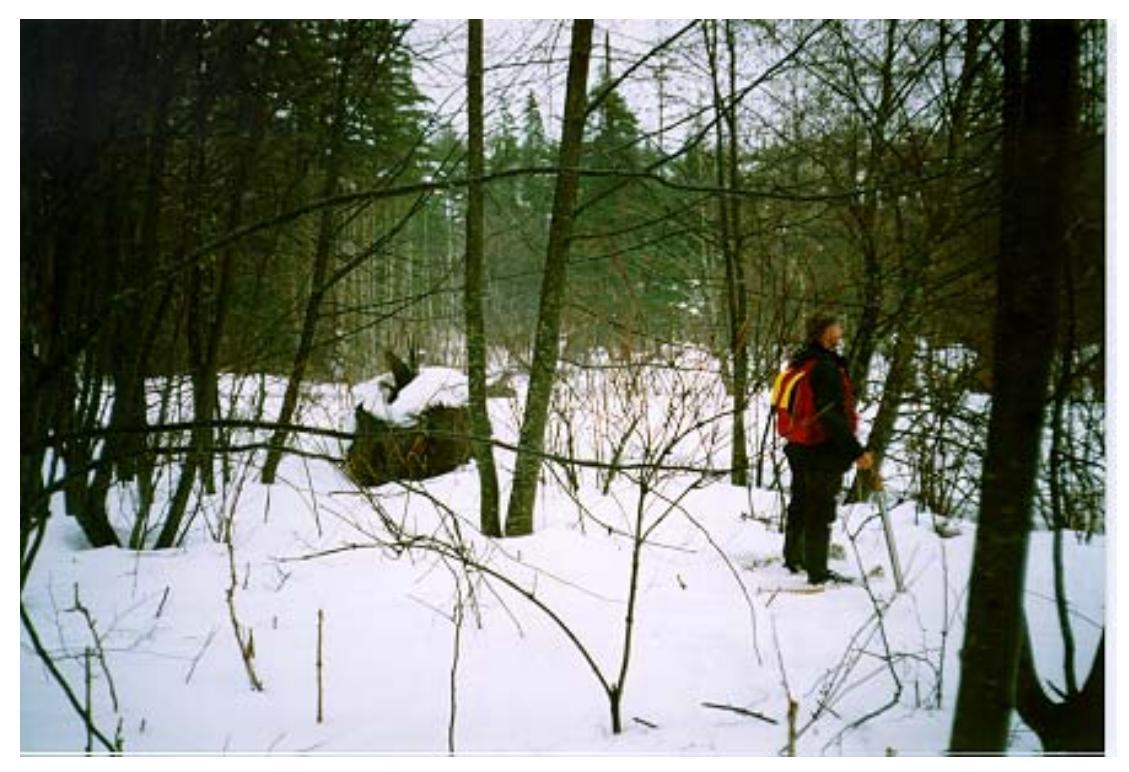
The riparian area around the lower part of the stream had been logged.

Photo 29. Looking east upstream at the L bend in End Creek 320 meters above junction.

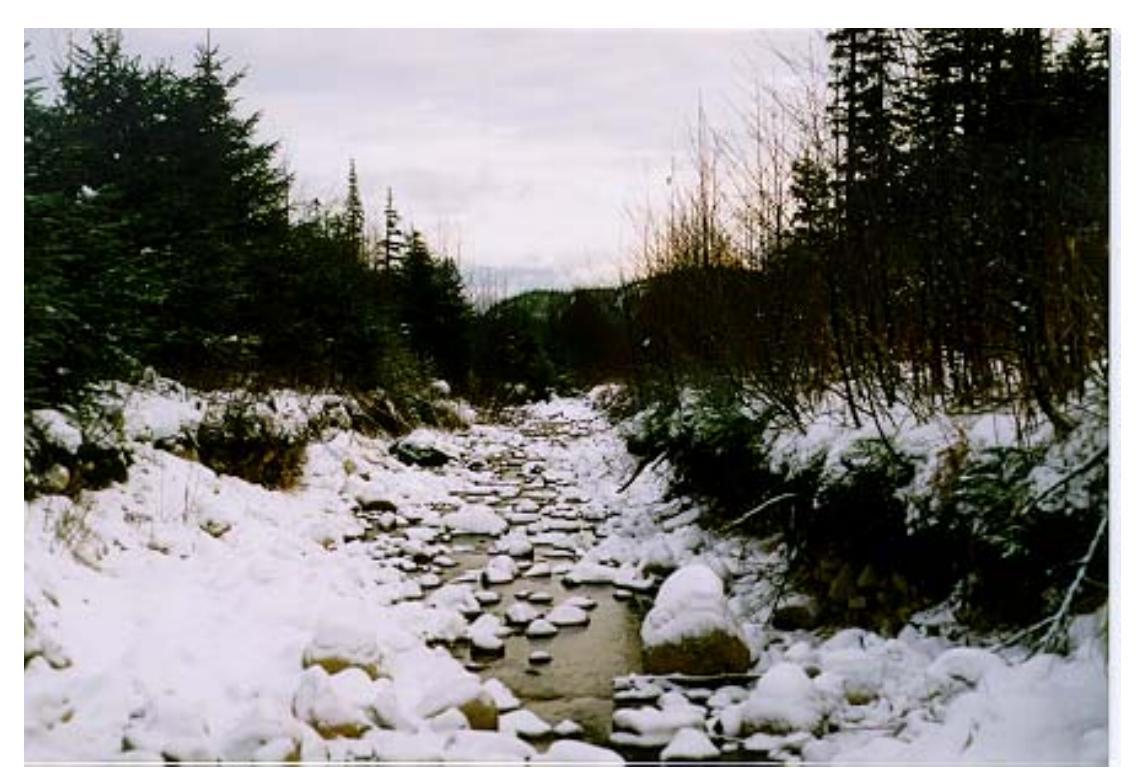
The Coldwater FSR crossings of both of the distributary channels had been damaged. At the Coldwater FSR crossing of the easternmost of these two distributary channels from Coldwater Creek, water had eroded through the road and onto the road surface, flowing southeast down the road bed. This had resulted in erosion of the road surface, degrading it up to 2 m below the former surface. This erosion extended approximately 400 m before dissipating. At this point the water apparently had run south into the Tributary 30 system and off the road, leaving a metal culvert eroded and dysfunctional. The erosion appeared to have continued cutting the surface down until it had reached an elevation that was a few centimetres below the elevation of the water table at normal low water conditions, so that, during most of the year this channel has some flow. The erosion also likely progressed headward and laterally and probably does so during every high water event. During extremely low water conditions, this channel likely dries up, stranding fish in isolated pools.

Photo 30. Looking downstream and southeast along the eroded road in the Trib 30 system.
