## REGIONAL EXAMPLES OF FISH HABITAT PROJECTS OF THE WATERSHED RESTORATION PROGRAM 1994 - 1996

November 1996

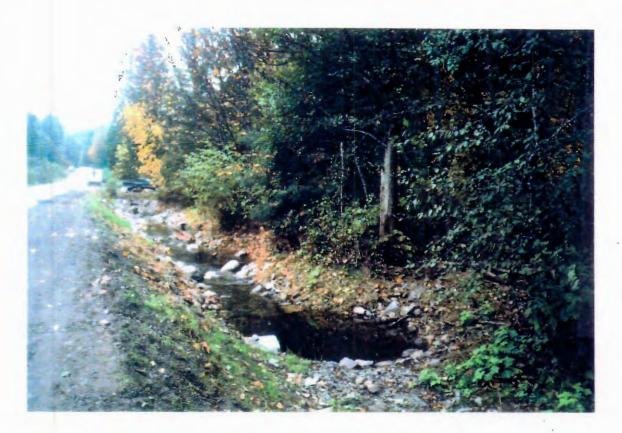
Photo 5. Downstream spawning and rearing channel below culvert.

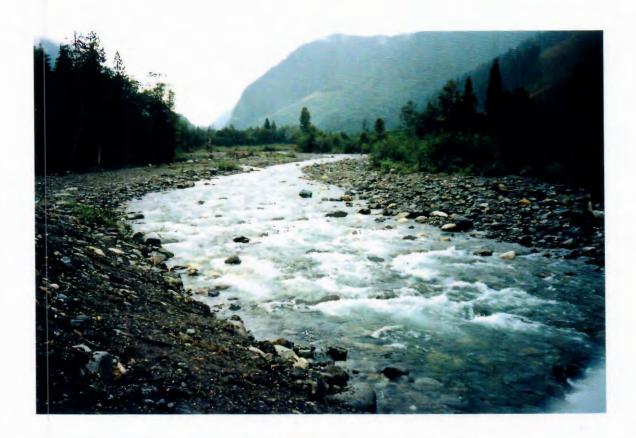
Photo 2. Slesse Creek. Note lack of habitat complexity and logged riparian zone.

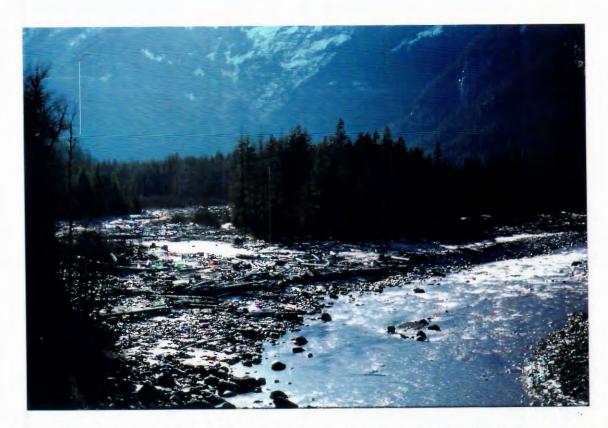
Photo 1. 1984 breakout of the high water channel (left) of the Squamish River (right at low flow), thus degrading Shovelnose Creek (not shown) in spring-summer with silty waters.

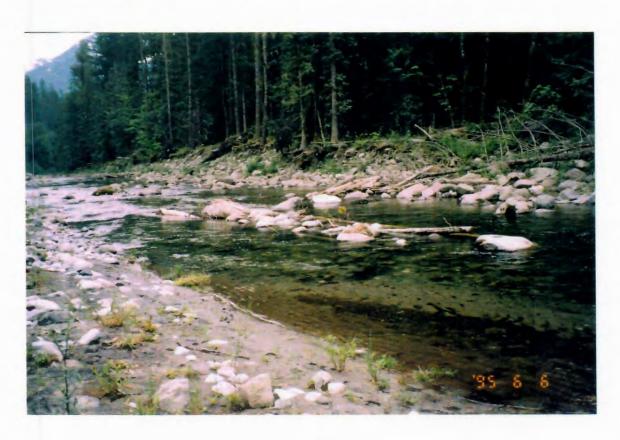
Photos 13 & 14. Depressed fish abundance resulting from logging impacts (often combined with overfishing) depresses the availability of nutrients (phosphorus and nitrogen) crucial to the salmonid food chain. Nutrients can be restored by the use of pellets that release at extremely low target levels (<5 ppb).

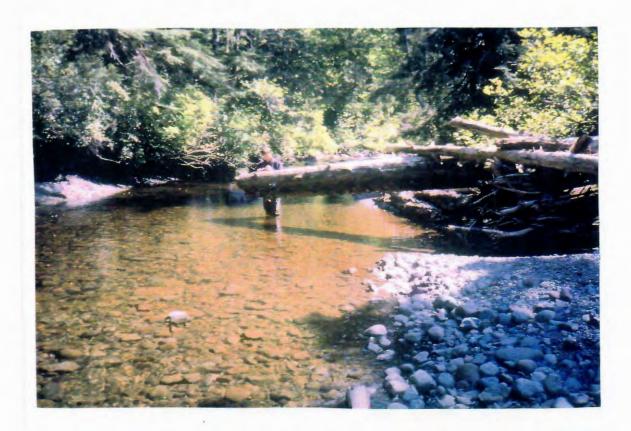
Photo 3. W80 site prior to placements of boulder clusters combined with large woody debris.

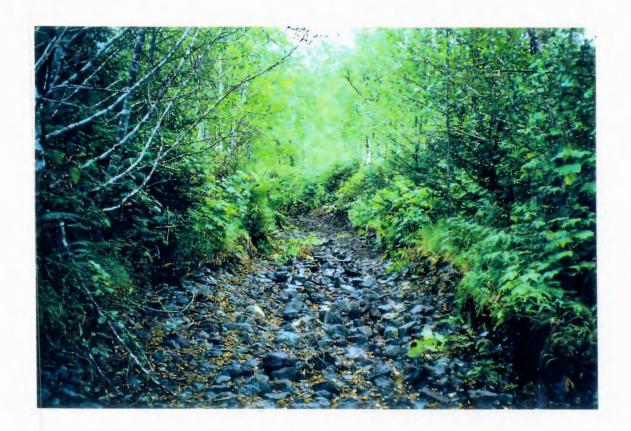
Photo 1. Historic channel (Trib. 1.37) prior to reconnection and reconstruction.

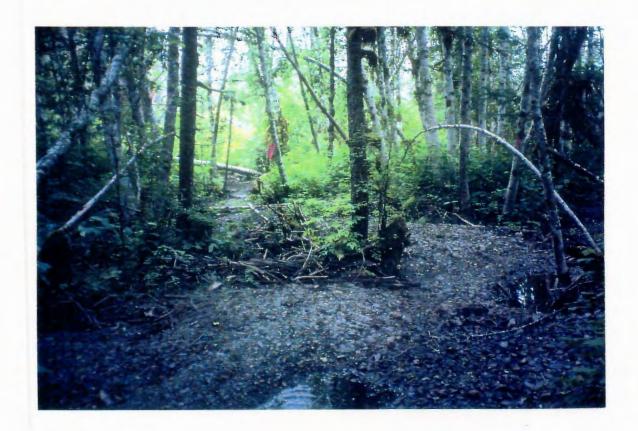
Photo 7. Ginulak avulsion berm (before).

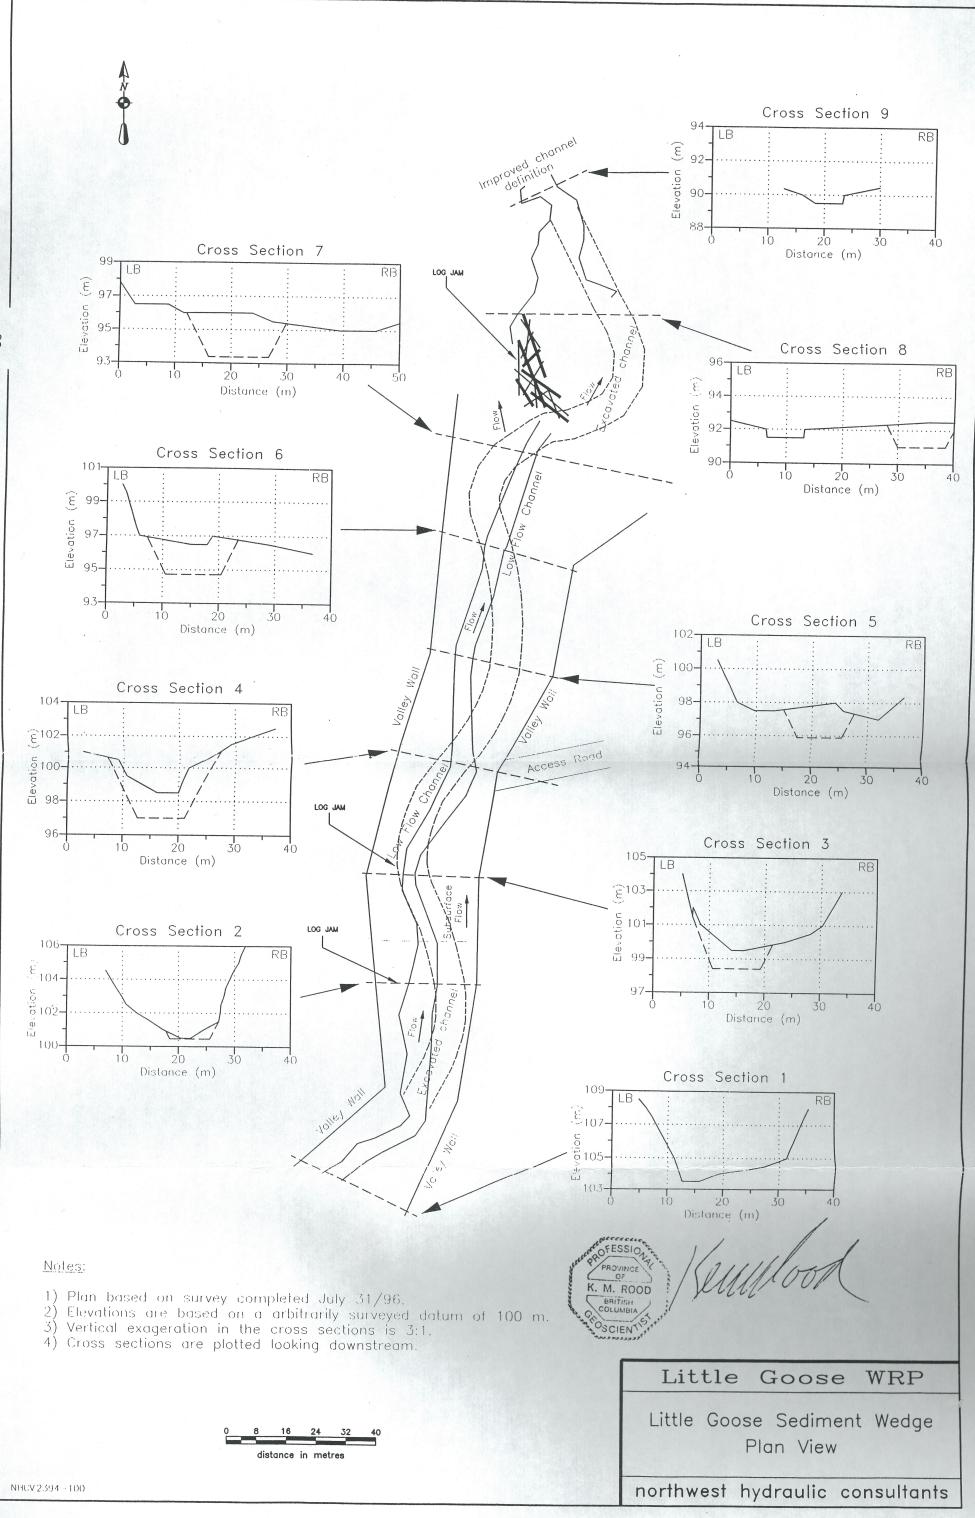
Figure 1

- j) At Riffle 5, cross-channel logs exposed during excavation were removed and replaced with a sill log buried along the upstream edge of the riffle.
  - An off-channel, high flow refuge was created on the left bank at Log Jam 1 near Cross-section 2.
