Zymoetz River Watershed Restoration Program:

Hydrological Assessment of Site 9,
Off-Channel Project

Alan Glichrist, Ph.D.

September 1998

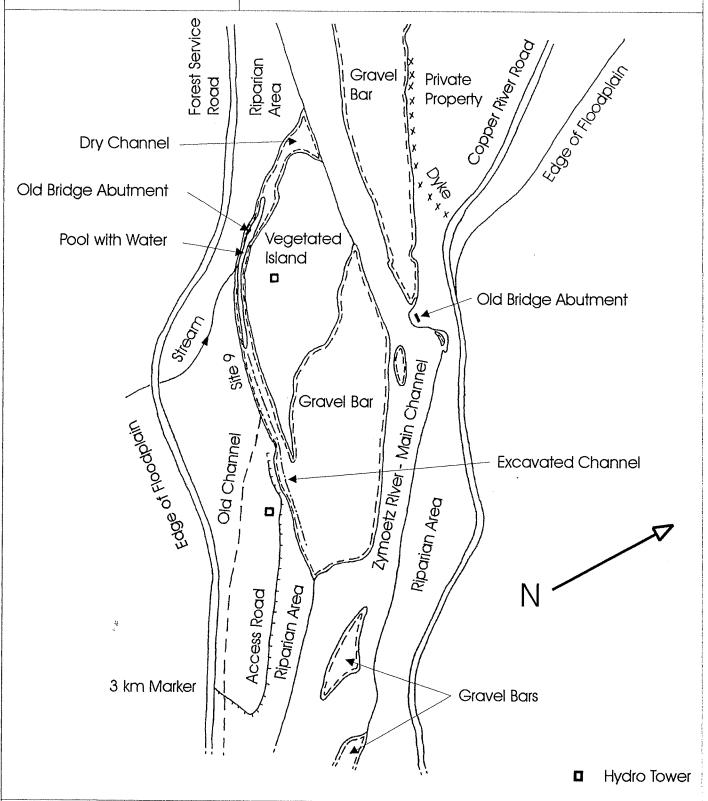
Figure 4. Site 9 Plan (August 1998).

A plan of site 9 is shown in Figure 4 which includes major morphological features of the site, access and property information. Site 9 can be easily accessed by traveling along the Copper River Forest Service Road to the 3 kilometer marker where a track leads off to the left onto the floodplain. This track can be followed, keeping to the left, for approximately 500 metres to beneath a hydro pylon which is next to site 9.

Site 9 is an off-channel area with gravel substrate that is next to the main channel of the Zymoetz River. During major floods, some of the water in the main channel is diverted down the off-channel for approximately 900 metres before re-entering the main channel again. The off-channel and main channel are separated by a gravel bar at the head of the off-channel and a vegetated island in the middle and lower sections (Figures 4 & 5). The crest of the gravel bar, which is similar in height to the surrounding floodplain, was about 3 metres higher than the water level in the main channel at the time of the site visits for this contract. At the crest of the bar there were significant accumulations of large woody debris and boulders with intermediate axes up to 20 centimetres long that were deposited during a major flood. This material suggests flood water depths of at least 80 centimetres at the crest of the bar (Costa, 1983) which would have overtopped the channel banks and inundated parts of the floodplain.

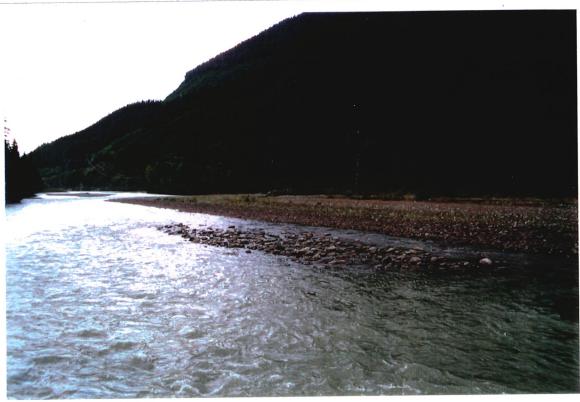
Figure 5. View of main channel and gravel bar (off-channel site 9 just beyond) from northern old bridge abutment.

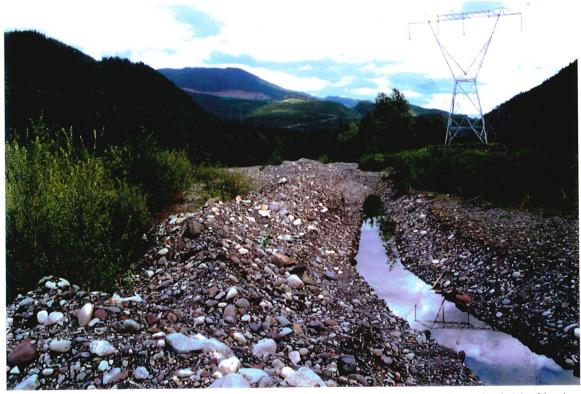
A test channel was excavated to find groundwater at this site in July 1998 (Figure 6) which was about 300 metres long and 3 metres deep at the head, declining to no excavation and the original channel bed at the lower end, which merged with a pool of slowly moving water. Discharge in the excavated channel near the head was 0.02 m³/s. The pool (Figure 7) continued downstream, past a small stream that entered from the south, to a point some 100 metres from the off-channel exit back into the main channel of the Zymoetz River. The off-channel area was dry downstream of the pool (Figure 8). A survey of the site was conducted by McElhanney Consulting Services Ltd. after the test channel was dug. The plan view and five cross sections are shown in Figures 9 and 10.

Figure 6. View of upper portion of excavated test channel looking east. Old channel runs to right of hydro pylon.

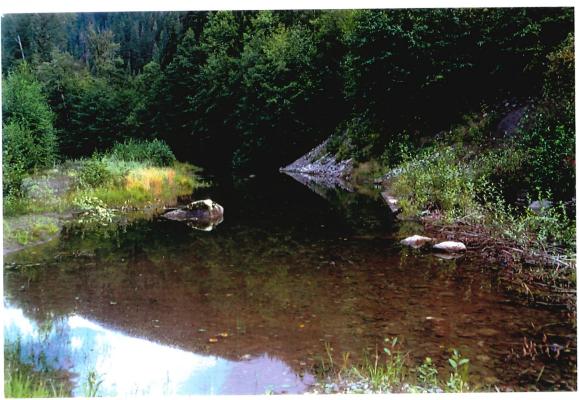
Fine grained sediments (e.g. silt and sand) had accumulated in some sections of the pool area and towards the sides of the off-channel area in the middle and lower sections. Fine sediments covering the base of the pool suggest that flows from the small stream are limited, so that fine materials settle from suspension. Fine sediments along the sides of the off-channel area (Figure 8) were likely deposited during declining flood waters as stream velocity slowed, allowing smaller particles to settle. The crest of the gravel bar, separating the off-channel and main channel was also covered by fine grained deposits laid down during waning flood flows.

Figure 7. Central pool section of off-channel site 9. Note old bridge abutment to right of photo centre.

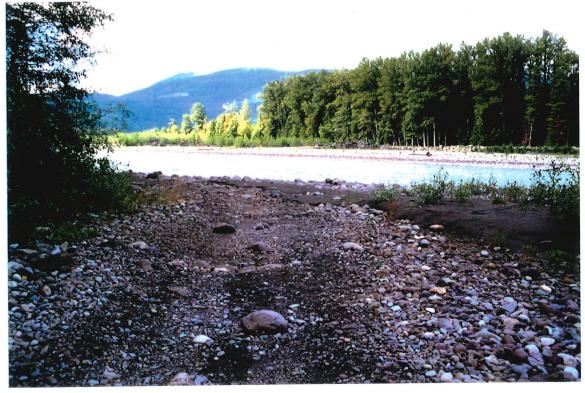
Figure 8. Lower dry section of off-channel site 9. Note fines at channel edge and dyke on other side of main stem.

- The prescription as it stands will need to be modified to allow year round fish access since the lower part of the off-channel area is currently dry at a time when salmon are moving up the Zymoetz River to spawn. This will probably require excavation of the lower part of the off-channel area.

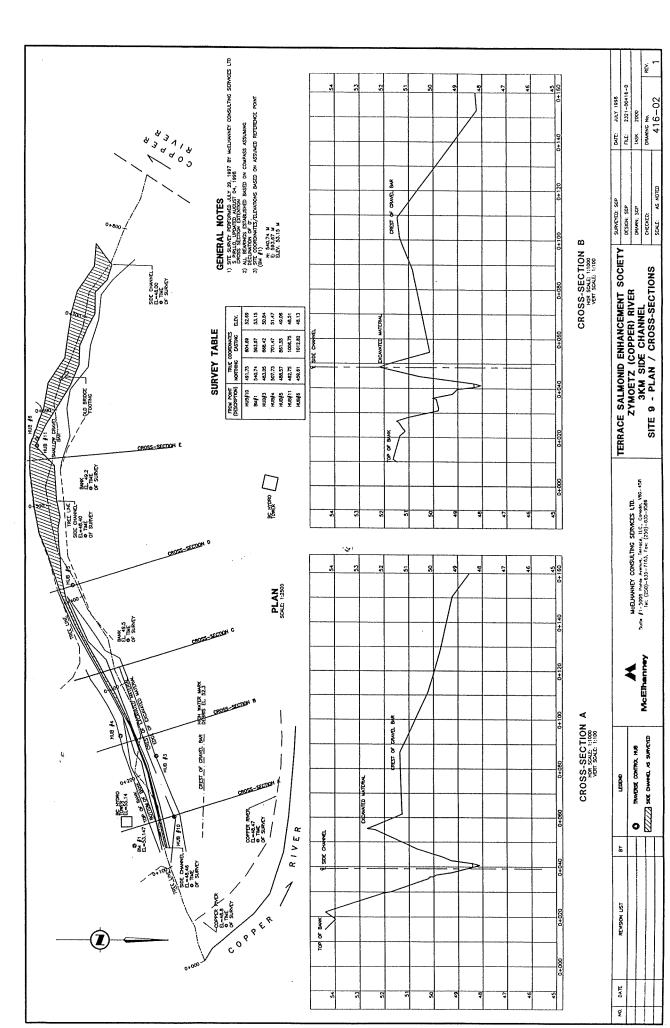
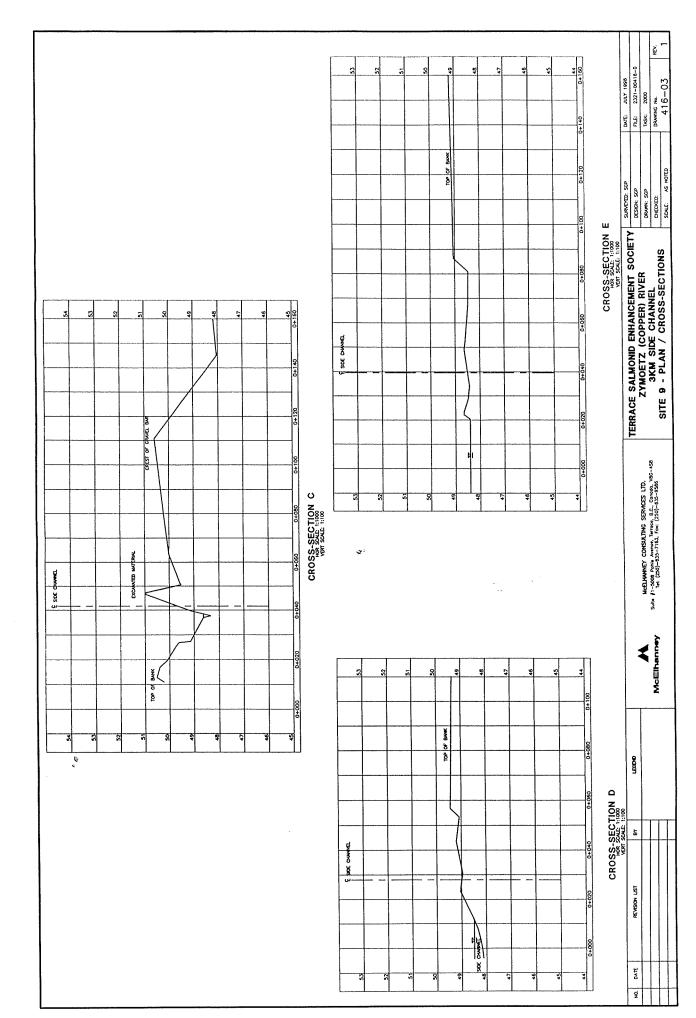
The survey by McElhanney (Figures 9 & 10) shows that water levels in the main channel and in the excavated channel were almost the same (within 1 cm of each other at a given point along the axis of the valley). This suggests that there is no hydraulic gradient across the valley and there is no tendency for sub-surface water to move across the floodplain from side to side. Instead, sub-surface water simply moves down the axis of the river valley. This is to be expected in the coarse gravel substrate that makes up the floodplain. In addition, sub-surface water levels likely fluctuate rapidly in response to changing water levels in the main channel. The sub-surface water probably has a relatively short residence time in the floodplain gravels since they are very porous and permeable. Therefore, the geochemical properties of the sub-surface water are likely to be similar to surface waters.

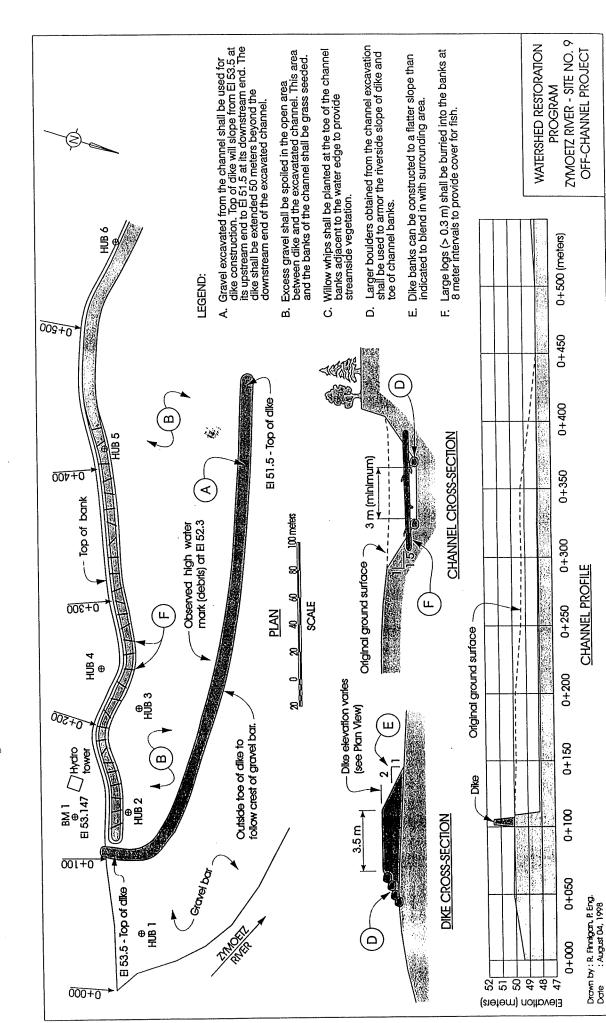
The prescription developed by R. Finnigan, P.Eng. for site 9 is shown in Figure 12. This requires a few words of explanation. The prescription is not definitive in that several other variants were also discussed with the author of this report by Jim Culp and R. Finnigan. A detailed analysis of these other options is not possible since few specific details were given. However, the basic elements of all prescriptions for a groundwater fed channel were the same as outlined below.

The prescription will prevent all but major floods from flowing down the off-channel area of site 9. Given the height of the proposed dike and the configuration of the channel, it is estimated that the dike will prevent floods up to about the 10 year recurrence interval from entering the off-channel. Floods of greater size will overtop the dike and some water will be directed down the off-channel. This will have several possible effects on the excavated channel. It is likely that the head of the channel will undergo scouring and erosion, depending upon the armoring applied to the channel. The middle and lower sections of the channel will likely be filled with sedimentary debris as the gradient of the excavated channel will be lower than at present. Fine grained deposits will be laid down ontop of the infilling debris as flood waters decrease and stream velocity slows. In any event, when the dike is overtopped with flood waters, significant damage to the project will occur which will have to be rectified to maintain it's effectiveness as a spawning channel.

Of perhaps greater importance is the effect of preventing all but major floods from passing down the off-channel. During these smaller floods, more water is maintained in the main channel, hence the water level is higher than previously for a similar magnitude flood. The main channel narrows just below the entrance to the off-channel area and is defined by a rock outcrop with an old bridge abutment on the north bank. The opposing bank is the vegetated island which will be prone to increased rates of erosion as more water is passing at a greater velocity. The effect of the prescription will be to effectively increase the erosive capability of the waters in the main channel, which can only erode the vegetated island, at lower water levels.

- Excavate a channel down to the water table across at least the upper part of the off-channel area. If surface flows in the lower portions are not sufficient after these initial works, consider excavating out the lower portion to allow unimpeded fish access during low water levels.
- Install a dike (A on figure 12) to prevent flood flows from entering the excavated channel and altering it's morphology.
- Complex the excavated channel to provide cover for fish.

- Because of the close proximity of site 9 to the main channel, and the morphology of the surrounding area, the dike will only be able to prevent floods with about a 10 year recurrence interval from entering the off-channel area. This is a relatively short period of time. With the likely consequences of flooding (infilling of the excavated channel with coarse and fine sediments) significant effort (and money) would be required to maintain the functionality of the prescription at this site.
