MAXAN WATERSHED STREAM HABITAT RESTORATION WORKS

1998/99

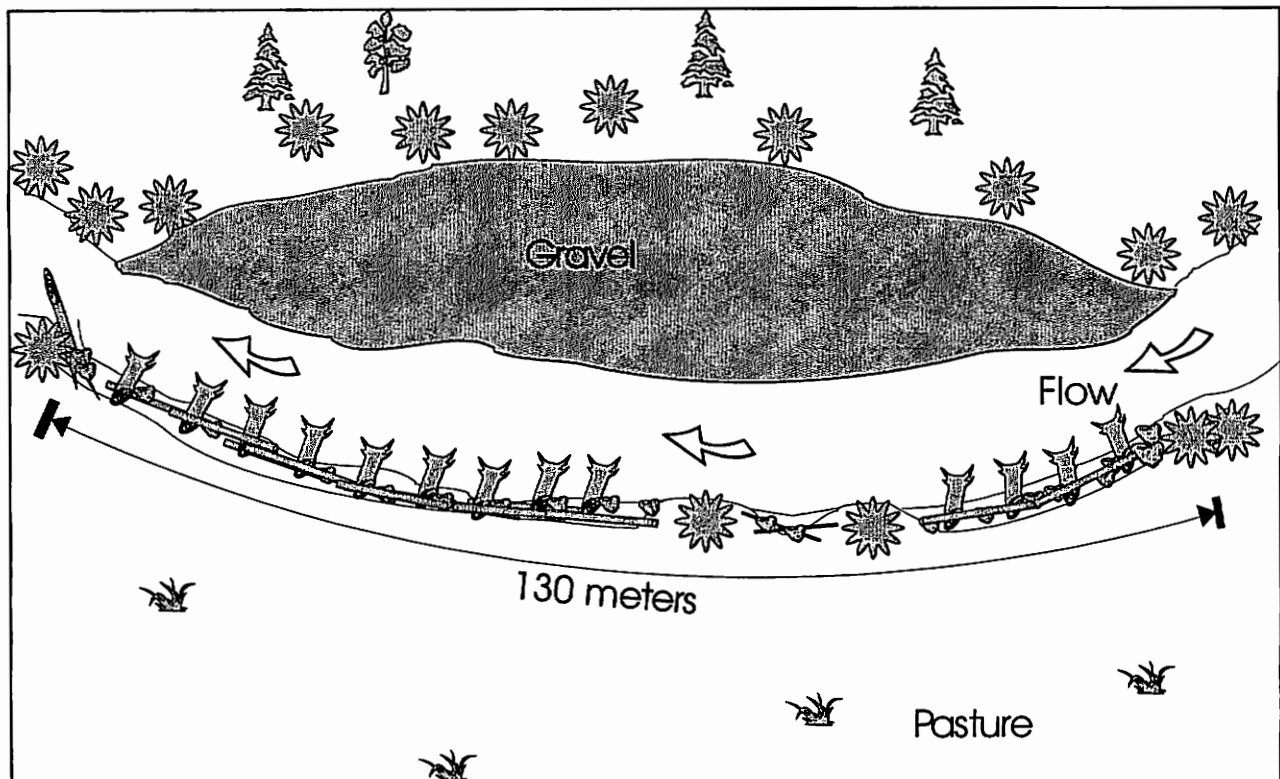
Figure 5: Site 1

Maxan Creek Site 1 corresponds to site 11A of AEE (1997). It is approximately 130 m in length and is located adjacent to a large cleared pasture area. The streambank was about 2.0 meters in height, vertically reposed and actively eroding. The stream at this point is a straight, relatively shallow riffle / run complex. Instream cover is limited by an absence of pools, pocket water, overhanging vegetation and LWD.

The eroding streambank at this site was stabilized using a large woody debris revetment (Figure 5). Approximately 40 tree/root wads were used along with 5 loads of rock, 800 willow cuttings, 1.5 bags of grass seed, 300 feet of aircraft cable and 10 driveable anchors.

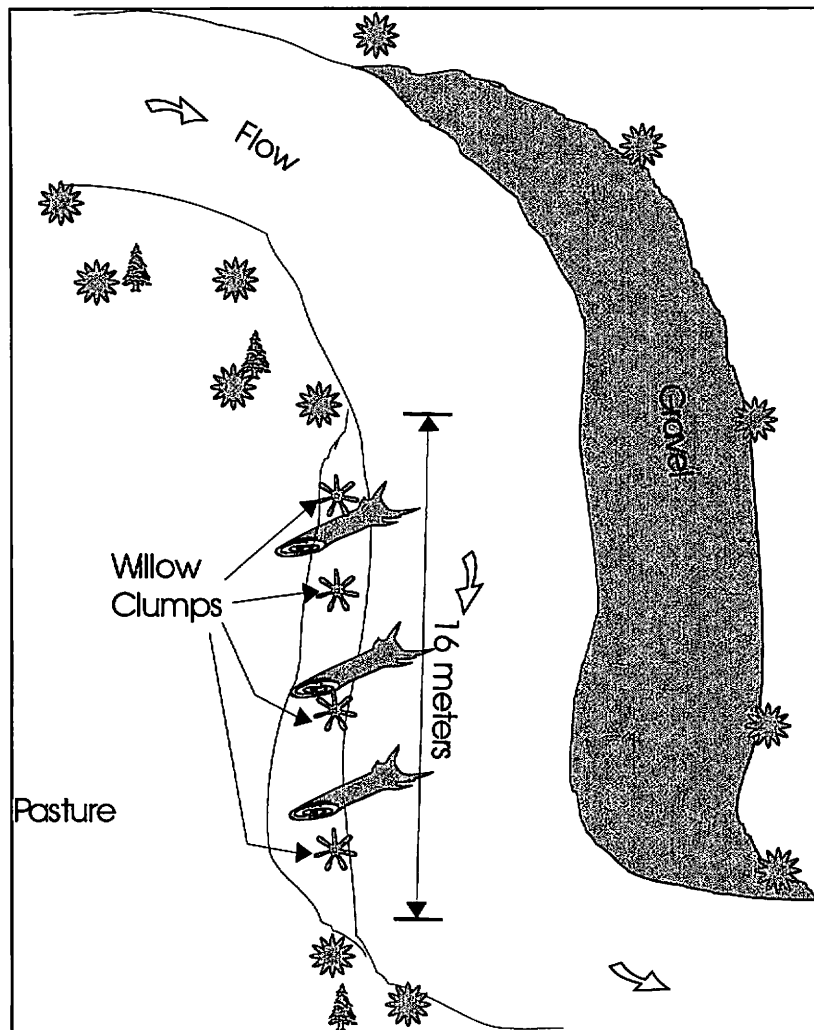
Figure 6: Site 2

Maxan Creek Site 2 was not prescribed for in AEE (1997). It is approximately 16 m in length and located adjacent to a large cleared pasture area. The streambank was about 2.0 meters in height, vertically reposed and actively eroding. The stream at this point is a straight, relatively shallow riffle / run complex. Instream cover is limited by an absence of pools, pocket water, overhanging vegetation and LWD.

The eroding streambank at this site was stabilized using a large woody debris revetment (Figure 6). Approximately 3 tree/root wads were used along with 4 clumps of live willow, 1/2 bag of grass seed and 100 feet of aircraft cable. Live willow clumps were scooped up by the excavator from a nearby area, and placed between root wads, near the wetted perimeter.

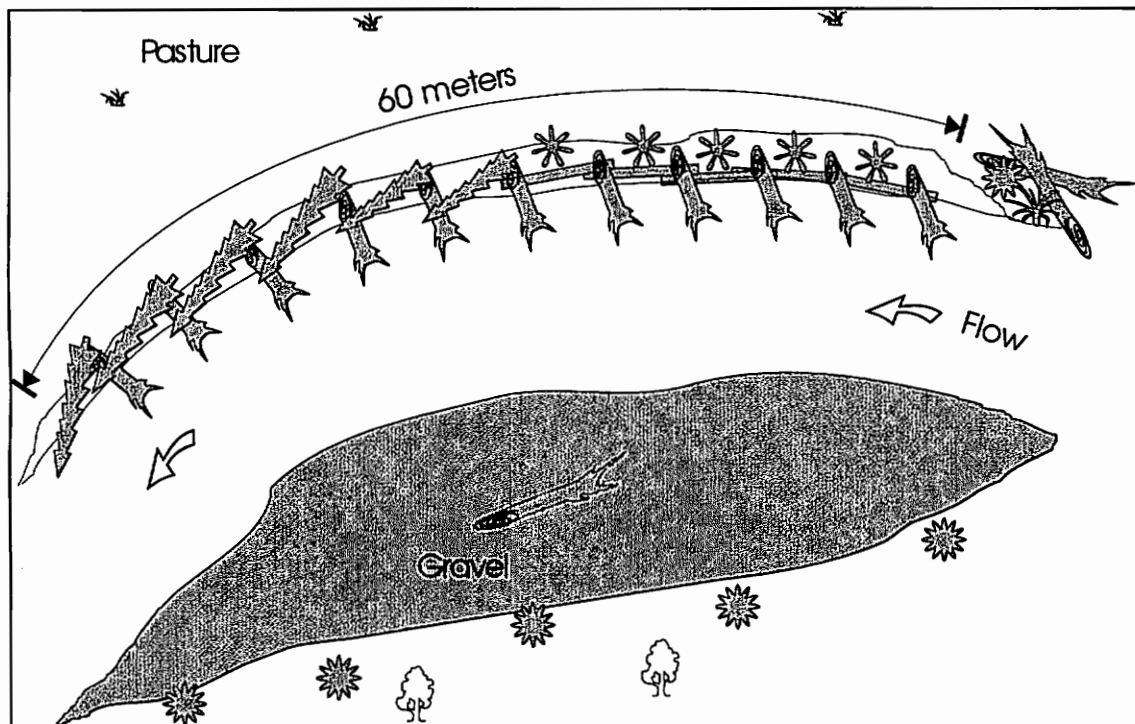
Figure 7: Site 3

Maxan Creek Site 3 was not prescribed for in AEE (1997). It is approximately 60 m in length and is also located adjacent to a cleared pasture area and trail. The streambank was about 1.5 meters in height, vertically reposed and actively eroding. The stream here is a gently curving, relatively shallow riffle / run complex. Instream cover is limited by an absence of pools, pocket water, overhanging vegetation and LWD.

The eroding streambank at this site was stabilized using a large woody debris revetment (Figure 7). Approximately 17 tree/root wads were used along with 8 branched spruce trees, 5 clumps of live willow, 4 loads of rock, one bag of grass seed and 250 feet of aircraft cable. Live willow clumps were scooped up by the excavator from a nearby area, and placed between rootwads, near the wetted perimeter. Branched spruce trees were used as header logs for about half the revetment. They were placed with the butt on top of the upstream root wad and the top underneath the downstream root wad. Their branches should further reduce water velocities along the bank.

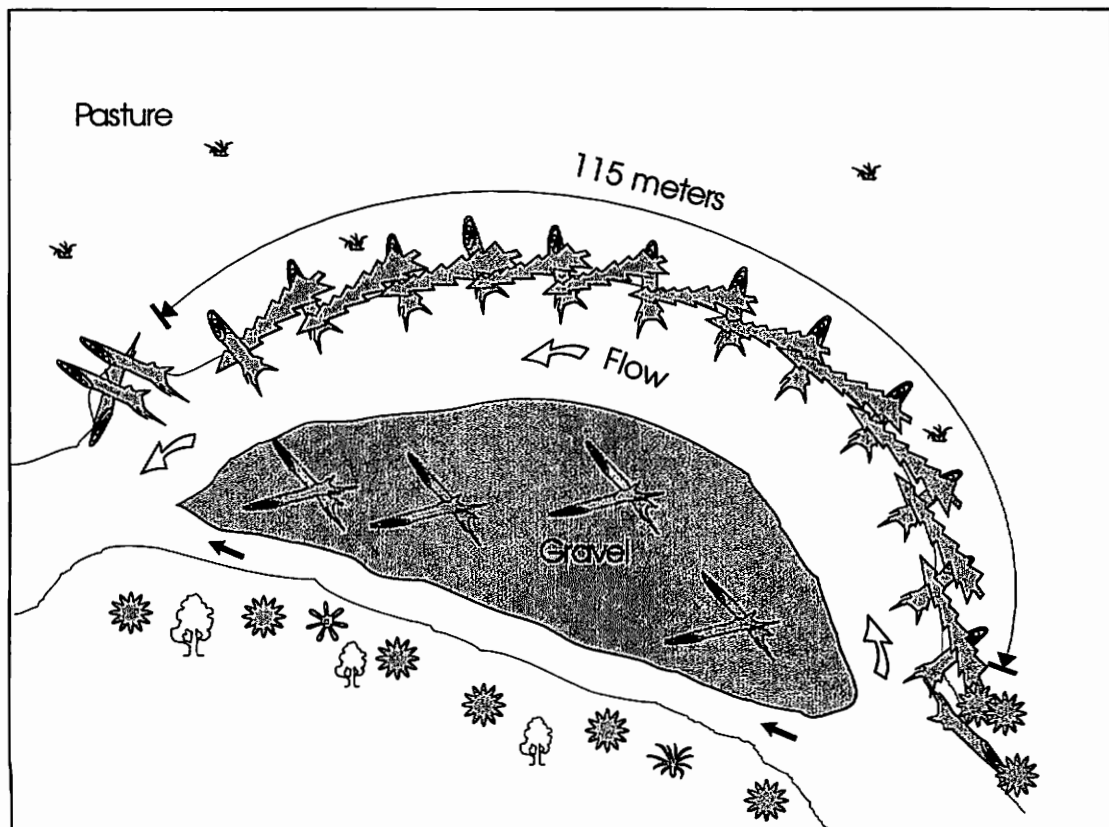
Figure 8: Site 4

Maxan Creek Site 4 was not prescribed for in AEE (1997). It is approximately 115 m in length and is located adjacent to a cleared pasture area and trail. The streambank was about 1.5 meters in height, vertically reposed and actively eroding. The stream here is a curving, relatively shallow riffle / run complex. The channel is divided. At the beginning of the project the majority of flow was along the outside of the meander bend. A beaver dam was constructed shortly afterwards, redirecting the majority of flow through the shallow cut off channel. Instream cover is limited by an absence of pools, pocket water, overhanging vegetation and LWD.

The eroding streambank at this site was stabilized using a large woody debris revetment (Figure 8). Approximately 32 tree/root wads were used along with; 20 branched spruce trees, 850 willow cuttings, one bag of grass seed and 300 feet of aircraft cable. Branched spruce trees were used as header logs. These were placed such that the butt rested on top of the upstream root wad and underneath the downstream root wad.

An attempt was made to stabilize the large gravel bar at this site using 4 LWD structures. Each of these structures consisted of 2 tree/root wads, cabled together and anchored in place using driveable anchors.

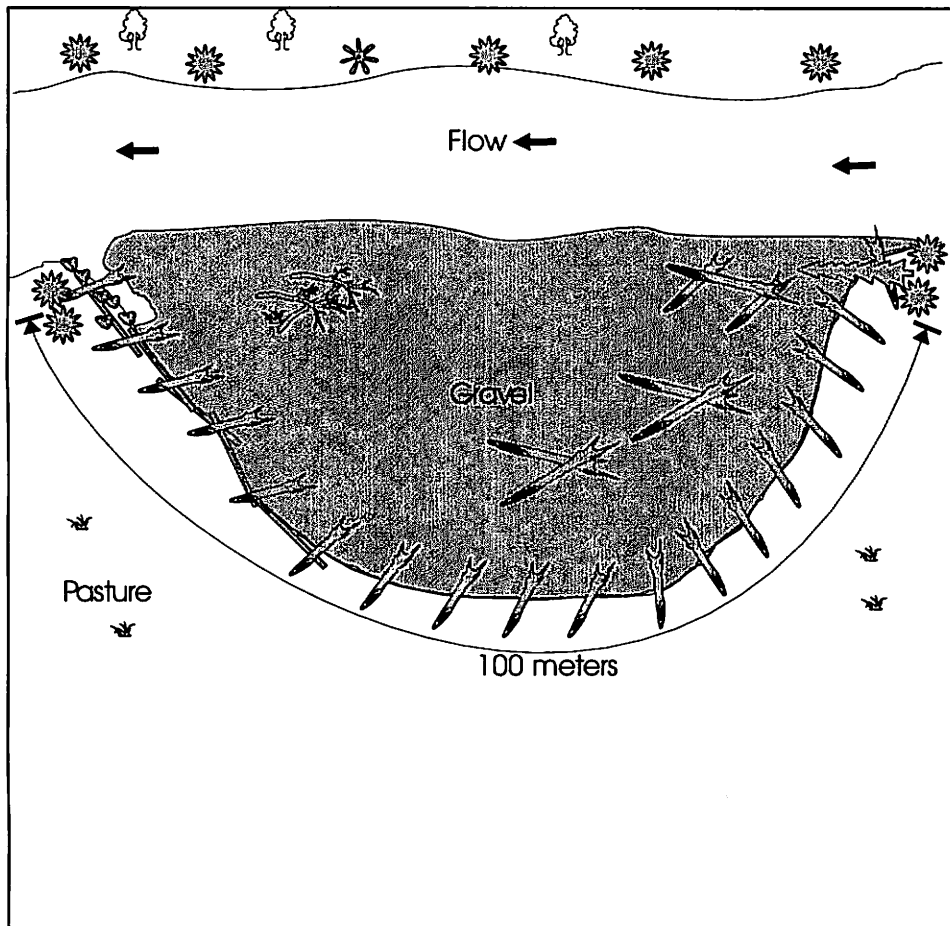
Figure 9: Site 5

Maxan Creek Site 5 corresponds to Site 10 in AEE (1997). It is approximately 100 m in length and is located adjacent to a cleared pasture area. The stream channel is divided. All flow in 1998 was through the shallow, straight, cut off channel. At higher flows water would flow along the outside of the meander bend as well. This bank was about 0.5 to 1.0 meters in height, vertically reposed and actively eroding.

The bank was stabilized using a large woody debris revetment (Figure 9). Approximately 19 tree/root wads were used along with; 6 loads of rock, 1000 willow cuttings, 1.5 bags of grass seed and 300 feet of aircraft cable.

The large gravel bar at this site was stabilized using 3 LWD structures. Each of these structures consisted of 2 - 3 tree/root wads cabled together and anchored in place using driveable anchors.

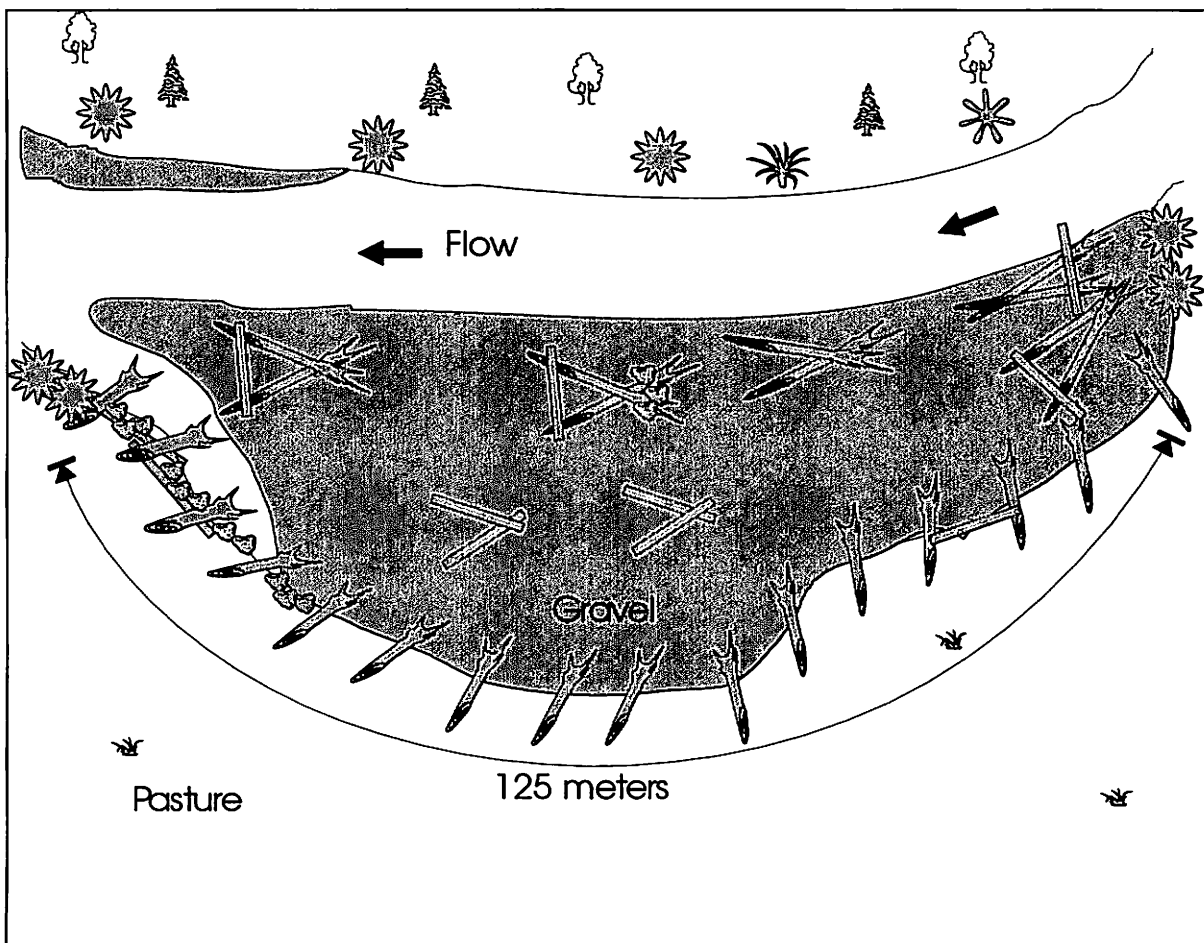
Figure 10: Site 6

Maxan Creek Site 6 is not prescribed in AEE (1997). It is approximately 125 m in length and is located adjacent to a cleared pasture area. The stream channel is divided. All flow in 1998 was through the shallow, straight, cut off channel. At higher flows water would flow along the outside of the meander bend as well. This bank was about 0.5 to 1.0 meters in height, vertically reposed and actively eroding.

The bank was stabilized using a large woody debris revetment (Figure 10). Approximately 30 tree/root wads were used along with; 5 loads of rock, 1000 willow cuttings, 1.5 bags of grass seed and 350 feet of aircraft cable.

The large gravel bar at this site was stabilized using 7 LWD structures. Each of these structures consisted of 2 - 3 tree/root wads cabled together and anchored in place using driveable anchors.

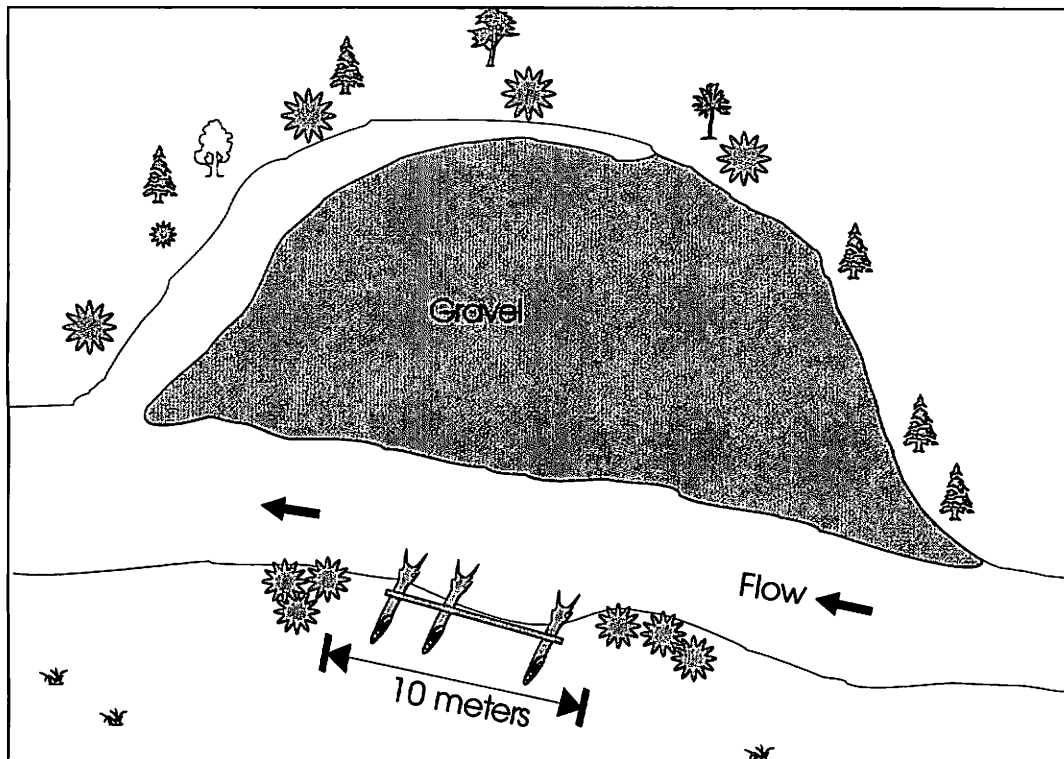
Figure 11: Site 7

Maxan Creek Site 7 corresponds to Site 9 in AEE (1997). It is approximately 10 m in length. The banks are destabilized by heavy livestock use.

The stream channel at this site is straight or gently curving. At higher flows water would also flow along the outside of the meander bend opposite from the site.

The bank was stabilized using a large woody debris revetment (Figure 11). Approximately 3 tree/root wads were used along with; 50 willow cuttings, and 50 feet of aircraft cable.

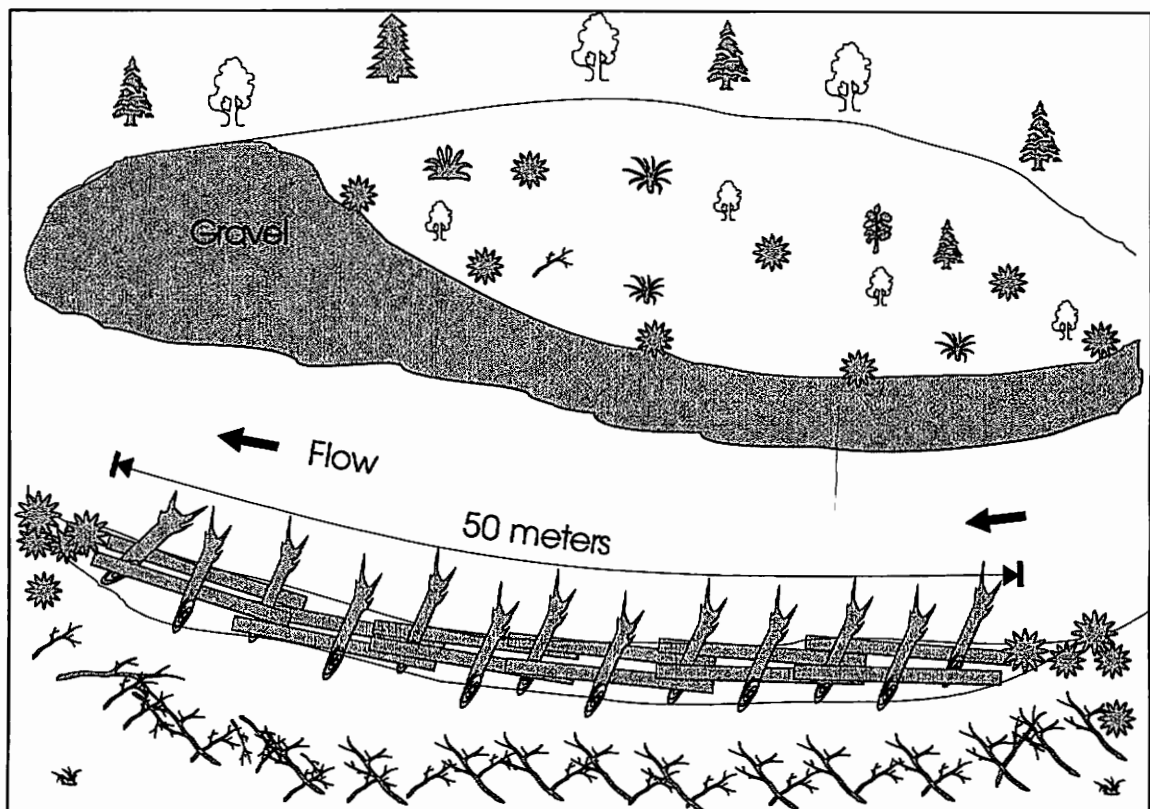
Figure 12: Site 8

Maxan Creek Site 6 is not prescribed for in AEE (1997). It is approximately 50 m in length and is located adjacent to a cleared pasture area. There is no deep rooted riparian vegetation remaining on this side of the creek. The streambank was about 1.5 - 2.0 meters in height, vertically reposed and actively eroding. The stream is a gently curving, relatively shallow riffle / run complex. Instream cover is limited by an absence of pools, pocket water, overhanging vegetation and LWD.

The bank was stabilized using a large woody debris revetment (Figure 12). Two layers of rootwads were used. The top layer was placed over top of the header logs. A brush/debris barrier was placed about 3 meters back from the revetment to limit livestock access.

Approximately 26 tree/root wads were used along with; 500 willow cuttings, one bag of grass seed and 350 feet of aircraft cable.

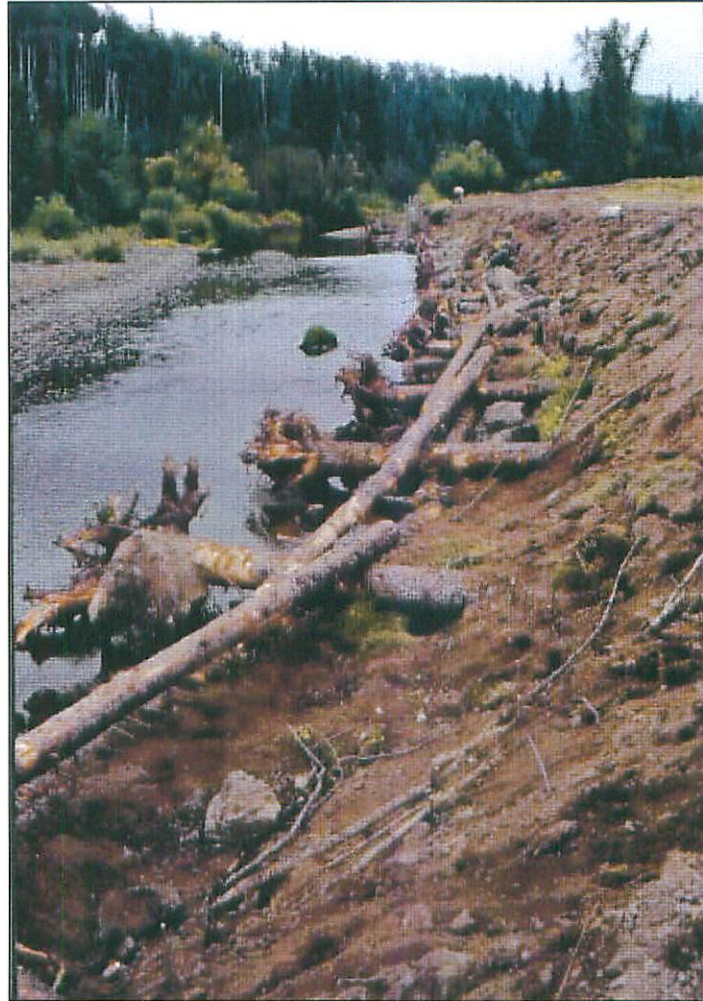
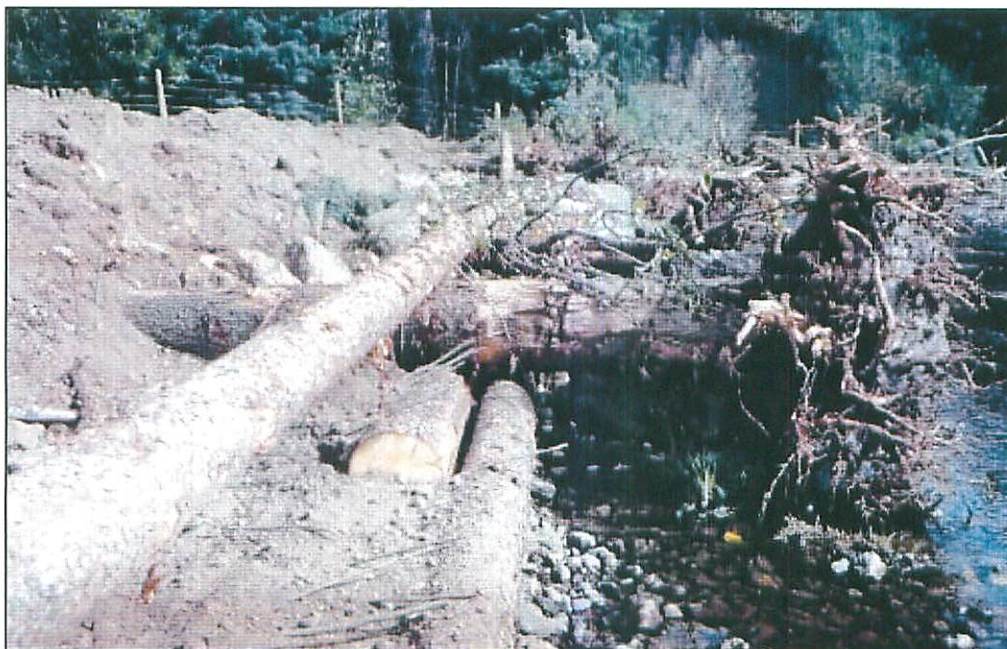
Figure 3: Site 1 - LWD Revetment

Figure 2: Site 1 - LWD Revetment

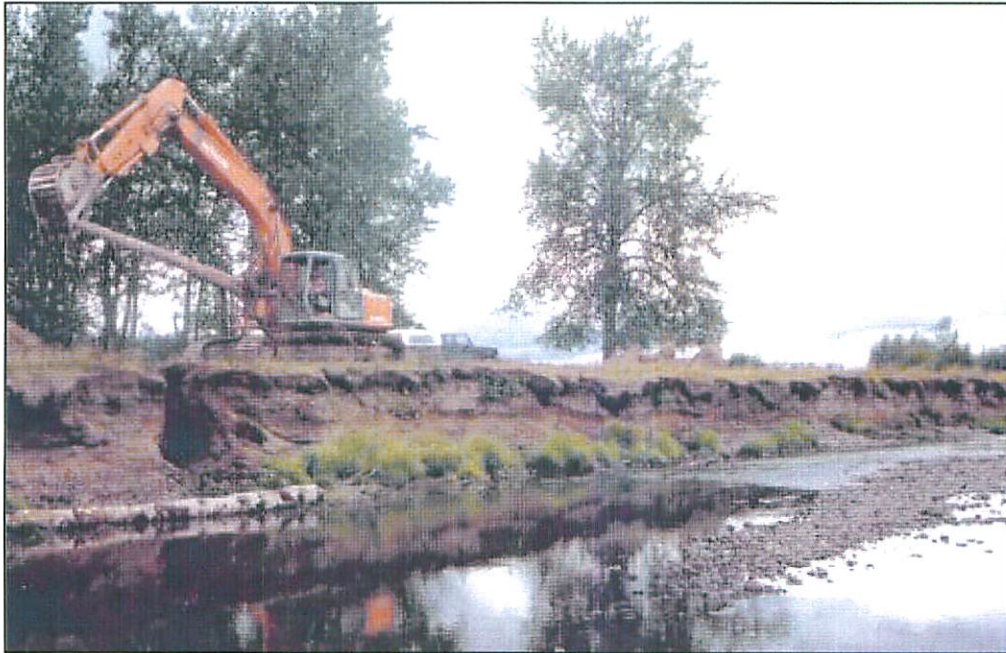
Figure 1: Site 1 - Placing LWD

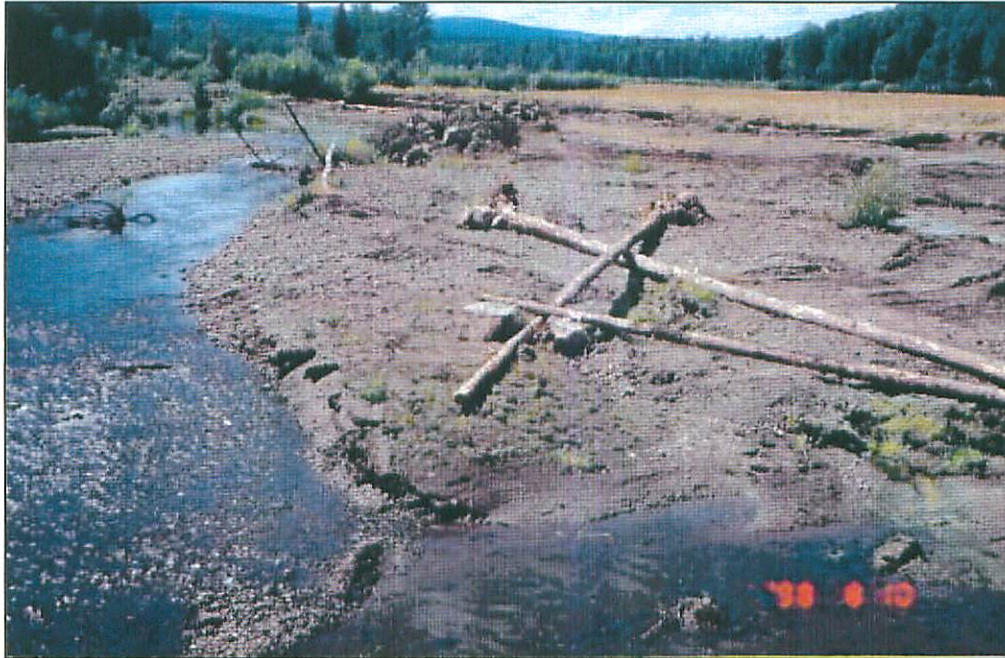
Figure 4: Site 6 - Bar Stabilization Structure

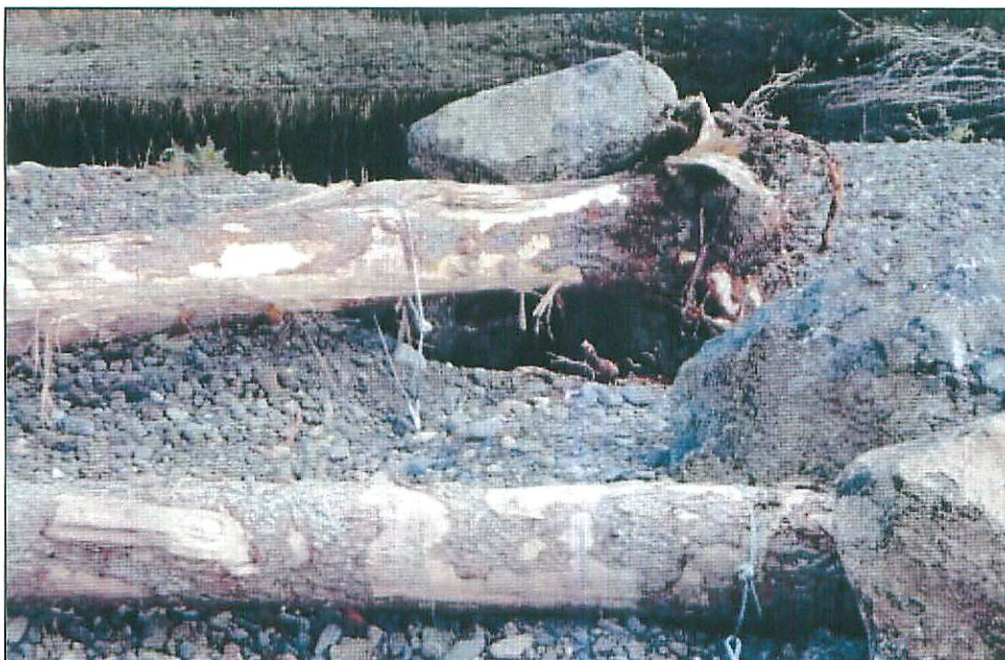
Figure 5: Site 6 - Anchoring for Bar Stabilization Structures
