## **Mid-Bulkley Overview FHAP Appendices**

Data Forms, Oblique Photos, Stream Classifications,  
Stereo Air Photos, and Maps

## **Appendix 6**

### **Oblique Photos**

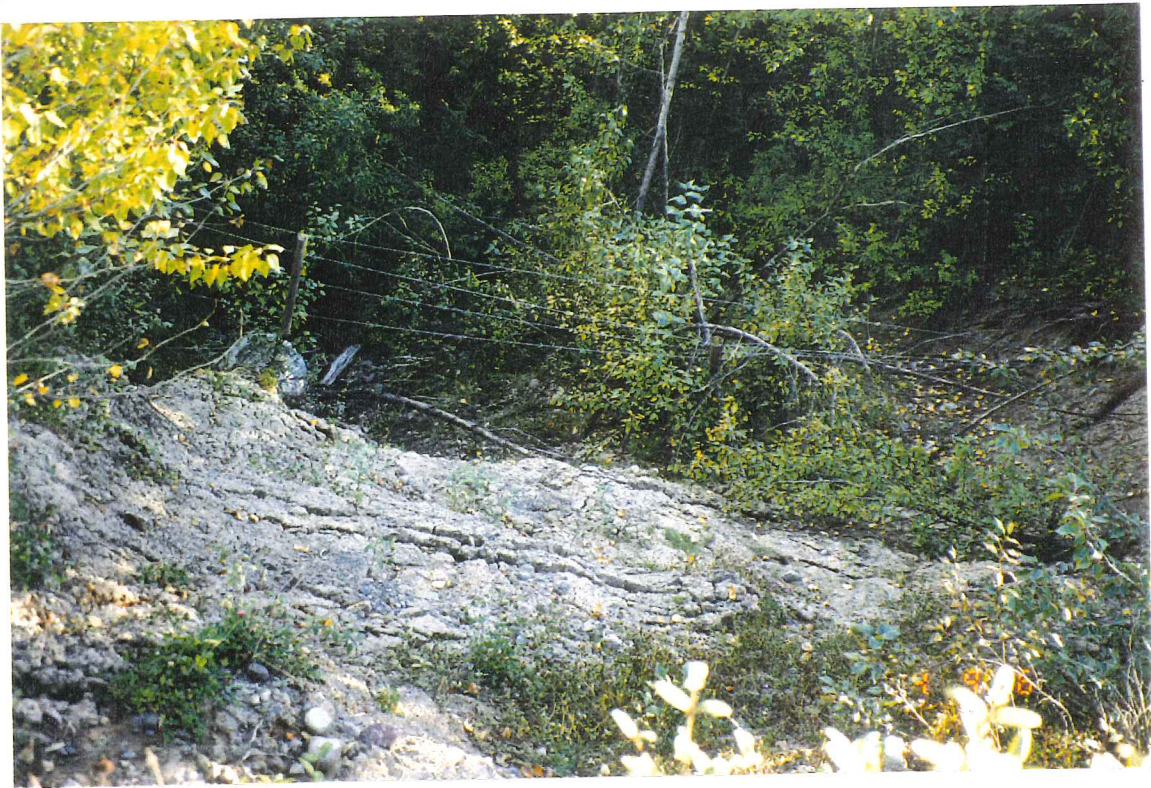
**Plate 3:** Large rotational clay slump at the Michelle Bay FSR. Occurred at a culvert for a small intermittent unnamed creek and was likely caused by the geotechnical and/or hydraulic failure of the fine-textured fill.

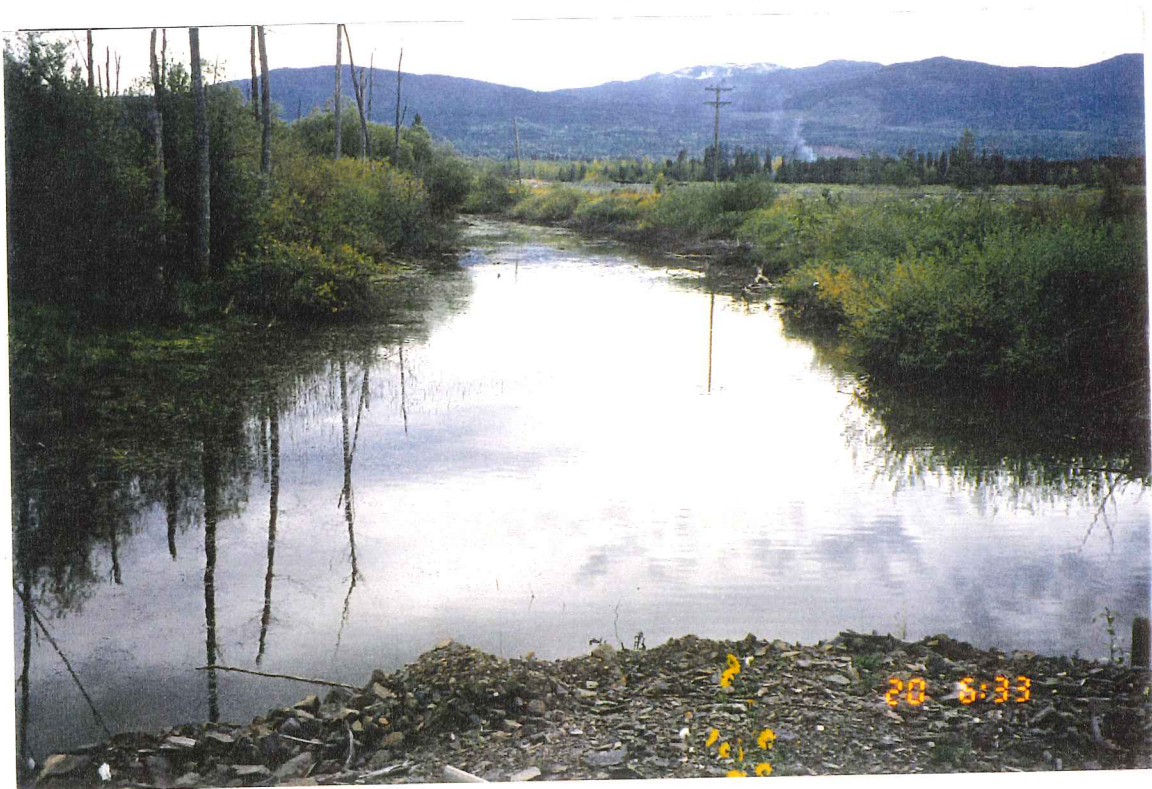
**Plate 4:** A large ground and surface water-fed sidechannel of Reach 1 which has been cutoff from the mainstem for fish access. Locally known as "Silverthorne" because Silverthorne Creek was diverted into this area from the Morice watershed.

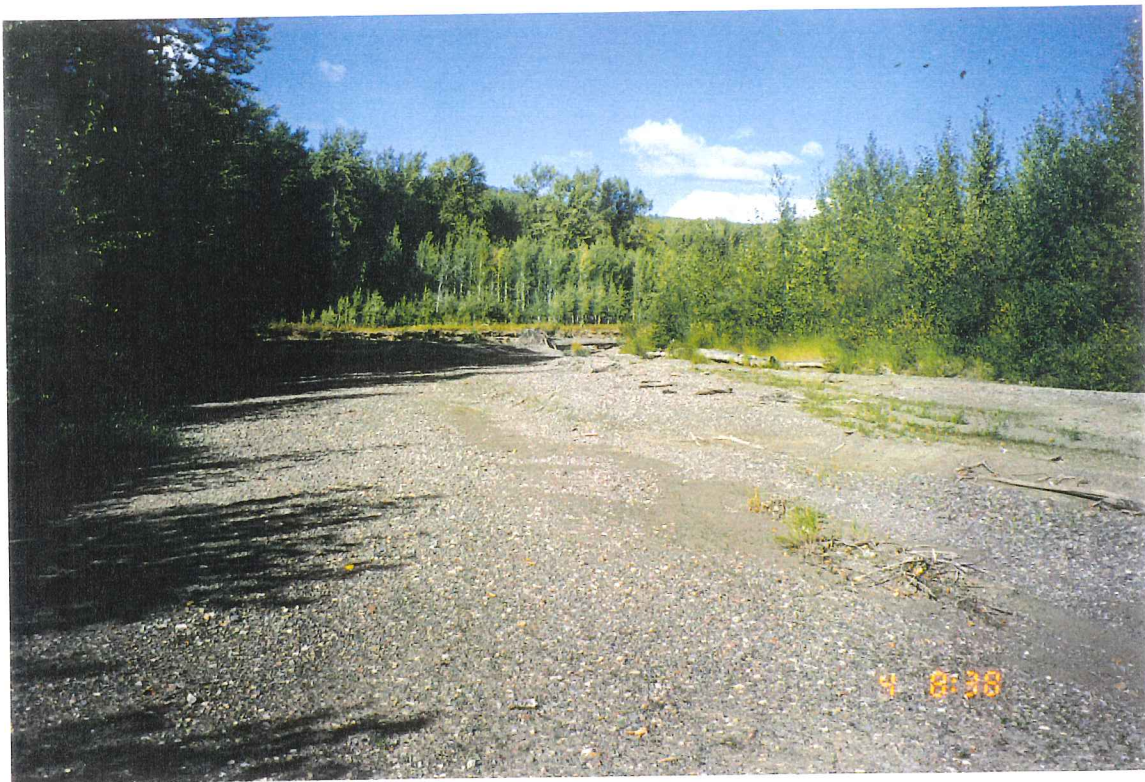
**Plate 5:** Reactivated offchannel area behind Paul's Automotive. Reactivated during the spring flood of 1997. The reactivation of relic channels is an internal sediment source.

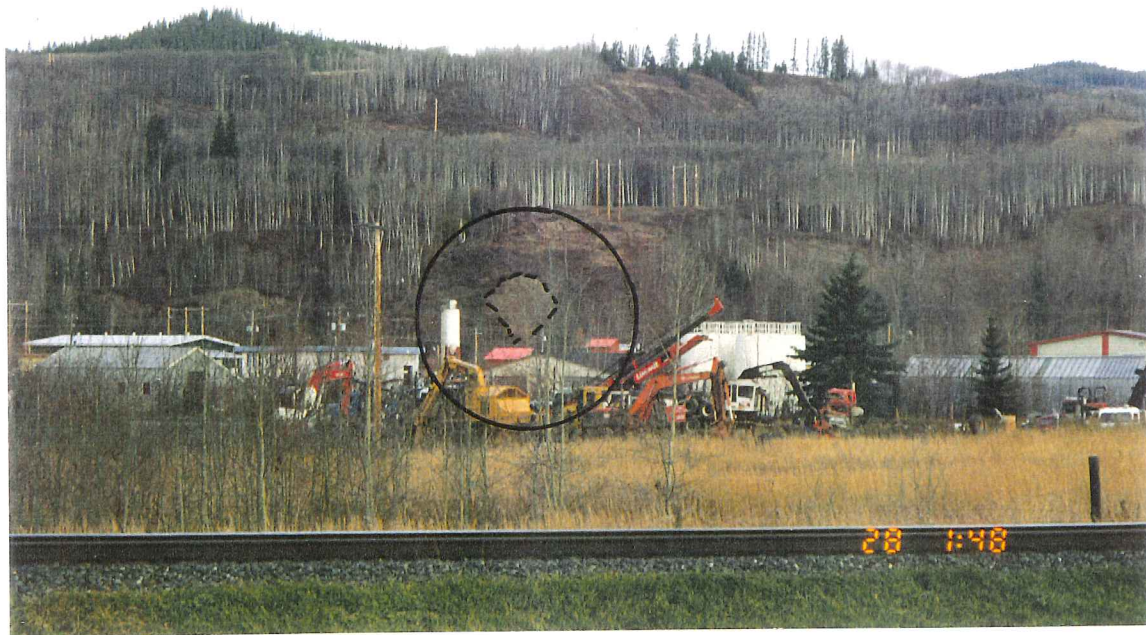
**Plate 6:** Powerline crossing of Bulkley River at Houston showing an actively eroding section on the cleared slope.

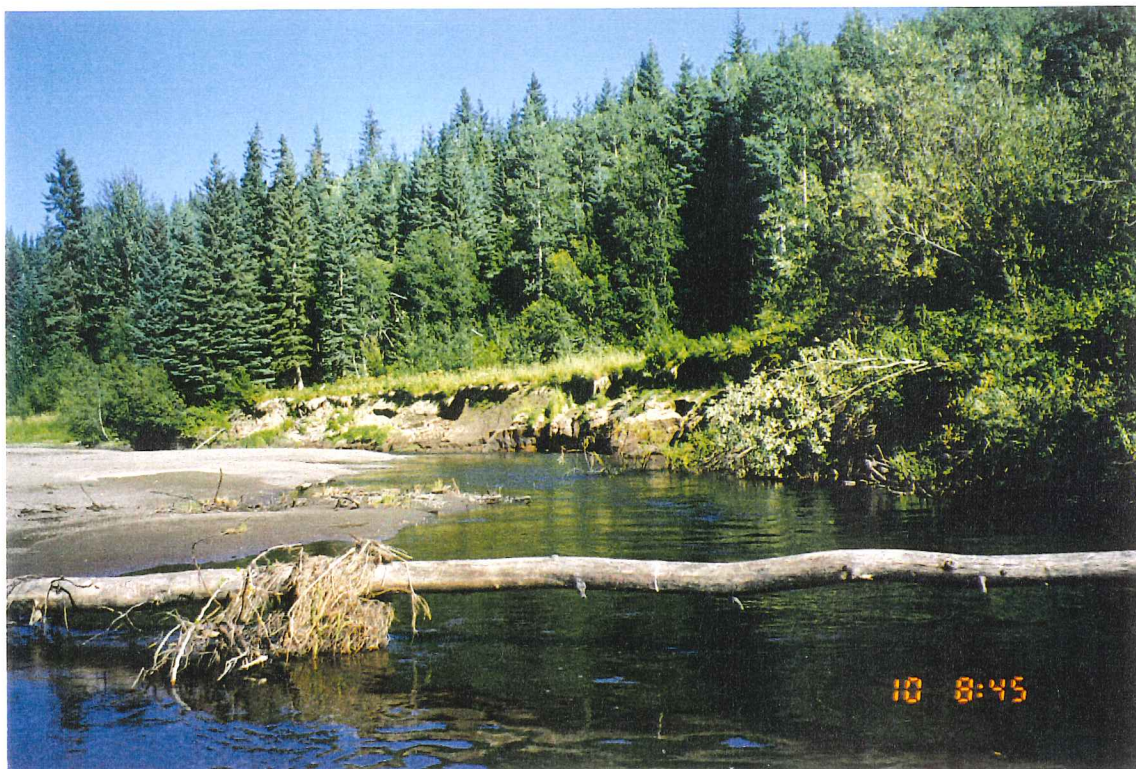
**Plate 7:** Bank erosion on a bend at cleared land in Reach 2. Note the height of banks relative to width of channel and deposition of fines in point bars downstream (foreground). Taken at midflow conditions in July, 1997.

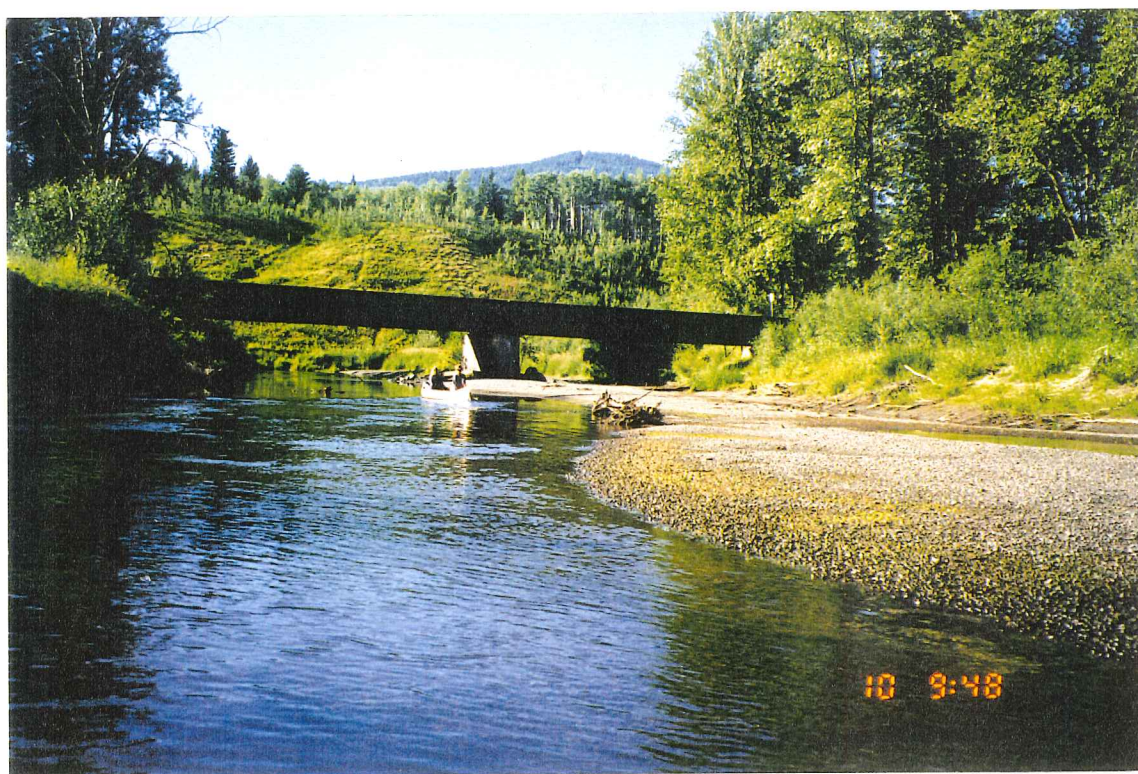
**Plate 8:** Unstable aggradation occurring behind a CNR railway bridge pillar in Reach 2 near Houson. Deposited just downstream of a rip-rapped bend.

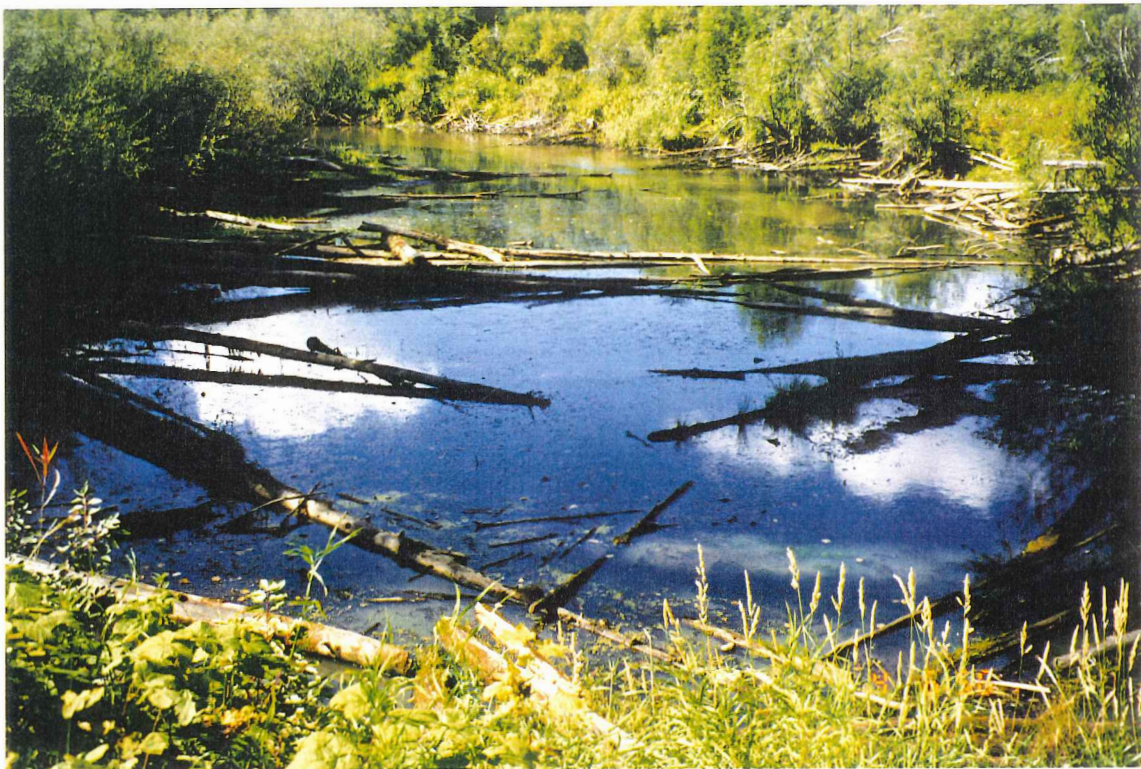
**Plate 11:** Typical oxbow which has either limited or no access to fish and floodwaters due to floodplain development of the railway and highway corridors. Reach 2, Bulkley River.

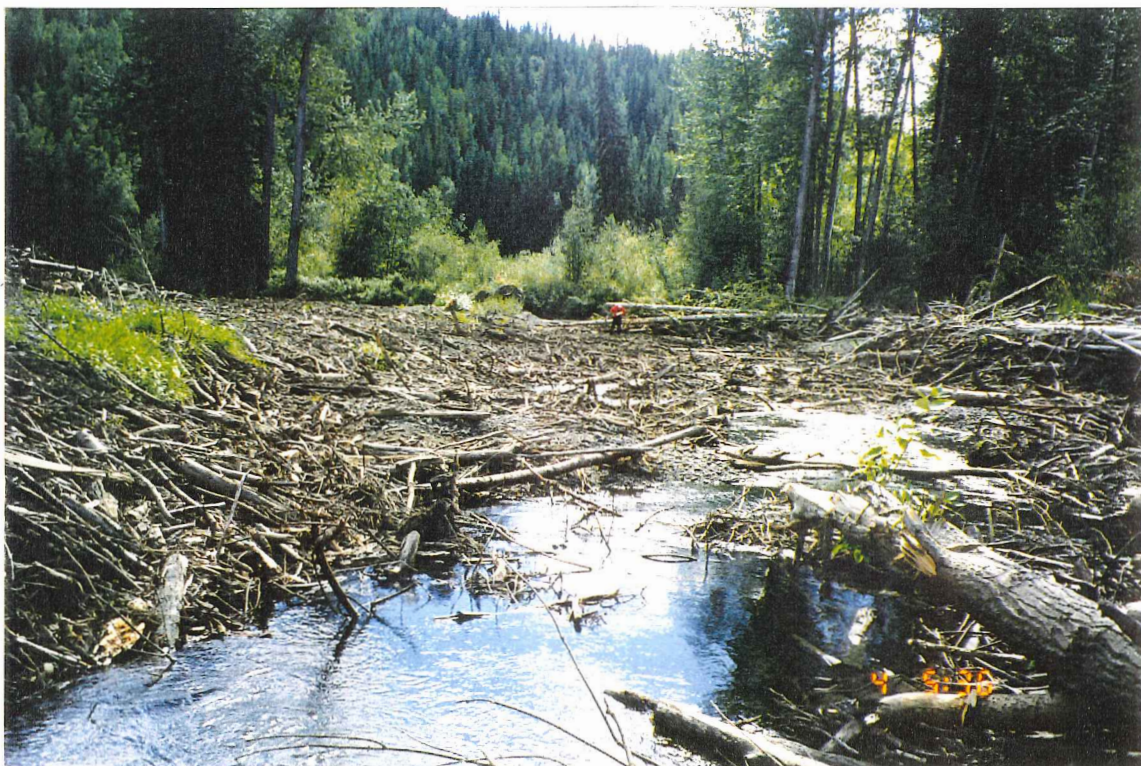
**Plate 12:** One of two major log jams which threatened or damaged property during the spring flood of 1997. The log jam was removed by heavy equipment working in the stream and LWD was moved to the side of the river. The wood remains in the confines of the active channel width, as does the large sediment wedge which built up behind it. (see plates 84-85 of Bulkley River photo mosaics)

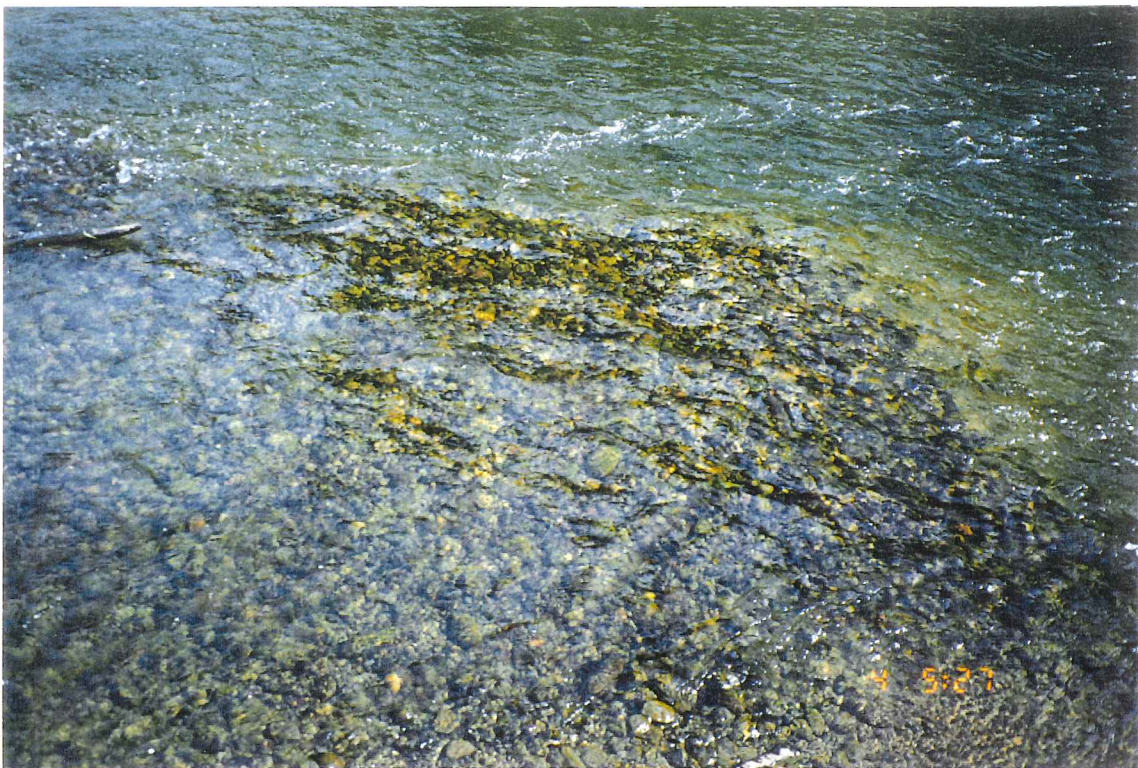
**Plate 13:** An area of good, clean uncompacted spawning gravels were found just downstream of the CN Log Jam, and are now threatened due to the large, exposed sediment wedge.

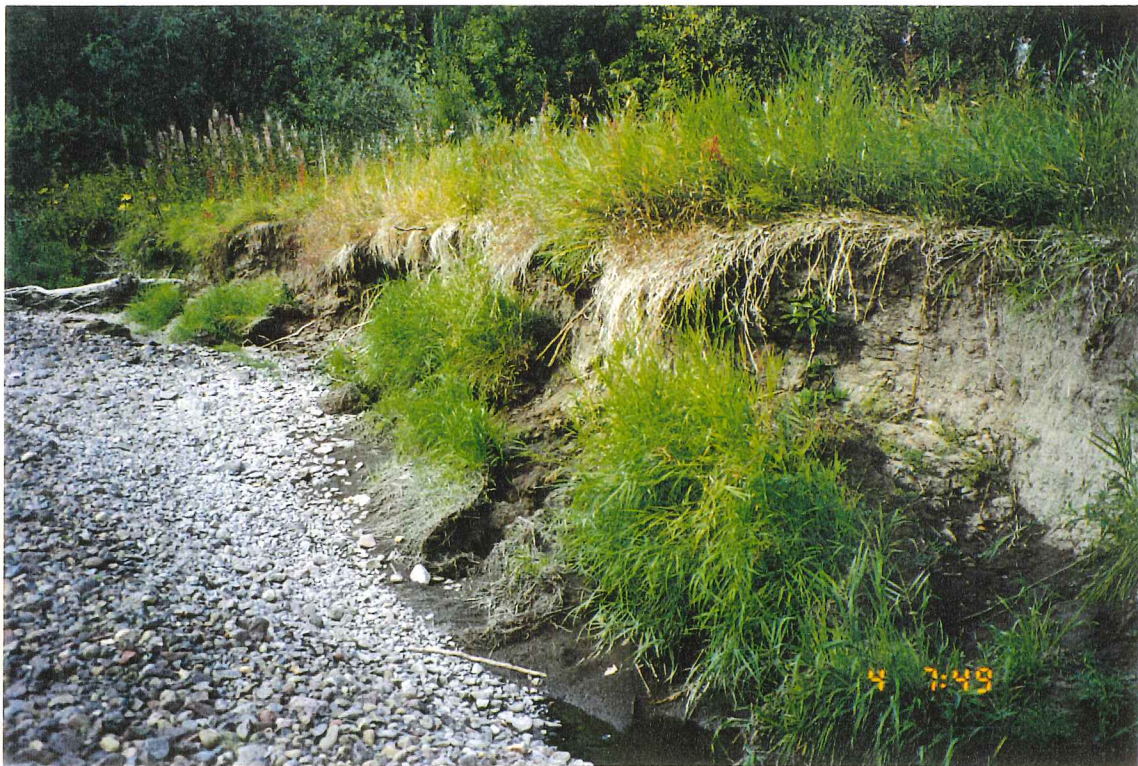
**Plate 16:** Extensive bank erosion downstream of the channelized section of Buck Creek (Reach 1B).

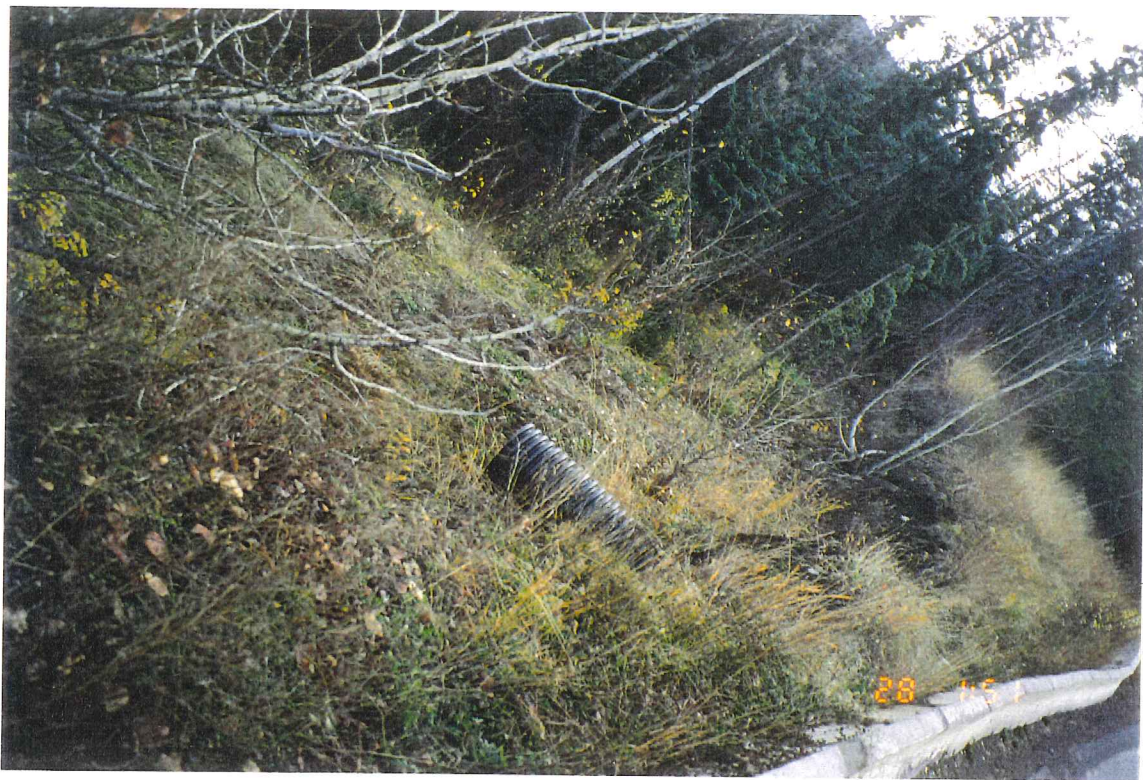
**Plate 19:** Slide scarp of large rotational slump above Buck Creek, Reach 1C. The slump is occurring at the edge of a suburban road along the lip of the slope. It shows high connectivity to the active channel of Buck Creek.

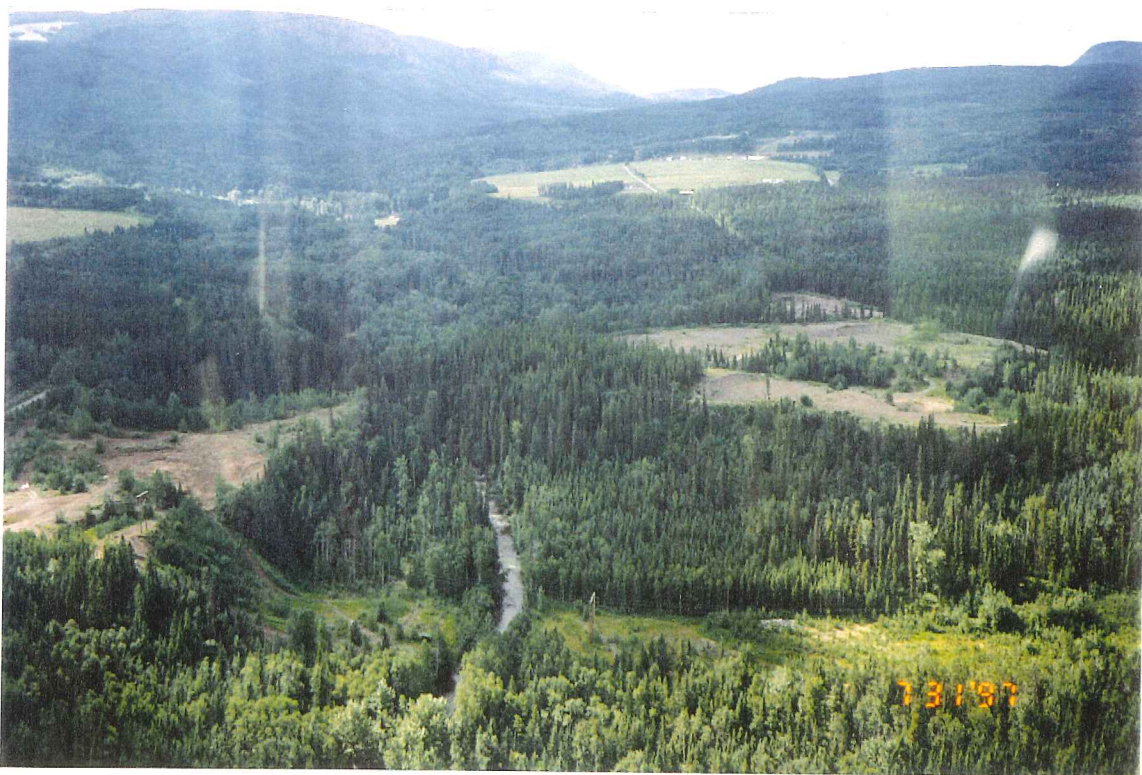
**Plate 20:** Reach 2 of Buck Creek, showing powerline crossing and gravel quarries. The right-of-way is eroding from runoff being concentrated down the road to the creek crossing (to the left of the photo).

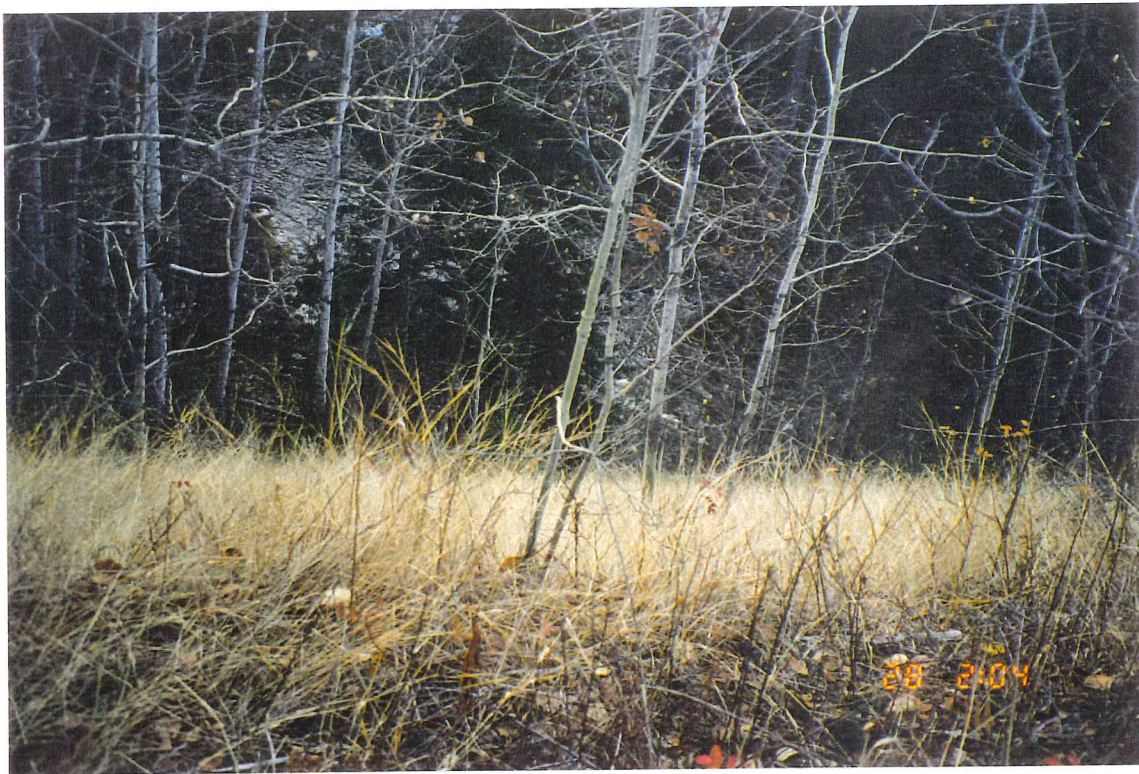
**Plate 21:** Large grassy slope below gravel quarry showing the recently revegetated slip surface of a slide into Buck Creek. Adjacent slopes showed signs of movement as well.

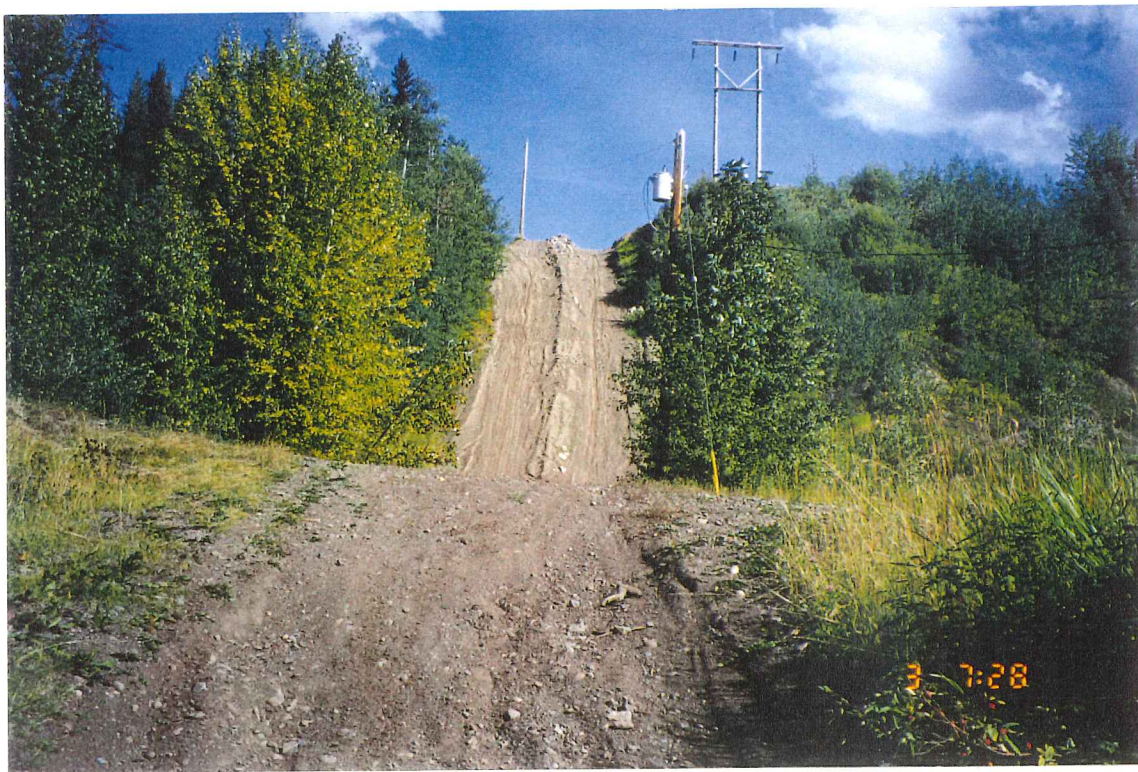
**Plate 22:** Powerline access road in Reach 2, Buck Creek, eroding due to concentration of runoff. An external source of fine sediment.

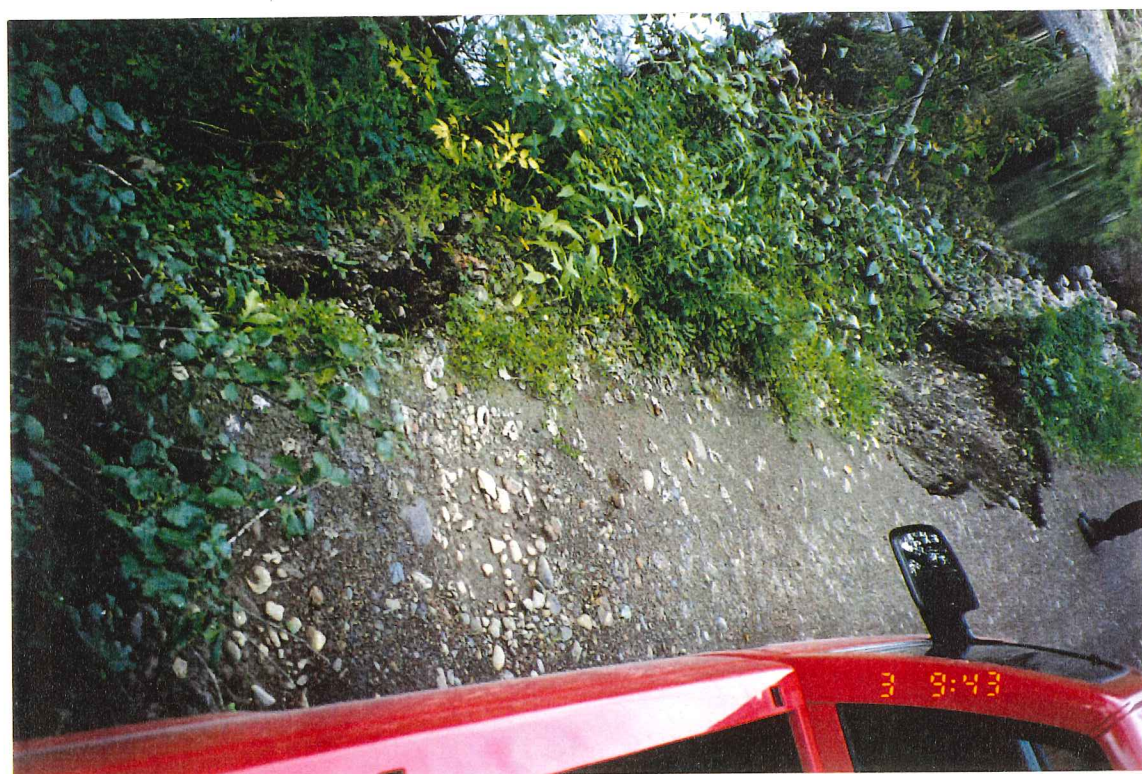
**Plate 24:** Road adjacent to Buck Creek in Reach 4B eroding directly into creek.

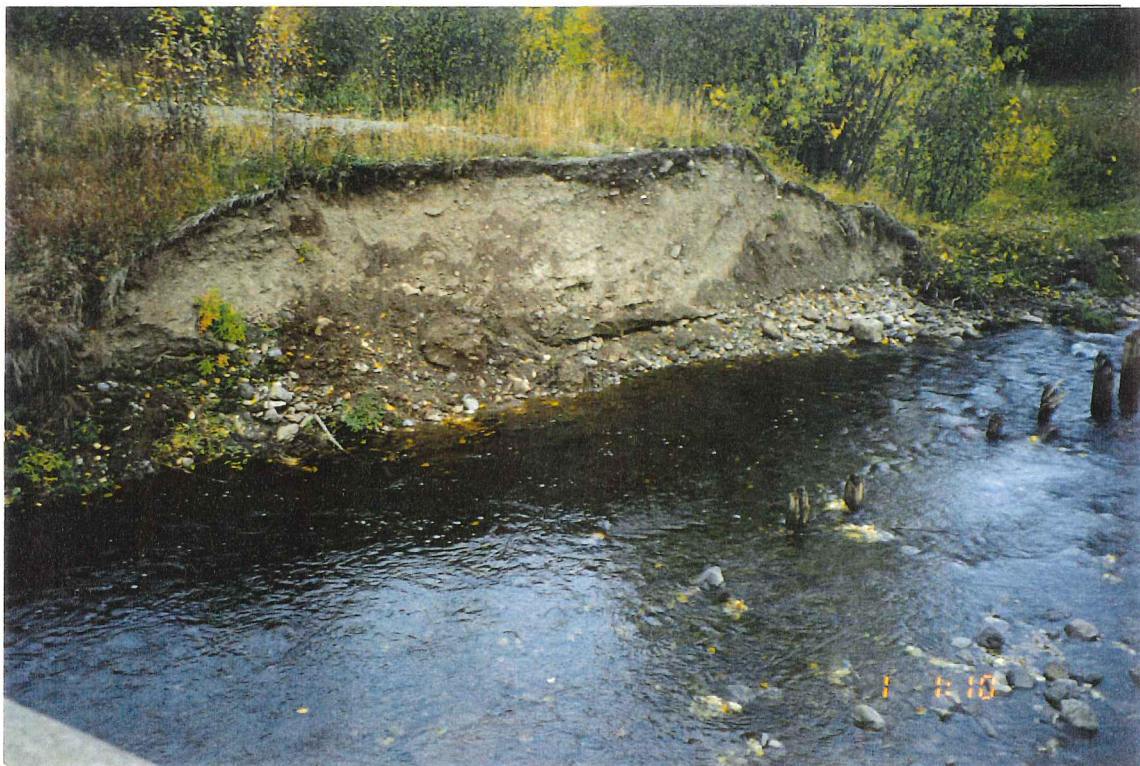
**Plate 26:** Old bridge abutment at the second Buck Flats Road bridge is wasting into the creek.

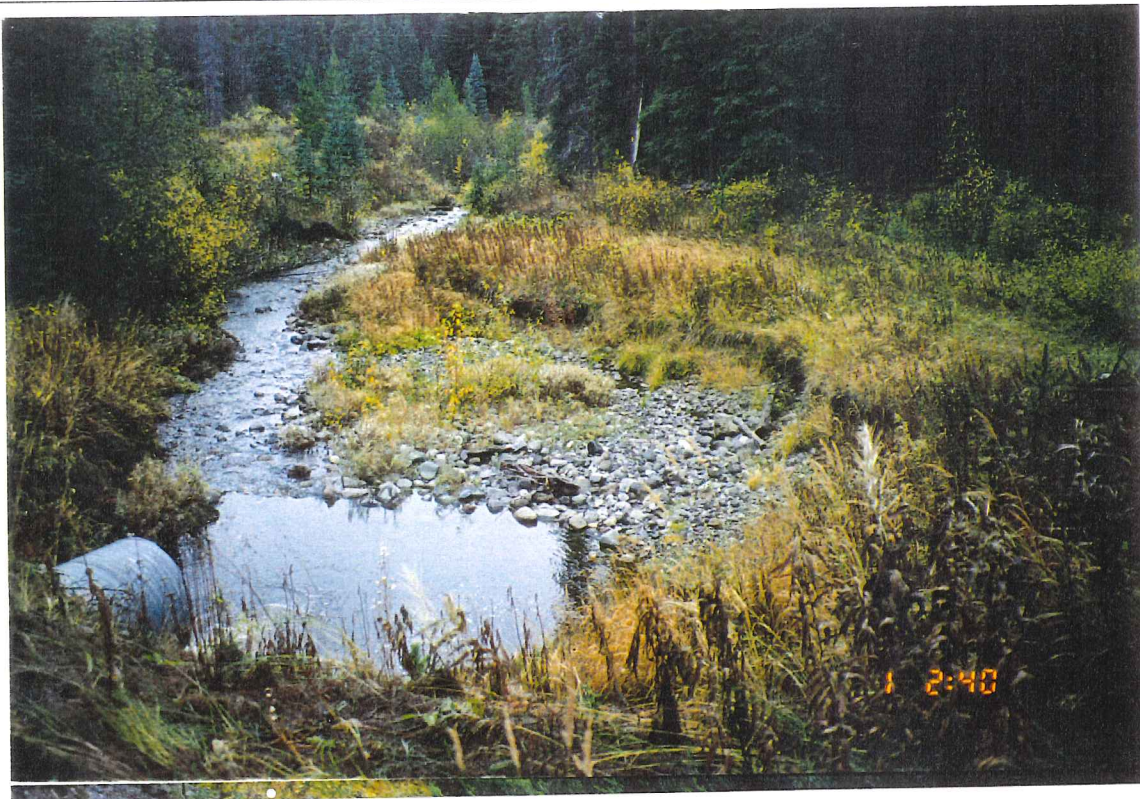
**Plate 31:** Erosion and bank instability below FSR crossing of Unnamed Creek draining from the southwest into the top of Reach 11, Upper Buck Creek.

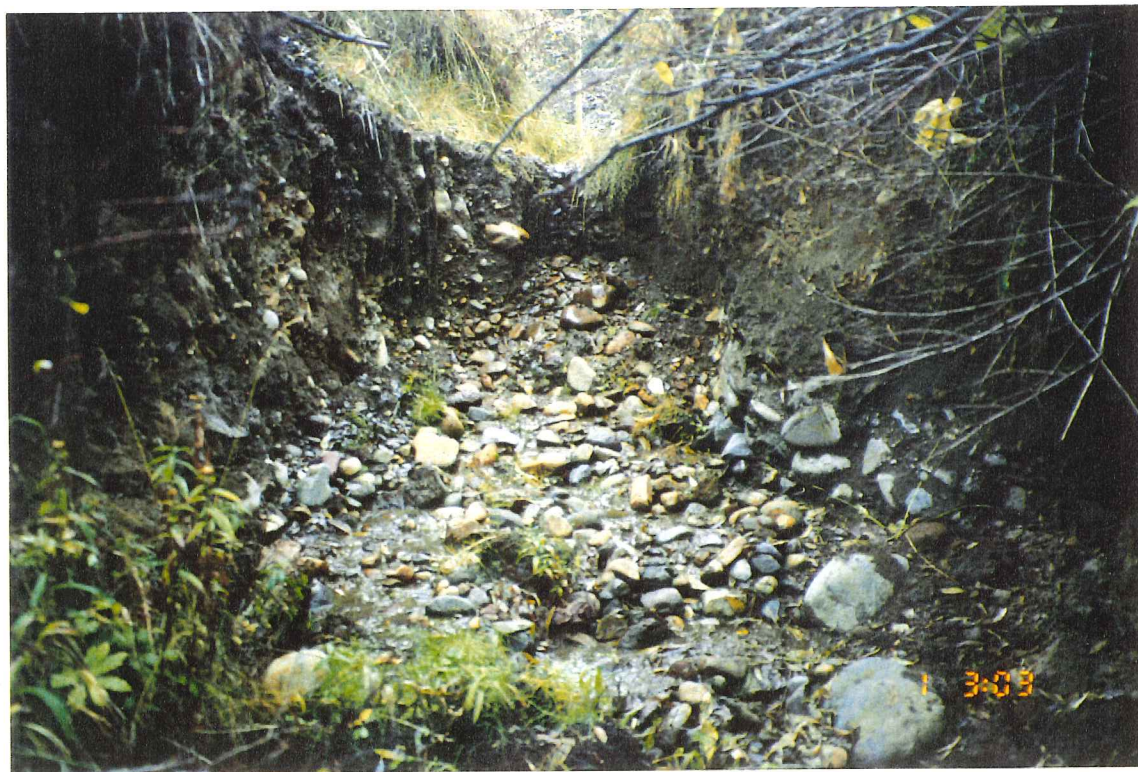
**Plate 32:** Failing crossditch line on FSR delivering sediment to Upper Buck Creek, Reach 11B.

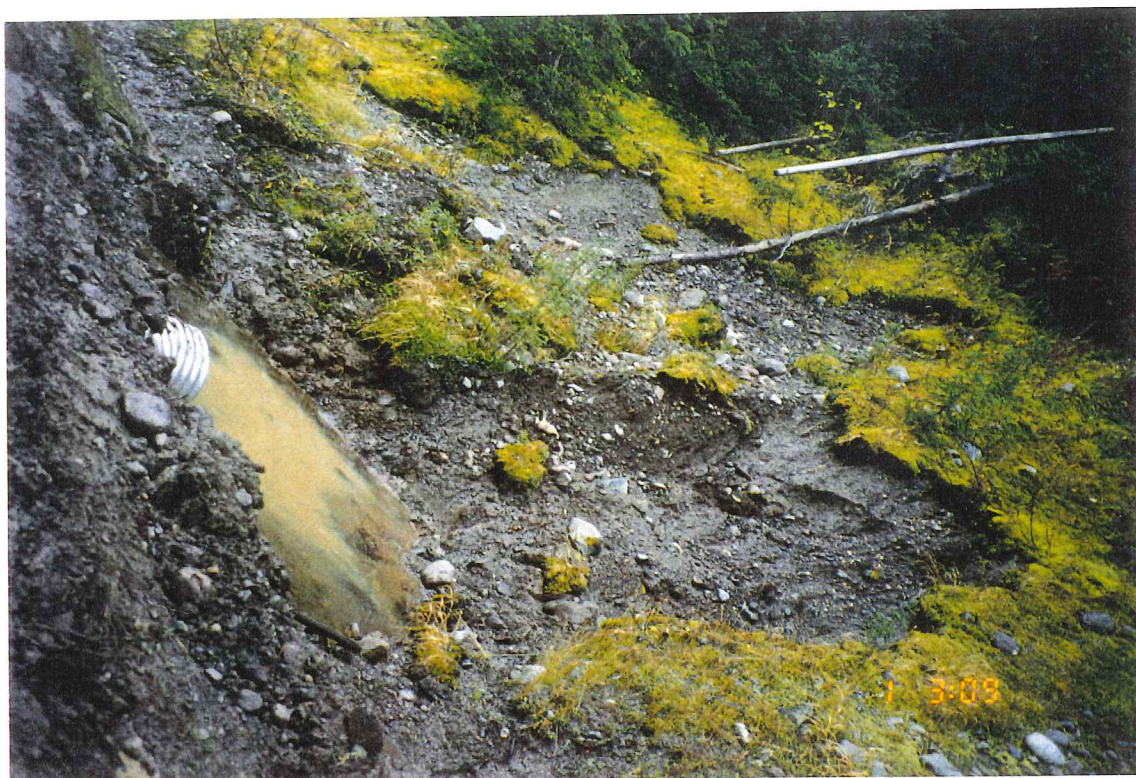
**Plate 33:** Failing slope above culvert on FSR is a source of fines to Upper Buck Creek, Reach 11B.

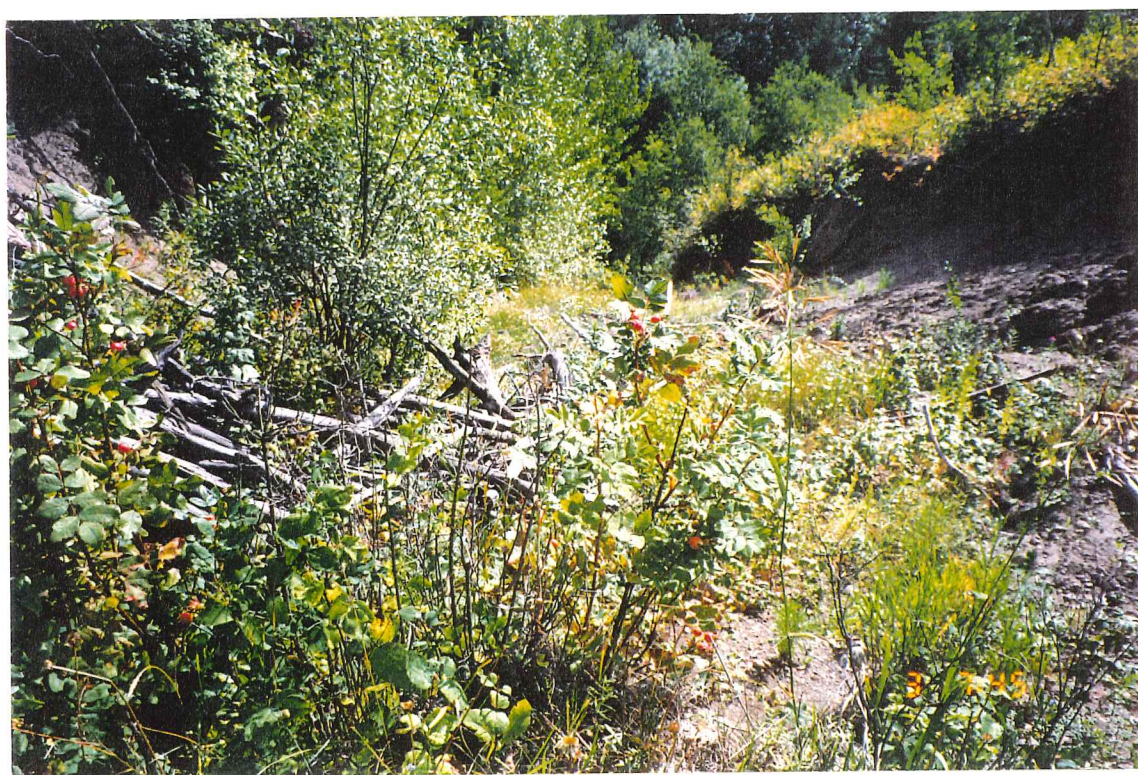
**Plate 34:** Large mass movement from the farm road upslope of Dungate Creek, Reach 1 (to the North) into the floodplain.

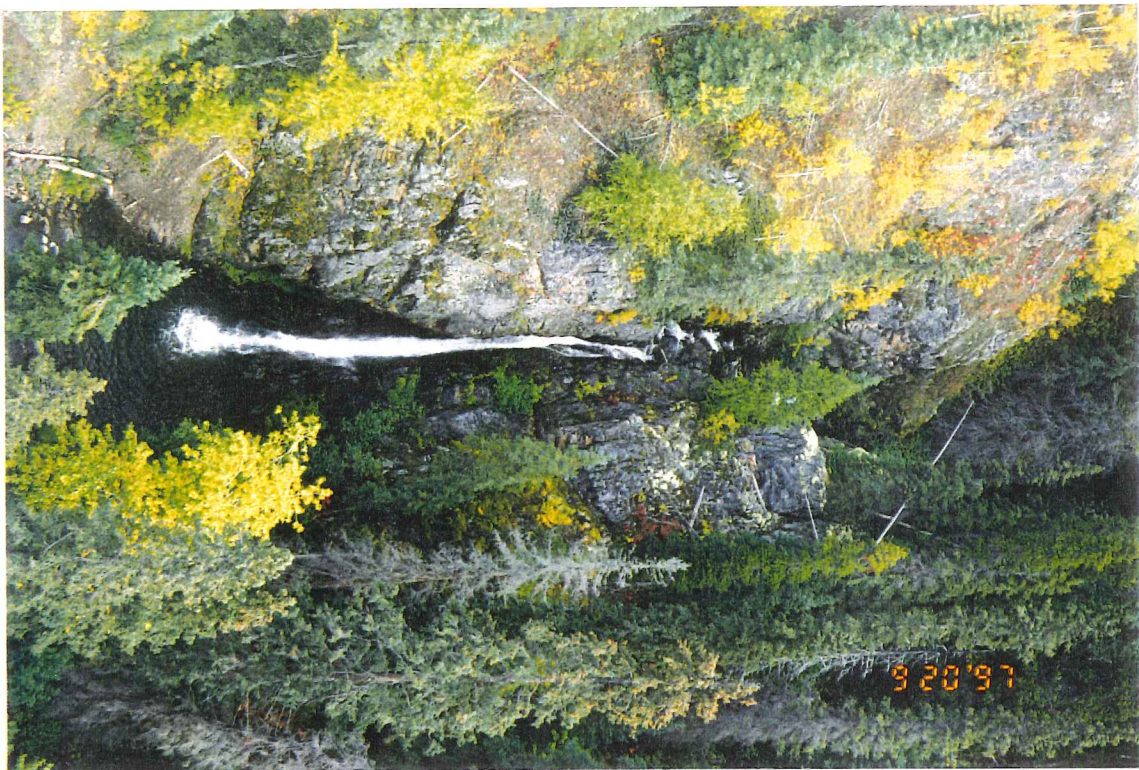
**Plate 35:** The first set of impassable falls on Dungate Creek, Reach 2. Note overhanging section and absence of ledges/pools which is the crux to fish passage.

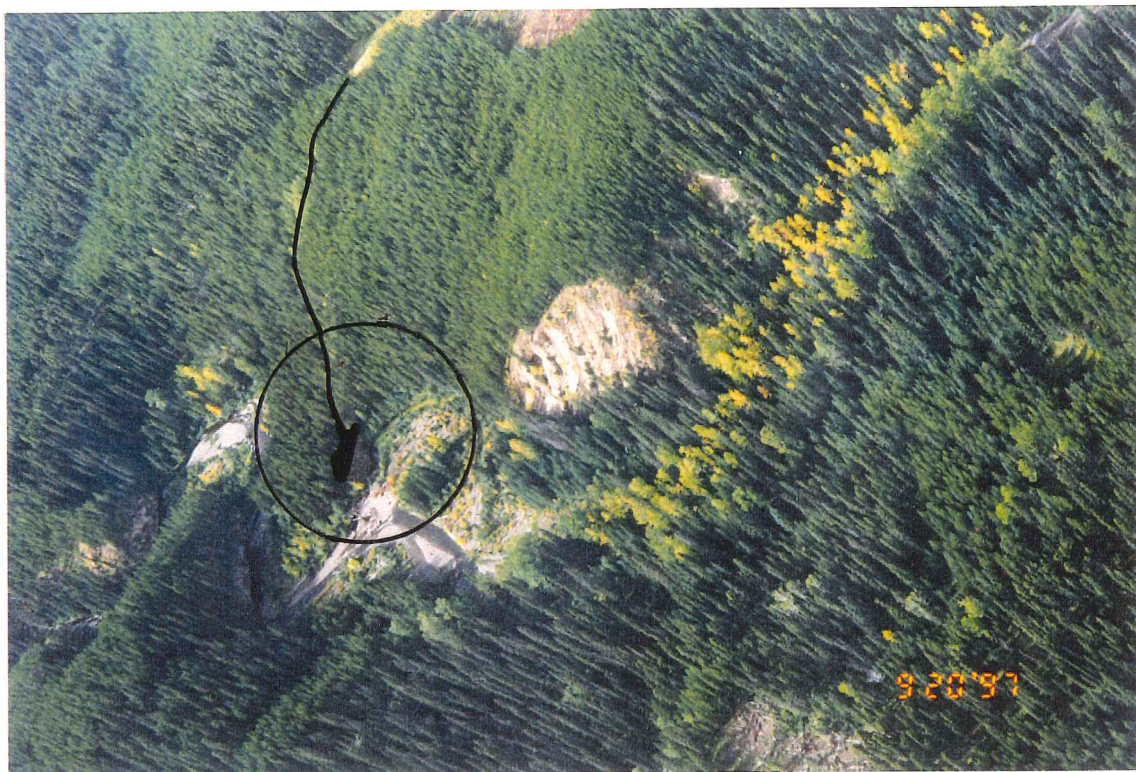
**Plate 37:** Representative photo of Kilo Creek, Reach 2. Path of a gully failure from an upslope clearcut is indicated by the black line.

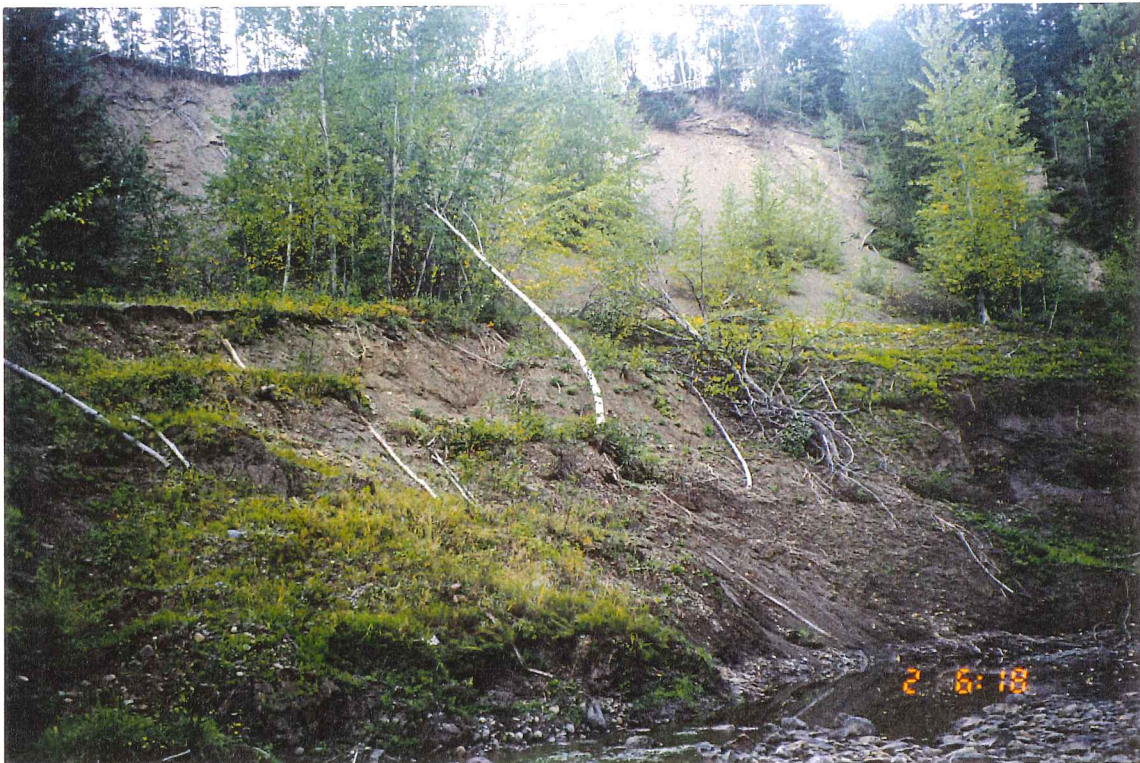
**Plate 40:** Large slump at the Reach  $\frac{1}{2}$  break of Richfield Creek. Note the numerous active blocks below the bottom slide scarp. Cattle use the benches of this slide for passage across and down to the waterline.

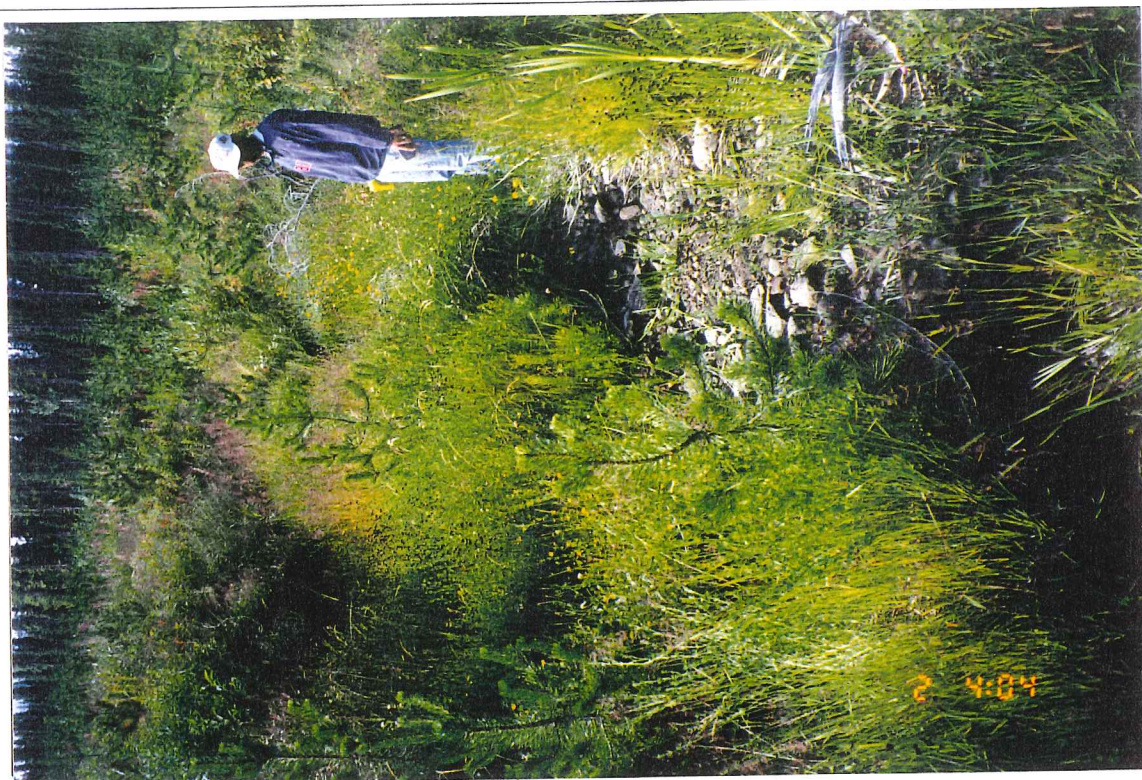
**Plate 43:** Eroding fire break in the headwaters of Redtop Creek is causing a debris torrent into the forest below the Granisle Highway crossing. This erosion is entering a large wetland complex at Redtop Creek, but the capacity of this wetland for sediment storage is unknown.

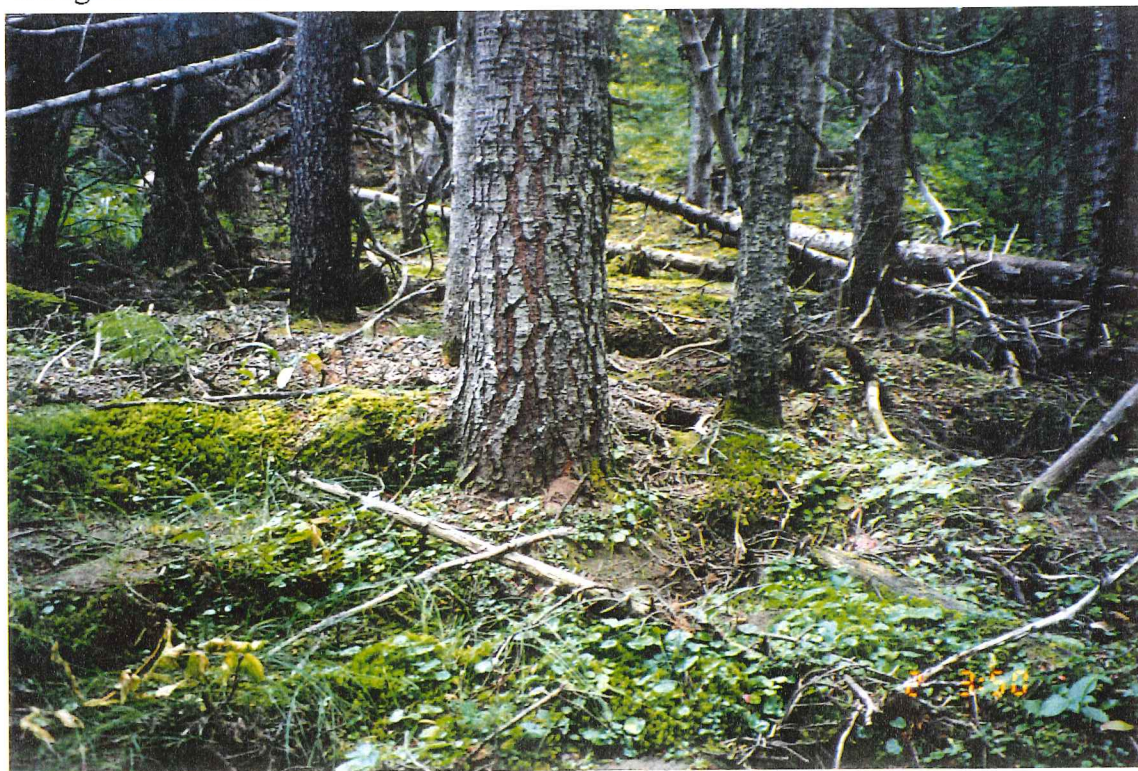
**Plate 44:** Debris torrent fan below Granisle highway. Note that the bottom sections of the tree trunks are buried. The fan was approximately 10 metres wide at its snout. This is not an appreciably large torrent, but may be a persistent problem over many years to come.
