## **Mid-Bulkley Overview FHAP Appendices**

Data Forms, Oblique Photos, Stream Classifications,  
Stereo Air Photos, and Maps

## **Appendix 6**

### **Oblique Photos**

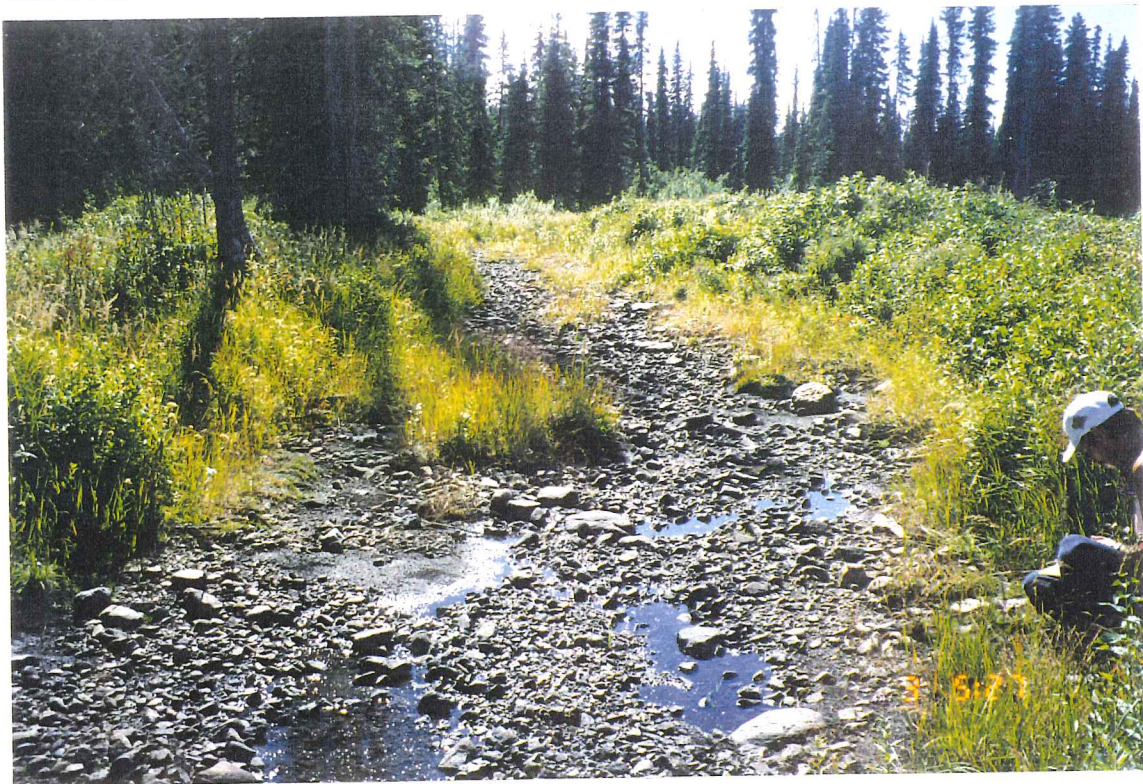
**Plate 45:** Eroding fire break at clearcut in the headwaters of Robert Hatch Creek which delivers sediment into a wetland area behind a beaver dam. The water running over this fire break is Robert Hatch Creek.

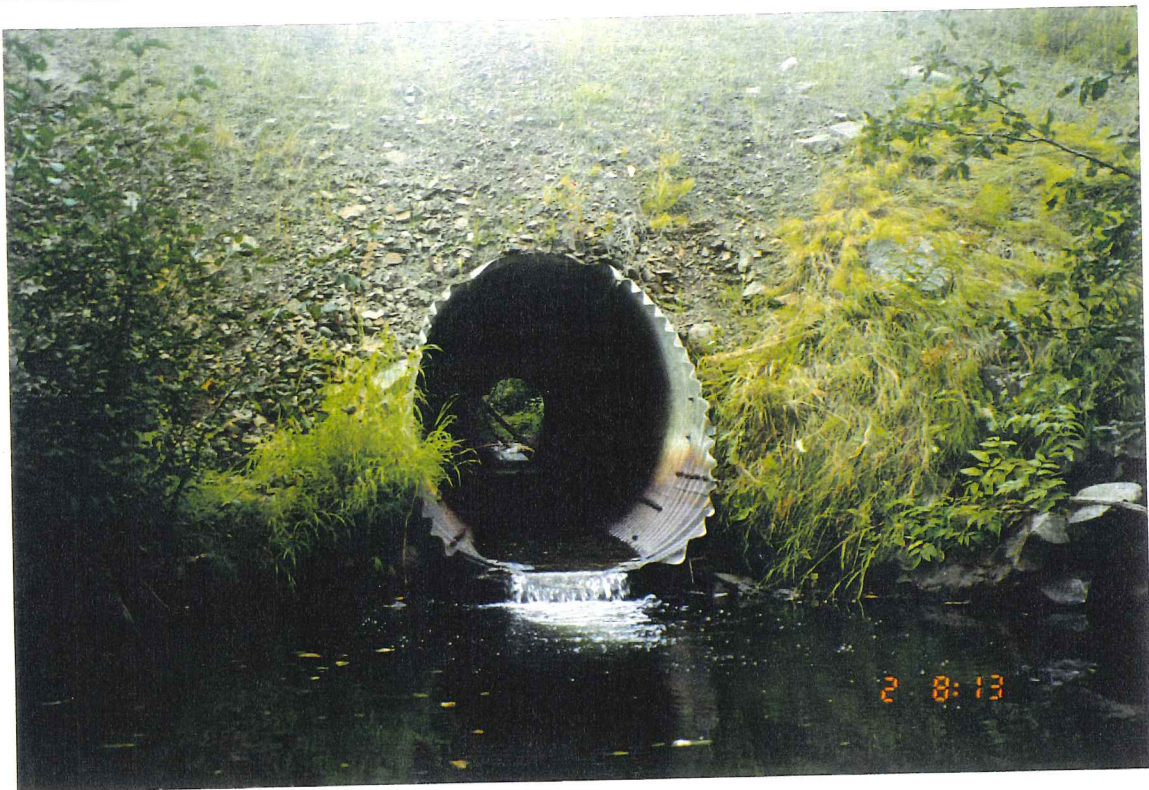
**Plate 47:** Highway culvert on Johnny David Creek. This culvert does not appear to be a barrier due to gradient and height of inlet/outlet above the channel surface. It may be impassable due to water velocities at higher flows and water levels at low flows. Photo taken at low flows.

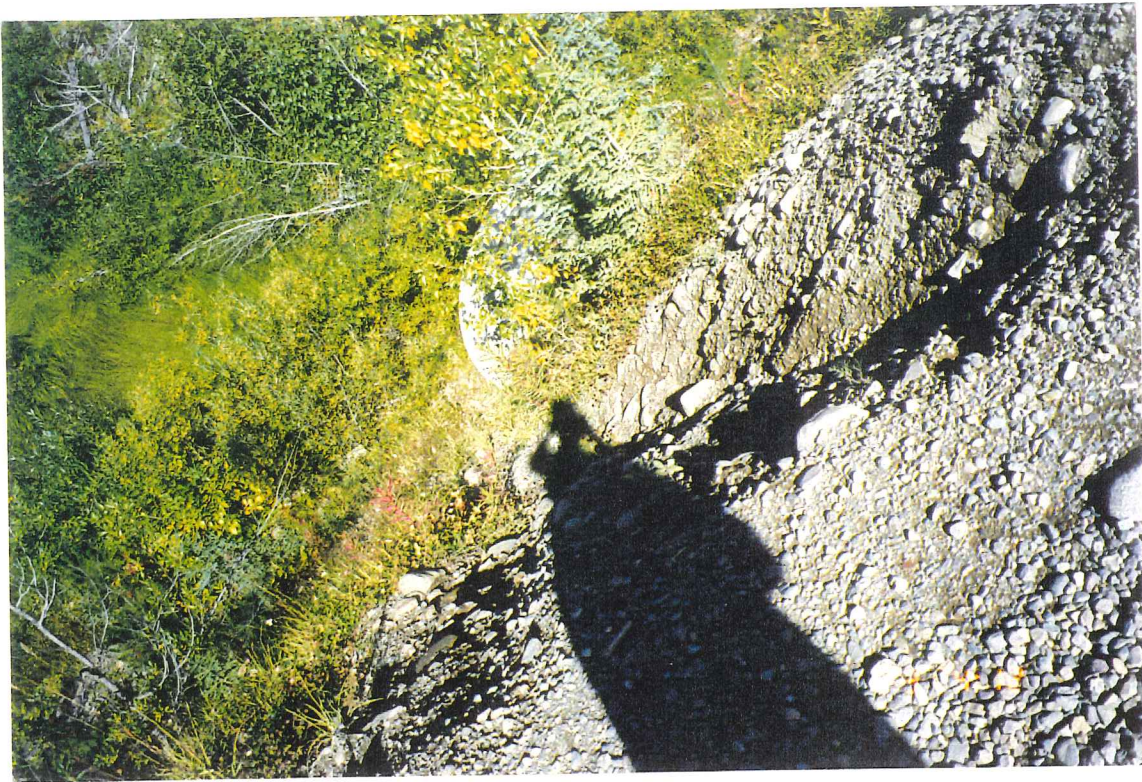
**Plate 49:** Extensive erosion of the North Road FSR fill slope into an intermittent Unnamed tributary to Johnny David Creek. The fill slope is eroding on both sides of the crossing due to use of relatively fine-textured fill.

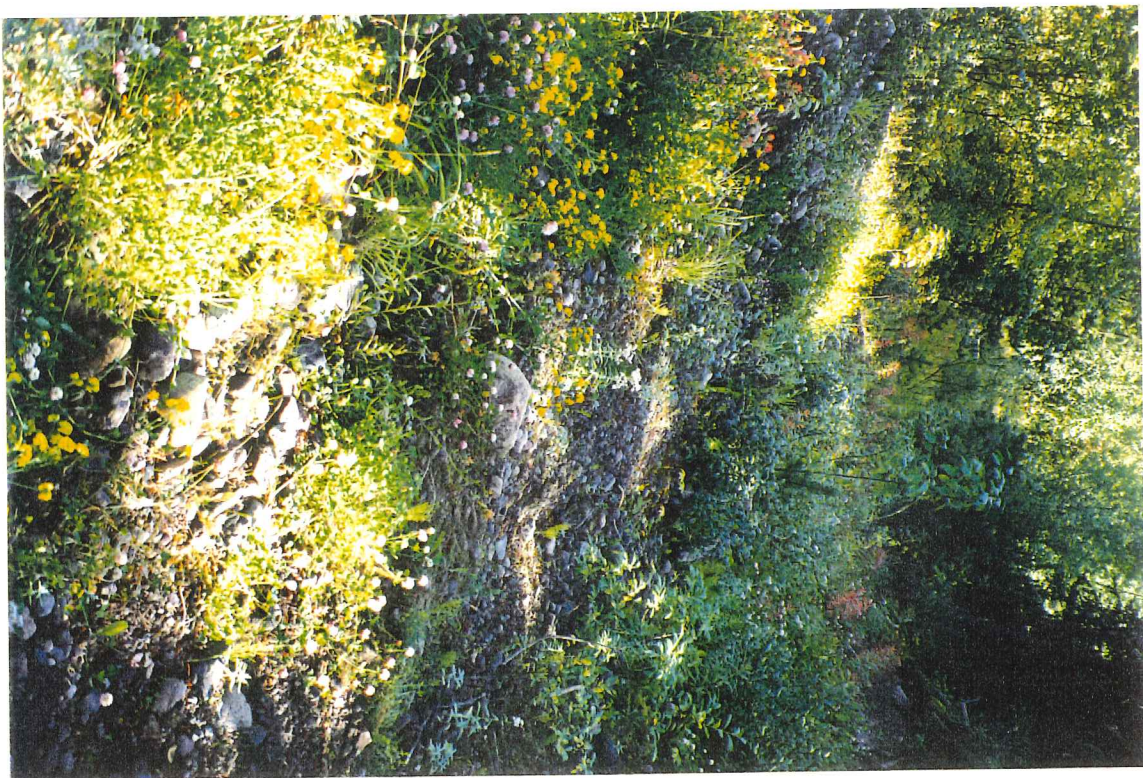
**Plate 50:** Old skid trail leading down into intermittent Unnamed tributary to Johnny David Creek at North Road FSR is eroding into the channel.

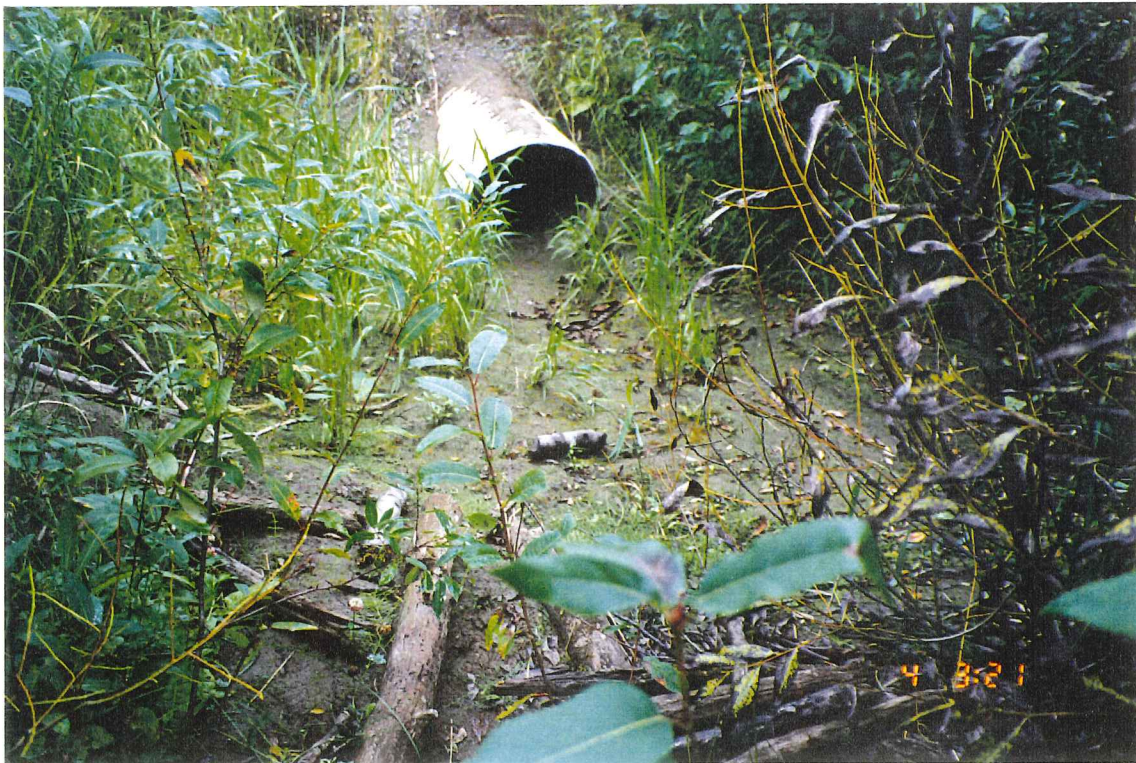
**Plate 52:** Blocked culvert to downstream end of offchannel area on Byman Creek. The other side of the culvert is high and dry.

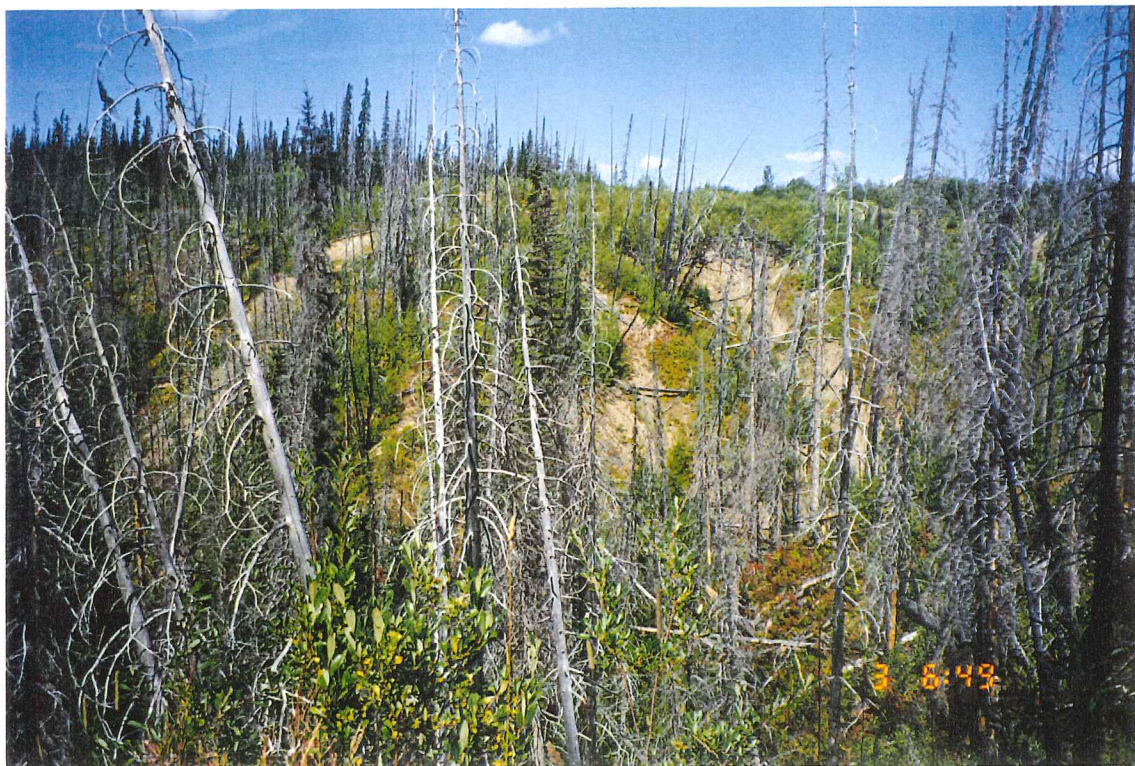
**Plate 54:** Debris torrents and flows at Byman Creek, Reach 3 in the Row fire area. This activity occurs at or just below the lip of the canyon. There has been extensive salvage logging here which may play a part in the landslide activity.

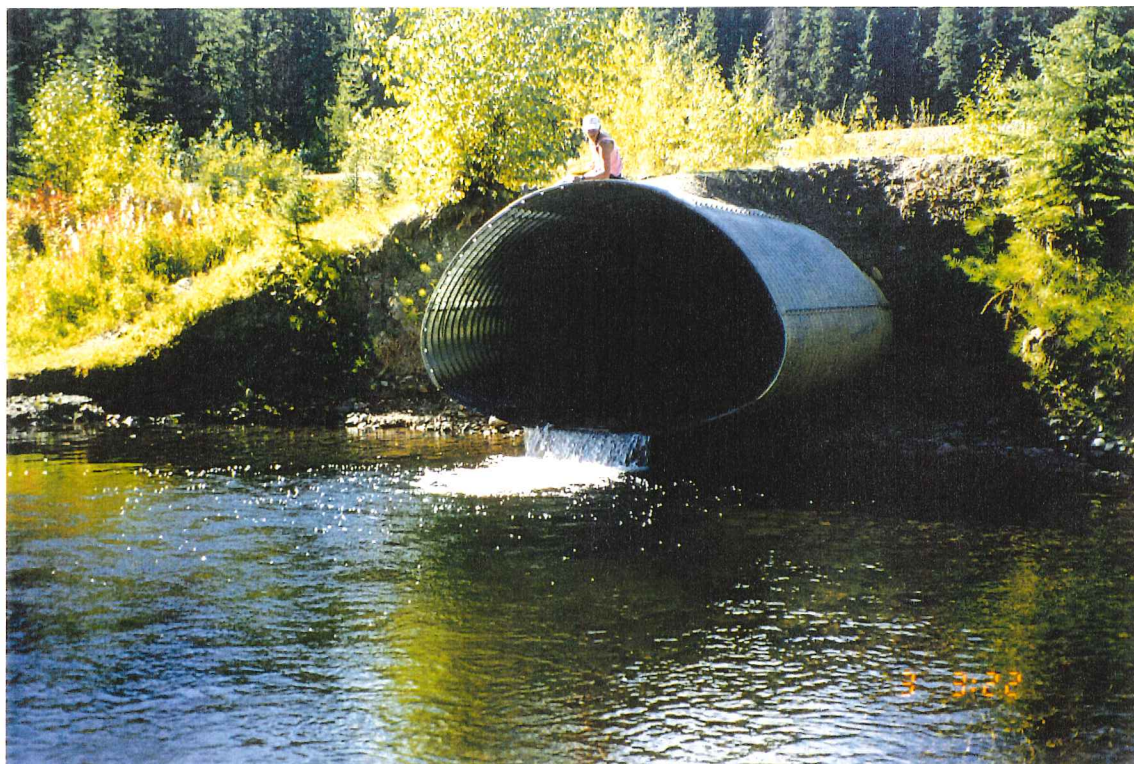
**Plate 56:** Culvert on McQuarrie Creek at the North Road FSR. This culvert may be a barrier to fish migration due to water levels and velocities, as well as length. It will definitely become more of a problem as height from the water surface to the culvert inlet increases due to downcutting. Note the already extensive erosion.

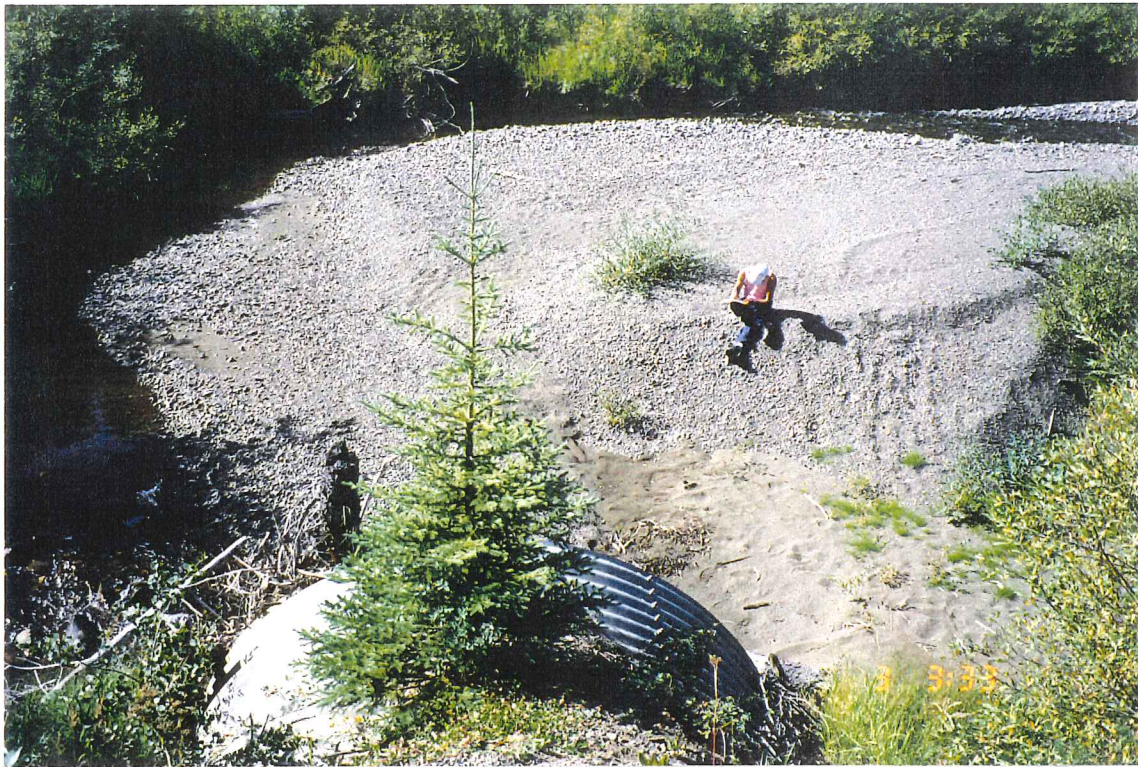
**Plate 57:** Aggradation above North Road FSR culvert on McQuarrie Creek. There is good fish habitat and minimal land-use from here to McQuarrie Lake provided that no barriers exist in the upstream canyon.

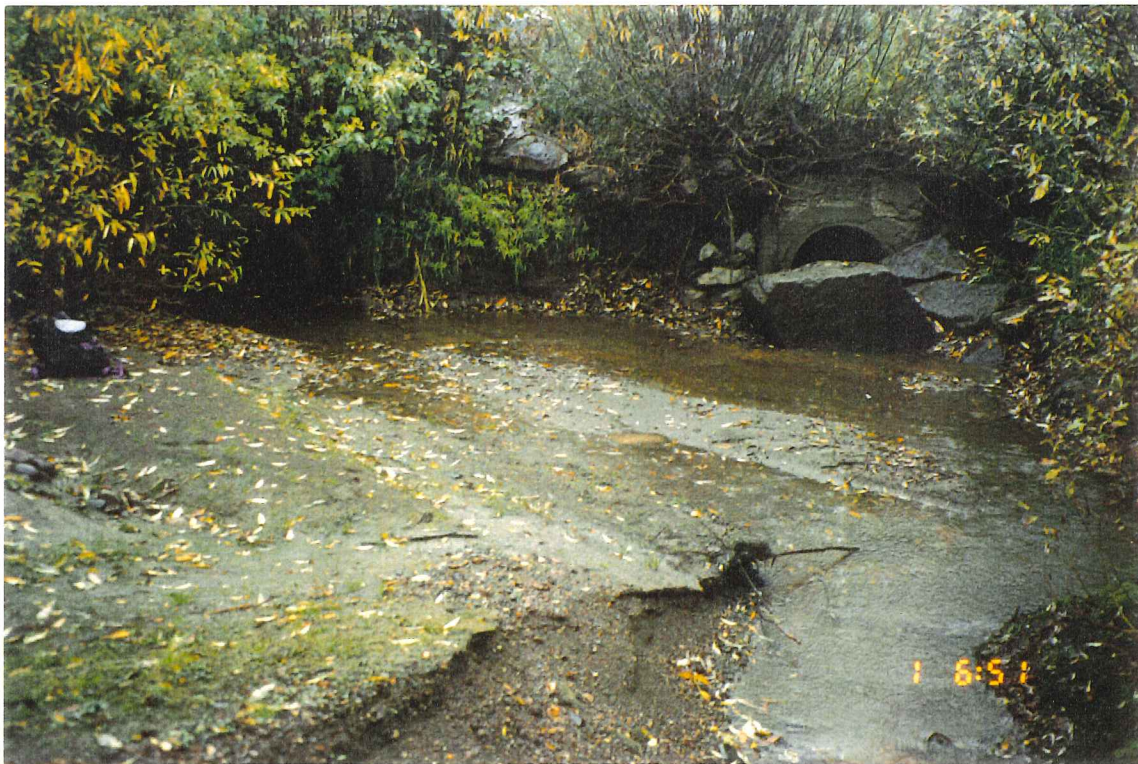
**Plate 58:** Barren Creek at the Bulkley River. Note that the mouth is heavily aggraded with fine material and one culvert is blocked in the background. These concrete culverts at the CN Rail crossing are very smooth and consequently water velocities will be high. They are also probably too undersized to facilitate fish passage in even normal bankfull flood events.

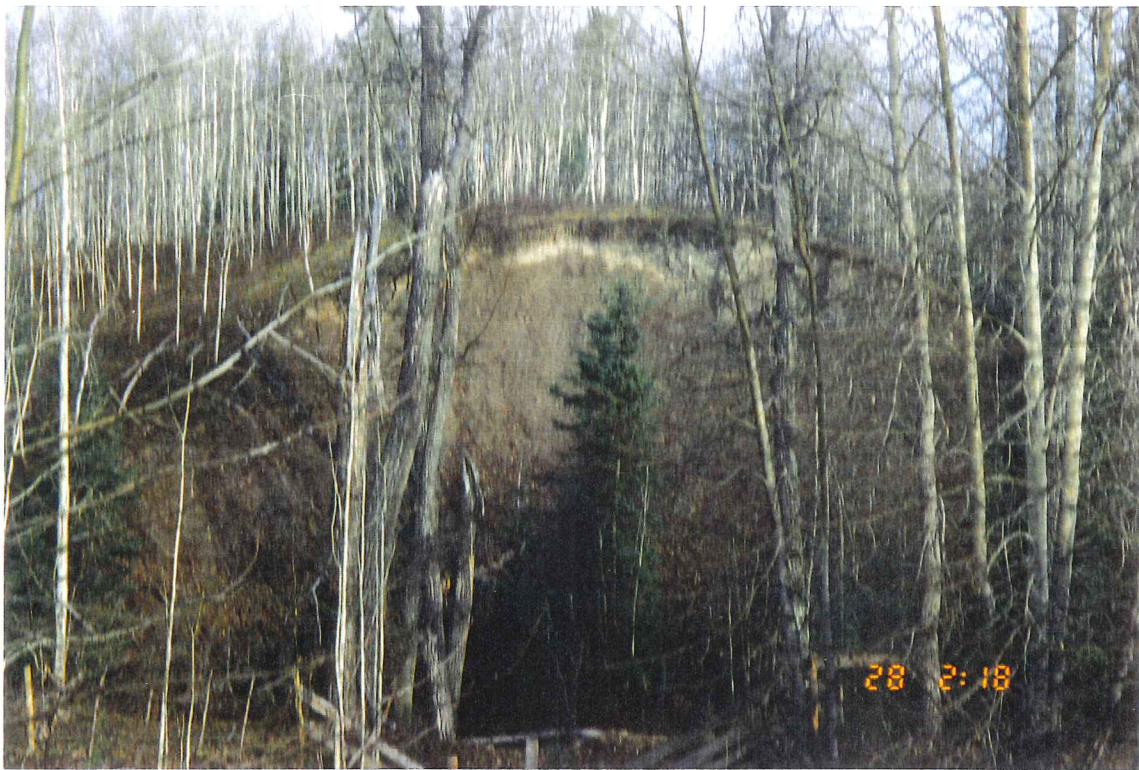
**Plate 61:** Mass movement just upstream of the Reach ½ break on Barren Creek. The slide may have been caused by land clearing, as indicated by the secondary successional poplar forest above.

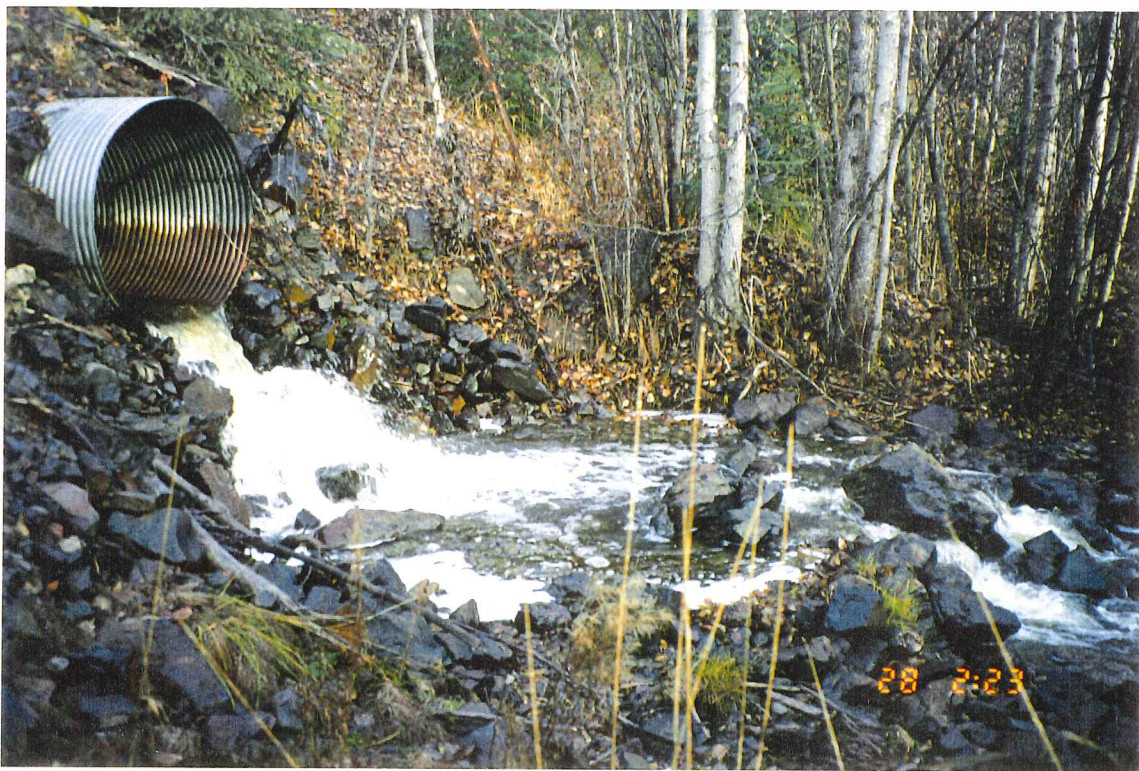
**Plate 62:** Culvert at North Road FSR crossing of Barren Creek. The culvert is thought to be a barrier to fish passage due to the absence of a plunge pool and the accumulation of rubble at the outlet, and height above the stream surface.
