HISTORICAL CHANGES IN CHANNEL MORPHOLOGY MAXAN CREEK AND BULKLEY RIVER

M. Miles and Associates Ltd.

November 2021

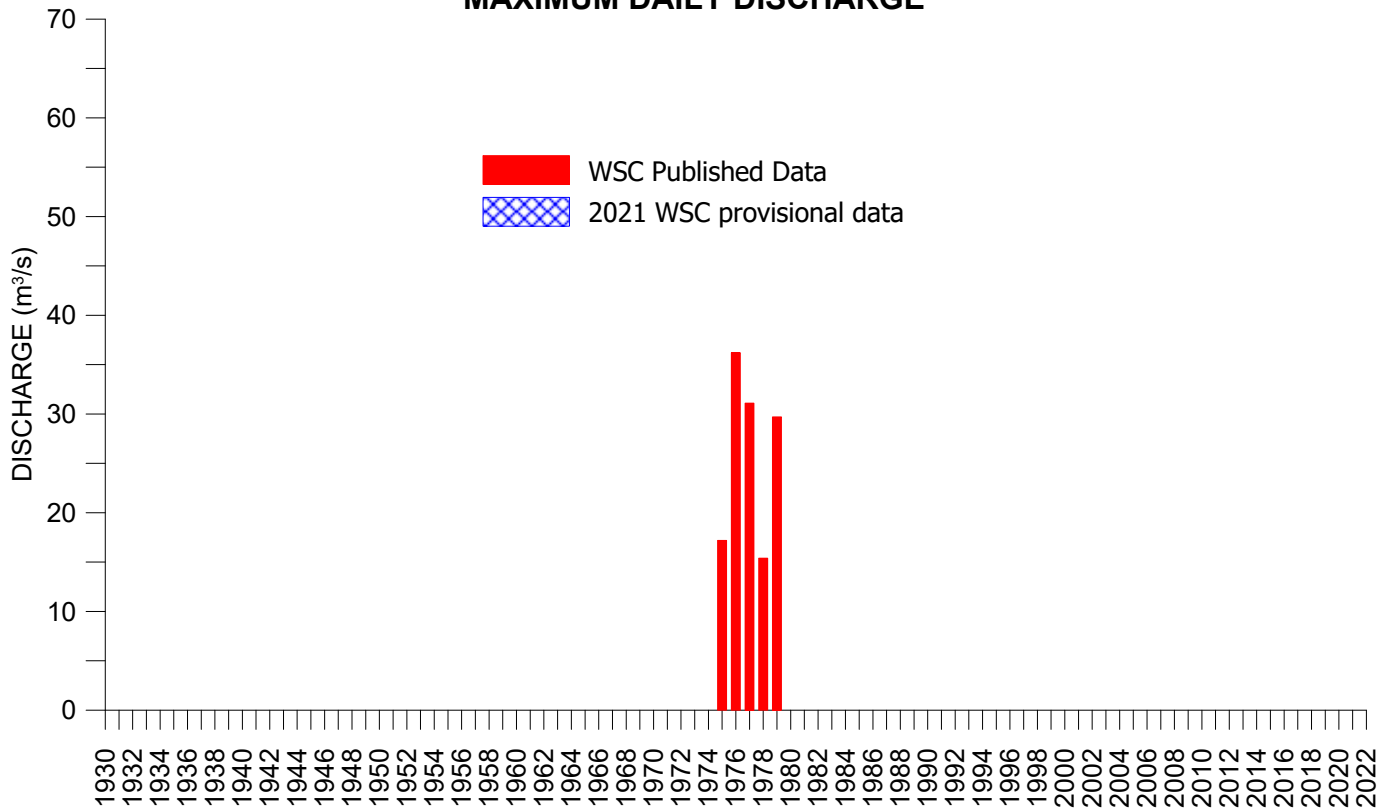
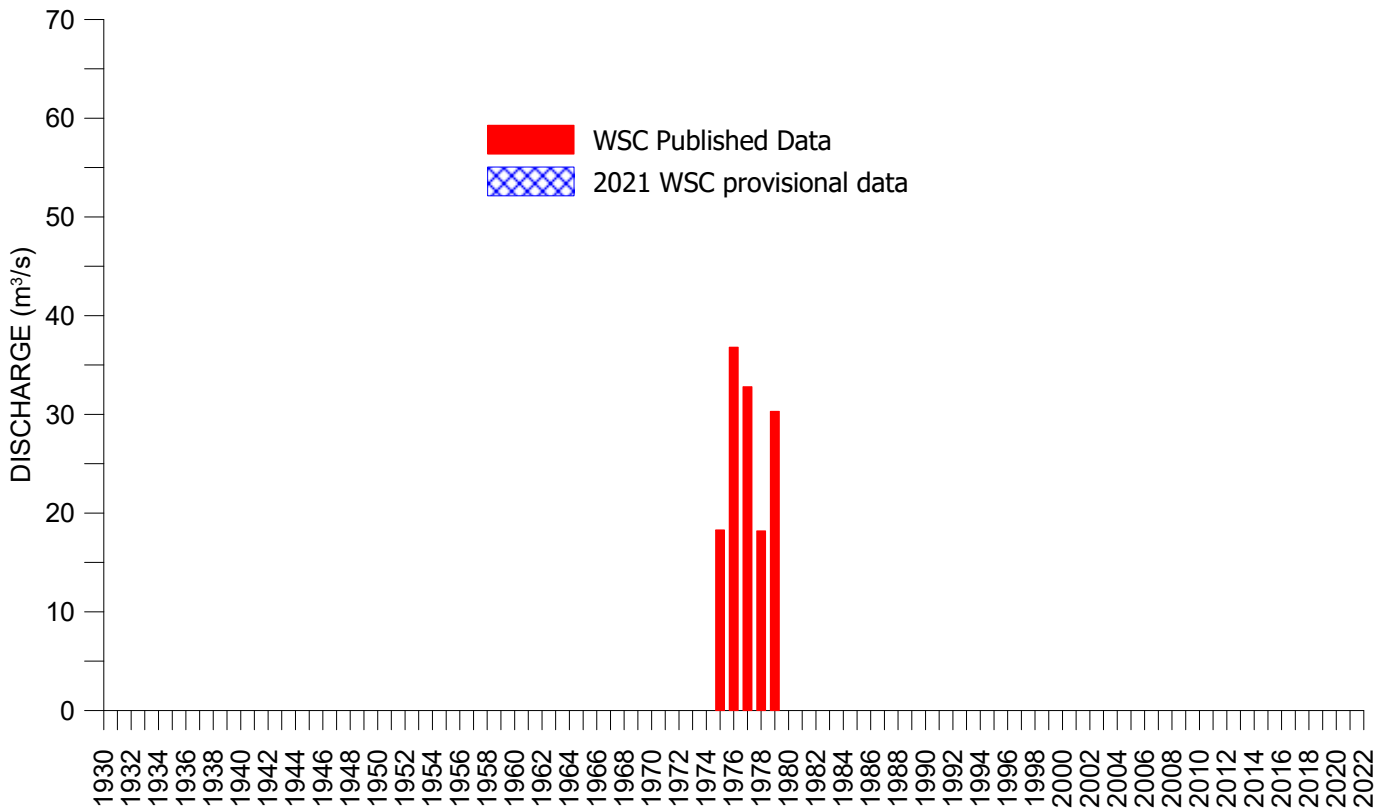
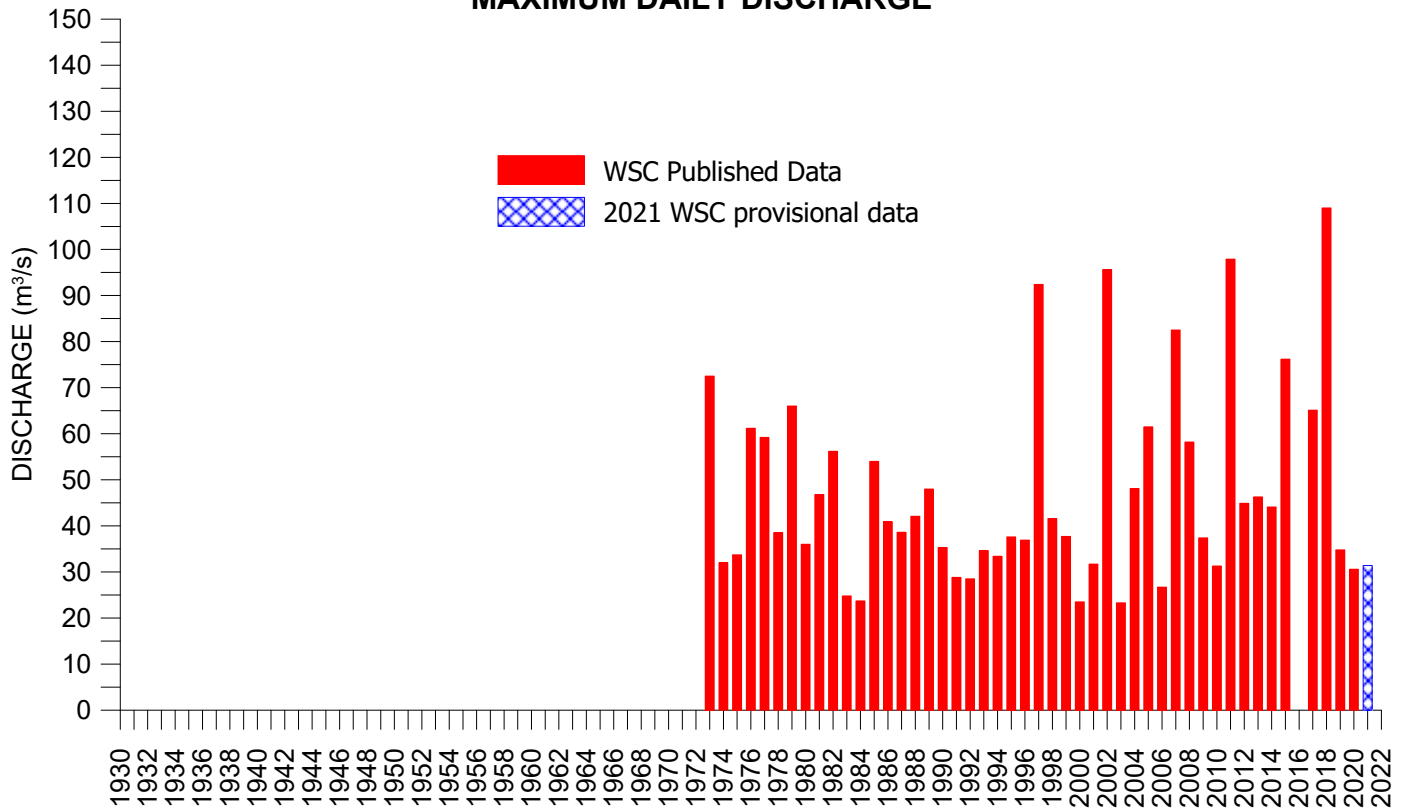
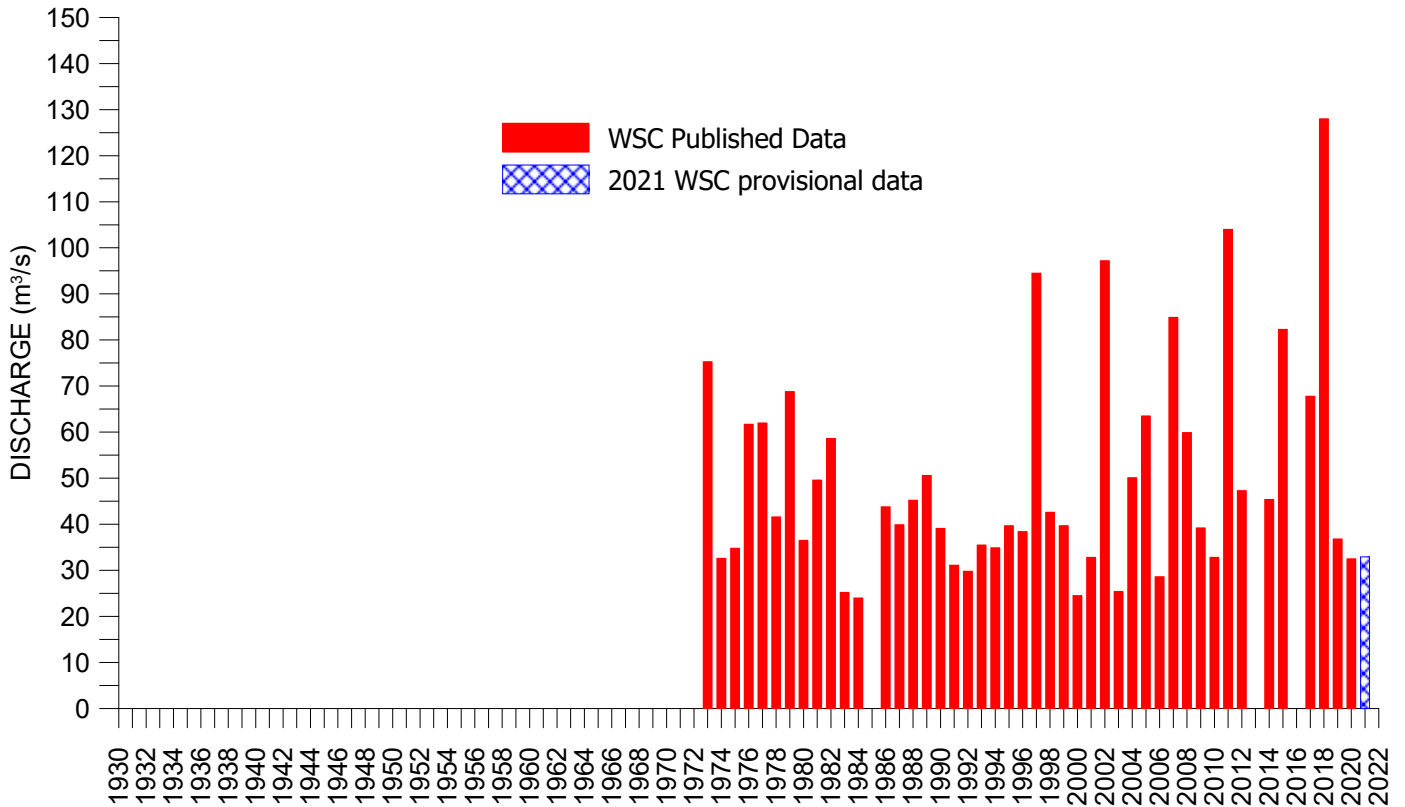
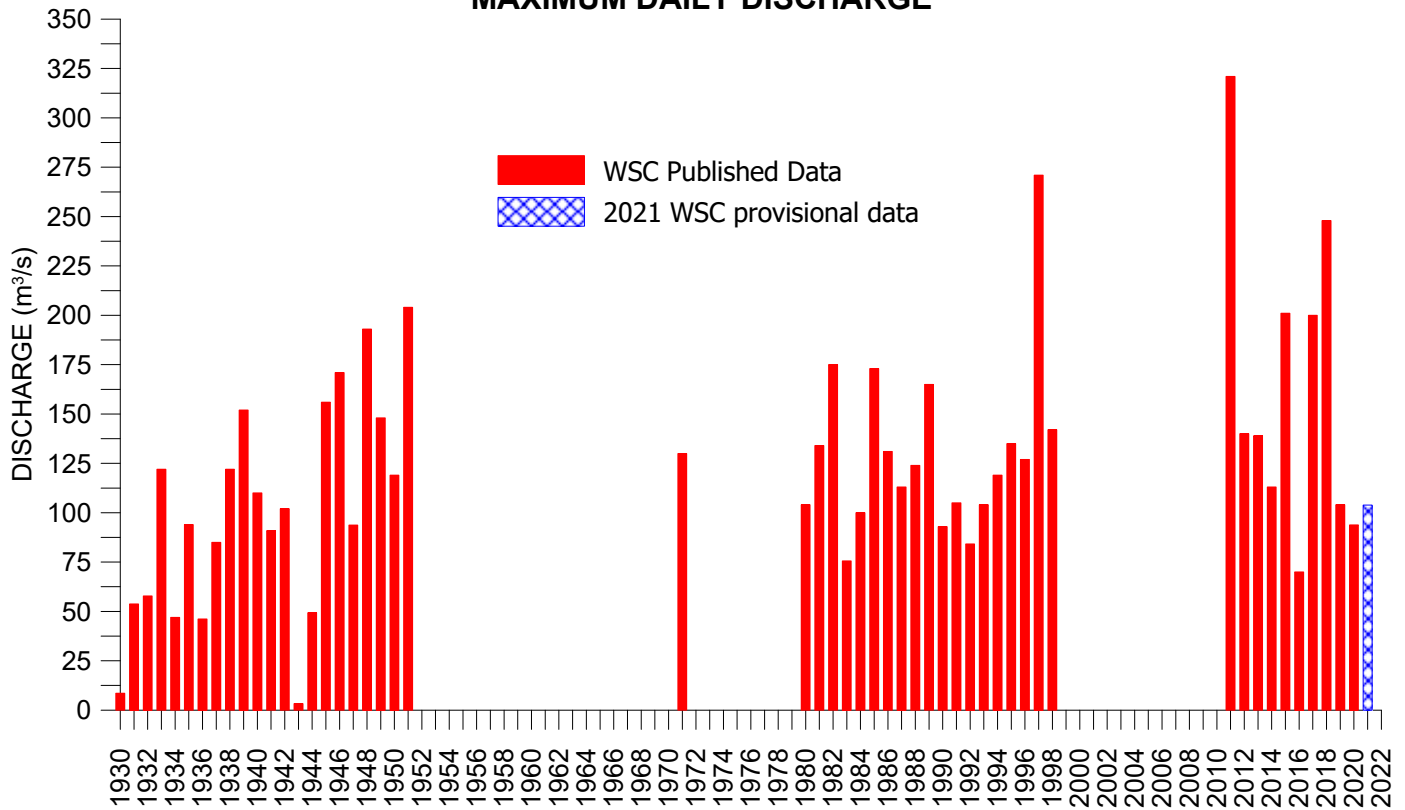
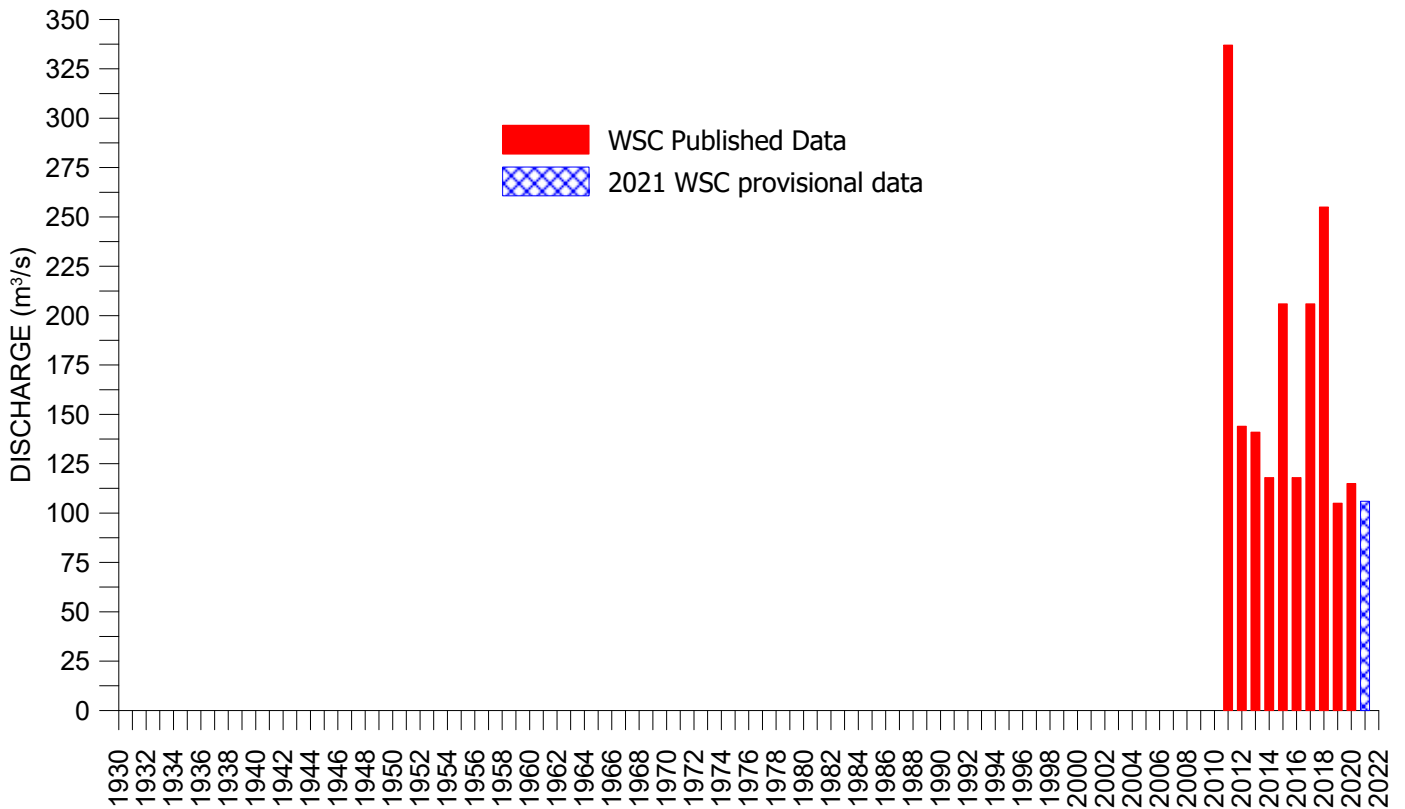
The historical variation in peak flows observed at the WSC gauging stations is illustrated on Figures 4.6 to 4.8. These data indicate that maximum flows observed at the Maxan Creek Above Bulkley Lake gauging station approached approximately 40 m³/s in the period between 1974 and 1979. On the basis of regional data, sizeable flood events likely occurred in 1997, 2002, 2011 and 2018. These regional data suggest that there might be a trend towards larger flood flows. Statistical analyses (Q, R and W statistics described in Buishand, 1982) indicate that the annual maximum peak flows observed at Bulkley River near Houston have experienced a statistically significant shift in regime. The flood

flows are larger than those which occurred prior to 1994. Inspection of the historical air photos also suggest that a sizeable flood likely occurred between 1971 and 1975.

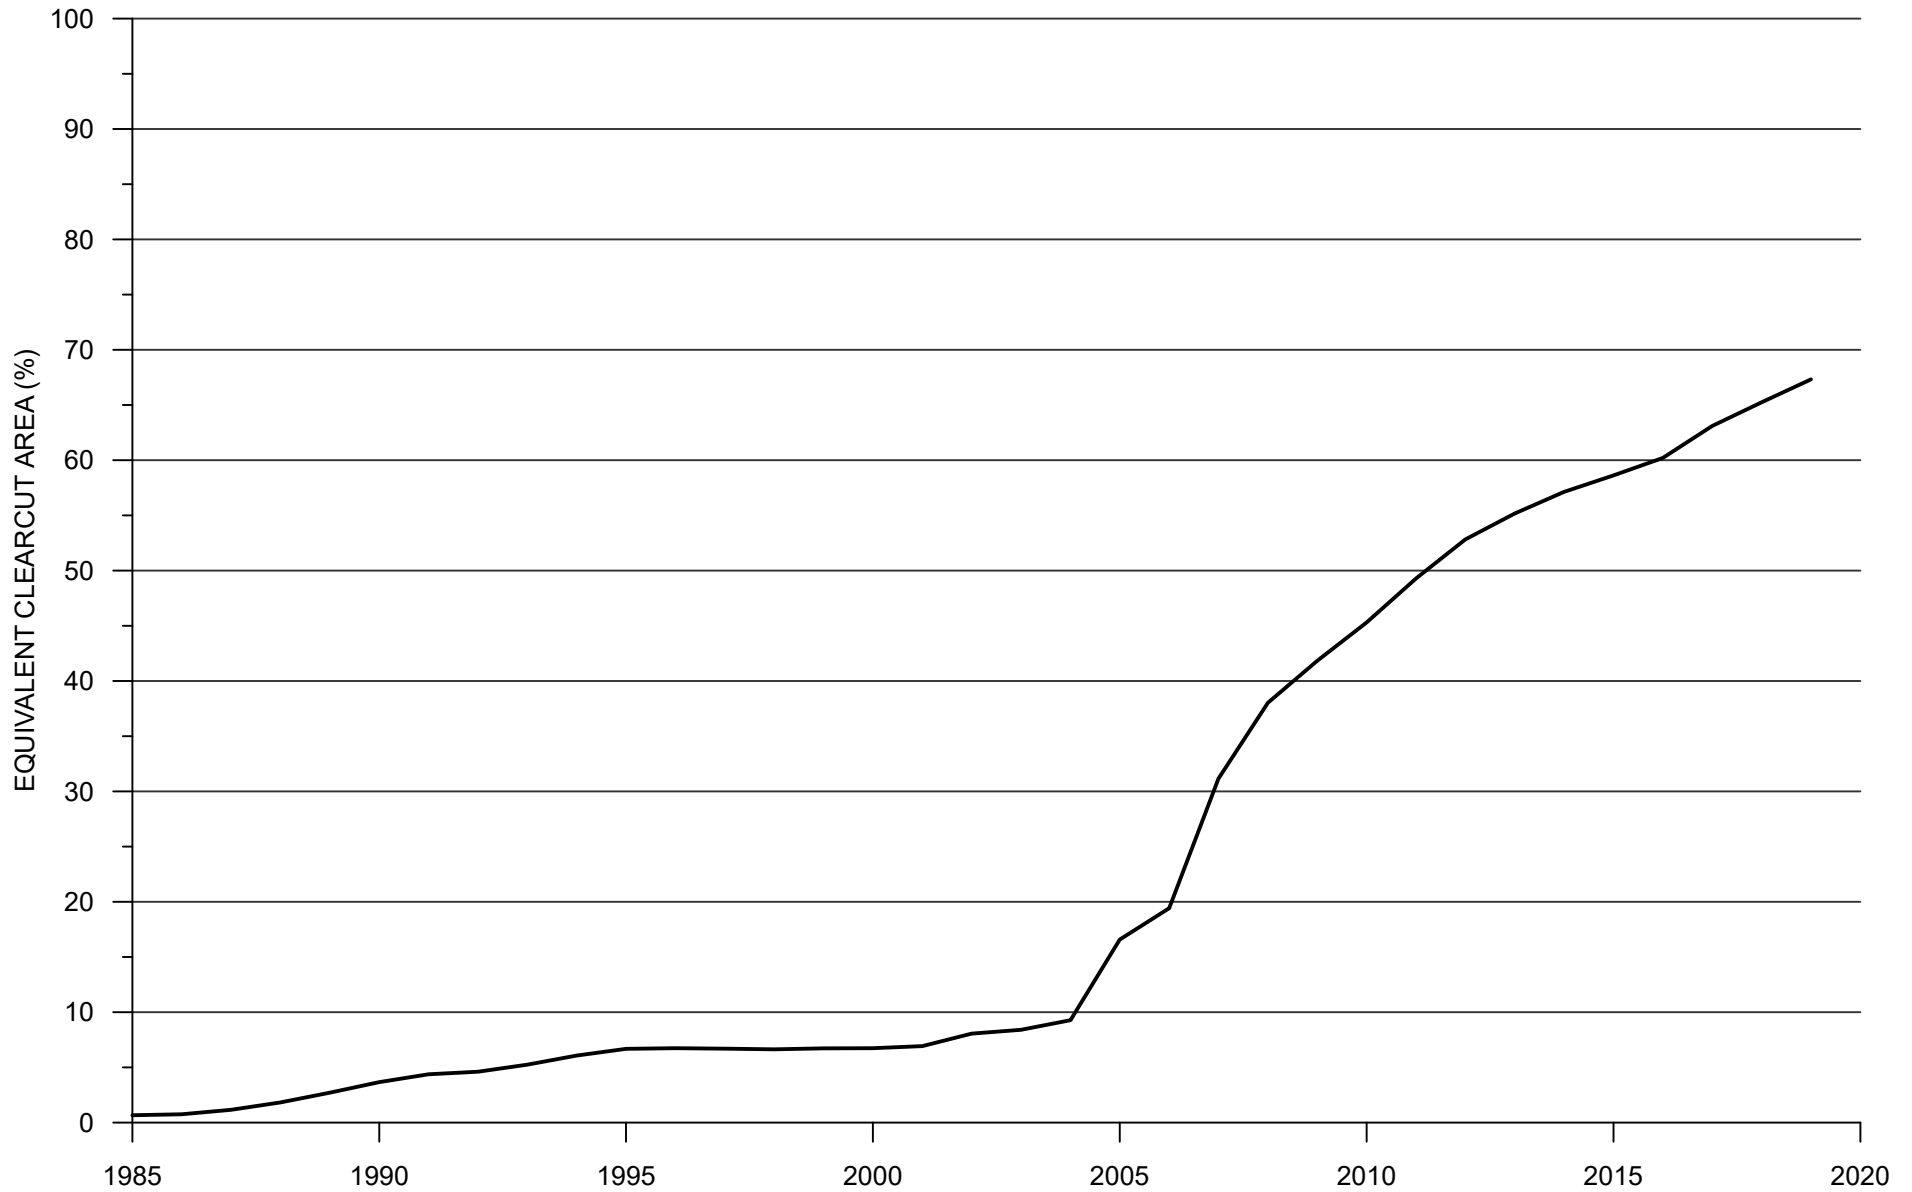
Figure 5.3: Post 1985 initial equivalent clearcut area (ECA) values, Maxan Creek at the confluence with Bulkley Lake. (Data provided by Foundry Spatial, 2021).

Figure 5.3 illustrates the post 1985 changes in equivalent clearcut area (ECA) on Maxan Creek at the confluence with Bulkley Lake, based on preliminary analyses provided by Foundry Spatial (Ben Kerr, pers. comm.). These data are potentially confounded as they reflect harvest, pest and fire history. However, there is a significant increase in ECA values between 2004 (9.3%) and 2008 (38.0%). The ECA in 2019 (the most recent available number) was 67.3 %. This indicates that forest cover has been severely impacted since the mid 2000's and changes in stream channel conditions should be expected.
