Richfield Creek Riparian Fencing Installation Report 2021

Adam Wrench B.NRSc. on behalf of
Northwest Research and Monitoring Ltd.

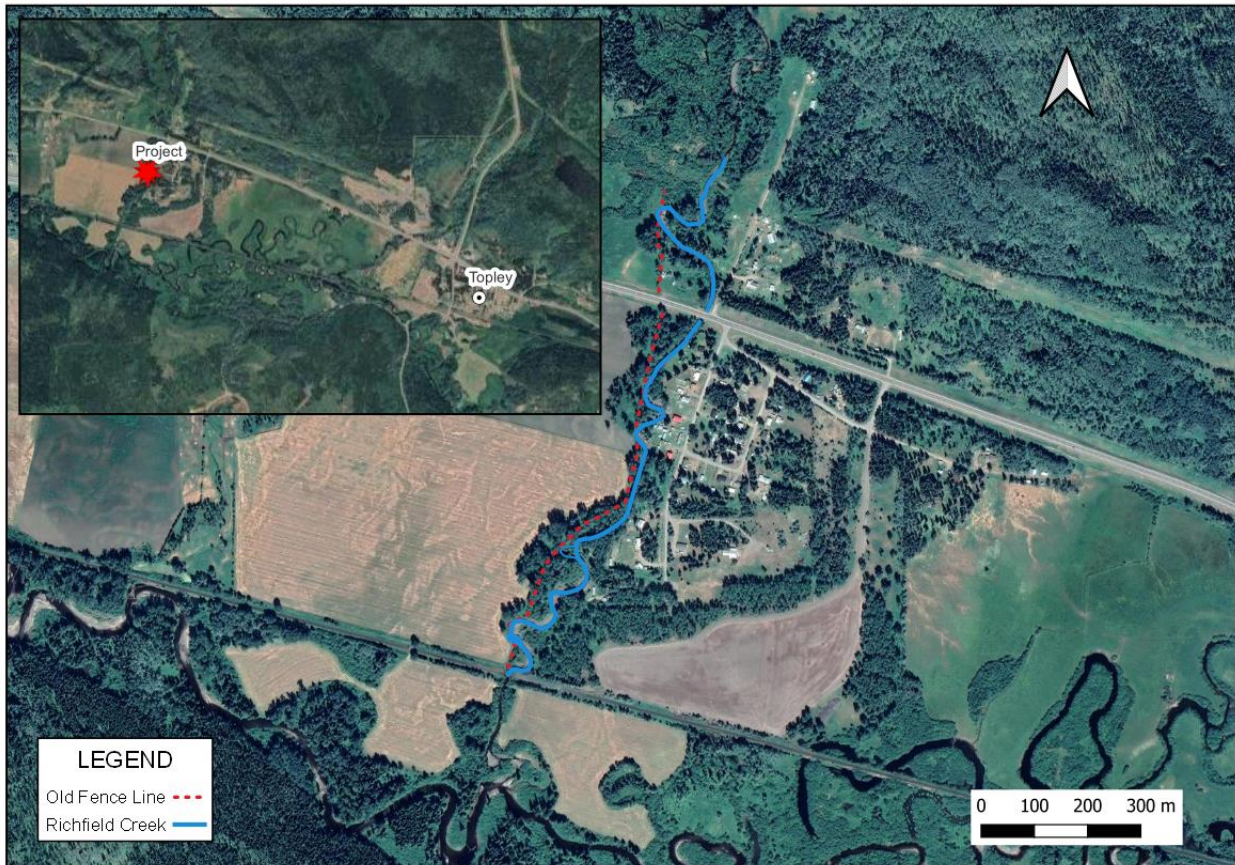
Much of the riparian zone along the eastern boundary of Richfield Creek is heavily degraded or absent and the stream has nowhere to move in that direction due to the homes and private land there. Along the western bank is mostly a well forested riparian zone bordering hay fields owned by Hatch Creek Ranch Ltd. Mature black cottonwood (*Populus trichocarpa*) tower over the western zone and exist in a corridor ranging in width, but regularly exceeding 30 m from the water's edge. Due to poor placement of historic fencing very close to Richfield Creek (Table 1), much of the understory vegetation and spruce have been eliminated from this zone due to the presence of cattle. In addition, in several places the historic fence line was lost to erosion from Richfield Creek into the adjacent hay fields. An inadequate riparian zone existed as a result of poor fence line placement historically (Figure 2 & Appendix A).

Figure 2: Project overview showing Richfield Creek with existing riparian zone and historic fence line.

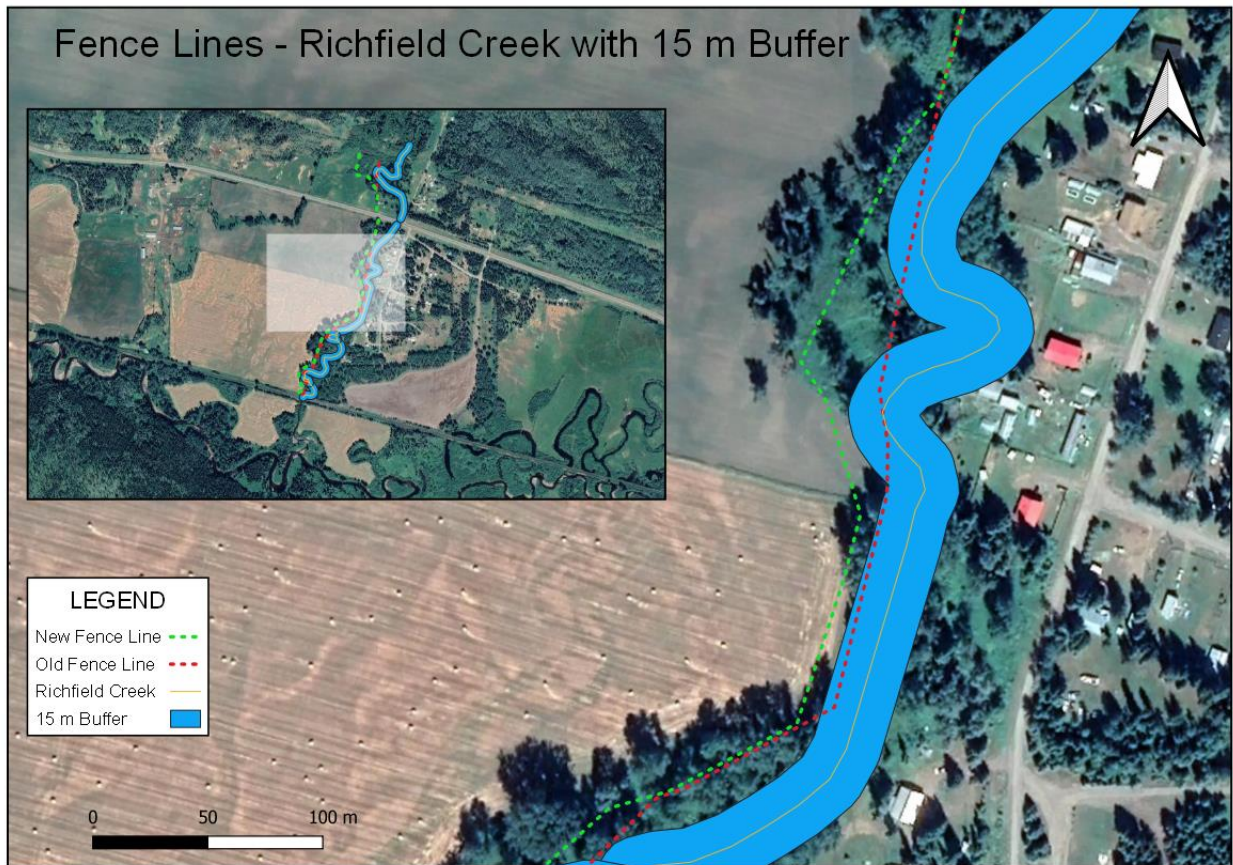
Figure (5) illustrates the improvement of the riparian corridor along one section of Richfield Creek; a 15 m buffer was added to Richfield creek to illustrate how much of the old fence line was within the 15 m riparian corridor. Appendix (A), includes a series of maps illustrating the riparian improvement as a result of new fencing for the entire project site.

Figure 5: Map showing Richfield Creek with 15 m buffer and old and new fence lines overlaid in central part of project area.
