P/FR/SK/6
MORRIS, M.
MORICE RIVER STREAM SURVEY

MORICE RIVER
STREAM SURVEY

AUGUST 1975

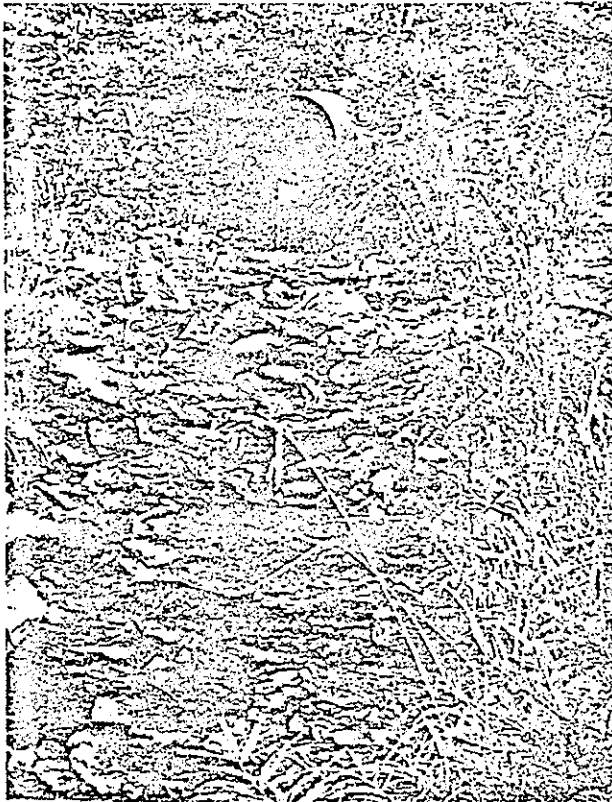
Fig. 1

These reaches were located near the end of Morice River road where it crosses Tributary 1 and 2. (Mile 36.4) The creeks were small (1 c/s) and only about 50 m apart and were therefore quite similar. Productivity of the creeks was limited by their size and lack of spawning gravel; the fish found there probably being of a resident population. The nearly closed canopy and instream branches and logs suggests potential habitat for cutthroat as well as the Dolly Varden found. (Figs. 1 and 2).

Tributary 1, note barrier.
Dolly Varden from pool below
culvert.

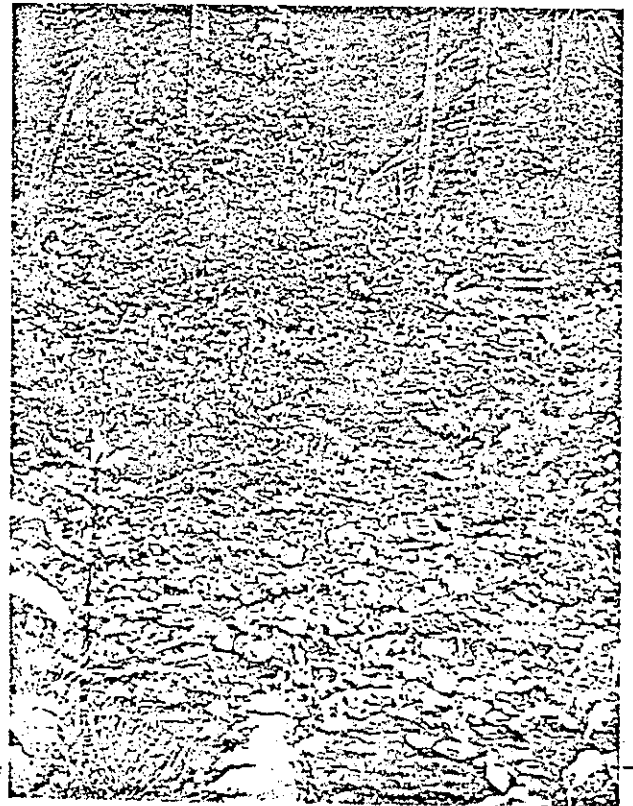
Fig. 2

Tributary 2, downstream from road
crossing.

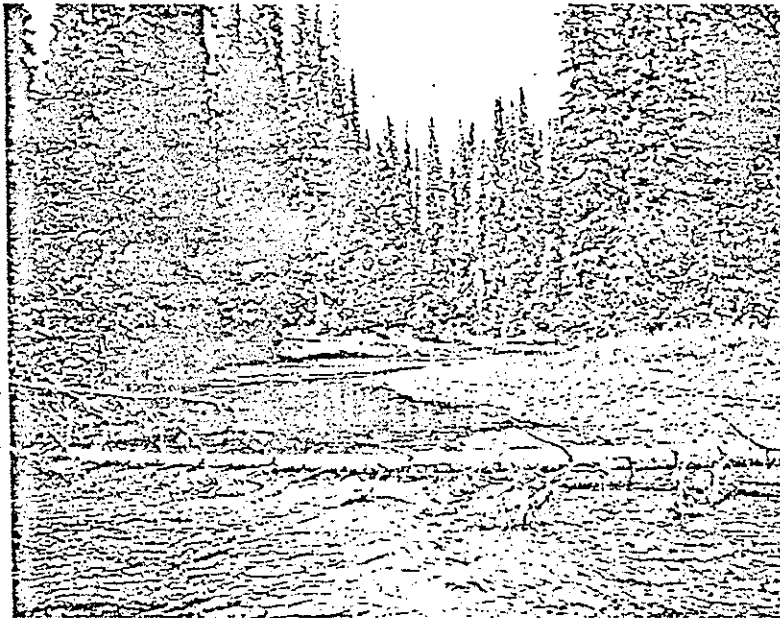
Fig. 6

This tributary was located across and slightly downstream from Cedric Creek. Observation was conducted upstream from side channel of the mainstem. Swampy terrain and low gradient provided excellent rearing habitat for coho. More than forty fry were observed in a ten meter flat section. There was fresh moose sign in the area. (Fig. 6)

Side channel to Tributary 5

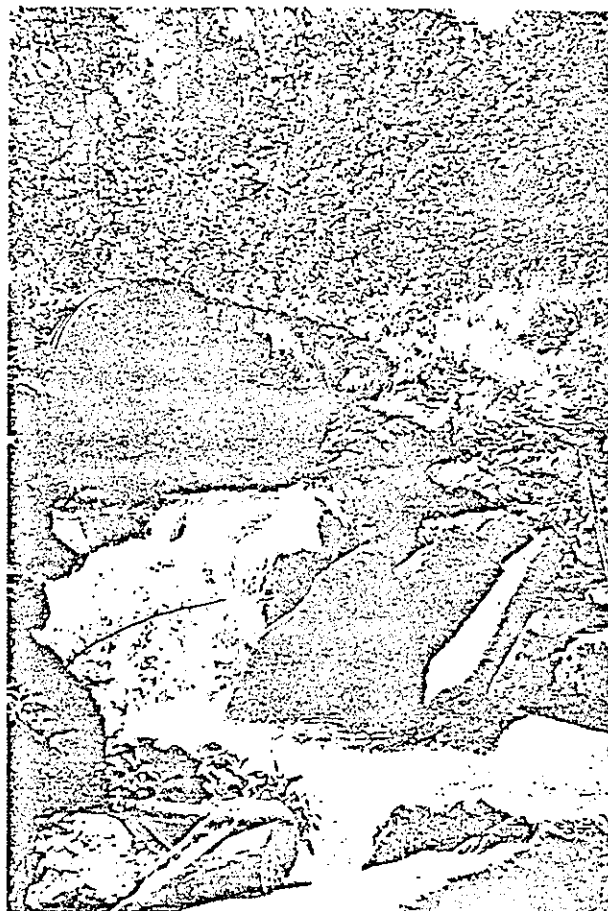
Fig. 7

Peacock Creek was sampled 100 meters above and below road crossing at mile 5 on the main road to Morice Lake. The wood stove culvert, in the mid section of reach proves to be a barrier to upstream fish movement. The outflow cascades 2 meters over angular boulders into a small plunge pool (Fig. 7). Populations of Dolly Varden, rainbow and whitefish were found below and only Dolly Varden located above culvert. Shocking was very effective in this tributary, with fish being attracted from distances greater than 2 meters. People squatting downstream from reach section, have ponded a small length of the stream, but this obstruction does not appear to affect fish movement.

Peacock Creek. Note barrier at culvert.

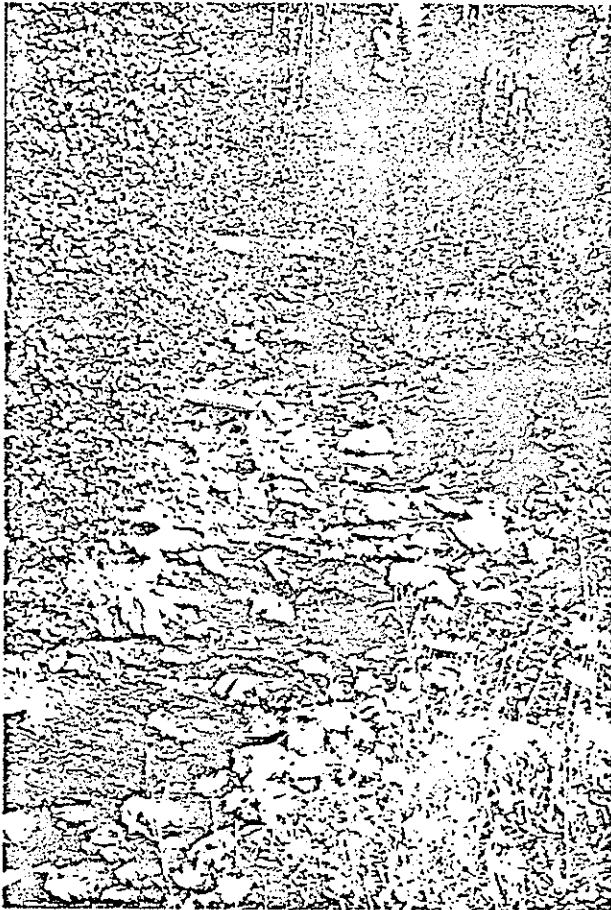
Fig. 8

The reach section on this creek was established 100 meters above and below road crossing. The culvert at roadway appears to be passable to larger fish, but absence of rainbow fry and smolts above road crossing may suggest some problem with culvert design. The numbers of rainbow smolts found in lower end of reach indicate that the fish have moved out of the mainstem to rear.

Tributary at mile 13.2 above
culvert.

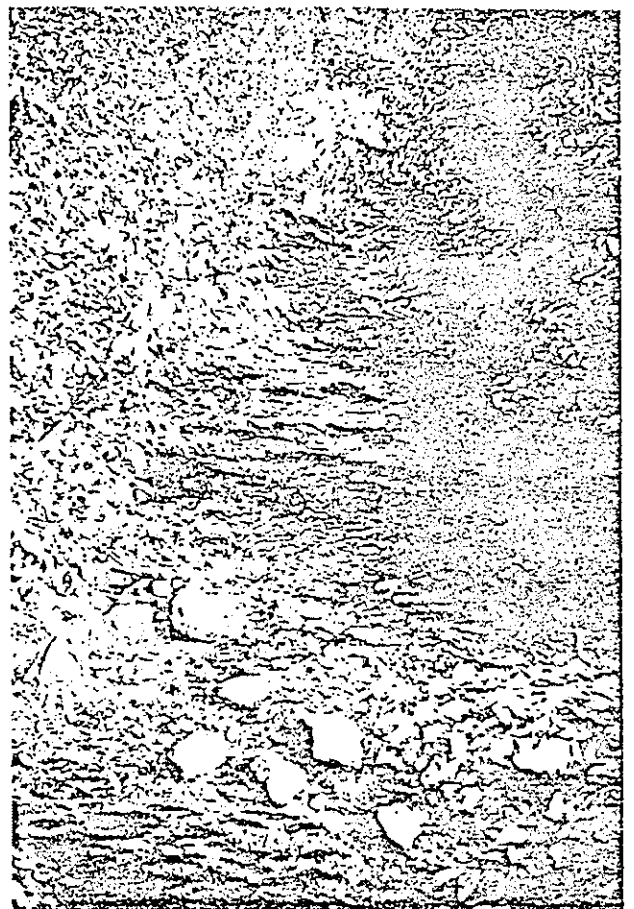
Fig. 9

This tributary was observed 100 meters above and below wood stove culvert on main road. The creek at this point flowed through stable terrain vegetated with willow and alder. The culvert was considered adequate to allow fish movement in medium and high flows, but again due to steepness of cement apron at inflow, movement in low flows would be impossible.

Tributary at mile 15.1

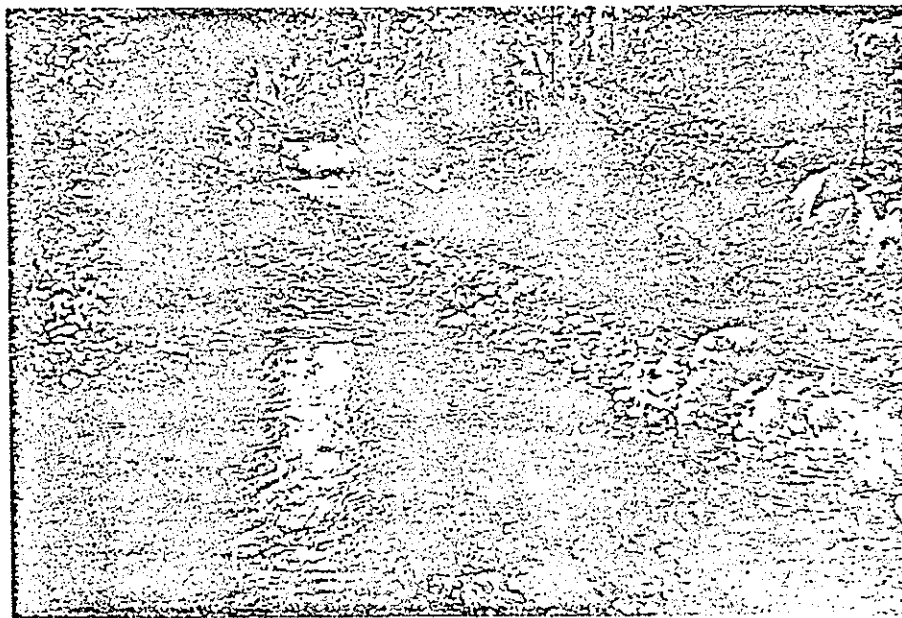
Fig. 11

This creek was surveyed from road crossing downstream 75 meters. At this point the flow was very stable. Good culvert placement provides for peak flows and unhindered fish movement. (Fig. 11)

Tributary at mile 24.5. Picture shows sampled reach below culvert.

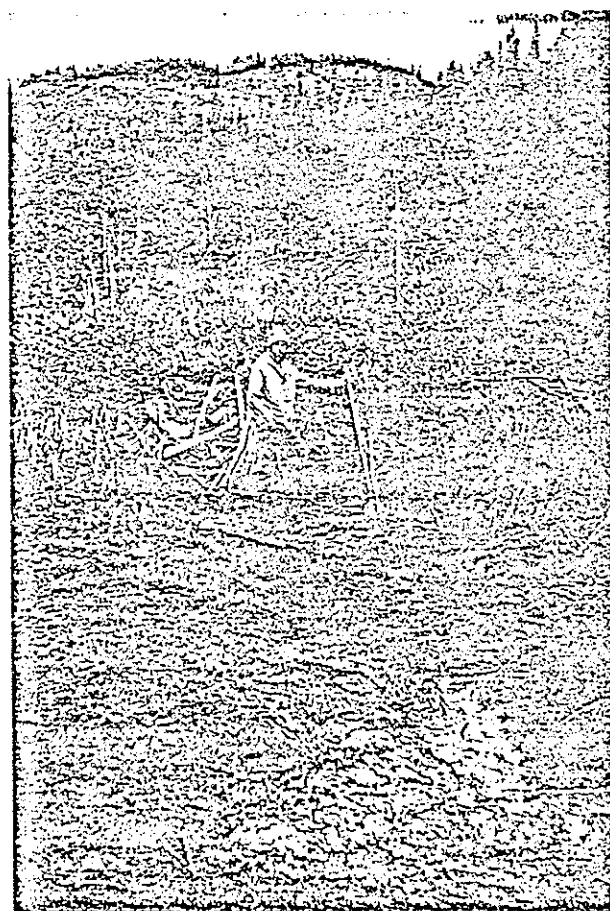
Fig. 13

These tributaries were found to be none productive in terms of fisheries. Tributary 11 was located in swampy terrain with only seepage entering main river. Tributary 12 was completely ponded by 2 meter beaver dam. (Fig. 13). Tributary 13 was a day channel running through steep rocky terrain.

Beaver dam blocking Tributary 12.

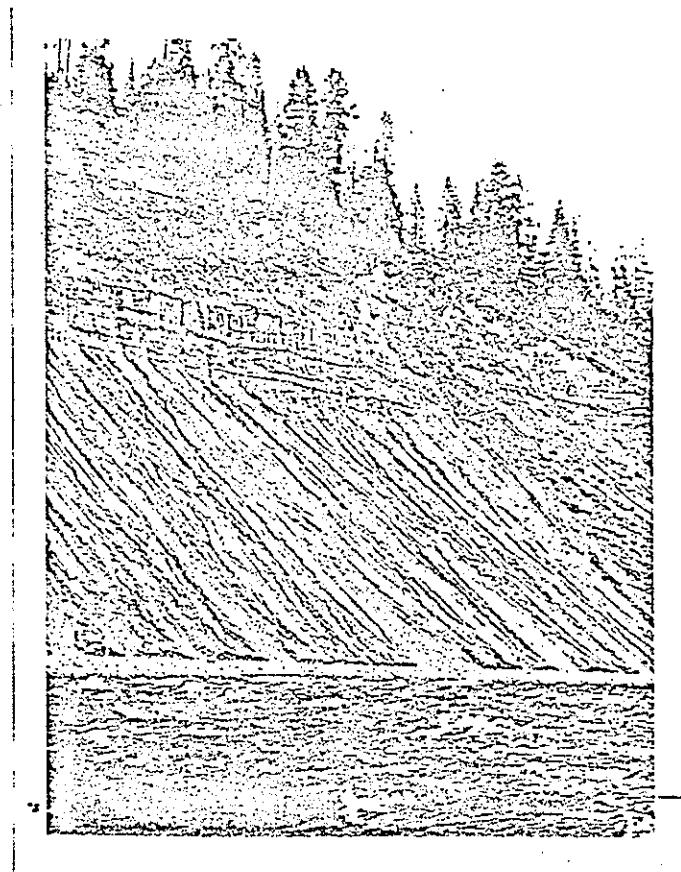
Fig. 14

Bank instability above mile 34 on the main river.

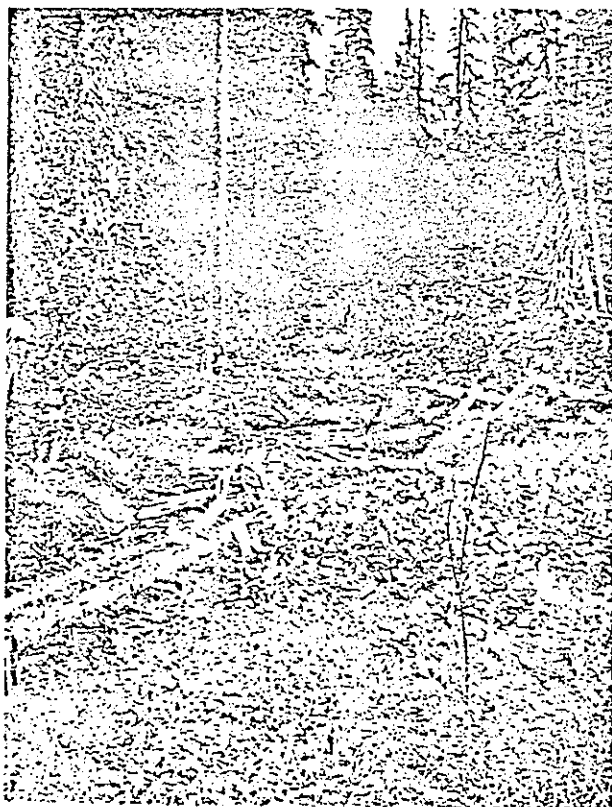
Fig. 17

Near lake outflow this reach was surrounded by patch logging. There was a lot of windfall and debris in the stream as a result of the logging which created potential barriers. Many fry were seen along the reach probably progeny of lake rainbows spawning in the outflow. (Fig. 17).

Lamprey Creek, shock site on creek
near the lake. (Reach 24).

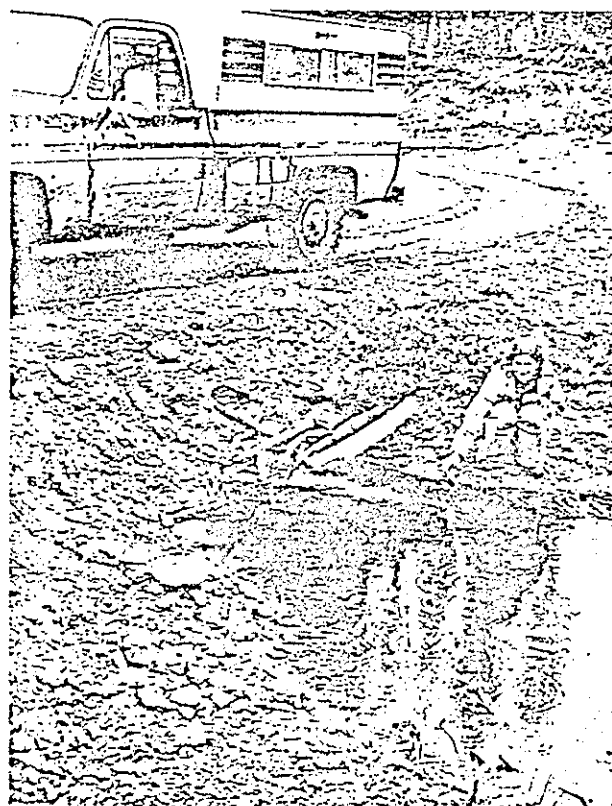
Fig. 18

Where the road to Tributary 1 crosses Lamprey Creek there is a barrier. The area is swampy and flat, the stream being crossed by log road through the water. The only way fish could pass this point is by crossing in the water which runs over the road. (Fig. 18)

Barrier at road crossing.
Lamprey Creek near tributary 1
confluence.

3. More carefully constructed road crossings are necessary on some small tributaries. Blockages of several streams were noted due to culverts and logging debris.

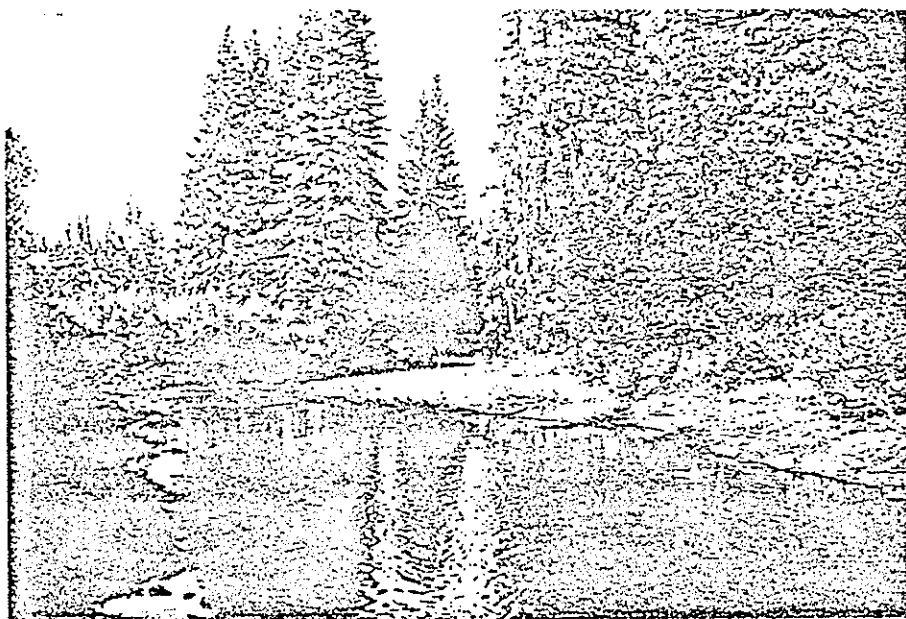
Fig. 19

Mid section of Lamprey Creek near confluence of Pimpernel Creek. looking downstream.

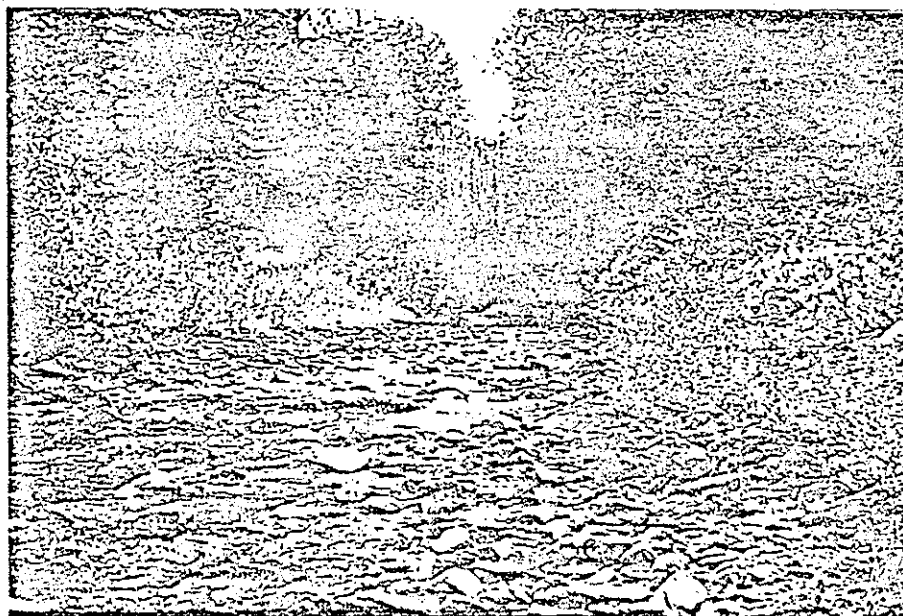
Fig. 20

Near the mouth of Lamprey Creek, the stream is mainly riffle and the bottom is covered with an algae mat. From air photo study, this type of habitat extends upstream about $2\frac{1}{2}$ miles to the wider valley bottom, habitat described in Reach 29. Spawning gravel is limited the substrate being mainly rubble sized. Though some coho and rainbow smolts were found rearing here, it seems the main importance of this section of creek is passage to upper sections. (Fig. 20).

Lamprey Creek mouth. (Reach 30).

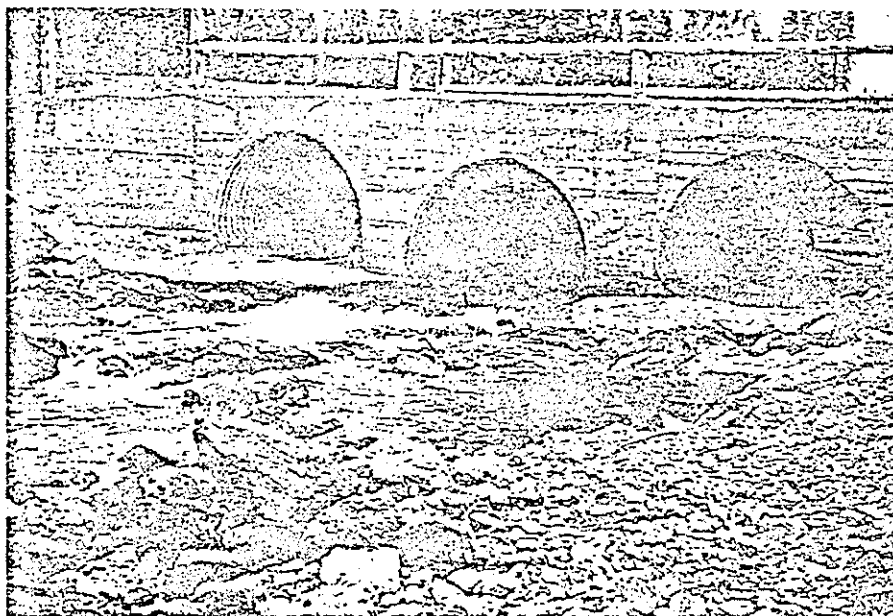
Fig. 21

Owen Creek. Compare this picture to the one in the Owen Creek report by Pinsent. Culverts are no longer a barrier since riprap was dumped below cement apron.
