## WATERSHED REVIEW LAMPREY CREEK WATERSHED

### BIOPHYSICAL CHARACTERISTICS OF WATERSHED

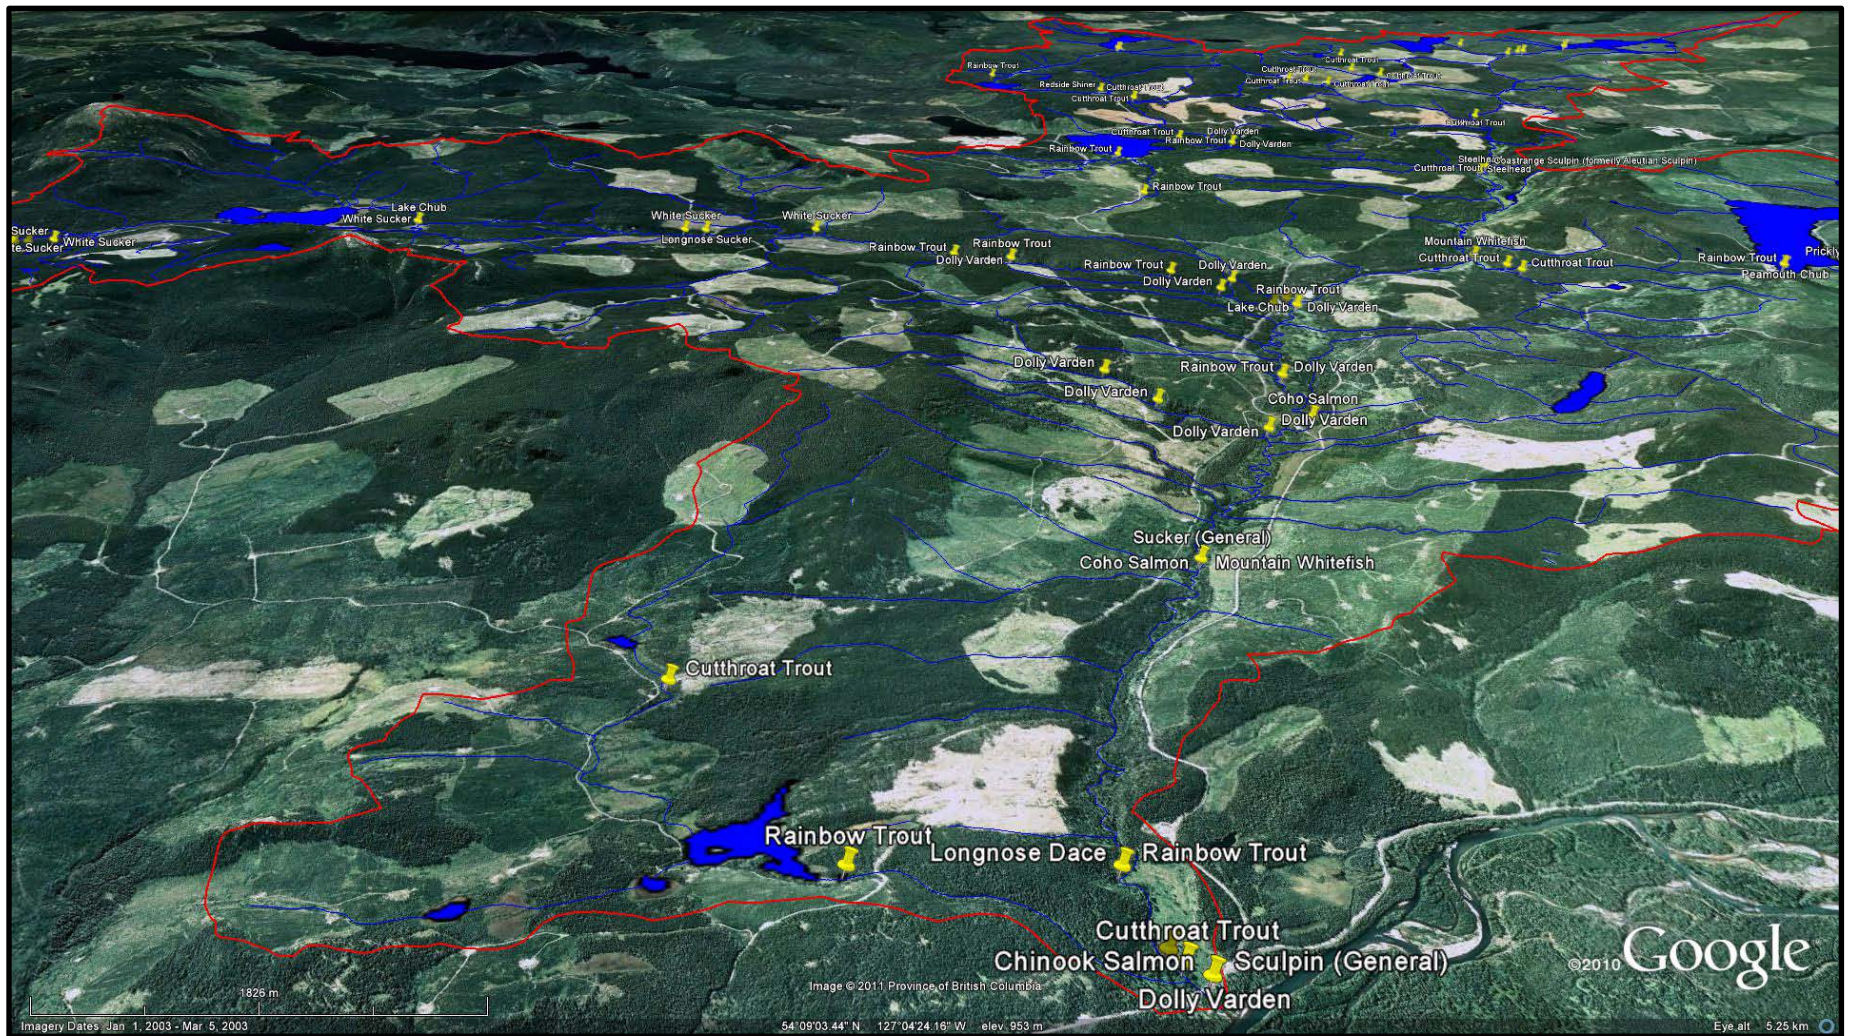
<b>Comment #1</b>	Terrain is quite flat. Forest harvesting is distributed throughout watershed.
<b>Comment #2</b>	There are sensitive fish species throughout the watershed and Dolly Varden well into the upper reaches of the watershed.
<b>Comment #3</b>	No significant issues with management of landslide prone terrain, other than localized potential problems with flat-over-steep terrain (Figure 4 and 8) and most recent development moving into steeper terrain (Fig 9).
<b>Comment #4</b>	Upper fluvial systems are dominated by E4/wetland complexes that are generally less sensitive to forest harvesting type impacts.
<b>Comment #5</b>	A WQEE survey has already been completed in this watershed and identified that about 7% of stream crossings had erosion and sediment control problems.
<b>Comment #6</b>	There appears to be some accelerated bank erosion and channel aggradation along the C4/C5 type lower reaches. This can only be explained by higher peak flows as there are no landslides or significant riparian logging or riparian disturbances. Thus the main control in this watershed should probably be one of HEDA.

Figure 2. General fish species distribution in the Lamprey Creek watershed.

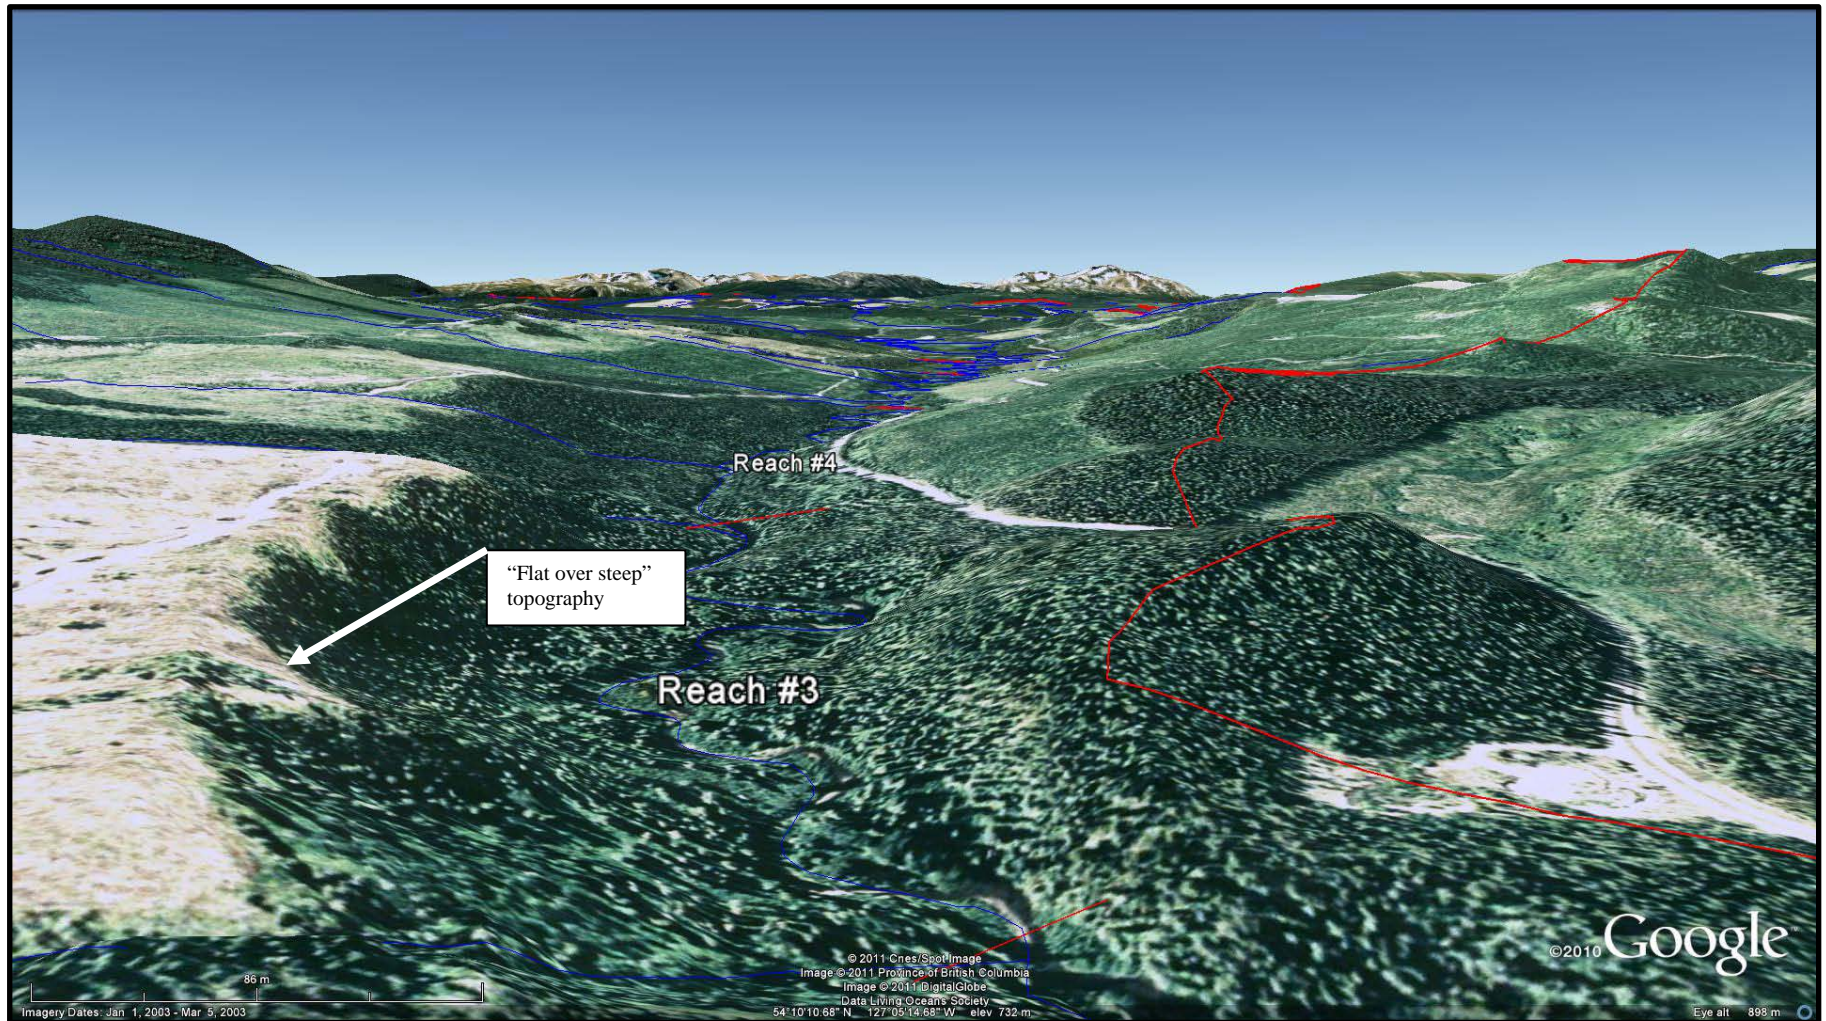
Figure 4. Google Earth image of reaches 3 and 4 of Lamprey Creek, looking up into the watershed.

5. Prior to the initiation of any treatment activities, identify the presence of any ‘flat-over steep’ topography and manage appropriately where needed (Figure 4 and 8). These topographic features can be prone to slope instability when forest cover is removed and localized drainage is not well planned.

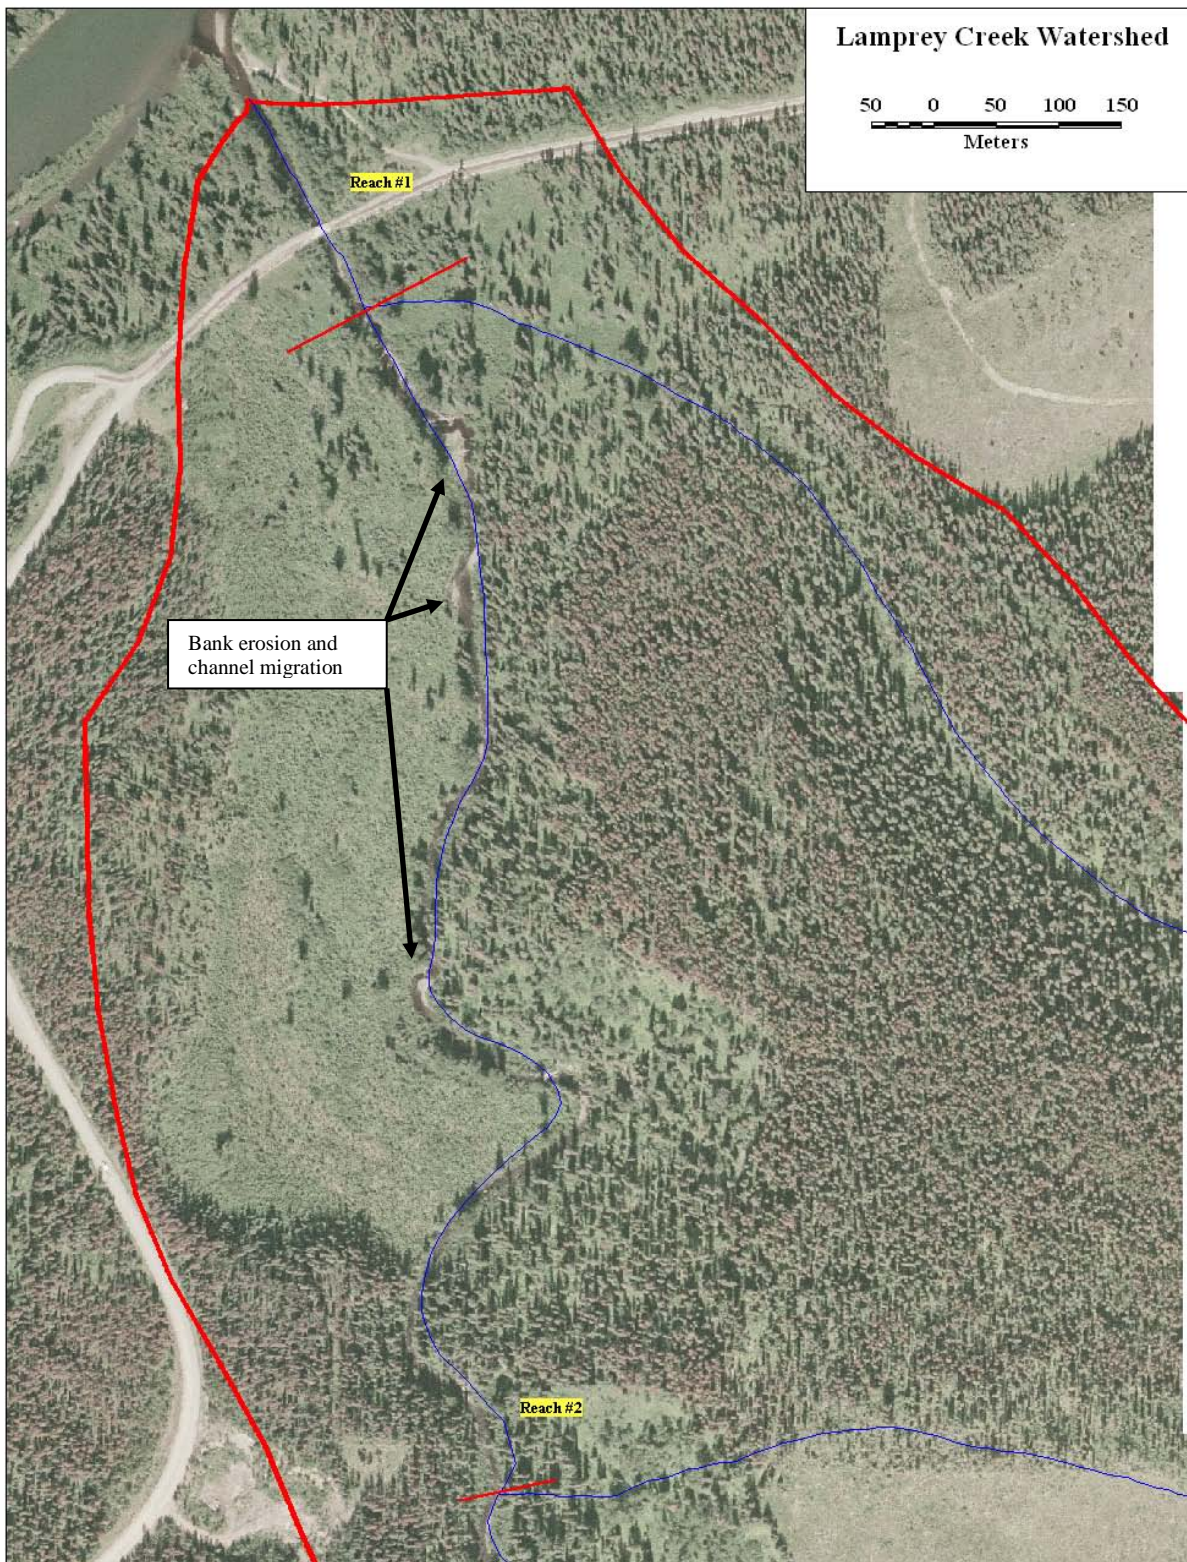
Reach Number	Rosgen Stream Type	Reach Length (m)	% riparian logged (as interpreted from air photos)	Apparent stability and other comments (as viewed from air photos)
1	B5-Stable	241	0.0	Stable
2	C5 - Unstable/disturbed	1143	83.4	Moderately De-stabilized
3	B5-Stable	1150	0.0	Very Stable
4	B5-Stable	1740	0.0	Stable
5	C6- Stable	1980	0.0	Stable
Hazard Scores:			Hazard Rating Score	Hazard Rating
			1.5	Low

Figure 5. Vertical ortho-photo of reaches 1 and 2 of Lamprey Creek. Note bank erosion and channel migration into cutblock where the riparian forest was removed (left bank).

3. Maintain long term recruitment of large woody debris (LWD), shade and bank stability by retaining at least 90% of the riparian area. This riparian area refers to the management area measured from the closest streambank to a distance 15m upslope from the streambank on:

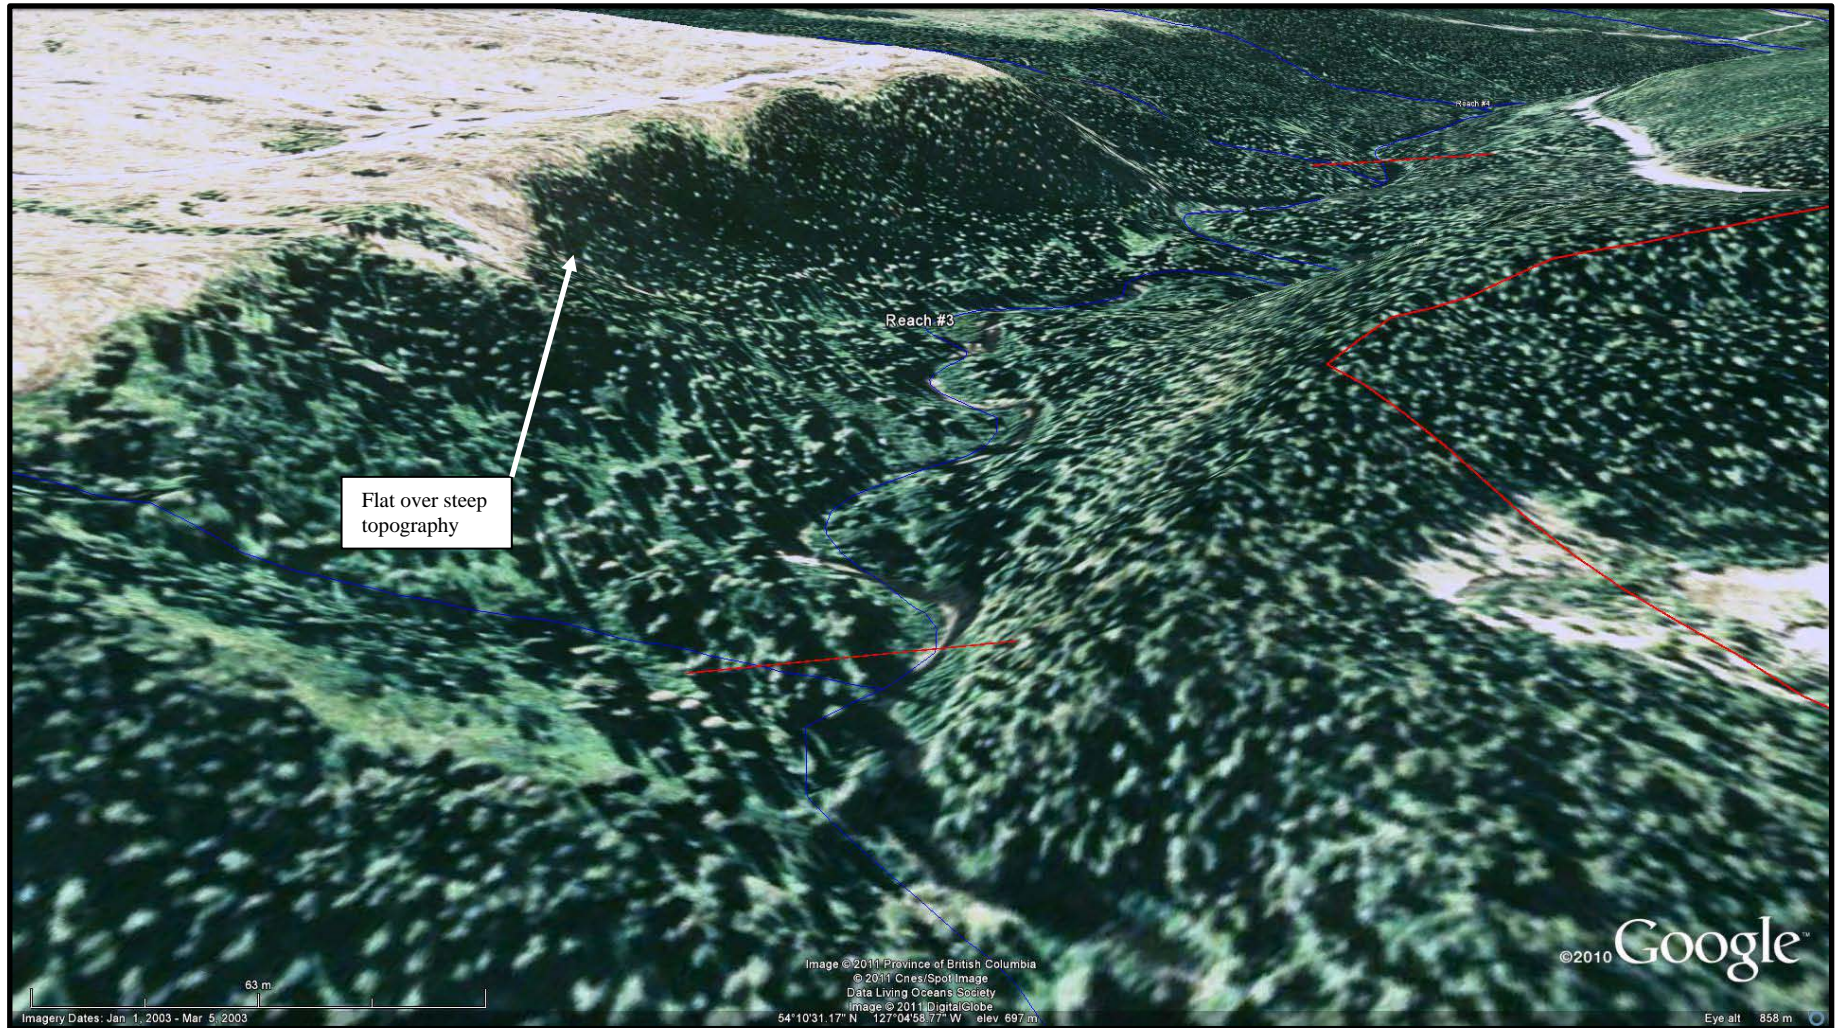
Figure 8. Example of “flat-over steep” terrain along Reach #3 of Lamprey Creek.

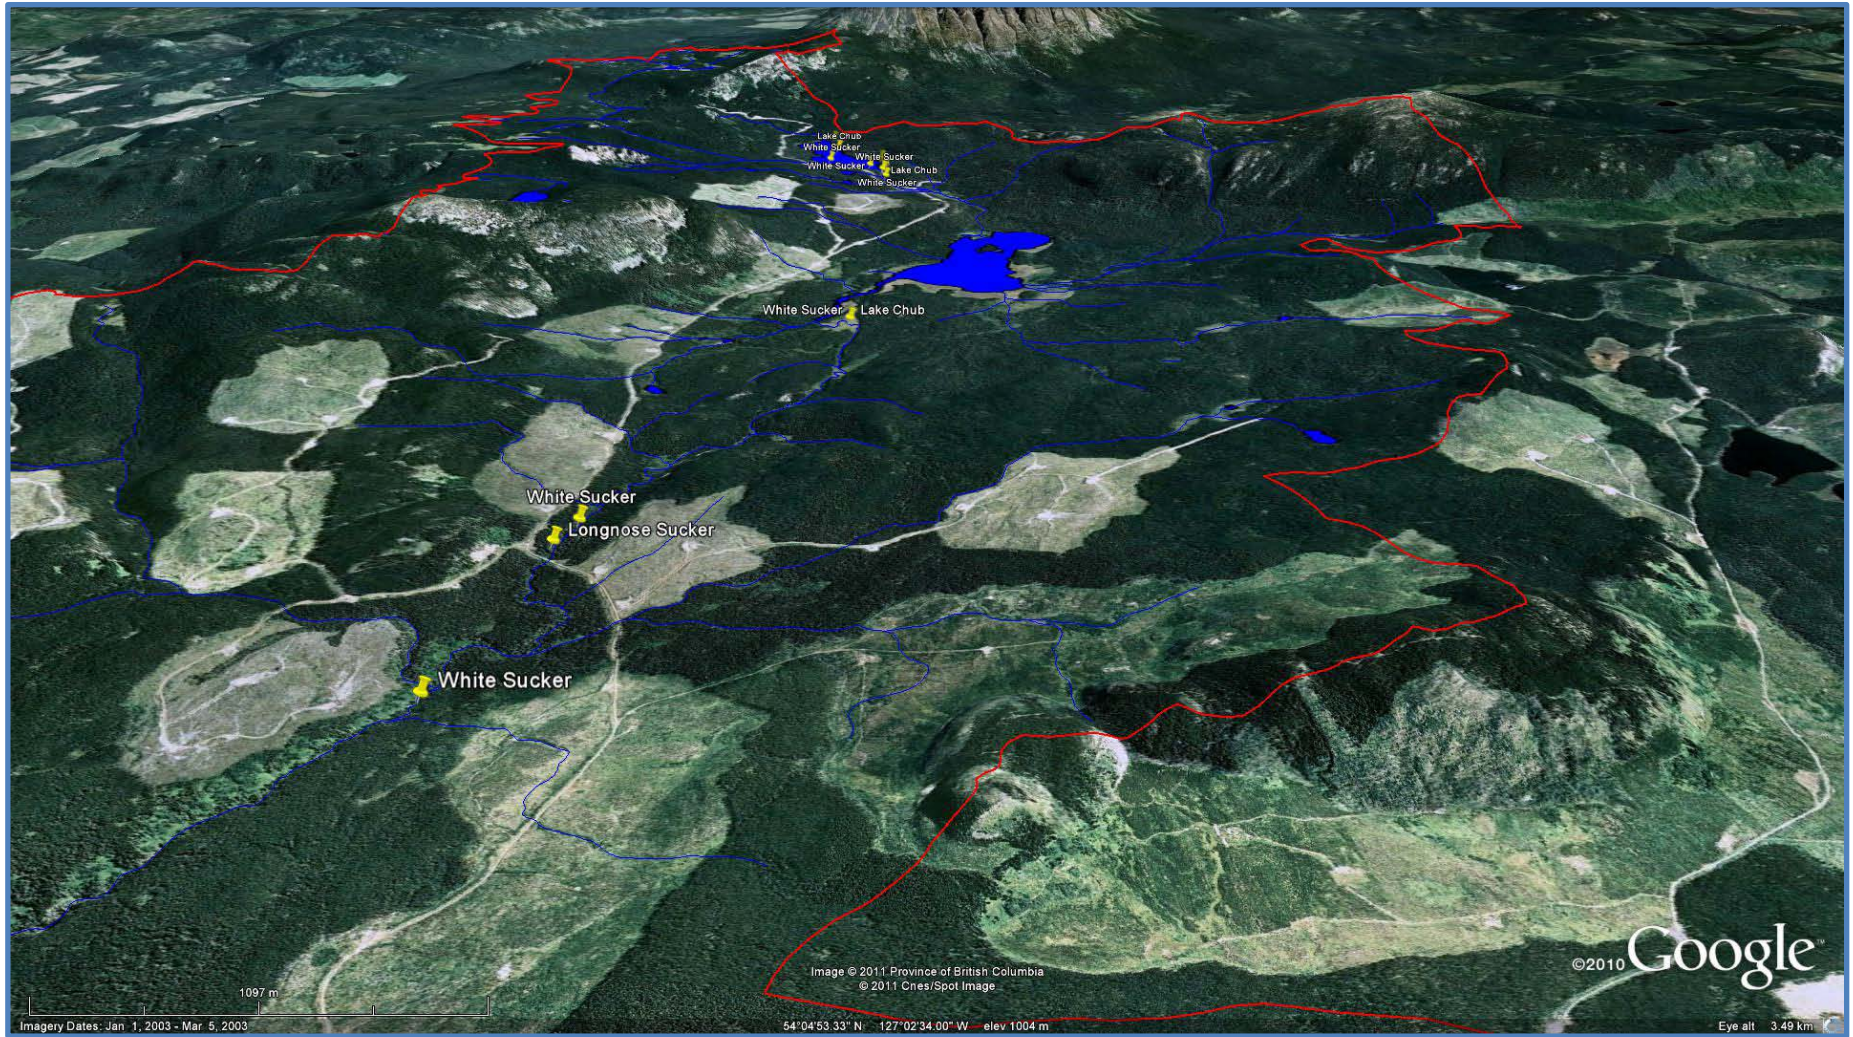
Figure 9. Forest harvesting slowly progressing into steeper areas of the watershed.
