KM 34 STREAM CROSSING

STREAM RESTORATION CULVERT OUTLET

**(W.C. 46 - 700 - 30-130)
SUSKWA FOREST SERVICE ROAD**

March 31, 1999

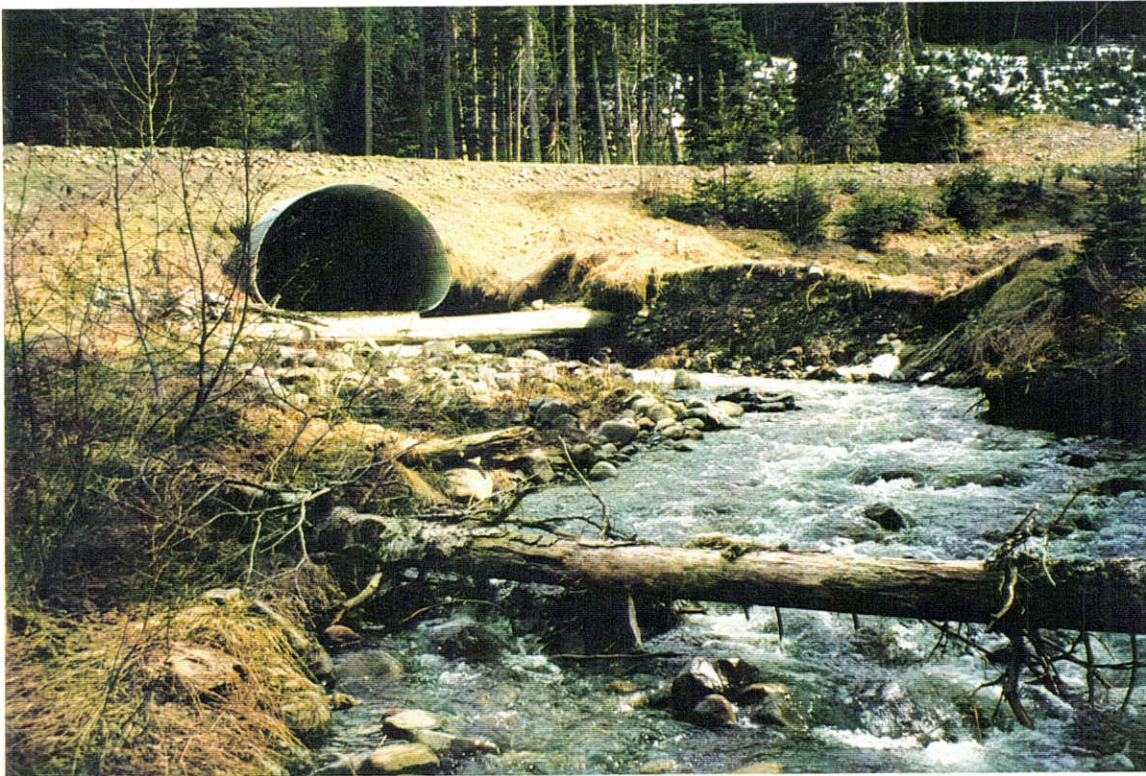
In the 3,890 x 2,690 mm multi plate arch culvert, the natural channel width is reduced to less than 4 m. Flow is accelerated, causing erosion and scour at the outlet of the culvert. Presently, the culvert outlet is .85 m perched above an 0.8 m deep scour pool. Continuing erosion at the outlet slowly enlarges the scour pool, and has caused 0.9 m wide undercutting under the culvert invert. Bedload is mobilized from the 1.5 m high channel banks just below the culvert and is deposited in the gentler channel section in the forest downstream. Two logs were placed perpendicular to the stream flow, 4.5 m downstream of the culvert, spanning the entire channel width. The logs may have been partly embedded in a 5 % channel bed when the culvert outlet was built in 1988. They are now undermined and have approximately 0.7 m clearance above

Photo 1: Culvert outlet; looking upstream; 17/05/98

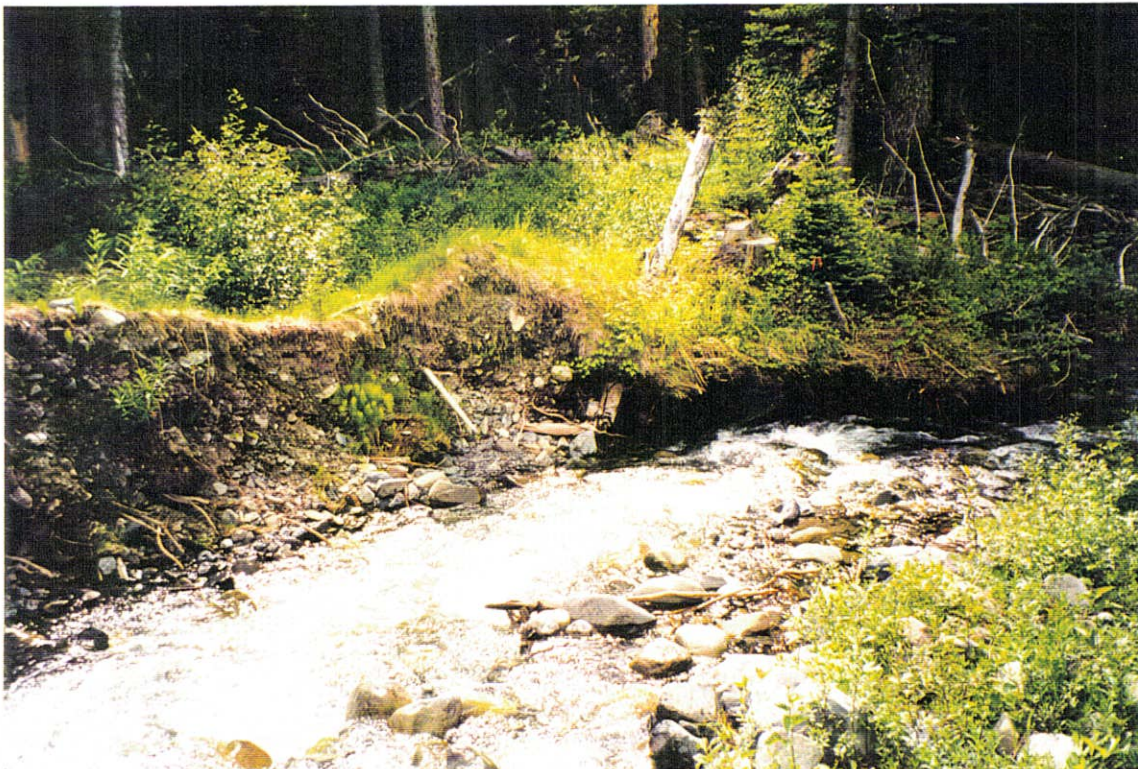
the channel bottom. The down-cut channel section extends over a length of 16 m below the culvert. Downstream of 20 m, the pre-construction channel banks remain intact. Bank height is 30 to 70 cm.

Photo 2: Transition from scoured high channel bank to lower undisturbed pre-construction; looking downstream; 16/06/98
