Annual Compendium Of Aquatic Rehabilitation Projects For The Watershed Restoration Program 1998 - 1999

Watershed Restoration Project Report No. 13
1999

Deep Creek Side Channel and Bank Stabilization

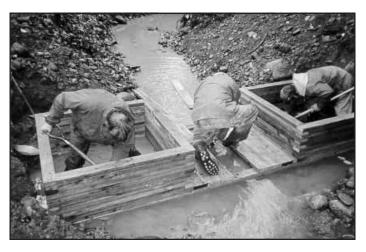
Figure 6-14. Box culvert construction; controls flow into side channel.

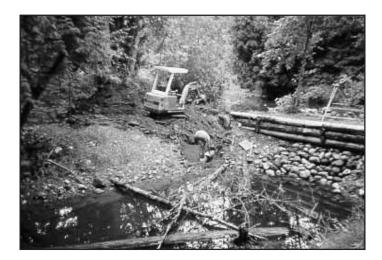
Drought conditions during July 1998 caused very low water conditions in Deep Creek resulting in the channel inflow to be dramatically reduced. This threatened the ability of the channel to maintain suitable water conditions for fish to rear in. To alleviate the low flows into the channel during drought periods, a 20'x 12" culvert was placed under the berm at the top of Deep Creek side channel in August 1998 (Fig. 6-15). To accomplish this, a trench was excavated with a mini excavator and covered over by the restoration crew who also completed the bank cleanup and rock placement. The end result of this additional intake was the establishment of suitable flows that will support spawning, incubation and rearing of salmonids during low flows (Fig. 6-16).

Figure 6-15. Additional culvert intake installed to increase low flow levels in the side channel.

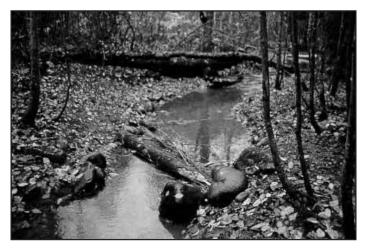
Figure 6-16. Deep Creek side channel water levels during low flows.

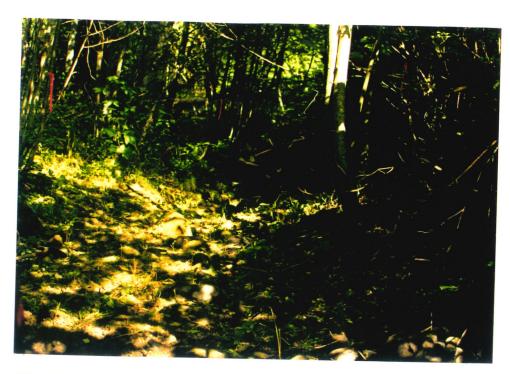
Photo 1. Deep Creek side channel location before construction began.

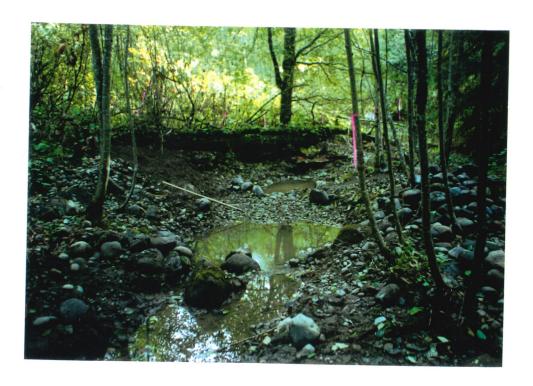
Photo 2: Side channel after excavation.

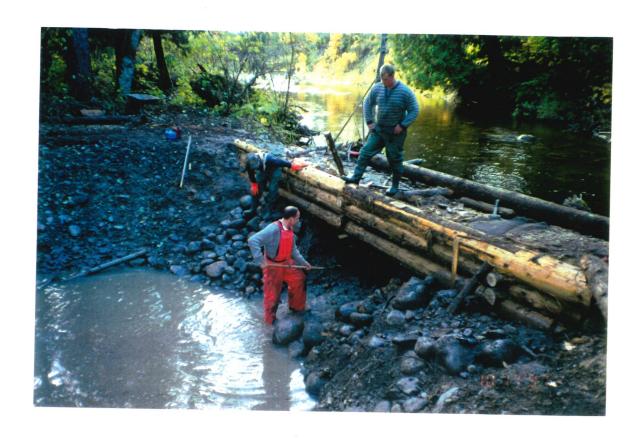
Photo 3: Berm construction.

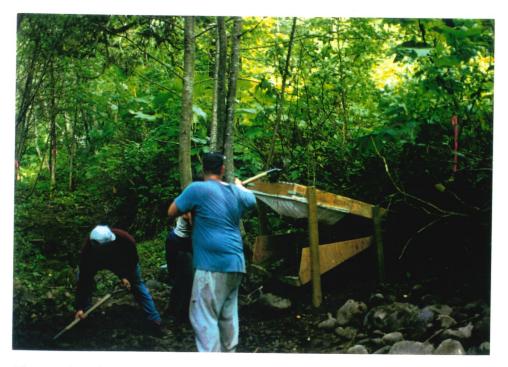
Photo 4: Gravel grader, constructed by TSES.

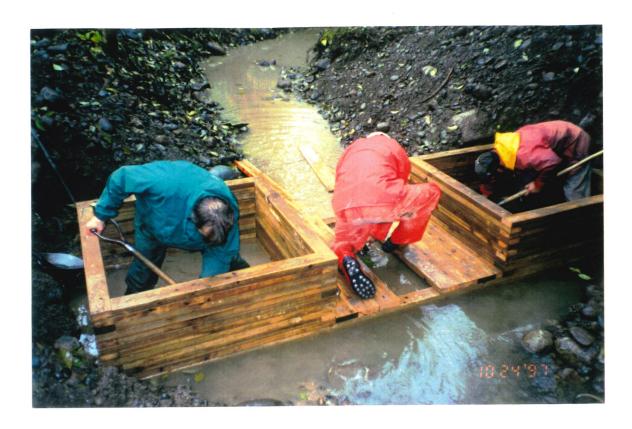
Photo 5: Box culvert construction; controls flow into side channel.

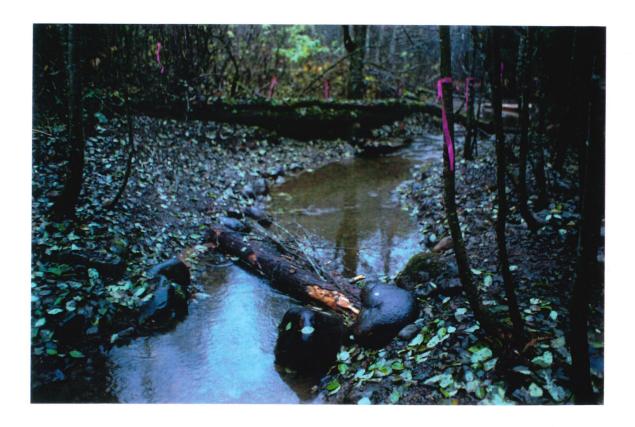
Photo 6: Deep Creek side channel after complexing.

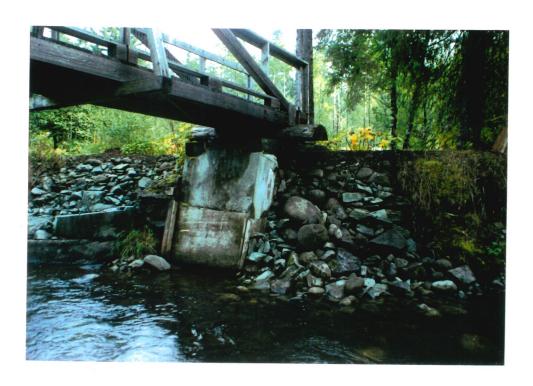
A steady water flow was maintained in the side channel for most of the winter of 1997/98. The bank stabilization under the walking bridge is holding to date.

Photo 7: Bank stabilization below the walking bridge.

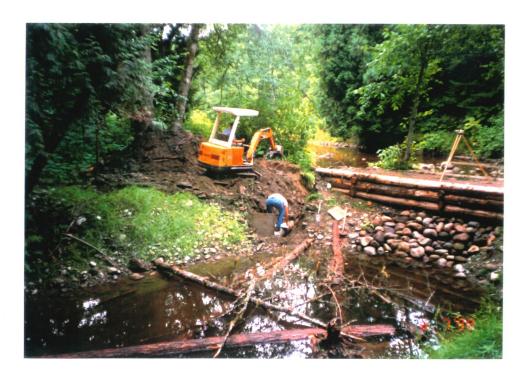
The culvert installed in August 1998 is working very well, providing a flow of water to the channel that should be sufficient during the lowest Deep Creek water conditions.

Photo 8: Culvert installed August 1998 to allow additional water flow from Deep Creek.
