# *Gitanyow Fisheries Authority*

2008 Assessment of Forestry Road Crossings in the Kispiox River Watershed using the Water Quality Effectiveness Evaluation

**Report Prepared by:** Kevin Koch, BSc. and Mike McCarthy, HBSc. Gitanyow Fisheries Authority PO Box 148 Kitwanga, BC V0J 2A0

> > March 30, 2009

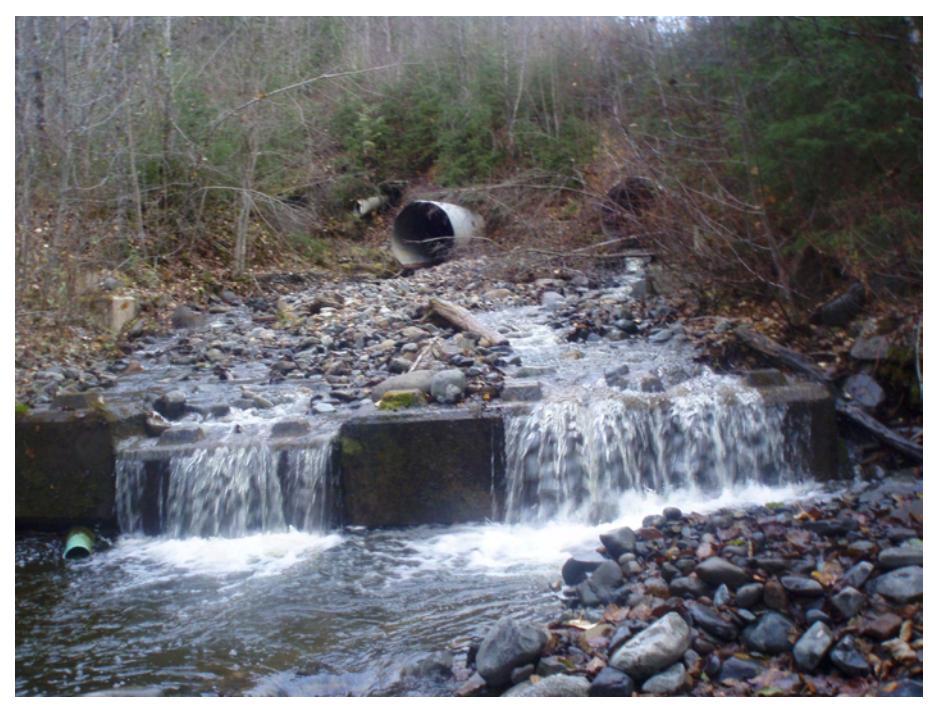
Photo 1: Site 99. Looking upstream at culvert outlet. Note 2 large culverts and one smaller one in background left.

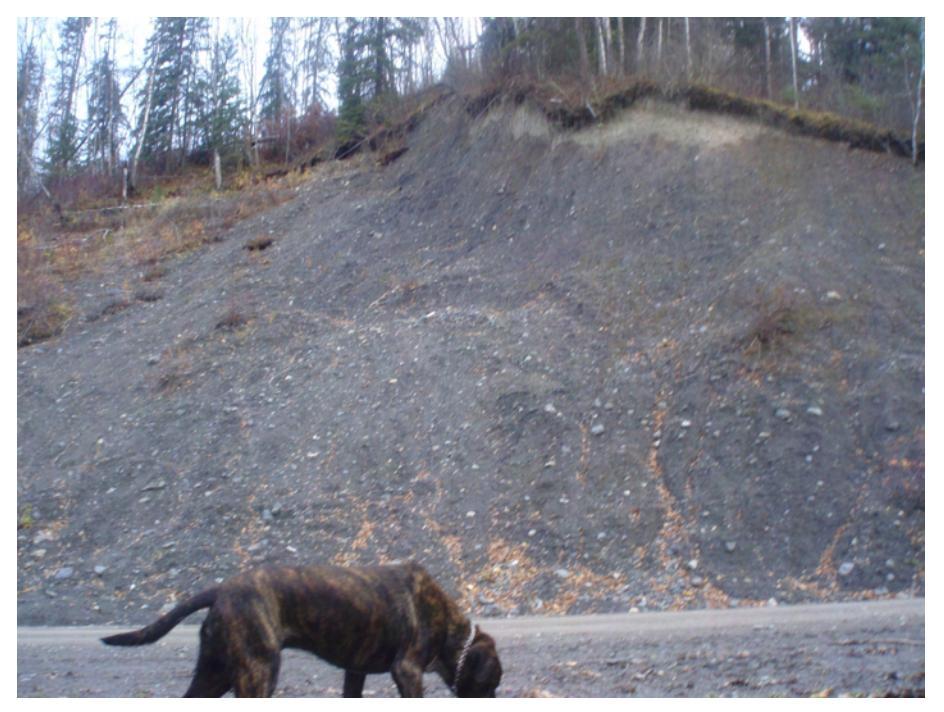
Photo 2: Site 99. Looking at un-vegetated cutbank on the left road cut (upper side). Bioengineering is recommended to stabilize this slope.

> Fall trees along the top of slope that are unstable, or have already partially fallen. Bring these trees down onto the slope to assist in stabilization and to reduce work hazards at the site (may need to conduct a Danger Tree assessment before deploying crews to site).

- ➢ Grass-seed
- > Apply straw mulch and/or erosion control blankets.
- > Clear ditches of sediment and dispose of appropriately.
- > After cleaning ditches, inspect culverts for potential replacement.
- > Remove improperly installed sediment fence on downstream side of Site 100 culvert.

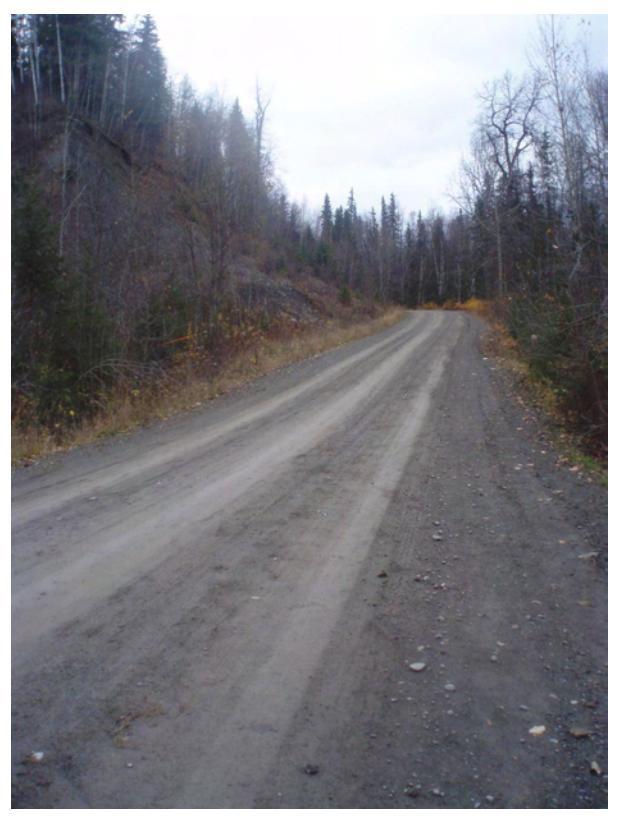
Photo 3: Site 99. Looking away from the crossing at the left road surface. This surface contributed significantly to the high ranking of this crossing, due to its erodible surface and connectivity to the stream.

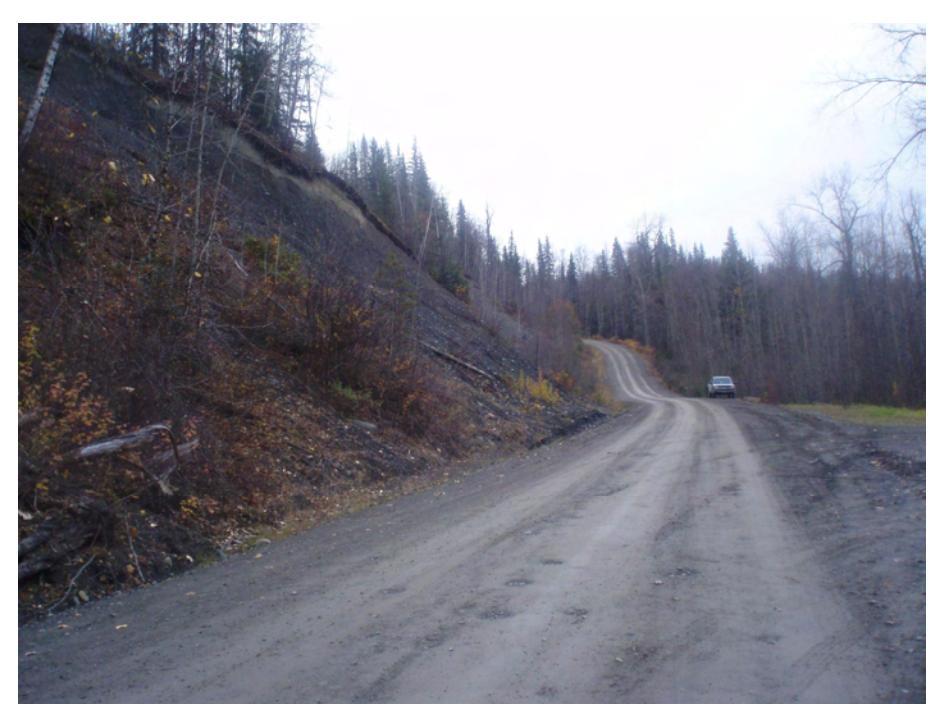
Photo 4: Site 100. Looking at eroded cutbank requiring stabilization on the left road cut (upper side). Note that ditch on upper side (left side photo) is almost full of sediment.

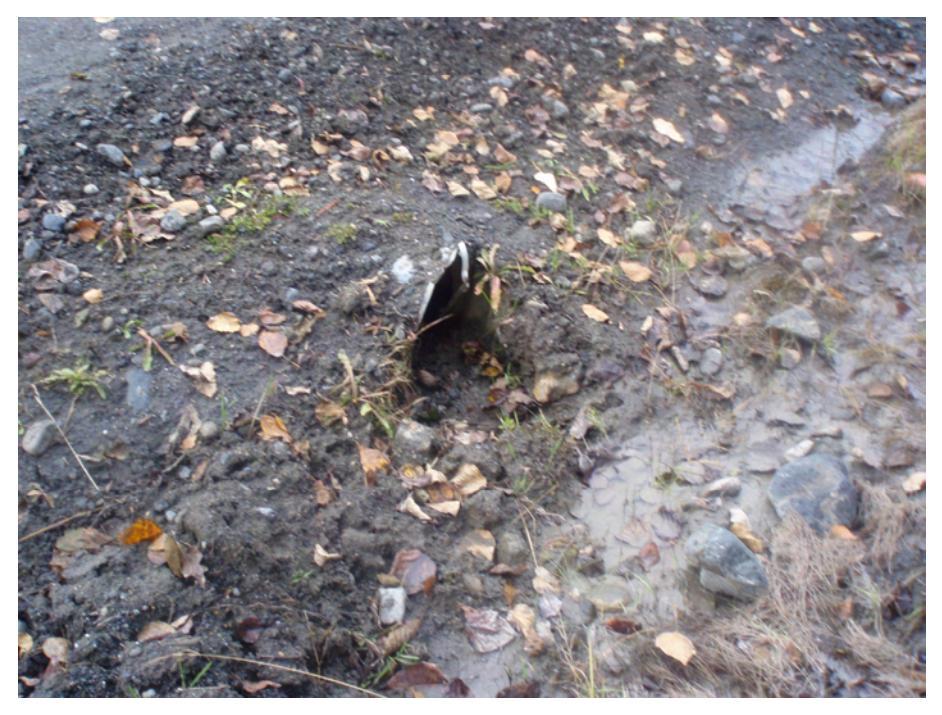
Photo 5: Site 100. Looking at upstream end of culvert, with large accumulation of highly erodible sediment.

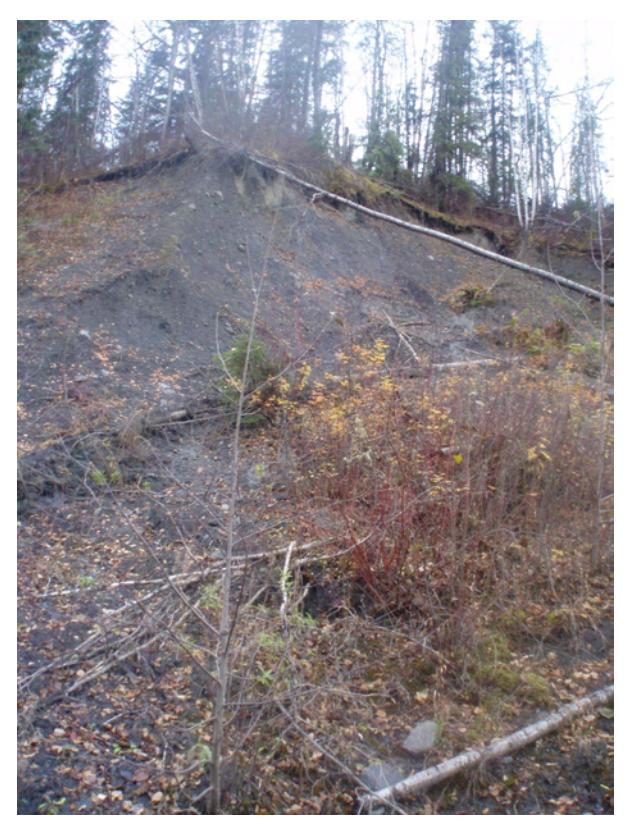
Photo 6: Site 101. Looking at eroded cutbank on left road cut (upper side). Another example of highly unstable banks in this area requiring rehabilitation.

The cutbanks along this stretch of road are quite steep, and are clearly not able to revegetate naturally. Along the top of the cutbanks, as the slope unravels, there are trees either falling down or already down, creating further instability. A detailed prescription is required for this slope, but general recommendations are as follows:

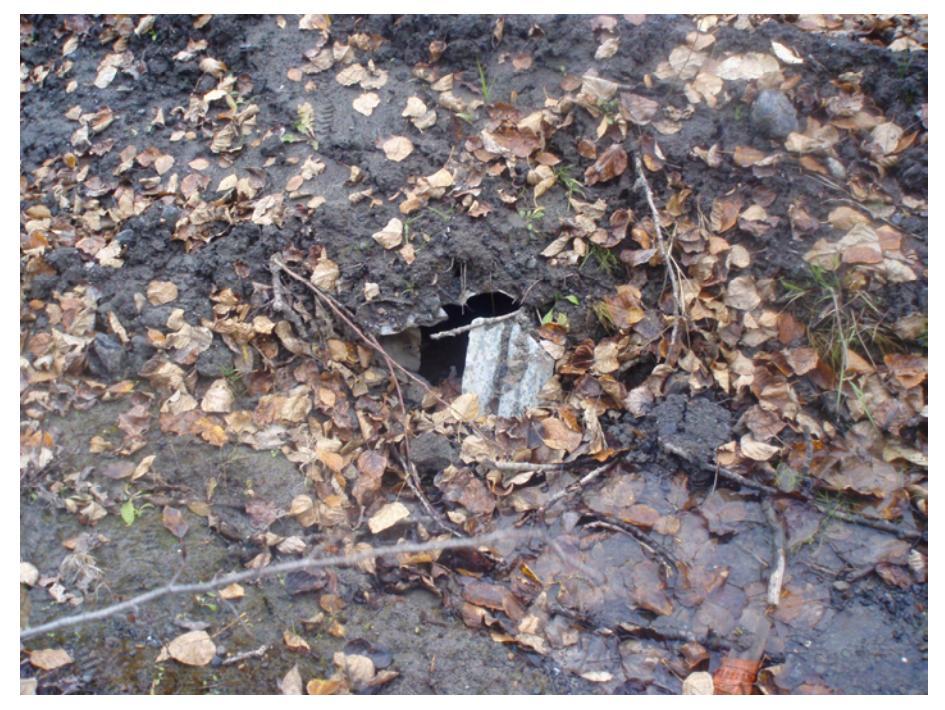
Photo 7: Site 101. Looking at upstream end of culvert, which is almost completely full of sediment, originating from the eroding cutbank in the previous photo.

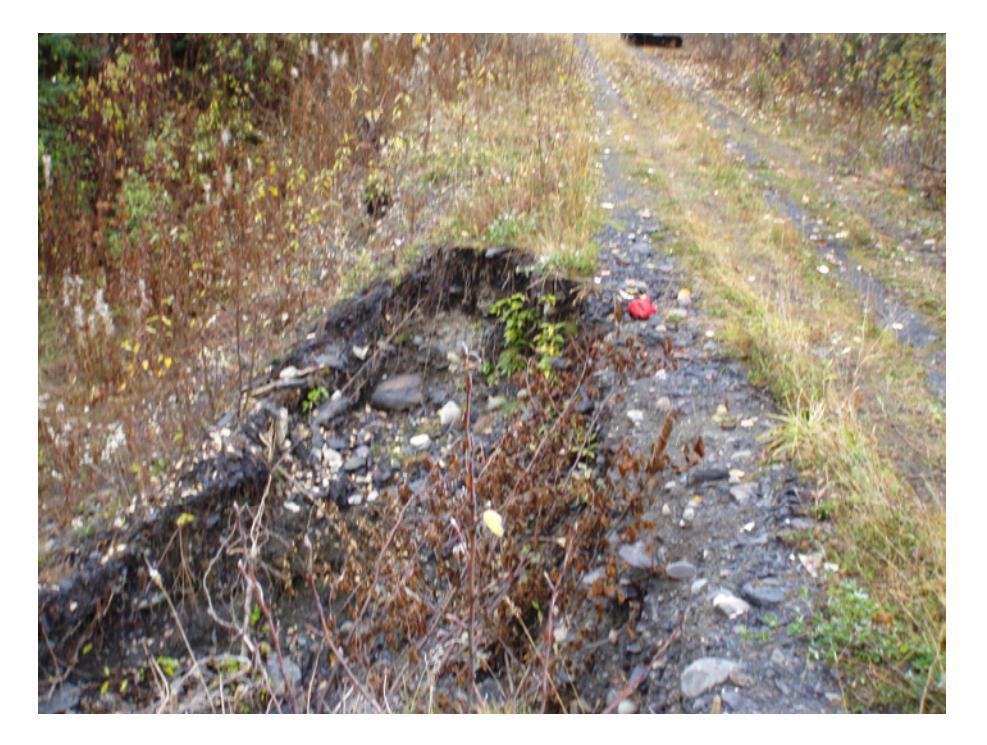
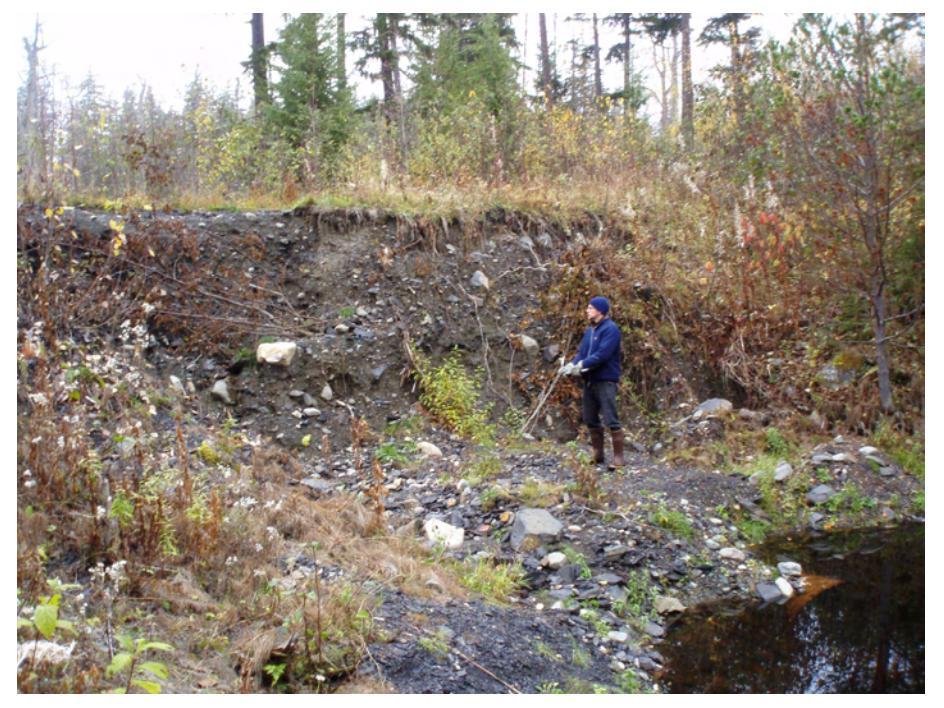
This crossing is a round metal culvert that passes an S3/S4 sized stream which Rabnett and Wilson (2007) confirmed is fish-bearing. There are large beaver dams on both sides of the road, and the road is washing out but still passable. The biggest erosion risk at this site is if the road washes out, which is possible. An area of mass wasting on the downstream side of the culvert has already deposited a large amount of sediment into the stream, and is now exposed and eroding.

Photo 8: Site 45. Looking at a large washout on the downstream side of the Bailey FSR at the Site 45 crossing.

Photo 9: Site 45. Looking at an area of mass wasting and exposed soil on the downstream side of the crossing. Submerged culvert is visible in lower right side of photo.

Requires engineer assessment to determine best course of action (deactivation/replacement). Is currently a **major safety issue**, as this road is used frequently by hunters and mushroom pickers.

> Recommend applying grass-seed, erosion control blankets and straw mulch to the site this season, while a decision is made about the ultimate fate of this crossing.

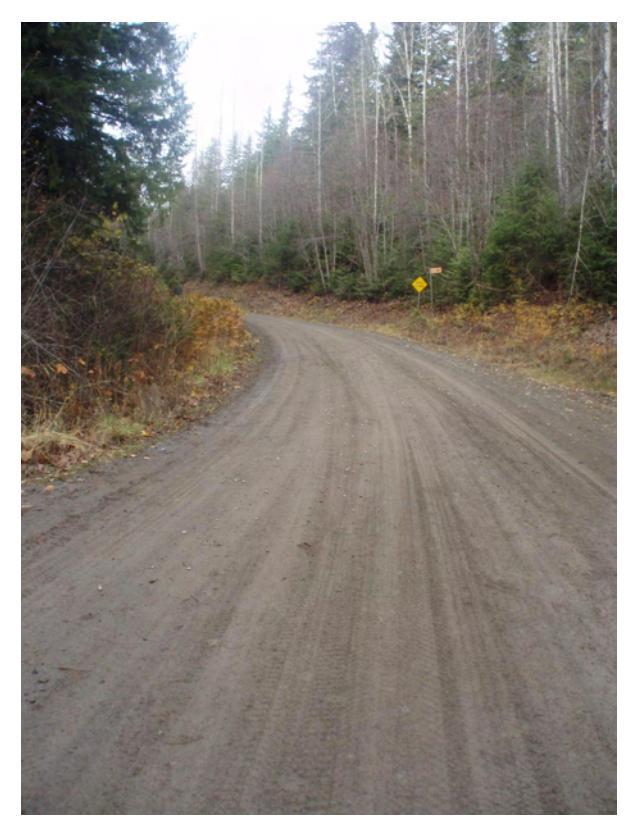
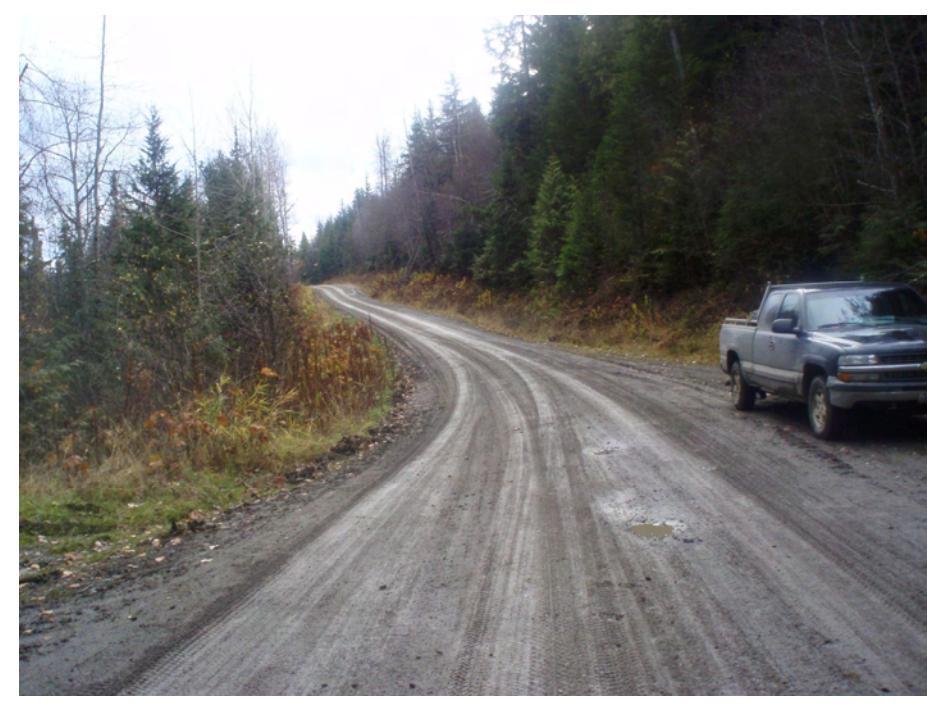
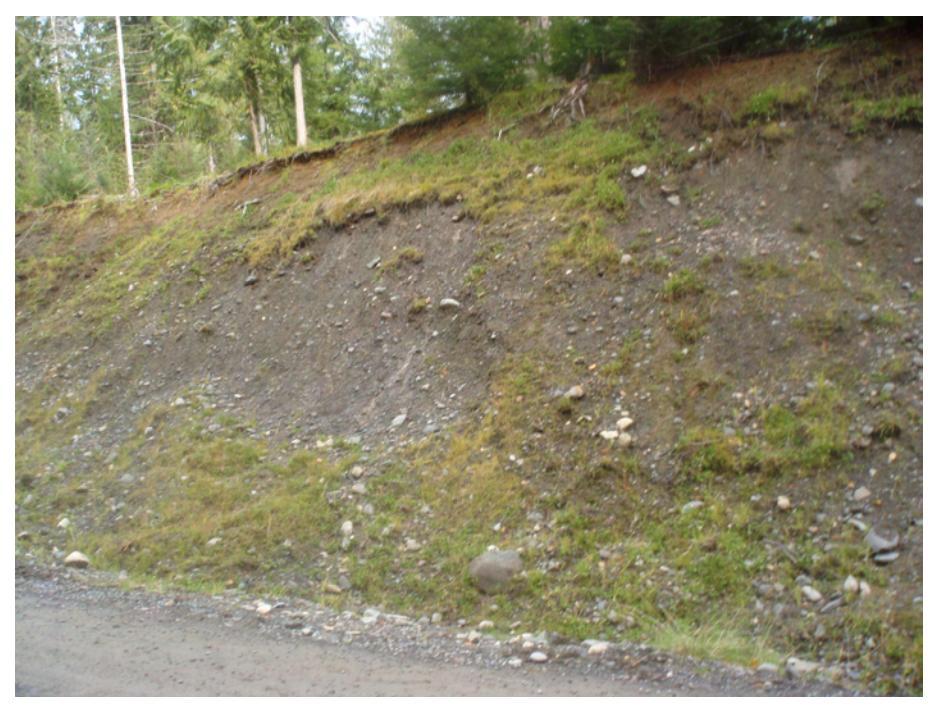
Photo 10: Site 98. Looking at left road surface, a  $\sim$ 500m stretch of highly erodible surface, directly connected to an S4 sized stream.

Photo 11: Site 98. Looking at the right road surface, also highly erodible.

Photo 12: Site 98. An example of the partially vegetated left bank cut (lower side), requiring some remediation.

The main issue at this site is the relatively long and steep erodible road surfaces that lead directly into a creek, and that this road had logging activity at the time of survey. The recommendations are:

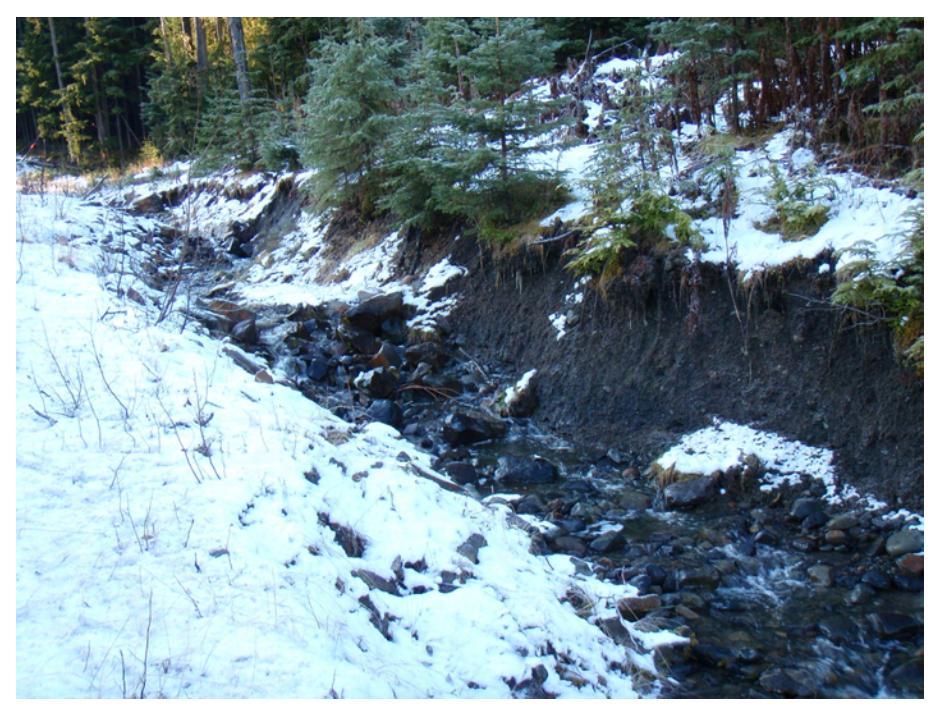
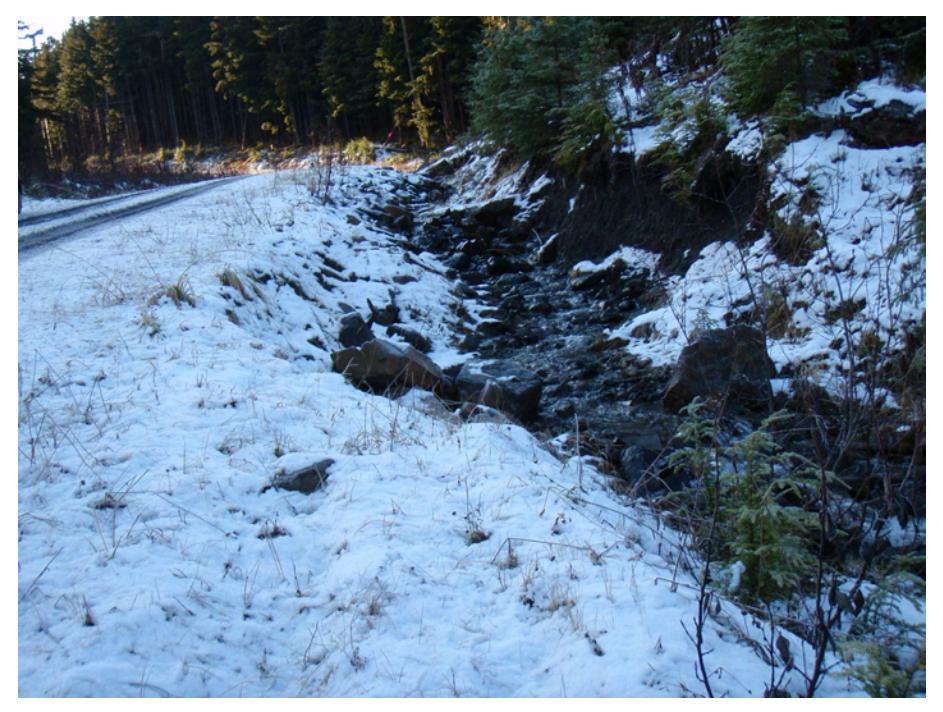
Photo 13: Site 121. Eroding RRD(u) where original stream has been channeled at Helen FSR 2000 Road km 3.0.

Photo 14: Site 121. Eroding RRD(u) and exposed RRC(u) in background at Helen FSR 2000 Road km 3.0.

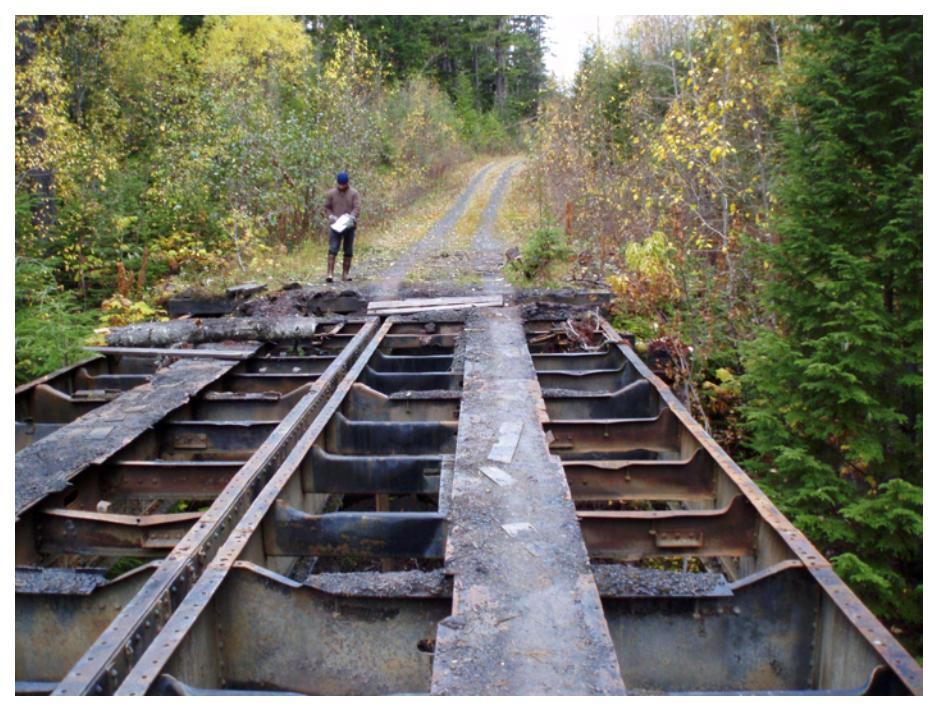
Site 34 consists of severely degraded bridge with no deck, overtop an S4 stream, in which Rabnett and Wilson (2007) have confirmed fish presence. This bridge is a **major safety issue**, as there was evidence that people have still been driving vehicles over. Erodible road surfaces were the main sediment risk at this site, with a minor contribution from an eroding left road cutbank. No sites were surveyed beyond this point as it was foot access only beyond this bridge.

Photo 15: Site 34. Looking across degraded bridge with no deck.

> Road engineer should assess and appropriate licensees/MoF determine whether bridge should be removed/replaced.

> Remove/replace bridge and re-vegetate site appropriately.

> If bridge is replaced, construct road in vicinity of crossing to minimize sedimentation of stream.

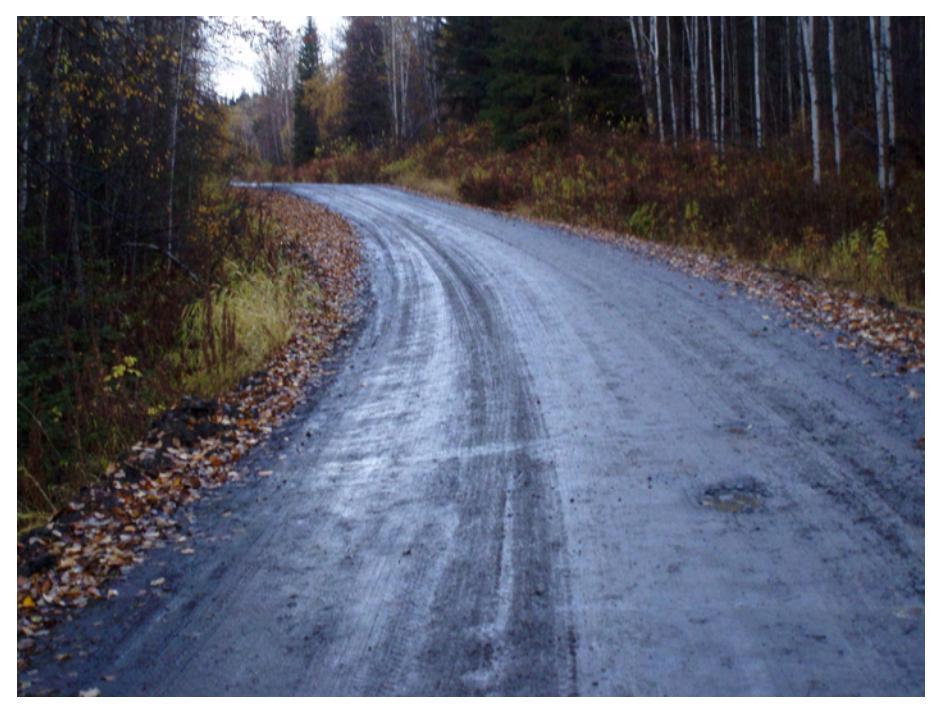
A large round wooden culvert passes Corral Creek at Site 71, which is a confirmed fishbearing stream (Rabnett and Wilson 2007). The left and right road surfaces are the biggest sediment risk here, as well as a pile of debris left overtop the culvert from road grading.

Photo 16: Looking at right road surface with small pile of un-vegetated debris on bottom left side of photo, left over from road grading.

- > Requires assessment by road engineer for potential re-surfacing.
- > Grass-seeding and mulch exposed soil in and around culvert.

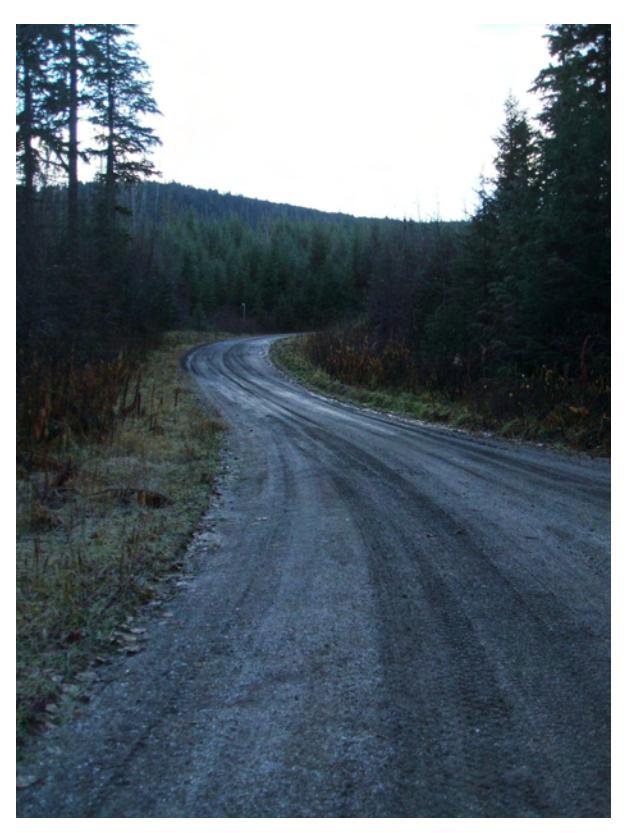
Photo 17: Site 139. Long 200-meter run of left road surface directing runoff towards stream at Helen FSR km 8.7.

> Recommend that a qualified road engineer inspect the road surfaces.

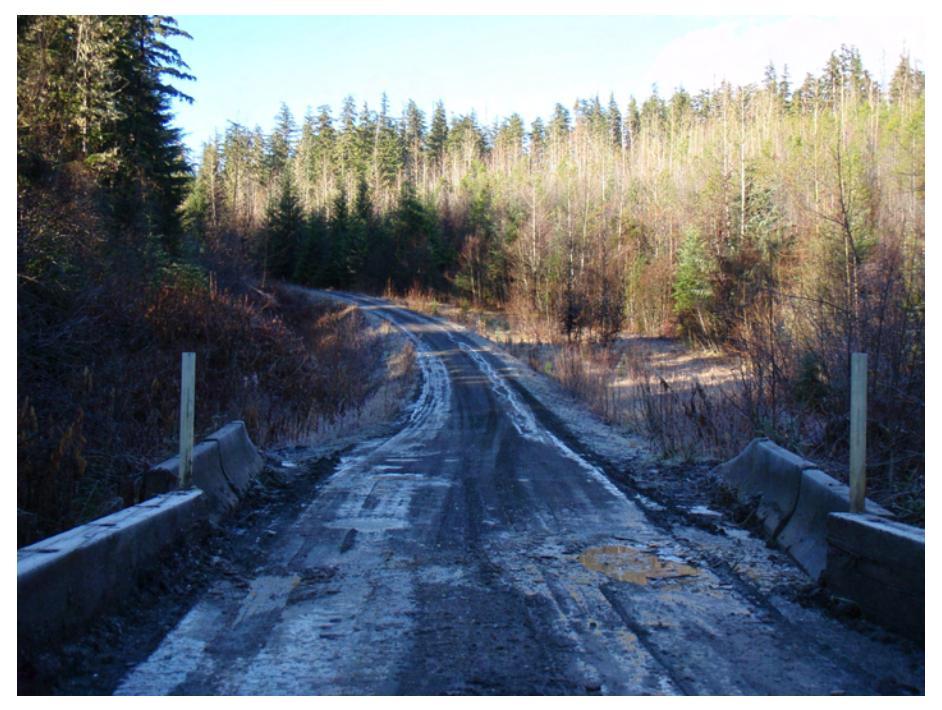
Photo 18: Site 125. Ruts on LRS drawing sediment towards a fish-bearing stream at Helen Lake FSR km 19.

> Recommend that a qualified road engineer inspect the road surfaces.

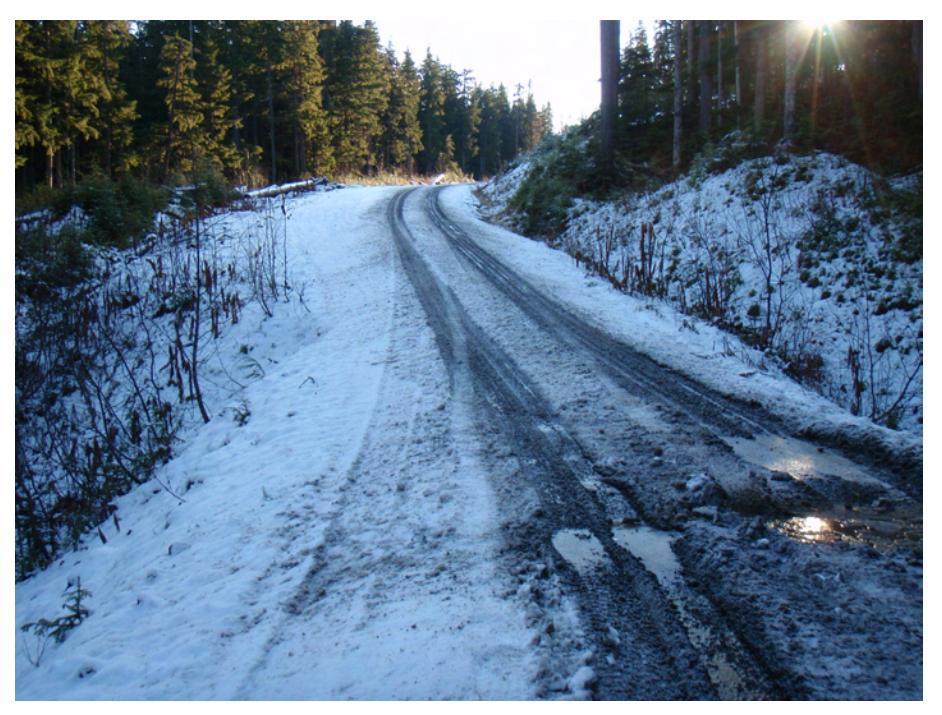
Photo 19: Site 124. Long 300 meter run on RRS and potholes above the crossing at Helen FSR 2000 Road km 3.8.

> Recommend that a qualified road engineer inspect the road surfaces.

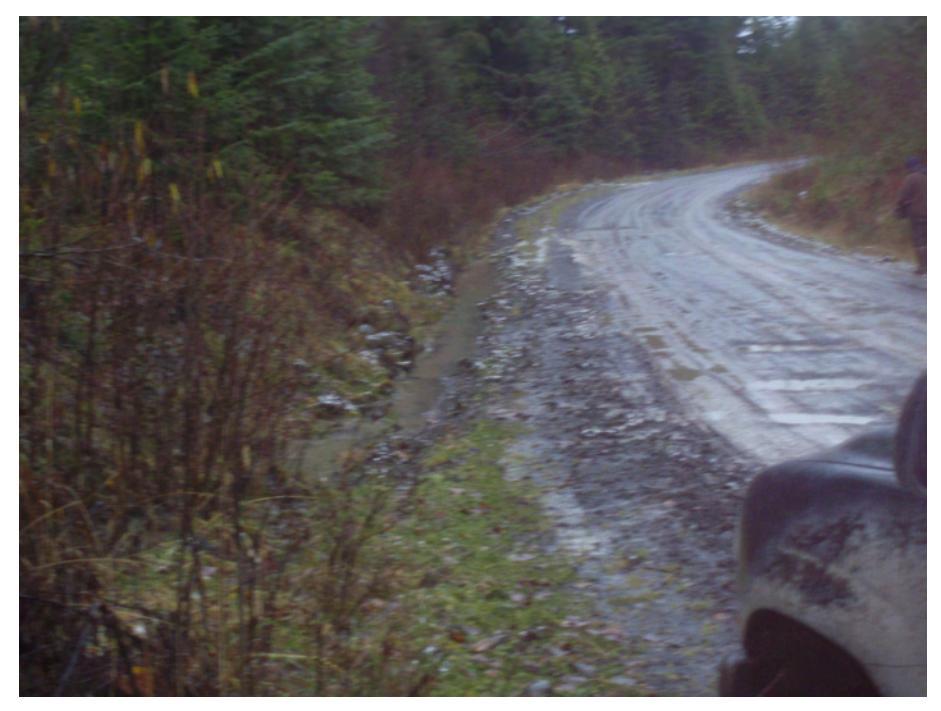
A round metal culvert passes an S4 sized stream at Site 118, which is confirmed to be fish-bearing (Rabnett and Wilson, 2007). Erodible road surfaces are the main sediment risk here, as well as the left road ditch (upper side).

Photo 20: Site 118. Looking at left road and left ditch (upper side).

> Requires assessment by road engineer for potential re-surfacing with clean coarse roadbed material.

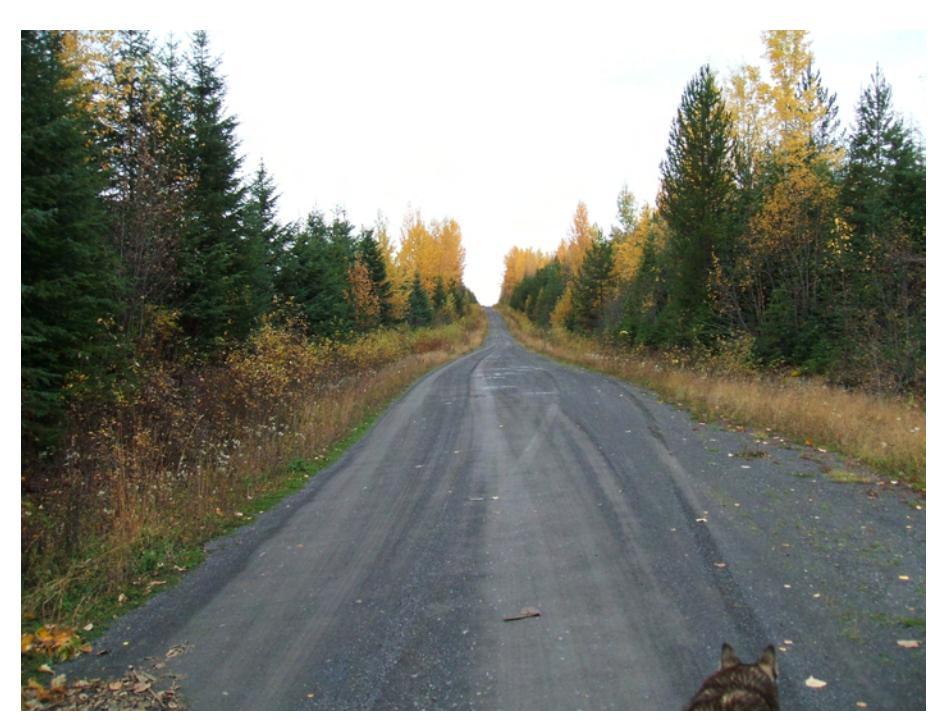
Photo 21: Site 17. Long 600 meter run on LRS leading to fish-bearing stream at Kuldo FSR km 15.2.

> Recommend that a qualified road engineer inspect the road surfaces.

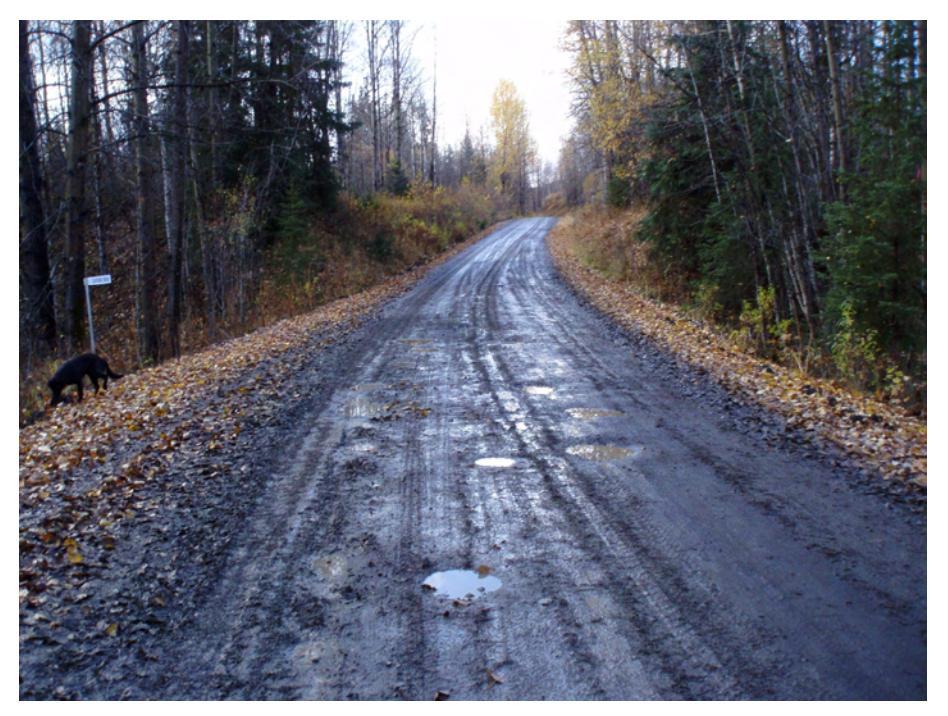
A large round wooden culvert passes Clifford Creek at Site 64, which is a confirmed fishbearing stream (Rabnett and Wilson, 2007). The road surfaces are highly erodible here, and high amounts of sediment likely enter the creek during rainstorms.

Photo 22: Site 64. Looking at the highly erodible road surface.

Considering this culvert is recommended as high priority for replacement, it is not recommended as cost effective to be conducting erosion control work at this time. What is required is a commitment and timeline from the MoT on when this culvert will be replaced. If it will be more than two years, then it is recommended that in the meantime:

Considering the previously established fish values in this creek and the recommendation for replacement of this culvert, and now with the high ranking for sediment risk, it is considered overdue for this culvert to be replaced.

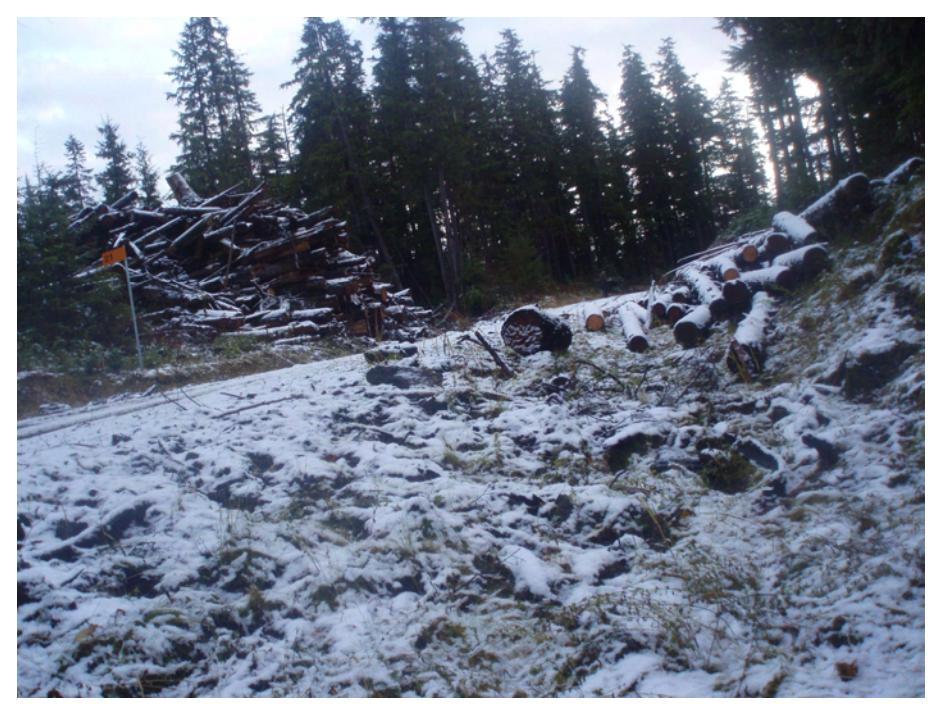
A round metal culvert passes an S4/S6 sized stream at Site 107, which has a fishbearing status of unknown (Rabnett and Wilson, 2007). There was active logging in the immediate vicinity of this site when it was surveyed in 2008, and a light snow cover. The road surfaces and ditches were all quite disturbed and erodible, likely because the logging was just done.

Photo 23: Site 107. Looking at the right road ditch (upper side) with decked logs in background.

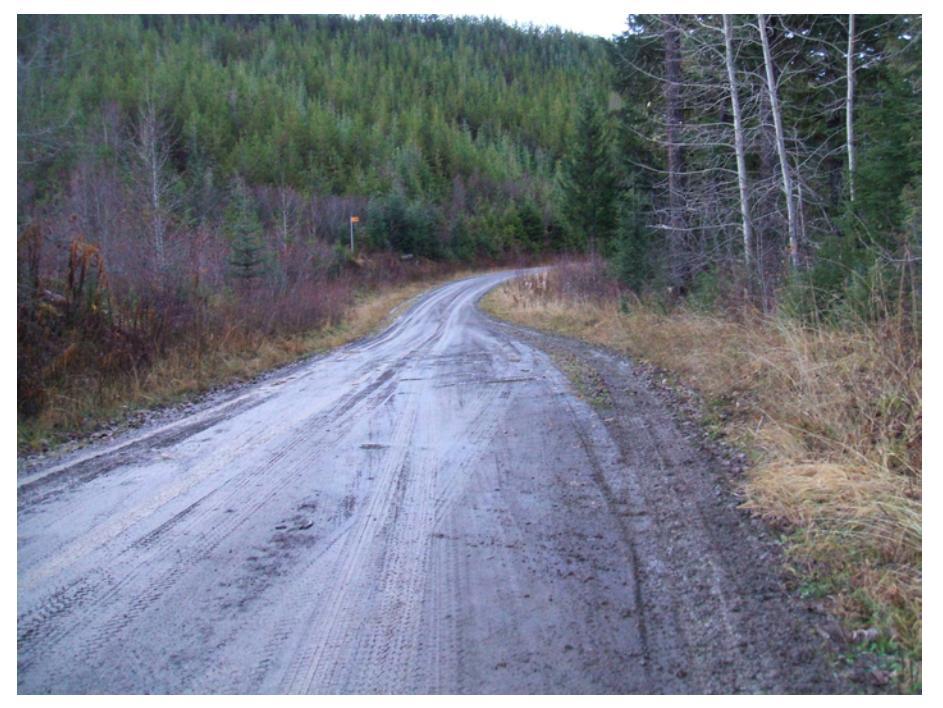
Photo 24: Site 137. Muddy LRS leading to crossing at Helen FSR km 9.9.

> Recommend that a qualified road engineer inspect the road surfaces.

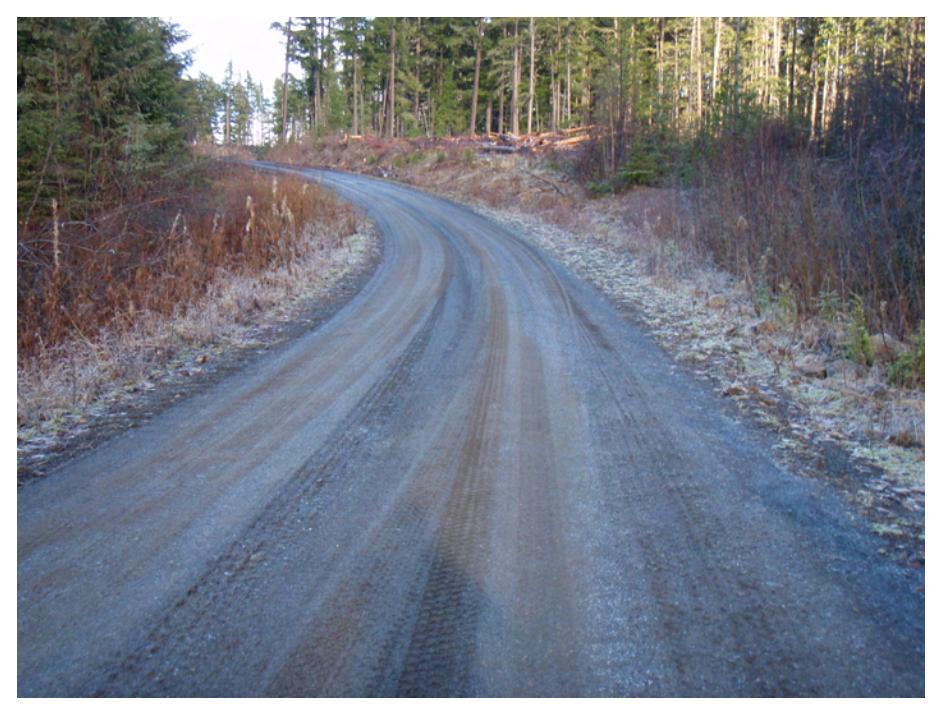
Photo 25: Site 129. Muddy LRS leading to crossing at Helen FSR km 14.8.

Recommend that a qualified road engineer inspect the LRS (150 meters) and the RRS (120 meters).

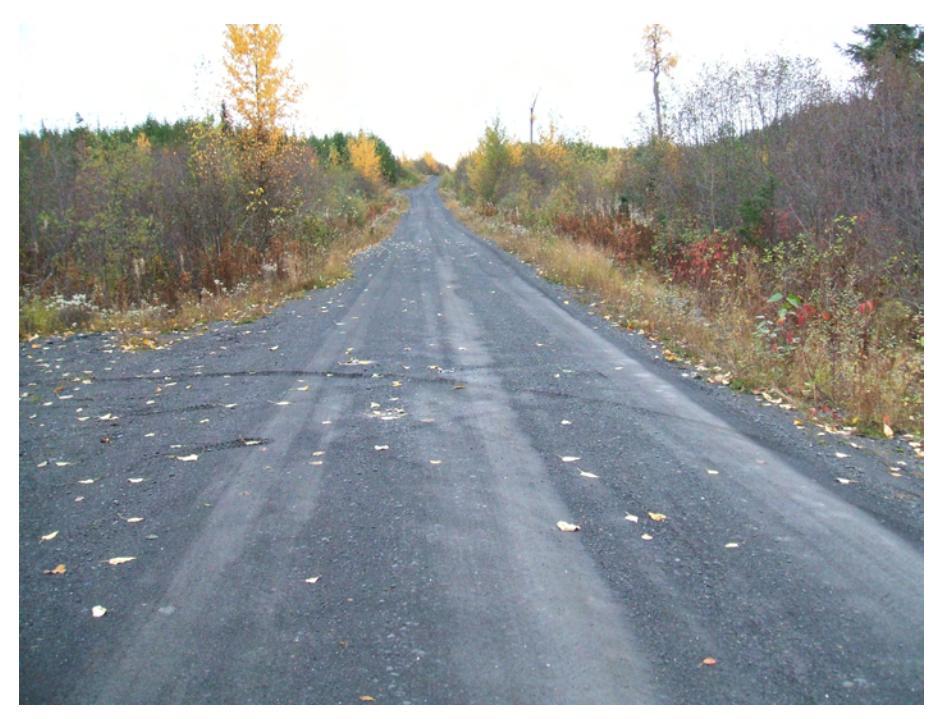
Photo 26: Site 11. Long 350-meter run on the RRS leading to stream at Kuldo FSR km 23.

> Recommend that a qualified road engineer inspect the road surfaces.

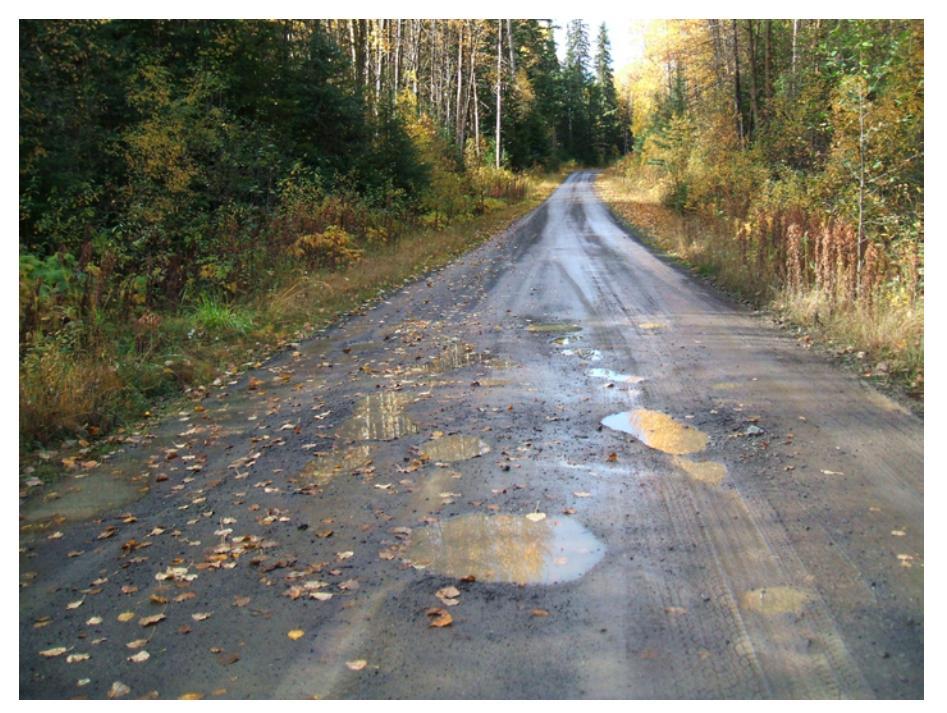
Photo 27: Site 7. Muddy potholes over stream and muddy RRS leading to stream at Kuldo FSR Km 7.8.

> Recommend that a qualified road engineer inspect the road surfaces.

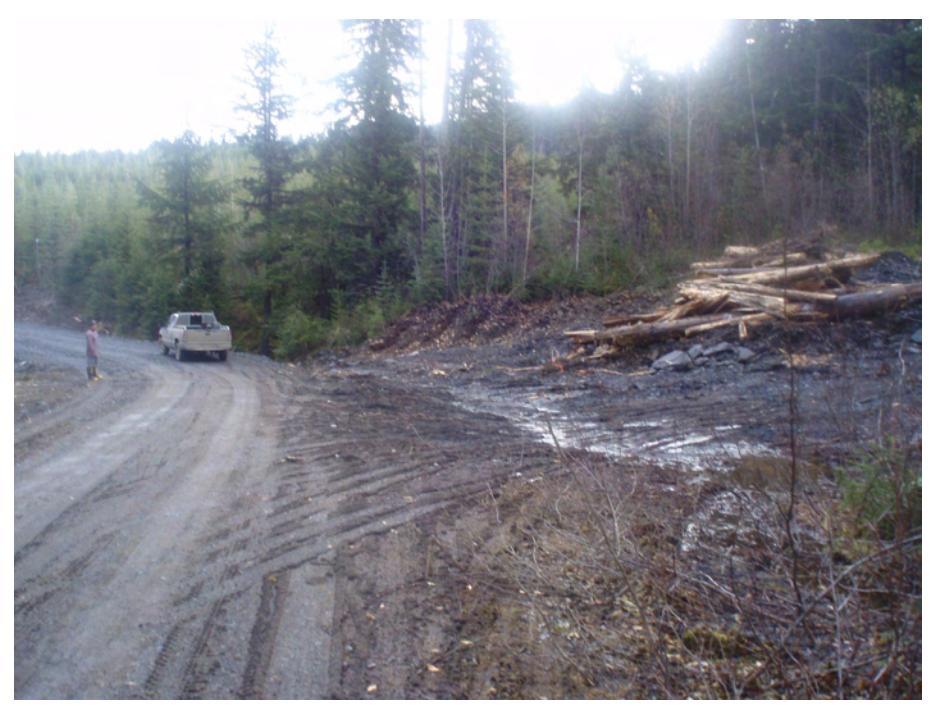
Photo 28: Site 20. Exposed soil following recent construction project (bridge removal/culvert installation) at Skeena Carrigan FSR.

> Recommend applying grass-seed and straw mulch over all exposed soil (landing, front fill, back fill, cutbanks, approximately 300  $m^2$ ).

$\succ$  Recommend that a cross-ditch culvert be installed upslope of the landing across the left road or that the LRD(u) is reconstructed through the landing (these two options require an assessment by a road engineer).

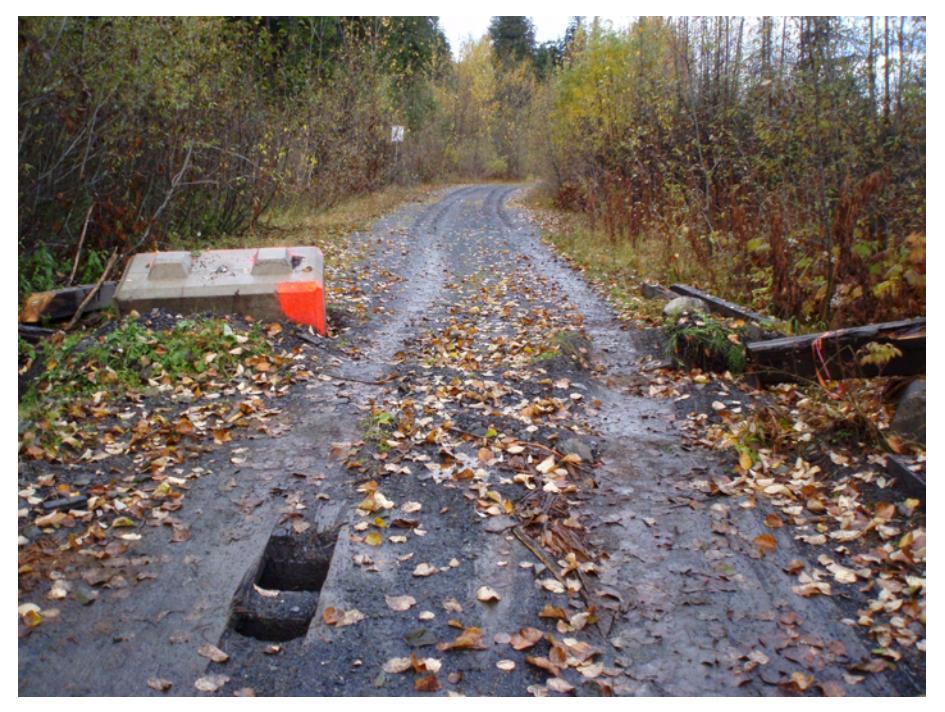
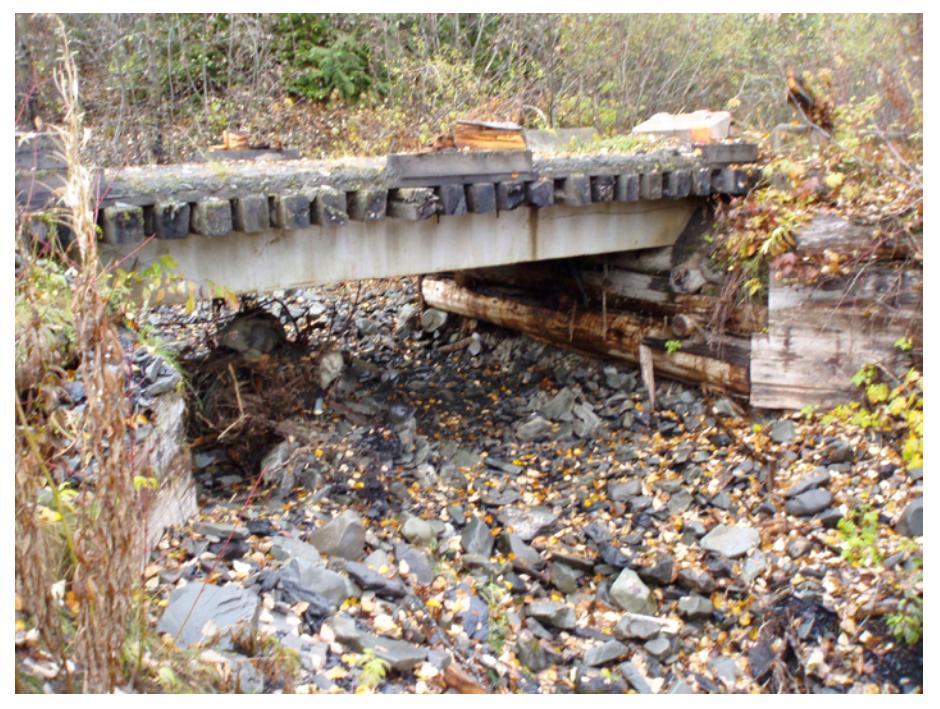
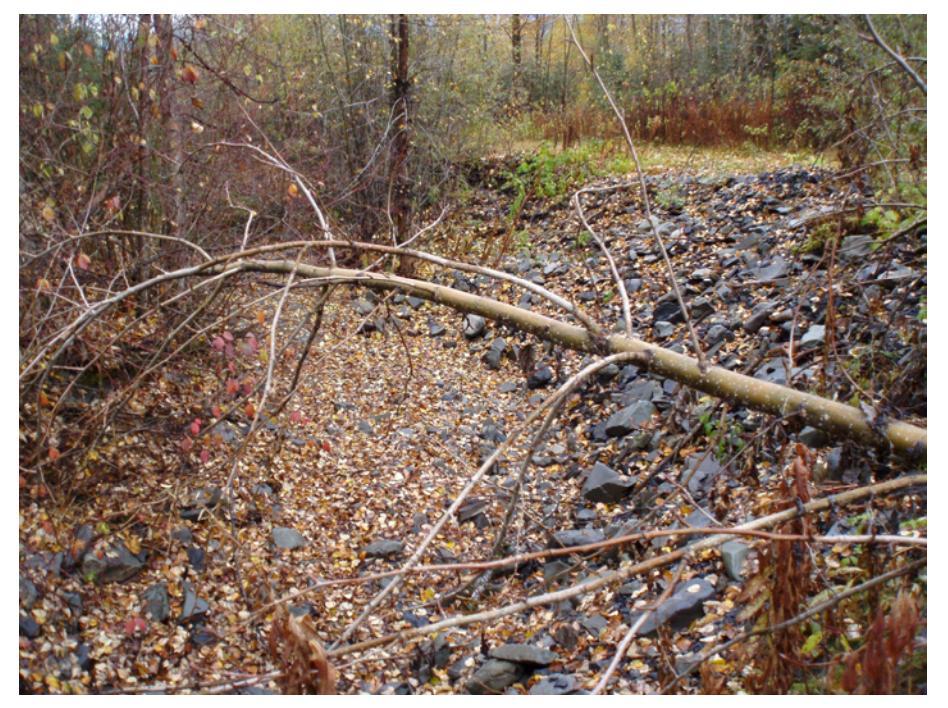
This site is the location of the current road closure at 7.3km on the Mitten FSR. People have moved the barrier aside and are currently using the road. Sediment related issues are low at this site, with the right road surface being the only current sediment contributor. The main issues at this site are the bridge itself being a safety concern, and the current state of the habitat in the creek. At the time of survey, the creek was completely dry. Rabnett and Wilson (2007) confirmed fish presence in this creek.

Photo 29: Site 49. Looking empty up the Mitten FSR at the Site 49 crossing.

Photo 30: Site 49. Looking upstream at the bridge at 7.3 km on the Mitten FSR. Note the dry channel.

Photo 31: Site 49. Looking downstream from the bridge at a dry channel.

- > Have engineer assess site for bridge replacement.
- > Replace bridge.
