# *Gitanyow Fisheries Authority*

2008 Assessment of Forestry Road Crossings in the Kispiox River Watershed using the Water Quality Effectiveness Evaluation

**Report Prepared by:** Kevin Koch, BSc. and Mike McCarthy, HBSc. Gitanyow Fisheries Authority PO Box 148 Kitwanga, BC V0J 2A0

> > March 30, 2009

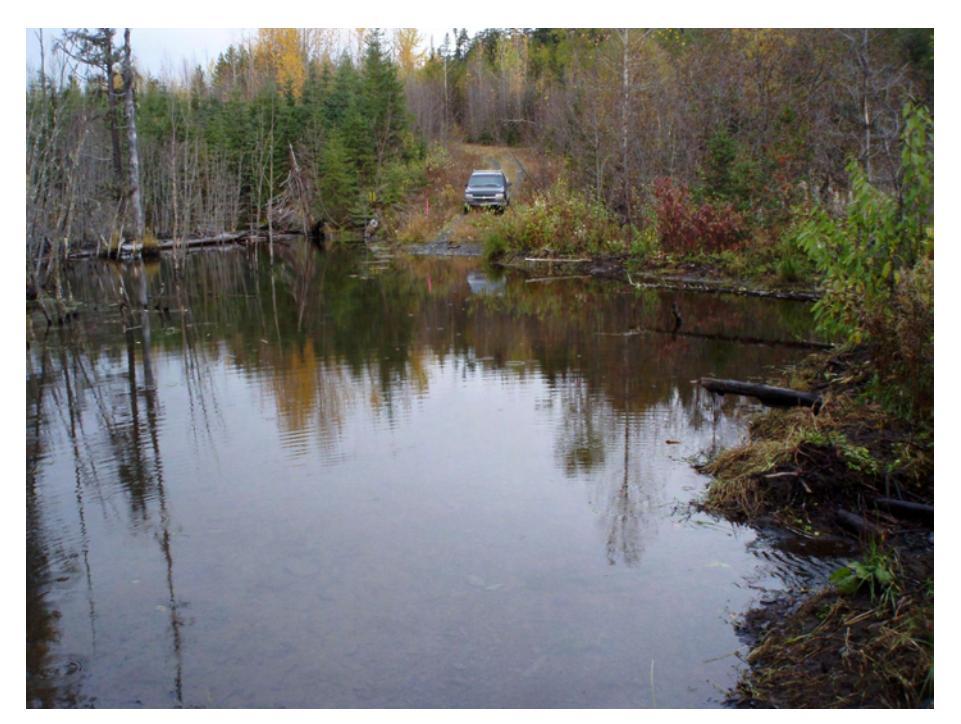
A large beaver dam on the downstream side of the road has flooded the road at this site. We could drive through but water levels were quite deep. The dam looks quite old. Rabnett and Wilson (2007) inferred fish presence at this site.

Photo 32: Site 27. Road flooded by beaver dam on Cancel FSR.

> If the road is repaired and a new culvert installed, it is recommended to use a beaver stop.

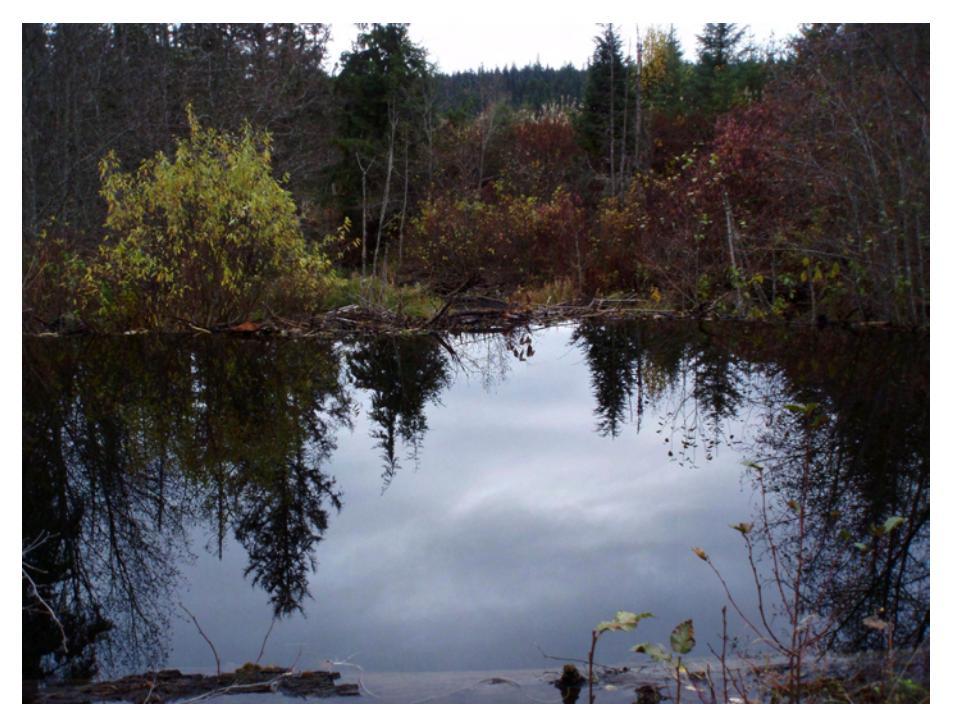
Large beaver dams exist on both sides of the road at this site, however the road is not yet flooded. There is a hole forming in the road, however, which is full of water. The road is currently driveable but not very safe. The culvert is not visible on either side and is likely plugged. Rabnett and Wilson (2007) did not survey this site, however the stream is shown as fish-bearing on maps produced in 2006 by the Gitxsan Watershed Authority (Williams, 2006).

Photo 33: Site 36. Looking downstream from crossing at large beaver dam. Water level is close to road level at this site.

➢ Road repair or deactivation is required soon for this site (engineer assessment required).

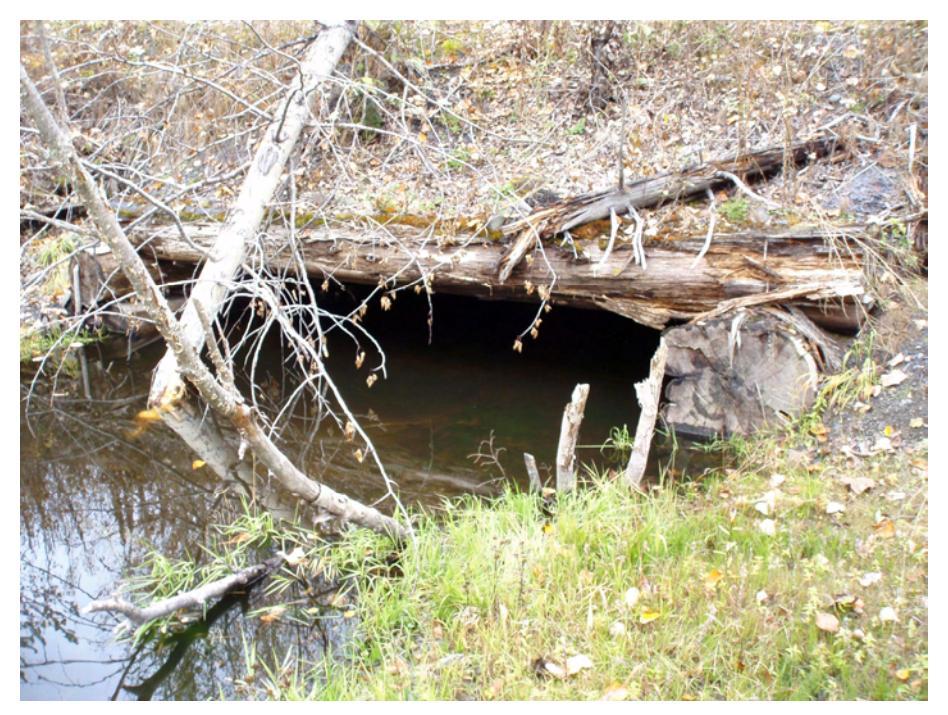
There are large beaver ponds on both sides of this crossing, which is an old wood box culvert ~4m wide. There appears to be clear passage through this culvert. There are recent trees felled by beavers onto the culvert, which could be the start of the culvert being dammed again. This crossing was not assessed by Rabnett and Wilson (2007) but the stream was mapped as fish-bearing (Williams, 2006).

Photo 34: Site 38. Looking at upstream side of culvert with new beaver felled tree resting on wood box culvert.

➢ Recommend checking this site periodically throughout the fall to see if culvert becomes blocked with beaver debris.

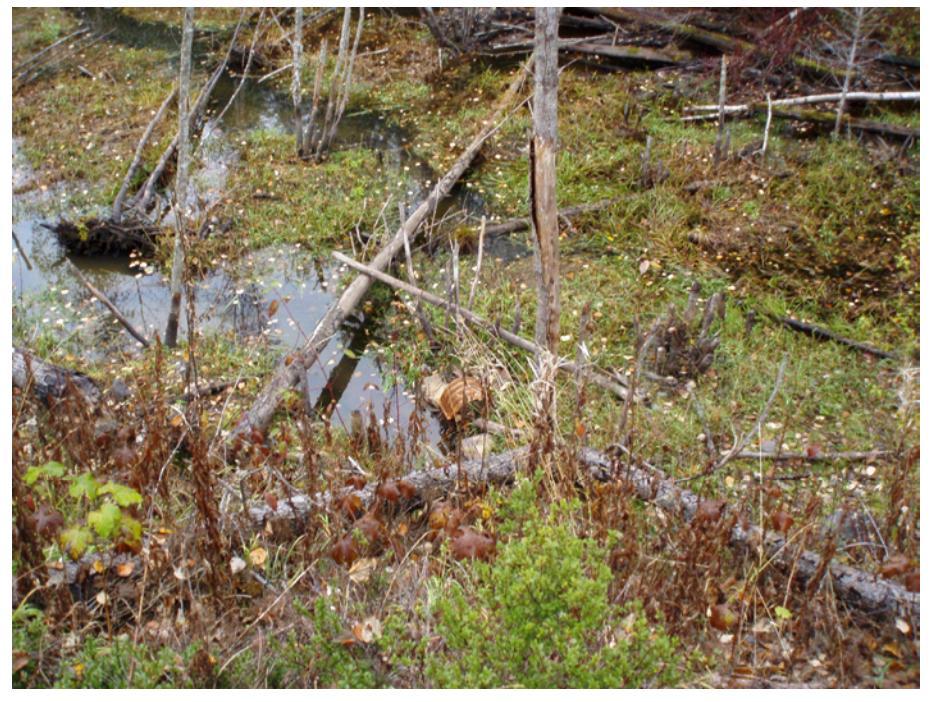
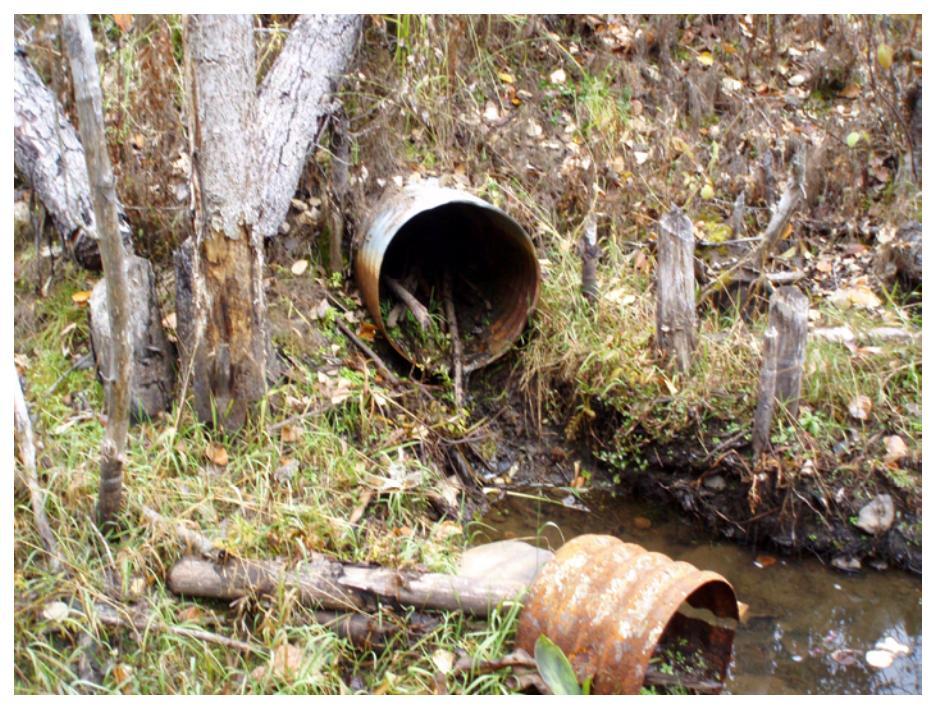
trees on the downstream side are evidence that this side has been ponded by beavers in the past as well. The culvert is mostly full of beaver debris. Rabnett and Wilson (2007) inferred fish presence at this crossing.

Photo 35: Site 46. Looking at downstream side of crossing. Note dead standing trees of evidence of past flooding.

Photo 36: Site 46. Looking at downstream end of culvert with beaver debris in it.
