**Annual Compendium Of WRP Aquatic Rehabilitation
Projects For The Watershed Restoration Program
1997 - 1998**

**Watershed Restoration Project Report No. 8
1998**

Re-establishing Flows to the Lower 2 km of Thurston Creek

King Creek Groundwater Side Channel - Rearing Habitat Development

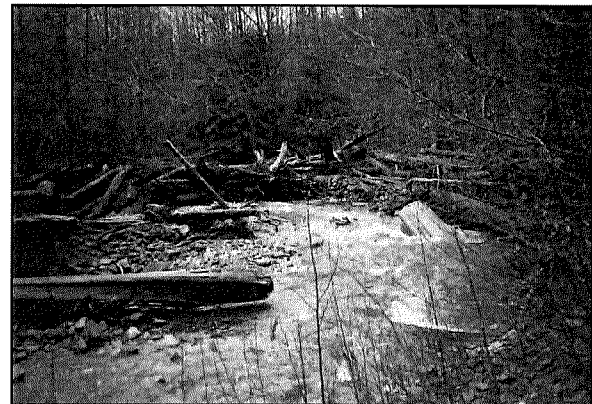
from the estuary. One or several debris torrents triggered by intense rainstorms in either 1978 or 1987 carried a large volume of sediment and logs downstream to the point of diversion. Thurston Creek jumped out of its channel into an adjacent cutblock where it joined a small non-productive creek (North Creek) which drains to the ocean on the north side of Talunkwan Island. North Creek is inaccessible to anadromous fish due to a cascade/falls at its mouth. The result of this diversion is that the water quantity for lower Thurston Creek has been substantially reduced for the past 10 to 20 years. Fortunately, small tributaries joining lower Thurston Creek were maintaining some marginal flows and fish habitat in Reach 1 of the creek. Remnant populations of chum, coho, pink, cutthroat, and Dolly Varden are presently utilizing Reach 1 of Thurston Creek.

Figure 6-2. The site of the Thurston Creek diversion (upper limit of Reach 2). Note age of riparian growth on the debris plug indicates the age of diversion to be approximately 10 to 20 years old.

- Construct a guide bank that would close off the blowout channel to North Creek and direct the flows back into Reach 2 of Thurston Creek.
- Excavate a 150 m long channel through the debris jam located at the diversion site at the top end of Reach 2.
- Rehabilitate the fish habitat in the excavated channel by developing riffles and installing LWD.

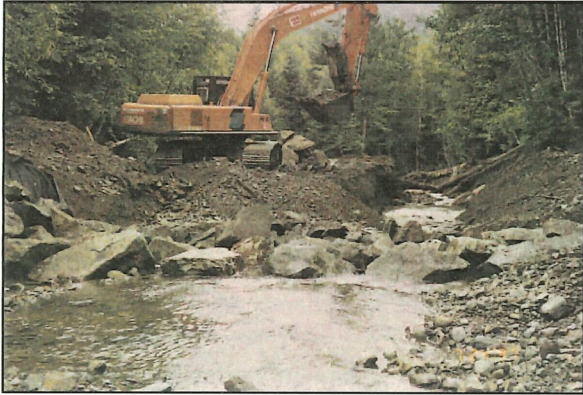
Figure 6-3. Latter stages of removing tormented material at the site of the diversion. This stage of work reconnected upper Thurston Creek with lower Thurston Creek after 10 to 20 years of de-watering.

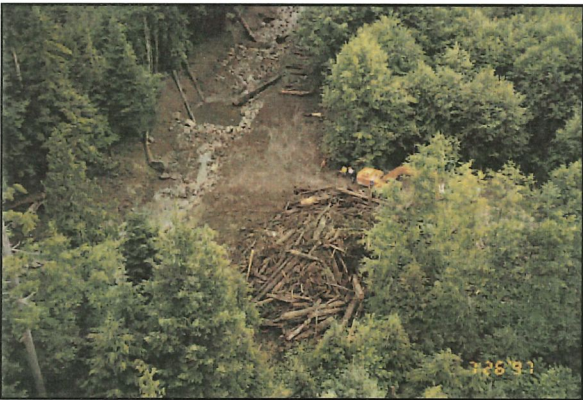
Figure 6-4. Stockpile of tormented material removed from the diversion at Thurston Creek.

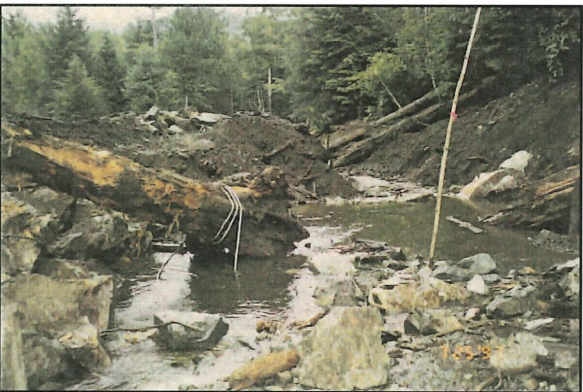
Figure 6-5. Initial placement of LWD in a partially constructed channel prior to reconnecting stream flows on Thurston Creek.

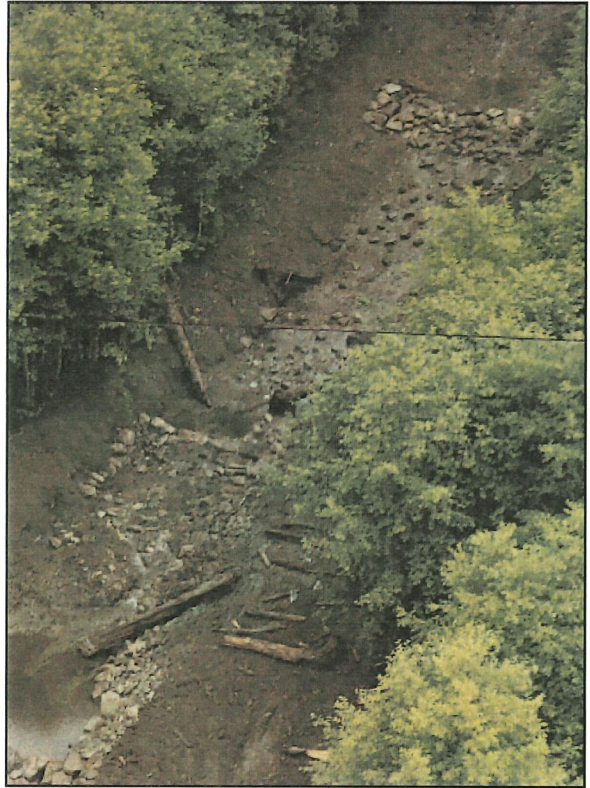
Figure 6-6. New channel reconnecting upper Thurston Creek and lower Thurston Creek (prior to reconnecting water).

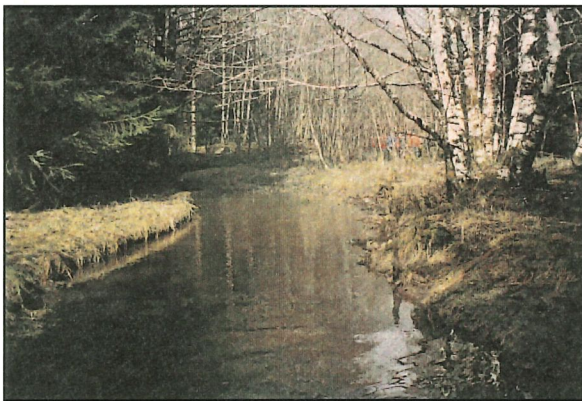
Figure 6-8. Natural entrance off of King Creek mainstem into "blind" side channel.

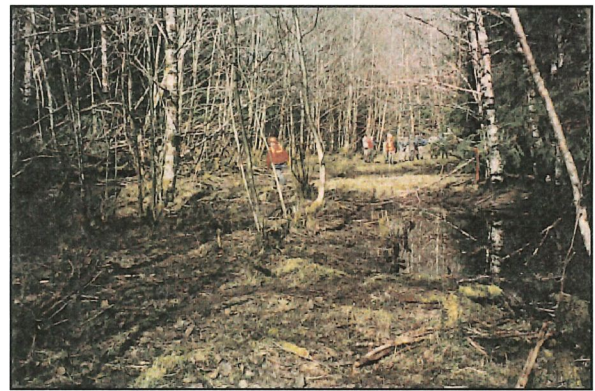
Figure 6-9. Lower end of "blind" side channel off of King Creek prior to developing groundwater sources.

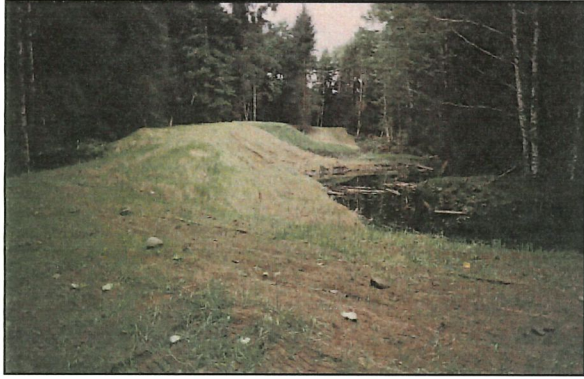
Figure 6-10. King Creek blind side channel after developing groundwater for rearing habitat.

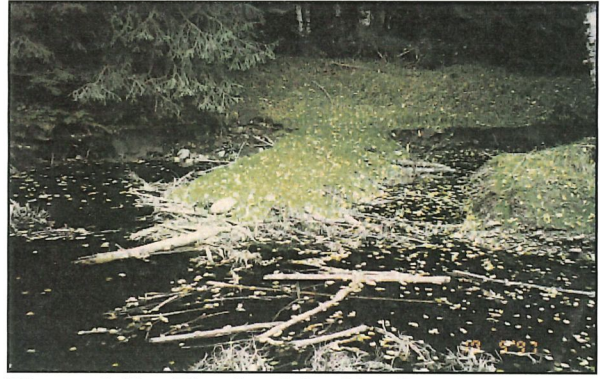
Figure 6-13. Floating island/reef constructed to increase both cover and benthic invertebrate food production.

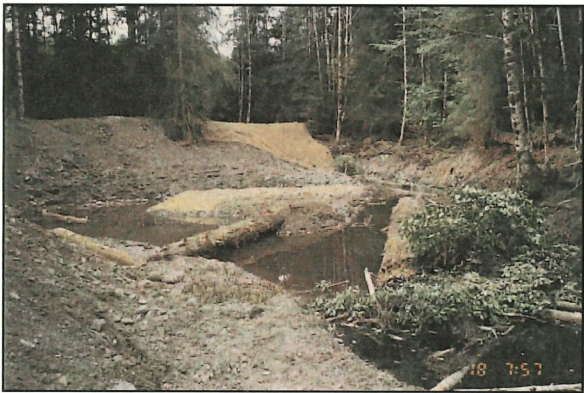
Figure 6-11. Upper end of King Creek "blind" side channel prior to laying of erosion control matting. Note construction of island to increase the irregularity of the channel margin.

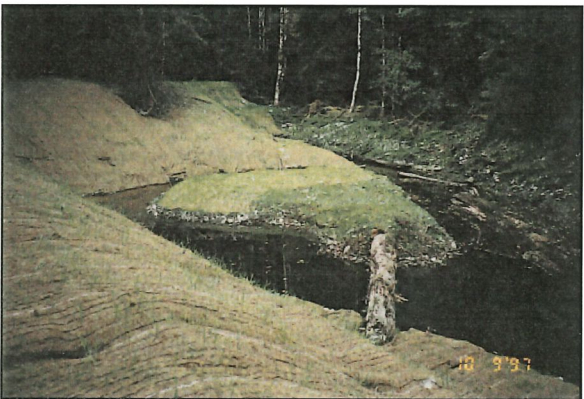
Figure 6-12. Upper end of King Creek "blind" side channel after placement of erosion control matting and grass seeding.
