Copper River Watershed Restoration

2001-02 Constructed Works

Site 77 Outlet Channel 3 Km Ponds

Final Report: March, 2002

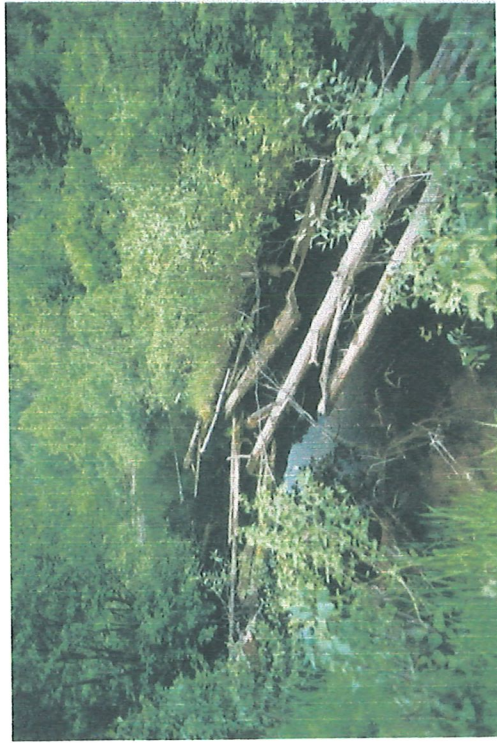
Photo 1. July 1999. Looking upstream into the pond from photo point 5. Prime rearing habitat during summer and good overwintering habitat.

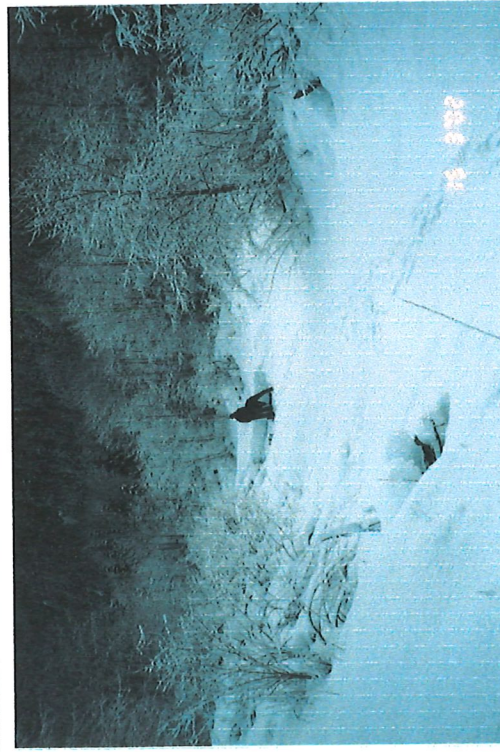
Photo 2. March, 2002. Looking upstream from photo point 5 at frozen pond. Coho captured in minnow traps and good dissolved oxygen levels.

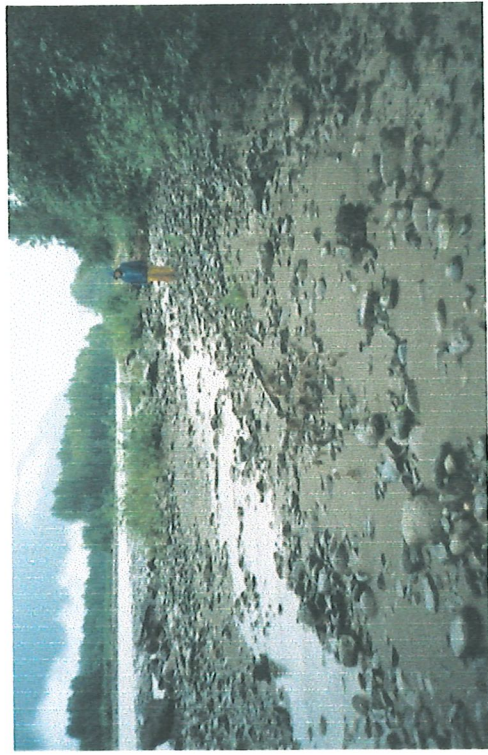
Photo 3. July 1999. Looking upstream from photo point 4 gravel bar downstream from the culvert. Person is standing at future corner in new channel.

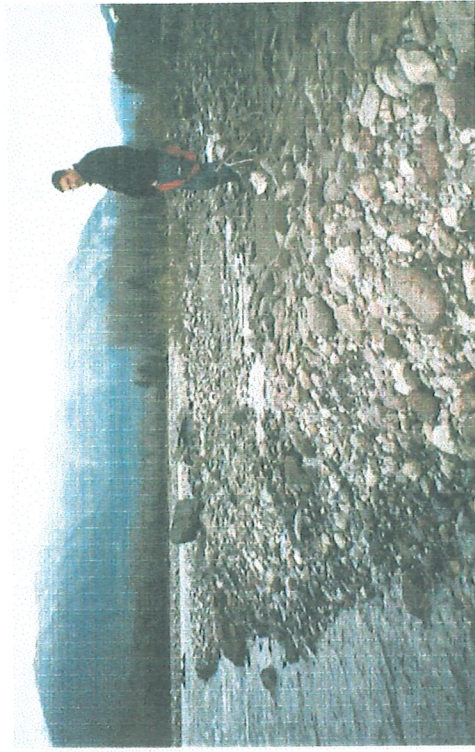
The pond at Site 77 is located at 28 km on the Copper River Mainline. The site is an isolated flood channel of the river, approximately 160 m in length and 6 m wide. A small tributary, 0.3 m in width, feeds water into the upstream end of the pond. Water exits the pond via a narrow channel adjacent to the logging road that is approximately 10 m in length with 10% gradient. The narrow channel carries water into the 1500 mm diameter culvert which was installed in August of 1999 under the Copper River Mainline. The water exits the culvert on the north side and flows into the Copper River 40 m downstream. Prior to construction of the outlet channel, the stream dispersed across 40 m of unvegetated cobble bar and dropped down the steep face of the bar (1 m in height) into the Copper River during low flows. When the river levels were moderate during spring and fall flooding the bar was inundated and the water exiting the culvert entered the river within 15m of the culvert. The problem for fish which exit the culvert is the dispersed flow would trap emigrating fish amongst the cobble on the bar. Another problem was the lack of defined channel and steep obstruction along the edge of the bar which fry could not ascend from the river during low flows.

Photo 4. October 1999. Looking at the confluence of outflow creek from Site 77 and Copper River. Note drop into the Copper River, obstruction for fry.

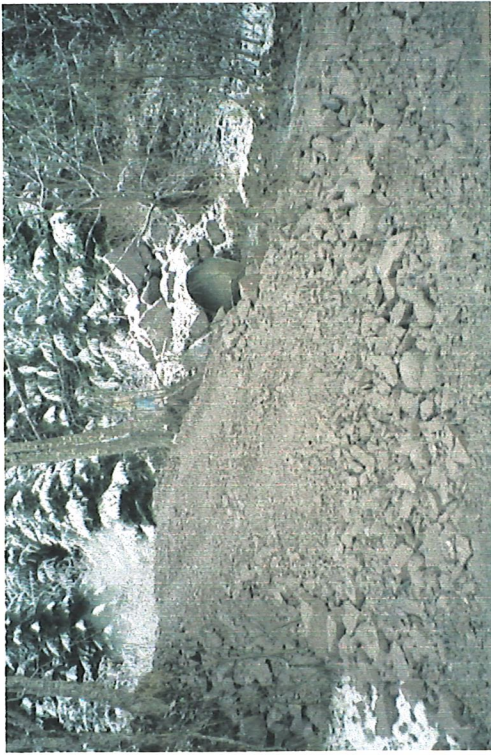
To provide access to the floodplain on the north side of the road, a 10 m long ramp and tote trail was constructed from the road so a machine could excavate the channel and place riprap (see as-built sketch in Appendix 2). This road was partially removed after construction and the ramp was left to allow future access for site maintenance. The ramp also provides protection for the east side of the channel when the Copper River inundates the surrounding gravel bars.

Photo 5. November 2001. Ramp for access to floodplain from the Copper River Mainline. Culvert and channel at right of photo. photo point 2.

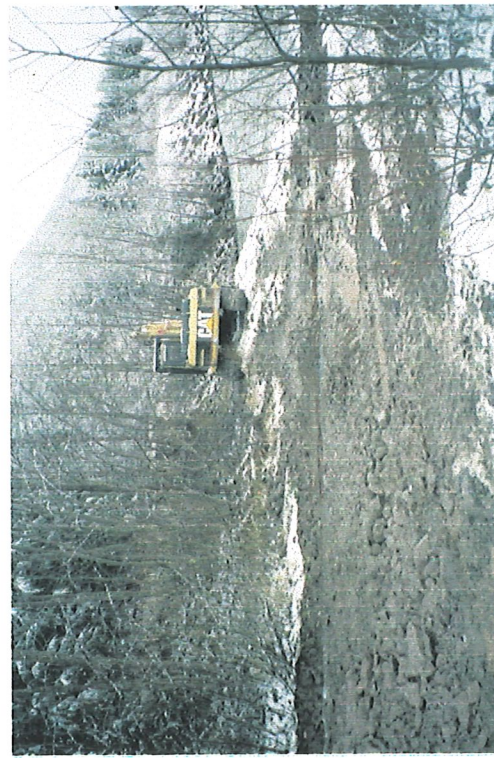
Photo 6. November 2001. Looking across gravel bar at outlet channel prior to excavation. Photo point 2.

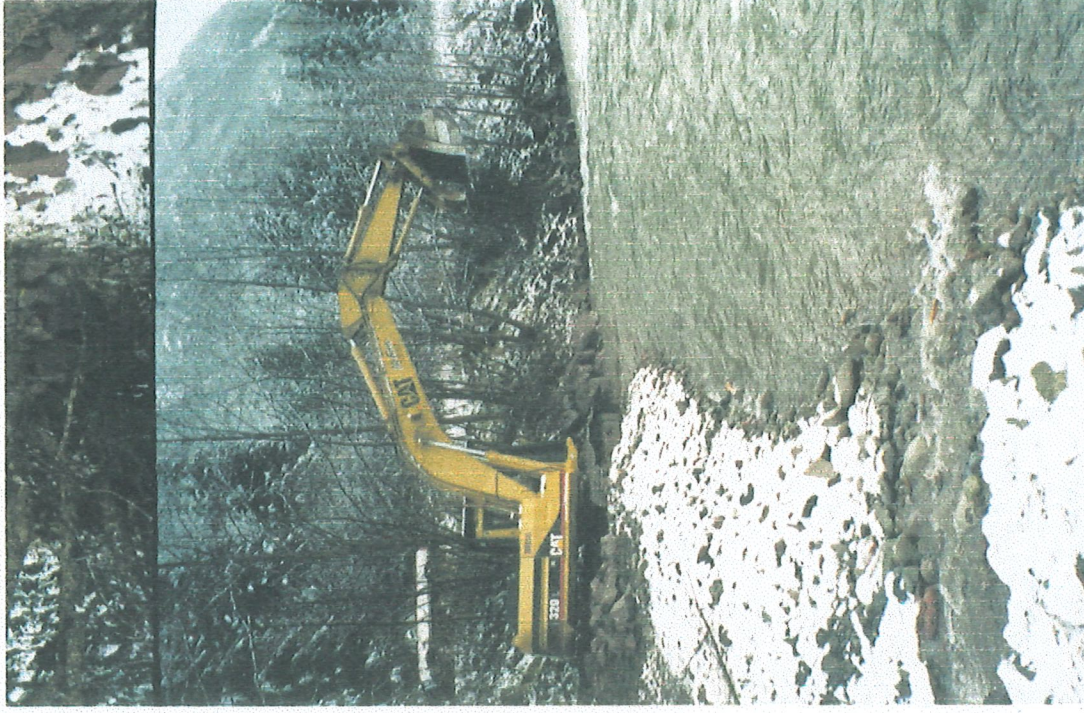
Photo 7. November 2001. Looking downstream along the Copper River at the excavator placing rip rap along the toe of the road. The old outlet channel is in the foreground.

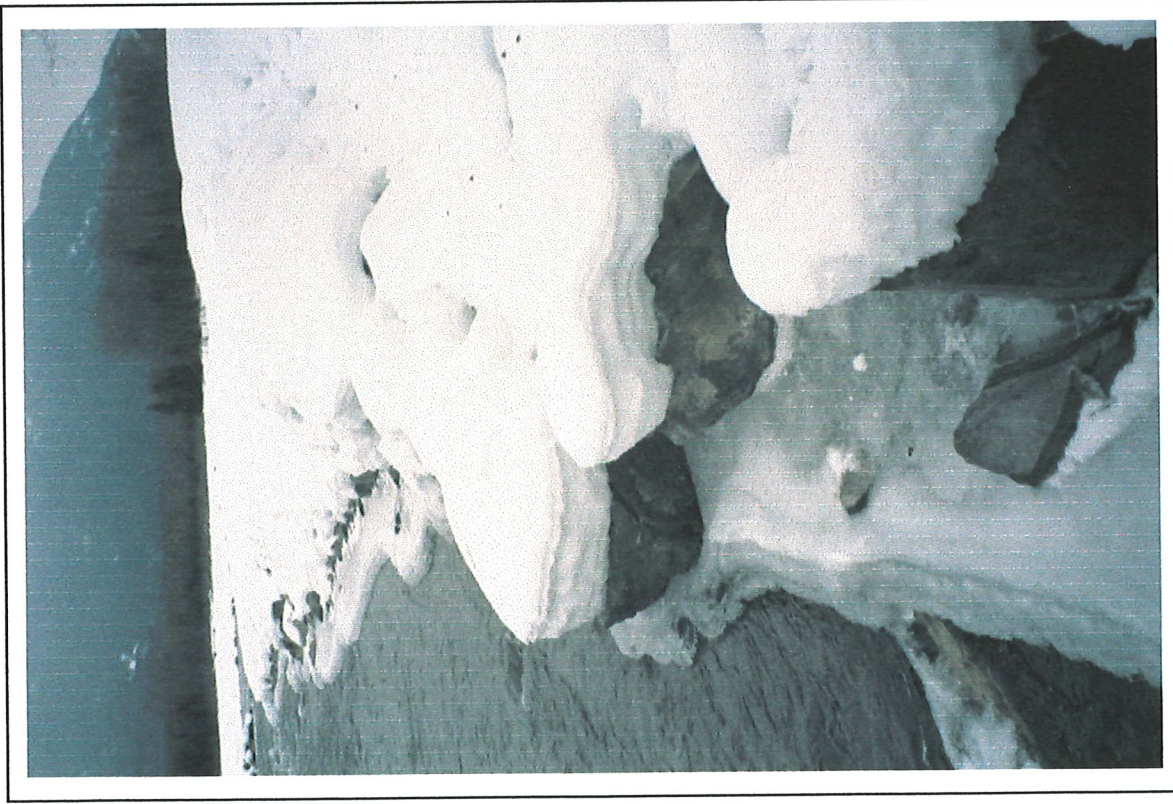
Photo 8. March 2002. Looking upstream at the confluence of the outlet channel with the Copper River from photo point 1. Note channel on right.

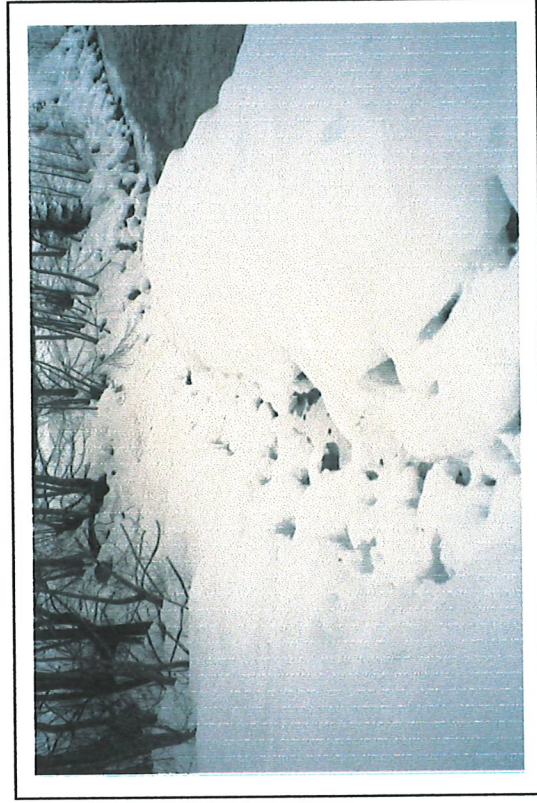
Photo 9. March 2002. Looking downstream on the outlet channel toward the confluence from photo point 2.

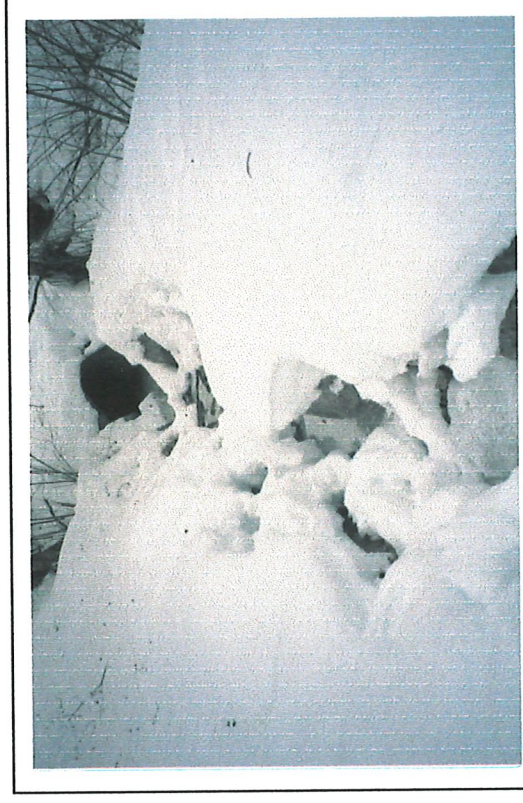
Photo 10. March 2002. Looking upstream along the outlet channel to the culvert installed in 1999 from photo point 2.

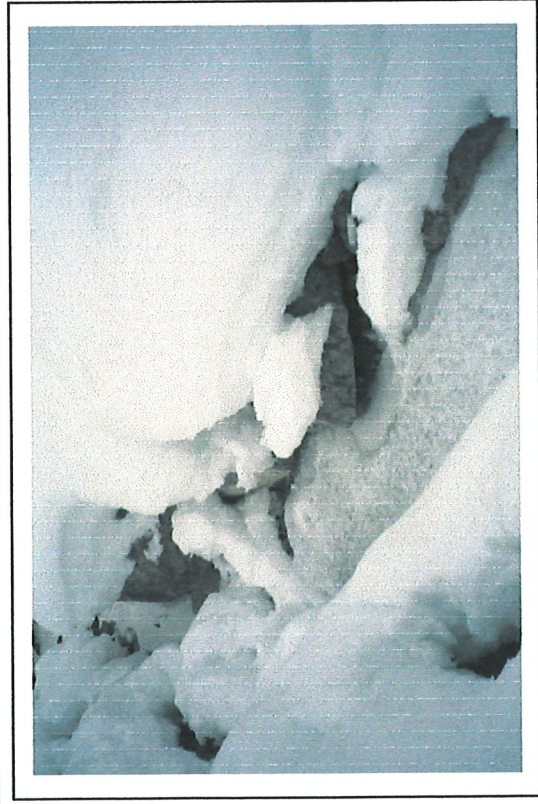
Photo 11. March 2002. Looking downstream from the culvert from photo point 3 to photo point 2.

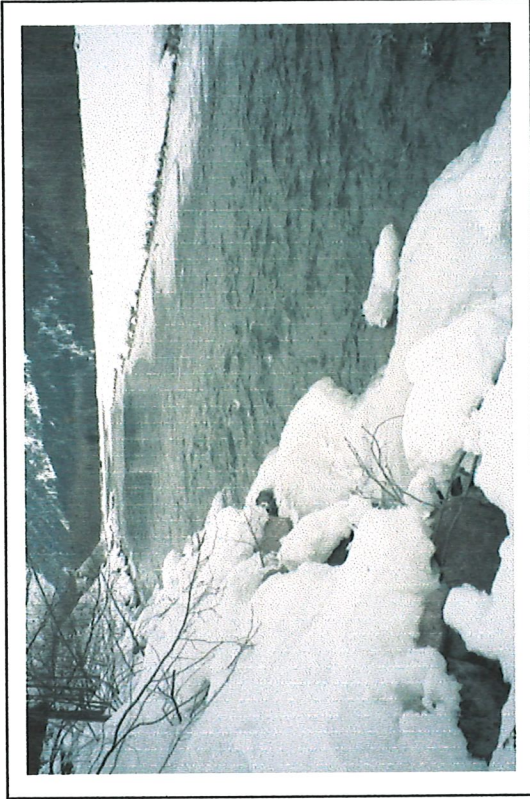
Photo 12. Looking downstream from the confluence of the outlet channel at additional bank protection installed as part of this project. Photo point 1.

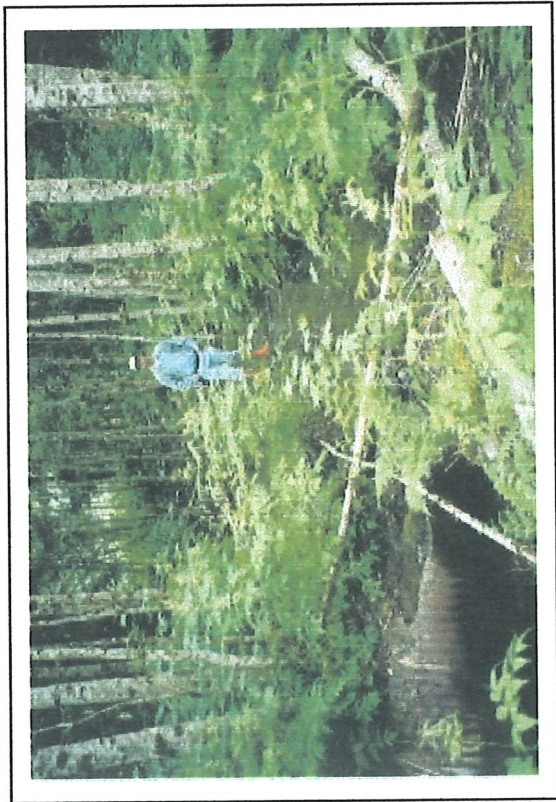
Photo 13. Summer 1999. Middle section of channel before construction with blocked culvert (foreground) which diverted flow down spur road.

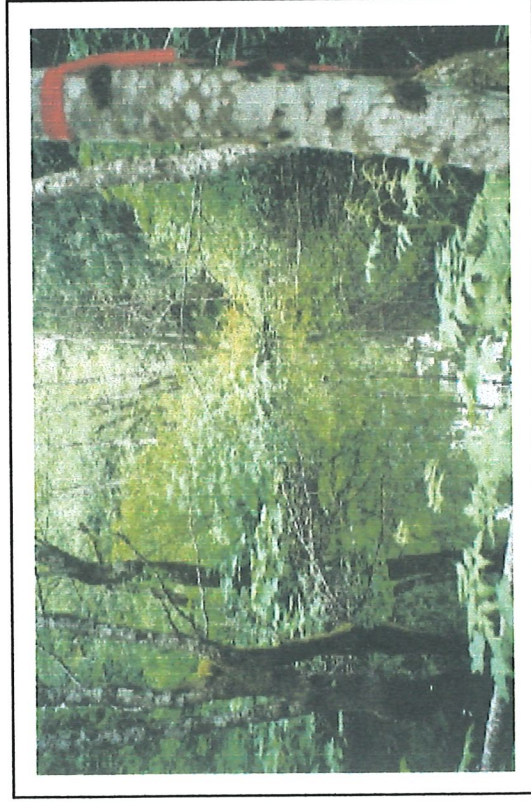
Photo 14. Summer 1999. Upper 100 m of ephemeral channel. Pooled water was due to blocked culvert was diverted down old spur road.

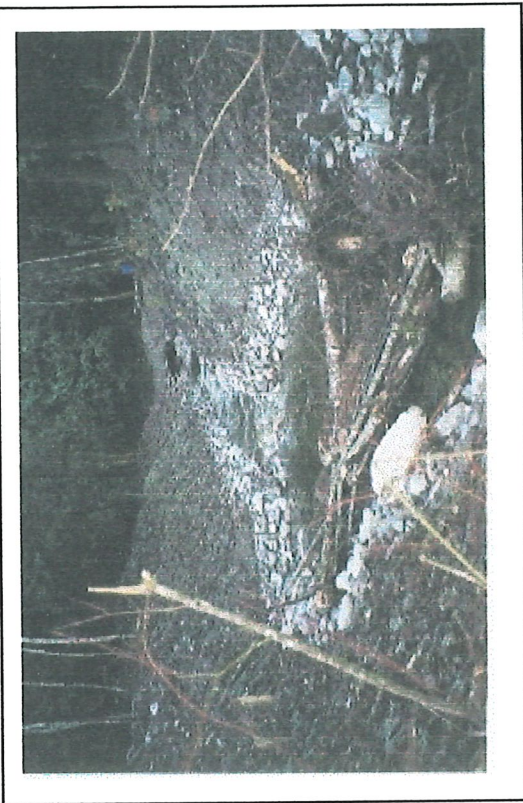
Photo 15. September 2000. Lower section of off-channel after phase 1 of excavation and complexing, looking upstream. Coho spawned immediately upstream of the pool in foreground.

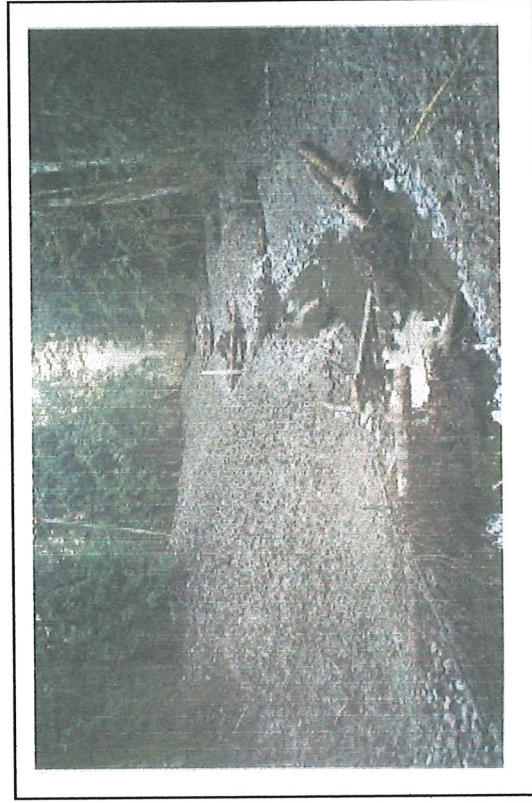
recommended by the author in September 2001 to prevent undercutting by flows and erosion of the banks. High fall flows in the 3 km channel, up to 0.8 m deep, were observed by the author in October 2000 and the cobble, placed in fall 2000 along sections of the channel, prevented erosion of the channel.

Photo 16. September 2000. Upper section of off-channel after phase 1 of excavation and complexing. Note cobble armoring along edges of channel which prevented flood damage in October.

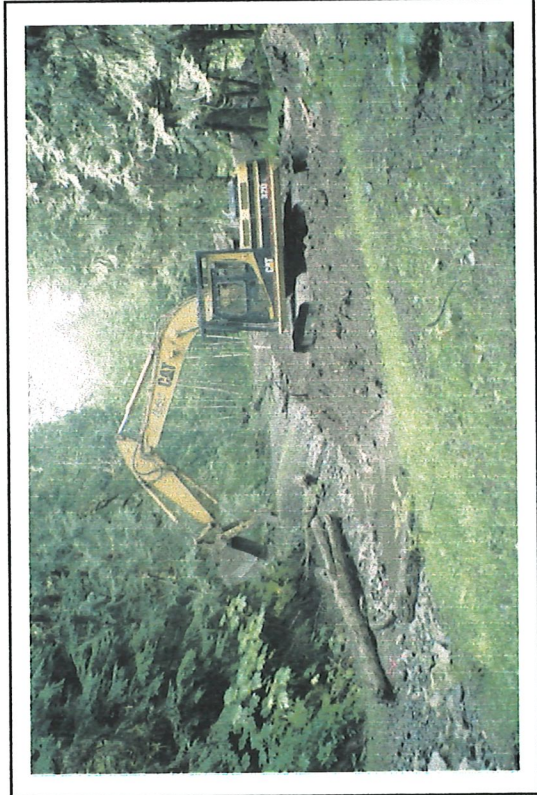
Photo 17. August 2001. 320 Caterpillar Excavator digging the head pond (Pond 1).

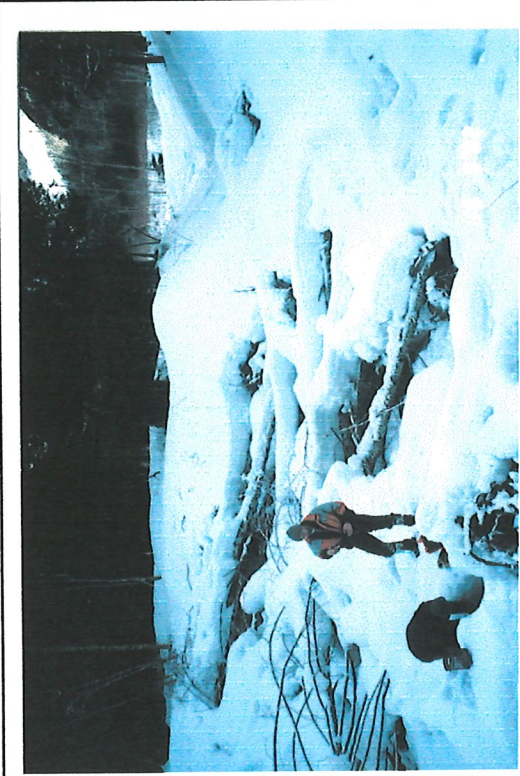
Photo 19. Looking downstream at constructed Pond 4 (alcove pond)

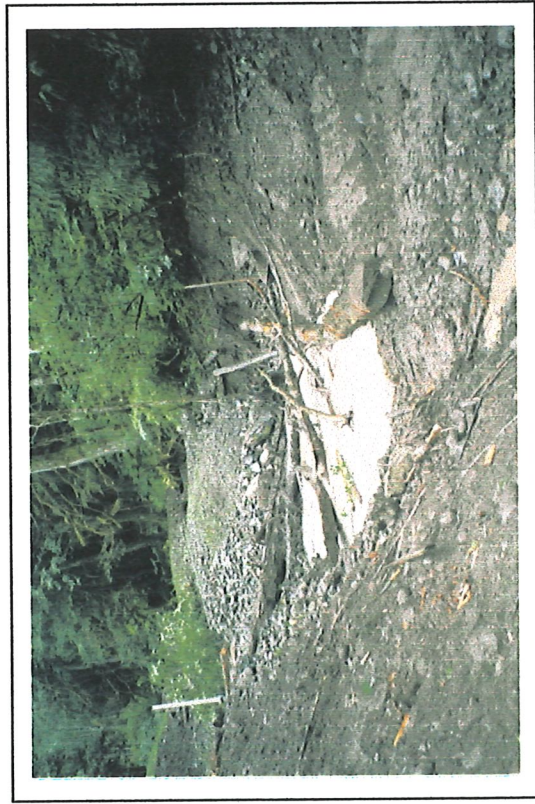
Photo 18. August 2001. Pond 3 after construction. Pond was isolated until the sediment settled out.

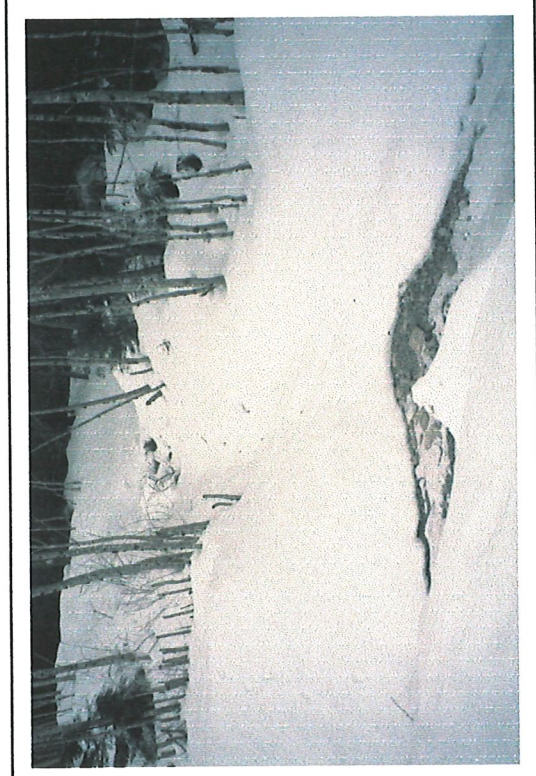
Photo 20. Looking upstream into the channel from Site 9. Location of cobble armouring to protect outlet from erosion.

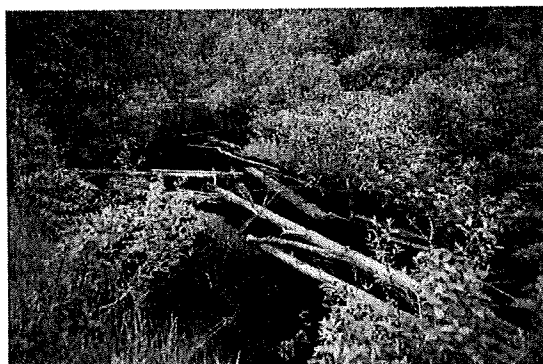
Figure 1. Isolated off-channel slough located upstream of culverts at Site 77.

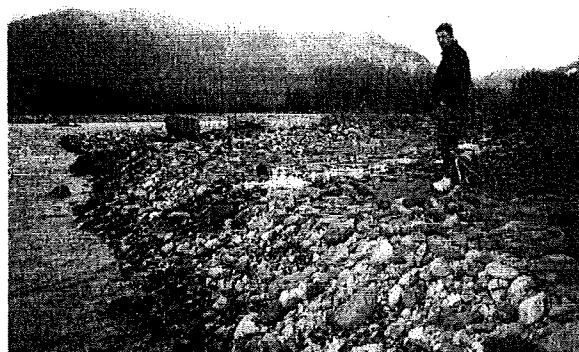
Phase 1 of the project involved replacement of two perched culverts in 1999 which enabled fish to access the pond. The outflow from the pond dispersed across a 50 m wide gravel bar before entering the river. Fry could not access the culvert at low flows due to the dispersed flow through cobble on the bar and lack of defined channel (obstruction to fish access).

Figure 2. Gravel bar with dispersed flow prior to construction of access channel across bar.

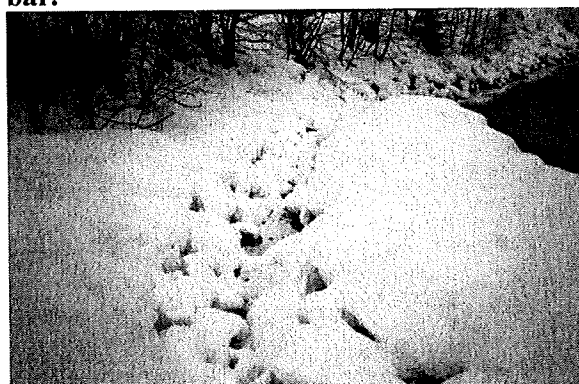
Figure 3. Constructed access channel in March 2002. Downstream view of lower 25 m and confluence with Copper River (right).
