## **Skeena Region**

# ZYMOETZ RIVER CULVERT REPLACEMENT (SITE 77)

Zymoetz (Copper) River

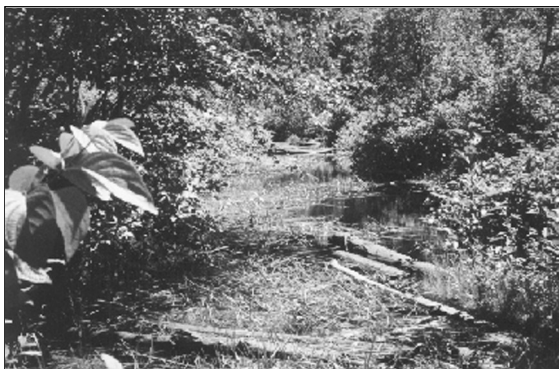
The slough at Site 77 is an isolated relic flood channel of the river, 200 m length and 7 m wide, located against the hillside and isolated from the river by the mainline road (Fig. 6-36). A small tributary and groundwater seepage maintains water levels in the slough.

Figure 6-36. Isolated off-channel slough located upstream of perched culverts at 28 km.

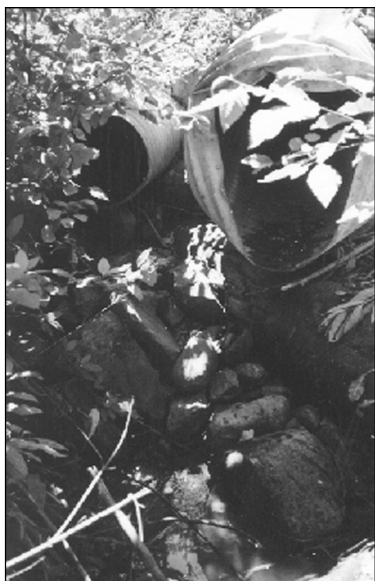
The problem consisted of two culverts, perched 50 cm above the floodplain on the upstream and downstream ends, which were accessible to juvenile fish only when backwatered during river high flows (Fig. 6-37). Hundreds

of juvenile coho were observed holding in the slack water below the culvert outfall during high runoff with no access to the off-channel habitat. Minnow trapping in the slough captured several coho smolts (160 to 180 mm in length) which were likely 3 years old and not able to exit the slough due to dispersed flow through the roadbed and perched culvert inlet. In addition to the metal culverts, an obstructed wooden box culvert was found during excavation, which dispersed water into the roadbed and prevented fish movement.

Figure 6-37. Outlet of two culverts perched 50 cm above the bed and only accessible at high flood river flows (inlet to left culvert buried).

In August of 1999, we replaced the two perched culverts with a 1500 mm culvert that ensured up and downstream fish passage and removed the box culvert to maintain adequate water depth in the slough upstream (Figs. 6-38, 6-39).

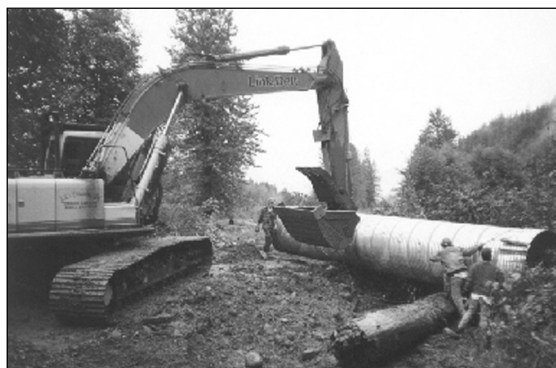
Figure 6-38. Installation of new 1500 mm culvert.

The two 40 ft culverts were removed with an excavator working from the road. The roadbed was excavated an additional three feet lower to accommodate the 1500 mm baffled culvert (55 feet in length). The new pipe was installed at 1% slope and clean gravel and riprap armoring was placed around the inlet and outlets. Beaver grating will be installed.

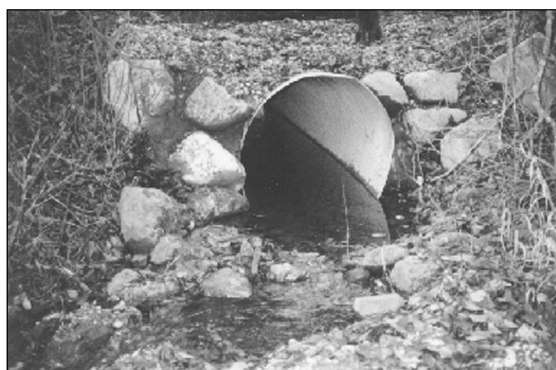
Figure 6-39. The new culvert provides upstream access to off-channel habitat and enables downstream migration of smolts.
