**Enumeration of Adult Steelhead in the
Upper Sustut River 1998
Appendix Report 1
Fence Modifications**

Skeena Fisheries Report SK 121

March 1999

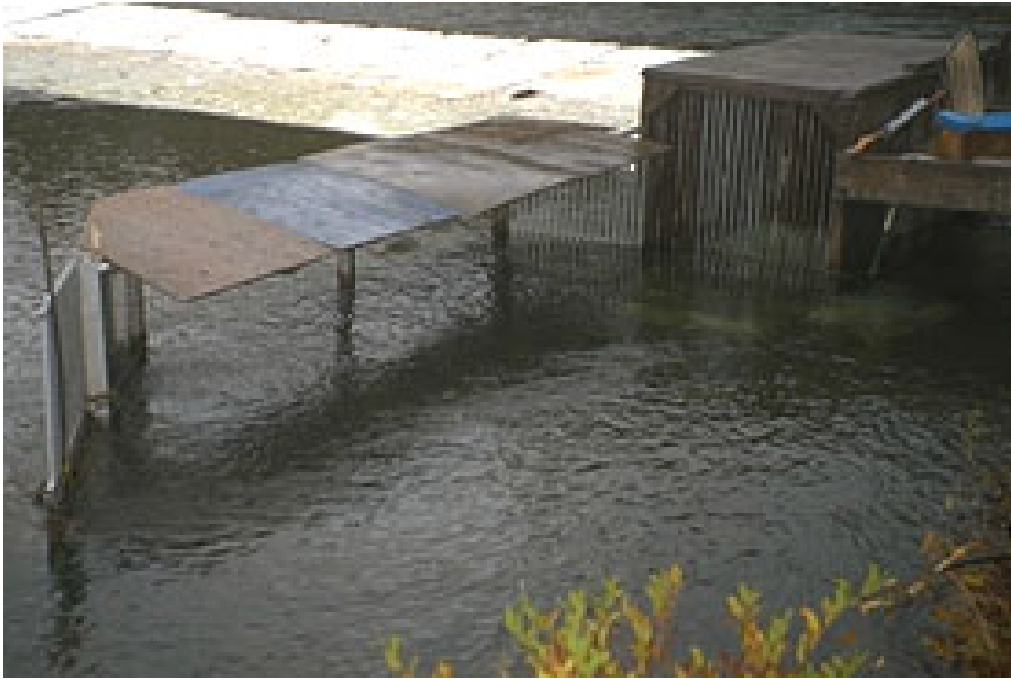
Several modifications to the fence trap box and holding area were made in 1998 to reduce repeat downstream swimming behaviour of handled fish. It can be assumed that for most fish entering the fence trap-box, the objective is to continue to migrate upstream after passing the fence. Fence personnel have observed that handled fish tend to look for holding areas to rest in before continuing migration. On the upstream side of the fence there is very little effective cover for at least 200 meters. Fish handled at the fence have three options: a) to hold under the trap deck or in front of the trap box, b) to swim upstream to look for cover c) to swim downstream to the deep pool below the fence. Prior to 1998, most fish chose to swim upstream or downstream. Fish swimming downstream most often became stranded on the fence and had to be rescued. Fish repeating this behaviour three times were released downstream to recover. For the 1998 field season, a covered holding area was constructed in the deeper water immediately in front of the trap box (Photo Figure 1). In 1997, over ten percent of the steelhead released upstream of the fence had to be

Photo Figure 1. View of holding area and the front of the trap box look downstream from the right bank.

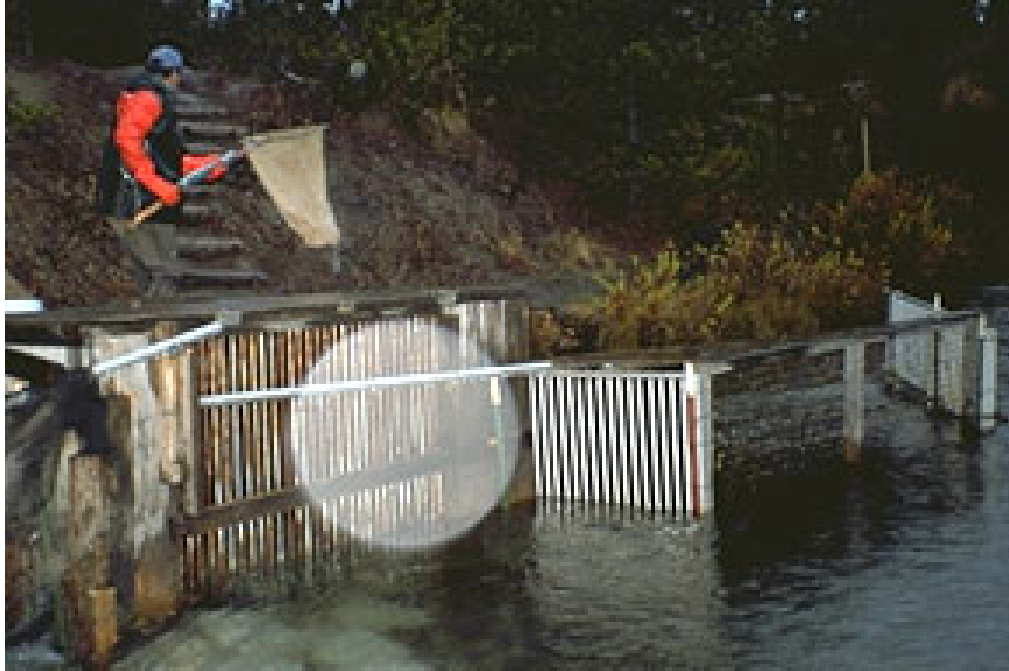
rescued and approximately five percent had to be released downstream. In 1998 after constructing a covered holding area only three steelhead had to be released downstream. The main holding area in front of the trap box was constructed around a scour depression in the streambed immediately in front of the trap box. In previous years a section of the old upper Sustut fence was used as a lead in front of the trap box. For 1998, a 1.2 m x 1.5 m section of aluminum panelling from Babine River fence was used to extend the width of the holding area toward the river left bank (Photo Figure 2). A set of 0.6 m x 1.2 m wide panels from the Babine fence was added to the upstream end of the lead and angled toward the river right bank (Photo Figure 1). To support a plywood cover for shade, an aluminum pole was fastened to the trap box and to the top of the angled panels (Photo Figure 2).

Photo Figure 2. View of the downstream end of holding area and left side of the trap box looking upstream towards the right bank. Note the 1.2-m wide aluminum panel in the center of the photo.

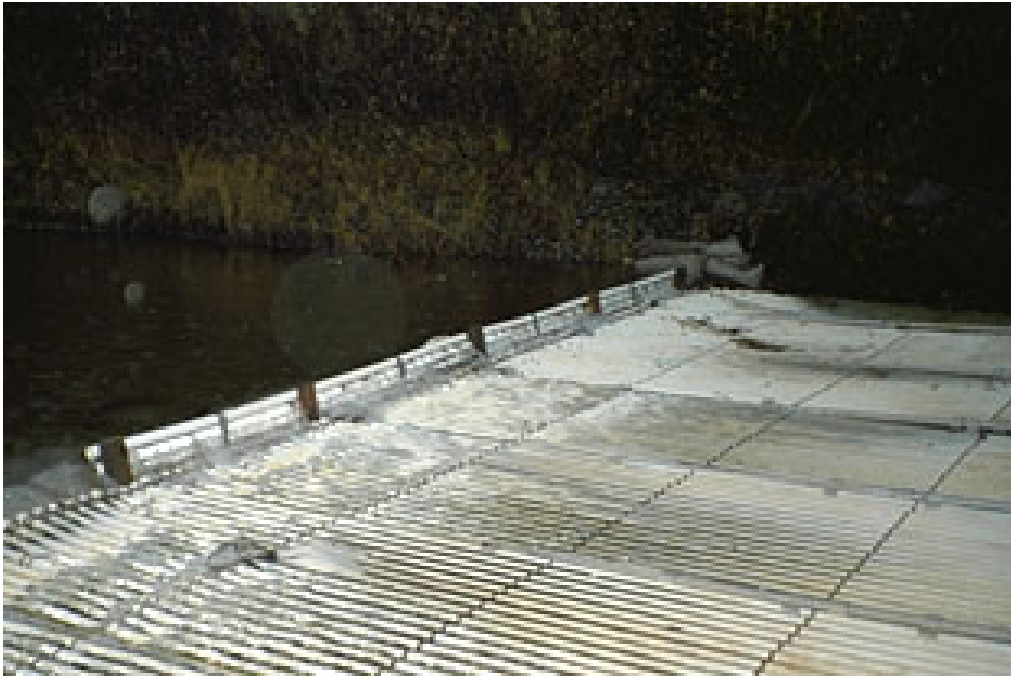
Seven out of ten steelhead mortalities at Sustut fence in 1997 were healthy fish that became stranded overnight on the river left side of the fence in low water (Williamson 1998). Williamson, recommended that a baffle-like device should be installed on the upstream leading edge of the fence in low water to prevent these mortalities. During the field season in 1998 fence personnel built and installed a baffle on the river left side of the fence (Photo Figure 3). There were no mortalities of healthy steelhead observed after installation of the baffle. The baffle was constructed from three 20 foot sections of 3.8 cm diameter PVC pipe that was attached to five approximately 40 cm lengths of 2" x 4" lumber. The pipe was attached using 2 inch hose clamps that were screwed on to the 2" x 4" with wood screws (Photo Figure 4). Duct tape was used to tape the pipes together between the 2" x 4"s for added strength. The 2" x 4" supports were wedged on end between the upstream edge of the fence panels and the steel railway rail on the streambed. The baffle was placed flush against the fence panels and sandbags were placed to block any gaps. One section of baffle was sufficient to prevent strandings in 1998; however, another section may be needed if the river falls to the levels recorded in 1997.

Photo Figure 3. View of low water baffle system. Note the lack of water on top of the panels.

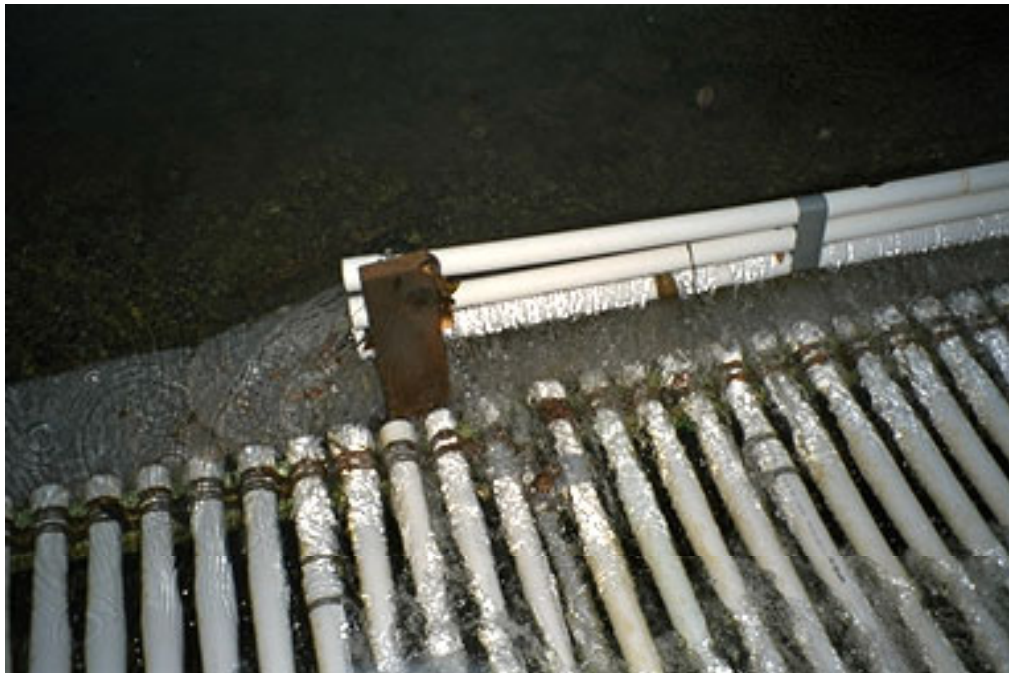
Photo Figure 4. Close-up, showing the baffle raised up off the panel. Note the 2x4 wood and the duct tape holding the P.V.C. pipes together.

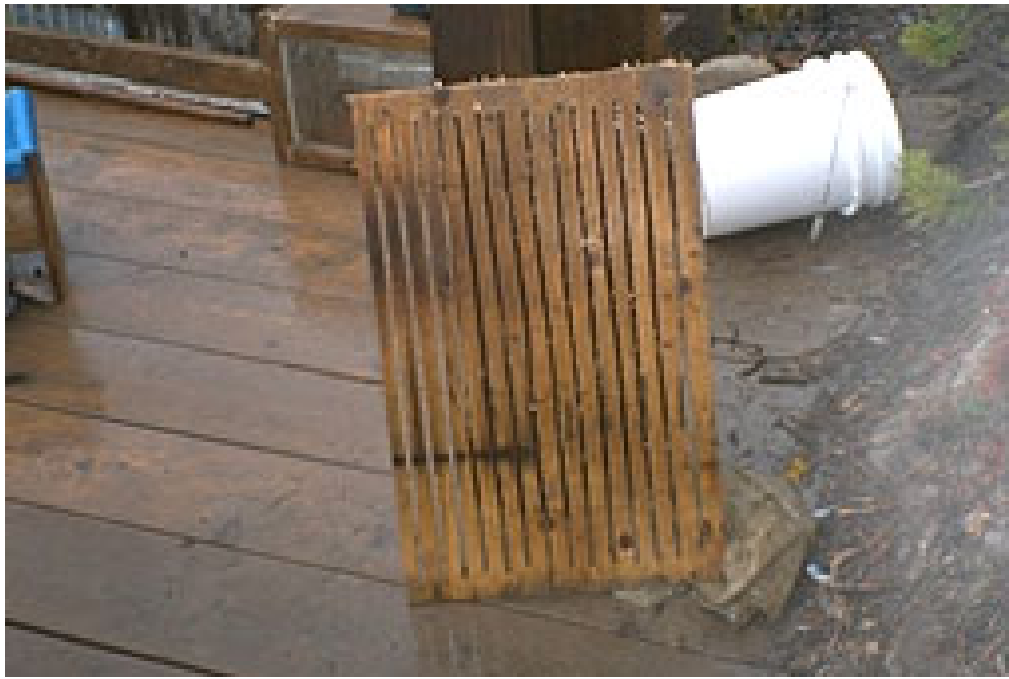
During operation of the fence in 1997 and 1998 eleven bull trout died in the Sustut fence trap box. Most of these fish would enter the trap box in the late evening and after dark. Mortalities would occur presumably because the fish would tire and slide backwards (downstream) and become 'gilled' in between the dowels in the rear of the trap box. The dowels form a 'vee' shaped opening into the trap box and are designed to prevent the escape of fish migrating into the box once they are in the box. A set of two plywood panels with 6-mm wide vertical slots were used to cover the upstream side of the dowels while allowing the passage of fish upstream into the box (Photo Figure 5). Further evaluation

Photo Figure 5. Slotted plywood panel.

of the effectiveness of the panels must be undertaken in future years. In 1998 the plywood panels were only used for the last four days of fence operation.

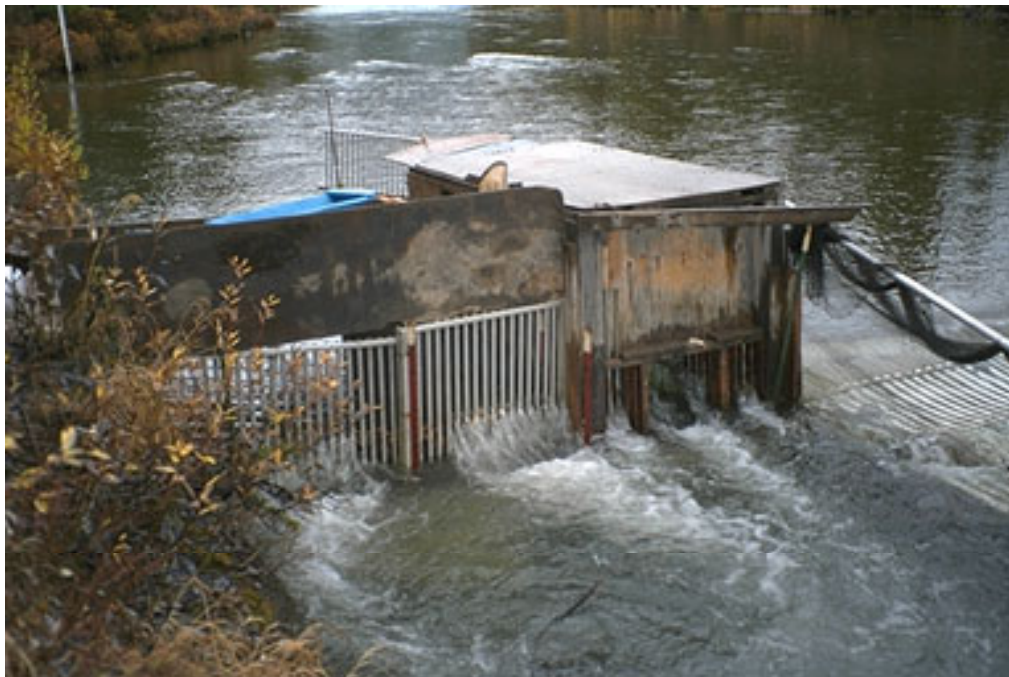
3. A piece of plywood was used to extend the height of the panels between the trap box and the right bank. Fish frequently attempted to jump over the panels. Without the plywood extension they would have easily escaped upstream uncounted (Photo Figure 6). On several occasions after installation of the board, sockeye and steelhead were observed attempting unsuccessfully to jump over the panels.

Photo Figure 6. View of downstream end of the fence trap box showing aluminum panels between the trap box and the right bank.

1. Personnel operating the fence in 1996 recommended replacement of the 2x4 and chicken wire panels used to block fish passage between the trap box and the right bank. The chicken wire panels were difficult to clean and often injured fish. In 1997, the chicken wire panels were replaced with aluminum panels (Photo Figure 6). Debris was more easily removed and fish that came into contact with the panels were less likely to be injured.

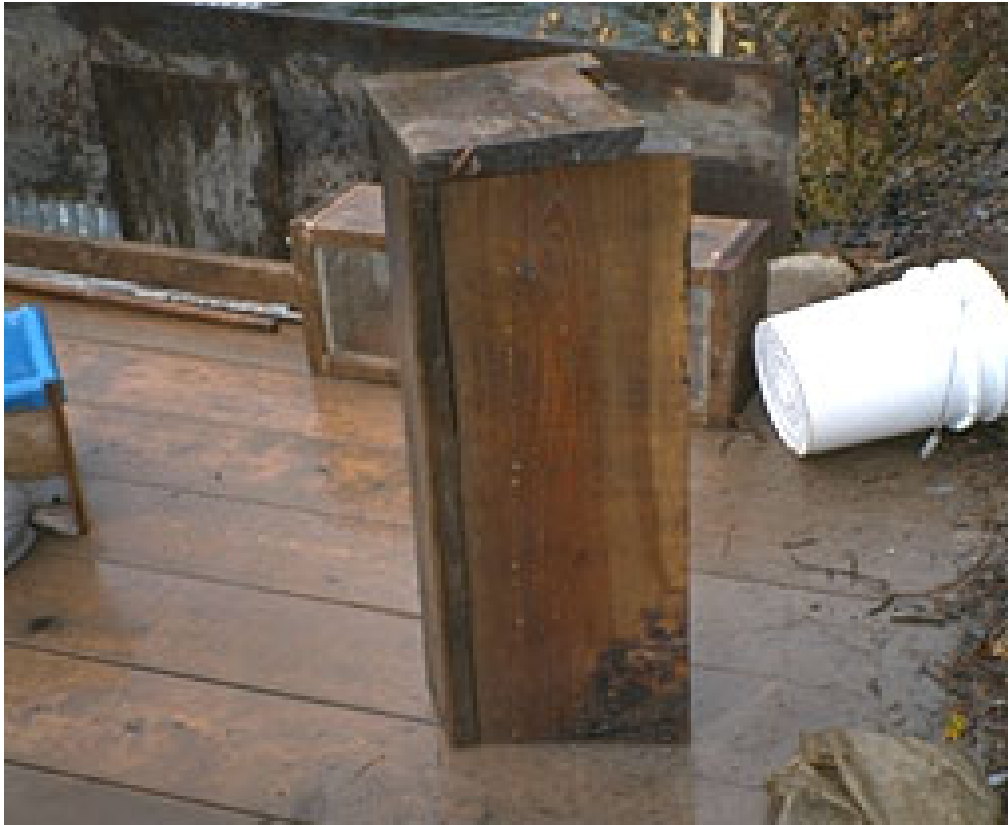
4. Metal doweling was originally used to block the 'vee' entrance of the trap box to prevent fish from escaping while they are being netted out of the box. Typically three or four dowels were used to block passage. Placing the dowels was cumbersome, especially in high turbid water and fish often escaped downstream. In 1997, a shroud was built that could be used to block the trap box entrance rapidly in one motion while minimising downstream escapees (Photo Figure 7).

Photo Figure 7. View of trap box shroud sitting on top of the fence work deck.
Note the acrylic bottomed viewing box behind the shroud.

5. During rain events, run-off from the Omenica Mining Access Road enters the Sustut River. The increased turbidity of the river during these periods prevents visual observation of fish captured in the trap box. Fish in the trap box often have to be netted out in order to facilitate correct species identification. To reduce stress on the fish caused by handling in nets, an acrylic bottomed viewing box was constructed in 1997 to help fence personnel identify fish in turbid water (Photo Figures 7, 9). The box was made from a 2" x 12" lumber frame with a 3-mm thick acrylic plastic bottom.

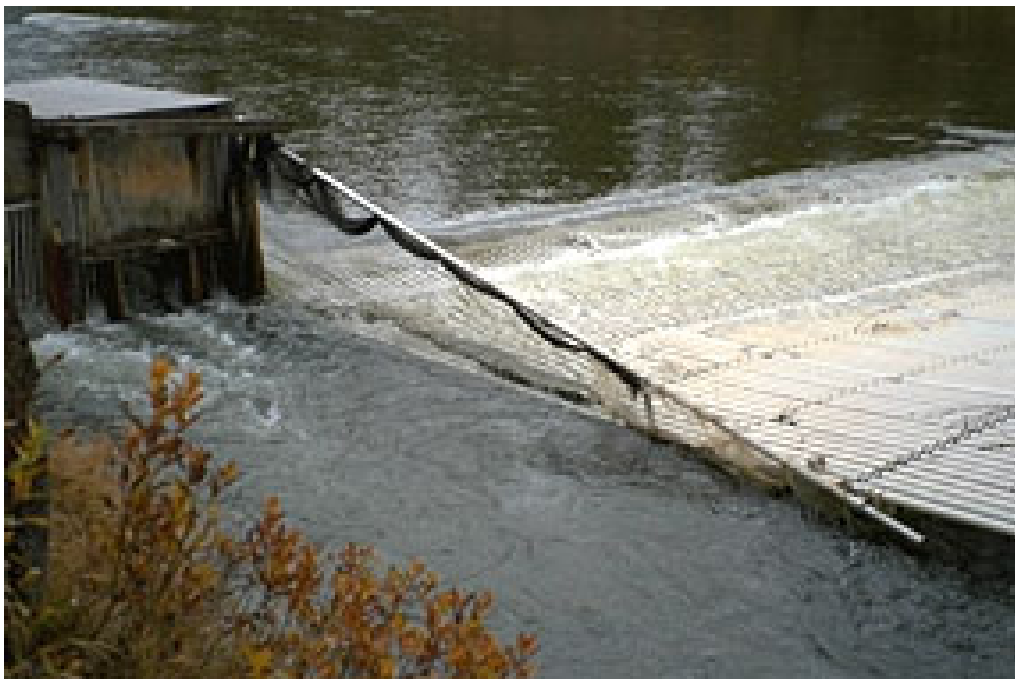
6. During a high water event in 1997, the netting used to block fish passage on the panel beside the trap box became extremely clogged with debris. The netting did not have anything holding it up vertically out of the water, which allowed it to become completely blocked. After the water receded an aluminum pole was added as a support to keep the net more out of the water preventing excessive debris accumulation (Photo Figure 8).

Photo Figure 8. View from right banking of aluminum pole holding up panel netting.

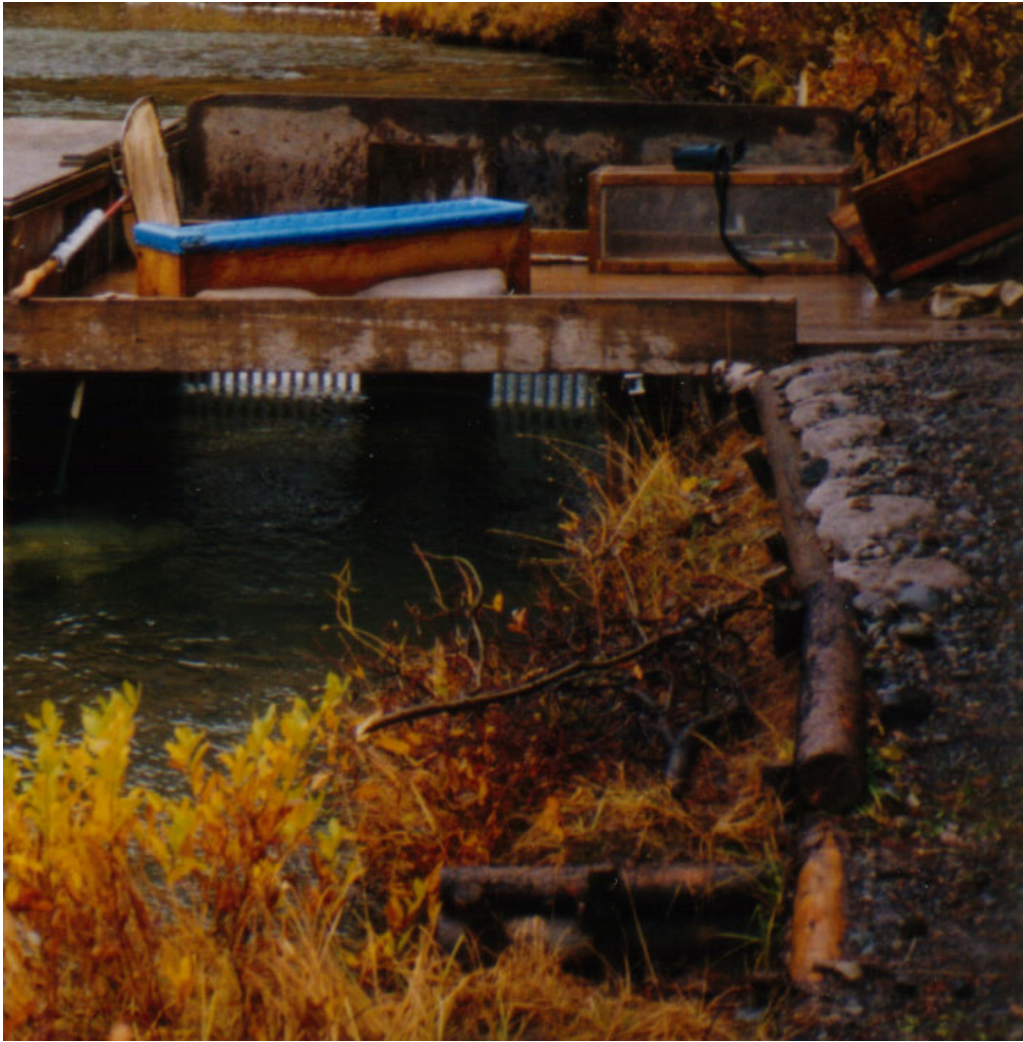
10. During the 1997 field season fence personnel noted that several years of activities around the fence had killed some of the vegetation along the right bank. The bank area immediately above the fence trap box was destabilised and was beginning to slough into the river. A walkway was built along the bank using sandbags, small logs and gravel to minimise future bank disturbance as well as to correct the existing problem (Photo Figure 9). Willows and other streamside vegetation were also planted in an effort to stabilise the bank. Sandbags were placed in the water along the right river margin to decrease undercutting.

Photo Figure 9. View of the right bank looking downstream towards the trap box deck. Note a) the blue foam lined measuring tray; b) the viewing box (top right); c) efforts to improve bank stabilisation around the fence working areas.

8. In 1998 a new free standing measuring tray was built to accommodate the entire size range of fish sampled from the Sustut River. The old measuring tray was only 97 cm. In the past some steelhead and a significant number of chinook salmon sampled were well over 97 cm.
