# Reconnaissance Level Fish and Fish Habitat Inventory for the Kispiox Forest District

*Prepared for:*

**Repap Smithers**

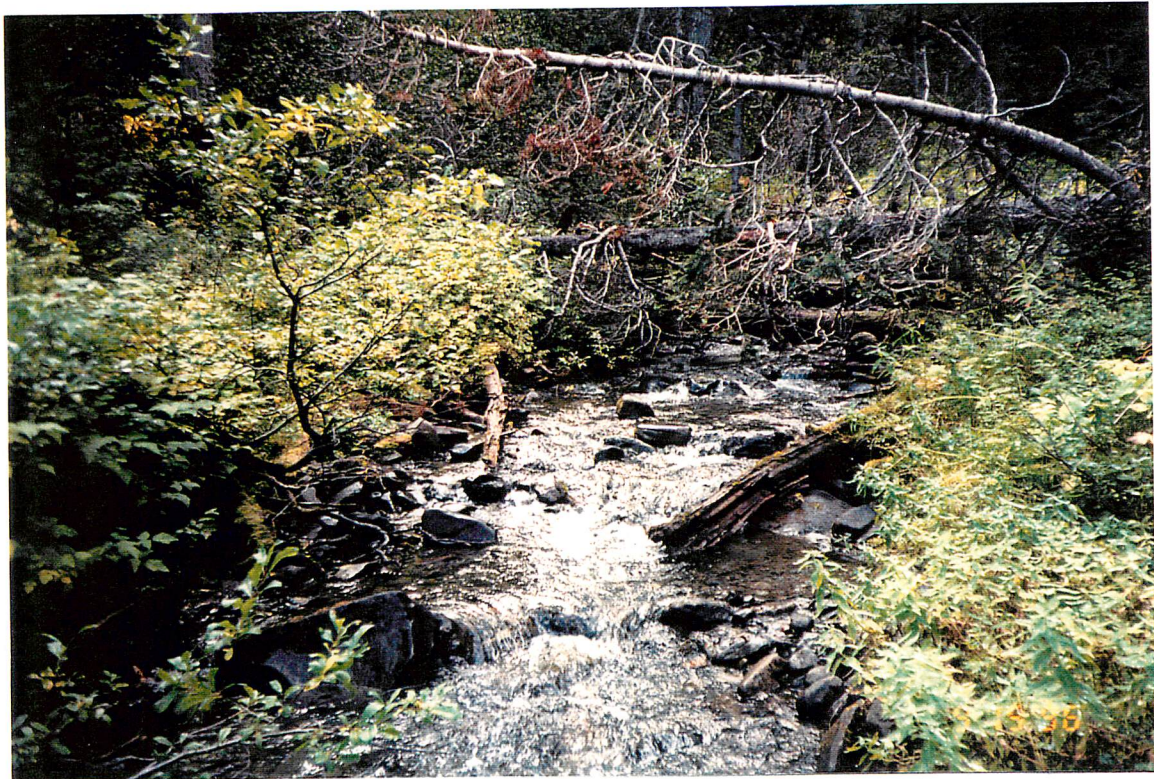
Photo #: A-4-10, 15-Sep-96  
Site #: A27, Looking upstream, blowdown across channel.

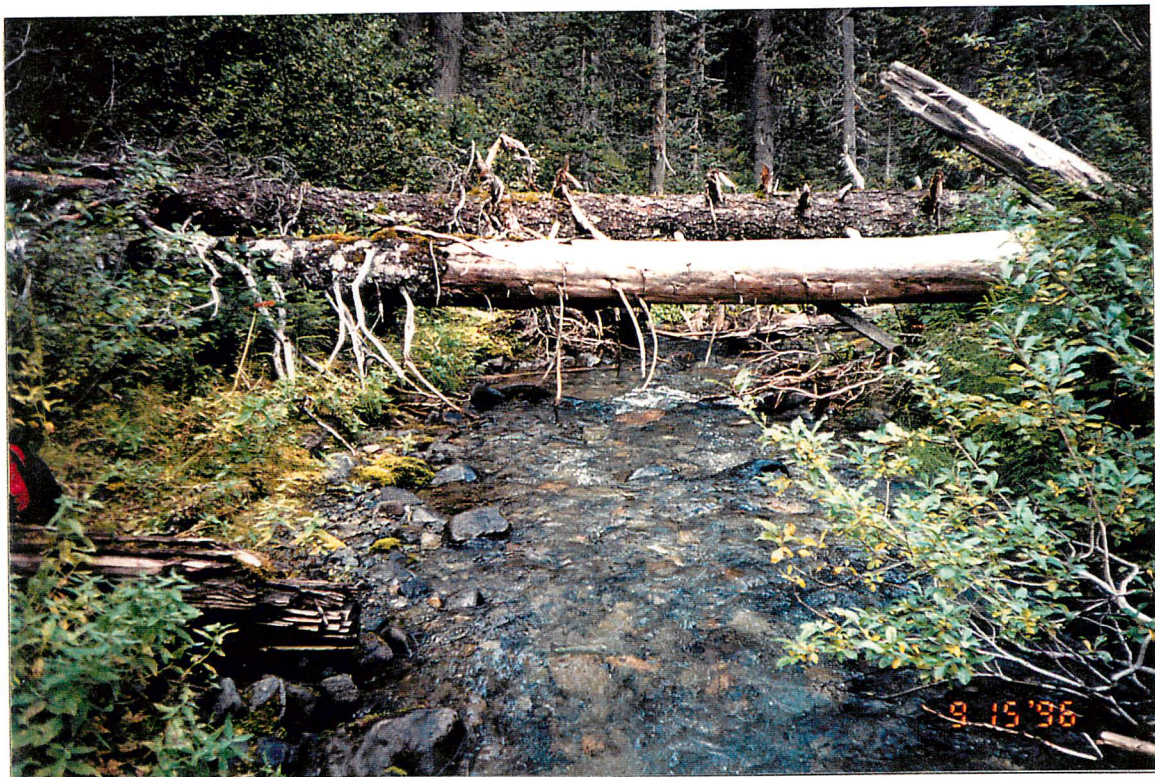
Photo #: A-4-11, 15-Sep-96  
Site #: A27, Looking downstream, 2 logs across channel..

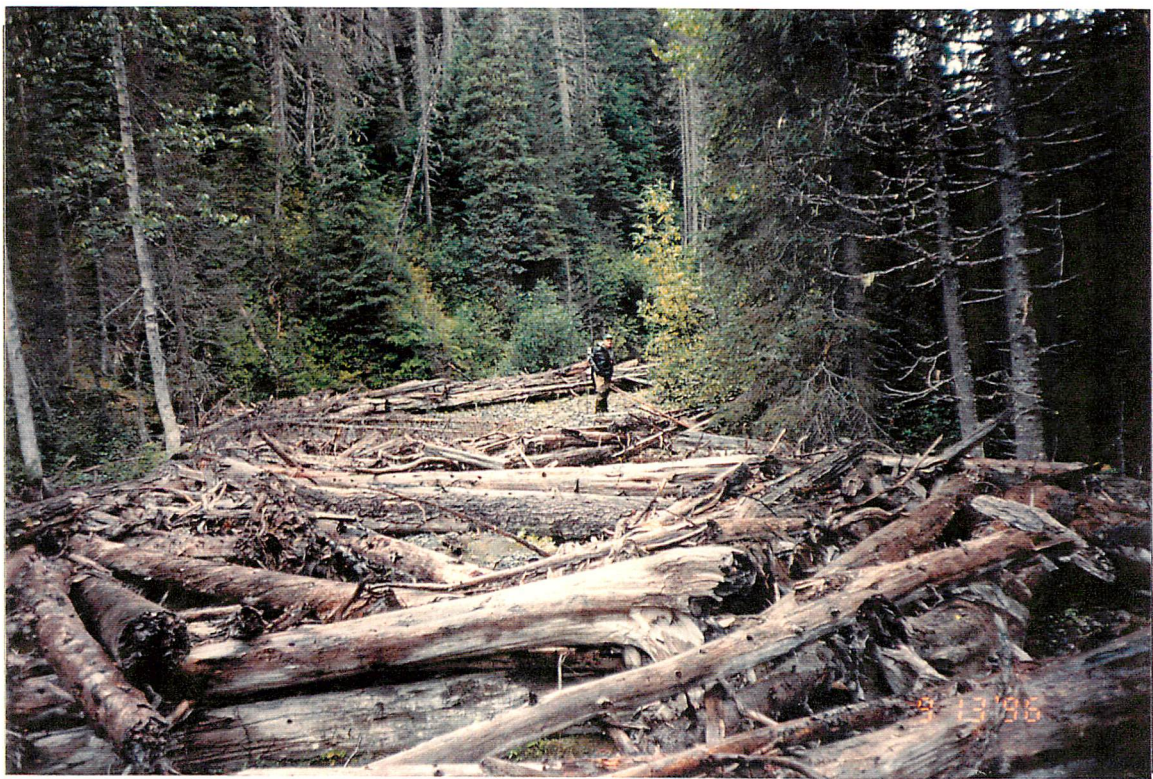
Upper Shedin Creek was sampled as well as Damsumlo Lake and its tributaries. Twenty-three sites were sampled including the mainstem of Upper Shedin Creek. There is a 15 m falls downstream of all the sites sampled in the Upper Shedin as well as a 25 m falls near the headwaters. The watershed has several small lakes upstream of the 25 m falls that are above the treeline which are classified as non-fish bearing. The mainstem of Shedin Creek appears to have a high debris transport potential indicated by the large log jam observed at B20 in a side channel.

Photo #: B-3-16, 13-Sep-96  
Site #: B20, Log jam on side channel of Shedrin Creek.

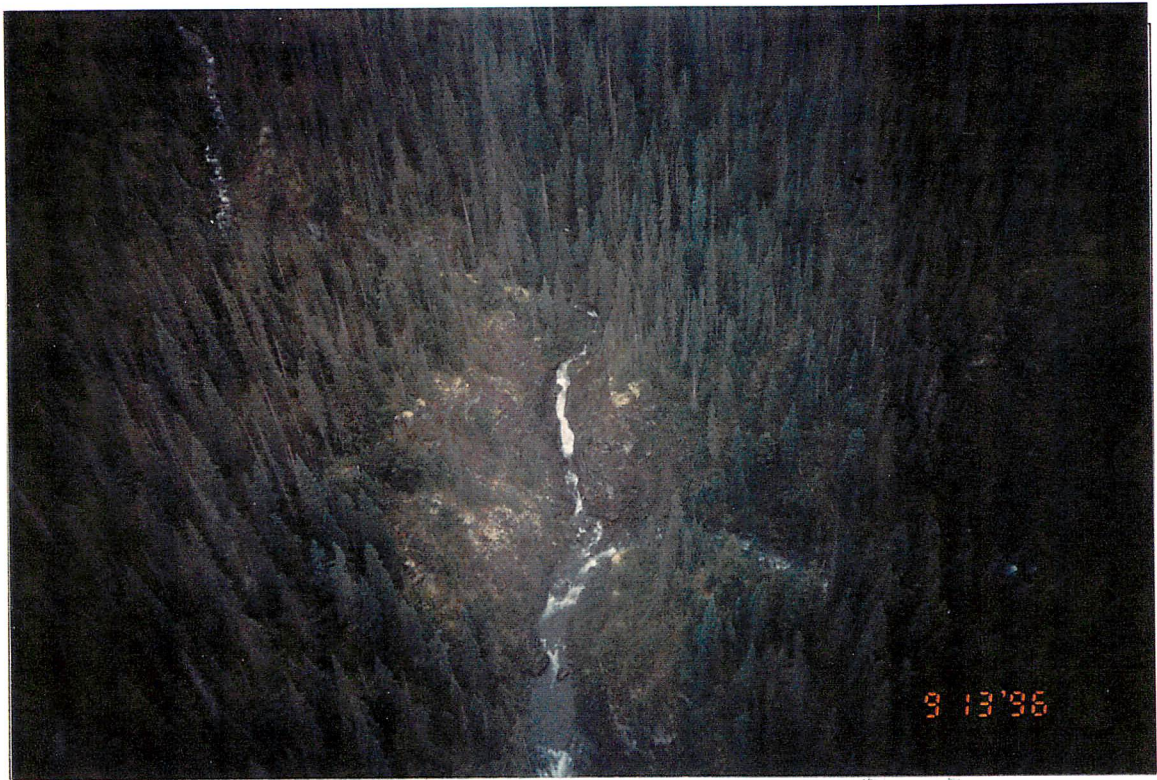
Site #: B22, Falls downstream of site, aerial photo.

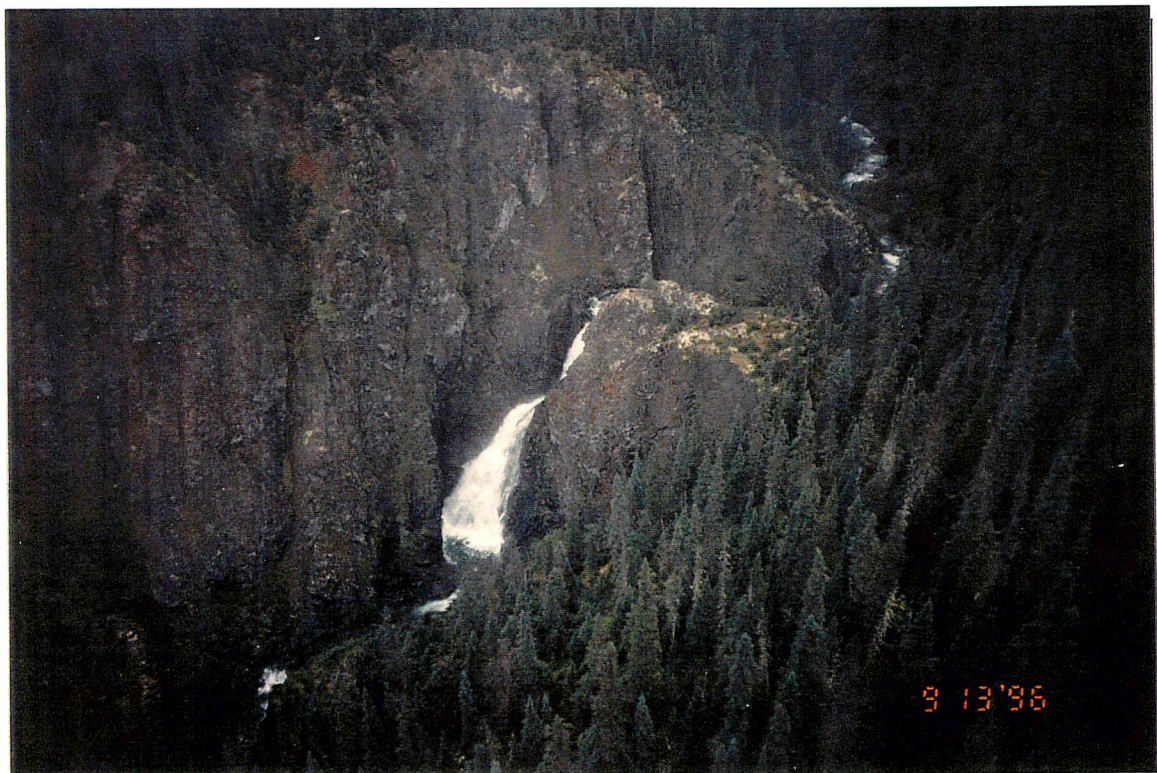
Site #: B22, Falls downstream of site, aerial photo.

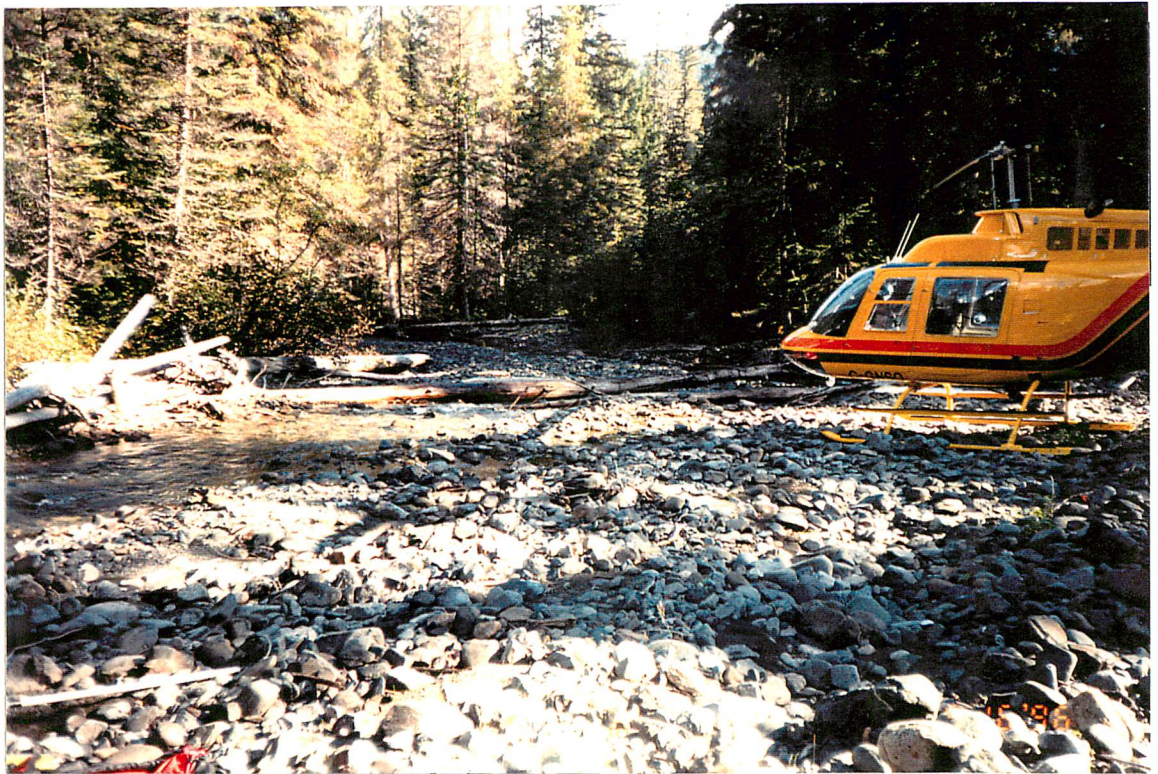
Photo #: A-4-18, 16-Sep-96  
Site #: A32, Large cobble/gravel bars.

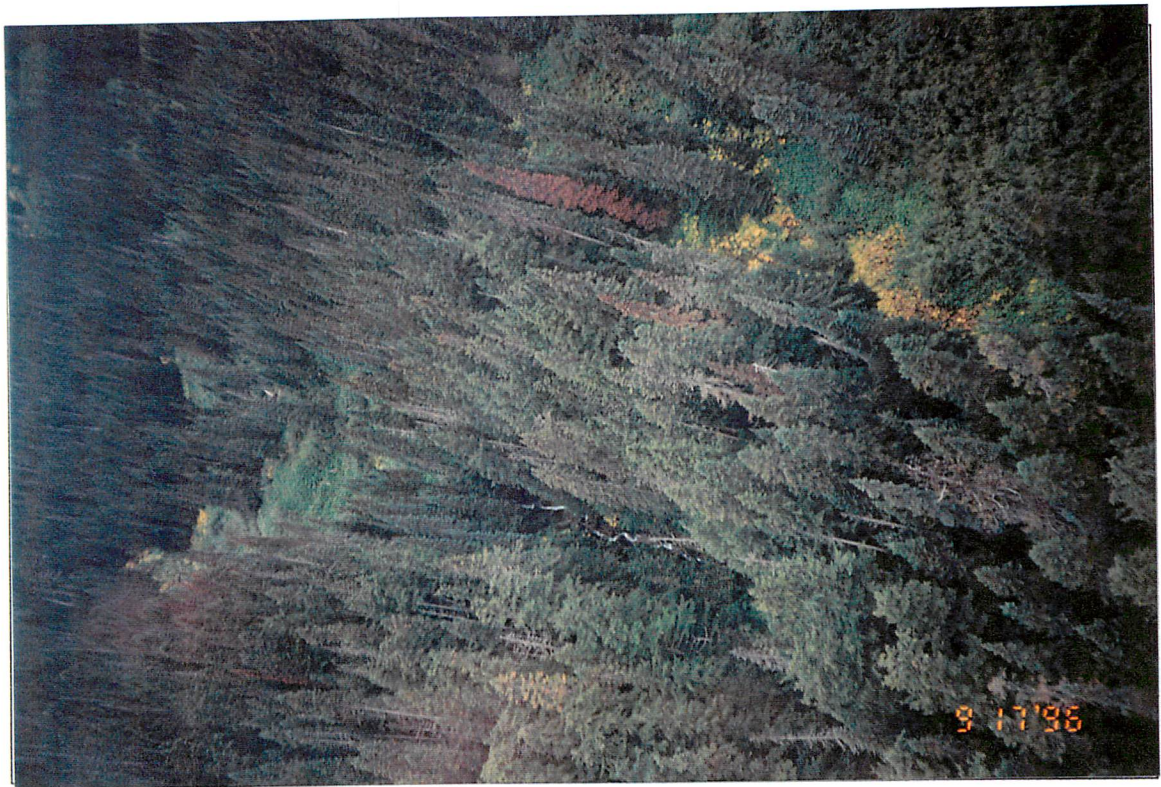
Photo #: B-6-20, 17-Sep-96  
Site #: B50, Aerial photo of cascades.

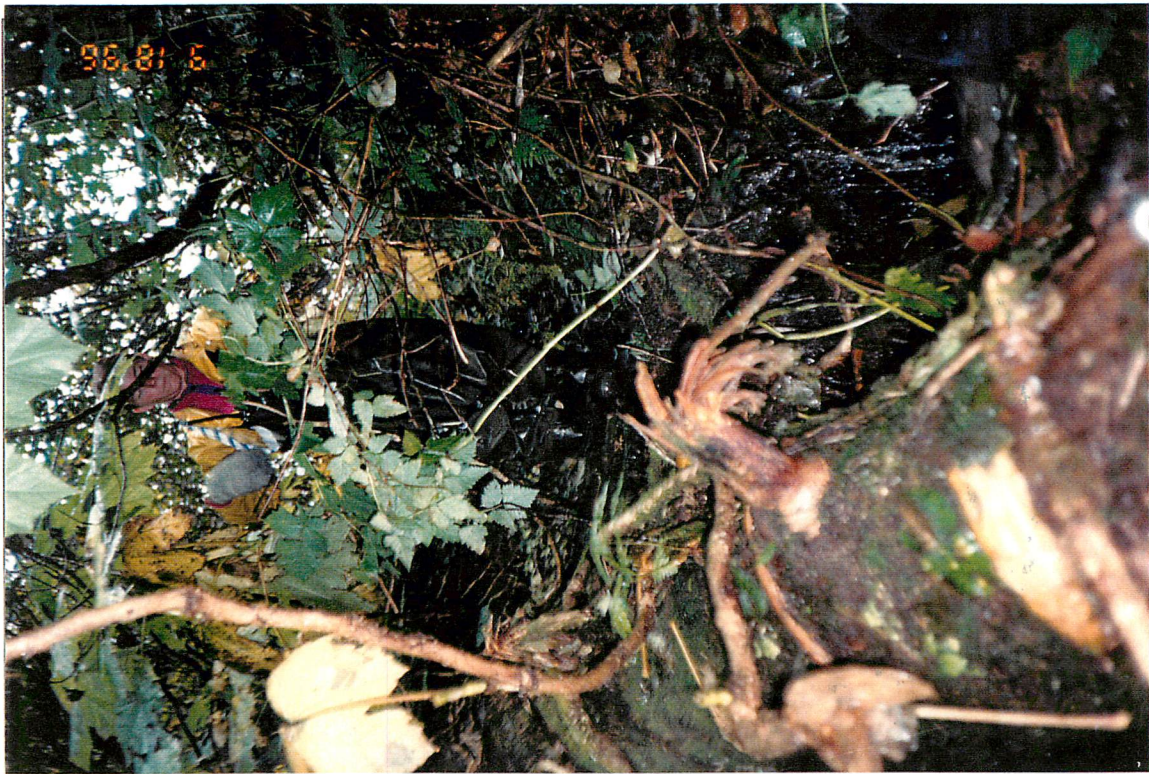
Photo #: A-6-16, 18-Sep-96  
Site #: A47, Small cascade.

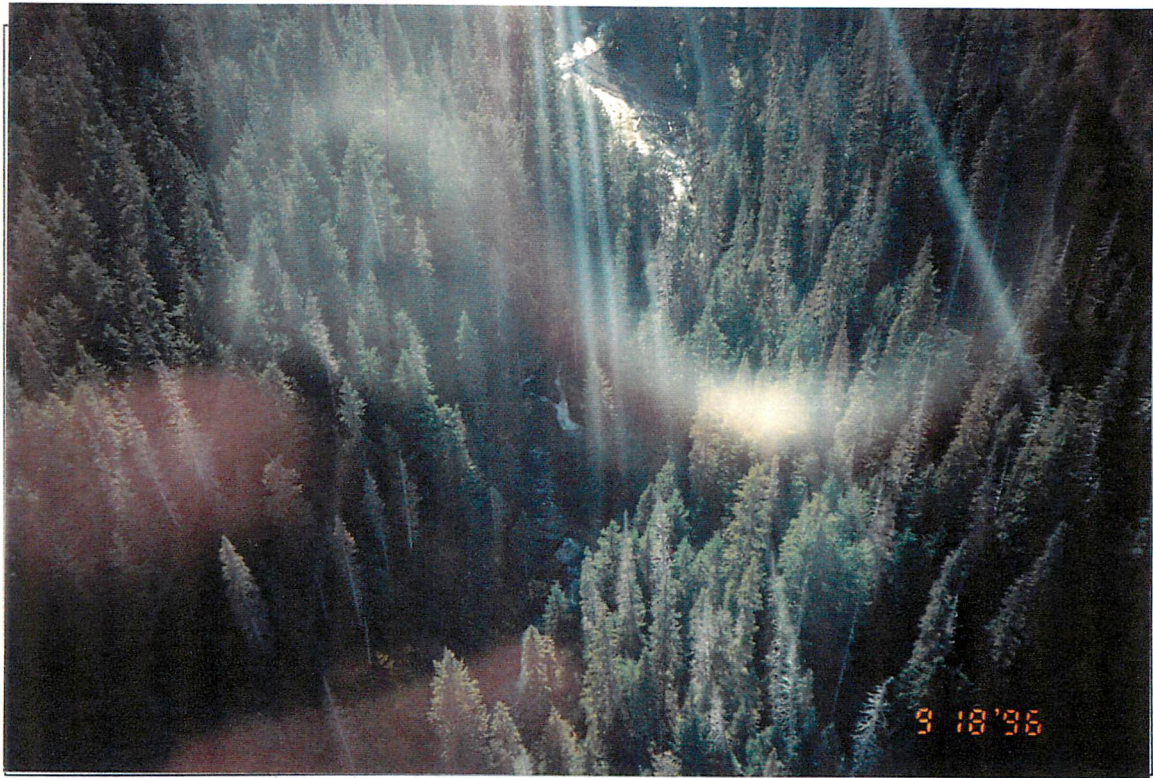
Photo #: B-7-12, 18-Sep-96  
Site #: B64, Falls from aerial photo.

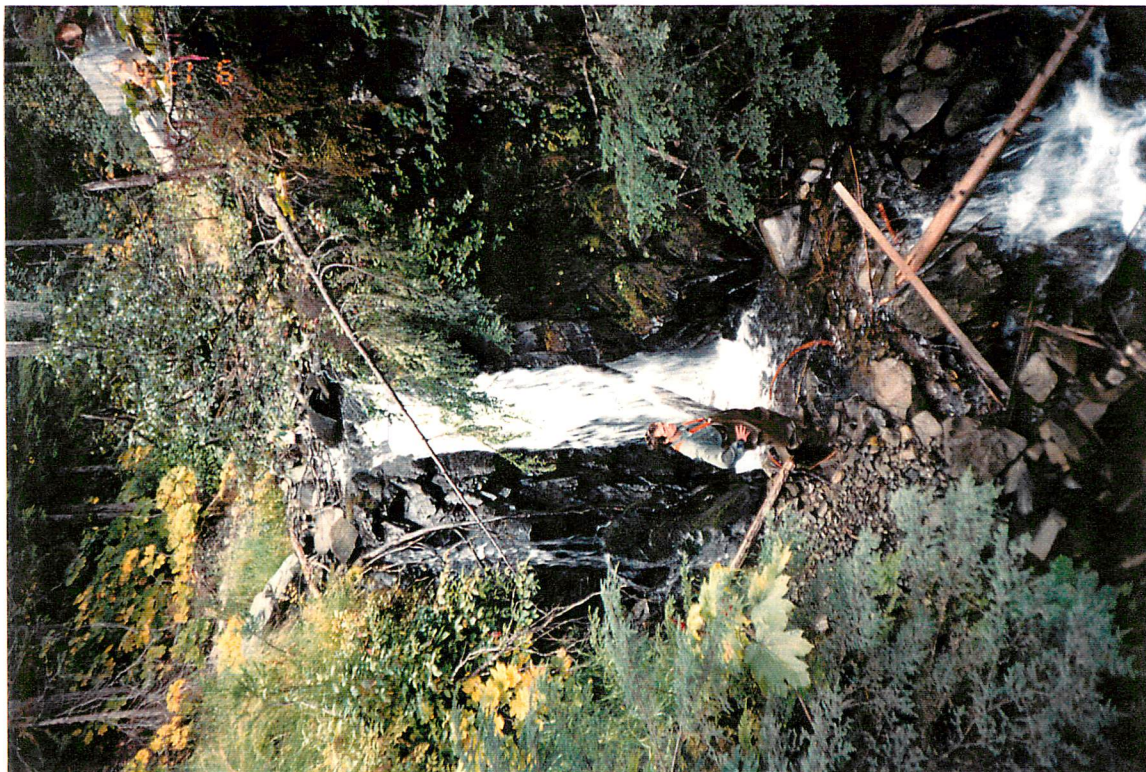
Photo #: A-3-6, 13-Sep-96  
 Site #: A17, Looking upstream at 5 m falls.
