A RECONNAISSANCE INVENTORY OF NETALZUL MEADOW LAKE (ALIAS)

Watershed Code Unknown

FINAL REPORT

MARCH, 1997

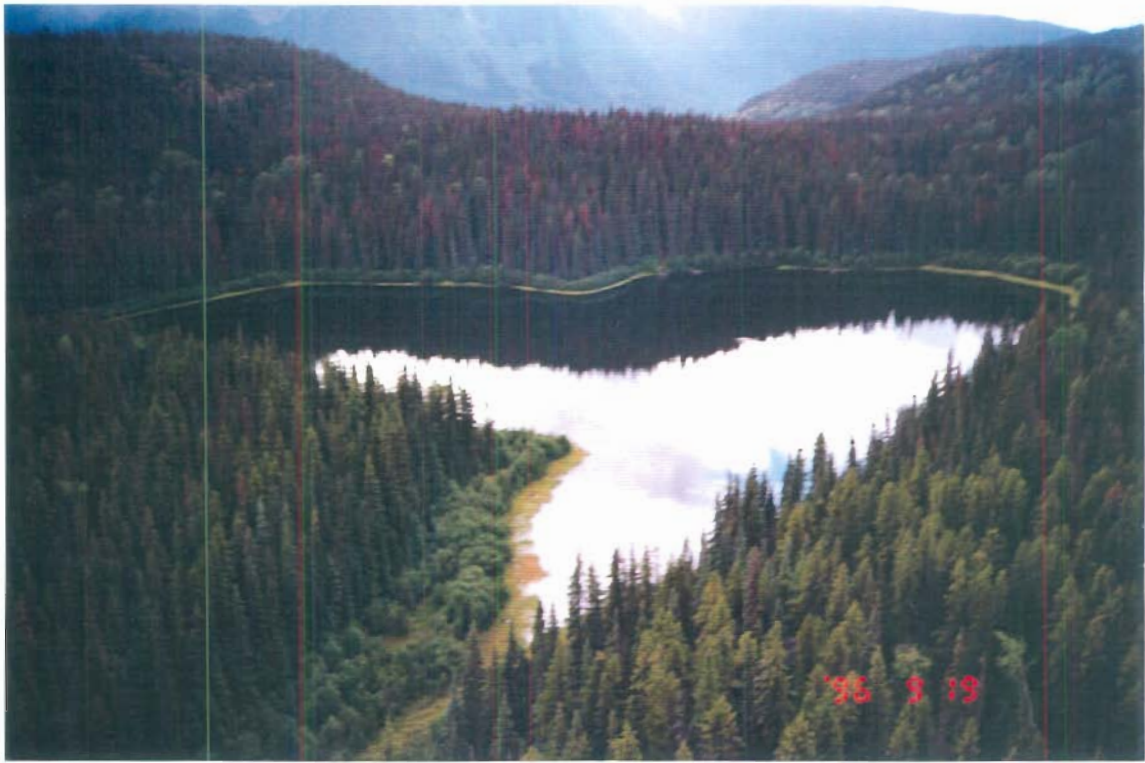
Plate 1 View of Netalzul Meadow Lake from helicopter. (Roll #4, Negative #23)

This lake is located in a divot on the top of a small mountain (Plate 1). The sides of this small mountain drop off quickly to both the southwest and northeast. A small lake located near Netalzul Meadow Lake but approximately 40 metres higher in elevation, drains into this lake at its northern shore.

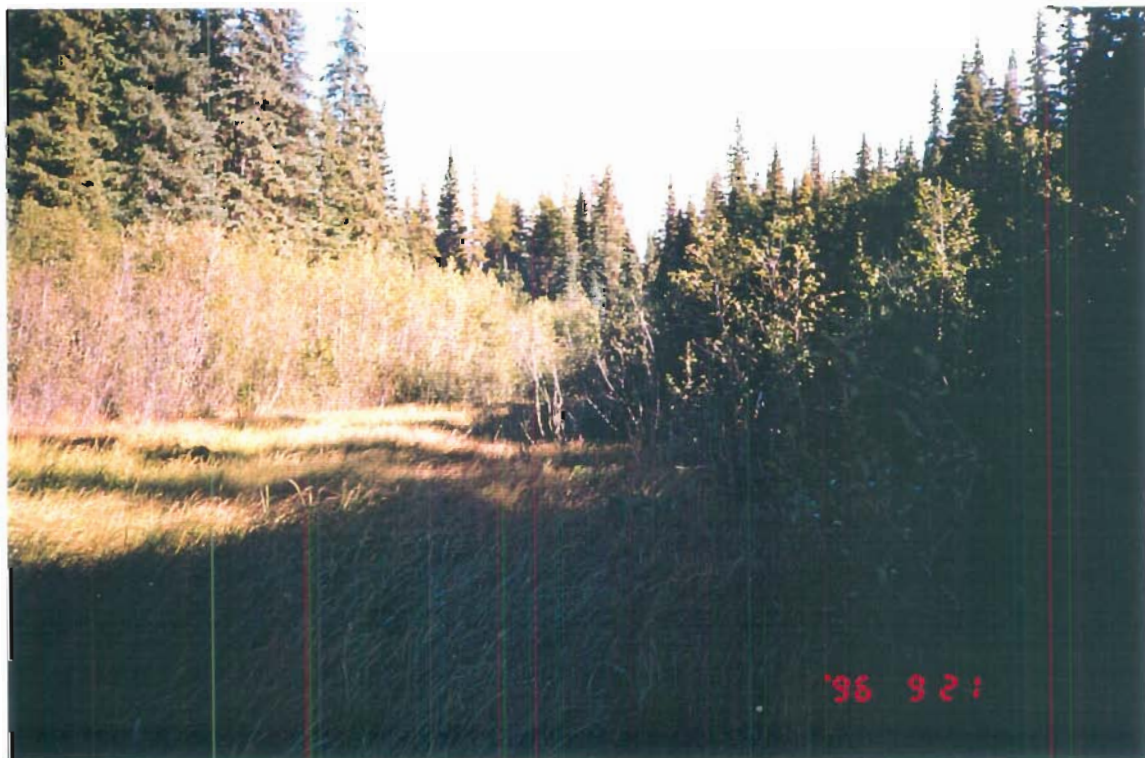
Plate 2 View of inlet and also the only suitable helicopter landing area. (Roll #4, Negative #29)

Stream #1 is the single outlet of Netalzul Meadow Lake. This stream begins at a small meadow (Plate 2) prior to draining into Netalzul Creek.

The only suitable helicopter landing area on this lake is in the grassy area near the lake outlet (Figures 2 and 3 and Plate 2). The water here is up to 1.2 metres deep and were it not for submerged logs extending across the outlet, helicopter access to this lake would only be possible with floats.

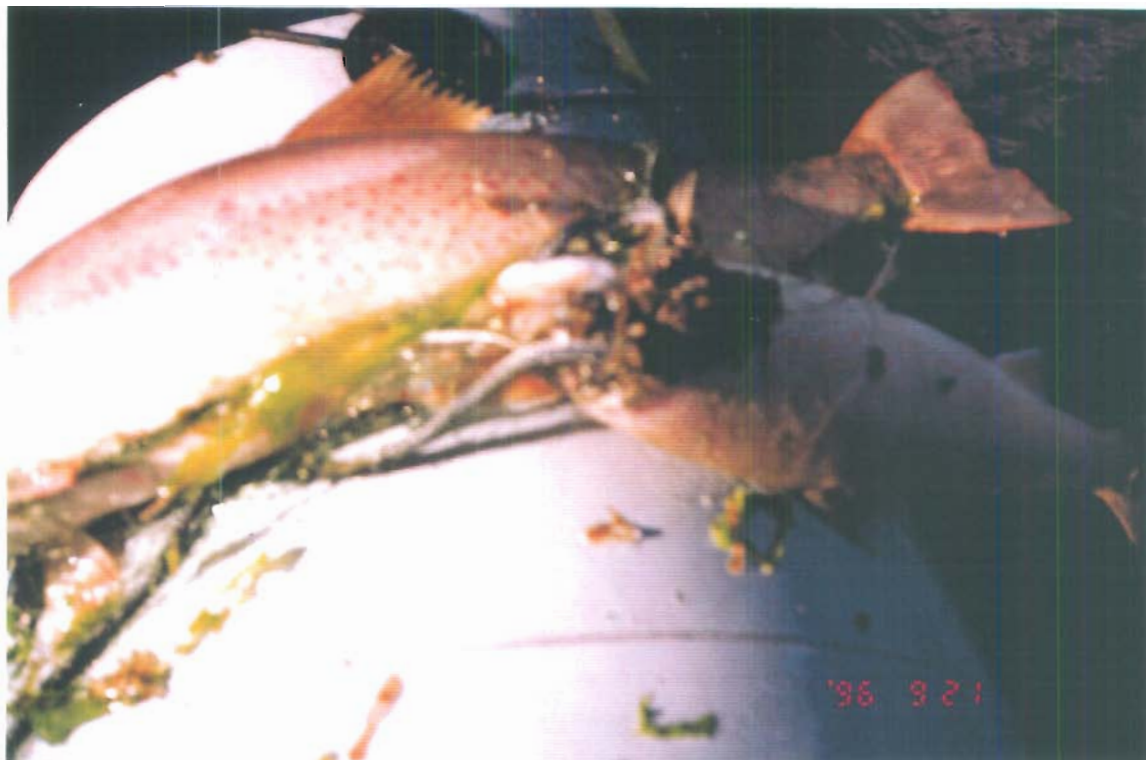
Plate 3 Example of fish specimens/Dolly Varden, (*Salvelinus malma*) and invertebrate infestation of the smaller specimen's opercular plate. (Roll #4, Negative #30)

Aquatic invertebrates were fairly abundant in this lake. Specific taxa noted in Netalzul Lake include macrocrustacea (*Amphipoda sp.*), leeches (*Hirudinea sp.*) and beetles (*Coleoptera sp.*). The former taxa were particularly abundant as clusters attached to the side of gillnet fish mortalities (Plate 3).

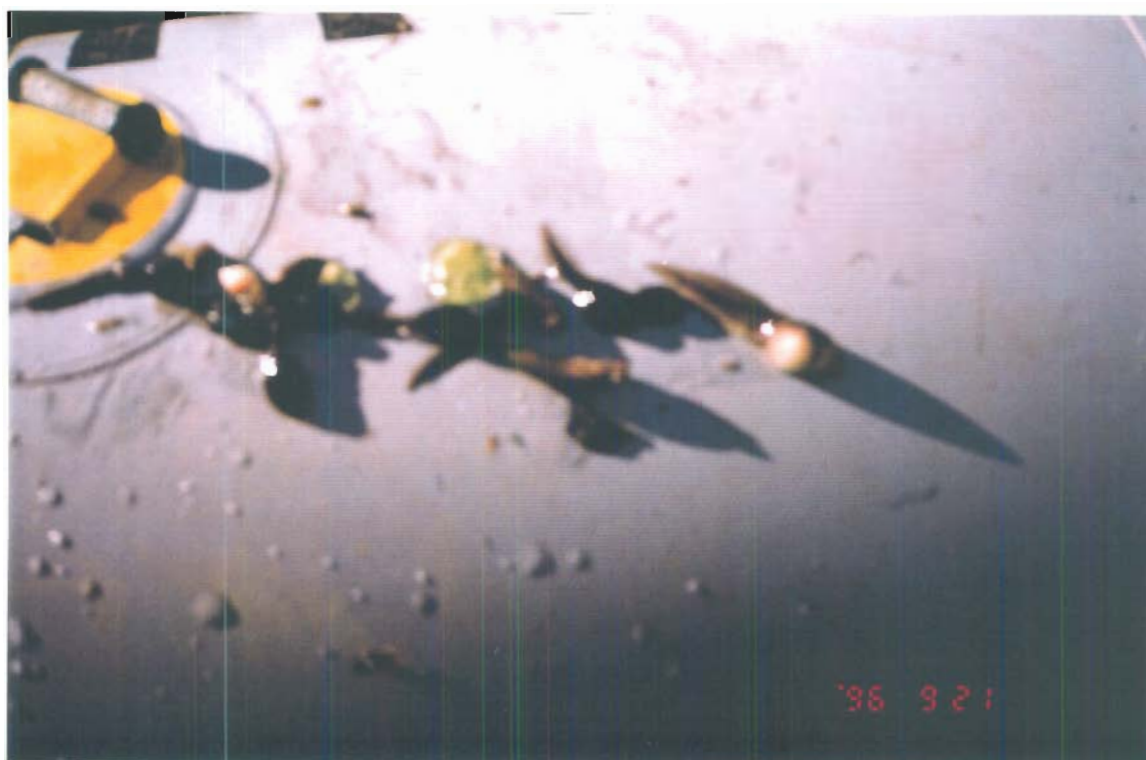
Plate 4 Example of tadpole specimens captured in minnow traps. (Roll #4, Negative #31)

Wildlife was fairly abundant in and around this lake. A pair of loons was nesting here and migratory ducks were also present. Moose activity was also noted along the shoreline. Tadpoles were also captured in two of the minnow traps (traps # 1 and 2) but they could not be identified (Plate 4).
