KILLUTSAL CREEK REARING POND ENHANCEMENT

Killutsal Creek Rearing Pond Enhancement

Ministry of Environment, Lands & Parks,
and
Fisheries Renewal, BC

June 2001

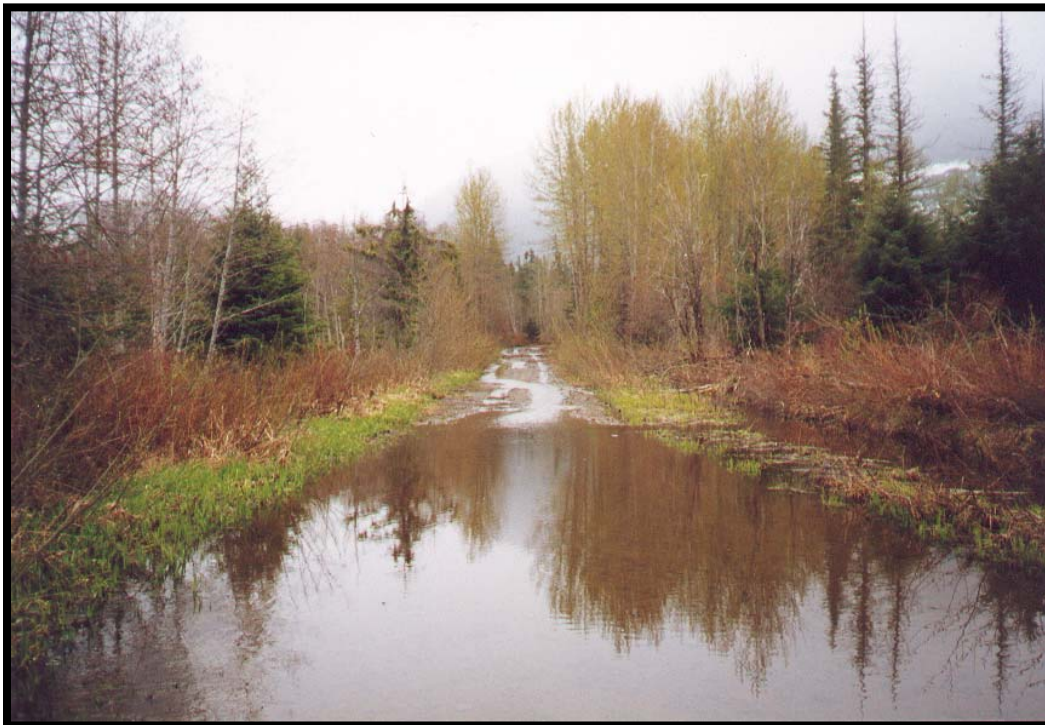
As a consequence, reduced levels of fish access, increased channel instability, and seasonal flooding of the White Creek Road have occurred (Figure 1). More over, as the seasonal floods receded they isolated large numbers of juvenile fish on the far side (southwestern) of the White Creek Road where they became stranded resulting in high rates of juvenile mortality (Heibein, 2000). Additionally, adults have been observed spawning, and juvenile fish holding, on the road. During high water events, industrial and recreational traffic conflicts further exacerbated negative fish impacts and DFO has been forced to close the road for extended periods.

Figure 1. Killutsal Creek flows flooding White Creek Road.

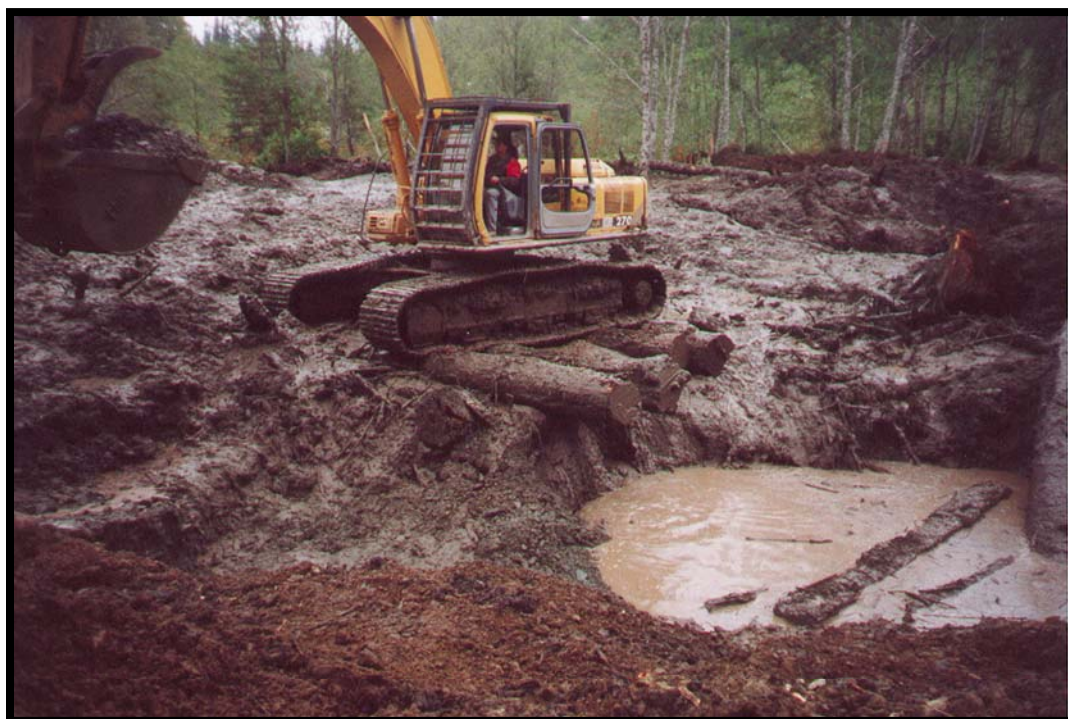
Figure 3. Corduroy road used during the pond construction.

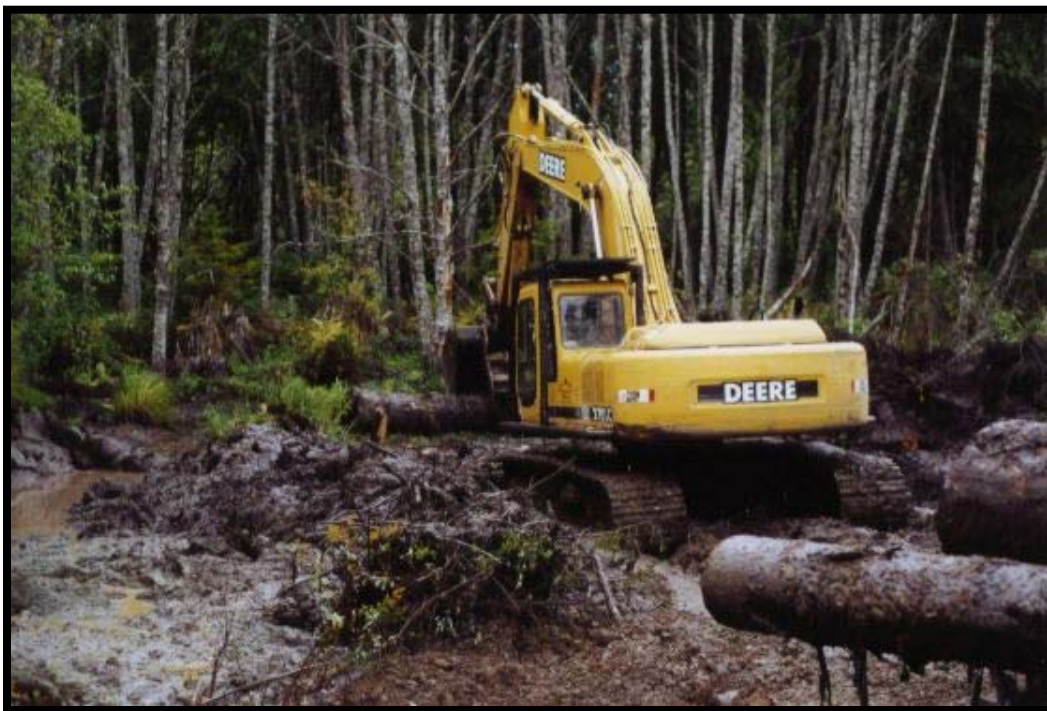
The lower pond has an area of 0.181 Ha (1810 m²) (Figure 4 and 5). It is formed by a J-shaped berm that runs west, parallel to the White Creek Road (Figure 6) and then curls north, toward Killutsal Creek and connects to a beaver dam. The dam was constructed shortly after the

Figure 4. Excavation of the lower pond.

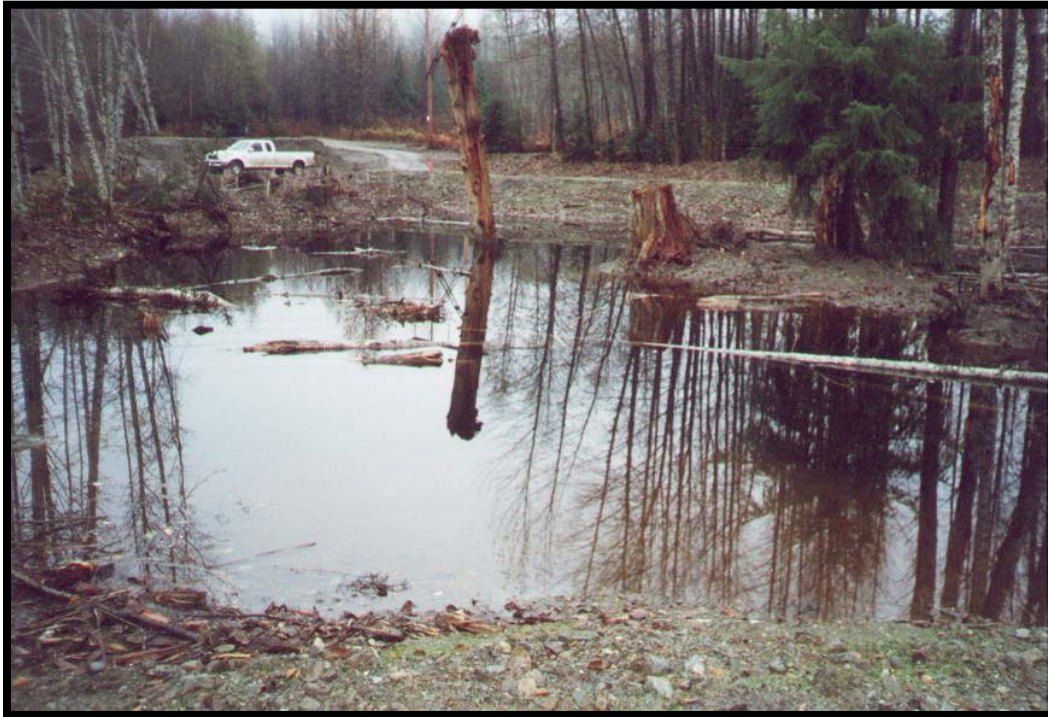
Figure 5. Lower rearing pond after construction. Note LWD.

The upper pond/channel has been complexed with rootwads and LWD that were displaced during construction. Six LWD structures, ranging in length between 3.4 m and 13 m, and nine rootwads of various sizes were placed in the stream channel to provide cover in rearing and spawning habitat. As well, a large number of whole alder trees were placed randomly in the lower pond.

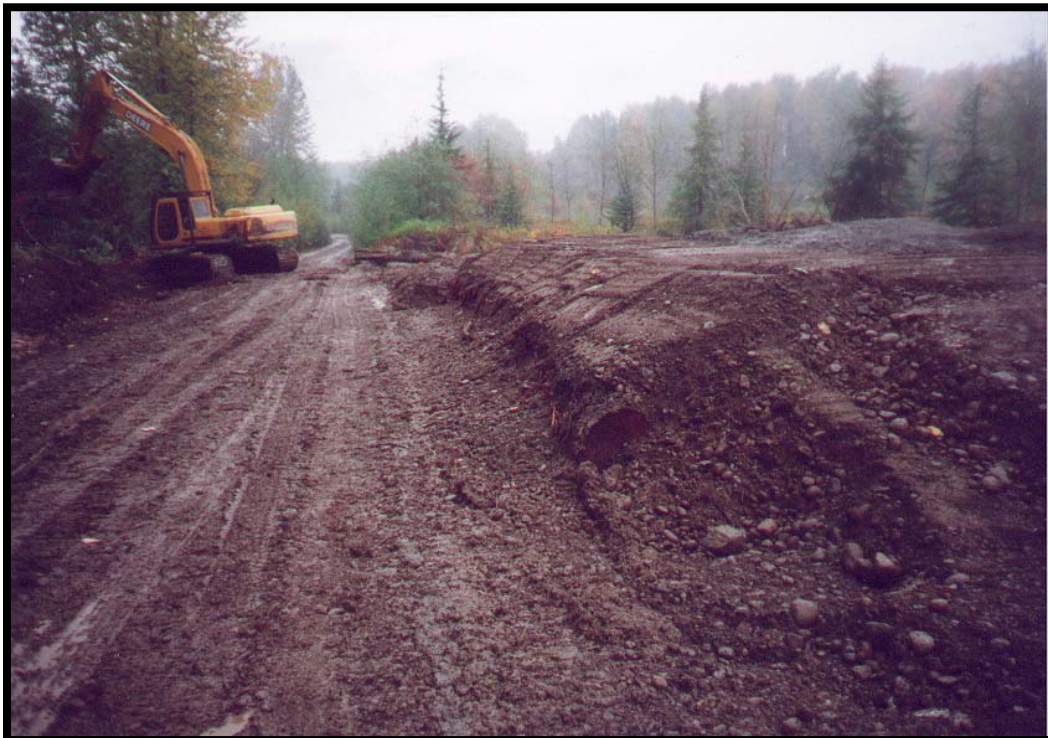
Figure 6. Berm construction parallel to White Creek Road.

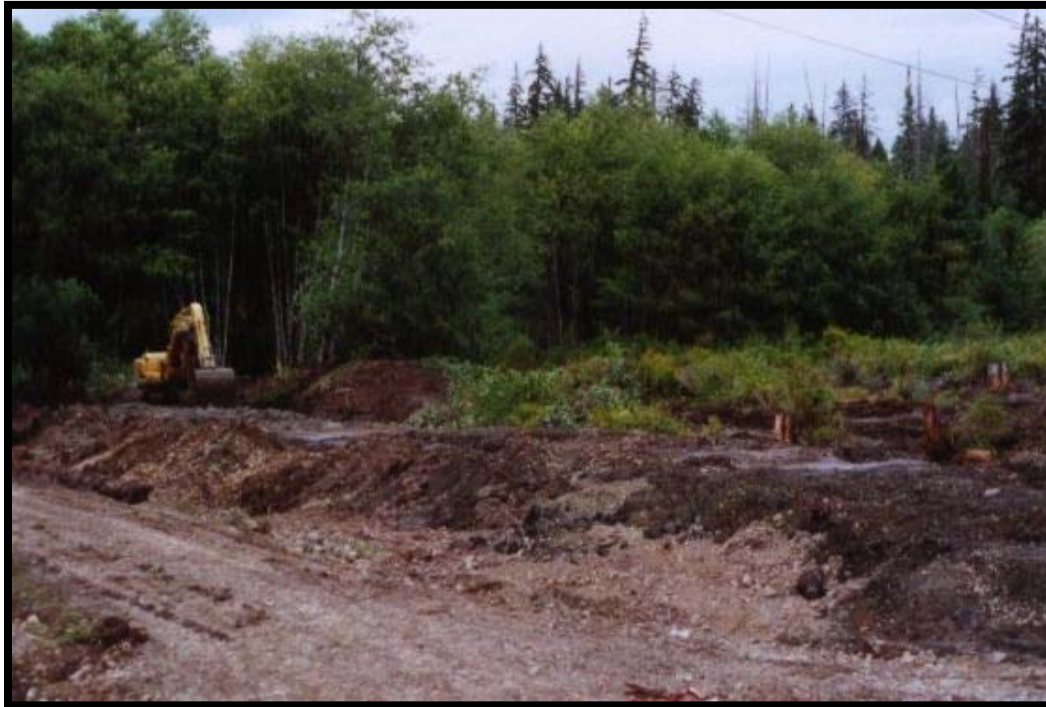
The upper pond is 0.09 Ha (900m²) in area (Figure 7). Killutsal Creek runs through the middle of this pond around a large island in the center. The upper pond is formed by a berm running parallel to the road and a historical beaver dam to the north.

Figure 7. Upper pond construction adjacent to the road.
