**1995 AND 1996 FISH AND FISH HABITAT INVENTORY  
WITHIN THE STUART LAKE AND BABINE LAKE  
WATERSHED GROUPS**

**Volume 1 of 3**

**Canadian Forest Products Ltd.**

EDI Project No. 500-04

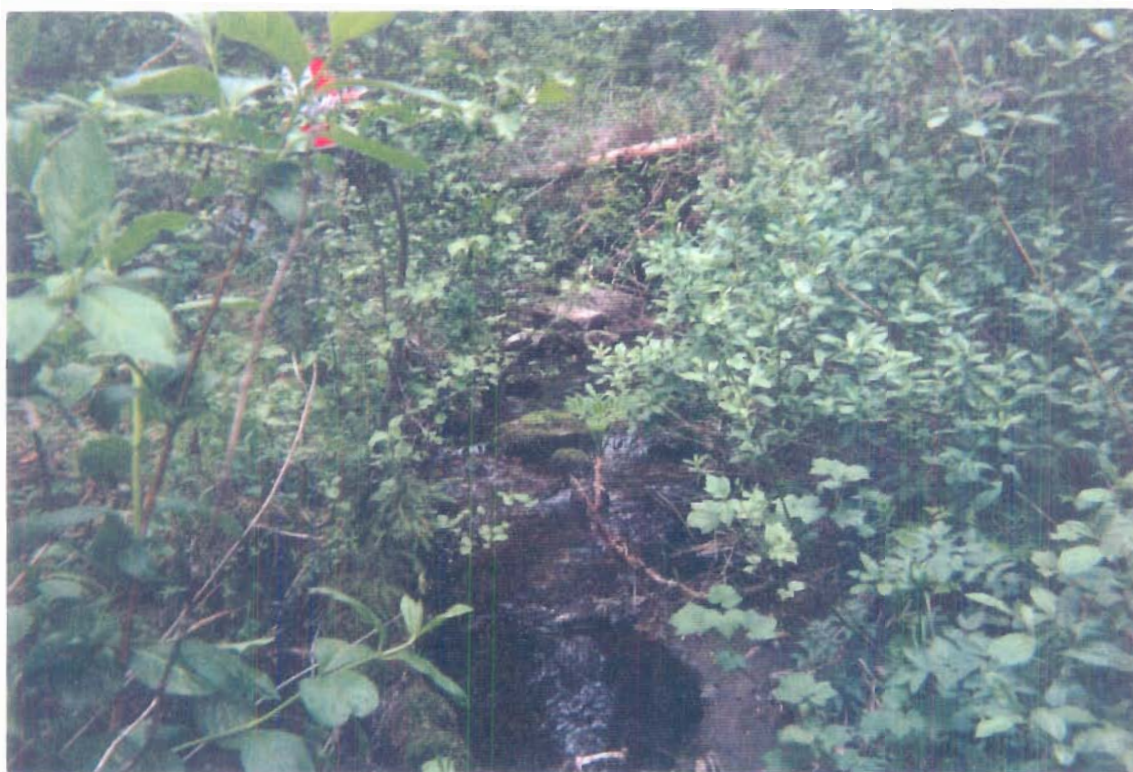
**Photo 1.** Upstream view of Stream 182-5941 at Reach 1

Fish sampling (electroshocking) was conducted for 118 seconds. Two rainbow trout were captured.

This section of stream was given a S-3 classification under the Forest Practices Code.

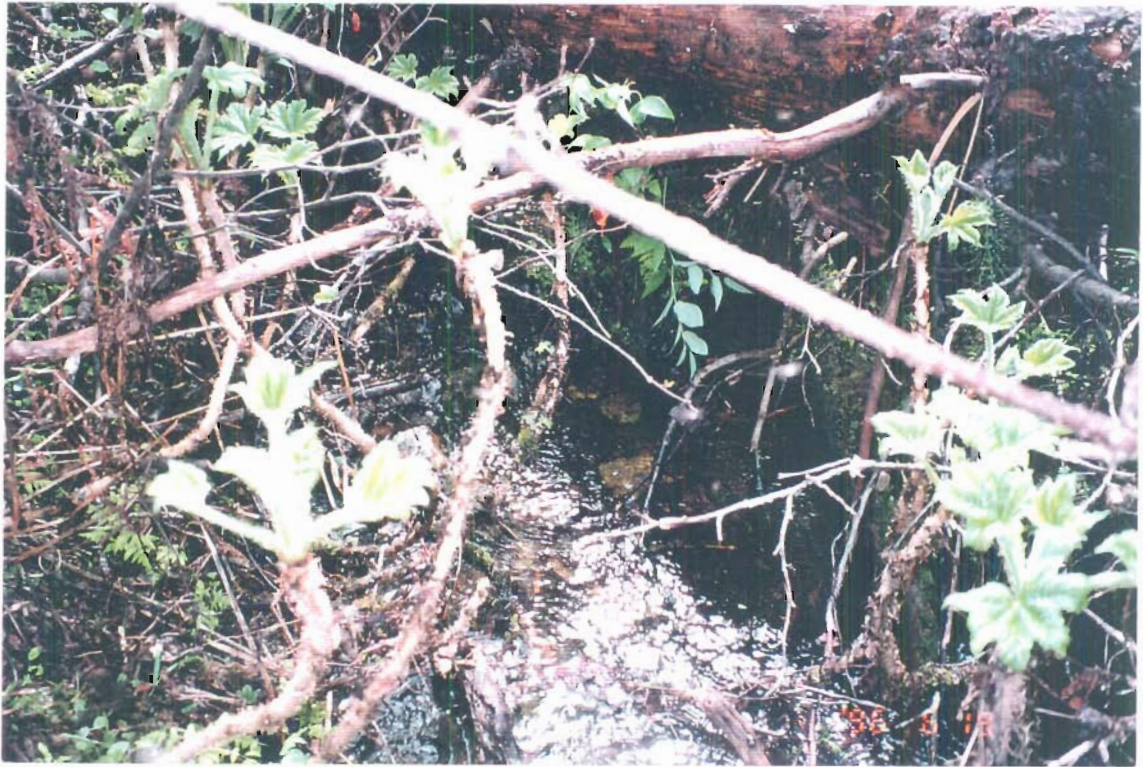
**Photo 2.** Upstream view of Stream 182-5941 at Reach B.

Fish sampling (electroshocking) was conducted for 65 seconds. No fish were captured or observed.

This stream has a S-6 classification.

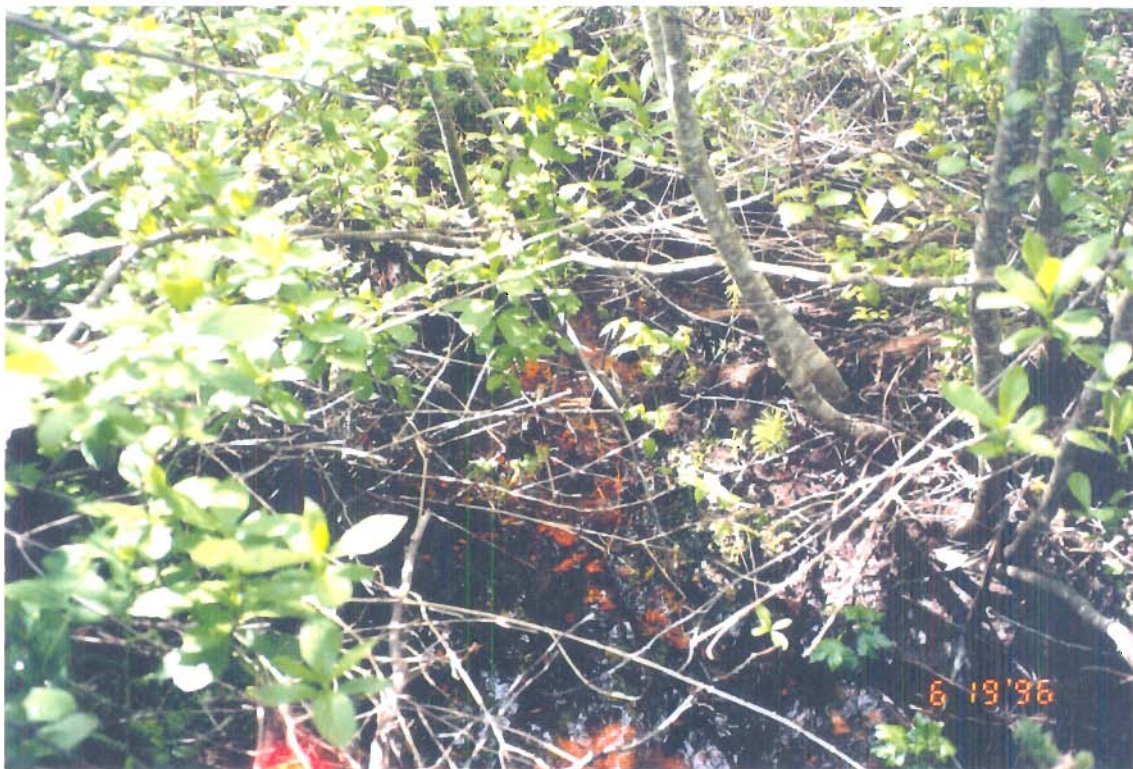
**Photo 4.** Upstream view of Stream 182-5941-890 at Site 1

Fish sampling (electroshocking) was conducted for 300 seconds. The electrofishing was conducted by a second crew member at a later time. No fish were captured or observed.

This stream does not have a stream classification under the Forest Practices Code.

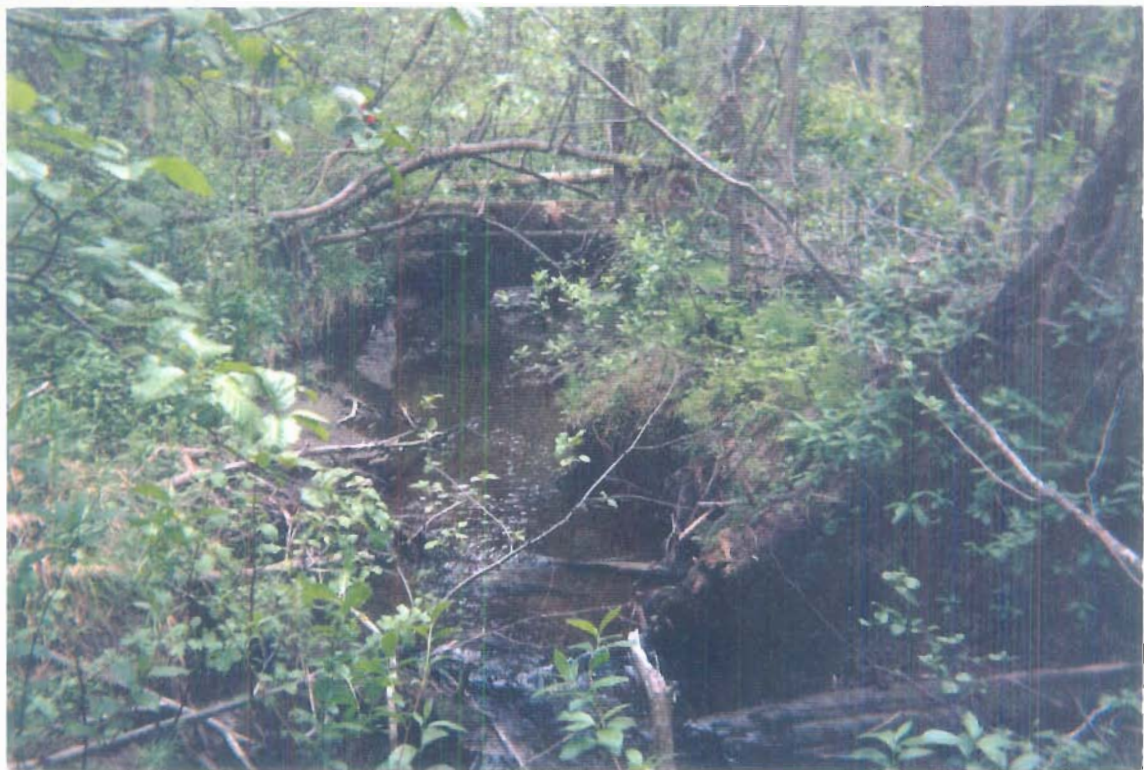
**Photo 6.** Upstream view of Stream 182-5941-711 at Reach 1

This reach was given a S-3 classification under the Forest Practices Code.

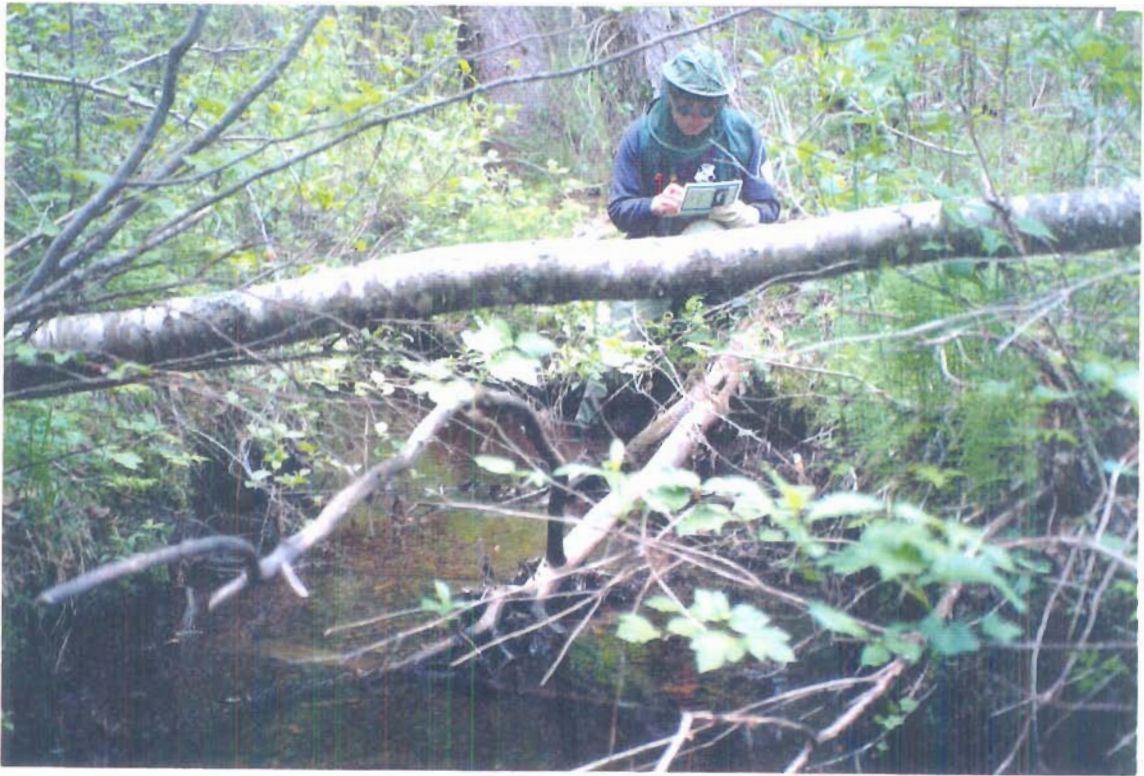
**Photo 7.** Upstream view of Stream 182-5941-711 at Reach A.

Fish sampling (electroshocking) was conducted for 680 seconds. No fish were captured or observed.

Location. This beaver dam is 3.6 km upstream of its confluence with Nahounli Lake.

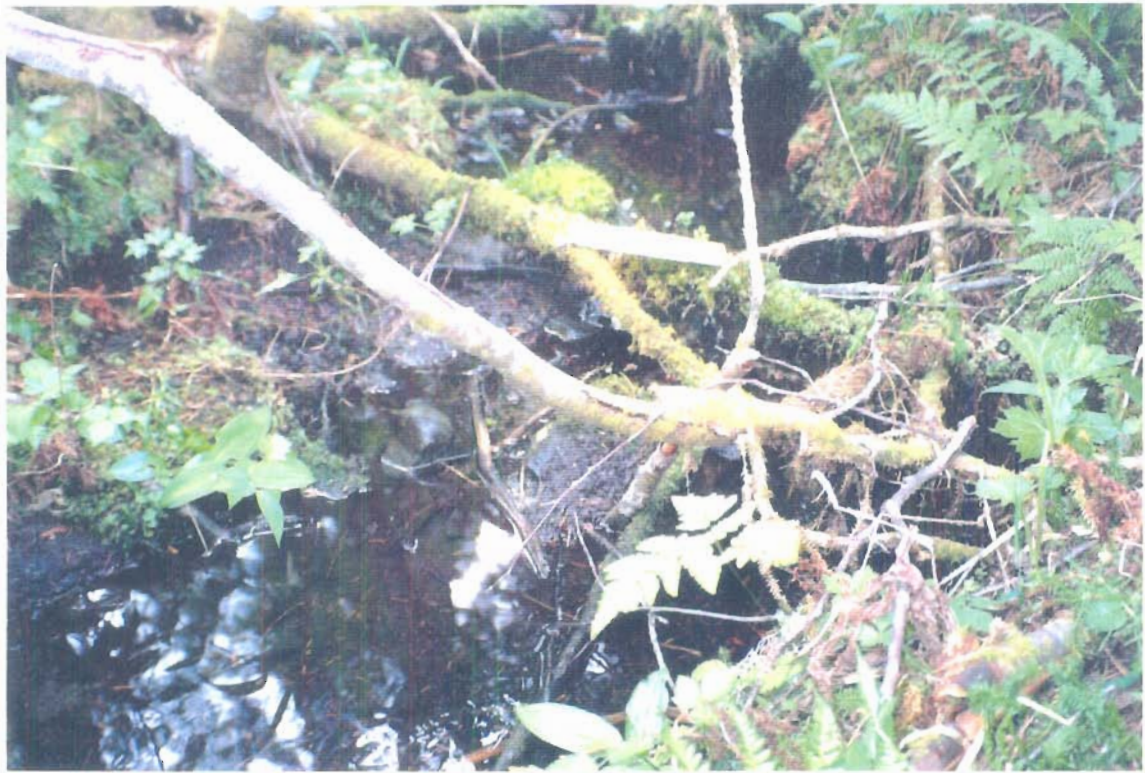
**Photo 12.** Upstream view of Stream EDI-549 at Reach 1

This stream had no fisheries potential as the habitat was poor and was classified as a S-6 under the Forest Practices Code

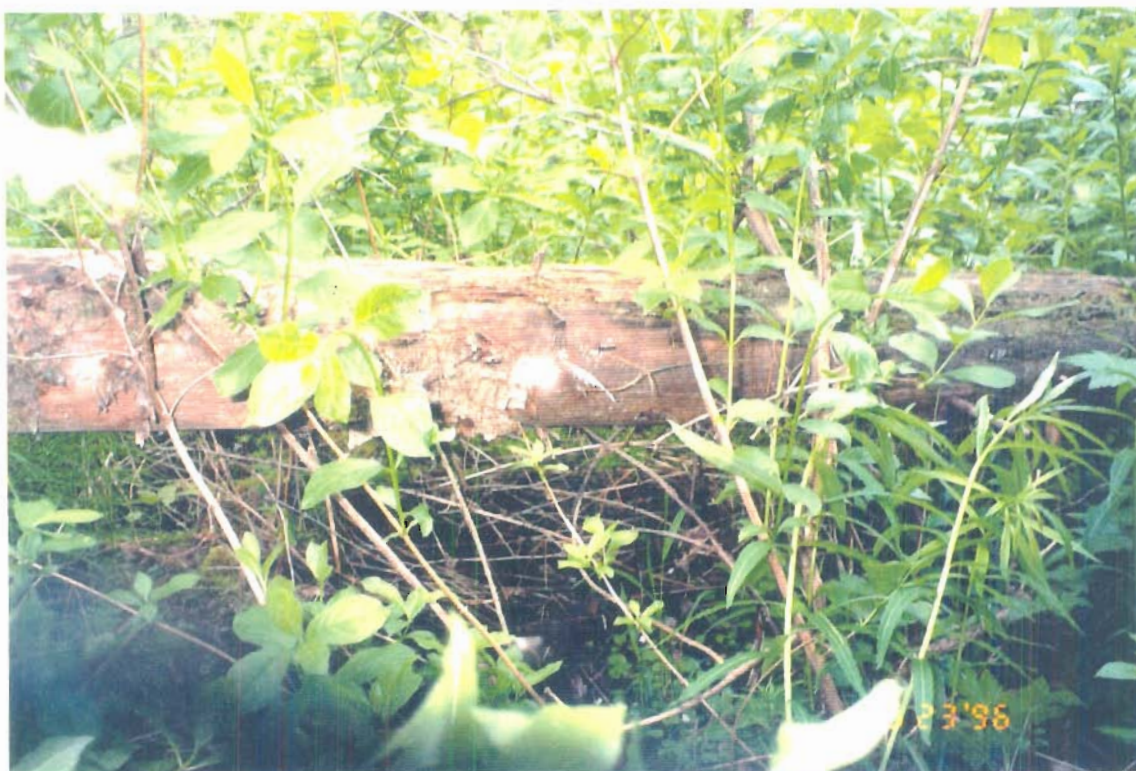
**Photo 13.** Downstream view of Stream EDI-549 at Site 1.

This site is within a reach that has been classified as a S-6 under the Forest Practices Code.

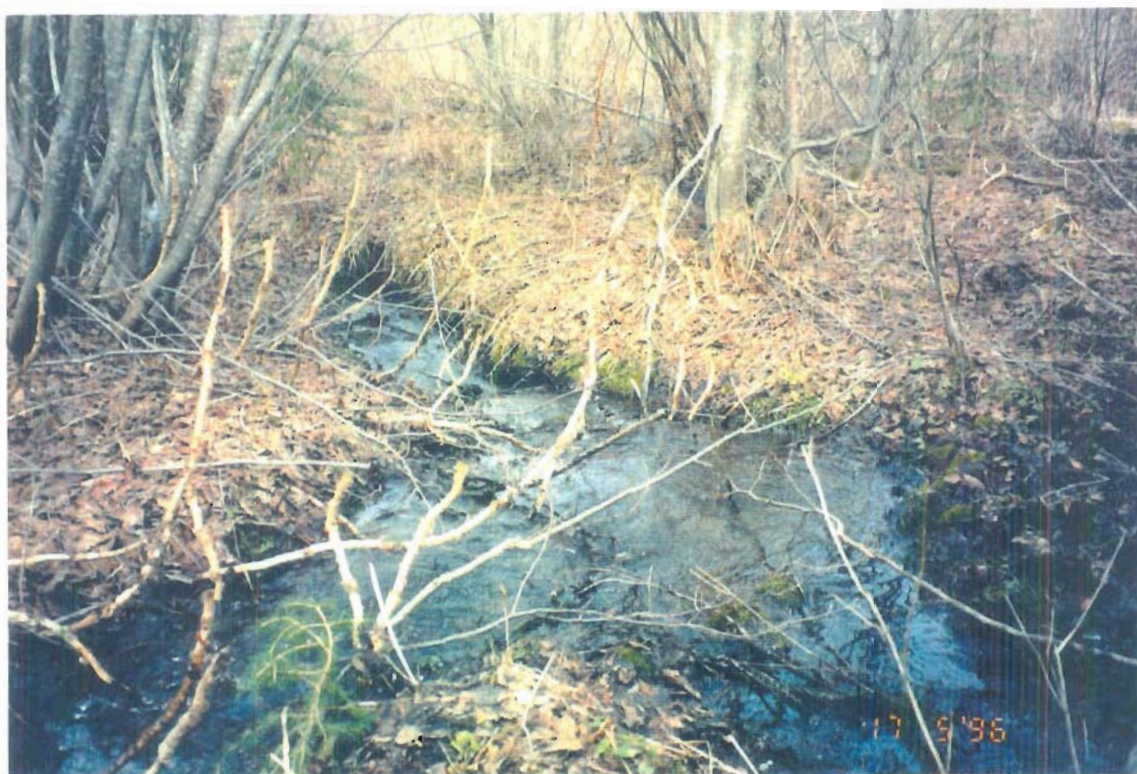
**Photo 18.** Upstream view of Stream EDI-788 at Reach 1.

This stream was given a S-6 classification under the Forest Practices Code.

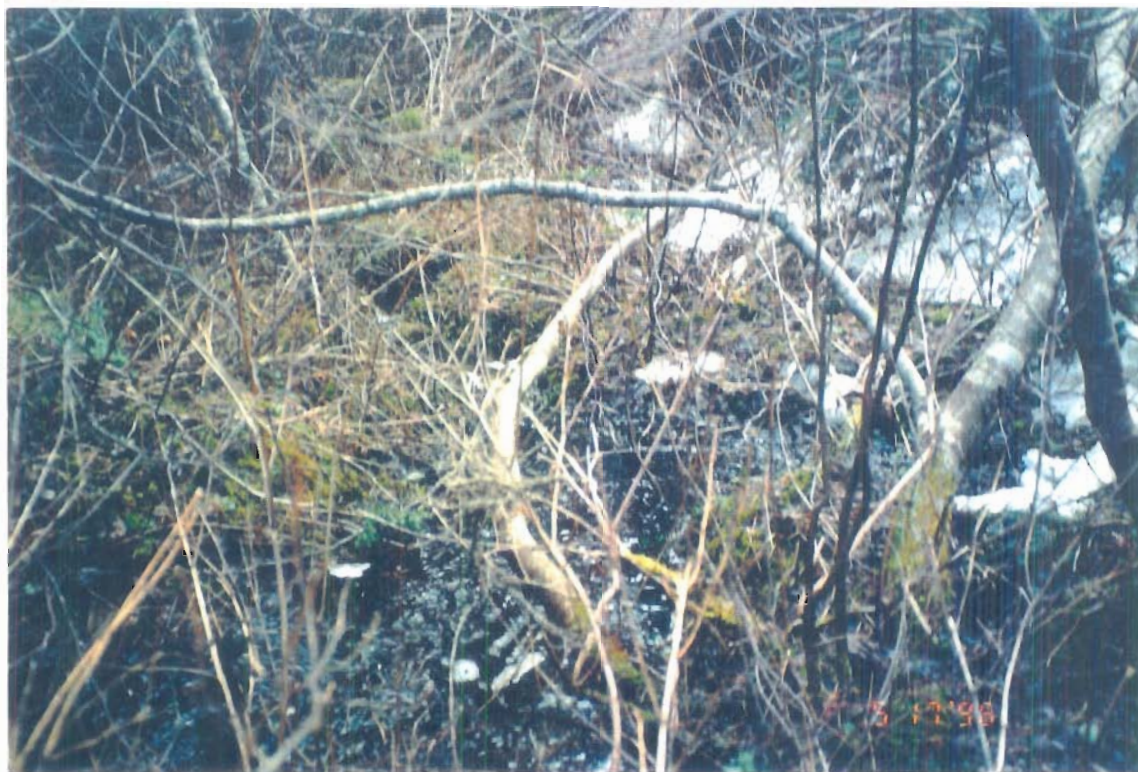
**Photo 25.** Downstream view of Stream 182-5941-711-544-842 at Reach 1.

The stream seems to be seasonal and contains low quality fish habitat and hence was given an S-6 stream classification under the Forest Practices Code. Upstream end of reach contains a 400cm culvert with a 250mm drop which could be a possible fish impasse.

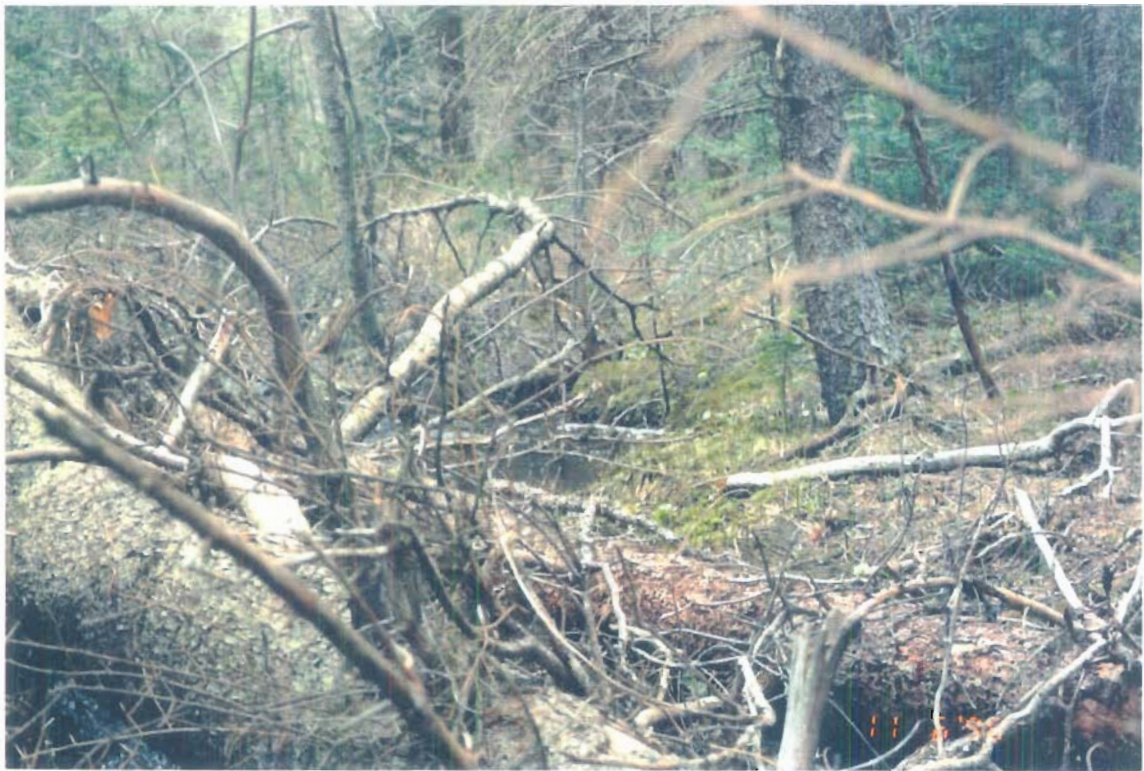
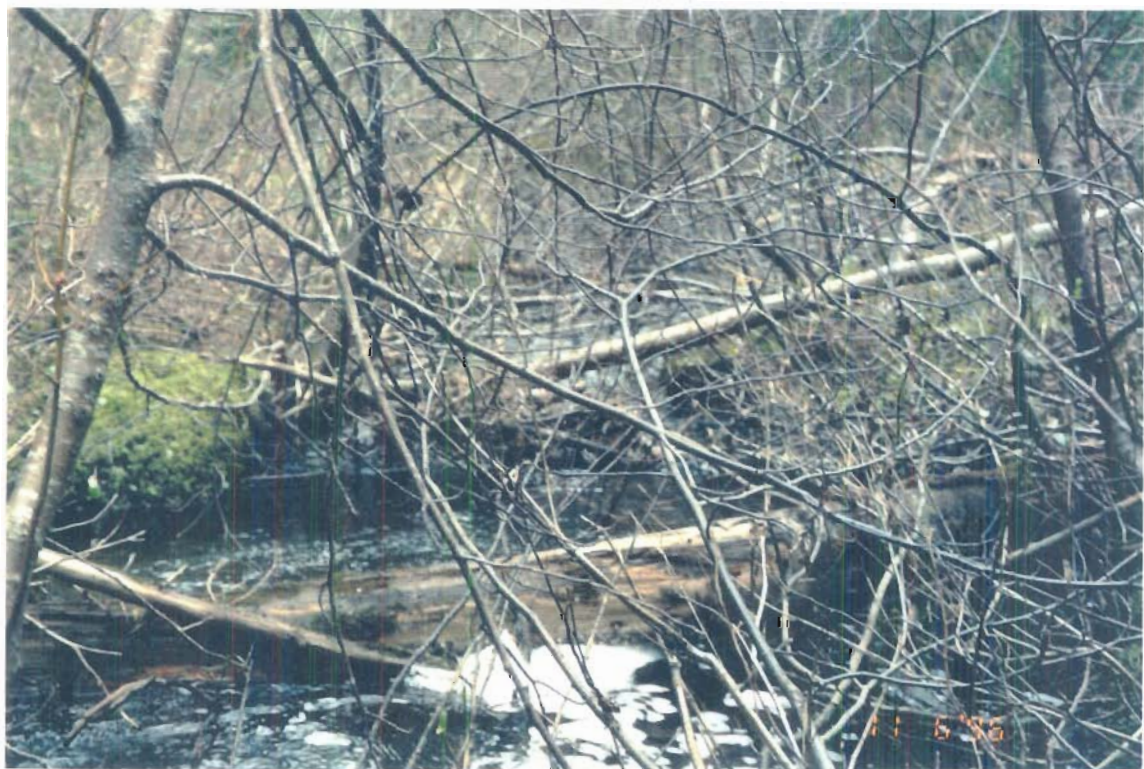
**Photo 42.** Upstream view of Stream 182-6350-570-401 at Reach C.

C1      Film 9: 6 d/s, 7 u/s.  
Note: Reach '997' should read Reach 'C'.  
Fish sampling (electroshocking) was conducted for 60 seconds. No fish were captured.  
This stream was assigned a defaulted S-3 classification under the Forest Practices Code.

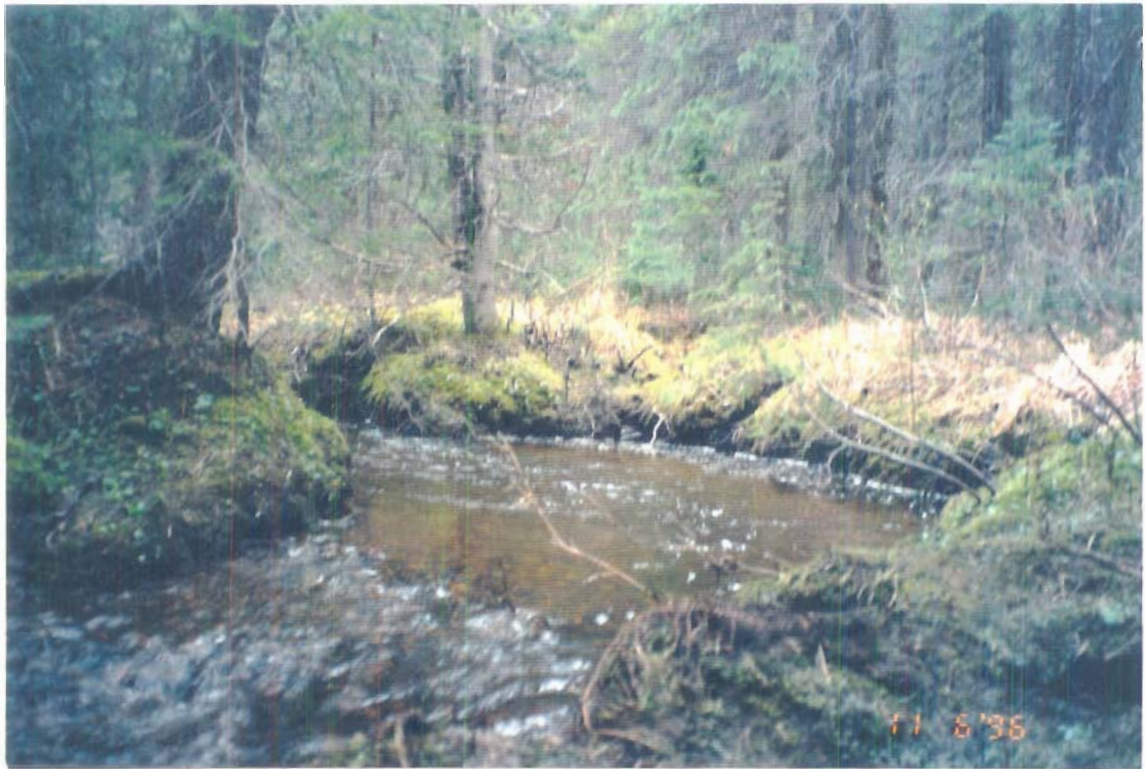
**Photo 44.** Upstream view of Stream 182-6350-570-401 at Reach D.

This stream has been defaulted to a S-3 classification. There is a wetland upstream of the upper limit, and should be considered a Fisheries Sensitive Zone.

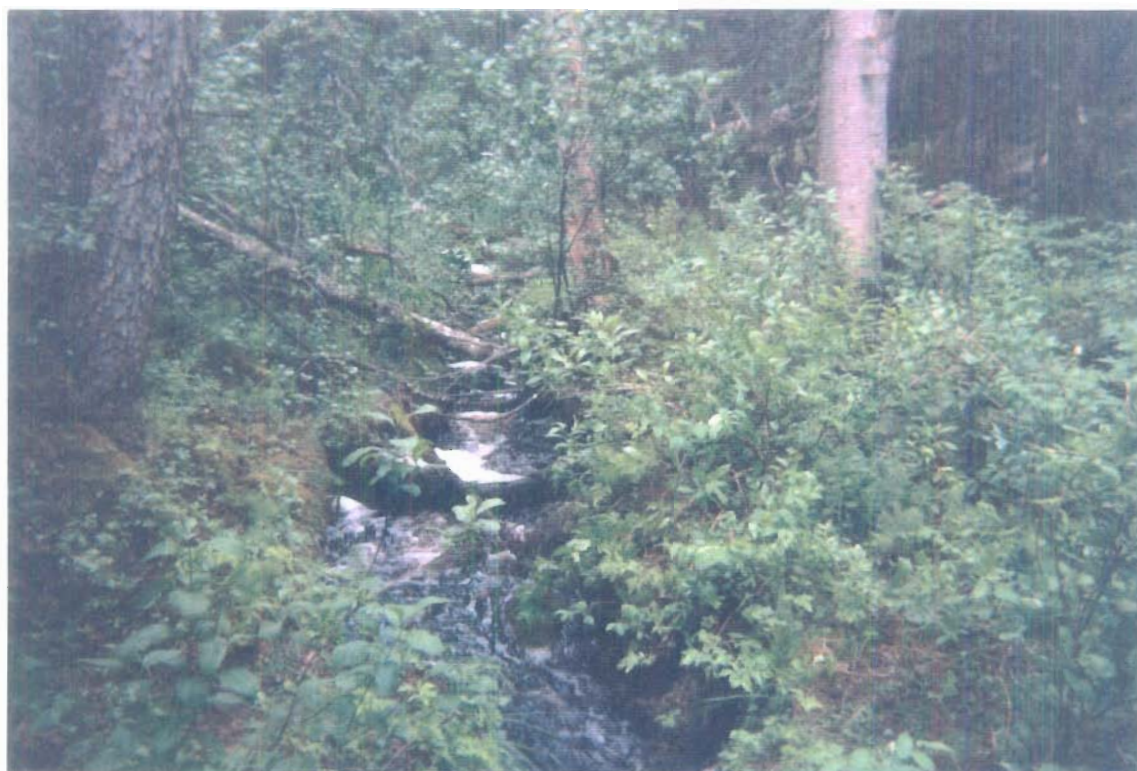
**Photo 46.** Upstream view of Stream 182-6350-570-401-205 at Reach 1.

Location 1: There is a 50 cm falls at the confluence of this stream with 182-6350-570-401. No jump pool has developed beneath the falls. Therefore this is likely a barrier to upstream migration for juvenile salmonids.

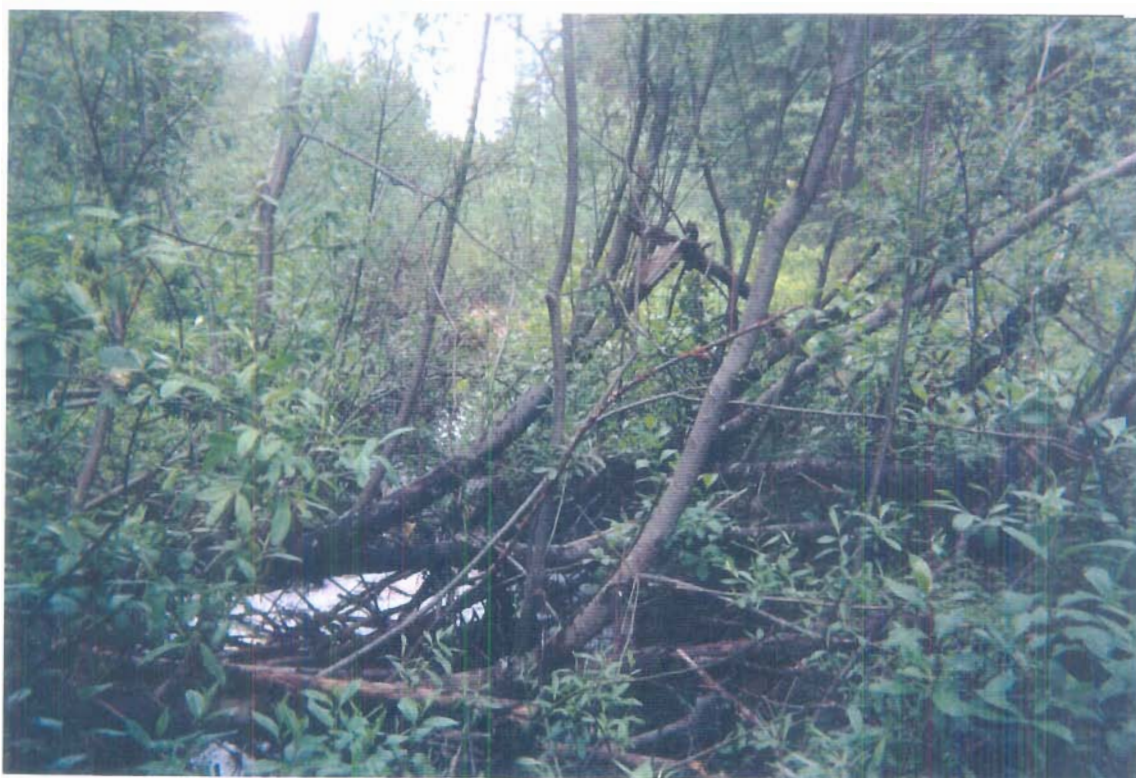
**Photo 48.** Upstream view of Stream 182-6350-570-438 at Reach A

Location 1: The beaver dam located at the lower reach break for this reach and 13 km upstream of the confluence with 182-6350, is a possible barrier to fish passage.

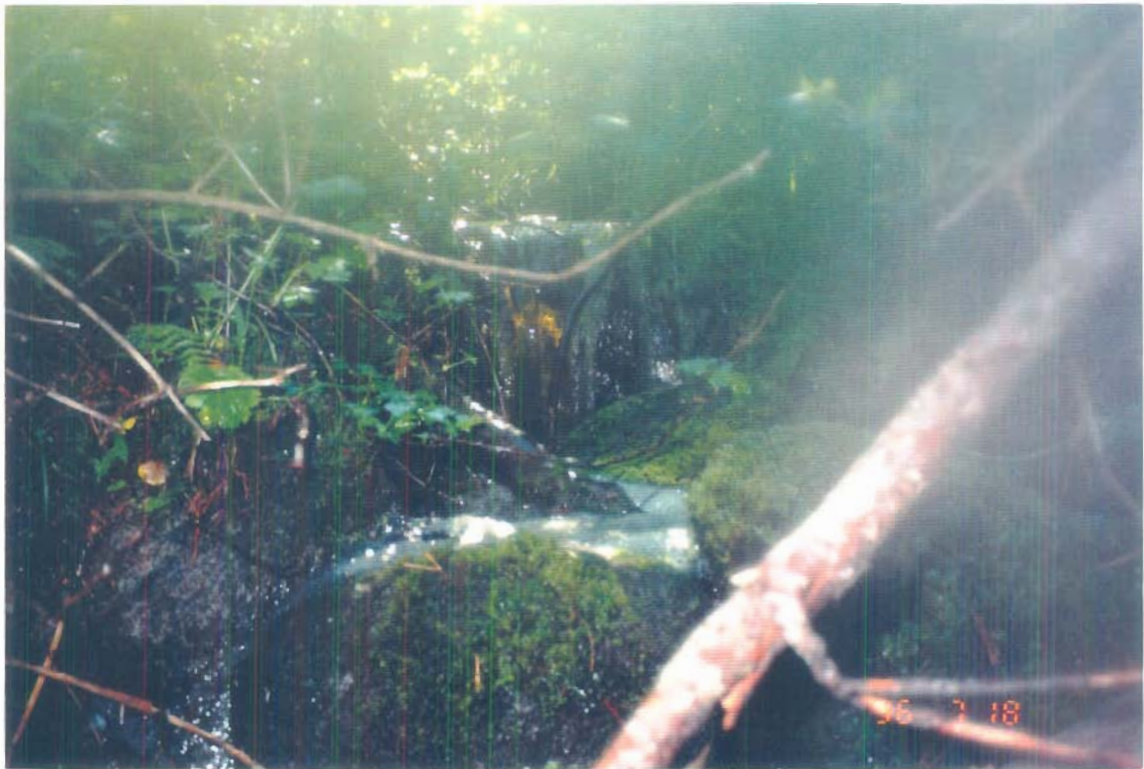
**Photo 89.** Upstream view of Stream 182-6350-570-220-274 at Reach 1.

C1      Film 11: 10 w/s, 11 u/s, 12 d/s.  
Fish sampling (electroshocking) was conducted for 241 seconds. No fish were captured or observed.  
This reach was assigned a S-6 classification under the Forest Practices Code.
