## **1995 AND 1996 FISH AND FISH HABITAT INVENTORY**

### **WITHIN THE STUART LAKE AND BABINE LAKE**

### **WATERSHED GROUPS**

#### **Volume 3 of 3**

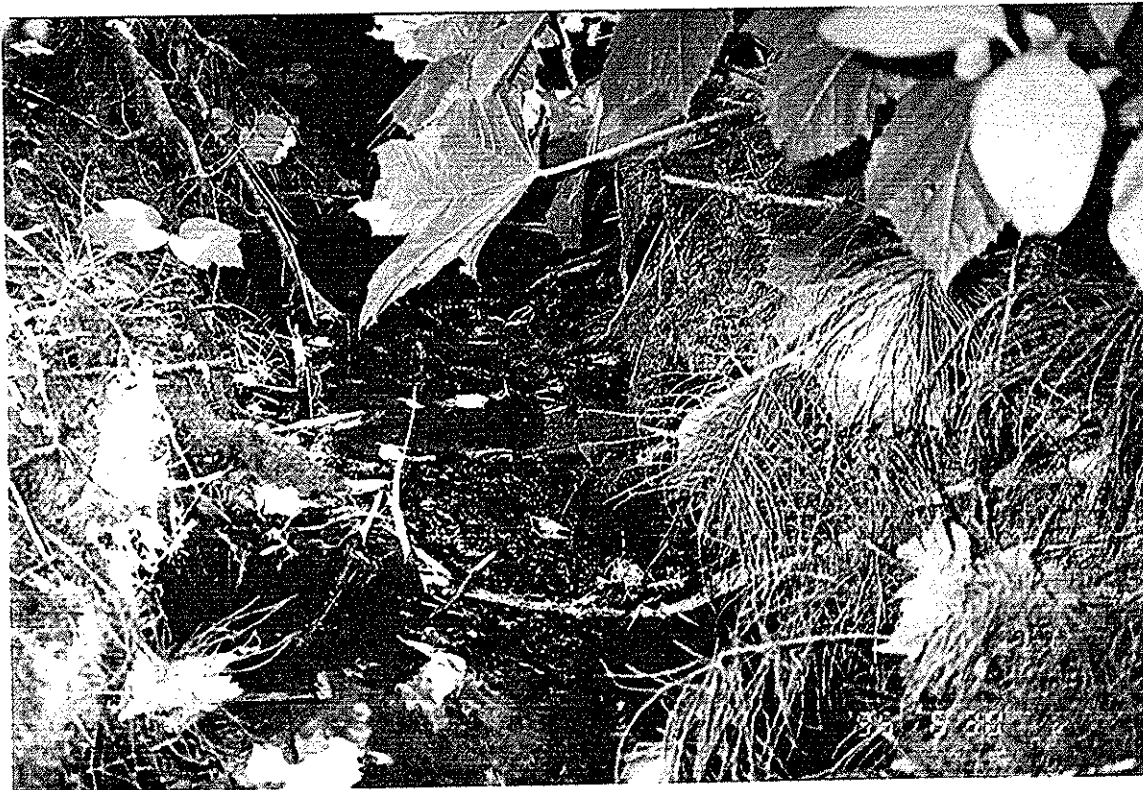
Fish sampling was not conducted in this reach. No fish were observed.

This reach was given a S-6 classification under the Forest Practices Code.

**Photo 178.** Upstream view of Stream 182-9146-525 at Reach 1.

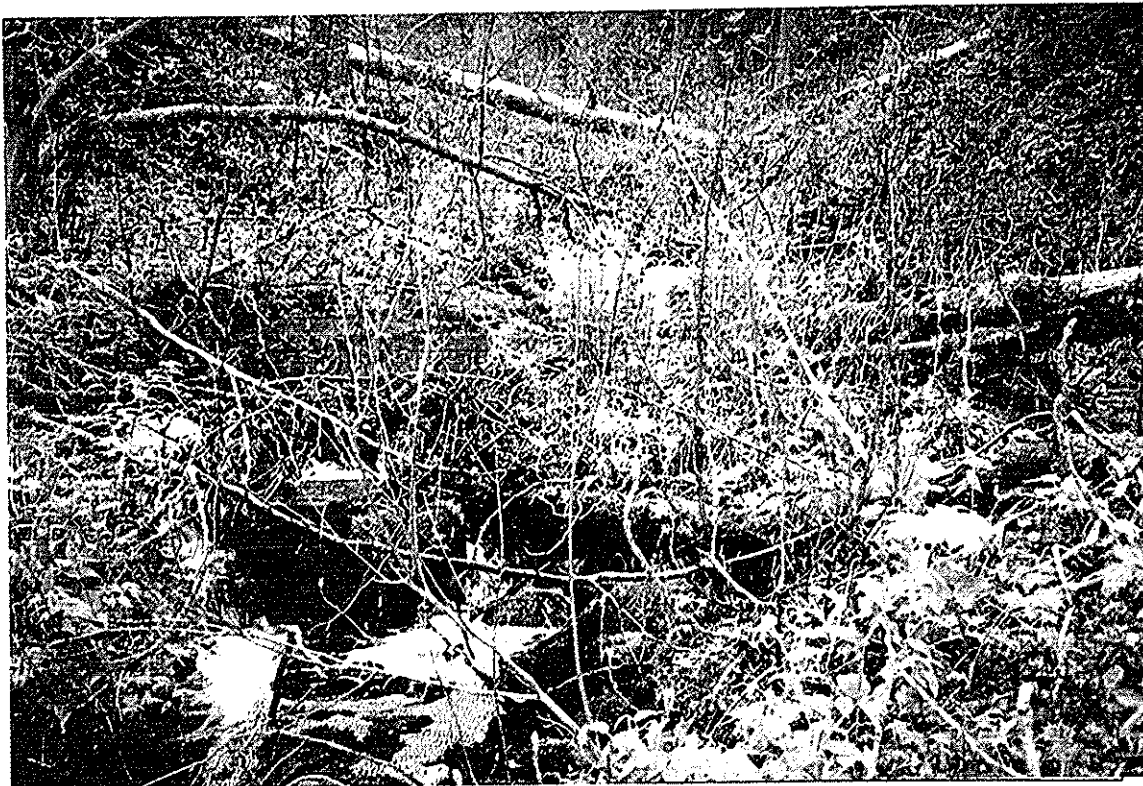
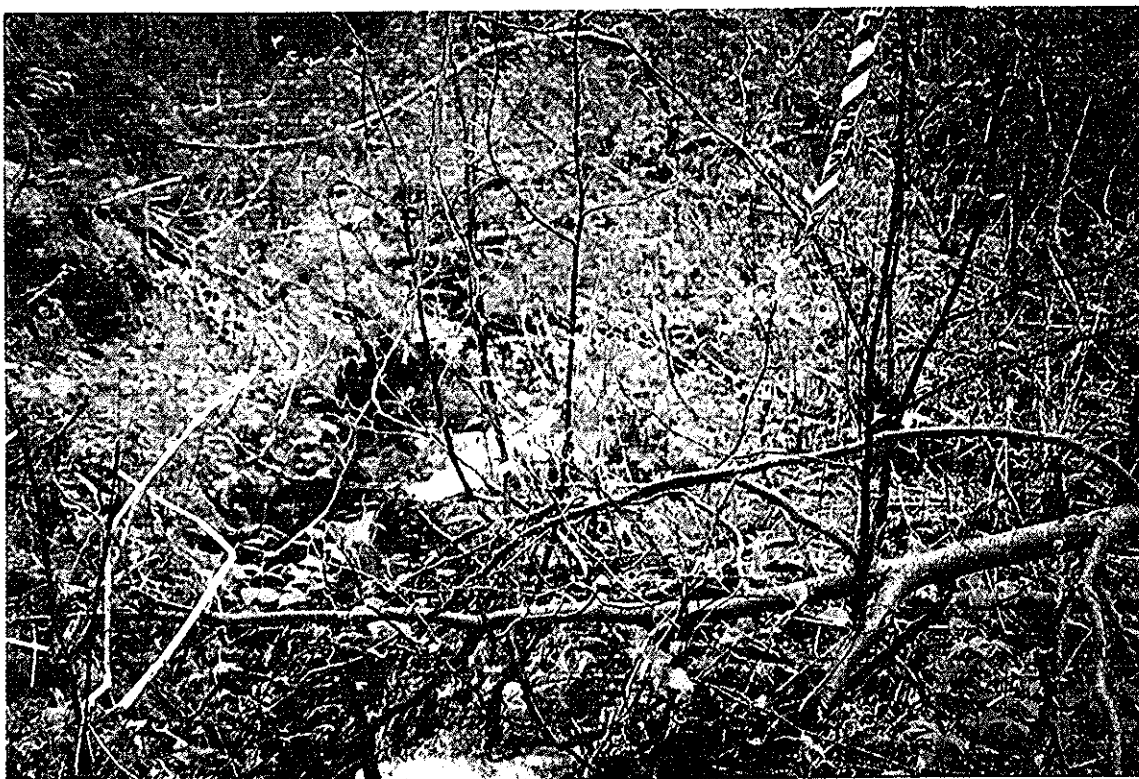
Fish sampling (electroshocking) was conducted for 349 seconds and one Rb was caught. Two other fish were observed but not identified.

The good fish habitat combined with the presence of regionally significant fish in this reach have determined that this stream be classified an S-3 under the Forest Practices Code.

**Photo 179.** Upstream view of Stream 182-9146-622 at Reach A.

**Photo 180.** Downstream view of Stream 182-9146-622 at Reach A.

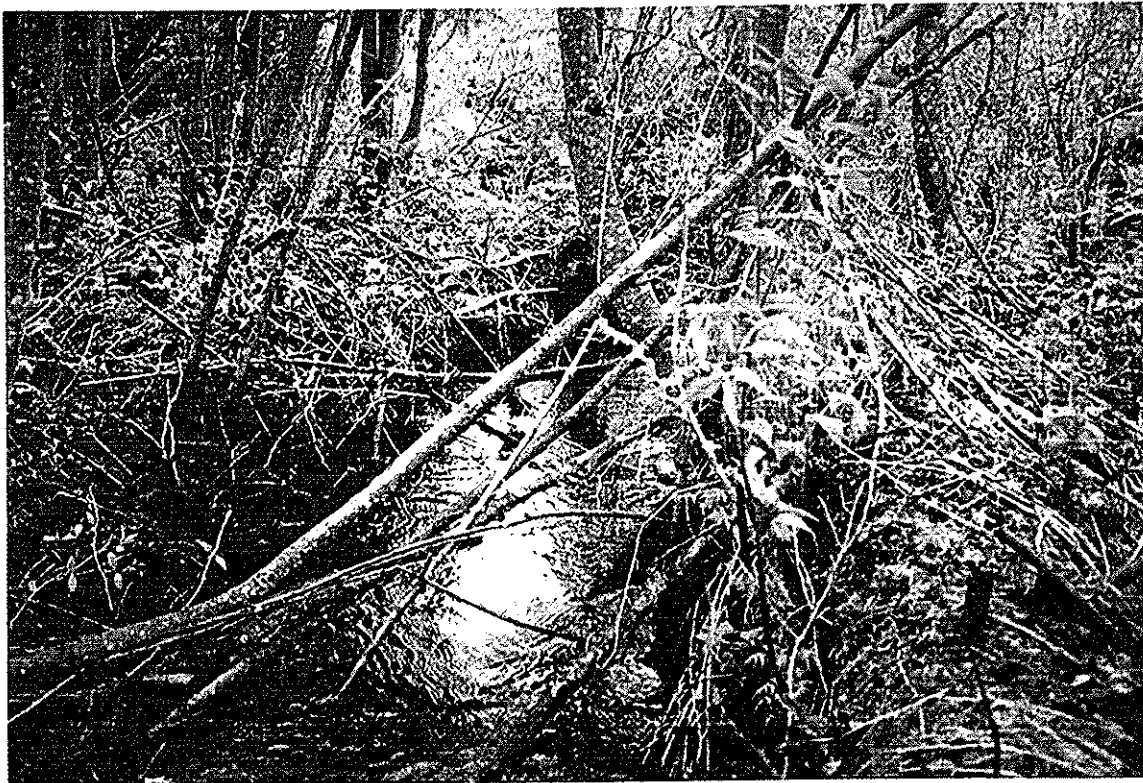
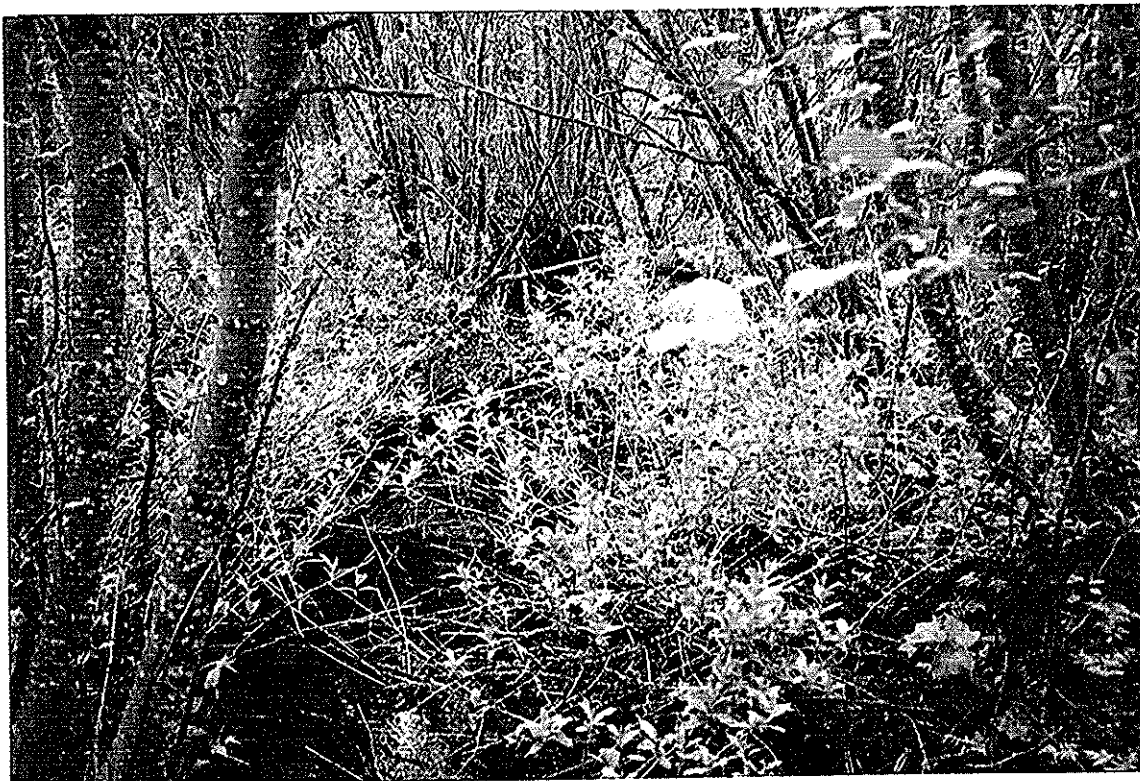
Fish sampling (electrofishing) was conducted for 75 seconds and no fish were caught or observed.

This stream has good rearing habitat and flows into a stream containing Rb. As a result, this stream has been defaulted to an S-3 stream under the Forest Practices Code, even though no fish were caught.

**Photo 181.** Upstream view of Stream 182-9146-622-391 at Reach 1.

**Photo 182.** Downstream view of Stream 182-9146-622-391 at Reach 1.

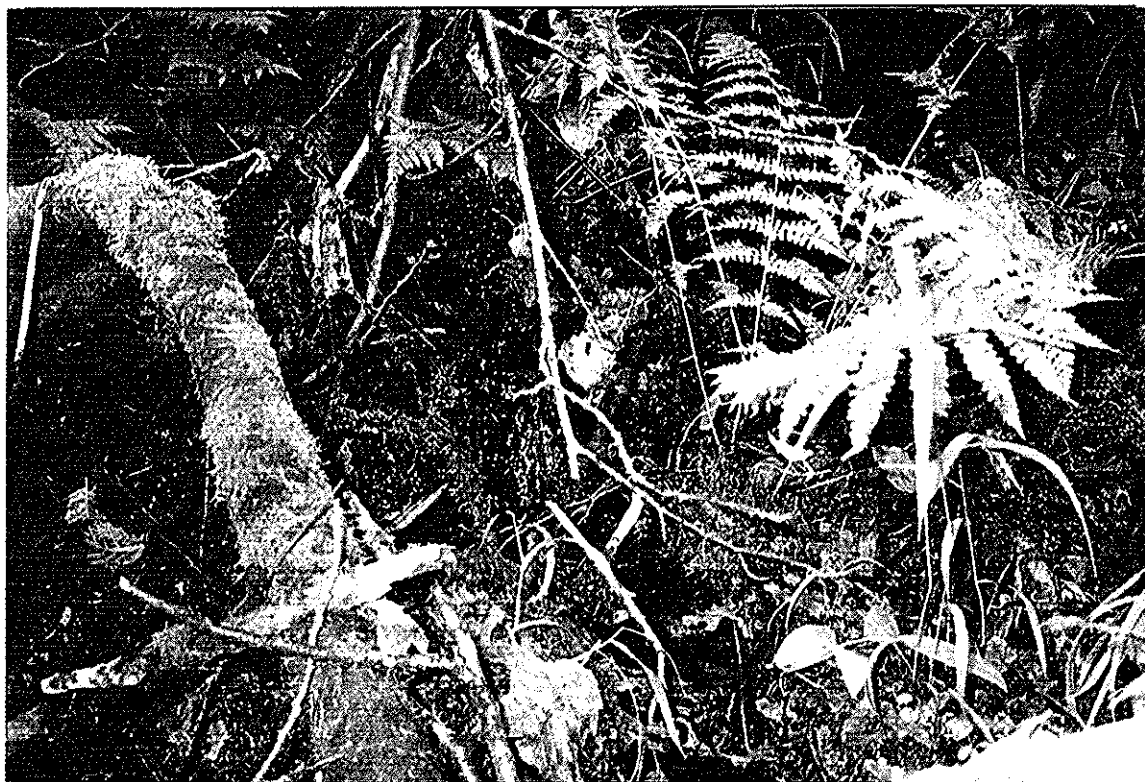
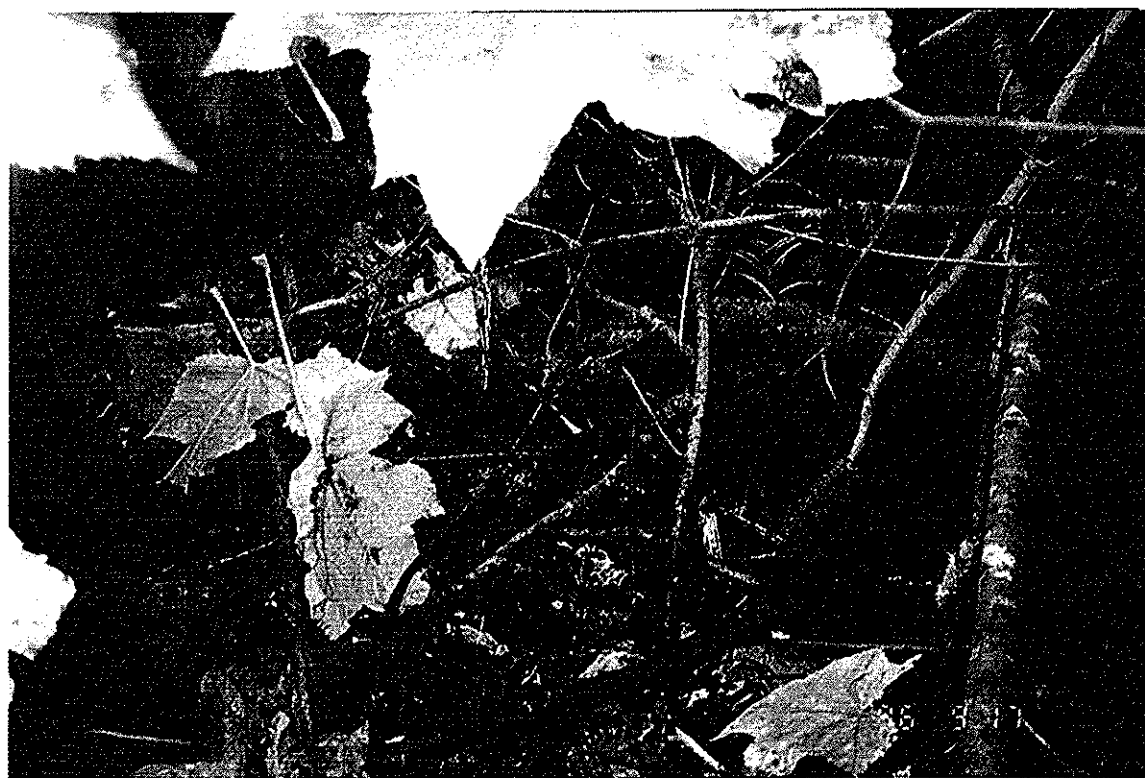
Fish sampling (electrofishing) was conducted for 75 seconds and no fish were captured or observed.

This reach was given a S-6 classification under the Forest Practices Code.

**Photo 183.** Upstream view of Stream EDI-845 at Reach 1.

**Photo 184.** Downstream view of Stream EDI-845 at Reach 1.

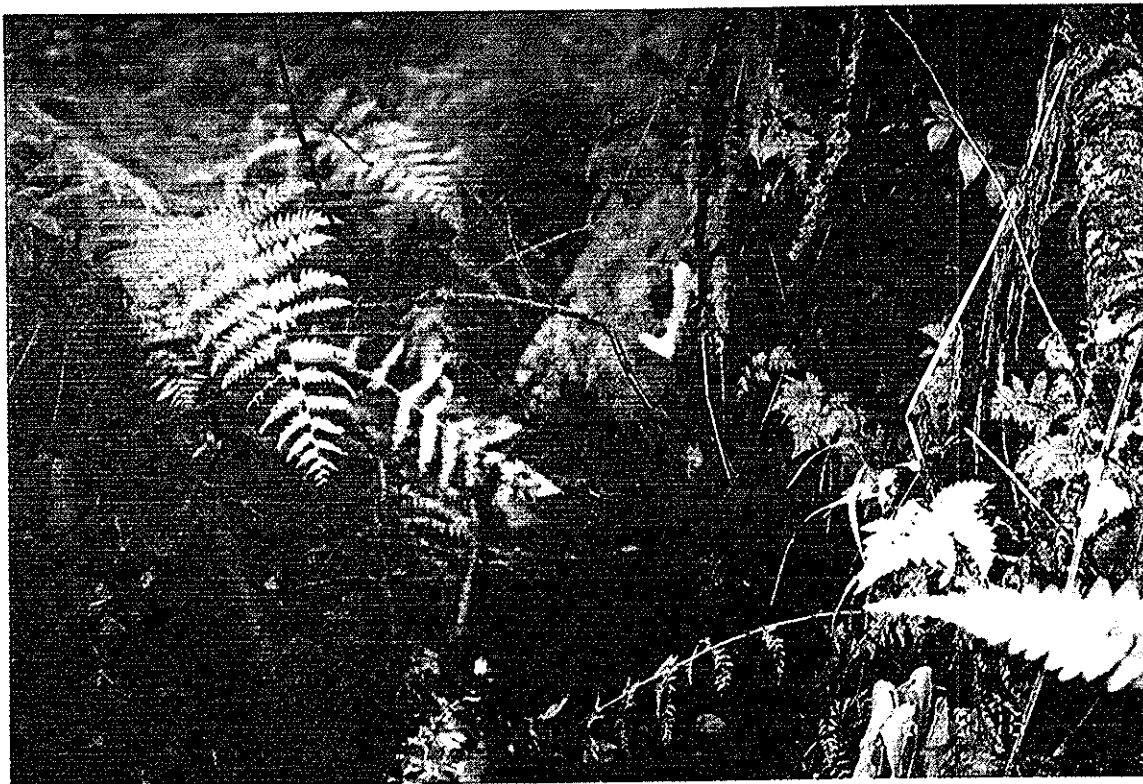
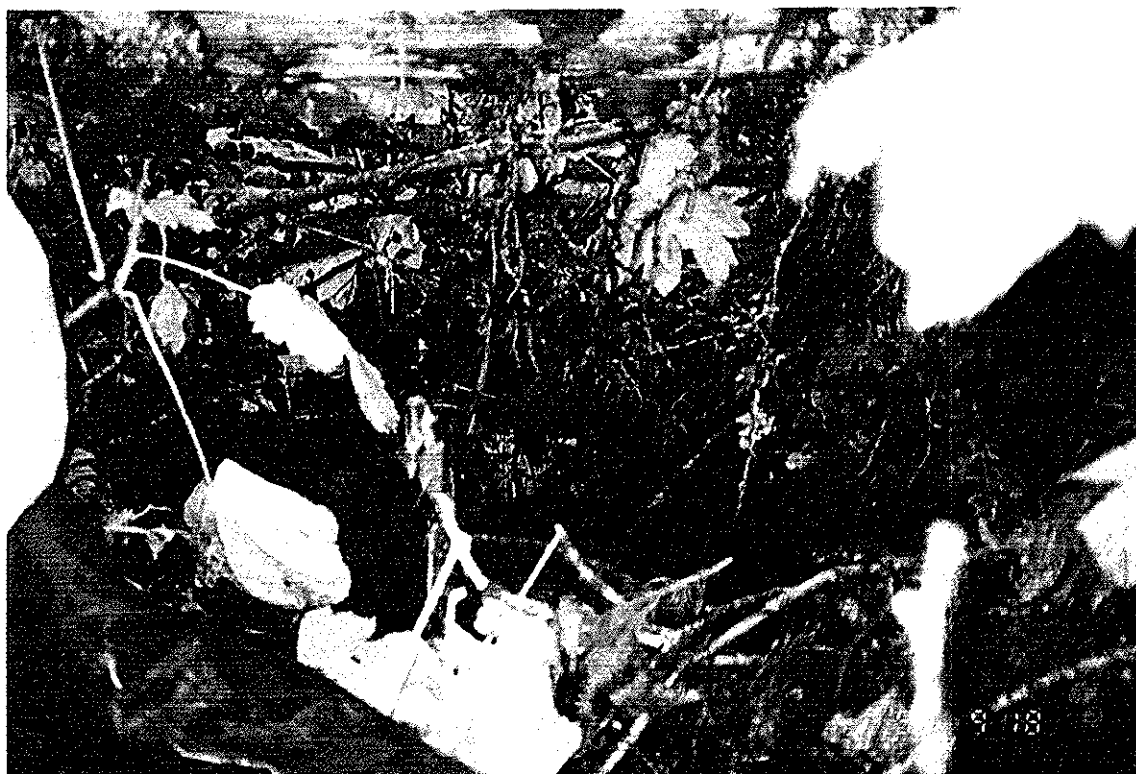
Fish sampling (electroshocking) was conducted for 175 seconds. Rainbow trout were captured.

This reach has been given a S-4 classification under the Forest Practices Code.

Photo 186. Upstream view of Stream EDI-536 at Reach 2.

Photo 187. Downstream view of Stream EDI-536 at Reach 2.

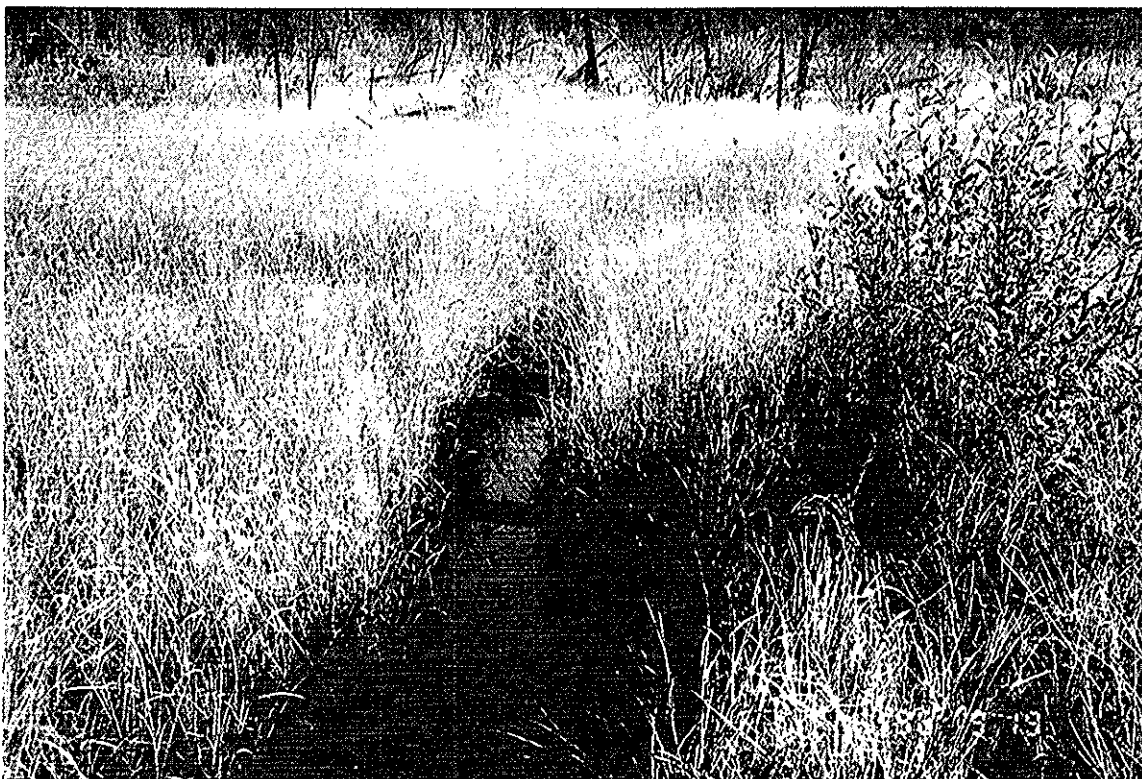
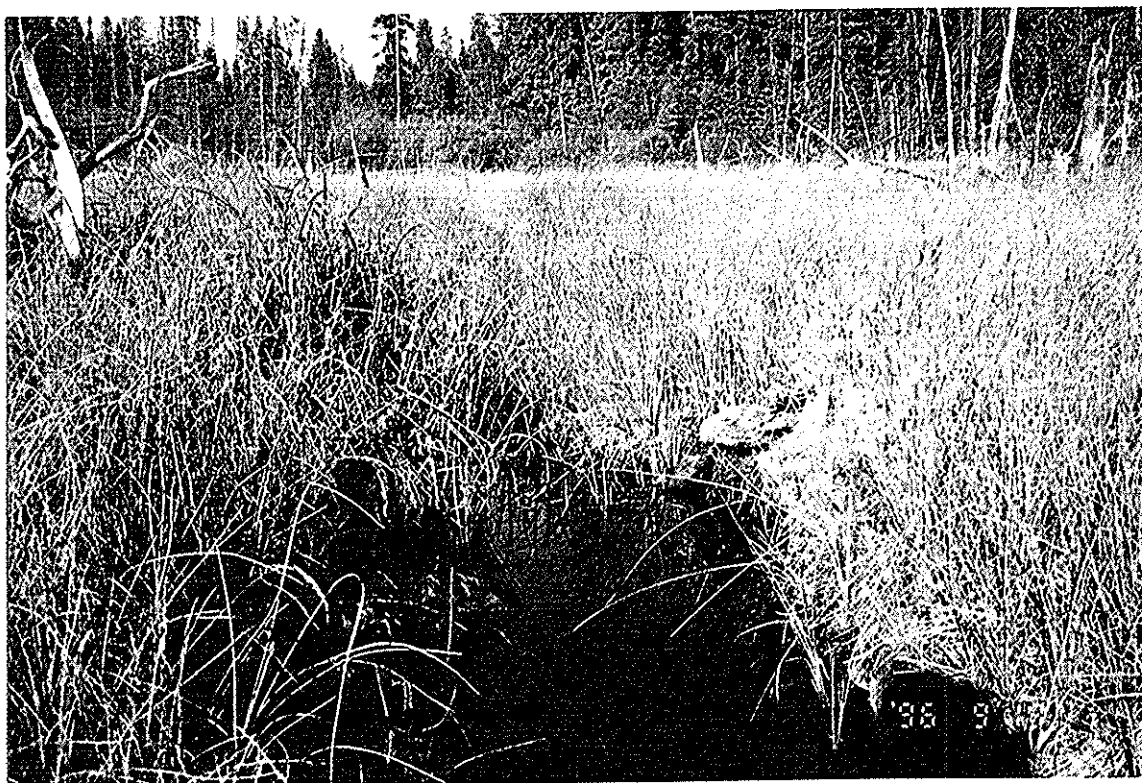
Fish sampling (electroshocking) was conducted for 247 seconds. No fish were captured or observed.

This reach was given a defaulted S-4 classification under the Forest Practices Code.

Photo 188. Upstream view of Stream EDI-536 at Reach 3.

Photo 189. Downstream view of Stream EDI-536 at Reach 3.

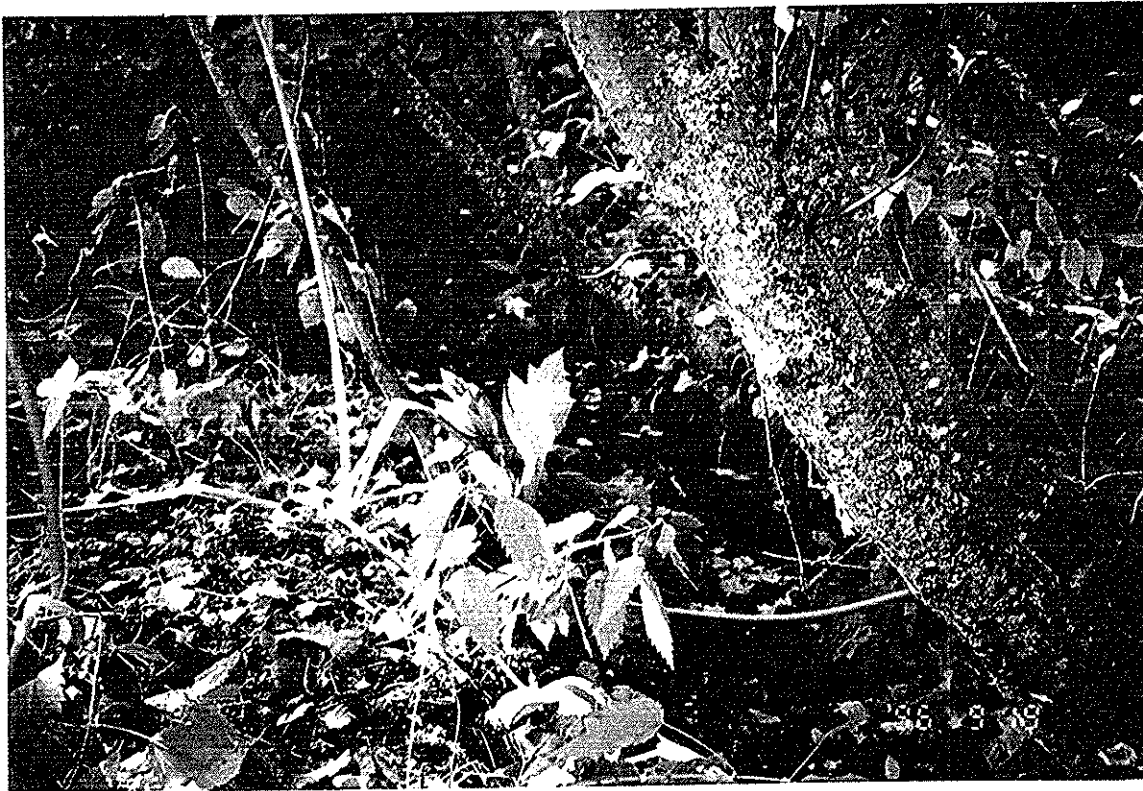
Fish sampling (electroshocking) was conducted for 98 seconds. No fish were captured or observed.

This reach was given a S-6 classification under the Forest Practices Code.

**Photo 190.** Upstream view of Stream EDI-536 at Reach 4.

**Photo 191.** Downstream view of Stream EDI-536 at Reach 4.

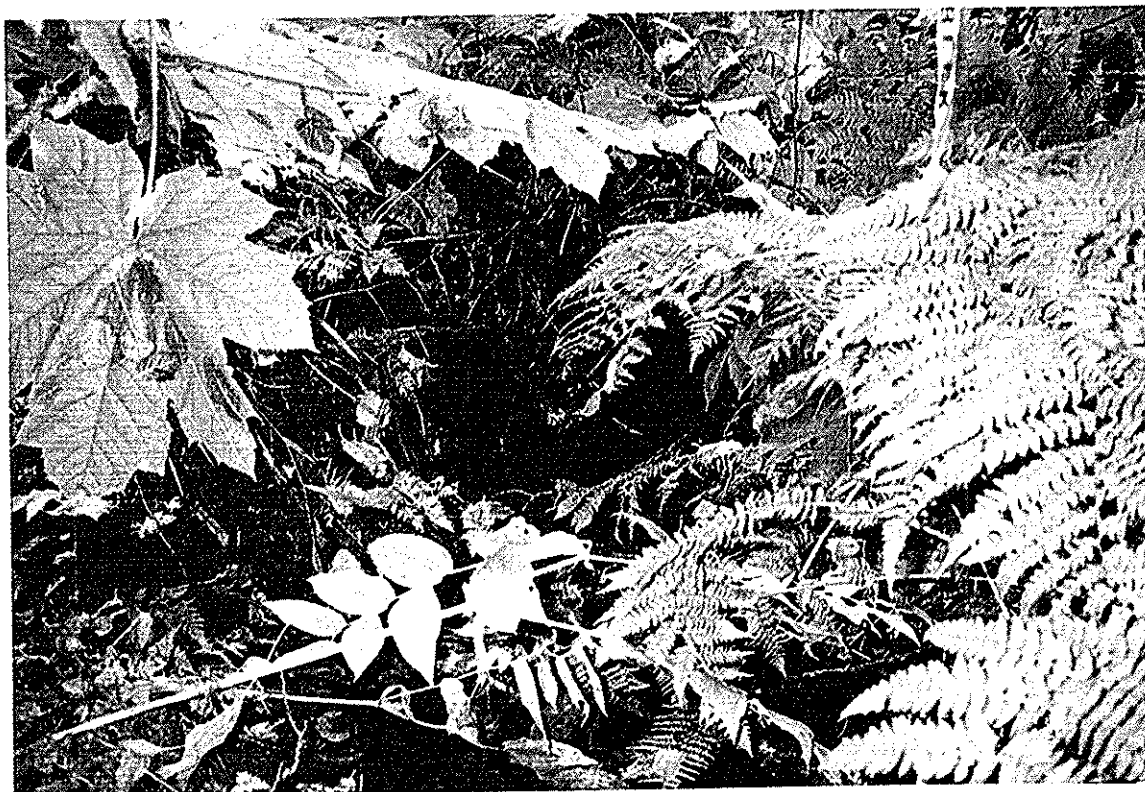
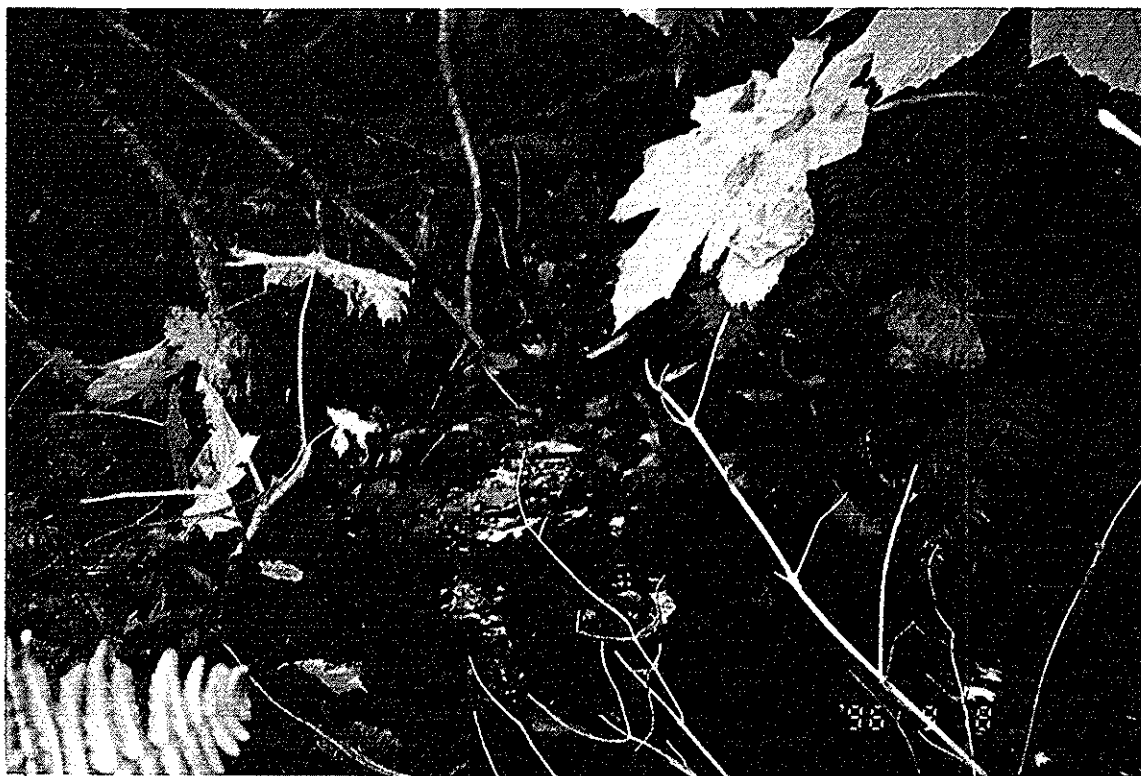
Fish sampling (electroshocking) was conducted for 32 seconds. No fish were captured or observed.

This site was given a S-6 classification under the Forest Practices Code.

Photo 192. Upstream view of Stream EDI-536 at Site 1.

Photo 193. Downstream view of Stream EDI-536 at Site 1.

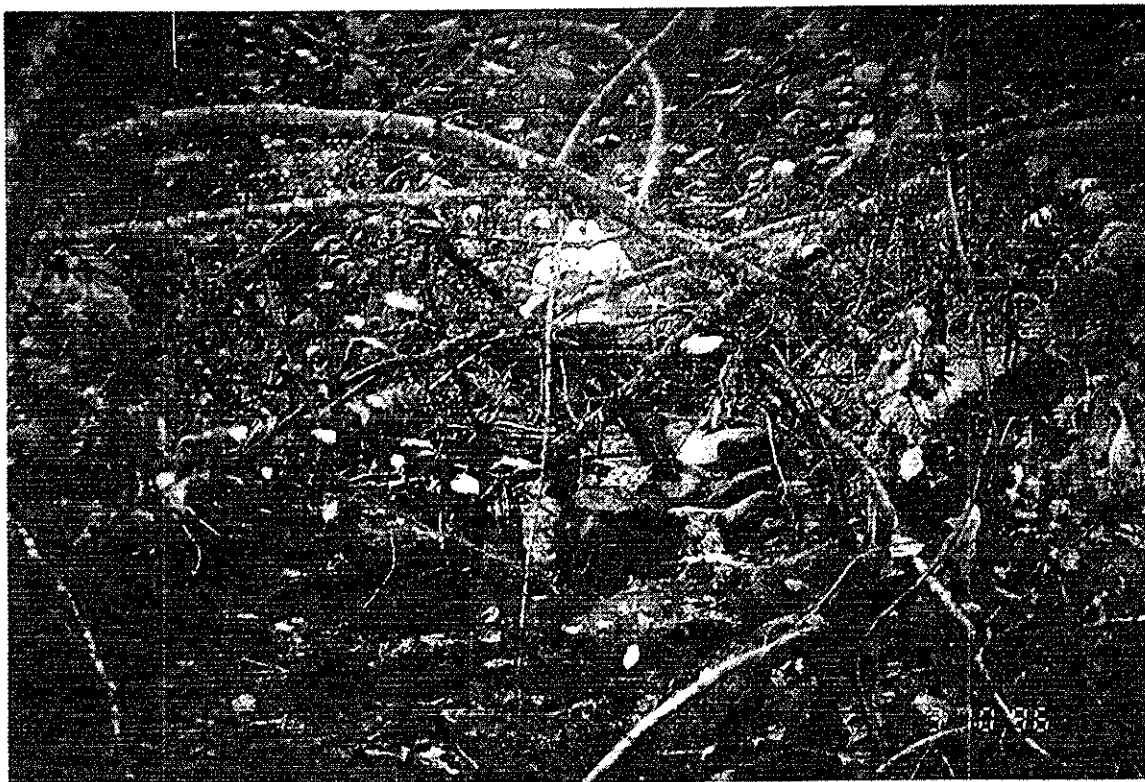
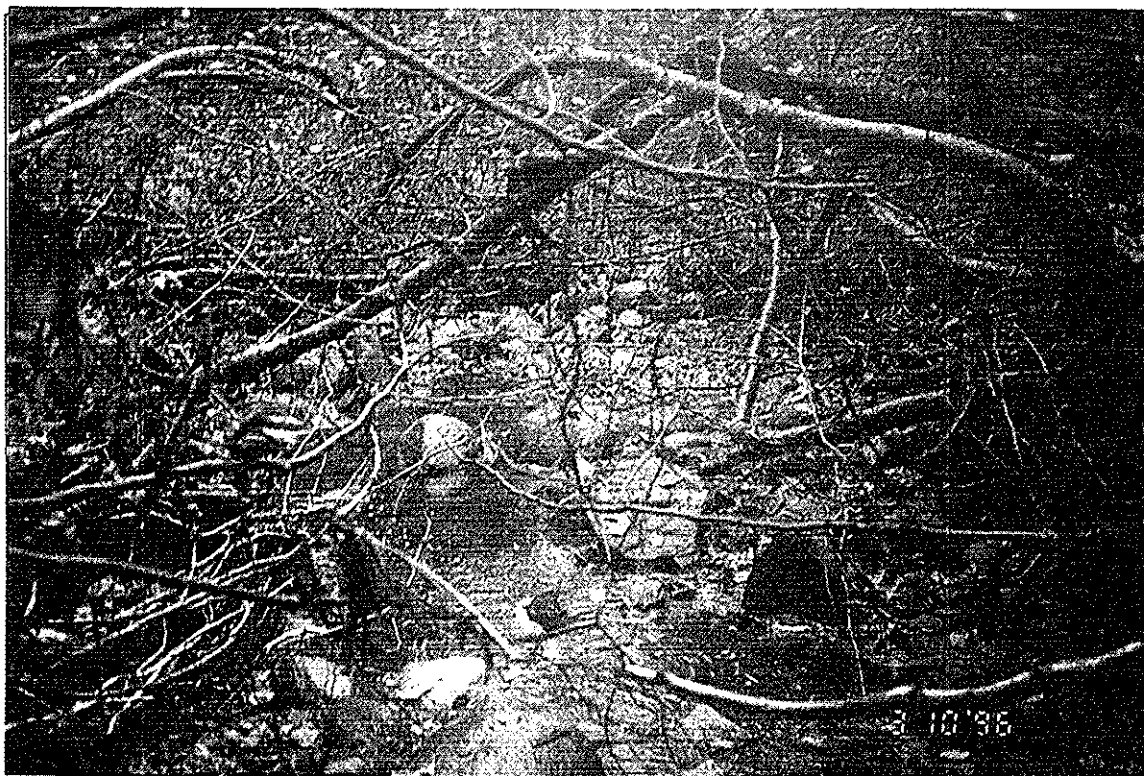
Fish sampling (electroshocking) was conducted for 96 seconds. No fish were captured or observed.

This reach was defaulted to a S-3 classification under the Forest Practices Code.

Photo 194. Upstream view of Stream 182-9146-727 at Reach 1.

Photo 195. Downstream view of Stream 182-9146-727 at Reach 1.

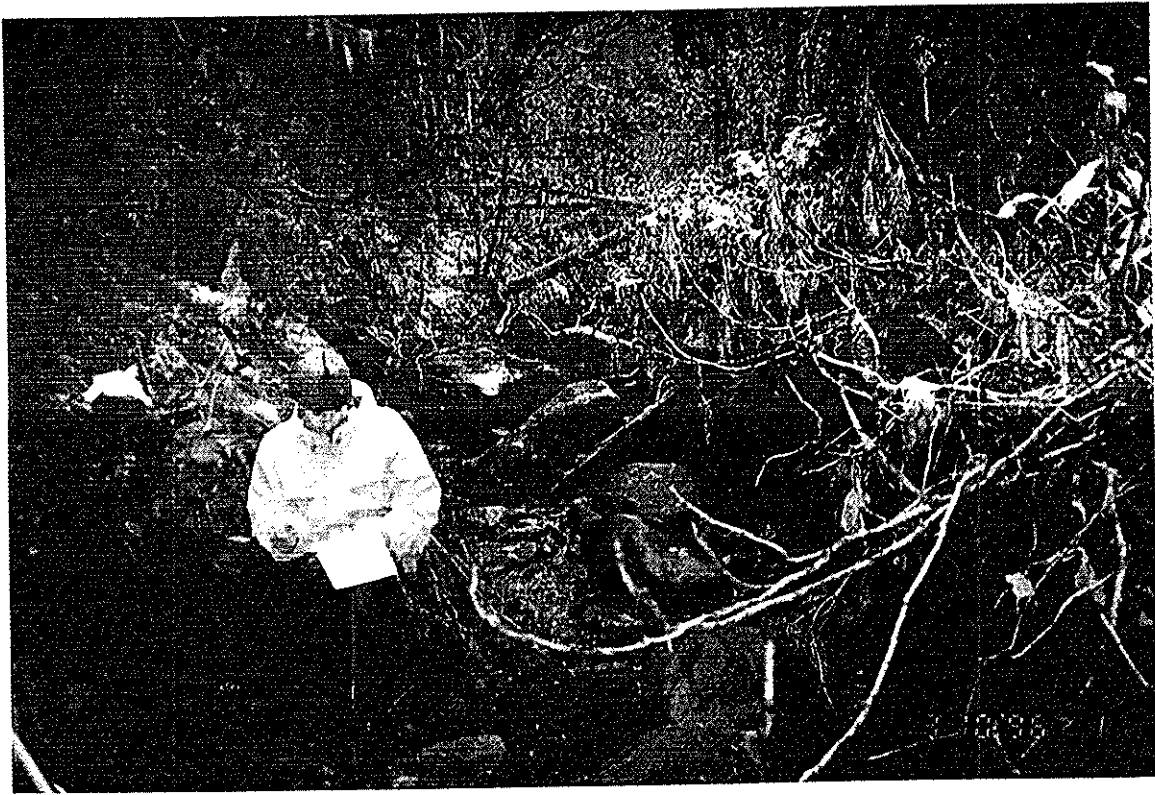
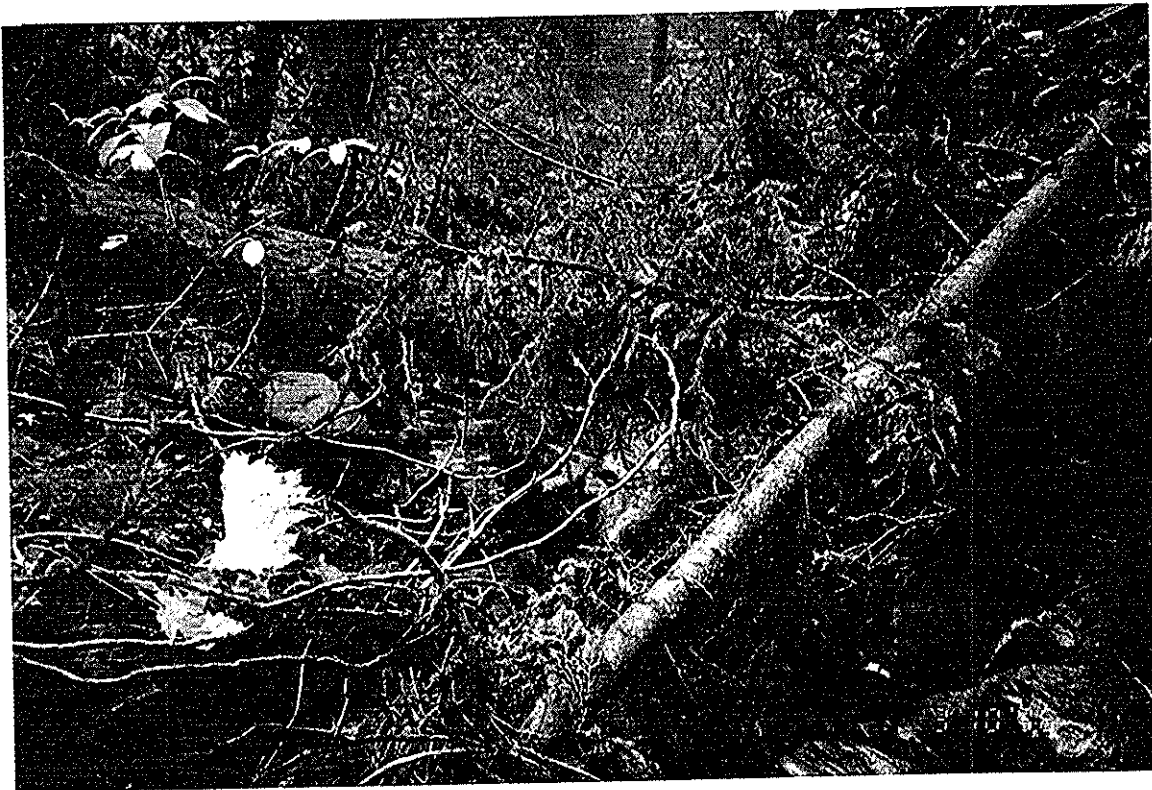
Fish sampling (electrofishing) was conducted for 266 seconds. No fish were captured or observed.

This reach has been given a defaulted S-3 classification under the Forest Practices Code.

**Photo 196.** Upstream view of Stream 182-9146-727 at Reach 2.

**Photo 197.** Downstream view of Stream 182-9146-727 at Reach 2.

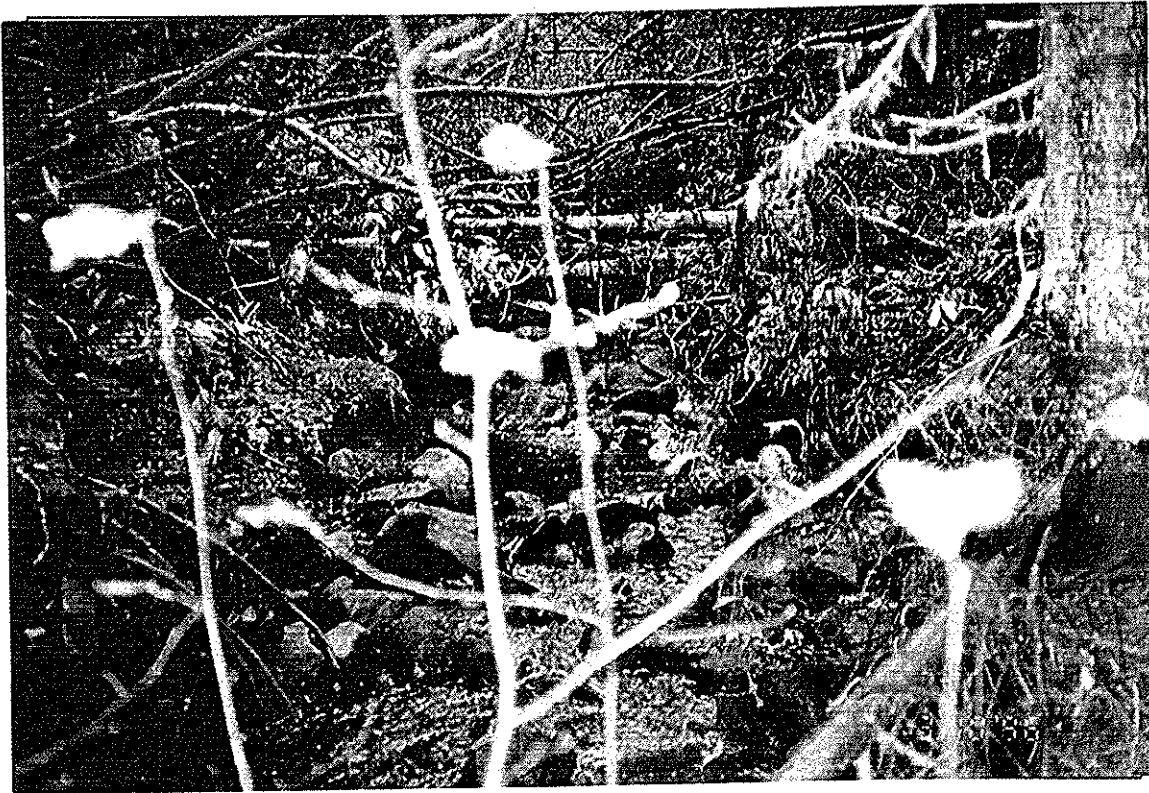
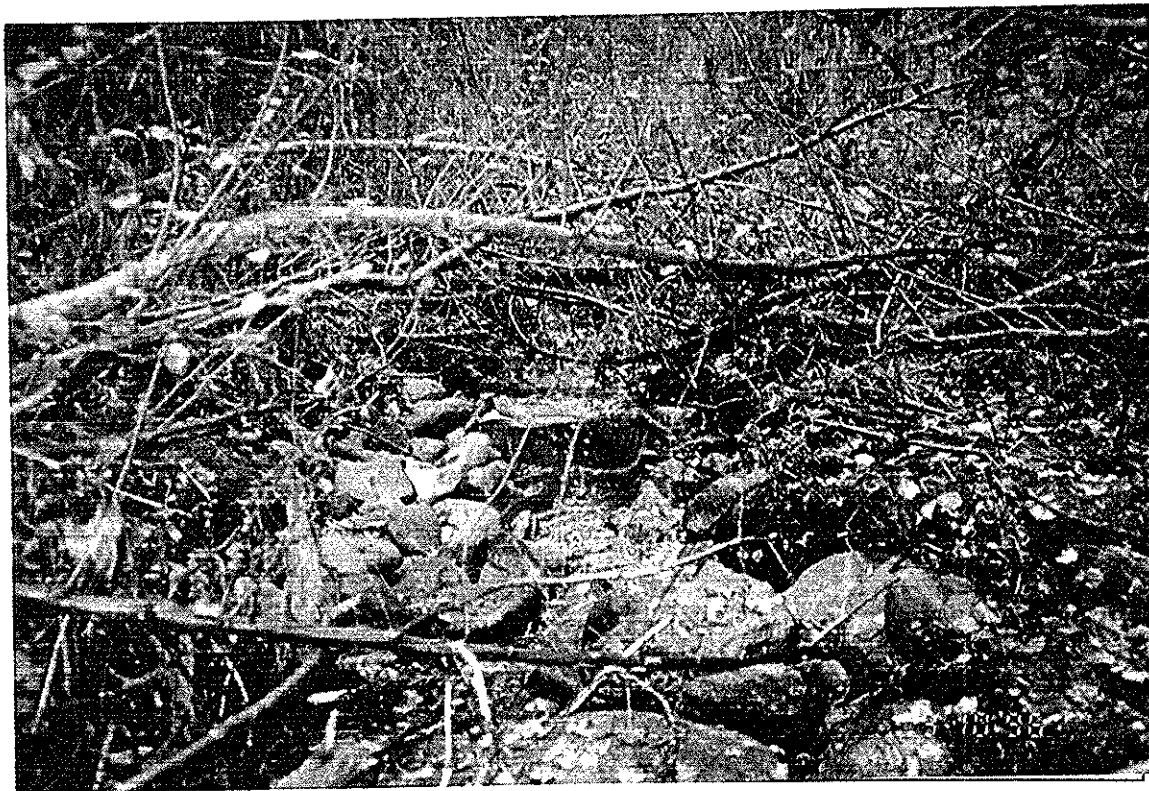
Fish sampling (electroshocking) was conducted for 321 seconds. No fish were captured or observed.

This section of stream was defaulted to a S-3 classification under the Forest Practices Code.

**Photo 198.** Upstream view of Stream 182-9146-727 at Reach 3.

**Photo 199.** Downstream view of Stream 182-9146-727 at Reach 3.

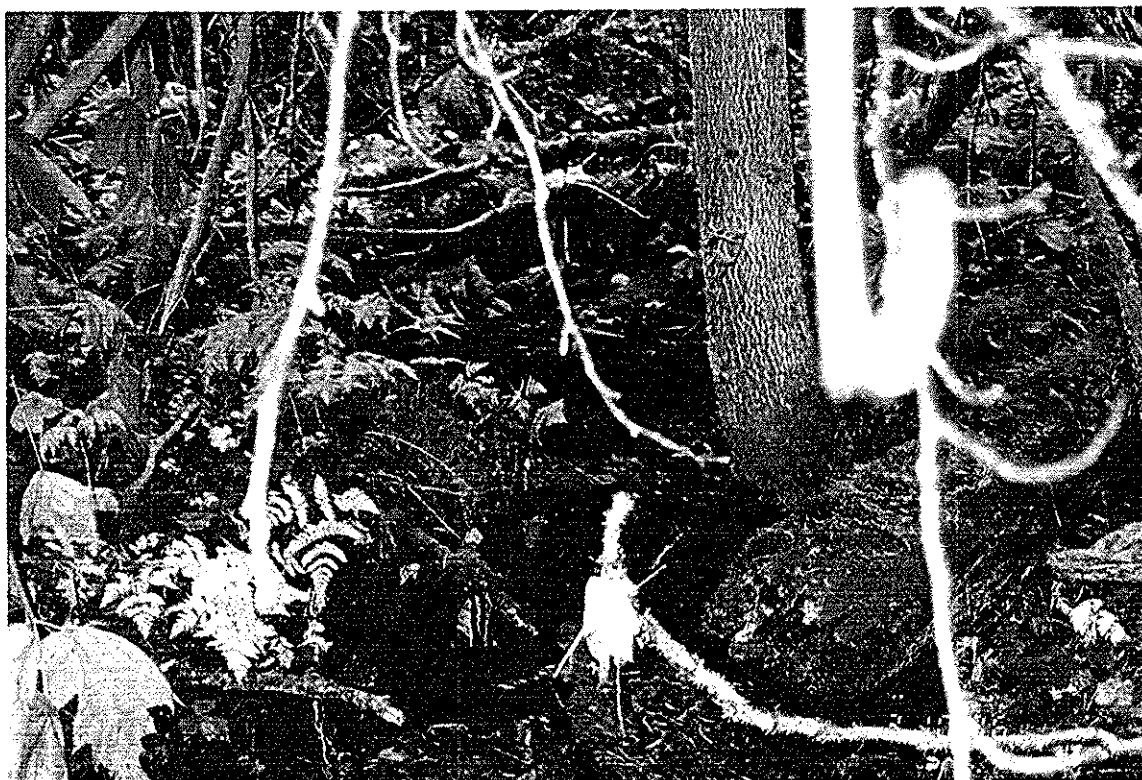
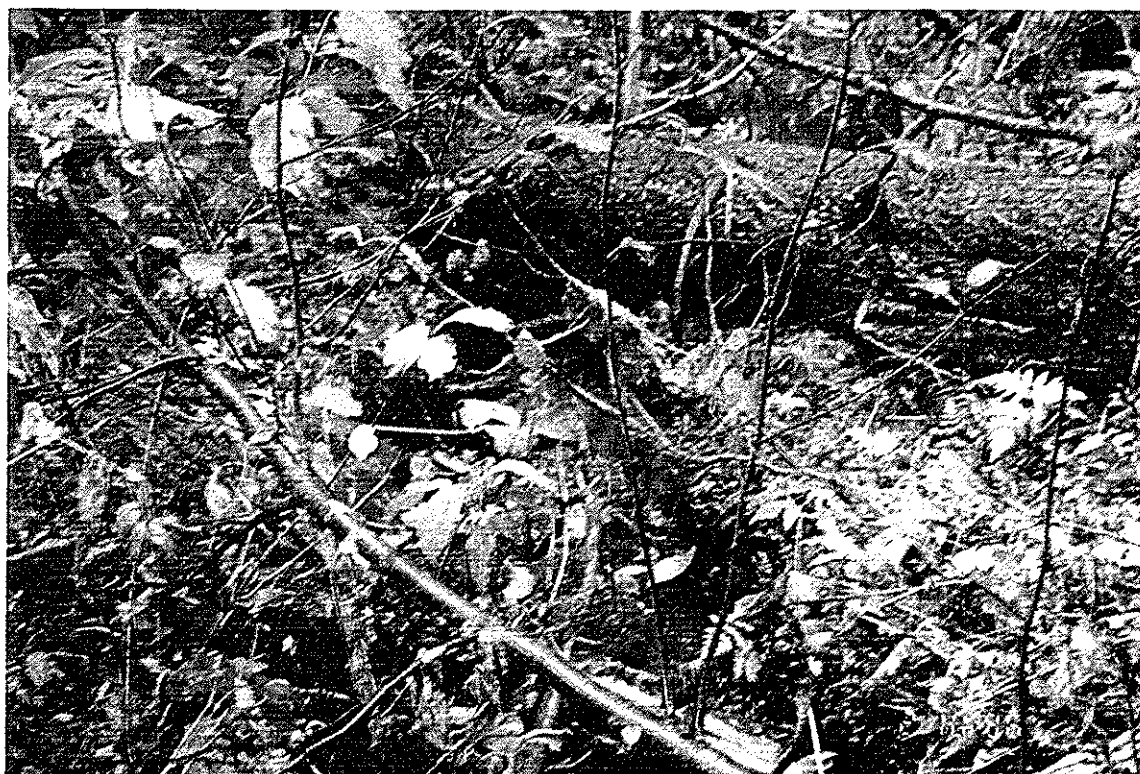
Fish sampling was conducted for 90 seconds (Setting M7, 300V). No fish were captured or observed.

This reach was defaulted to a S-4 classification under the Forest Practices Code.

**Photo 200.** Upstream view of Stream 182-9146-786 at Reach 1.

**Photo 201.** Downstream view of Stream 182-9146-786 at Reach 1.

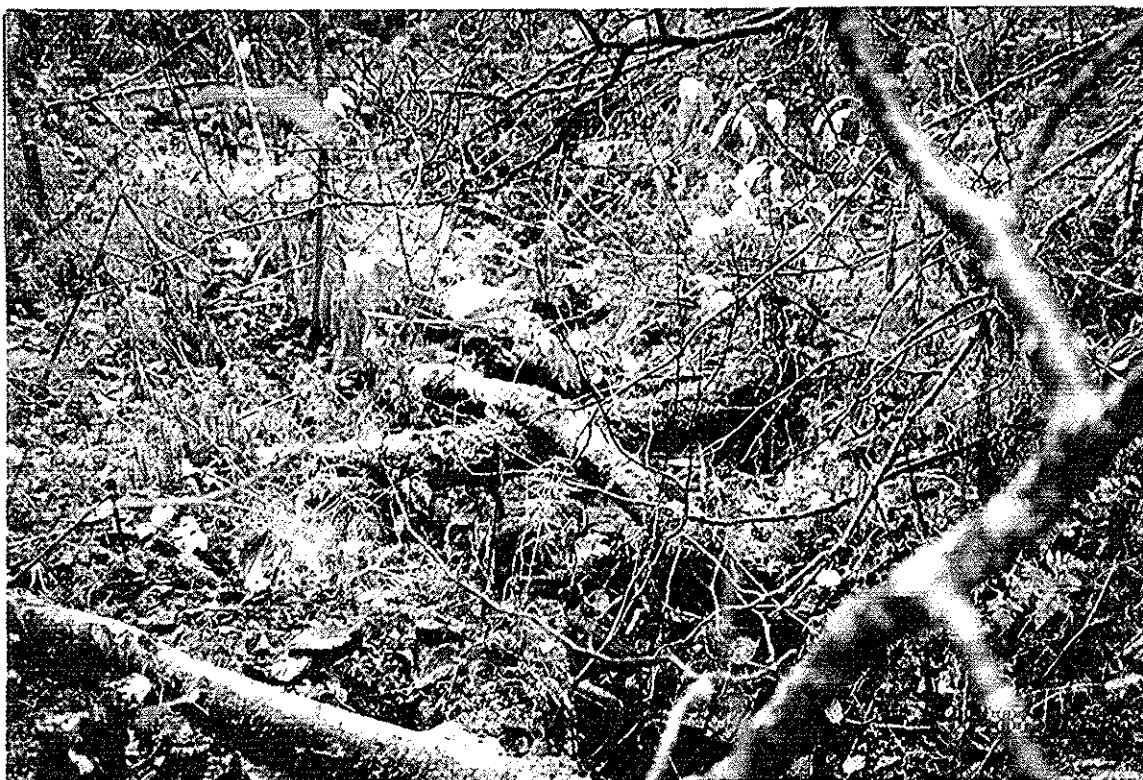
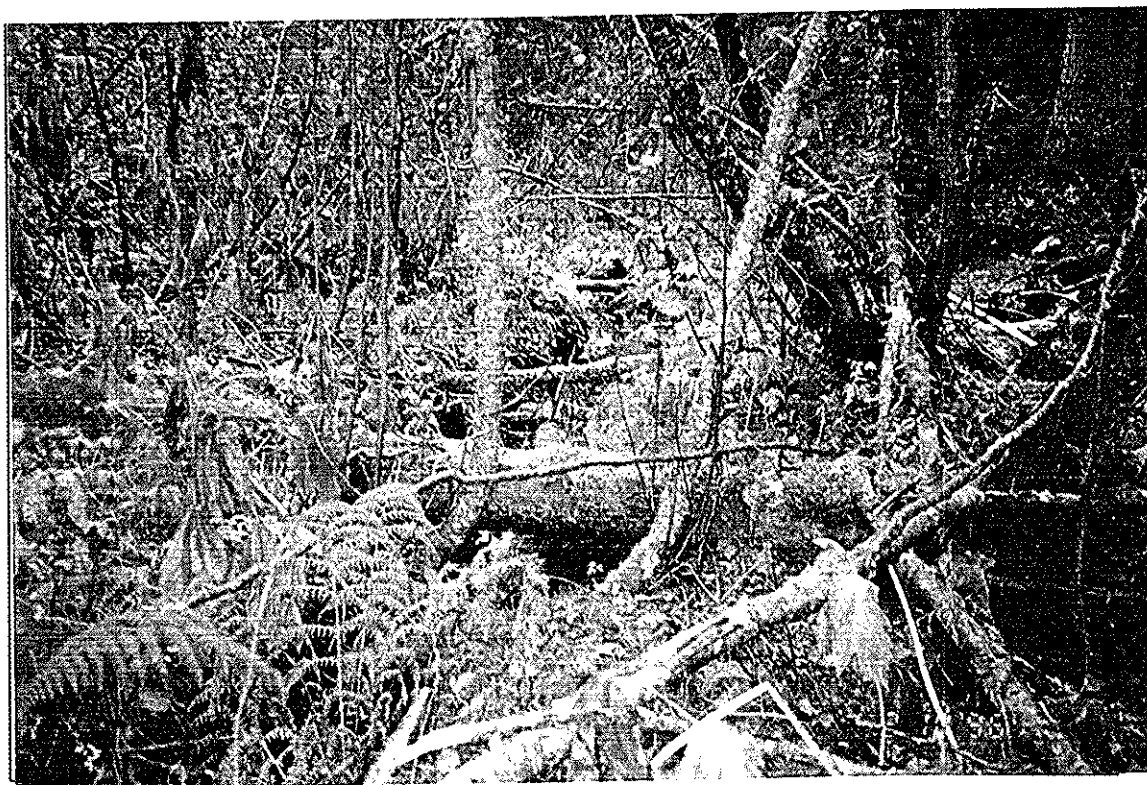
Fish sampling (electrofishing) was conducted for 83 seconds. No fish were captured or observed.

This reach was defaulted to a S-4 classification under the Forest Practices Code.

**Photo 202.** Upstream view of Stream 182-9146-786 at Reach 2.

**Photo 203.** Downstream view of Stream 182-9146-786 at Reach 2.
