## **1995 AND 1996 FISH AND FISH HABITAT INVENTORY**

### **WITHIN THE STUART LAKE AND BABINE LAKE**

### **WATERSHED GROUPS**

#### **Volume 3 of 3**

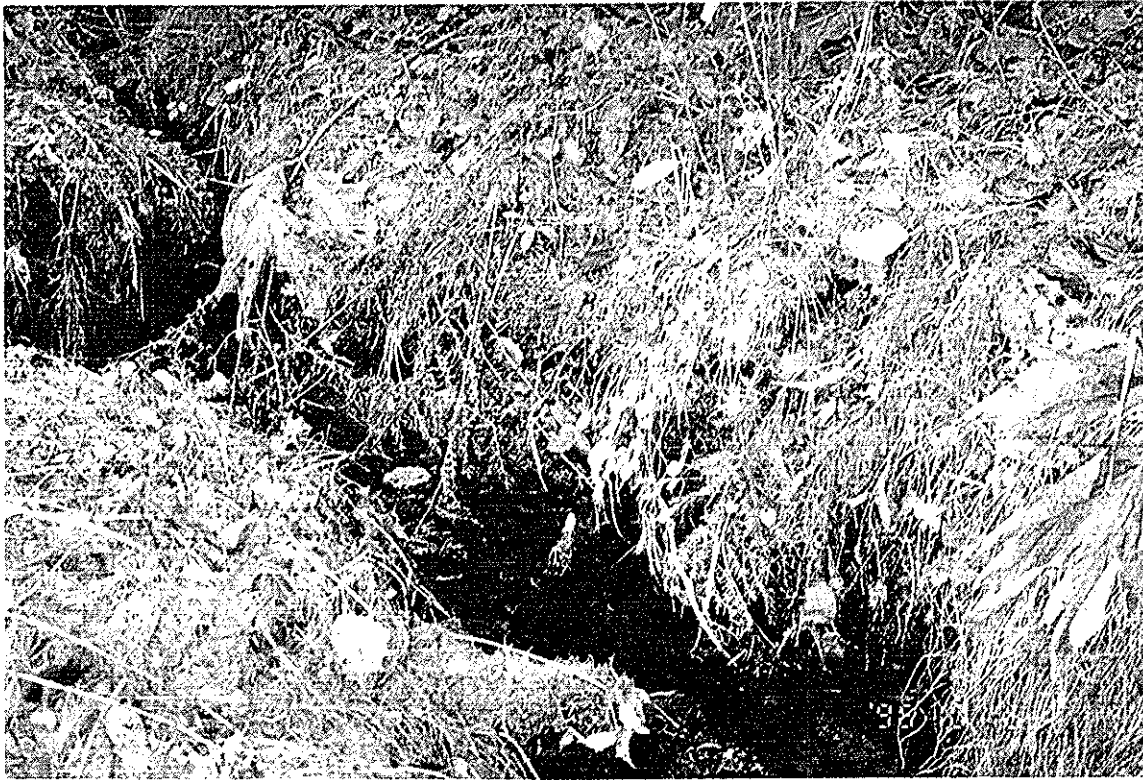
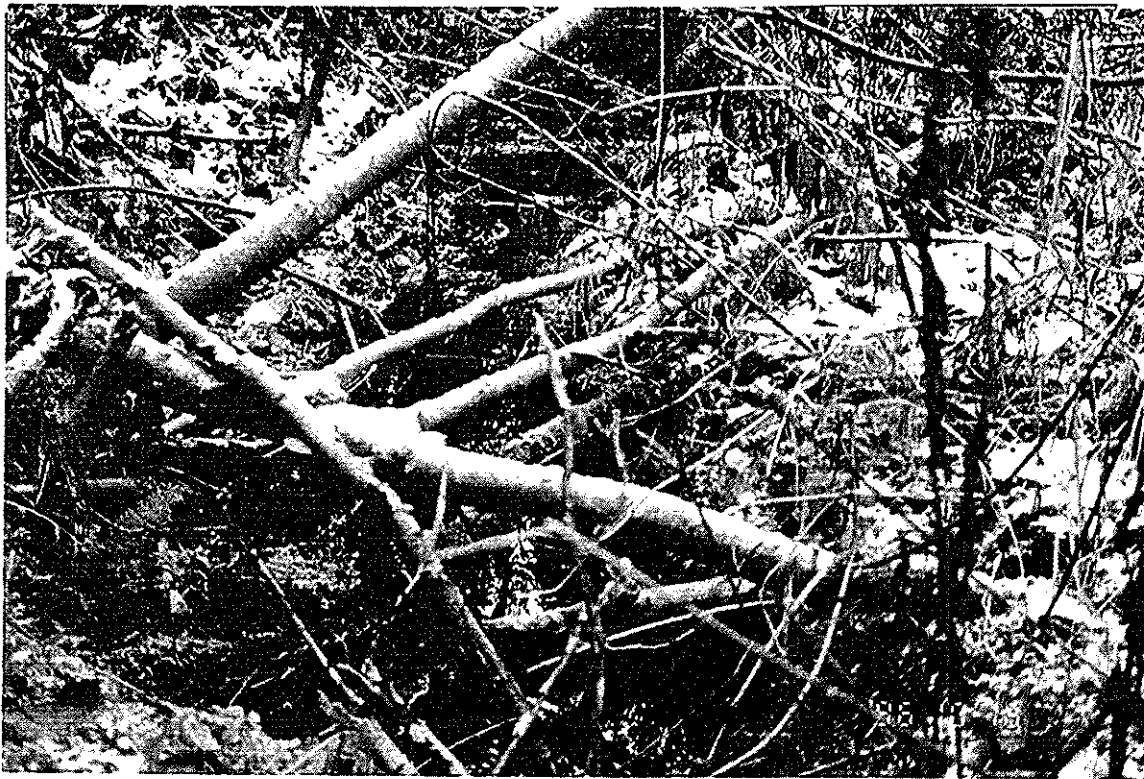
Fish sampling (electroshocking) was conducted for 73 seconds. No fish were captured or observed.

This reach was classified as a S-6 under the Forest Practices Code.

**Photo 204.** Upstream view of Stream 182-9146-786 at Reach 3.

**Photo 205.** Downstream view of Stream 182-9146-786 at Reach 3.

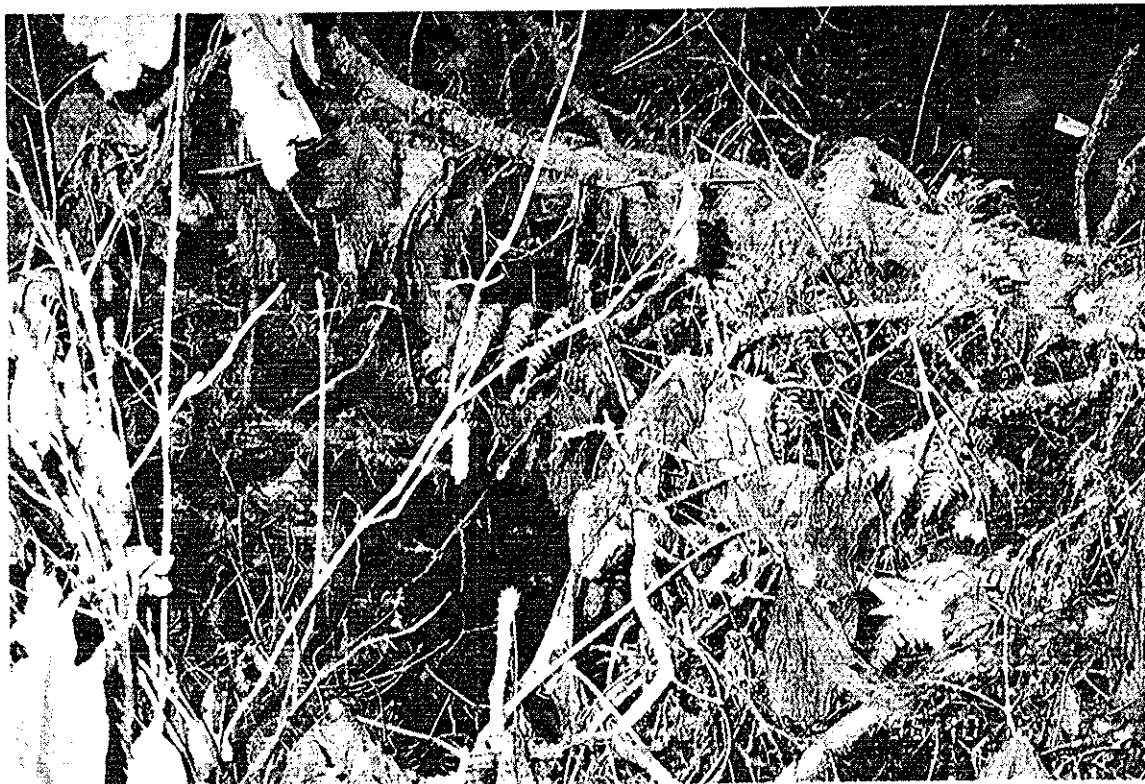
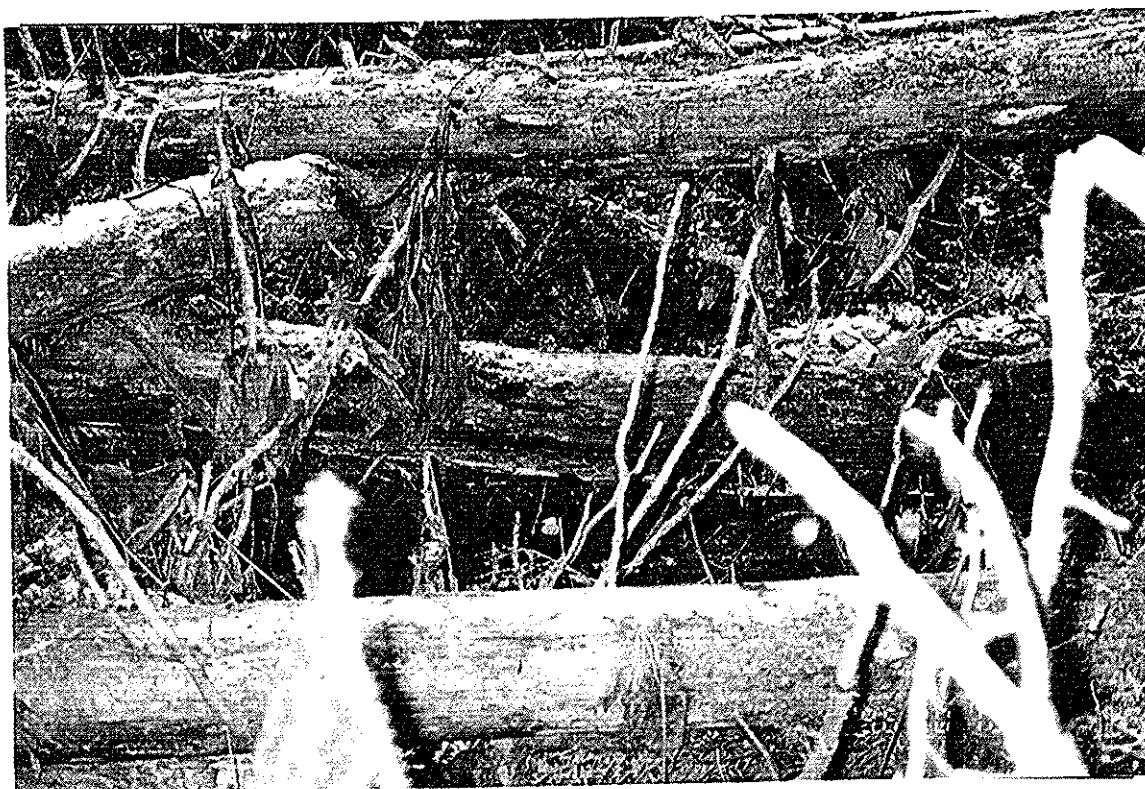
Fish sampling (electroshocking) was conducted for 77 seconds. No fish were captured or observed.

This reach was given a S-6 classification under the Forest Practices Code.

Photo 206. Upstream view of Stream 182-9146-786 at Reach 4.

Photo 207. Downstream view of Stream 182-9146-786 at Reach 4.

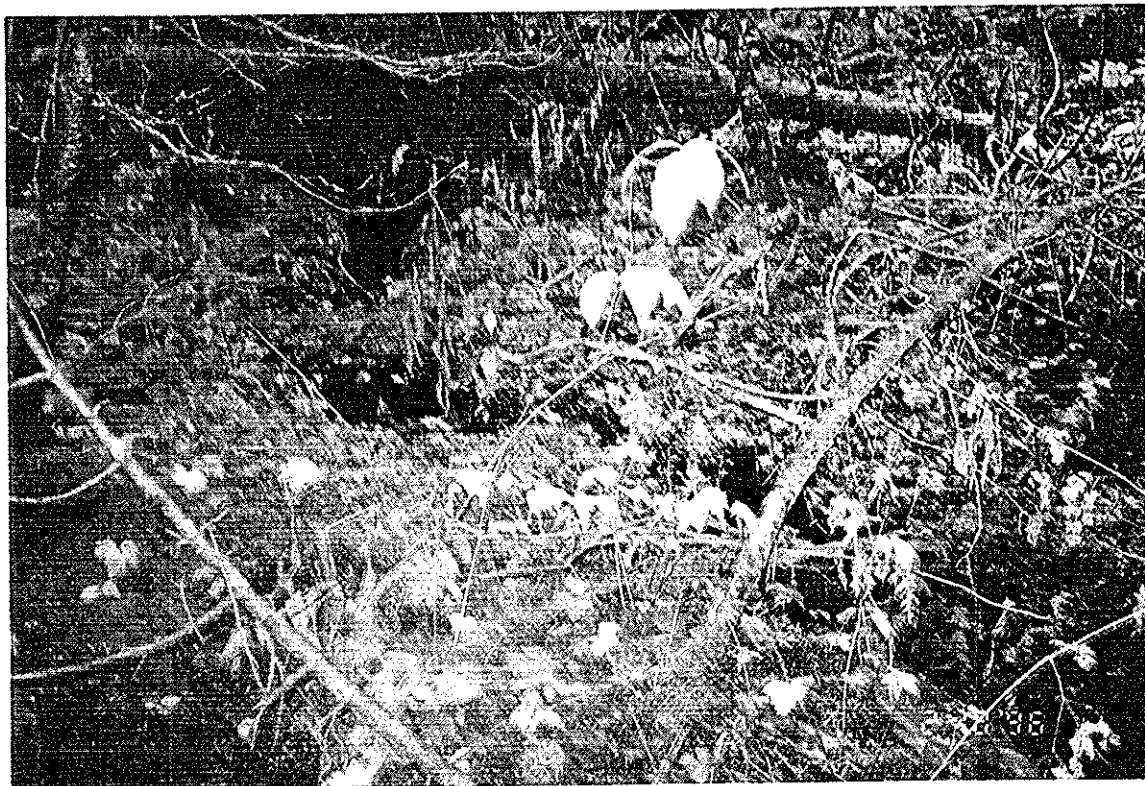
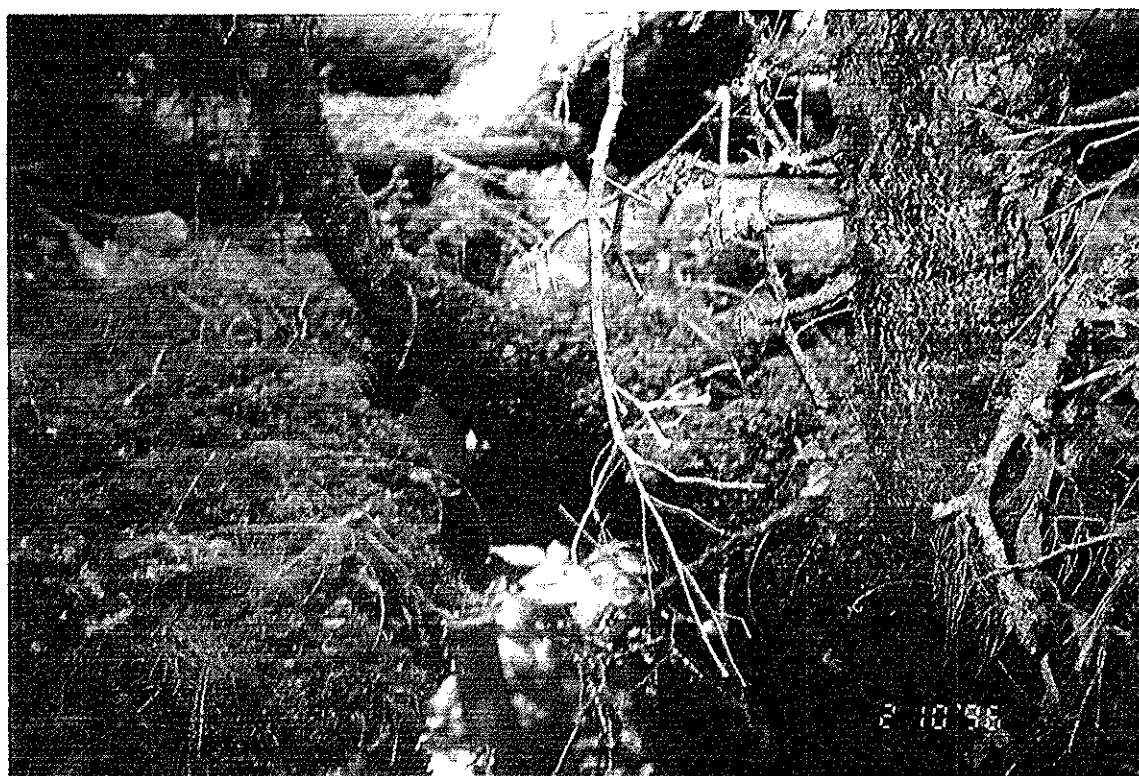
Fish sampling (electroshocking) was conducted in this reach. No fish were captured or observed.

**Photo 208.** Upstream view of Stream EDI-508 at Reach 1.

**Photo 209.** Downstream view of Stream EDI-508 at Reach 1.

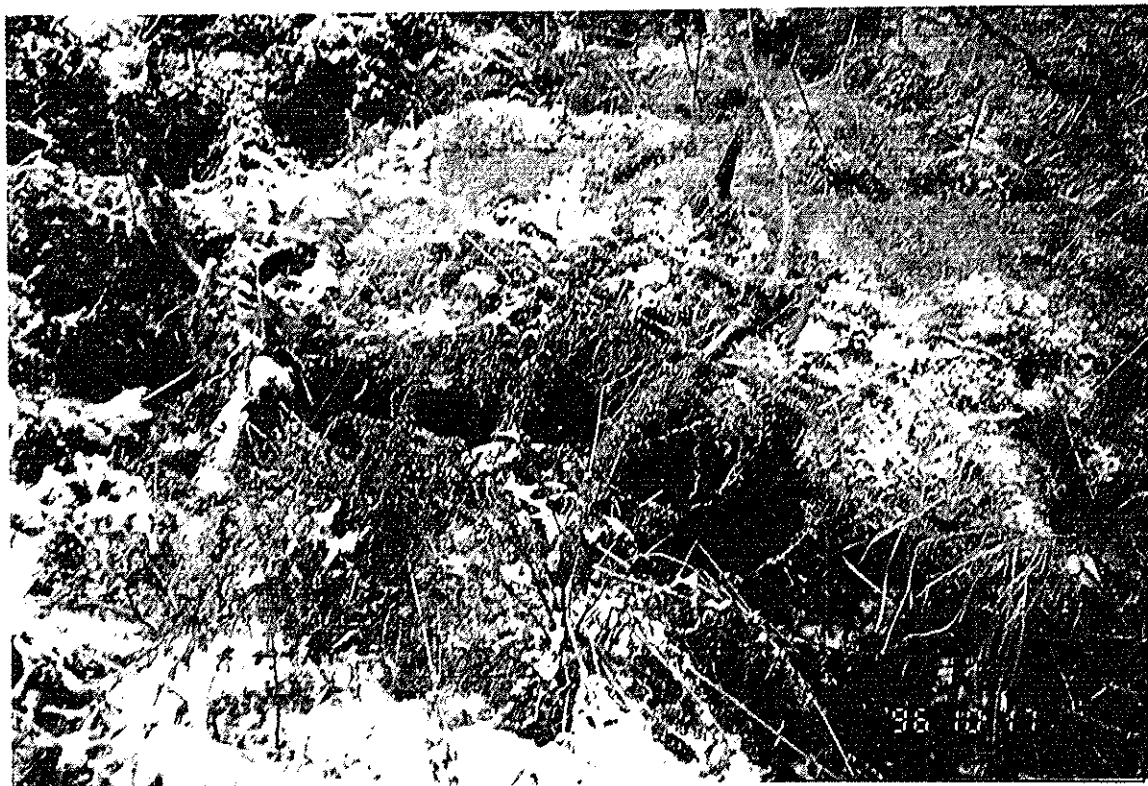
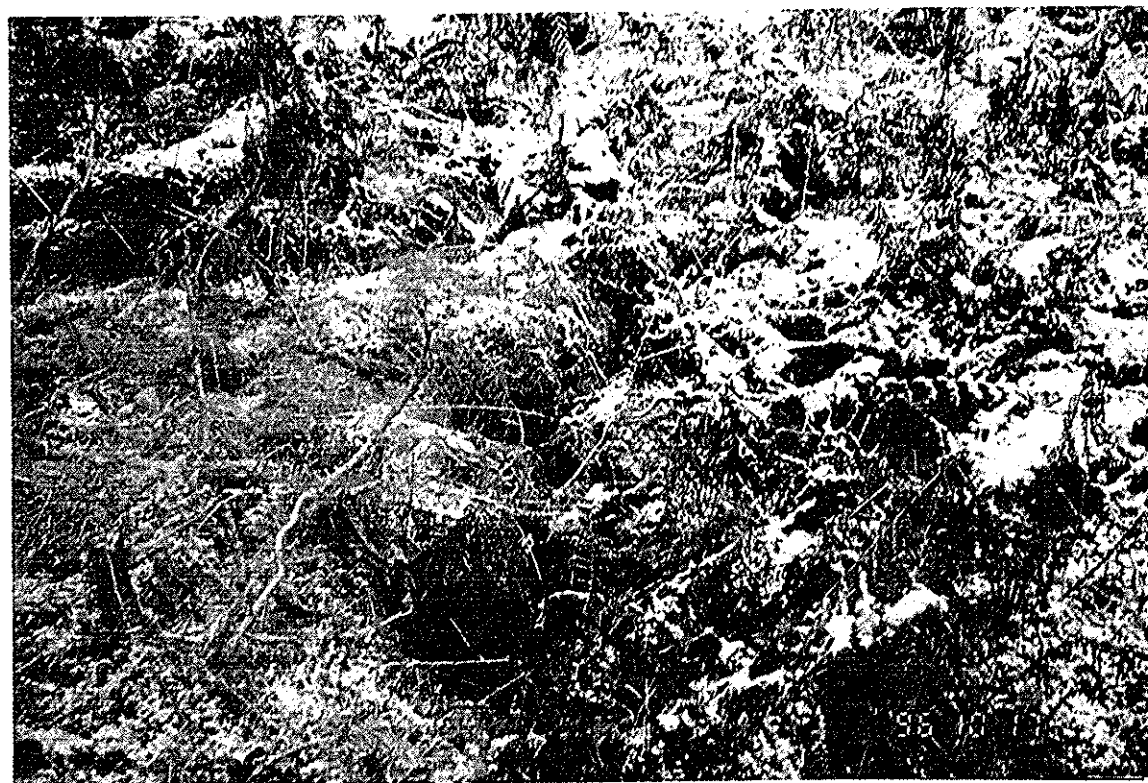
Fish sampling (electroshocking) was conducted for 102 seconds. No fish were captured or observed.

This reach was given a S-6 classification under the Forest Practices Code.

**Photo 210.** Upstream view of Stream EDI-508 at Reach 2.

**Photo 211.** Downstream view of Stream EDI-508 at Reach 2.

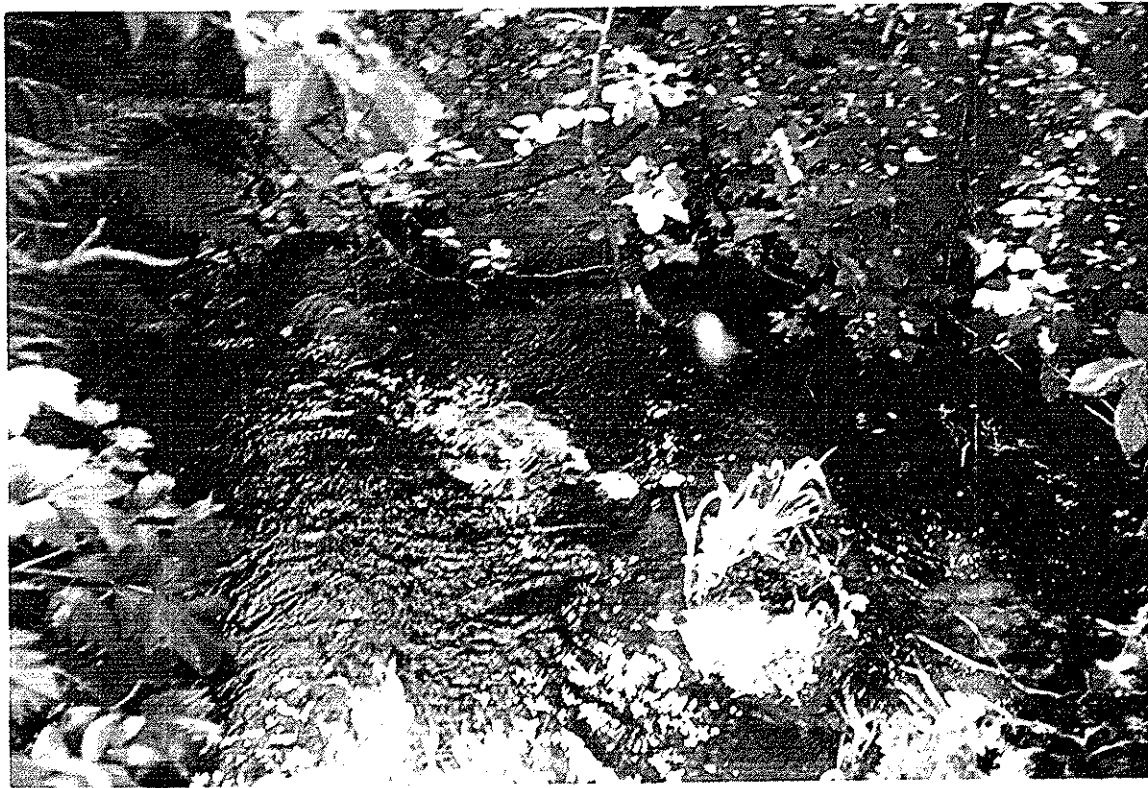
- C2 There is a beaver dam located at the top of the reach. It may be passable through a breach in the bottom.  
Note: Two rainbow trout were caught. One was an adult in spawning condition and the second was a juvenile using the stream in a rearing capacity.
- C1 Film 11: 11 d/s  
Fish sampling (electrofishing) was conducted for 205 seconds and rainbow trout were captured.  
This section of stream is classified as a S-3 stream under the Forest Practices Code.

**Photo 214.** Downstream view of Stream 480-9936-187 at Reach 1.

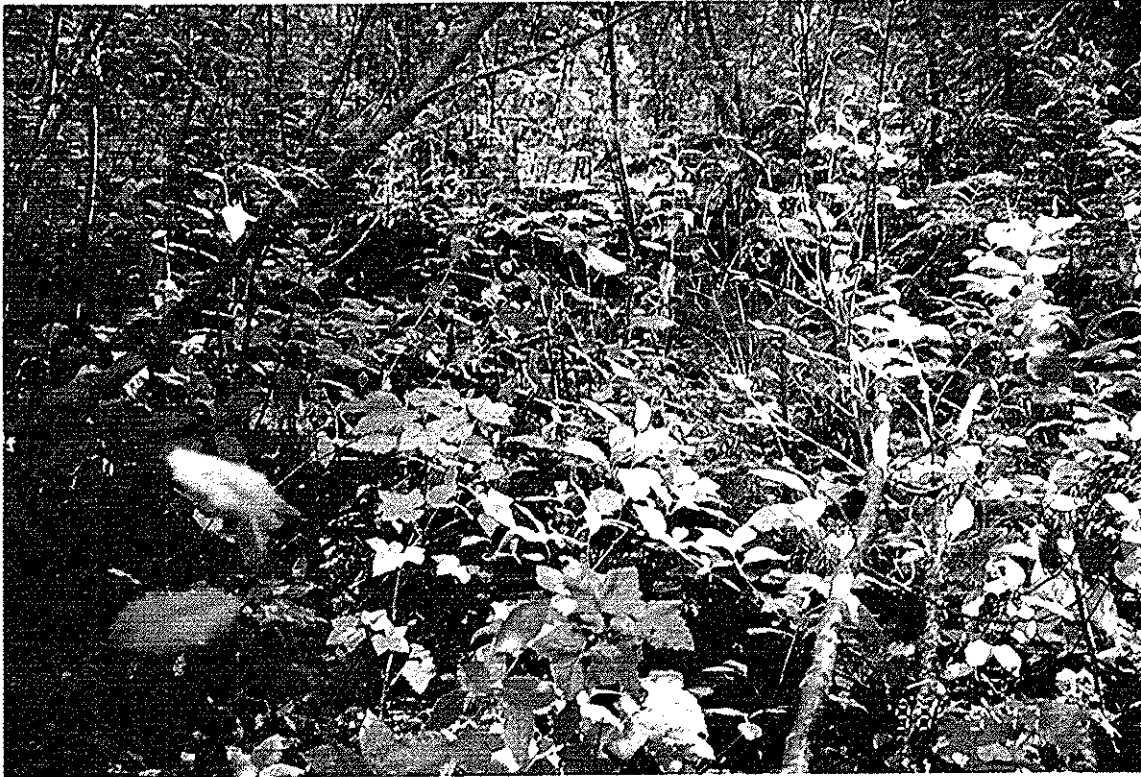
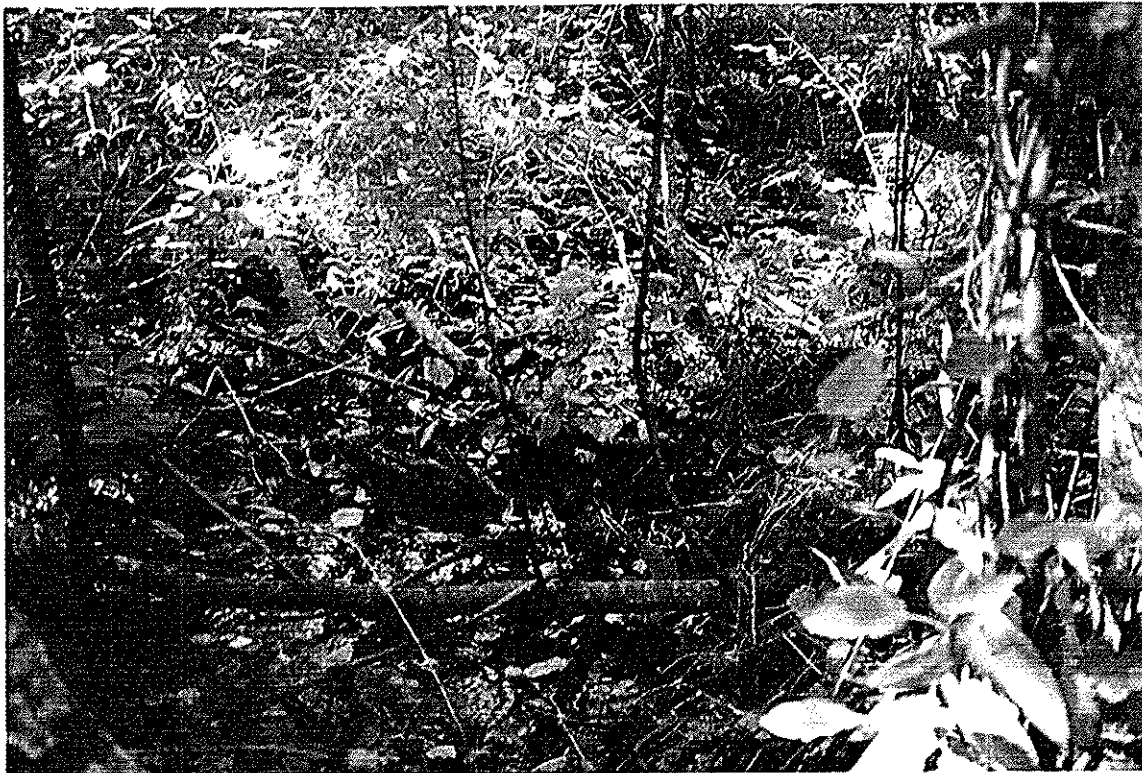
Fish sampling (electrofishing) was conducted for 165 seconds. No fish were captured or observed.

This section of stream is classified as a S-6 stream under the Forest Practices Code.

**Photo 216.** Upstream view of Stream 480-9936-187-799-369 at Reach 1.

**Photo 217.** Downstream view of Stream 480-9936-187-799-369 at Reach 1.

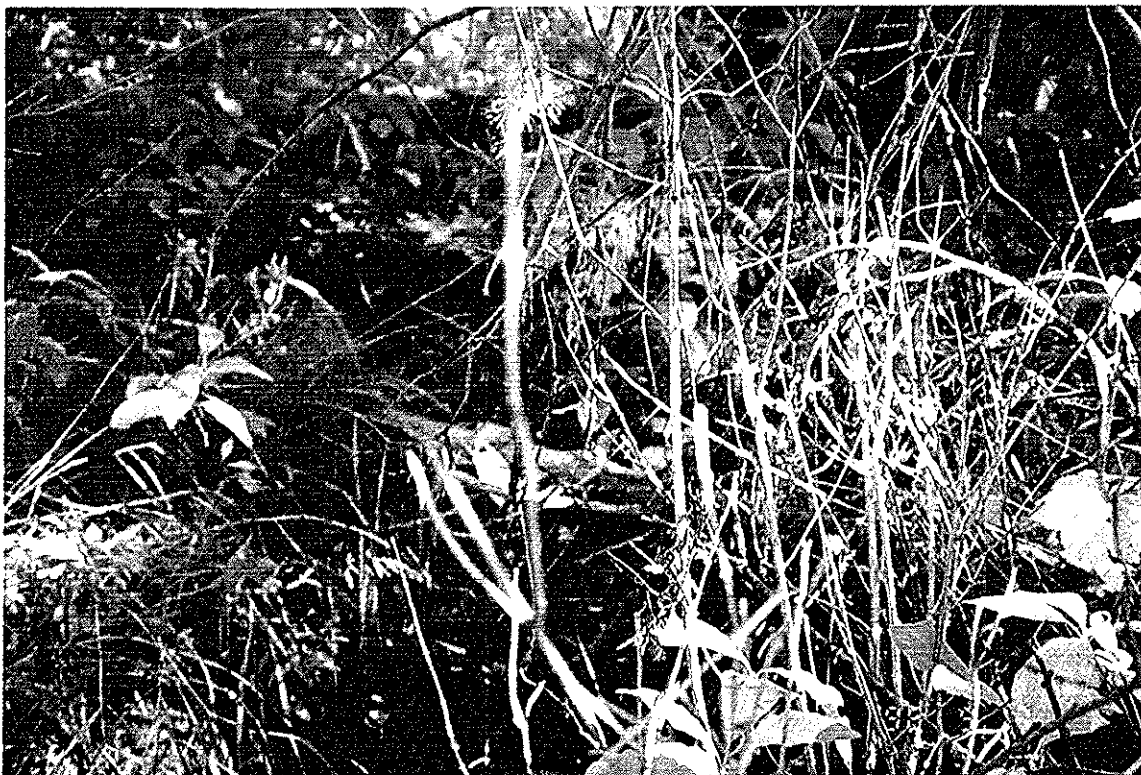
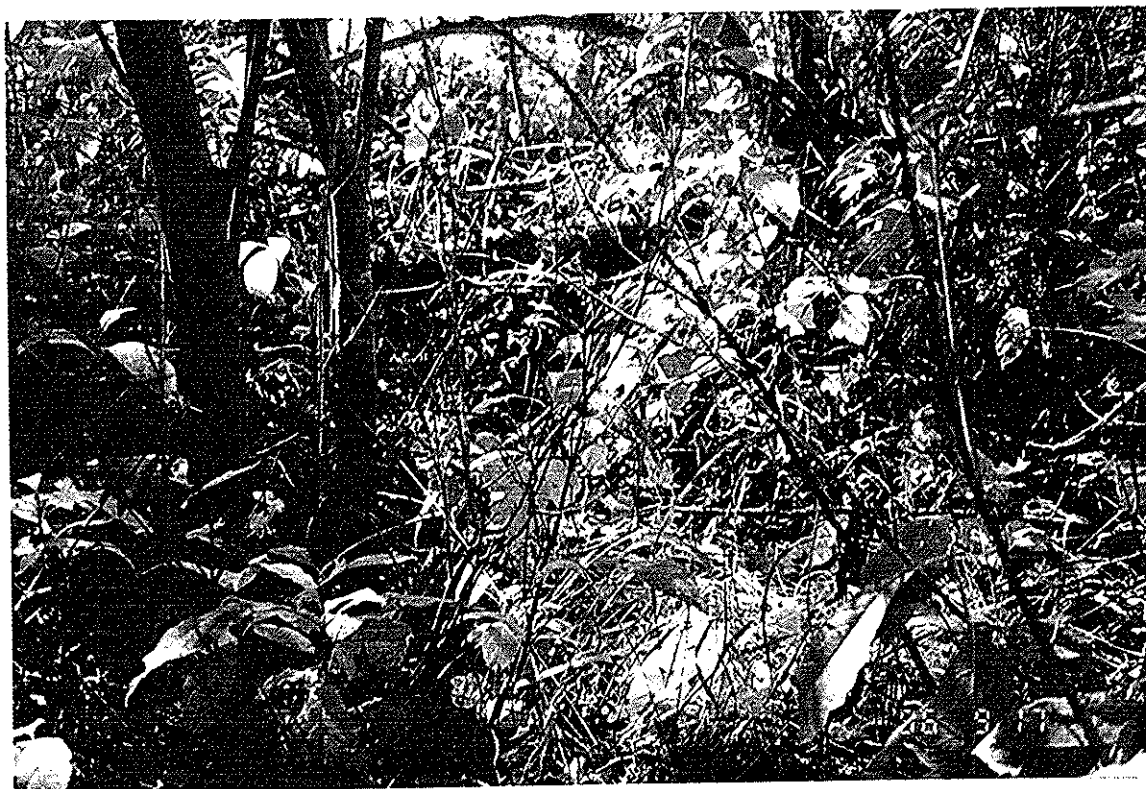
Fish sampling (electroshocking) was conducted for 156 seconds. No fish were captured or observed.

This reach is classified as S-6 under the Forest Practices Code.

**Photo 218.** Upstream view of Stream 480-9936-187-799-369 at Reach 2.

**Photo 219.** Downstream view of Stream 480-9936-187-799-369 at Reach 2.

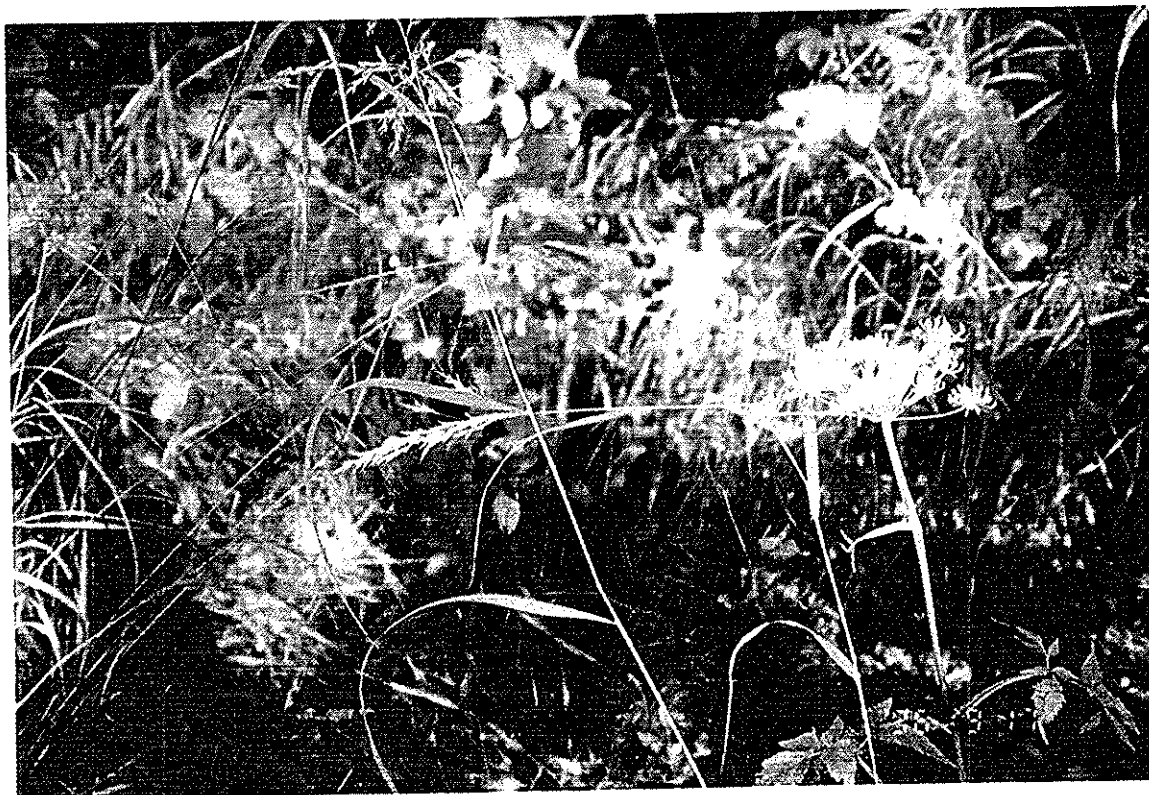
Fish sampling (electroshocking) was conducted for 98 seconds. No fish were captured or observed.

This reach is classified as S-6 under the Forest Practices Code.

**Photo 220.** Upstream view of Stream 480-9936-187-799-369 at Reach 3.

**Photo 221.** Downstream view of Stream 480-9936-187-799-369 at Reach 3.
