1995 AND 1996 FISH AND FISH HABITAT INVENTORY

WITHIN THE STUART LAKE AND BABINE LAKE

WATERSHED GROUPS

EDI Project No. 500-04

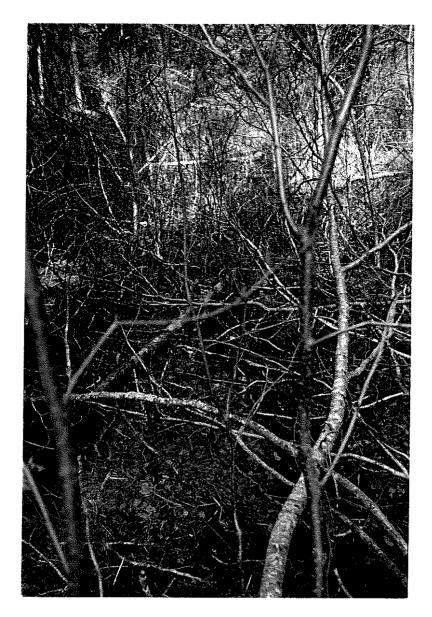
Photo 95. Downstream view of Stream 182-6976-879-131-609 at Reach A.

Fish sampling was not conducted and no fish were observed.

Since this reach has low quality fish habitat and no fish were observed, it was classified as S-6 under the Forest Practices Code.

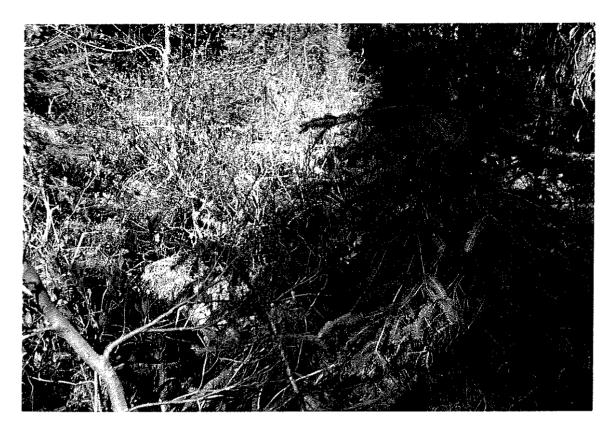
Photo 96. Downstream view of Stream 182-6976-879-131-807 at Reach 4.

Fish sampling was not conducted at this site, and no fish were observed.

Since this site provides low quality fish habitat and no fish were observed, it was classified as S-6 under the Forest Practices Code.

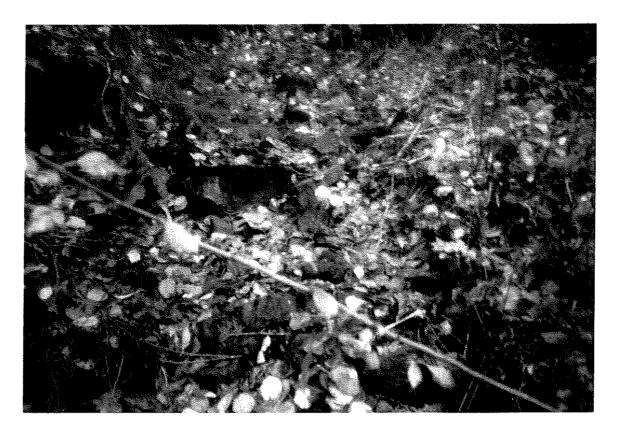
Photo 98. Upstream view of Stream 182-6976-879-131-821 at Reach 4.

Fish sampling (electroshocking) was conducted, however, no fish were captured or observed.

Recommendation: Further survey is recommended to determine fish presence and to find the upper limit of fish distribution.

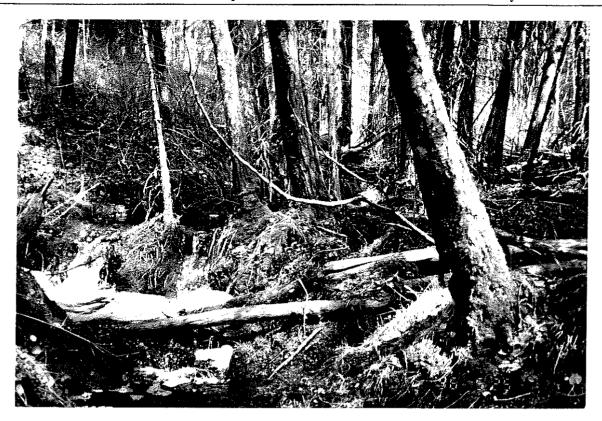
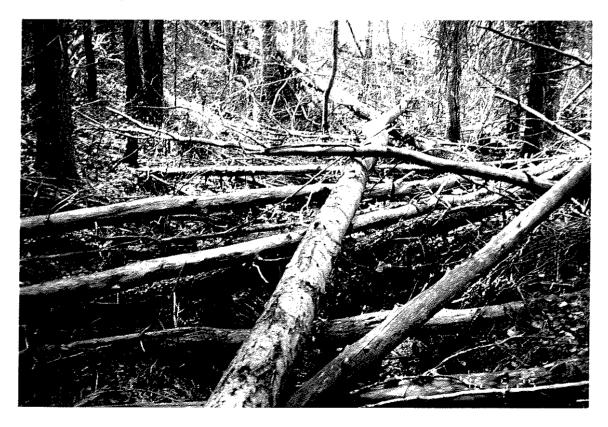
Fish sampling (electroshocking) was conducted for 85 sec. No fish were caught or observed.

Although there no fish were caught or observed, this reach contains potentially good spawning and rearing habitat, and this stream is a direct tributary to the Ocock River. It was, therefore, defaulted to S-4* classification under the Forest Practices Code.

Recommendation: Further surveying is recommended to determine fish presence, and to fish the upper limit of distribution.

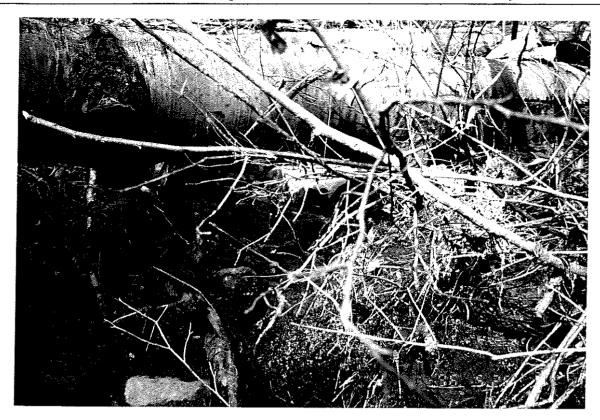
Photo 113. Upstream view of Stream 182-6976-928-613-110 at Reach 1.

Fish sampling was not conducted since fish access to this reach is impossible. No fish were observed.

C2 Stream flow appears to be impeded by absence of culvert.

Recommendation: At the road crossing, a culvert may be needed to prevent the road from eroding.

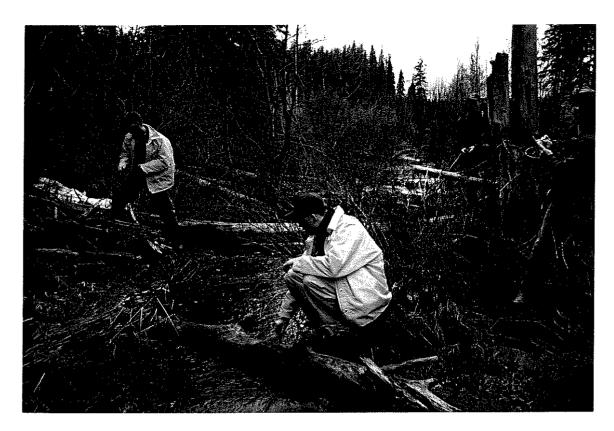
Photo 119. Upstream view of Stream 182-6976-928-704 at Reach 2.

Fish sampling (electroshocking) was conducted for 82 sec, however, no fish were captured or observed. The Forestry supervisor for this operating area stated that BC Environment staff had captured rainbow trout within this reach in the summer of 1995.

Recommendation: The culvert at Ocock Main road will need to be replaced with a larger culvert as the present culvert is too small. There are large pools on either side of the culvert, and the high velocity of the flow confirmed the insufficient size. At the time of the survey, this culvert was an impediment to fish movement.

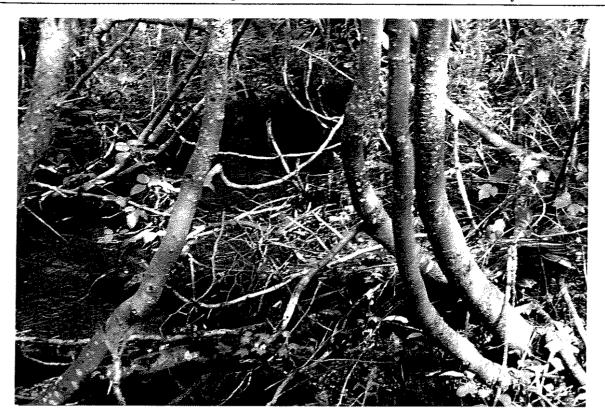
Photo 141. Upstream view of Stream 182-6976-928-932 at Reach B.

Fish sampling (electroshocking) was conducted for 183 seconds. No fish were captured or observed.

This stream has been defaulted to a S-4 classification under the Forest Practices Code, because it has good fisheries potential.

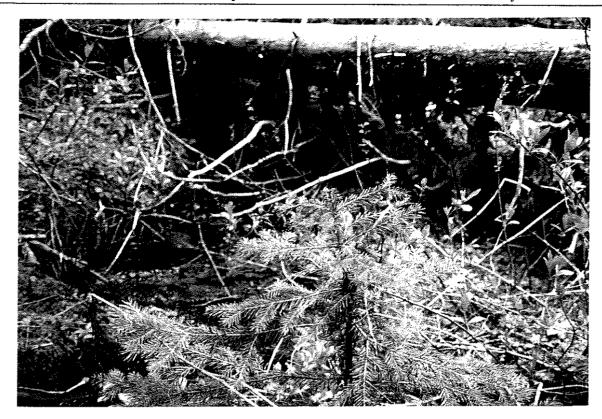
Photo 143. Upstream view of Stream 182-6976-928-932-660 at Reach 1.

Fish sampling (electroshocking) was conducted for 45 seconds. No fish were captured or observed.

This stream been defaulted to a S-4 classification under the Forest Practices Code, because it has good fisheries potential.

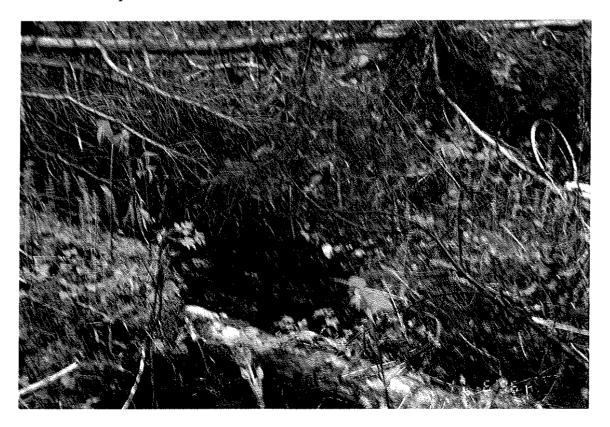
Photo 146. Downstream view of Stream EDI-574 at Reach 1.

Fish sampling (electroshocking) was conducted for 72 seconds. No fish were captured or observed.

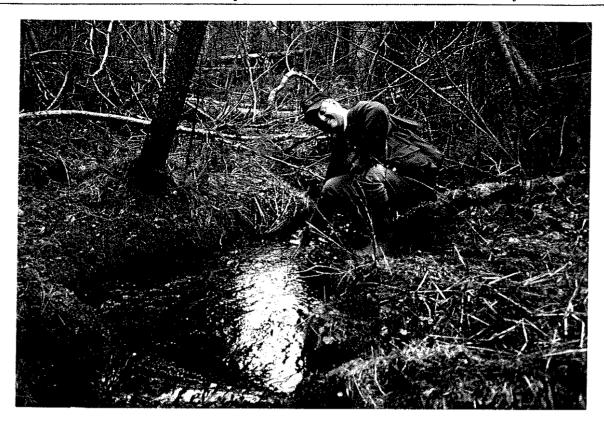
Photo 147. Upstream view of Stream 182-6976-928-965 at Reach 1.

Fish sampling (electroshocking) was conducted. Two juvenile RB were caught.

Since regionally significant fish were caught within this reach, it has been classified as an S-4 under the Forest Practices Code. This reach contains excellent spawning habitat.

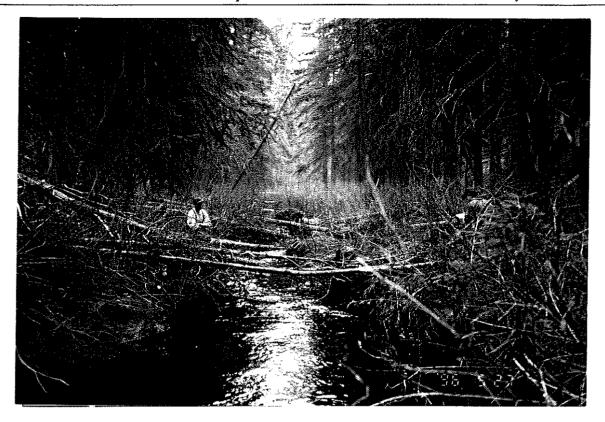
Photo 149. Upstream view of Stream 182-6976-928-682 at Reach 2.

Fish sampling (electroshocking) was conducted for 322 seconds over 250m area. Fish were visually observed, but were not captured.

This reach was defaulted to a S-3 classification under the Forest Practices Code due to its close proximity to the Ocock River, visual observation of unidentified fish and presence of good spawning and rearing habitat.

Recommendation: Further survey is recommended to determine the presence of regionally significant fish.

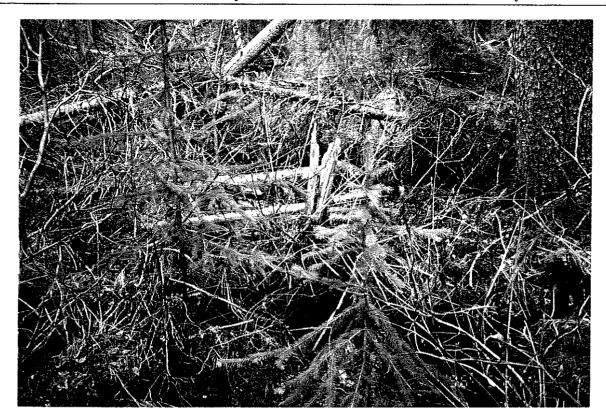
Photo 151. Upstream view of Stream EDI-816 at Reach 1.

Fish sampling (electroshocking) was conducted 100 seconds. No fish were captured or observed.

This reach was given a defaulted S-4 classification under the Forest Practices Code.

Recommendation: Further survey is recommended to determined fish presence and to find the upper limit of fish presence.

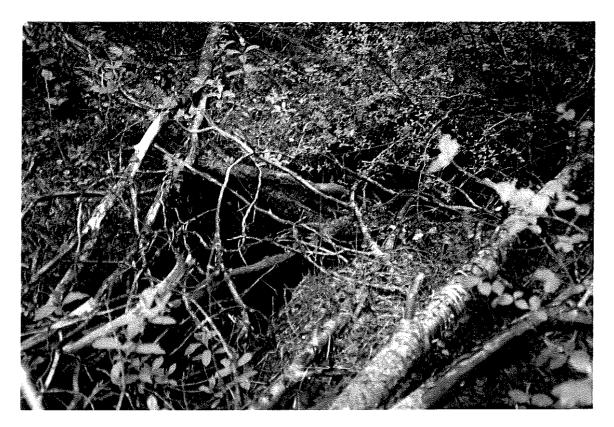
Photo 154. Upstream view of Stream EDI-795.

Fish sampling was not conducted. No fish were observed.

This stream reach has been assigned a S-6 classification under the Forest Practices Code due to the low quality fish habitat.

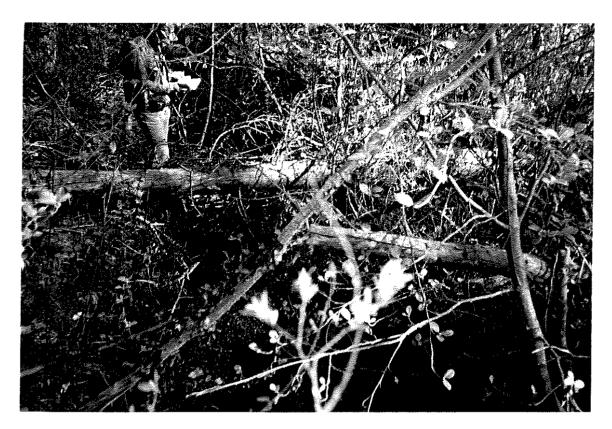
Photo 155. Downstream view of Stream 182-6976-928-682-476 at Reach 2.

This reach has been given a defaulted S-3 classification under the Forest Practices Code.

C2 Location 1. The culvert is located 1.7 km upstream from the confluence at the upper reach break.

Recommendation: The debris jam should be removed, and the culvert size should be assessed to determine if it is of sufficient size to accommodate the water flow. Additional fish sampling should be conducted to determine if regionally significant fish utilize this reach.

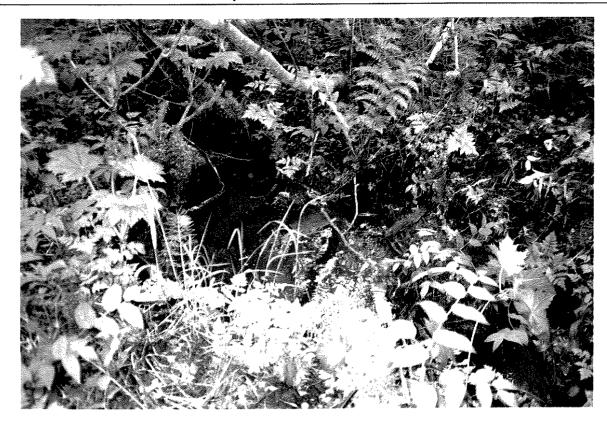
Photo 156. Upstream view of Stream 182-6976-928-682-586-371 at Reach 1.

Fish sampling (electroshocking) was conducted for 87 seconds.

This stream has been assigned a S-6 classification under the Forest Practices Code.

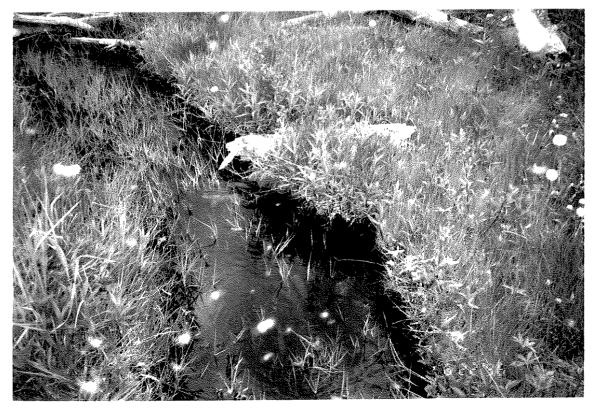
Photo 159. Downstream view of Stream 182-6976-928-682-586-371 at Reach 2.

Fish sampling (electroshocking) was conducted throughout the reach, however no fish were captured or observed.

This reach contains begins as a seepage area and contains minimal fisheries potential. This along with the fact that there weren't any fish observed, resulted in an S-6 fish stream classification under the Forest Practices Code.

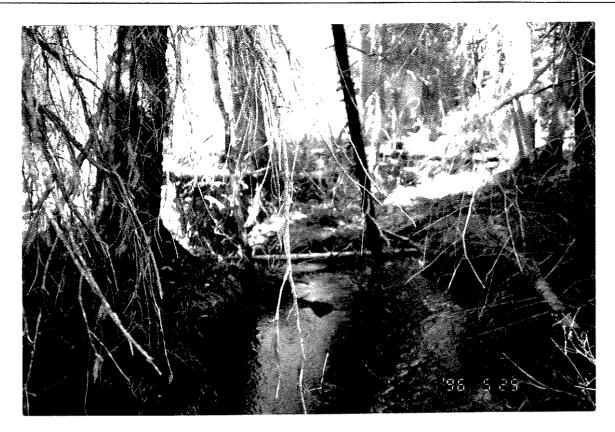
Photo 160. Upstream view of Stream 182-6976-928-761-582 at Reach 1.

This unnamed stream flows in a southeasterly direction above the northern edge of the cutblock. This small low gradient (1.5%) stream is characterized by 65% run, and 20% pool. The total cover 35% was provided by undercut bands (40%) deep pools (25%) and large organic debris (15%). The bed material consisted of 40% fines, 40% gravels, and 20% larges. Numerous redds were observed, proving the area to be excellent spawning habitat.

Fish sampling (electroshocking) was conducted for 31 seconds and rainbow trout were captured and visually observed.

This stream has a S-3 classification.

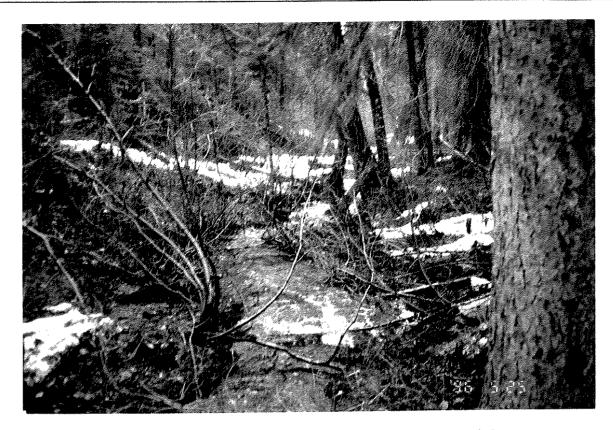
Photo 162. Upstream view of Stream 182-6976-928-761-582 at Reach 2.

This unnamed stream flows in a southeasterly direction above the northern corner of the cutblock. It is a small, low gradient reach (2.5%), which is characterized by 50% run, and 35% pool. The total cover (50%) is primarily due to overhanging vegetation(40%) and undercut bank (20%). The substrate consists of 40% fines, 40% gravels and 20% larges. Recent beaver activity was observed in the area, however, no major obstructions were present which would prevent fish passage. A 600 m section of the drainage upstream of Reach 2 is a wetland. This wetland contains 8 beaver dams.

Fish sampling (electroshocking) was conducted for 330 seconds and no fish were captured or observed.

This section of stream was given a S-3 classification under the Forest Practices Code.

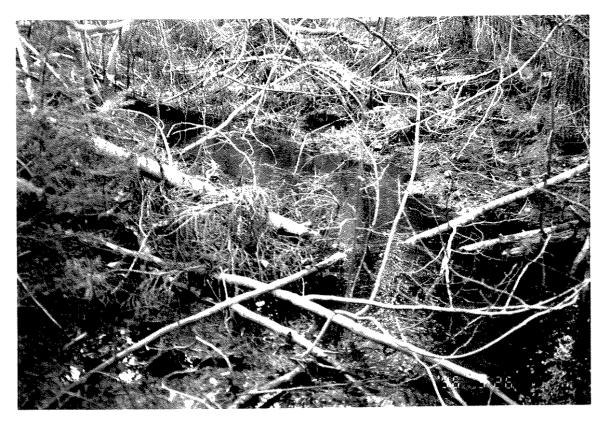
Photo 164. Upstream view of Stream 182-6976-928-761-582 at Reach 3.

Fish sampling (electroshocking) was conducted for 61 seconds and no fish were captured or observed.

The beaver dams ranged in height from 70 cm to 2.5 m, creating a large wetland complex.

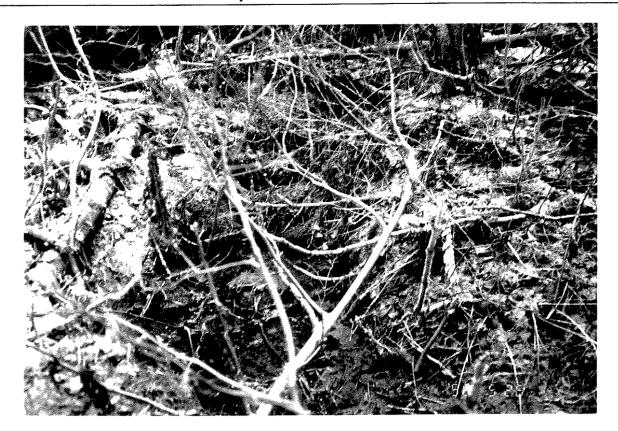
Photo 166. Upstream view of Stream 182-6976-928-761-582 at Reach 4.

This section of stream was given a S-6 classification under the Forest Practices Code.

C2 Channel charateristics were not recorded.

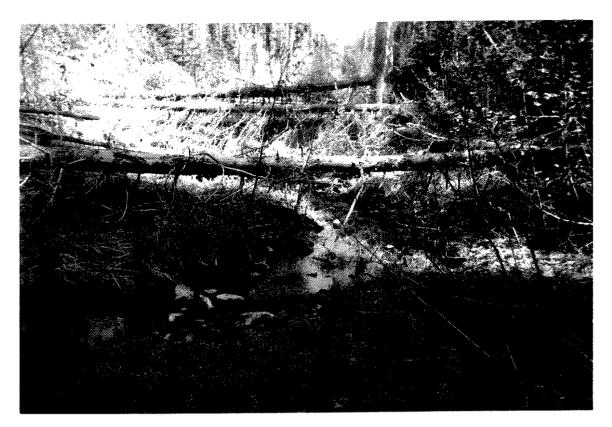
Photo 172. Downstream view of Stream 182-6976-928-781-100 at Site 2.

DFO/MoE 20-Aug-97	ELP Stream Survey Form Stream: Unnamed	• Watershed Code:	Stream Survey Report 182-6976-928-781-100-000-000-000-000-000-000-000
Fish Summ	ary	Obstructions	
Comments			
C1	Film 2: 5 d/s.		
	Fish sampling (minnow traps) was conducted. No fish were captured or observed.		
	This section of stream was given a S-6 classification under the Forest Practices Code.

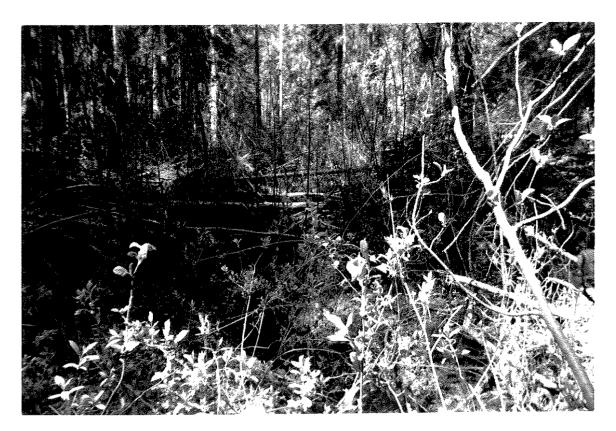
Photo 173. Upstream view of Stream 182-6976-928-781-490 at Reach A.

Fish sampling was not conducted. No fish were observed.

This reach was assigned a S-6 classification under the Forest Practices Code.

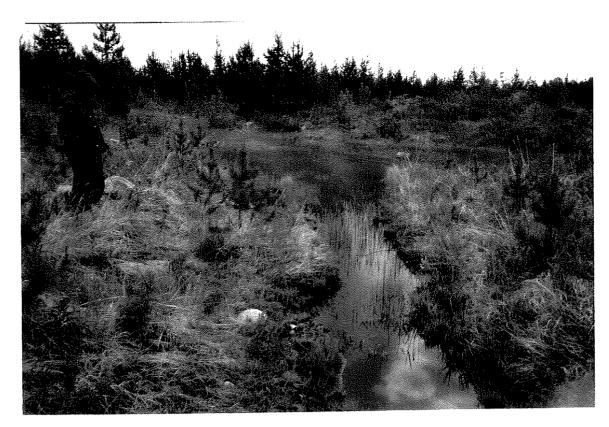
Photo 174. Downstream view of Stream EDI-1906 at Reach A.

Fish sampling was not conducted. No fish were observed.

This section of stream is classified as a S-6 stream under the Forest Practices Code.

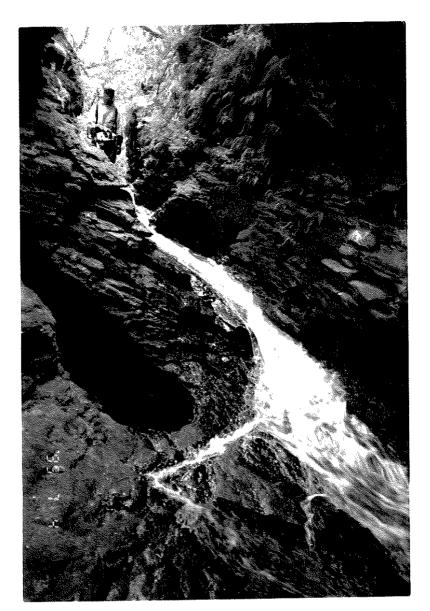
There is a series of falls (2.9 m and 2.9 m) located downstream on Camsell Creek (approximately 1.4 km upstream from the confluence) which is a barrier to fish migration upstream. This reach was given a S-6 classification under the Forest Practices Code.

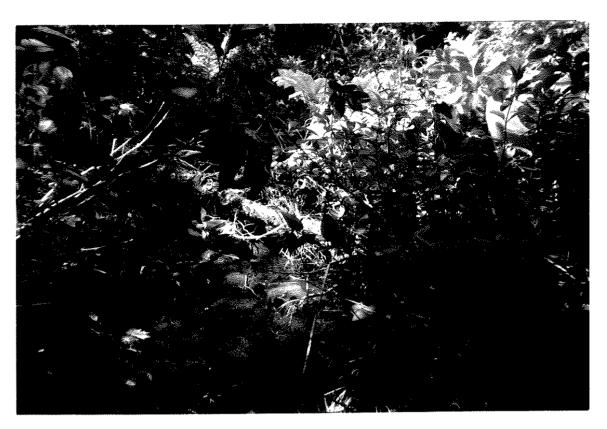
Photo 176. Upstream view of Stream 182-7851-772 at Reach 1.

DFO/MoE	LP Stream Survey Form Stream: Unnamed	Watershed Code:	Stream Survey Report
Fish Summ	ary	Obstructions	
Comments			
C1	Film 2: 19 w/s. Fish sampling (electroshocking) was conducted for 79 seconds. No fish were captured of this section of stream was given a S-6 classification under the Forest Practices Code.	or observed.

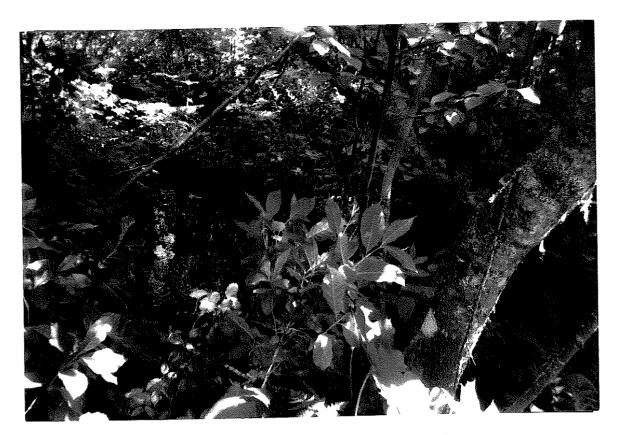
Photo 177. Downstream view of Stream 182-7851-772 at Reach 2.

Fish sampling (electroshocking) was conducted in this reach. No fish were captured or observed.

This reach has been given a S-6 classification under the Forest Practices Code.
