**Bill Nye Lake  
(460-600600-36400-64100-2380-01)  
01494MORR**

**SECONDARY LAKE INVENTORY  
1997 STUDIES**

**Ministry of Environment, Lands and Parks  
Project No. IVBVS622 (FRBC)**

**APRIL 1998**

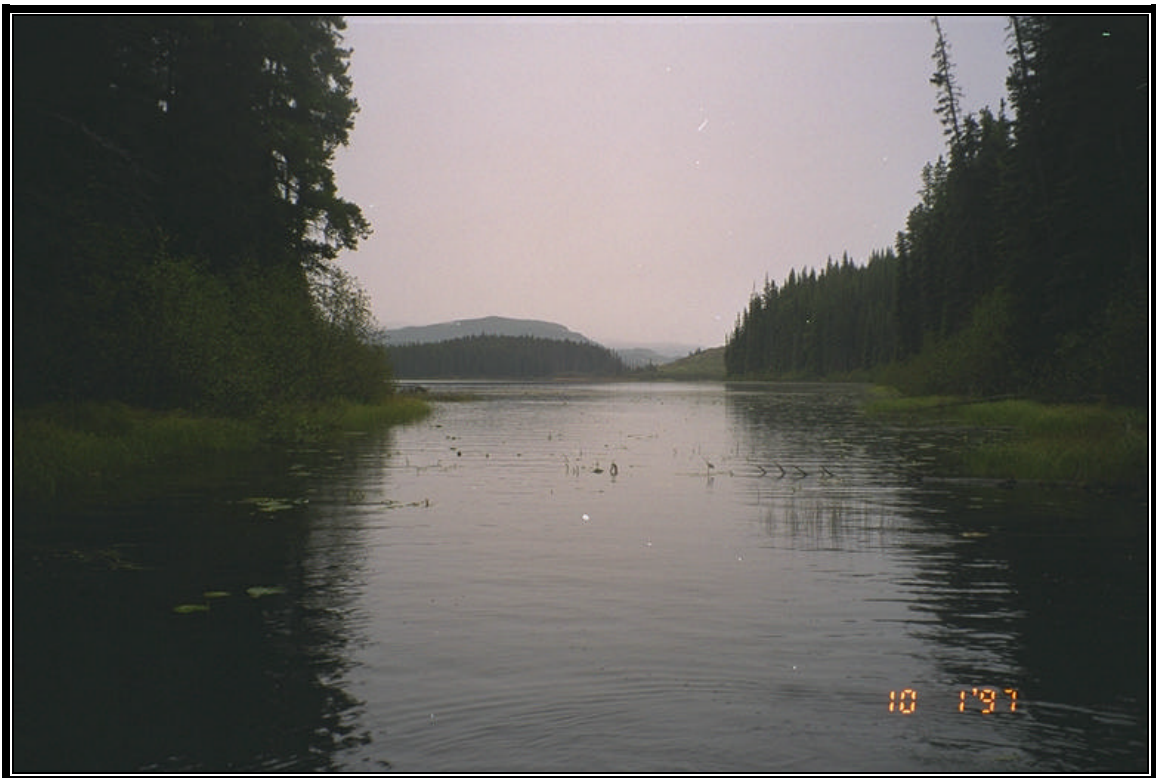
**Plate 2** View from near lake outlet looking east.

The outlet is a distinct channel. Discharge was low at the time of the survey. The channel is approximately 0.6 m wide at the lake and passes through a marsh/shrub area. The outlet area appears to have been dammed as a result of beaver activity. This has created rearing habitat near the outlet. The substrate is comprised of some gravel and small cobbles, but is mostly sand/silt further downstream. Suitable spawning areas were not observed.
