***Lakelse Lake Sockeye Rehabilitation Program:
Spawning Channel / Improved Spawning
Habitat Project***

Department of Fisheries and Oceans Canada
North Coast Resource Restoration Unit
Sandra Devcic, P.Eng., a/Restoration Engineer
Lana Miller – Restoration Biologist
North Coast Area Resource Restoration Unit
Oceans, Habitat and Enhancement Branch

August 2011

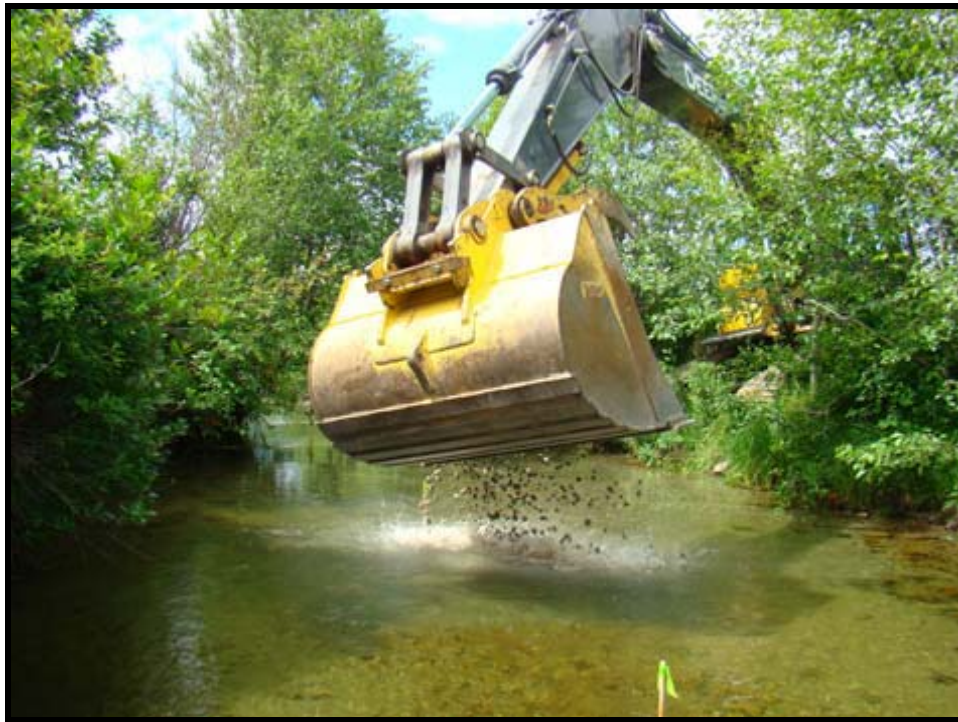
Photo 3 - Gravel being placed in Scully Mid-Channel by excavator.

Over a period of four days, gravel was placed at each site to a depth of 0.4 meters on average. The pilot gravel placement at all four sites totalled approximately 1120 square meters of enhanced spawning habitat.

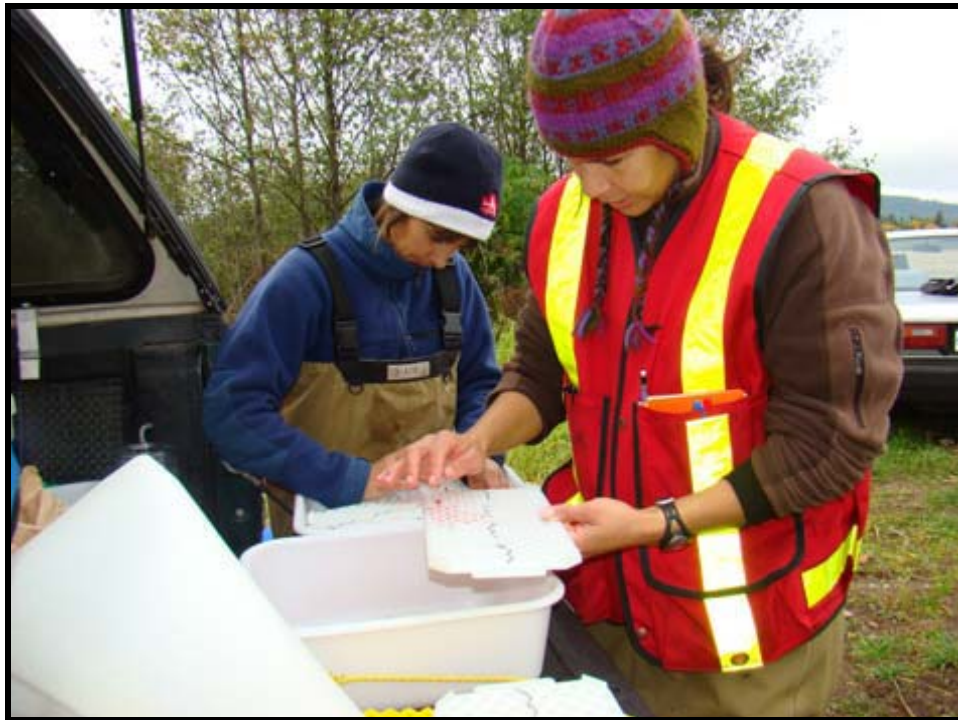
Photo 4 - Scully Creek - loading cassettes with eggs.

In summary, eight Jordan-Scotty cassette incubators with 100 eggs per cassette were buried at four sites for a total of 32 cassettes. Two of the three sites (Site 2 and 3) in Scully Creek Mid-channel were located on the recently constructed spawning gravel platforms, while the third site in Scully-Mid (Site 4), and the site in Scully south channel (Site 1) were located in unenhanced 'natural' spawning gravel as control sites. Assessment of incubation success was checked during two stages: 12 weeks after installation at the hatching stage; and 25 weeks after installation at the fry/emergence stage. For each assessment of incubation success, four cassettes from each incubation site were removed and assessed. Cassettes were not replaced in the gravel after assessment due to the amount of disturbance that would be required to excavate and replant the incubators.

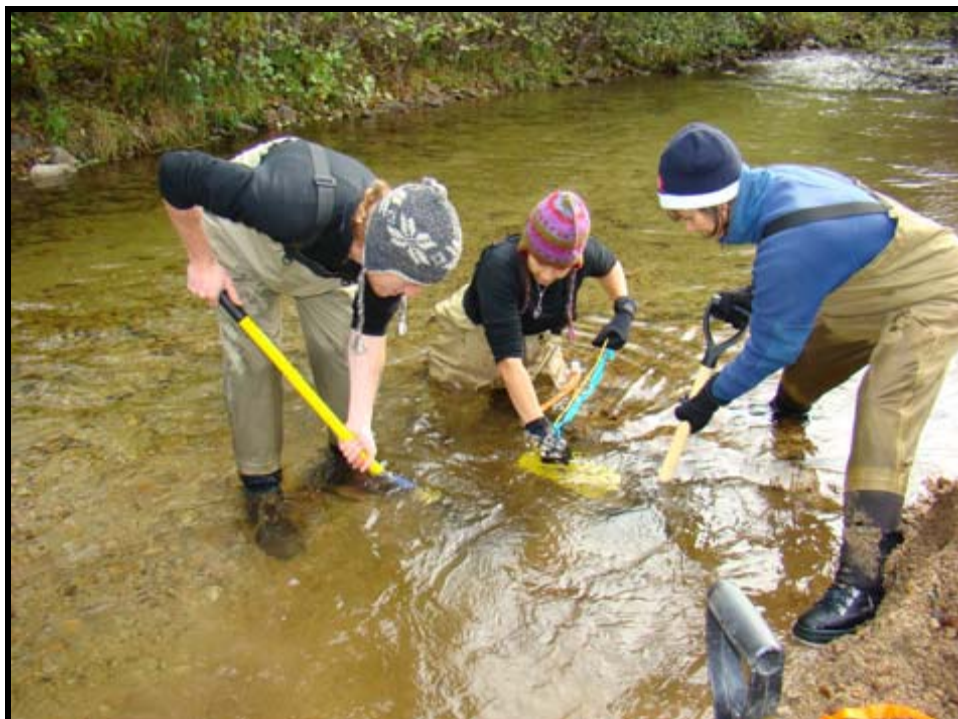
Photo 5 - Scully Creek - installing cassettes into the streambed.

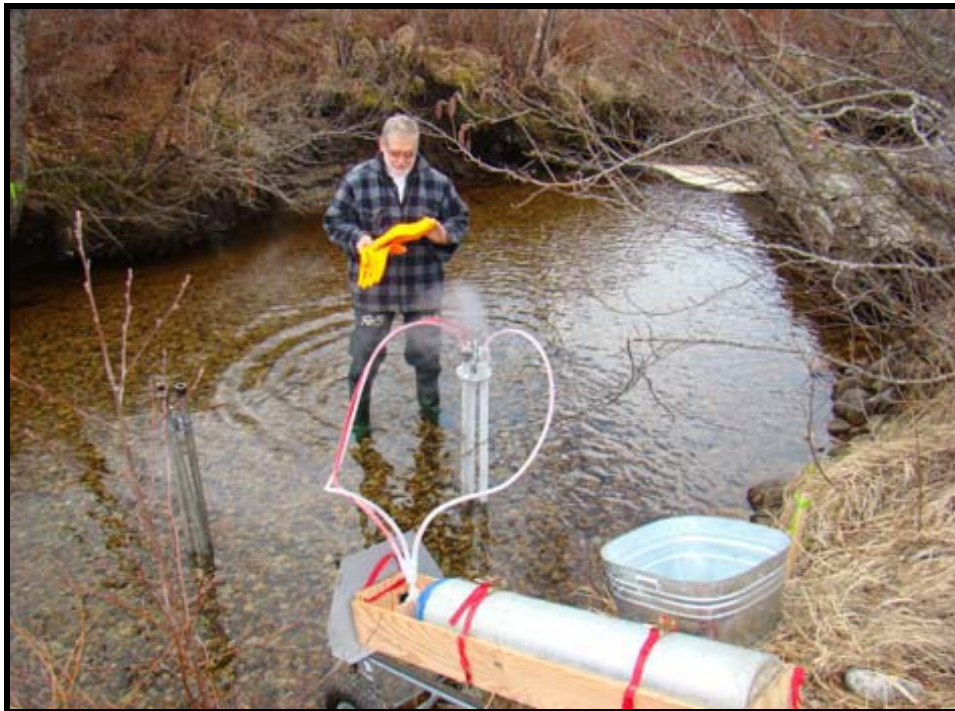
Photo 6 - Scully Creek - freeze core sampler at one of the spawning platforms.

In an attempt to capture the rate of sedimentation of the newly installed gravel, sampling and analysis was required before and after installation. Gravel samples were taken from the material before it was placed in the creek in July 2008 and then the gravel was sampled again in March 2009 to coincide with the end of the incubation study. When the gravel was placed in July 2008, the new gravel was sampled after it was stockpiled on site. The sampling technique employed was that used by BC Ministry of Transportation to sample large gravel stockpiles. The undisturbed areas were exposed (the center of the pile), then a shovel was inserted horizontally to withdraw the sample. This method tends to maintain the sample in as representative a state as possible. Nine samples were collected in total and delivered to McElhanney Consulting Services in Terrace BC for washed sieve analysis. For the March sampling, DFO staff built a freeze core sampler that was able to collect intact/complete substrate samples underwater. The sampler used pressurized CO₂ injected into a probe submerged in the gravel. The pressurized CO₂ froze a large sample of substrate to the probe which was then removed from the streambed and collected into a bag. Eighteen samples total were collected from all four pilot spawning platforms and the two control sites (three from each site). All samples were independently analyzed by a local geotechnical lab using washed sieve analysis.

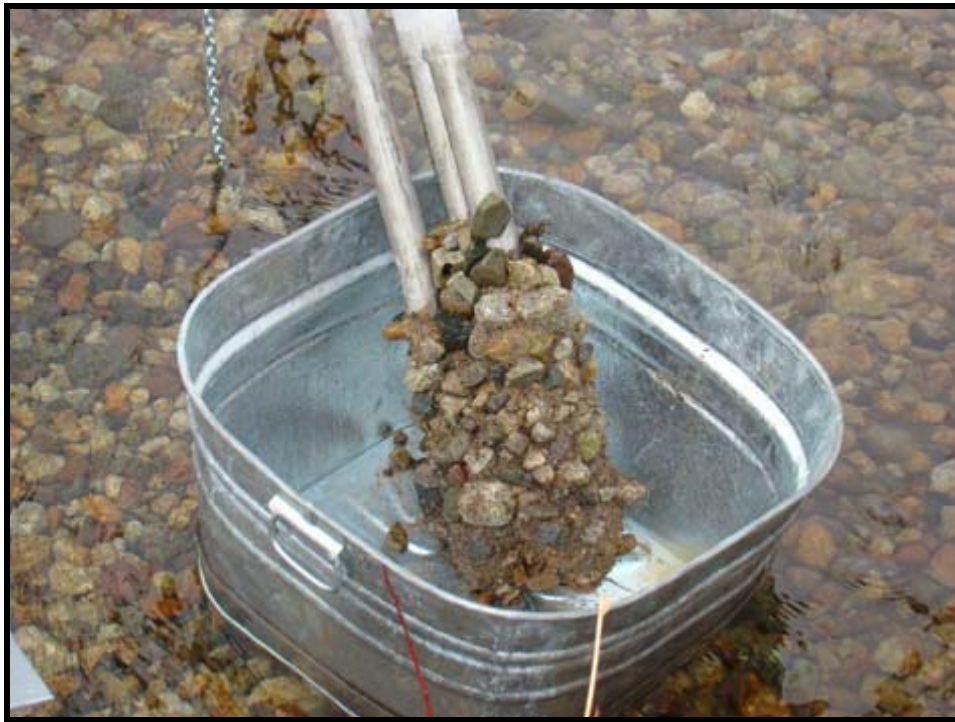
Photo 7 - Scully Creek - freeze core sampler with intact sample frozen to probe.

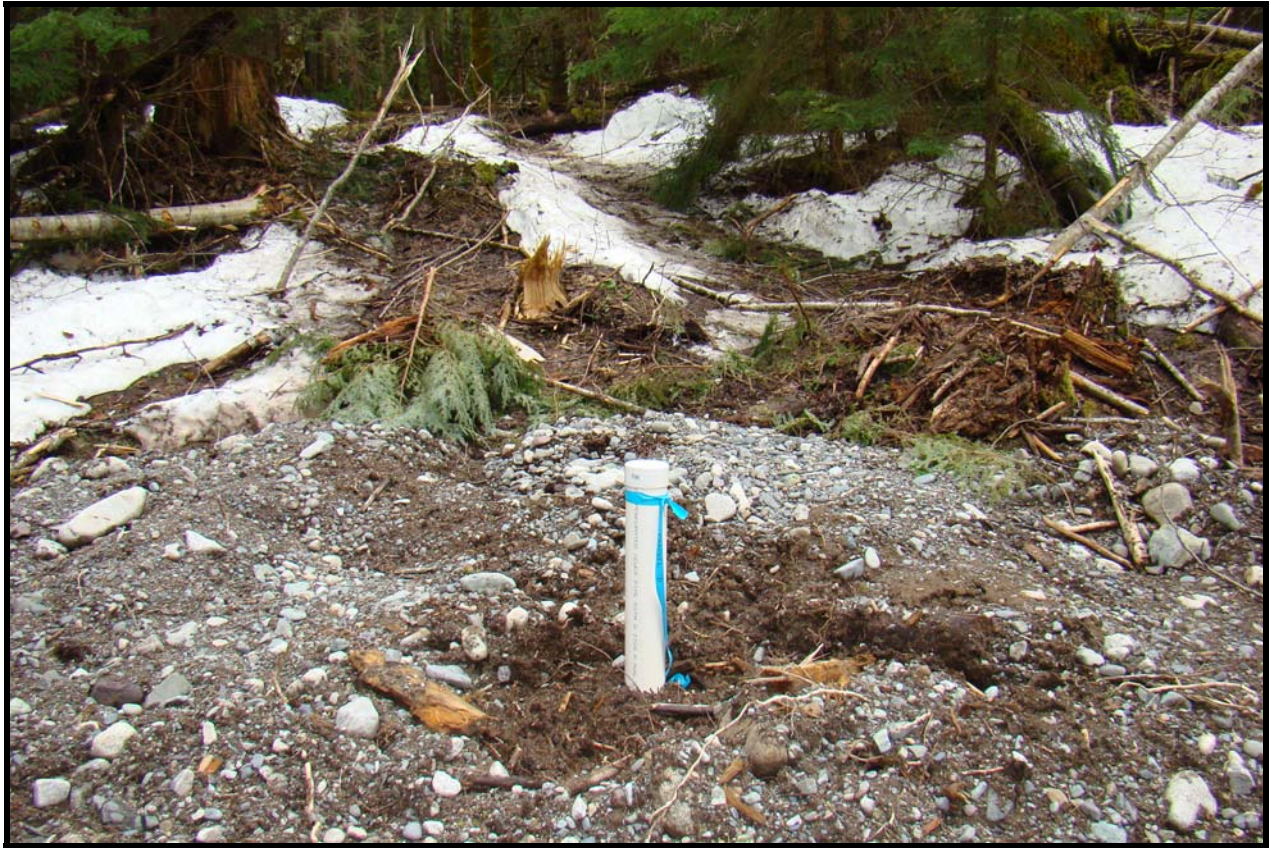
Photo 8 - Williams Creek - Typical test pit along proposed surface water channel route

After the channel excavation, five additional test pits were excavated along a proposed surface water channel route from the upstream end of the new test ditch upstream towards Old Lakelse Lake Road bridge on Williams Creek. The test pits were placed ~100 meters apart and excavation was discontinued when no water was found at a ~3m depth in the last 2 test pits. Later sampling indicated that at certain times of year, ground water levels were high enough to be measured in these originally 'dry' test pits.

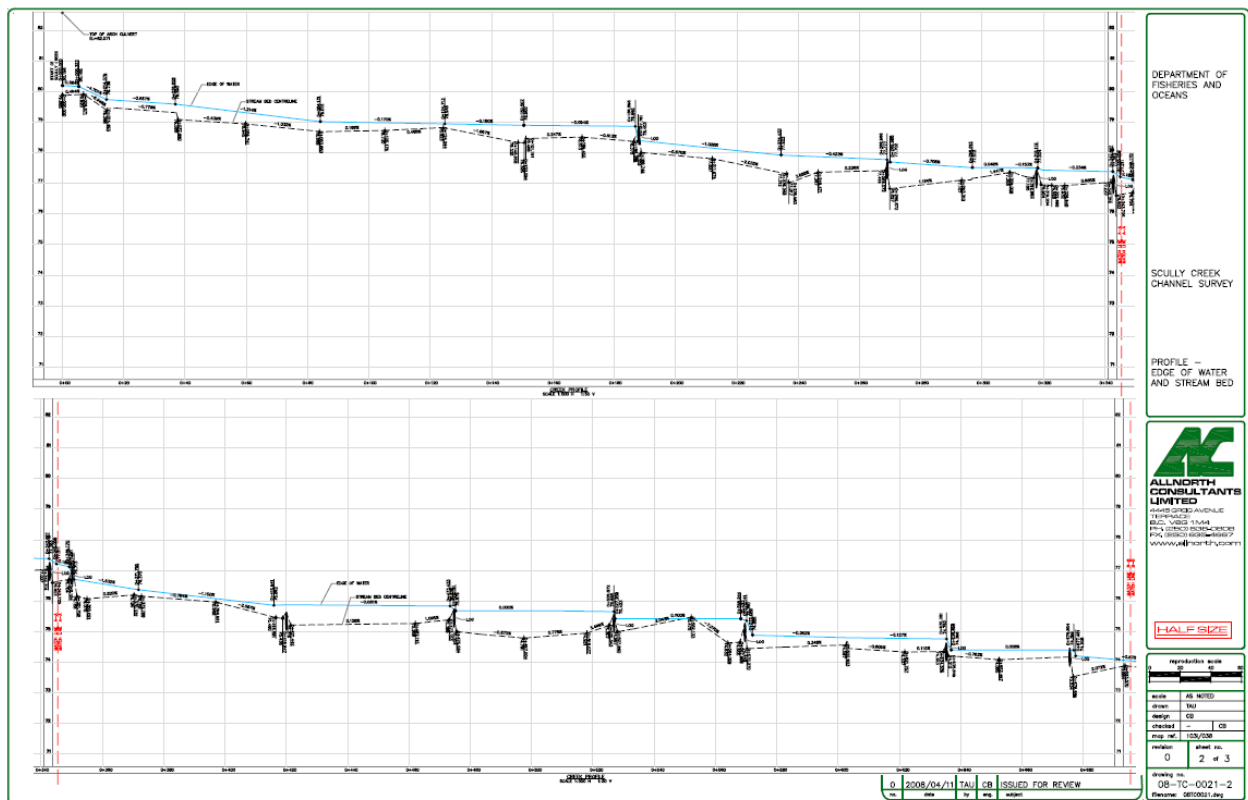
Figure 3 – Scully Mid-Channel stream profiles from 0+00 to 0+690

Based on the Allnorth Consultants site survey of Scully Mid Channel and DFO reconnaissance along this same length of stream to identify potential pilot gravel placement locations, four candidate sites were selected for the pilot spawning platforms. The plans that were used to identify the sites are shown in Figures 2, 3, 4 and Table 2.

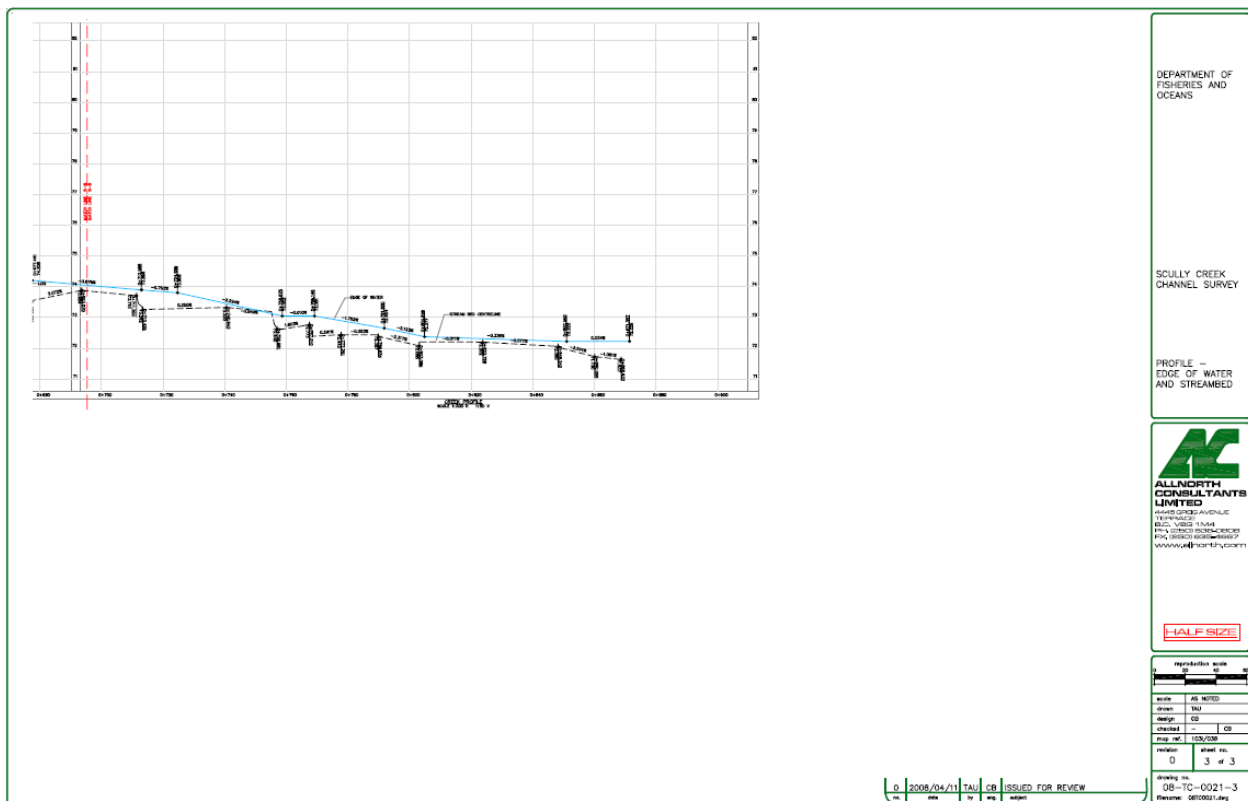
Figure 4 – Scully Mid-Channel stream profiles, 0+690 – 0+890

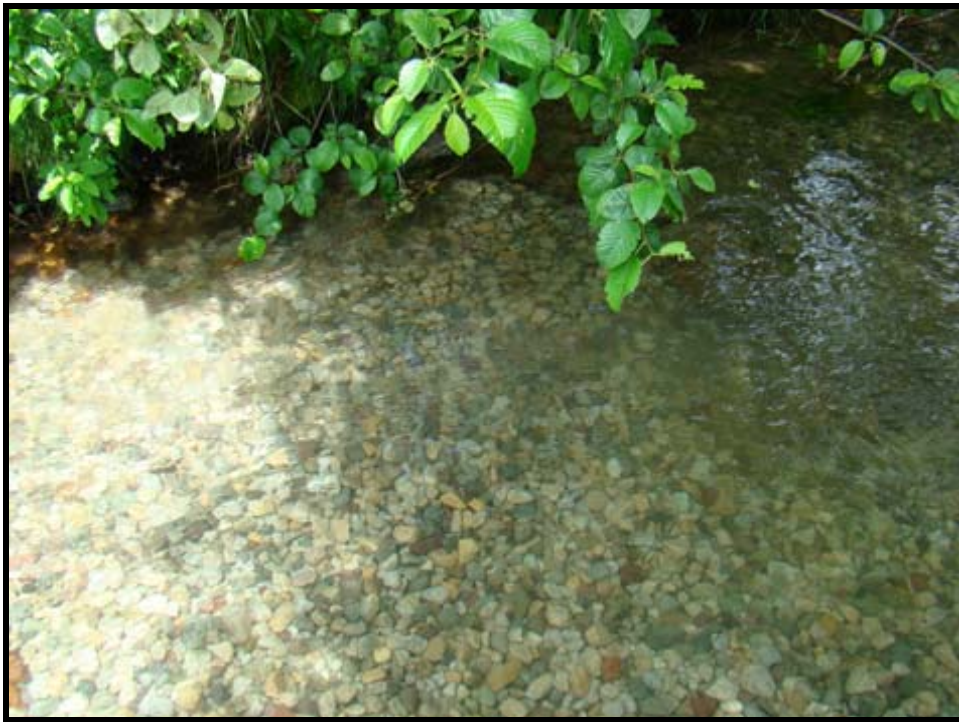
Photo 9 - Scully Creek - physical appearance of spawning platform gravel placed in the creek.

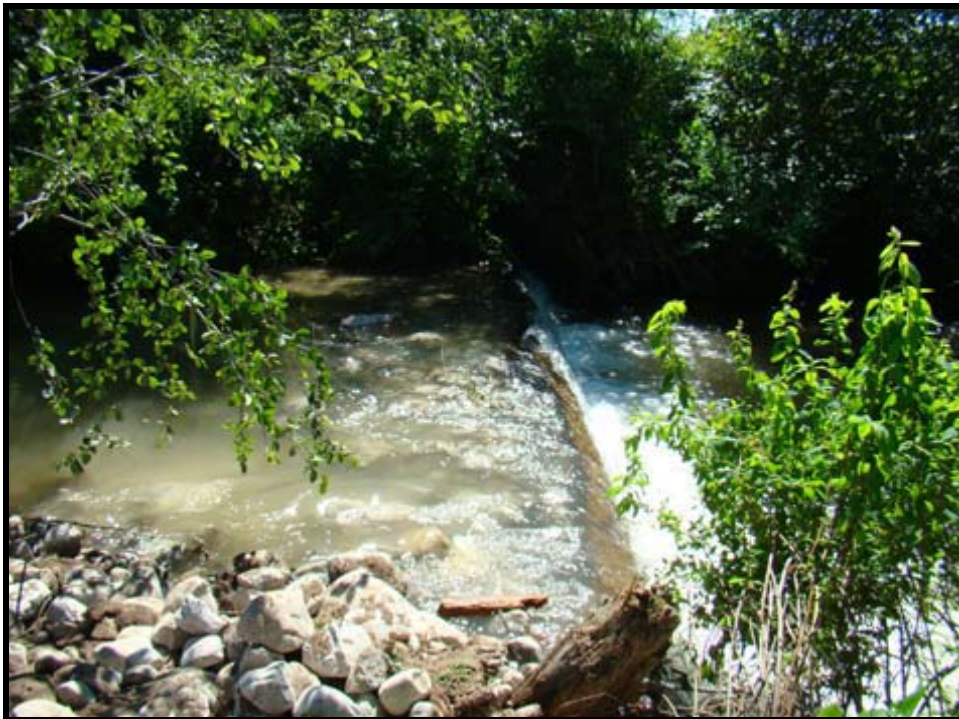
Photo 10 - Scully Creek - reinforced log weir at downstream end of one of the spawning platforms.

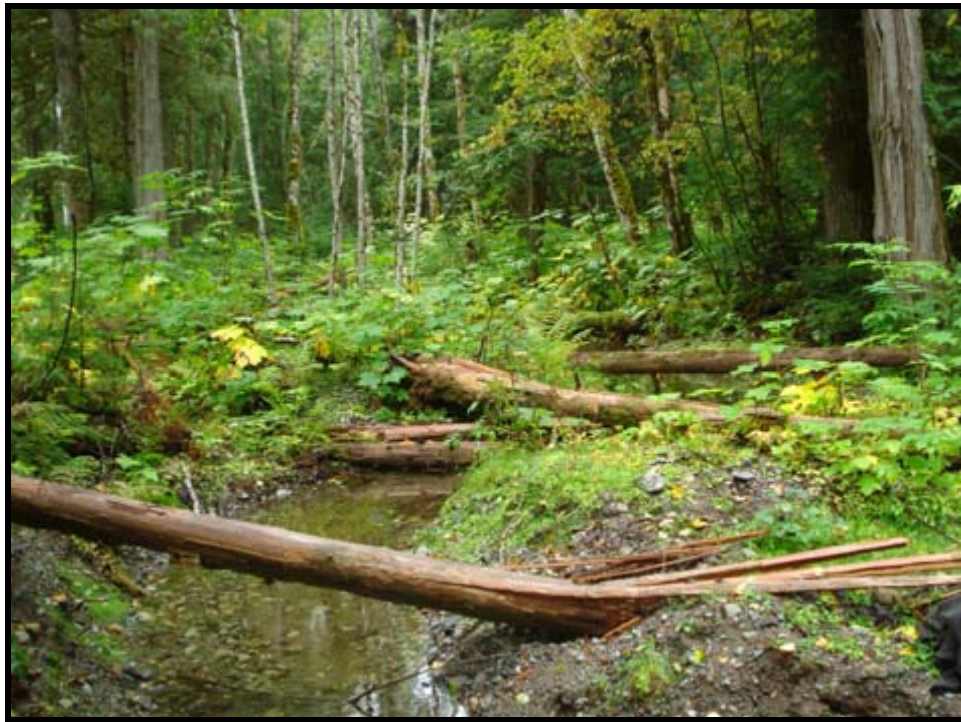
Photo 12 - Williams Creek - Typical test ditch construction.

After reviewing the data collected, one of the three sites was abandoned as a poor candidate for further development (little or no measurable groundwater). The test pits in the most downstream channel were subsequently removed (see Appendix 3 for survey drawings of the proposed channel options). The most promising site for future surface water channel development had additional test pits excavated and survey data collected upstream to the bridge across Williams Creek on Old Lakelse Lake Road. The best site for groundwater channel development was further developed into a test ditch and connected to a smaller groundwater channel flowing into Williams Creek. The excavated area was limited to 200 meters in length and ~2 meters in width as the groundwater table became too deep (~3m) for further channel development. Flows were estimated to range from ~0.5 to 2 cubic feet per second (cfs) and appeared to double downstream flows in the existing groundwater channel. The new habitat is characterized by excellent water quality and gravel substrates and some large woody debris for cover. Some minor sampling was conducted in the larger pool and over 30 juvenile coho and rainbow/steelhead trout were found. Several coho redds were also documented in the new channel in the fall of 2009.

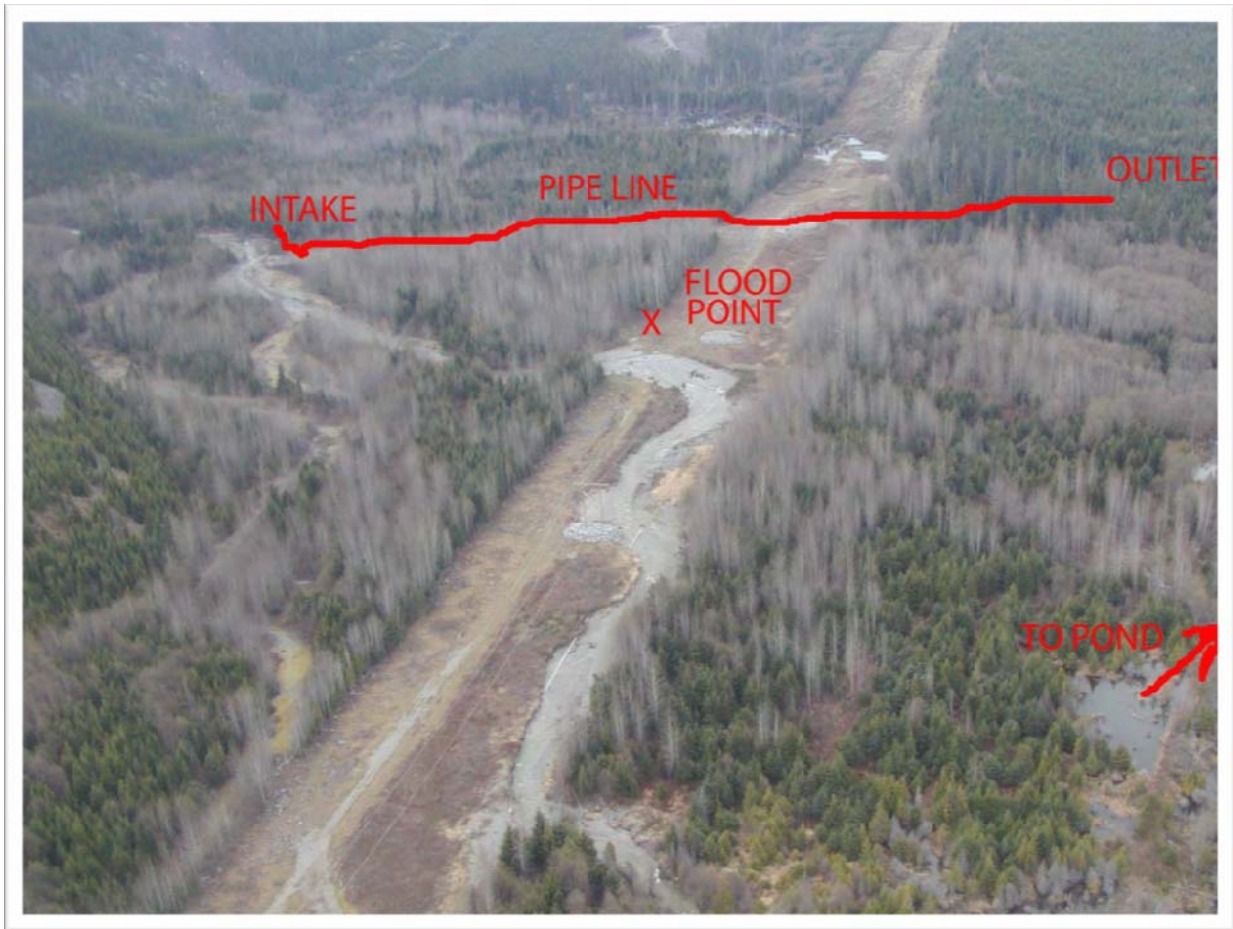
Photo 14 - Approximate location of proposed intake, outlet and pipeline route for the Scully Flow Diversion.

With additional information on prices, hydrology and finalizing the intake design and location, it is expected that minor revisions would be necessary, but further site investigation should be conducted in advance of any decision to view the locations following another freshet.

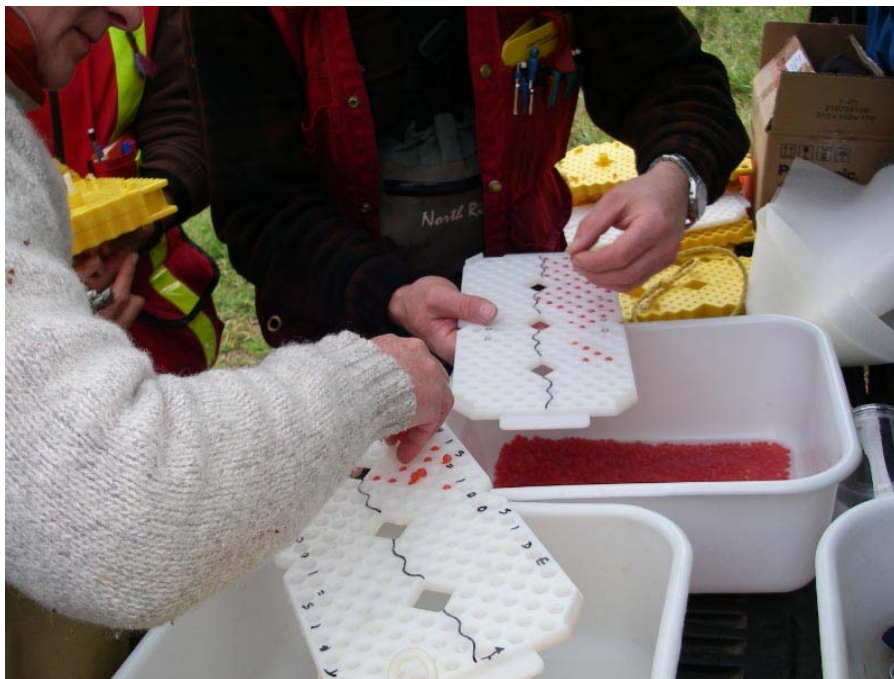
Photo 2. Loading eyed sockeye eggs into Jordan-Scotty incubation cassette loaders prior to transfer into yellow incubation cassettes (100 eggs per cassette).

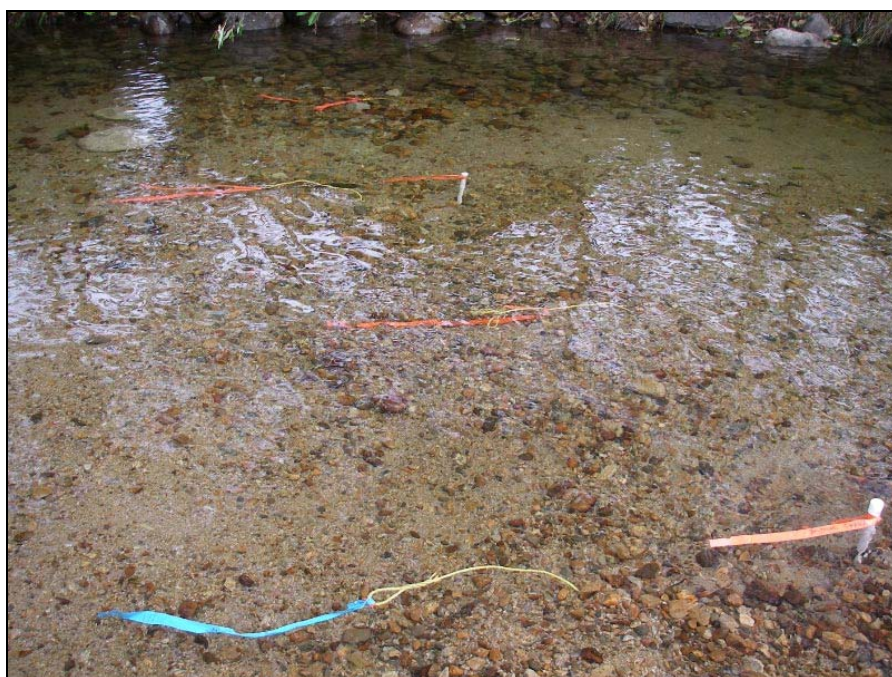
Photo 4. Completed installation of piezometers and buried incubation cassettes, flagged with poly rope and tape to facilitate locating for incubation assessments, at Site 4 in Scully Creek mid channel.

To monitor environmental conditions in the gravel, three mini-piezometers were installed at each incubation site. Piezometers were constructed of a 0.6 m long section of 15 mm (inner diameter) polyvinylchloride (PVC) pipe with a four 8 mm diameter holes drilled on each side in the lower 100 mm (4 inches) of the pipe. The end of the pipe was plugged and fitted with an anchor (drywall) that would help maintain its position in the gravel. The piezometers were planted with the permeable openings at approximately 0.25m depth in the undisturbed gravel, to compare with conditions in the water column. The top of the piezometer was capped to prevent surface water entry into the pipe. A hand pump was used to extract water from the piezometer during sampling.

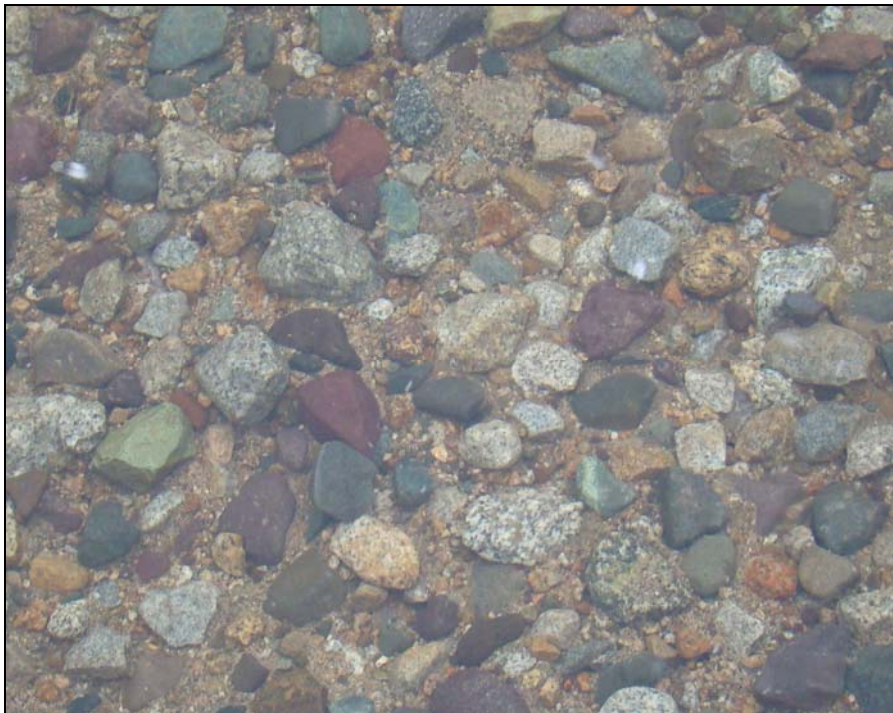
Photo 8. Spawning gravel at Scully Mid channel, January 7, 2009. Note sand and fines within interstitial spaces.

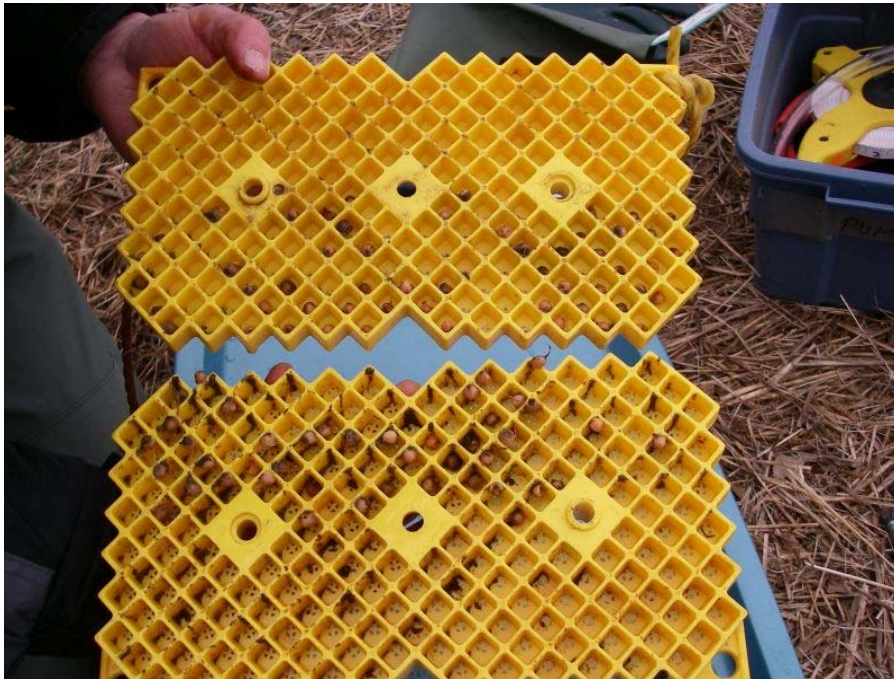
Photo 10. Mortality in one of four cassettes removed at Site 2 in Scully mid channel to assess survival to the fry stage.

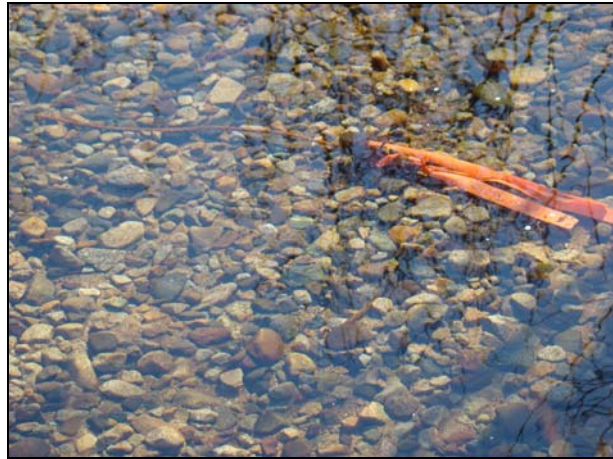
Photo 14 – Sediment (sands and silts) visible in the new gravel.
