**Water quality in the Toboggan Creek watershed 1996-1998:  
are land use activities affecting water quality  
and salmonid health?**

D. Remington<sup>1</sup> and B. Donas

Department of Fisheries and Oceans

March 31, 1999

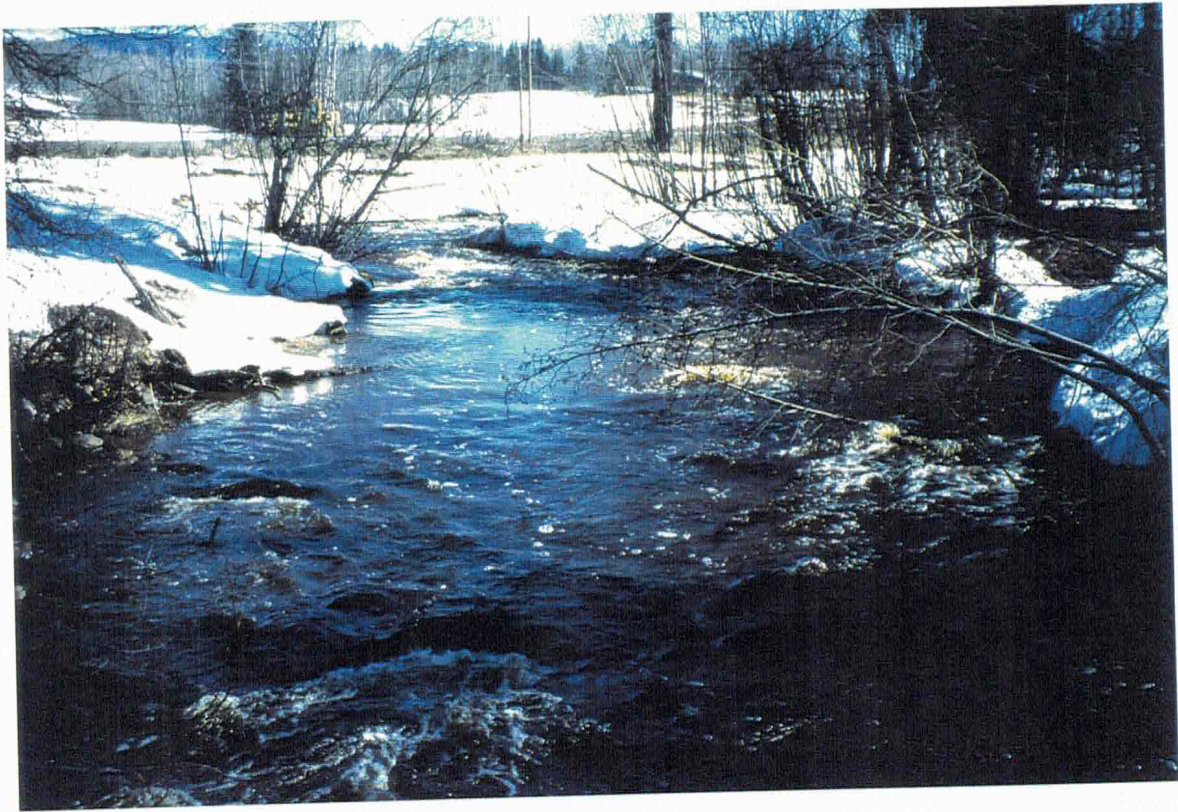
Site 4, Toboggan Creek upstream DFO salmonid assessment fence

*Site 4 Toboggan Creek at Fence* is located approximately 150 m downstream of the confluence of Owens Creek and 30 m upstream of the DFO salmonid assessment fence.

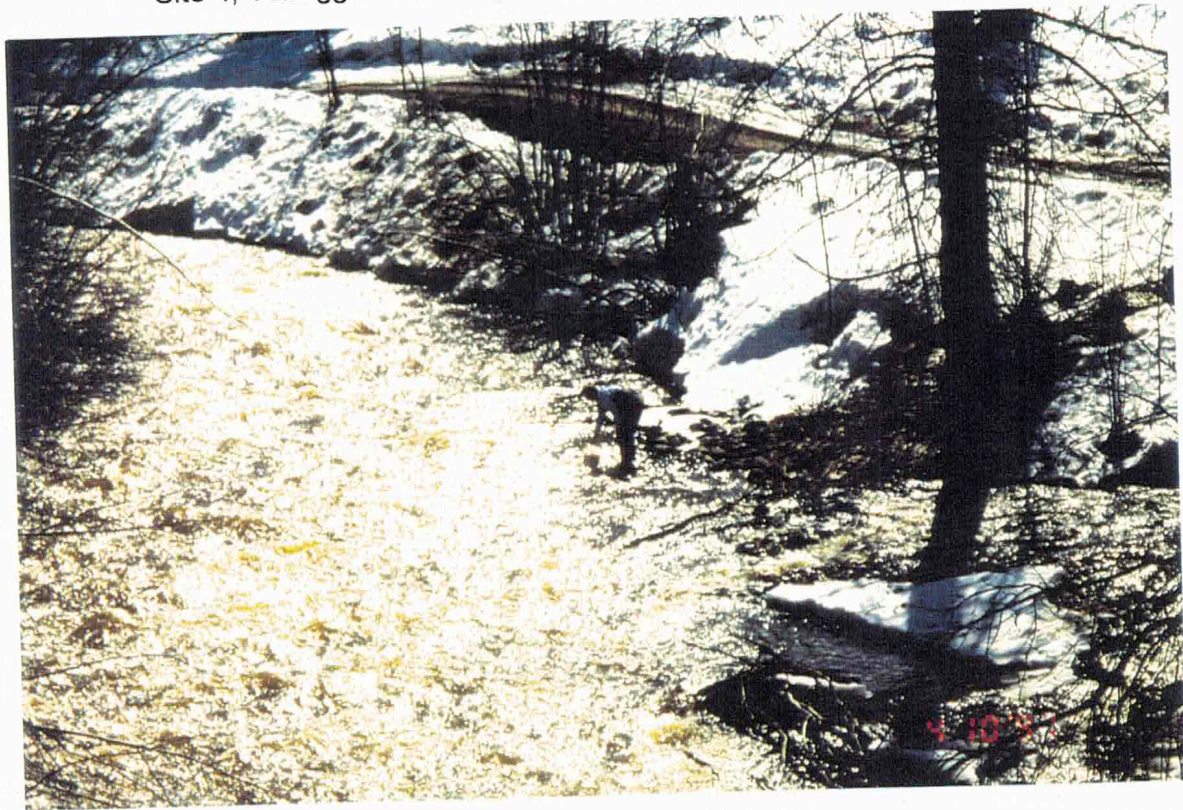
Site 5, Toboggan Creek upstream Highway 16 culvert

*Site 5 Toboggan Creek at Highway* is located approximately 500 m upstream of the confluence with the Bulkley River and 70 m upstream of the Highway 16 culvert.

Dissolved oxygen concentrations of 7-8 mg/l were recorded in Toboggan Creek at Site 4 and Site 5 in March and April 1998. These levels are lower than levels recommended in the water column over buried embryos or alevins. Spawning and incubation of pink and coho occurs throughout the mainstem Toboggan Creek, in the vicinity of these

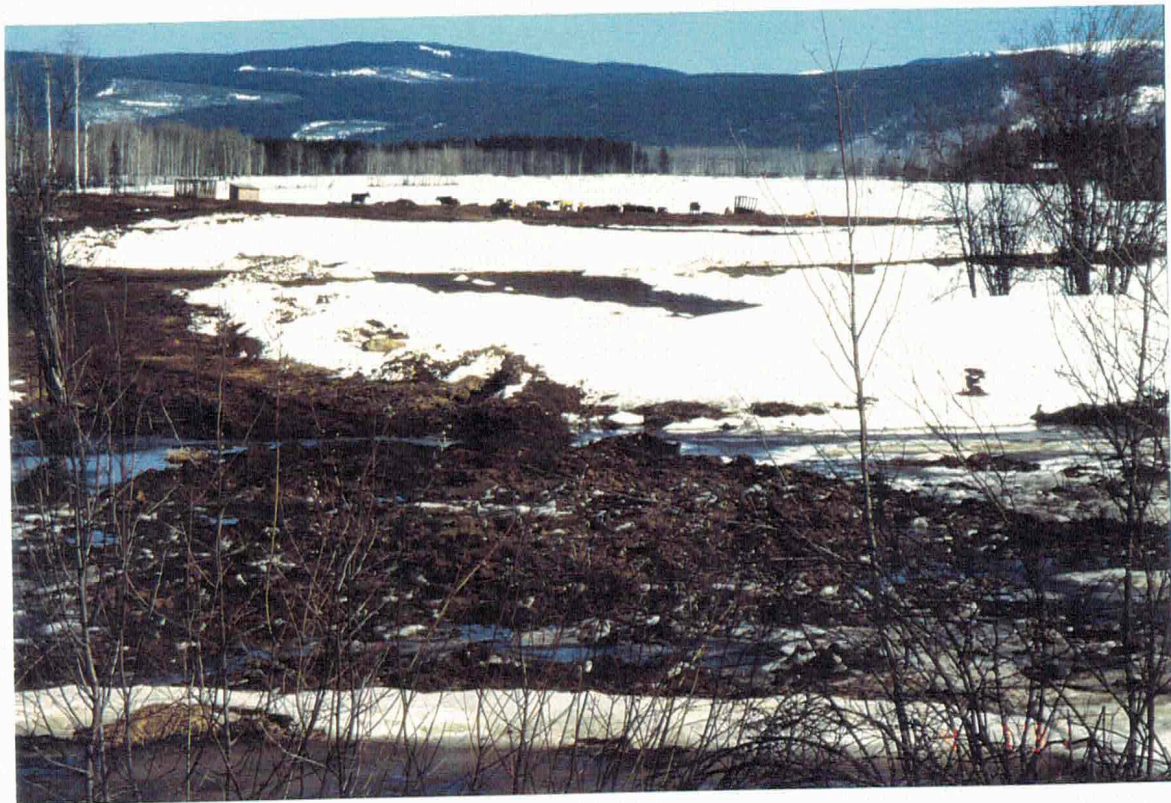
A dissolved oxygen level of 6 mg/l recorded in the farm slough 19 March 1998 was not related to temperature, which was 1° C on that date. It is likely that the very high ammonia concentration recorded on that date, over 2 mg/l ammonia-N, might have caused dissolved oxygen depression by creating biological oxygen demand.

The highest ammonia concentration recorded in this study was at Site 8, the farm slough excavated in a small Toboggan Creek tributary, on 19 March 1998. Ammonia concentration on that date was 2.162 mg/l-N (mean of two samples) at 1° C and 6.5 pH. This exceeds the MELP average 30-day ammonia guideline (1° C and 6.5 pH) which is 2.05 mg/l-N. The MELP maximum concentration guideline at that temperature and pH is 28.3 mg/l-N. Only one sample was taken during this time-period, which coincided with snowmelt and the first surface run-off from the nearby cattle winter feed lot. It was observed that juvenile coho and rainbow trout/steelhead were present both in the farm slough and in the wetland immediately downstream at the time.

Site 8, Farm slough. (Note cattle winter feedlot in background).

- Monitoring of nutrients and microbiological indicators in runoff from livestock wintering areas, manure and silage storage sites and dairy parlors is recommended for the Toboggan watershed. Landowner contact should only be undertaken in cooperation with Ministry of Agriculture, Fisheries and Food and the B.C. Cattlemen's Association peer advisory committee. The Conservation Check List found in the *Watershed stewardship: a guide for agriculture* (DFO 1997) could be an educational tool, in addition to focusing remedial action. A rating system based on terrain runoff potential, location relative to streams, and cattle numbers and management has been used successfully in focusing remedial action in other central interior watersheds (Hart and Mayall 1991). Alternatively, the environmental sustainability parameter (Palmer and Rising 1996), which was developed for the Fraser River Valley and rates farm waste management practices relative to a selected sample of area farms, could be adapted to this farming area.
