RECONNAISSANCE REPORT
(Fish Habitat Improvement)

PROJECT: Seymour Lake Rehabilitation .

PURPOSE: To provide further information on the proposed rehabilitation of Seymour Lake with special attention to potential problem areas and coarse fish barrier location.

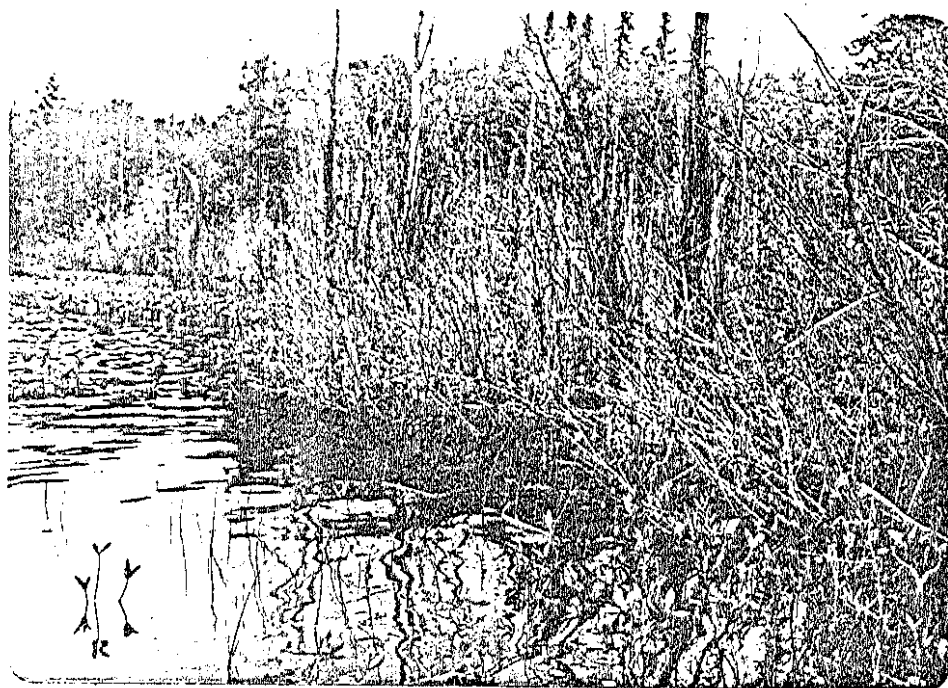
Beaver activity at the outlet of Seymour Lake (see map) has resulted in considerable flooding of several areas of the lake's shoreline. Vegetation is thick in many of these areas, and while they do not represent true swamps, piscicide treatment would be extremely difficult, necessitating special consideration (Fig. 3). Flooding at the outlet itself has caused a pond/swamp area of approximately 5000 m^2 (1.2 ac.). Most of this area is choked with fallen trees and flooded vegetation, and water depth exceeded 1.5 m in several spots (Fig. 4, 5). Flooding at the south end of the lake covers approximately 7000 m^2 (1.7 ac.). Beaver lodges were observed near the shore in the southwest corner and north end of the lake. Another extensive flooded area of approximately 3000 m^2 (0.74 ac.) occurs at the north end. Due to the relatively steep shores on the western and eastern shorelines, flooding of terrestrial vegetation is limited to a distance of less than 2-3 m (from the apparent original shoreline) in most cases. Assuming a mean distance of 1.5 m over a shoreline length of approximately 4000 m (exclusive of major flooded areas and swamps), this represents an additional flooded area of 6000 m^2 (1.5 ac.), for a total flooded area of $21,000 \text{ m}^2$ (5.2 ac.). At an approximated mean depth of 0.5 m, the water volume of the flooded areas is $10,500 \text{ m}^3$ (8.5 ac. ft.). Aquatic macrophytes, primarily lily pads, reeds, and Potamogeton, occur in relatively dense patches in the shoal areas at the north and south ends of the lake (Fig. 6). Again special attention will be required to ensure adequate chemical dispersal in these patches.

Fig. 3. Flooded vegetation on lake periphery.

- 4.2 In view of the difficulty in treating the flooded areas resultant from beaver activity, removal of beaver dams on the outlet and inlet (Shepard and Algard, 1977) would be highly advantageous. The probability of a complete kill would be greatly enhanced and there would be a saving in both chemical costs and required personnel. Discussion with lake residents (re lake level suitability) should precede any such activity.

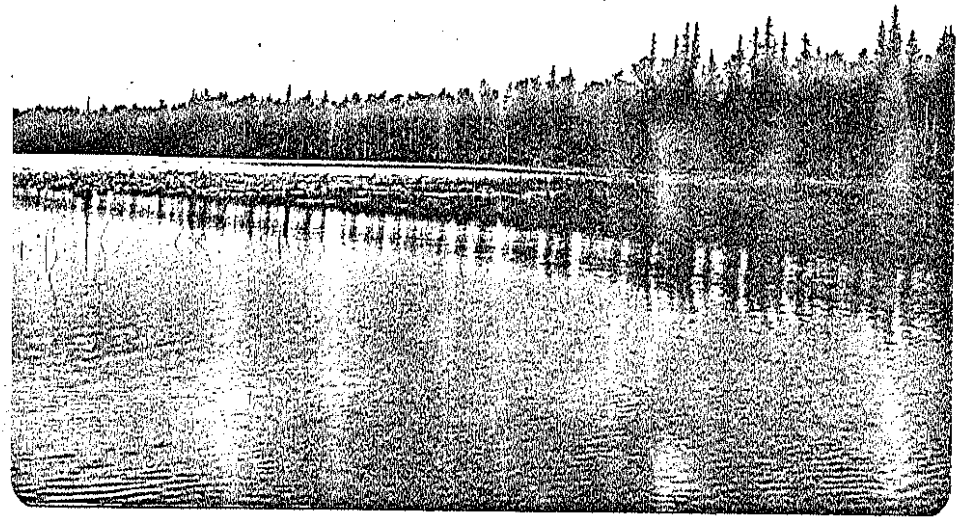
Fig. 6. Lily pads and reeds at SE end of lake.

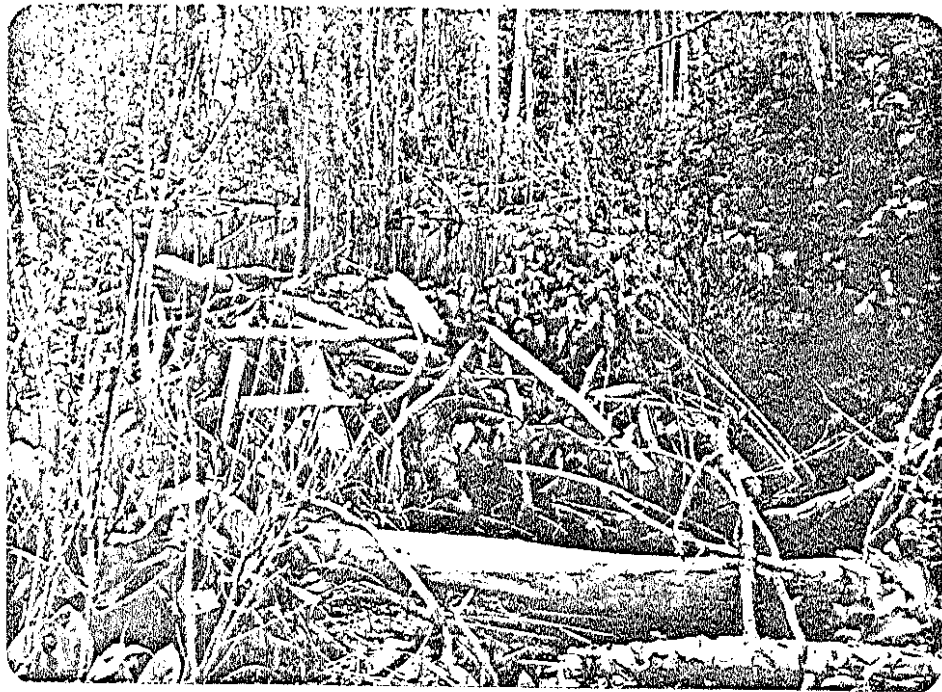
The outlet is located at the southeast end of the lake. Beaver activity is extensive for the first 150 m. Fifty meters from the lake there is a major dam approximately 1 m high and 5 m across (Fig. 7). A second major dam, approximately 1.2 m high and 3 m across is located about 100 m downstream from the first (Fig. 8). In addition, at least two other dams are present but have been flooded over by later activity. Below the second major dam the outlet stream follows a definite channel 2-3 m wide. At 170 m below the lake the stream is crossed by a bridge (Fig. 9-11). In following the stream for 550 m (1/3 mi.) below this crossing, although no further beaver activity was encountered, thick riparian vegetation, considerable braiding, side-pooling, and debris accumulation was observed.

Fig. 7. Beaver dam on outlet - 50 m from lake.

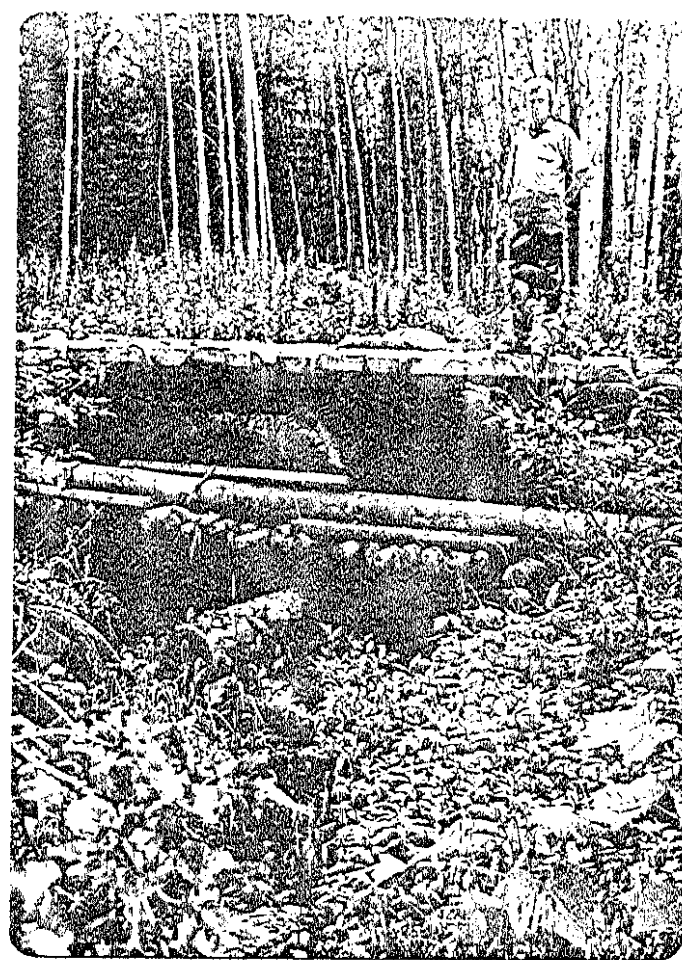
Shepard and Algard (1970) suggest that the barrier be located further down the outlet at the end of the ravine or near a lower road crossing. This would entail the treatment of between 0.8 and 1.5 km of the outlet's course. In view of the fact that coarse fish were observed throughout the outlet stream, the above proposal seems inadvisable because of the stream's complexity, resultant treatment difficulties, and low probabilities of a complete kill. To maximize success and minimize cost the barrier should be located at, or in the vicinity of the first bridge crossing. Ideally, an effective barrier could be constructed by modification of the existing bridge by installation of an oversized, flat-arch culvert or construction of a cement apron on the downstream edge (Fig. 11). Rising topography immediately to the north of the bridge and elevation of the road to the south (to form a dyke) eliminate any possibility of channel relocation subsequent to barrier installation. If permission is not forthcoming from the bridge/road owner to modify the structure, a barrier could be installed immediately above the bridge (channel width approx. 2 m, banks 0.5-1.2 m high) (Fig. 12), or, preferably, 25-50 m below the bridge (channel width approx. 2 m, banks 1-1.5 m high) (Fig. 13). Engineering advice should be sought to bring the above possibilities into technical and cost perspective.

Fig. 10. First bridge crossing on outlet

Fig. 11. (looking upstream)

- 4.4 For reasons previously mentioned, the coarse barrier should be located at, or near the first bridge crossing. The appropriate owner should be contacted regarding permission/approval to modify the bridge.
