# TABLE OF CONTENTS

## The Upper Zymoetz River and Tributaries

## 1.0 INTRODUCTION

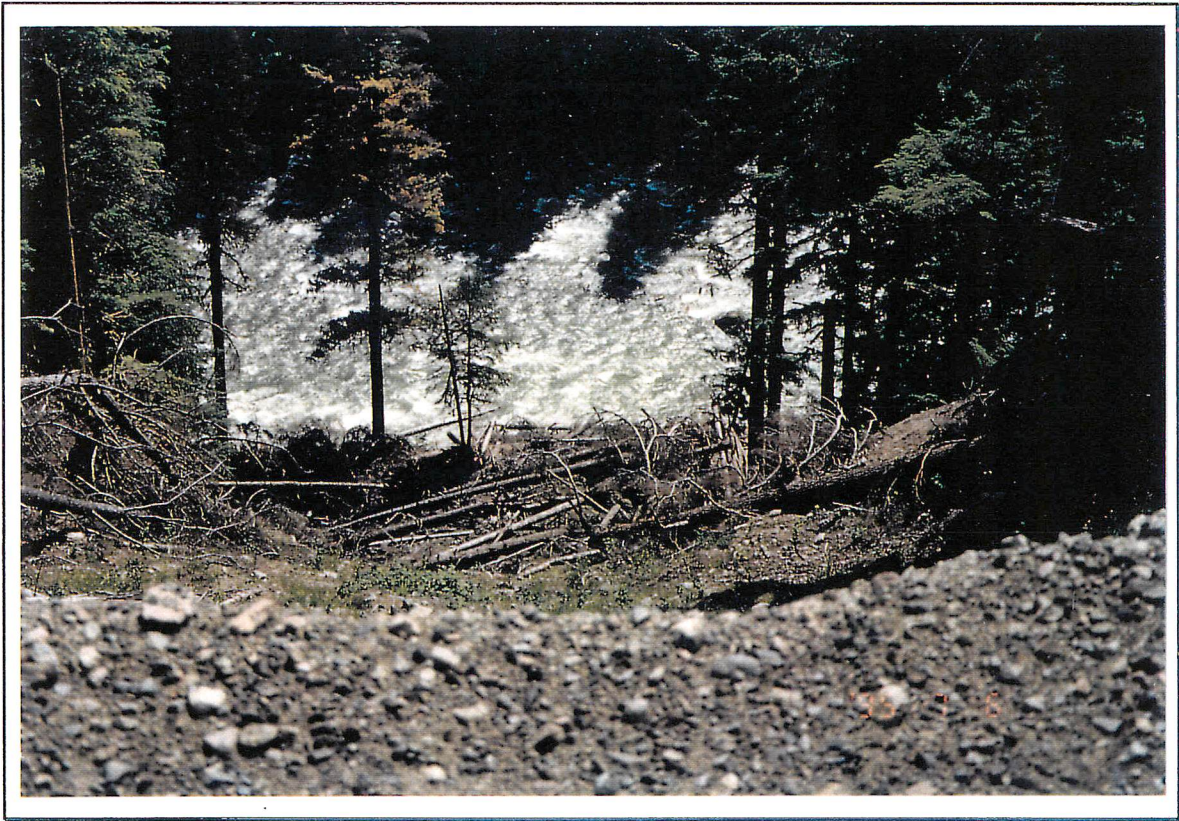
Figure 2.1) A view of the Zymoetz River from a slump initiated by Kleanza Creek Road in TFL #1. If forestry practices such as this continue, Class I angling water attributes associated with access control, water quality and pristine wilderness fishing experience will be lost at other locations along the Zymoetz.

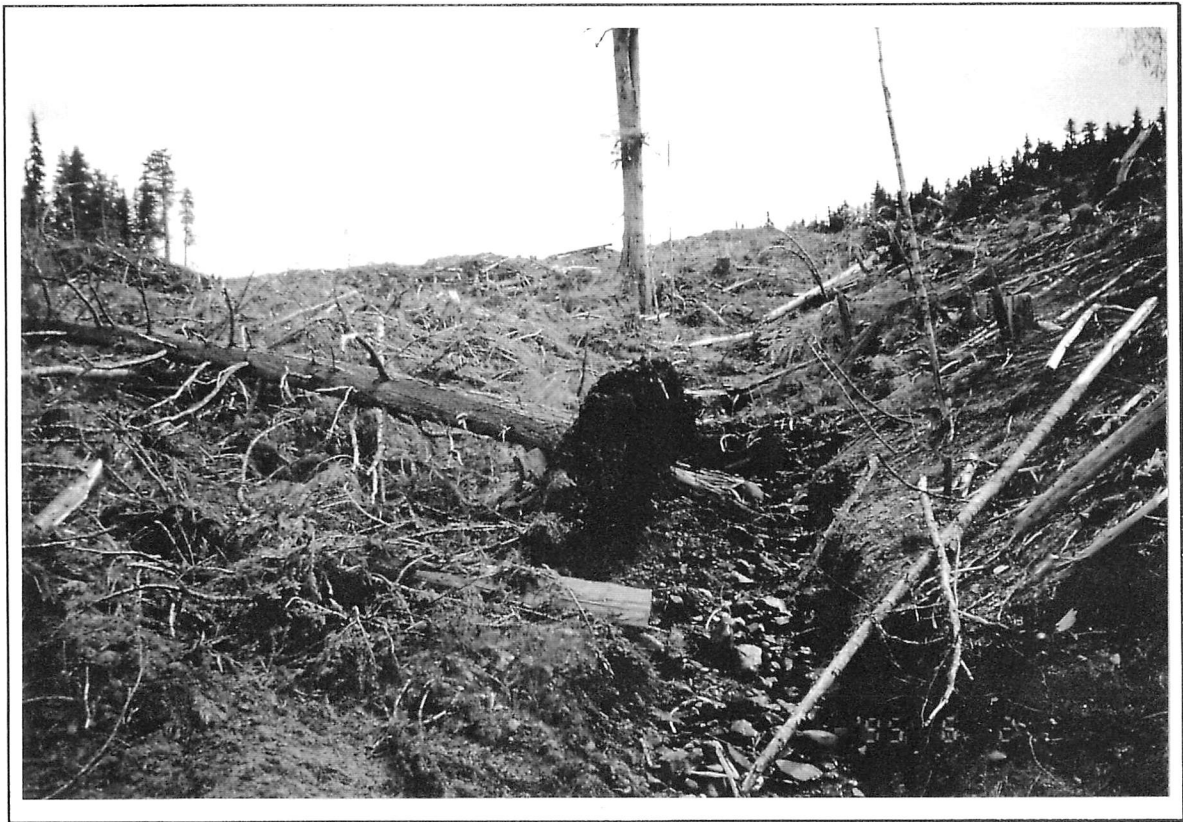
Figure 3.1) The terrain above is considered to be of very low concern to logging and road building operations. With a low (L) surface erosion potential and terrain stability classes II (interpreted using terrain stability and surface erosion potential map 93L.081 (Maynard 1994)), this terrain is considered to be a *green zone* where development may safely proceed. As seen above, slight problems of erosion from disturbed soils are to be expected in these zones. Periodic inspections of green zones and appropriate erosion control measures (such as grass seeding) may therefore be needed (D. Wilford, personal communication, August 1995). This photograph was taken from the McDonnell Main Road approximately 2 km south of the Moore Creek crossing.

Polygons which have been left uncoloured represent "green traffic-light" areas of very low concern to logging and road building operations. These polygons contain no evidence of current or past geomorphic processes which could contribute to mass movement. Surface erosion potential is, at most, low (L) and terrain stability class rating are II or less. Minor erosion of fines can be expected from disturbed soils and ditch lines in areas with a low surface erosion potential. Management is necessary to ensure that water is not channelled onto more sensitive sites. (FPC Mapping and Assessing Terrain Stability Guidebook 1995, p.14 and Schwab 1993, p.16). Because terrain stability classes are II and below, significant stability problems are not expected following timber harvesting or road construction (FPC Mapping and Assessing Terrain Stability Guidebook 1995, p.10 and Schwab 1993, p.13). Periodic inspections of logged and roaded terrain and immediate revegetation of disturbed sites in these zones should be carried out to correct minor erosion problems which may occur (see Figure 3.1) (D. Wilford, personal communication, August 1995).

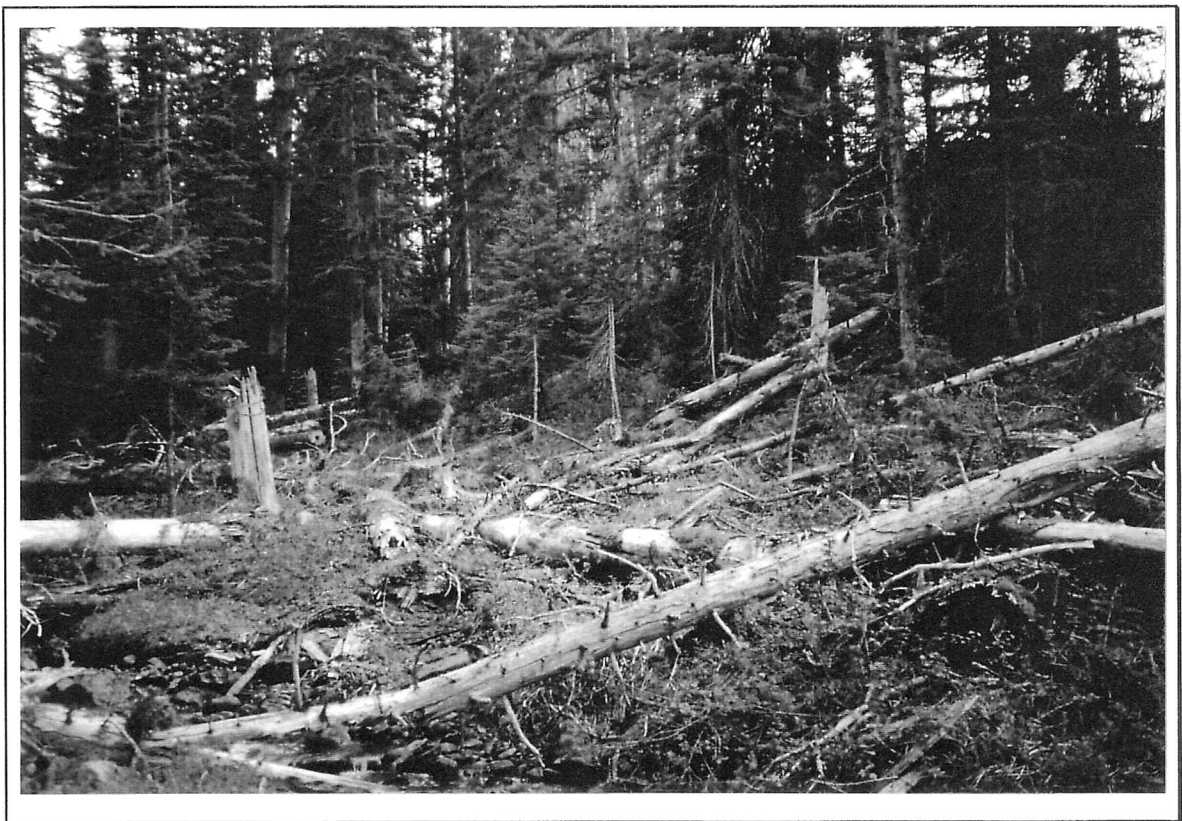
Figure 3.2) Terrain above has been interpreted to have a terrain stability class III rating with a high (H) surface erosion potential. This is an orange 1 zone of low concern where forestry operations must proceed with caution. Minor stability problems and slumping can be expected along the road cuts and water management is required. Highly erodable soils may be a major concern if water is channelled onto or over this location. The photograph was taken a few metres from the Moore Creek crossing facing north. Terrain was interpreted using terrain stability and surface erosion potential map 93L.081 (Maynard 1994).

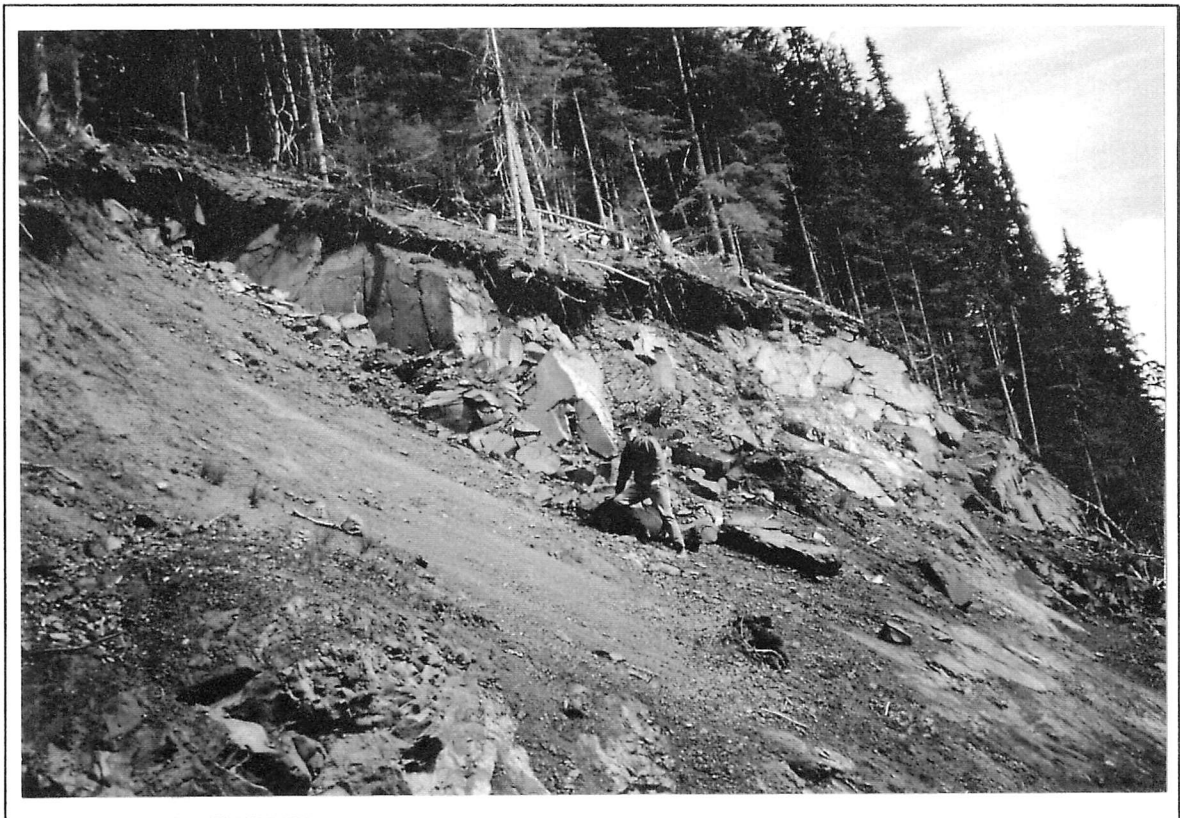
Figure 3.3) This recent, road initiated, small scale rockfall event was found on the McDonell Main Road approximately 150 metres west of the Irvine Creek crossing. As an *orange 2 zone* (of moderate concern), problems of instability can be expected following road building or clearcutting. This terrain is of stability class IV with a moderate (M) surface erosion potential (Maynard 1994, map 93L.081).

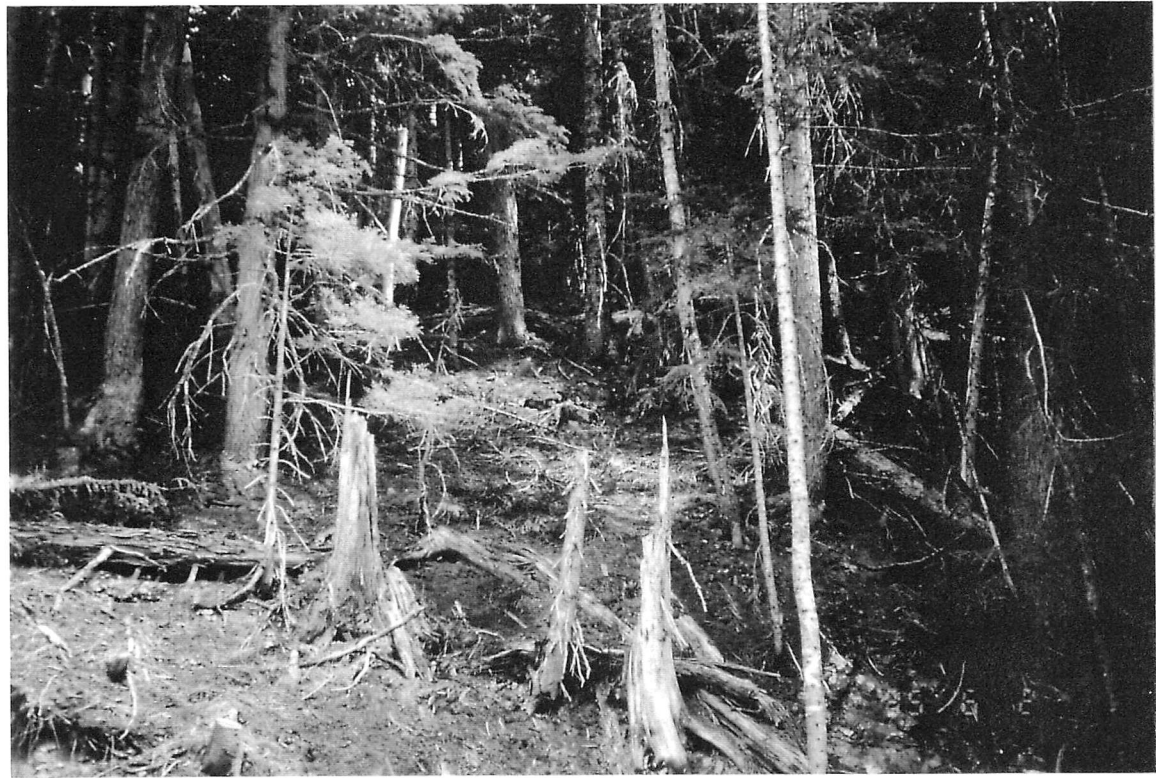
Figure 3.4) The irregular topography seen in the photograph above is *orange 3 zoned* terrain of high concern to logging and road operations. The terrain is of stability class IV with a high (H) surface erosion potential and evidence of active gully erosion by water and/or active landsliding (interpreted from: Maynard 1994, map 93L.081). The photograph is of the north-west side of an unnamed creek on the McDonell Main Road, 700 metres south-east from the proposed Johnson creek crossing.

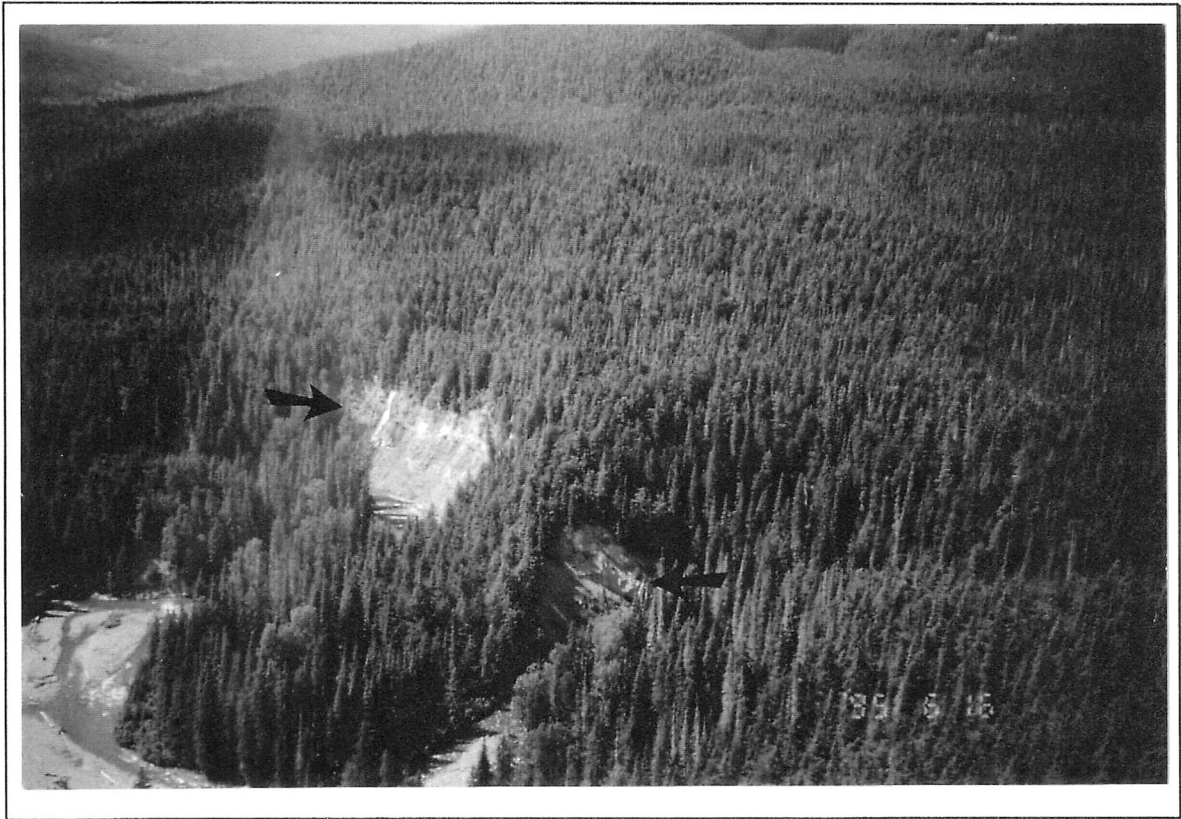
Figure 3.5) In the picture above, rapid erosion occurs naturally less than a kilometre from where Mulwain Creek enters the Zymoetz River. Rated by Denny Maynard as terrain stability class V with very high (VH) surface erosion potential (1994, Map 93L.071), the actively unstable terrain is considered a *red zone* to forestry development. No road construction or timber harvesting of any kind should take place in these actively unstable red zones unless approved by a qualified terrain specialist after careful field evaluation.

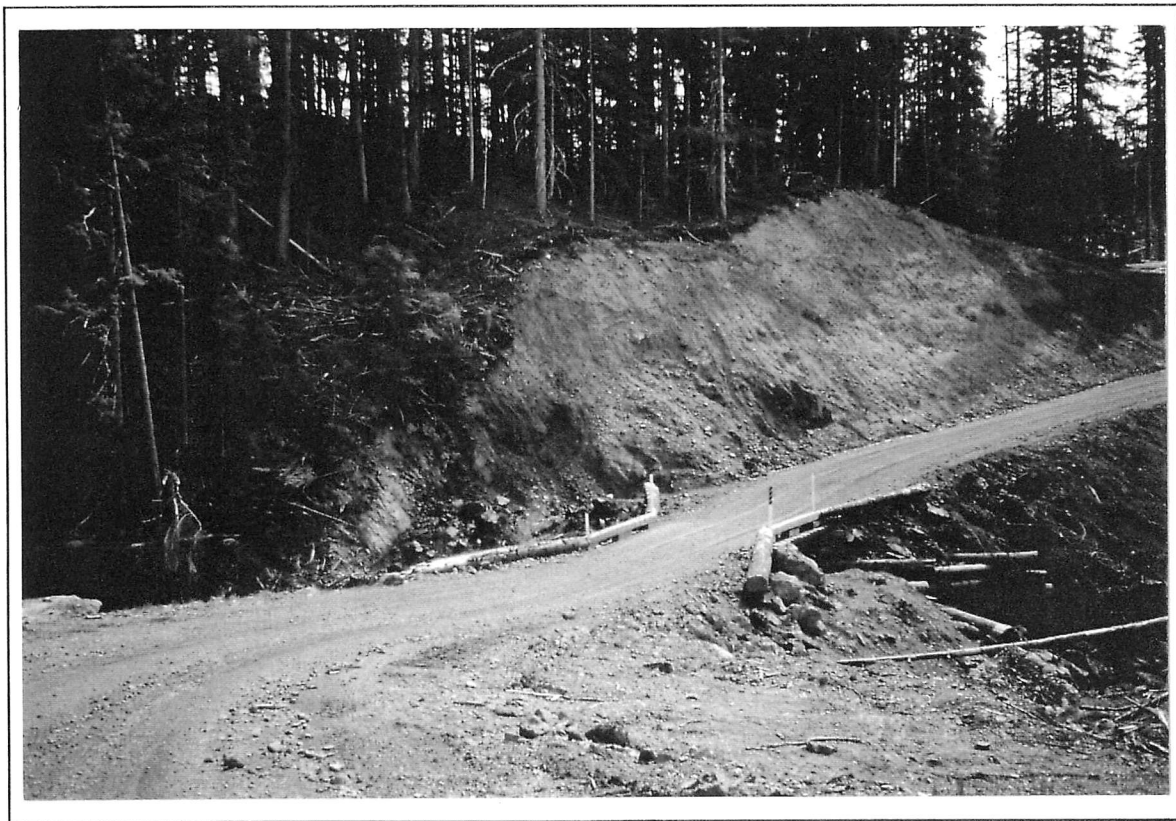
Figure 3.6) The photo above was taken at the Irvine Creek crossing on the McDonell Main Road. The bridge was built over a narrow *red zoned* corridor of the creek after approval by a Professional Engineer. According to map 93L.081 (Maynard 1994), the bridge crosses class V terrain with a H surface erosion potential and active gully erosion and/or landsliding. Care must be taken to ensure that erosion does not occur on the exposed cutbank and flow into the creek along the ditch. Grass seeding of the slope should be carried out for this purpose. Continued inspection and maintenance will be required for as long as the bridge exists.

precluded from this unit" (p.44). Planners should, therefore, assume that no development can be carried out in red zones unless it has been proven otherwise by a qualified terrain specialist (Figure 3.6).

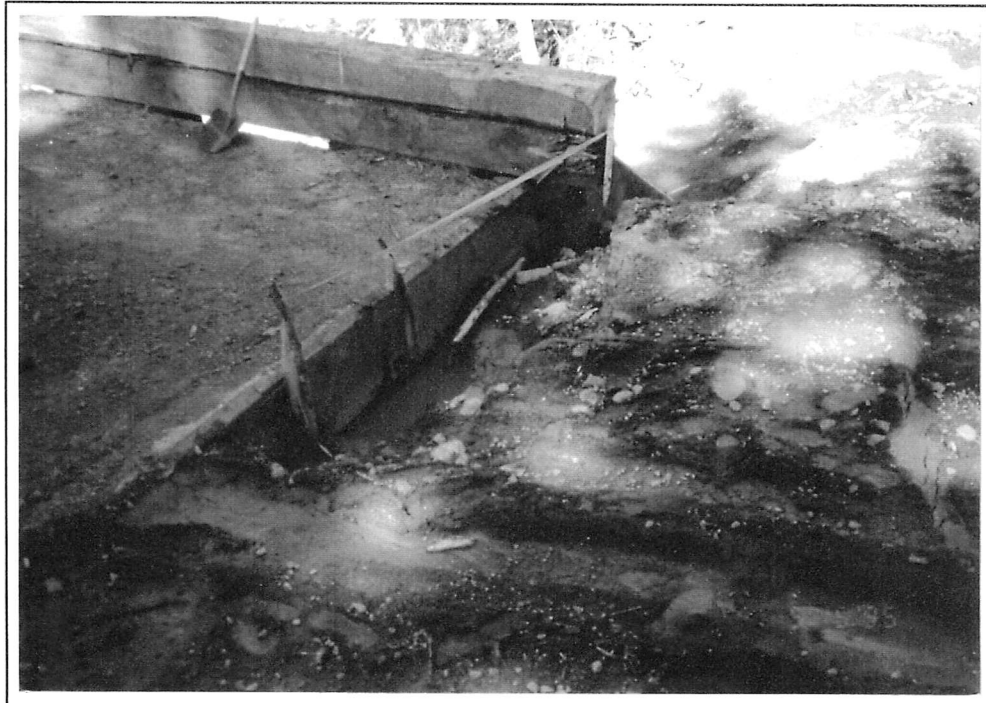
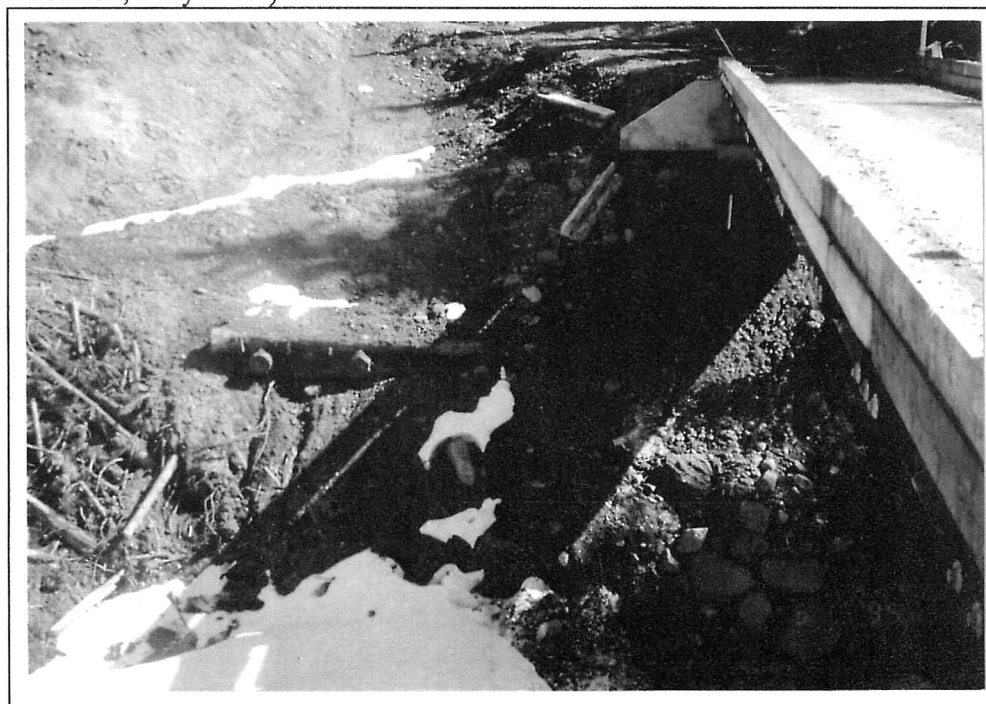
Figure 3.7a above & 3.7 b below) Red zoned terrain at this unnamed creek crossing at kilometre 3.7 on the South Copper Mainline was interpreted to be of stability class V with a very high (VH) surface erosion potential. Active rockfall and gully erosion by water and/or landsliding is also present (Maynard 1994, map 93L.072). At the time of this photograph, proper water management and erosion control precautions had not been taken at this location. As a result, runoff was eroding the soil foundation of the bridge and other disturbed areas, transporting it into the creek. (L. Vanderstar, personal communication, May 1995)

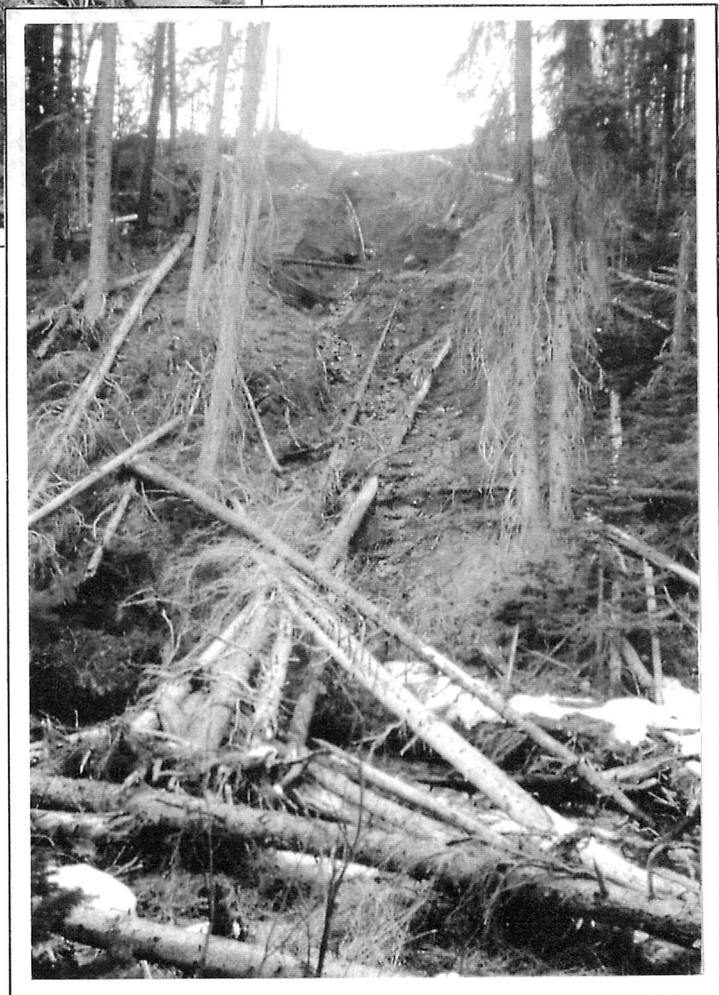
Figure 4.1b right) This picture was taken from Willow Creek looking south-west to cutblock 93L.083-014. An increase in subsurface flow and/or possible windfall may have initiated the landslide which made this gully. At the time this picture was taken, groundwater continued to flow to where it surfaced at the top of this slope. This small new stream continues the erosion process in the gully carrying sediment into Willow Creek. Although this site was logged before the FPC came into place, current practices under the code still allow logging to the break.

An example of one oversight in the FPC can be found at Willow Creek on the north-east edge of cutblock 93L.083-014. Currently, clearcut logging is permitted to the edge of any ravine or slope which neighbours the cutblock. However, in this instance, the practice of logging to the break in slope may be unsuited to the terrain of the McDonell Resource Planning Area (Figure 4.1a & 4.1b).

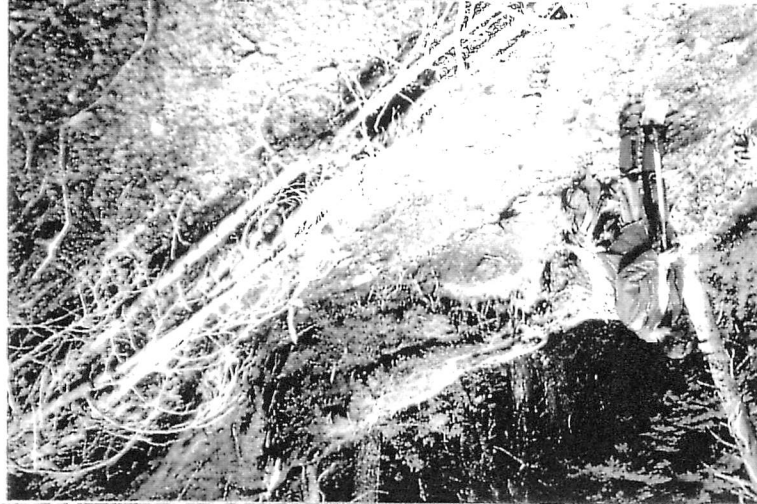
8

8. Bank failure on the east side of lower Mulwain canyon. Lateral undercutting causes instability and erosion of a thick sequence of advance glaciofluvial gravels and overlying till; this scarp segment is rated stability class V, erosion potential VH.

27. Bank failure in lower Mulwain canyon (see photo 8). Surface erosion during a summer rainstorm instantly muddies the creek. Sediment delivery potential is V.

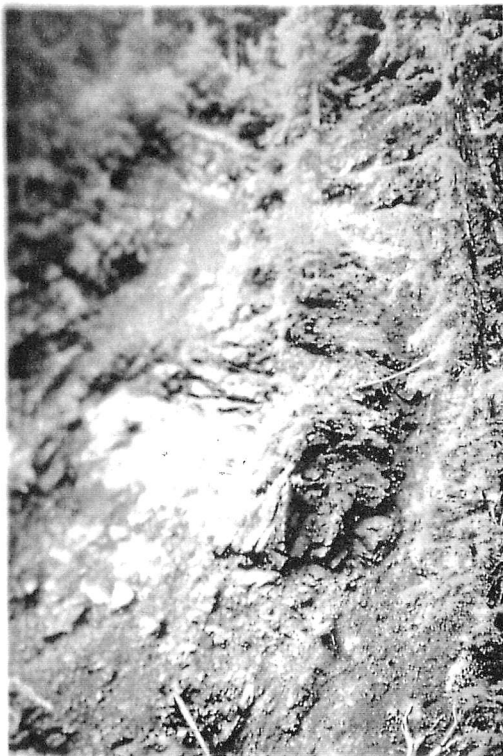
18

18. Bedrock-colluvial failure on sideslope of tributary canyon south of Zymoetz River, east of Red Canyon Creek confluence. Weathering of fine-grained volcanics produces fine sediment contributing to an erosion potential rating of H, stability class V.

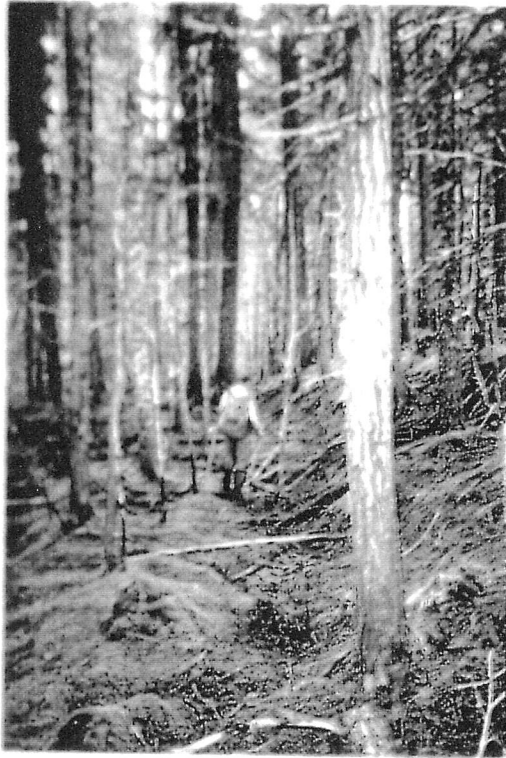
23

23. Slump-terraces in thick till at the scarp edge of Mulwain canyon, west bank south of Johnson Creek confluence. Indicates a very high potential for failure; stability class V, erosion potential VH.

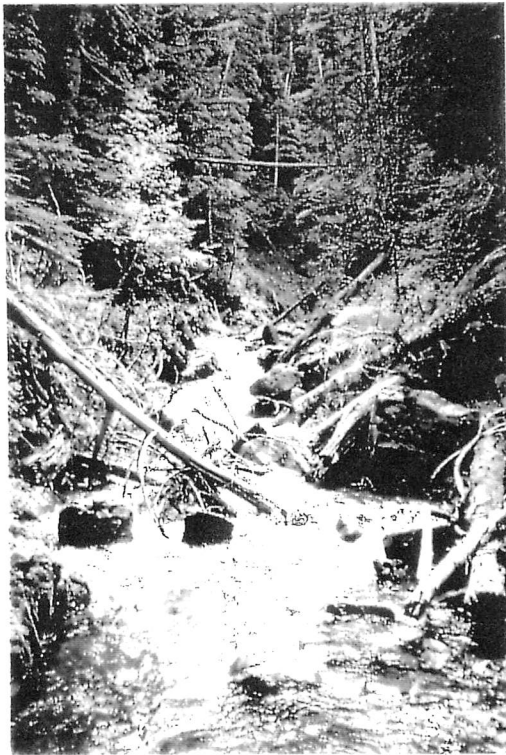
29

29. Example of a small tributary on the south side of Zymoetz River where a confined channel has a through-put potential rating of V.
30. Example of a small tributary on the south side of Zymoetz River where a broadening of the valley flat leads to temporary gravel deposition; through-put rating of this reach is 3.

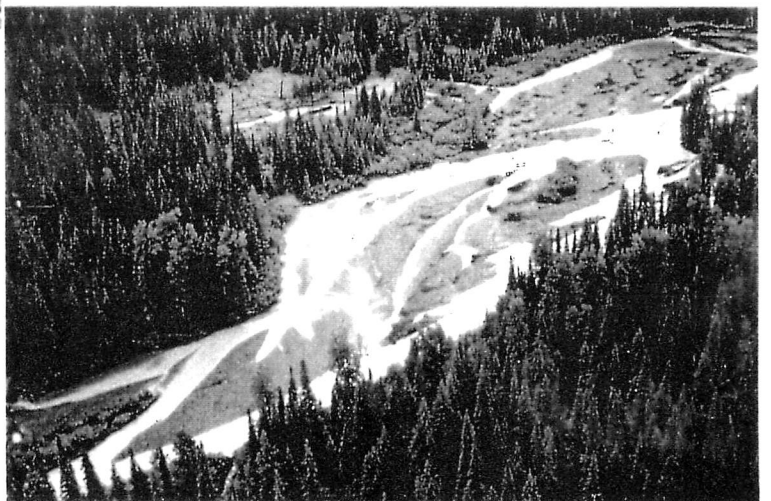
31

31. Lower Red Canyon Creek which has been muddied by transport of fine sediment from tributary streams (notably Bloody Mary Creek) during a summer rainstorm.
