**Reconnaissance (1:20,000) Fish and Fish Habitat Inventory  
Resampling in the Taltapin Sub-unit  
2002/03**

**WSC: 480-927700-\*\*\*\*\***

**Pinkut Creek and Taltapin Lake Tributaries**

Prepared for:  
**Babine Forest Products Co.**  
Box 4000  
Burns Lake, BC  
V0J 1E0

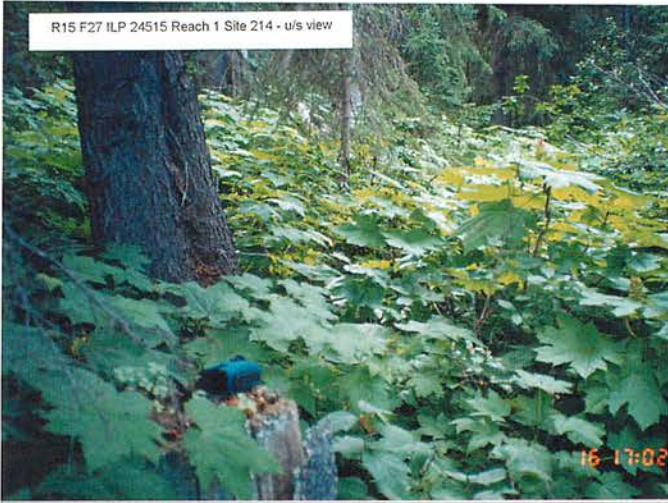
R15 F27 ILP 24515 Reach 1 Site 214 - u/s view

Roll# 15, Frame# 25, CD# 4, Image#347, Direction: Upstream, Scale/Comment:cam bag drainage is not an FPC stream, occasionally moist depression in terrain filled with Devils' club; lacks fluvium and continuous channel bed; leaves, detritus present from last fall. site = "mouth". Other - none

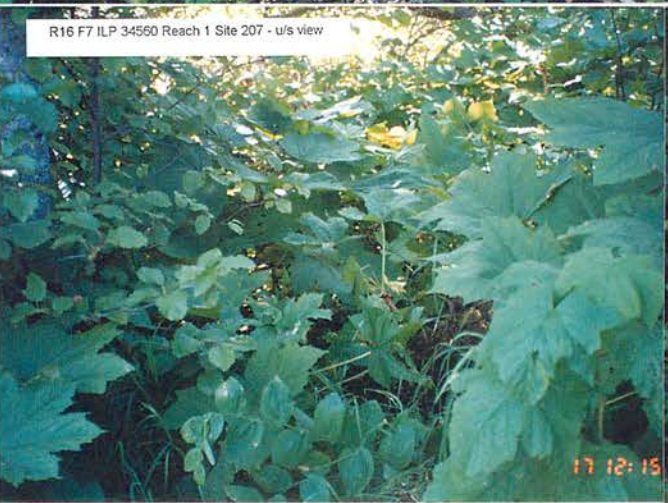
R16 F7 ILP 34560 Reach 1 Site 207 - u/s view

Roll# 16, Frame# 7, CD# 4, Image#355, Direction: Upstream, Scale/Comment:no scale  
site = UTM = "mouth". moist shrubby swale with no trace of channel - seepage; all vegetated by alder and Devil's Club. Other - No fish habitat

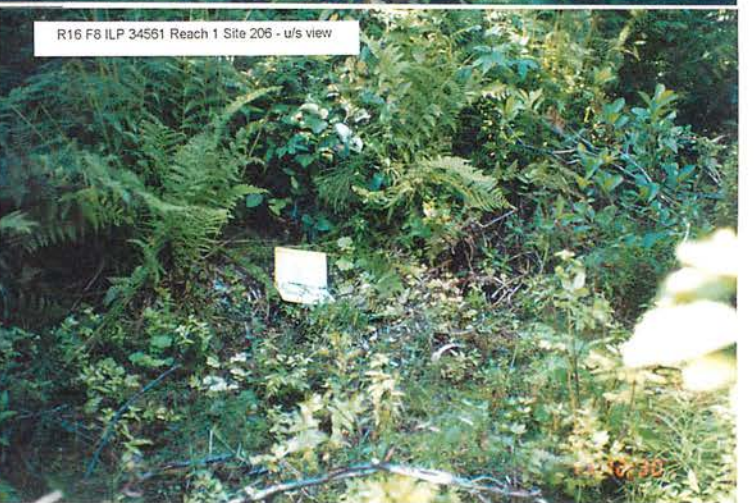
R16 F8 ILP 34561 Reach 1 Site 206 - u/s view

| Watershed Code | ILP | Reach | Site | Date | Avg CW (m) | Avg Grad (%) | Avg Wb Depth (m) | Exp FPC Spp. | FPC Class | Method | EF Dist (m) | EF Time (s) | Flow Stage | Water Temp (C) | Conductivity (uS/cm) | Turbidity | Voltage (V) | Frequency (Hz) | Pulse Width (uS) | Comments |
|---|---|---|---|---|---|---|---|---|---|---|---|---|---|---|---|---|---|---|---|---|
| | 34561 | 1 | 206 | 2002/08/17 | NA | NS | 0.0 | RB | NCD | NS | | | NA | | | | | | | Not an FPC stream at site location - lacks continuous channel bed. No fish habitat or potential, no connectivity to u/s reaches. Moist swale through shrubby corridor; watered only during spring runoff. Dissipates entirely 20m u/s from lake with no continuity. |

Roll# 16, Frame# 8, CD# 4, Image#356, Direction: Upstream, Scale/Comment:book  
moist swale through shrubby corridor; watered only during spring runoff, dissipates entirely 20m u/s from lake, no continuity, not a stream. site = UTM. Other - No fish habitat
