# **Toboggan Creek**

# **Watershed Restoration Project**

Level 1 and 2 Detailed Assessment

Prepared by: Lara Gibson **Nortec Consulting**

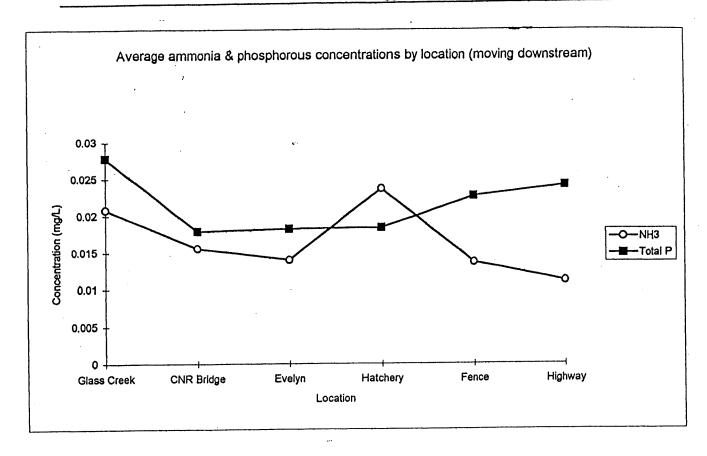
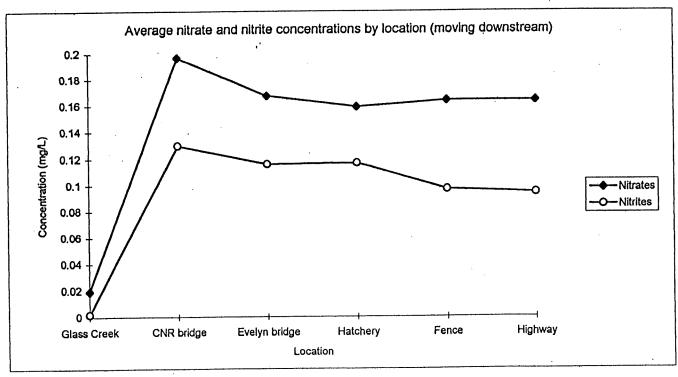
Figure 4: Average parameter concentrations by sample site along Toboggan Creek (April-October, 1996)

It is unknown what caused the nitrite peak, but it appears to be related to the lake drainage as Glass Creek remained below 0.001 mg/L and the concentration decreases progressing downstream (Figure 4). Further sampling is required to determine spatial and temporal concentrations, and the cause of the elevated nitrite.

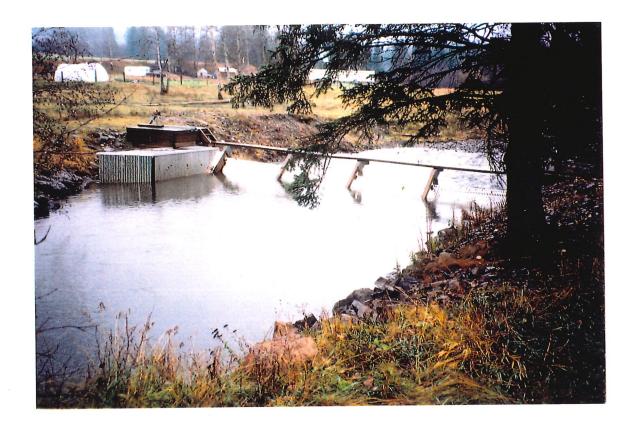
Photo Number: Toboggan 4

Comments: This permanent fish fence was erected in 1988, the fence operates in the spring to enumerate Steelhead runs and in the fall to enumerate salmonid runs. The fence can be lowered at high flows to prevent damage to the structure.

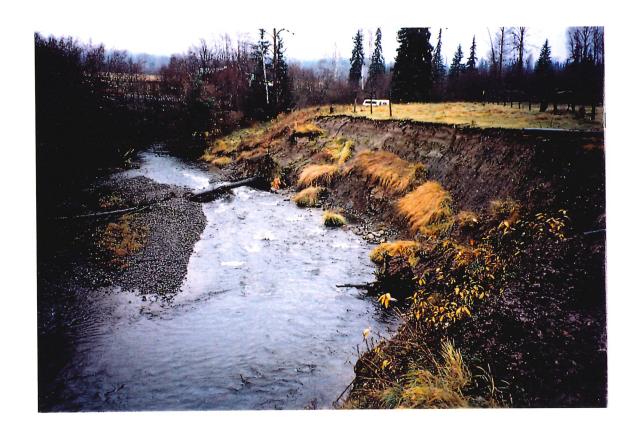
Photo Number: Toboggan 6

Comments: This picture shows extensive bank failures and lack of riparian cover. It also documents a large bar of gravels, on the right, there are numerous similar gravel bars throughout the lower reaches of Toboggan Creek.

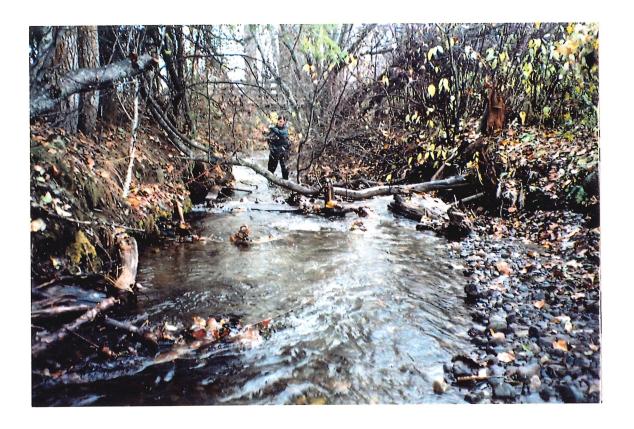
Photo Number: Owen 1

Comments: This is typical of the lower section of Owen Creek. This pictures shows several debris jams composed of small woody debris. This type of debris jam is prevalent throughout the lower end of this creek.

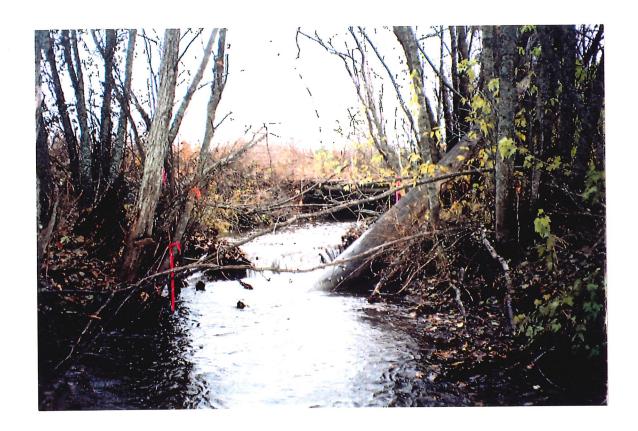
Photo Number: Owen 2

Comments: The bridge at the top of this picture is facing imminent failure and it should be removed. The red ribbon at the bottom left of this picture shows the placement of a Gee Trap. Coho Salmon, Rainbow Trout, Cutthroat Trout and Dolly Varden were found in this area.

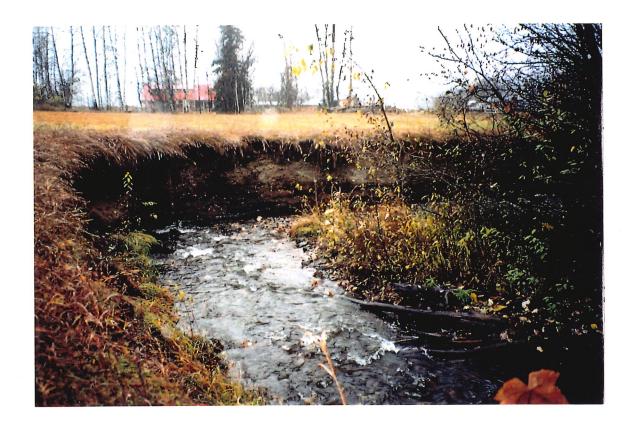
Photo Number: Owen 3

Comments: This large bank erosion is caused by the large sediment input at the powerline right-of-way, which has caused pool in filling, lateral channel movement and subsequent bank erosion. Direction of streamflow is away from photographer.

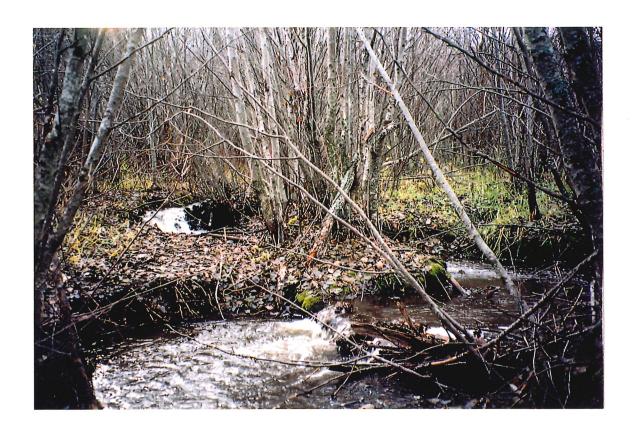
Photo Number: Feeny 1

Comments: This is the only section of stream that is not channelized in the lower reaches. The creek meanders through this section and the habitat contains pool and riffle complexes. This was the only section of stream in which fish were observed.

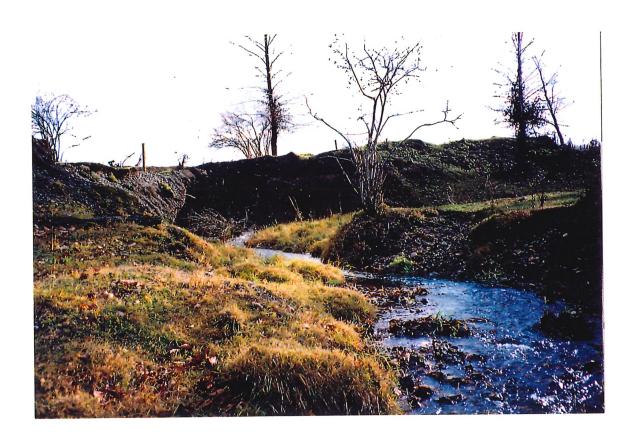
Photo Number; Feeny 2

Comments: This photo is typical of the reaches within the cleared lands. There is continued bank erosion and lateral channel movement in these areas due to the upstream impacts. There is a continued lack of riparian cover and in-stream structure throughout the channelized sections.

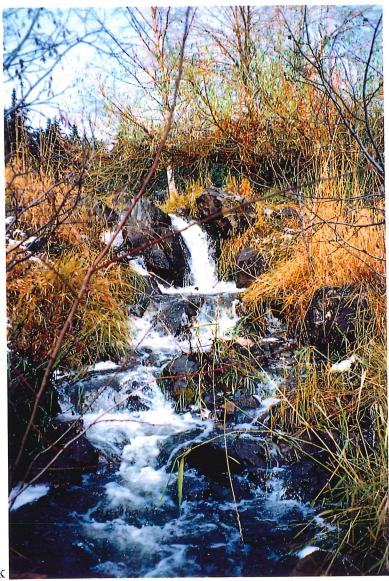
Photo Number: Feeny 3

Comments: This is a photo of one of a number of rock falls that occur along this property. This may be an obstruction to the upstream migration of juvenile fish.
