Assessment of Sockeye Fry Passage at the Babine River Adult Salmon Counting Fence

Prepared for the Department of Fisheries and Oceans by:
Janvier Doire,

May 2016

Skeena Fisheries Commission
3135 Barnes Crescent
Kispiox, BC
V0J 1Y4

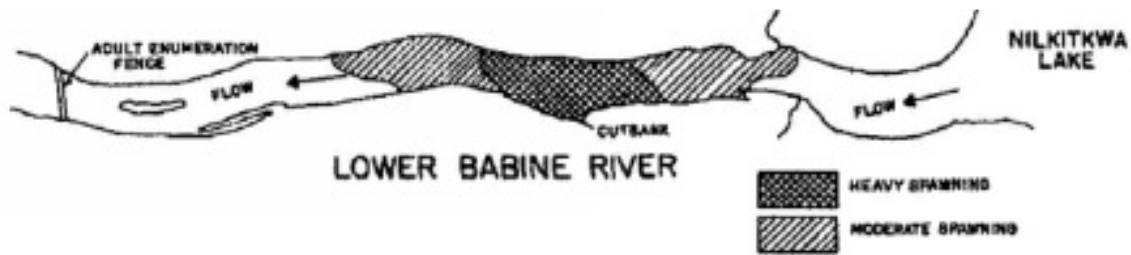
Figure 4. Map of the Lower Babine River showing the location of the sockeye spawning habitat, and the location of the Babine River adult salmon counting fence.

Newly emerged sockeye fry with limited swimming ability are washed downstream once they emerge from the spawning Lower Babine River areas located upstream of the Babine River adult salmon Counting Fence (Figure 4). Some of them drift downstream of the Babine River Counting Fence, and may not be able to migrate back upstream to reach Nilkitkwa Lake, or their upstream migration may be delayed. There are no suitable juvenile sockeye rearing habitats downstream of the Babine River Counting Fence. The proportion of fry washed downstream of the fence may be greater in years of high and early flow compared to years of lower flow. Clark and Smith (1972) estimated that a minimum of 7.5 million (or 18%) of the fry produced in 1966 drifted pass the Babine Counting Fence, and fry were unable to swim back upstream through the fence to reach their nursery habitat at Nilkitkwa Lake, however Clarke and Smith also reported that an estimated two million fry ascended an improvised temporary ladder by-passing the area of high velocity current under the fence on the western side of the Babine River. Clark and Smith assumed the fry that did not migrate upstream of the fence were lost, but this assumption was never verified.

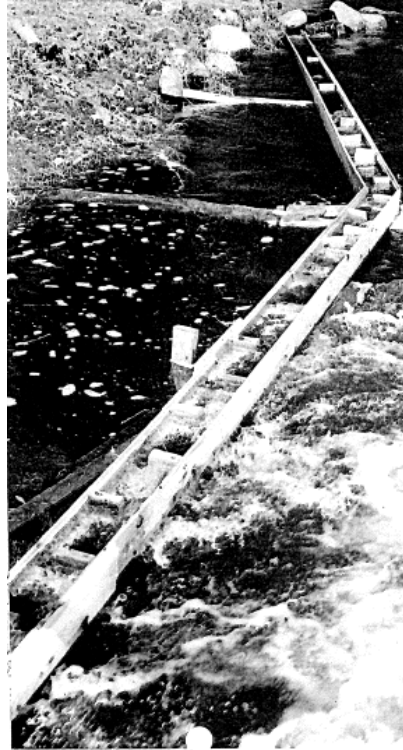
Fig. 4b. Downstream section of fry ladder.

Fig. 4c. Closeup of fry ladder.

Figure 5. Two different views showing fry using the improvised temporary fry ladder built by Clarke and Smith in 1966 to by-pass the area of high water velocity at the Babine Counting Fence.

Following the Clarke and Smith study in 1966, which showed that an estimated two million fry used an improvised temporary ladder to its full capacity (Figure 5) for over almost 20 days (Clarke and Smith 1967), a permanent fry migration channel made of sheet pilings and baffles was installed along the western shore to by-pass the area of high velocity current under the fence created by the approximately 60 cm fence sill (Figure 6). Over the following years fry effectively used the fry migration channel (Cameron West and David Southgate, pers. com.), however during the 1992-1993 winter the fence was totally redesigned and rebuilt with a sill leveled with the river bed. The sheet pilings making the fry migration channel were removed from the area downstream of the fence, but the sheet pilings upstream of the fence were left in place without baffles (Figure 7). The channel created by the remnant sheet pilings upstream of the fence is referred as the “remnant fry migration channel” throughout this report.

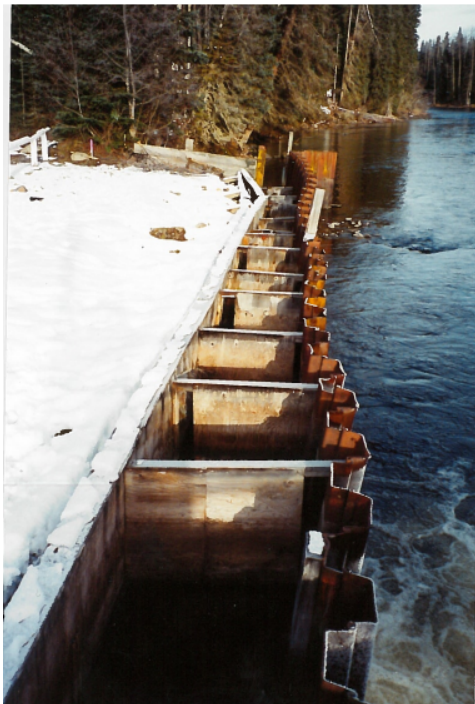
Figure 6. Downstream view of the permanent fry migration channel made of sheet pilings and baffles.

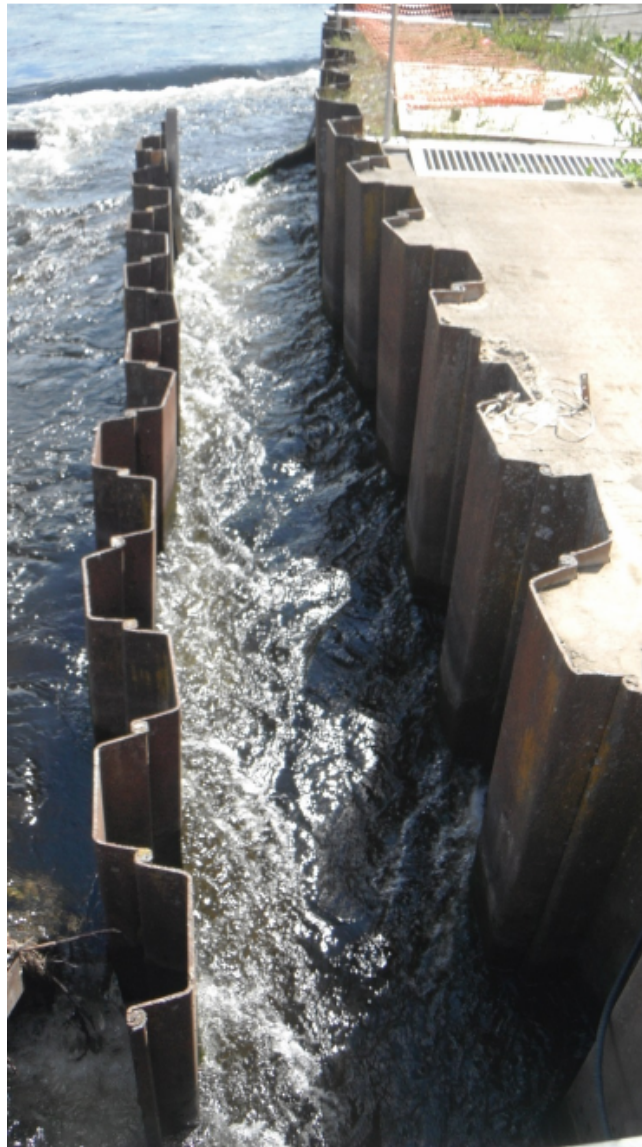
Figure 7.Upstream view of the “remnant fry migration channel” showing high velocity flow above 1.5m/s on average. June 20, 2015.

Depth (cm)	Water velocity (m/s)
5 - surface	1.31
50	1.30
75	1.96

Water velocity through the “remnant fry migration channel” was high, with an average above 1.5m/s between the surface and 75 cm depth (Table 2 and Figure 7).

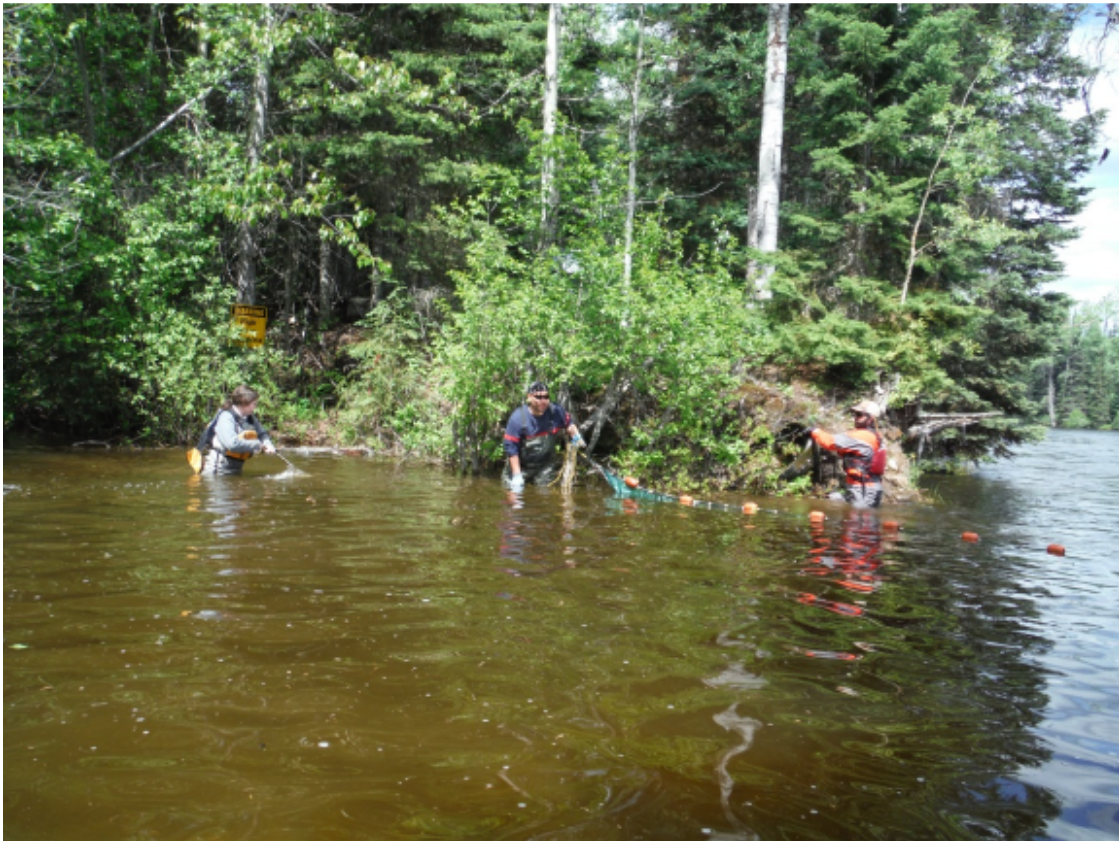
Figure 8. Seine net being set-up to capture sockeye fry at the boat launch approximately 30 m downstream of the Babine Counting Fence. June 11, 2015.

We monitored the movement of sockeye fry from downstream of the Babine Counting Fence to upstream of the facility using a simple marking technique. Sockeye fry were captured with a seine net in a back eddy created by a boat launch approximately 30 m downstream of the Babine Counting Fence, on the West side of the Babine River (Figure 8). Sockeye fry were dyed using Bismarck Brown Y following the instructions described in Lawler and Fitz-Earle (1968). Two groups of fry were dyed on two different days: June 11th, 2015, when approximately 20,000 fry were dyed, and June 16th, 2015, when approximately 40,000 fry were dyed. The number of fry dyed was approximated as counting them would have been time consuming and may have increased mortality. Large containers were used to hold the sockeye fry in the dye solution (Figures 9 and 10). Battery powered bubblers were used and the dye solution was agitated to keep oxygen at a safe level (Figures 9 and 10). Dyed fry were brightly brown colored when they were released at the location of their capture (Figure 11). Every day fry were dyed and released, a small group of dyed fry was kept as control to monitor survival of dyed fry, and the fading rate of the dye. The control dyed fry were kept in pierced containers which were kept in the back eddy downstream of the Babine Counting Fence (Figure 10).

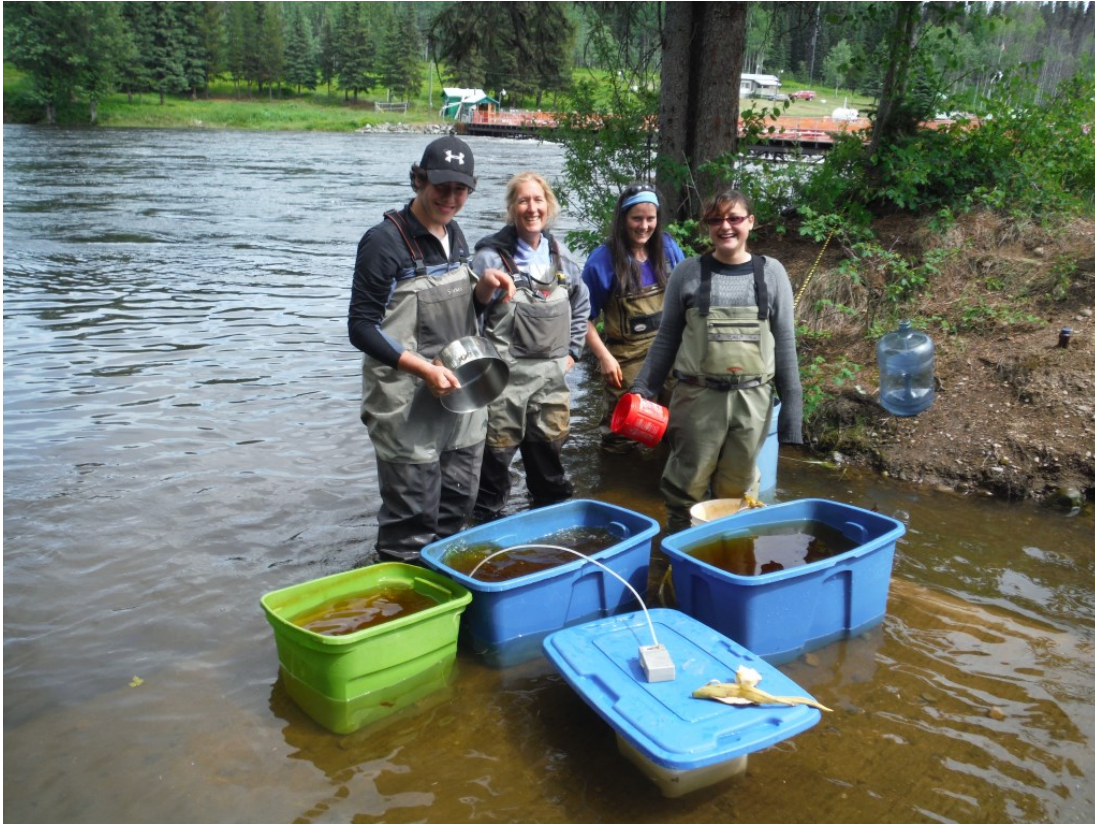
Figure 9. View of the fry dying containers and crew. June 11, 2015.

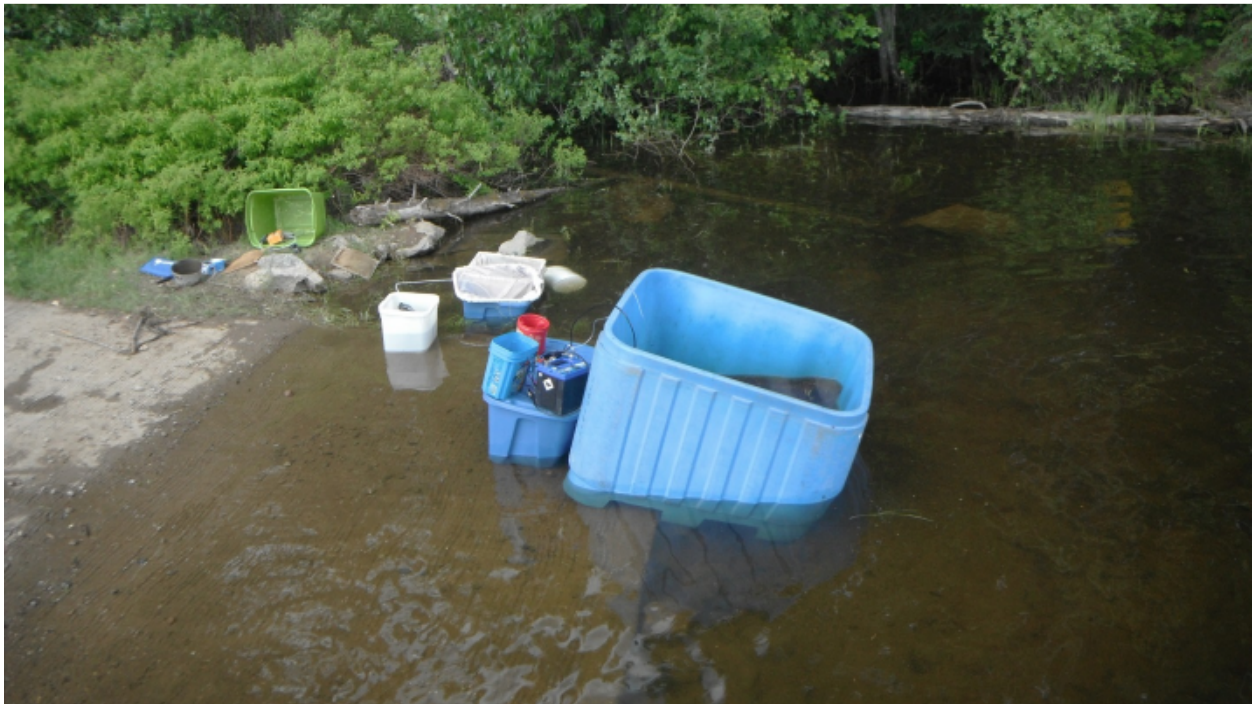
Figure 10. View of the fry dying container used on June 16, 2015. Note the control containers in the background.

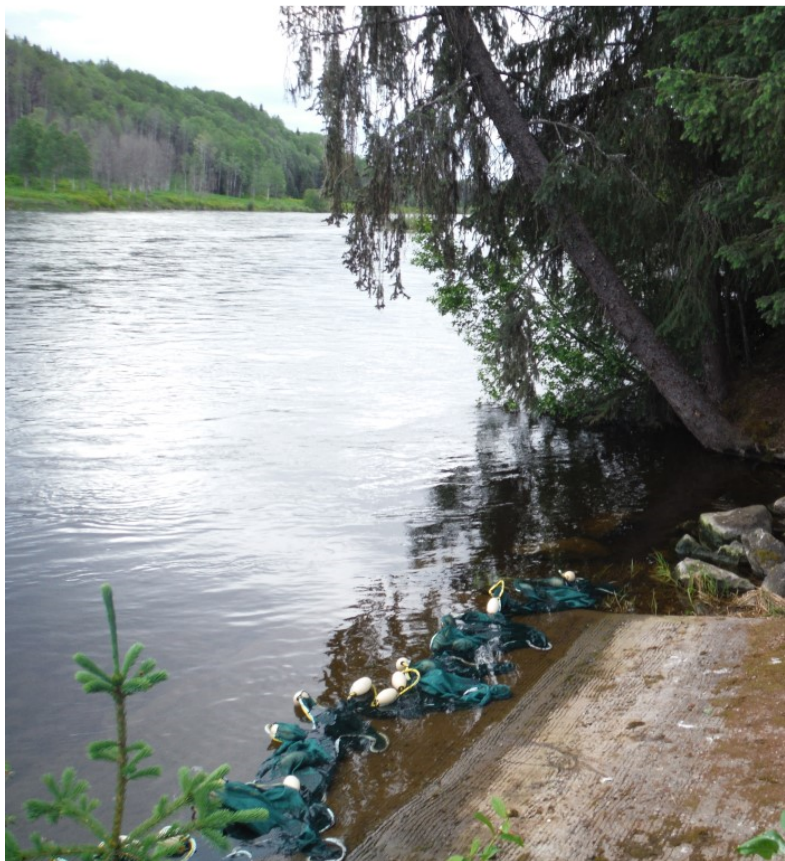
Figure 12. View of the boat launch located approximately 45 m upstream of the Babine Counting Fence, and the seine net used to capture sockeye fry. June 13, 2015.

On June 12th, 13th, 14th, 15th, 16th, 18th, 20th, and 22nd sockeye fry were captured in a back eddy created by a boat launch approximately 45 m upstream of the Babine Counting Fence, on the west side of the Babine River (Figure 12). Once captured, the sockeye fry were kept in containers until they were examined for signs of Bismarck Brown Y dye on their fins and body. After the examination, all fry captured were transported upstream where they were released to prevent re-capture of the same fry. Some of them were transported a few hundred metres upstream by foot, the rest were transported by jet-boat to the outlet of Nilkitkwa Lake, approximately 1.4 km upstream.

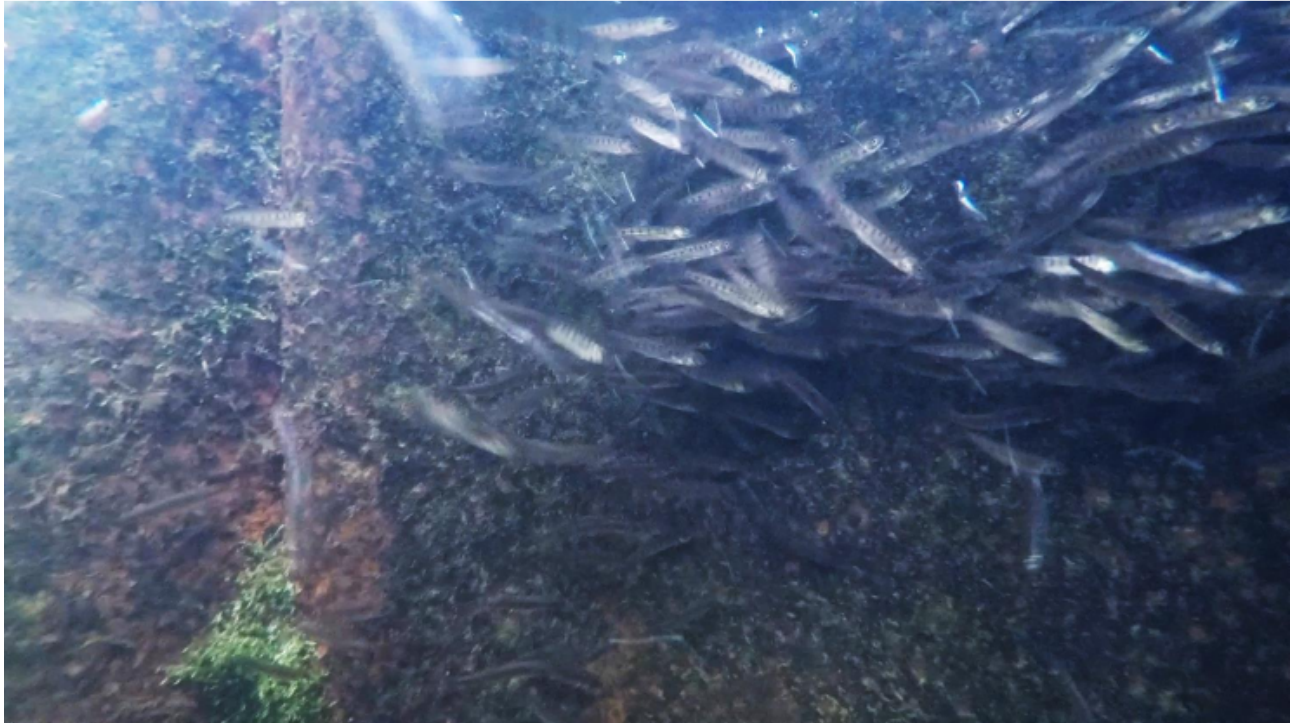
Figure 13. Image from an under-water video showing sockeye fry in turbulent water downstream of the western abutment of the Babine Counting Fence. Mid-June, 2015.

Under-water video footage taken below the Babine Counting Fence, and through the “remnant fry migration channel” shows sockeye fry caught in high flows and highly turbulent water. Fry appear to not be able to hold position (Figure 13). When some attempt to move upstream, they quickly drift back downstream because of the strong current. The under-water footage also shows a bull trout heavily feeding on the struggling fry.
