# KATHLYN CREEK CULVERT #2

WSC 460-345400-26700

## Stream Assessment Report

**March 2012**

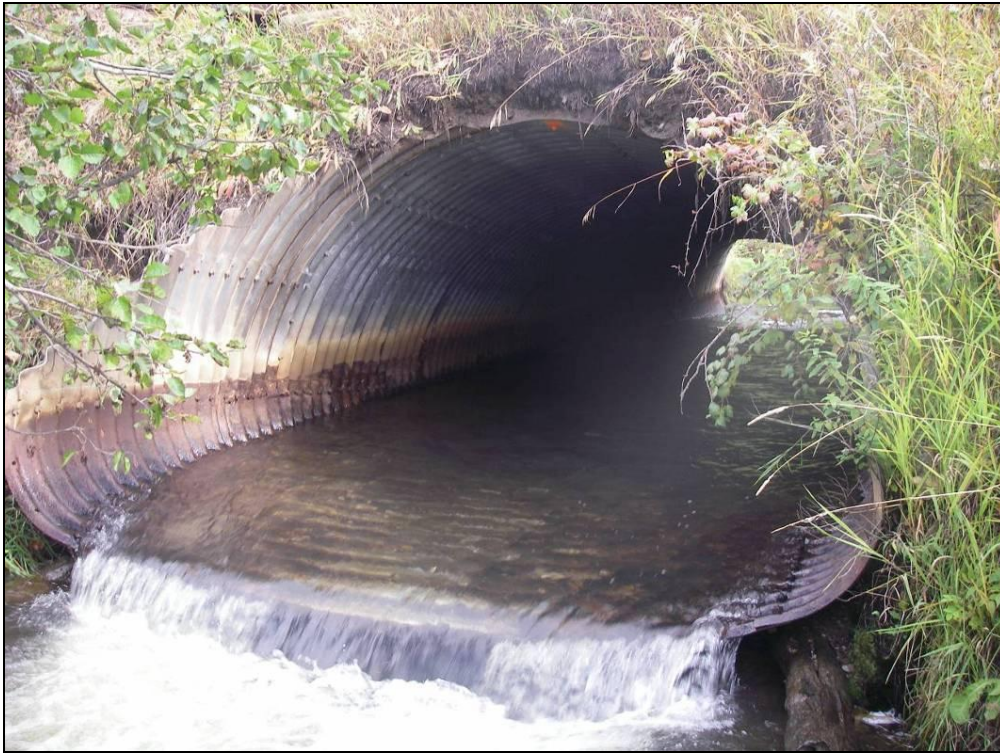
The flow from Kathlyn Creek passes under Highway 16 through a large, closed bottom elliptical culvert, 3500 mm wide by 2200 mm high (Figure 3). The culvert was not embedded and was 22 m in length. Water depth in the culvert was approximately 30 cm at the time MCSL visited the study area. A small amount of bed material was noted at mid-length on the culvert floor. The culvert inlet is flush with the stream bed (Figure 5) and there was a drop of 20 cm at the culvert exit into an outlet pool during the site visit (Figure 3 and 4). Cobbles were the predominant bed material from approximately 3 m downstream of the culvert outfall (riffle crest of outlet pool) to 9 m downstream of the outlet, then the bed material became predominantly small gravels and fines.

**Figure 3.** View upstream to outlet, 3500 mm wide by 2200 mm high elliptical culvert, 20 cm outlet drop (September 24, 2011).

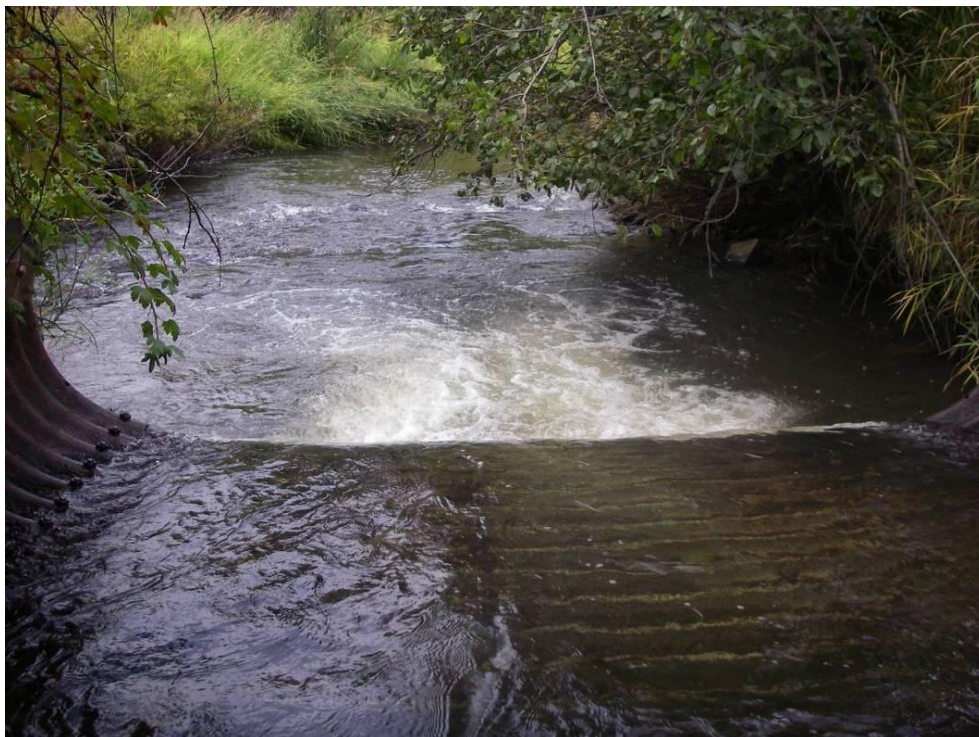
**Figure 4.** View downstream showing outlet pool and short riffle section (September 24, 2011).

Fish habitat immediately downstream of the Kathlyn Creek No. 2 culvert contained an outlet pool approximately 4 m long. Bed material at the riffle crest of the pool consisted predominantly of cobbles and continued for another 3-4 m downstream where the bed material transitioned to small gravels and fines similar to the bed material upstream of the culvert. As with the bed material on the inlet side of the culvert, there was poor quality salmonid spawning habitat as the fines filled the interstitial spaces between the gravel particles and tended to underlay the thin layer of gravel. No redds were observed during assessment of the channel downstream of the culvert.

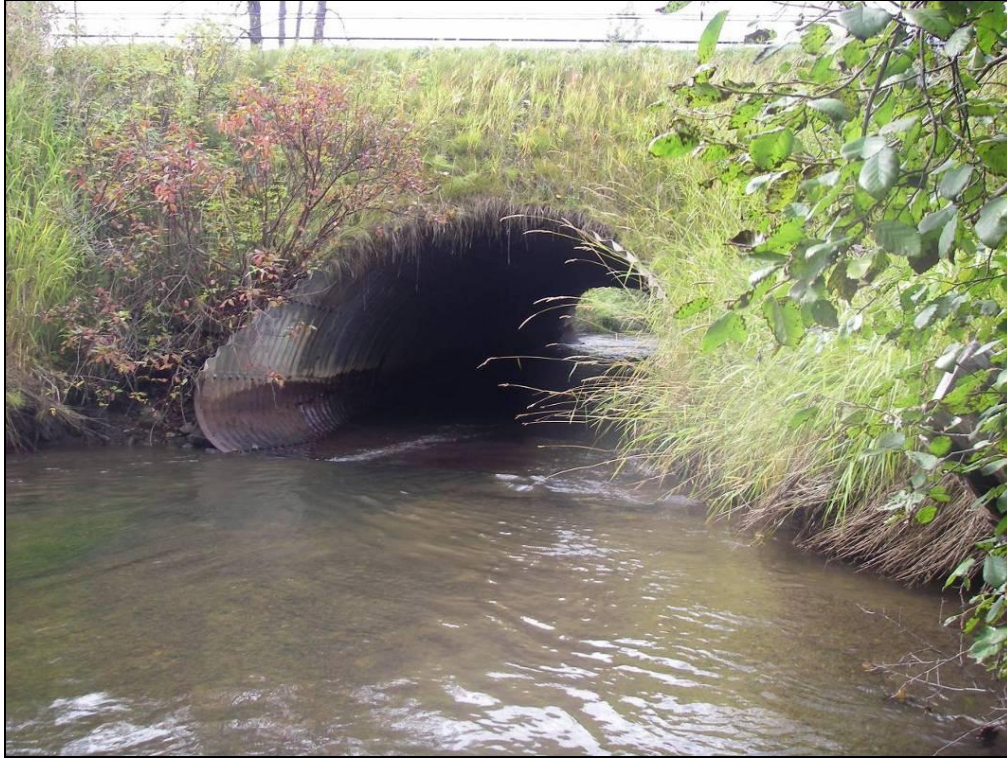
Figure 5. View downstream to inlet, inlet is flush with stream bed (September 24, 2011).

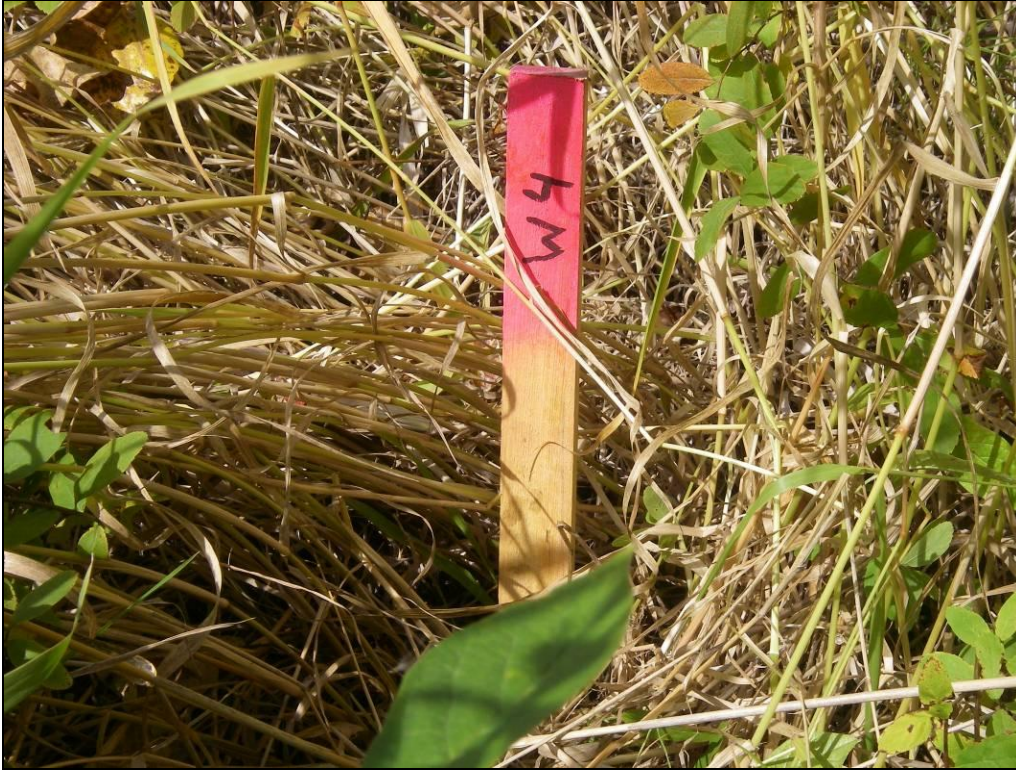
Stream channel widths were measured from top-of-bank to top-of-bank as per the Fish-stream Crossing Guidebook. Based on the first channel width measured (W4), subsequent channel widths were measured at 9 m intervals from the inlet and outlet of the culvert. Wetted width was measured from the wetted perimeter on one bank to the wetted perimeter on the opposite bank. Both parameters were recorded to obtain average channel and wetted widths (Table 1). Survey stakes were painted flo-pink, marked with the channel width station and driven into the stream bank to mark the channel width measurement locations (Figure 6). No stream training works were observed at the crossing.

Figure 6. Survey stake marking W4 channel width location (September 24, 2011).

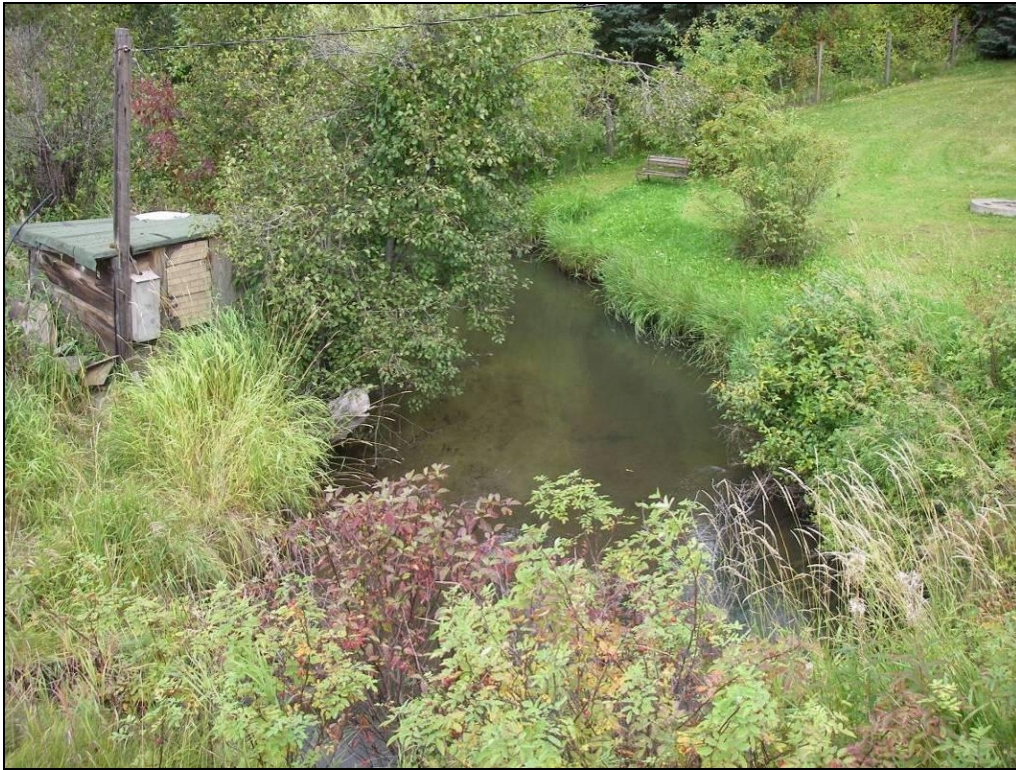
Stream morphology in the assessed section was best described as large channel type as it consisted primarily of glide type habitat (Figure 8). Surface flow was smooth and undisturbed. The stream depth varied between very shallow to greater than 50 cm deep, and no distinct pools were observed in the first 50 m upstream. Stream gradient in this reach was around 0.5 - 1.0%. Cover for fish was provided primarily by the deciduous shrubs growing along the stream banks and to a lesser extent by the undercut banks occurring on the outside of the stream bends. Potential over-wintering habitat was limited to those areas where the residual pool depth was greater than 0.5 m deep.

**Figure 8. View upstream from the Highway 16 culvert (September 24, 2011).**

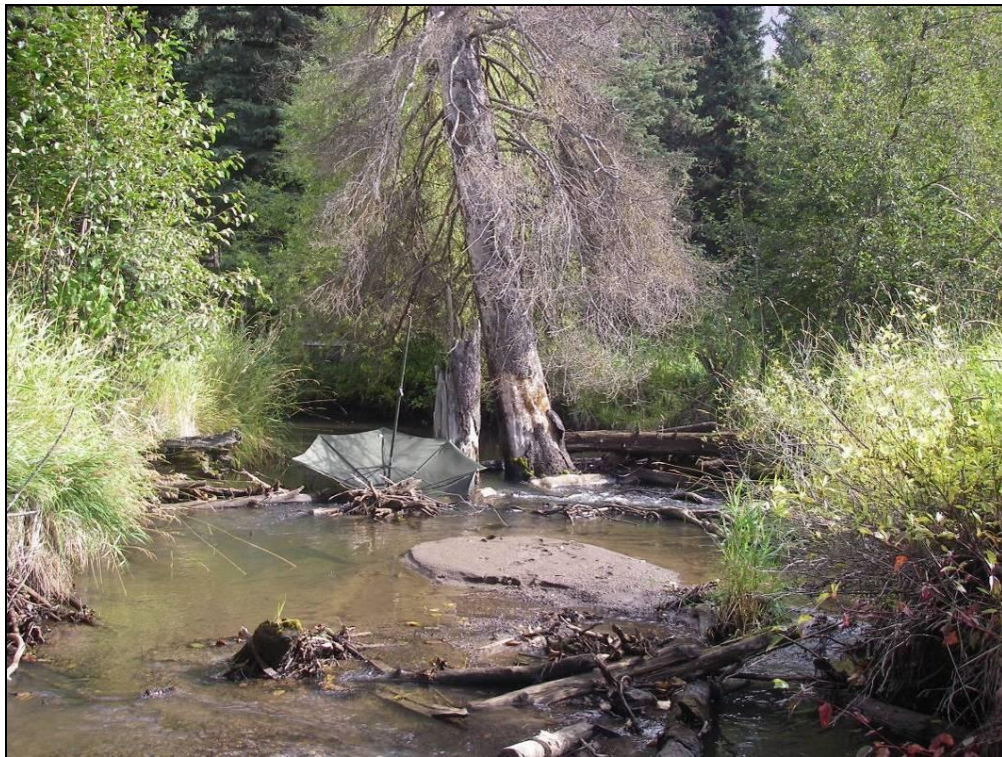
**Figure 9. Increase in forest cover and habitat complexity ~50 m upstream of Highway 16. September 24, 2011.**

Approximately 50 m upstream of the culvert, there was an increase in LWD and forest cover adjacent to the stream (Figure 9). Morphology changed from the large-channel type to a Riffle-Pool type with functioning LWD present. Substrates were still predominantly fines and small gravels.

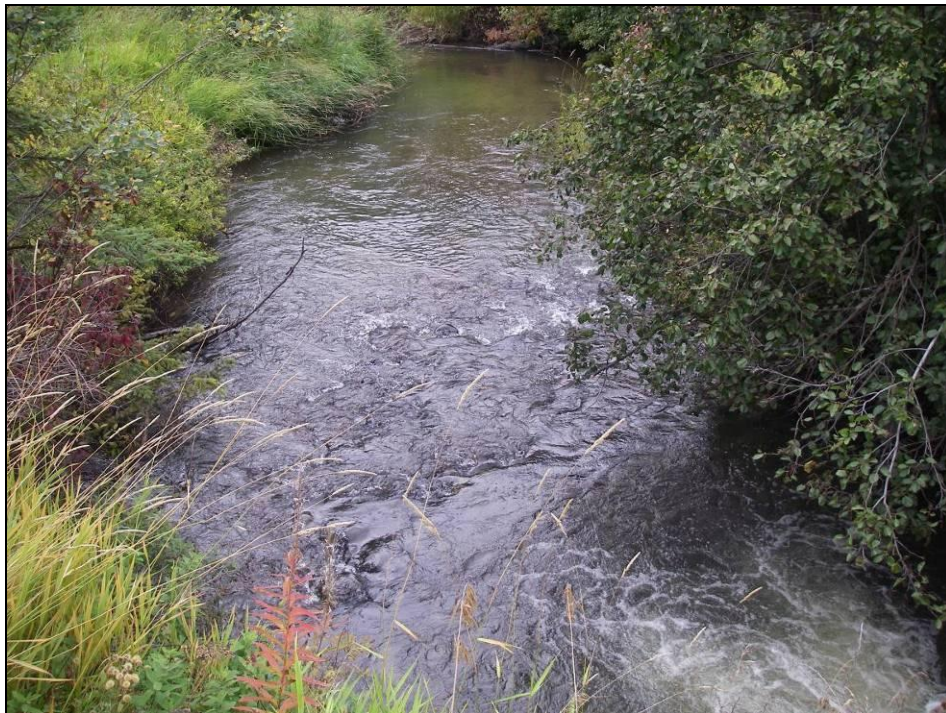
**Figure 10. Habitat immediately downstream of the Highway 16 culvert** (September 24, 2011).

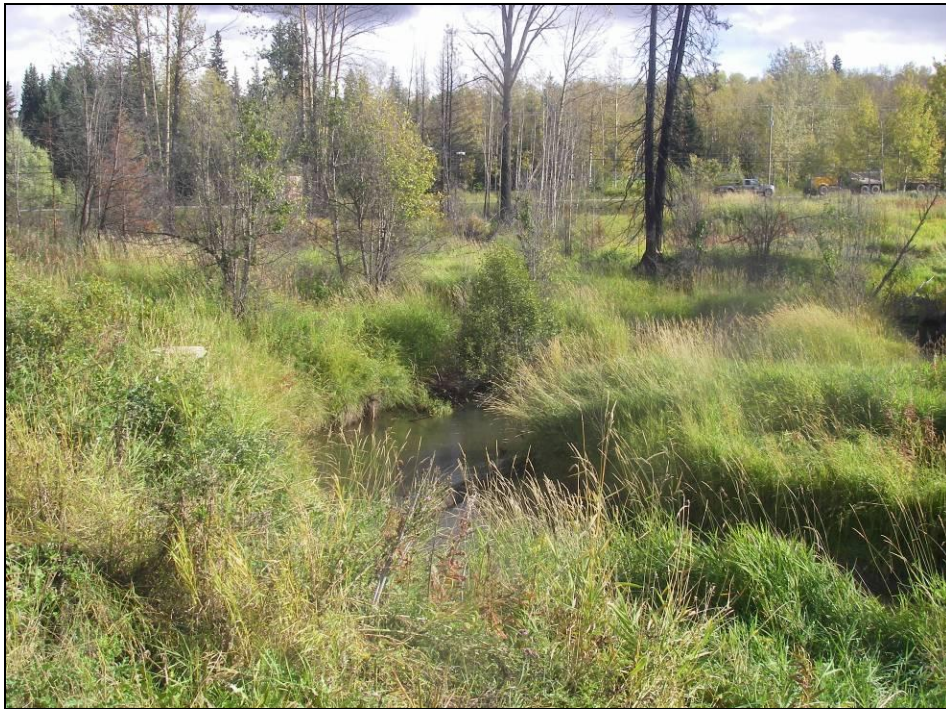
Other than the ~ 9 m of riffle-pool type habitat immediately downstream of the culvert, the remaining 90 m assessed downstream was primarily large channel type morphology. The shallow gradient and lack of functioning LWD (probably from anthropogenic influences) are likely the reason the stream exhibits this large channel morphology. The slow, smooth flows both upstream and downstream of the culvert provide good rearing conditions but suitable cover is limited. The section provides an important migration route to coho spawning locations in Simpson Creek

**Figure 11. View of downstream habitat looking back towards Highway 16 (September 24, 2011).**

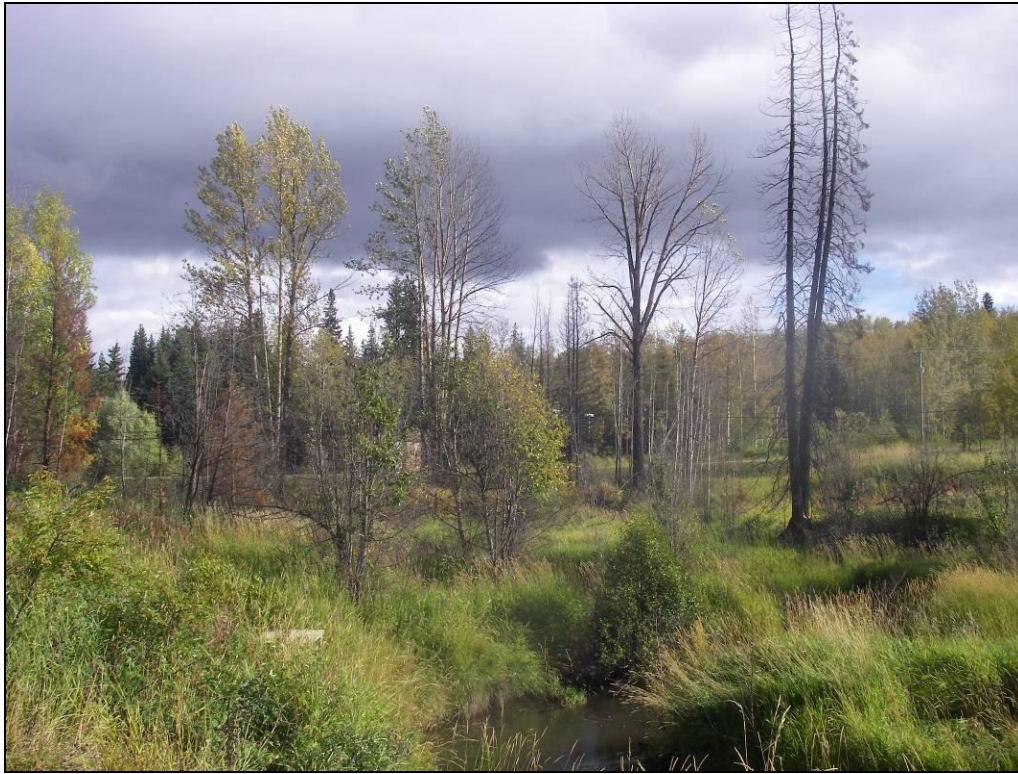
Figure 12. View northward to Highway 16 with burned area on right (September 24, 2011).

Vegetation on the downstream side of the Kathlyn Creek No. 2 Culvert crossing consisted primarily of an expansive grassy area with scattered alder and willow shrubs along with a few mature cottonwood trees (*Populus trichcarpa*) south of Highway 16 and east of Kathlyn Creek (Figure 7). A small fire had burned some of the vegetation and trees on the southeast side of the crossing (Figure 12). A few of the cottonwood exhibited some fire damage around the base of the trunk but only one appeared to have been killed by the fire. The fire also killed two larger spruce (*Picea sp.*) trees further away from the highway. The cottonwood trees nearest the creek and highway may need to be removed to replace the culvert. Some shrubs on the northwest and southwest side of the crossing site will likely need to be removed as well.

The fire-killed cottonwood and spruce trees will recruit into wildlife trees over time but due to the proximity of some of the trees to Highway 16, they may be considered danger trees which will require removal.

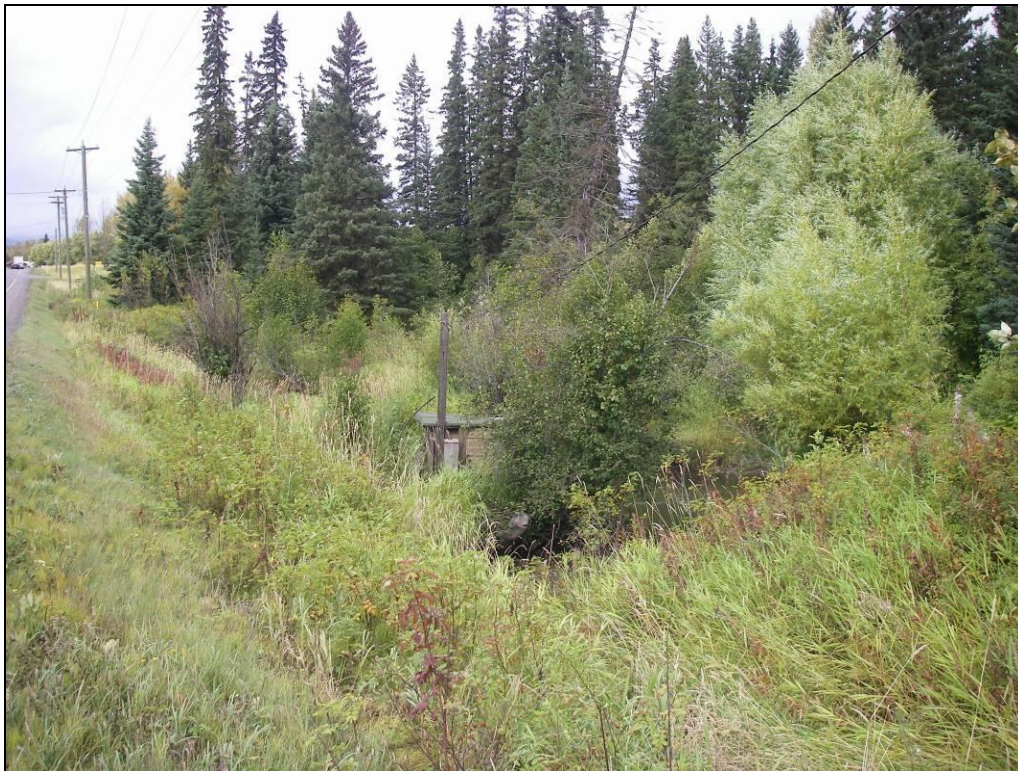
Terrestrial habitat on the upstream side of the crossing is predominantly shrubs with a small amount of grass interspersed (Figure 13). Fifty metres upstream of the inlet the vegetation changes to mature spruce forest (Figure 13).

Figure 13. View to northwest side of crossing with predominantly shrub vegetation near Kathlyn Creek and spruce in the background (September 24, 2011).
