Williams & Sockeye Creeks Pilot

FREP WSEP Note # 2, September 2021

Watershed Status Evaluation Report

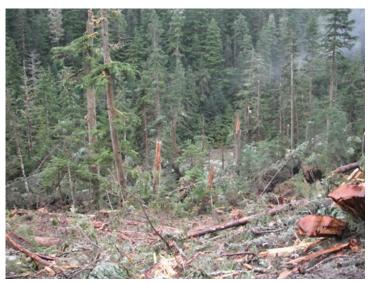
Figure 1. Williams Ck. Mainstem; while not part of a sample reach, this example depicts recent wind damage in Riparian Reserve Zone adjacent to clear cut forest harvesting.

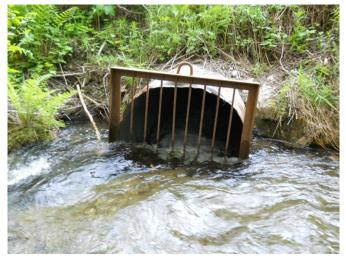
Figure 8a. Site W-0437, located along a public road (Old Lakelse Lake Road), and a 3rd order stream with beaver/debris guard was assessed to be a significant fish barrier. Issues included: undersized culvert restricting channel, velocity barrier, and outlet and inlet drops.

Management Opportunities — The study area (including adjacent sub-basins in The Lakelse watershed) should be considered for a fish passage census to identify and remediate problematic fish passage locations.

FISH PASSAGE – Several significant barriers to fish passage were observed (e.g., Sockeye Ck sub-basin). Remediate these as necessary to improve fish access/aquatic network connectivity and conduct an updated WSEP census of fishstream crossings throughout the sub-basin.

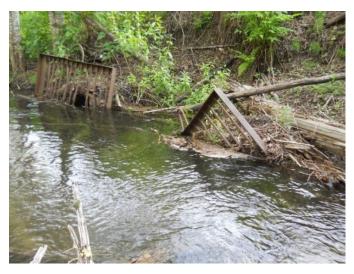
Figure 8b. This site, located along a public road (Old Lakelse Lake Road) and ~ 100 meters from site W-0437, is also a 3rd order stream with beaver/ debris guards. Although not assessed, it is another example of problematic beaver guarding impeding or blocking fish access.

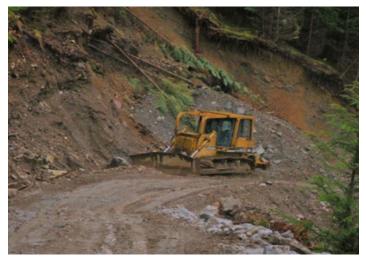
Figure 10. Recently constructed spur with active hauling. Site had poor water management and high road-related sediment generation, which was compounded by over-steepened cutslopes.

Management Opportunities — The watershed should be re assessed using the latest WSEP-FREP fine-sediment sampling methods and, where necessary, remediation measures implemented minimize sediment generation and delivery to streams.

SEDIMENT DELIVERY – Significant sources of sedimentation were observed. A new WSEP Fine Sediment survey is recommended. Measures to improve road maintenance and construction practices resulting in sediment generation should be implemented.
