# POTENTIAL EFFECTS OF AN OIL PIPELINE RUPTURE ON REACH 2 OF MORICE RIVER

A SUBMISSION TO THE JOINT REVIEW PANEL  
ENBRIDGE NORTHERN GATEWAY PROJECT

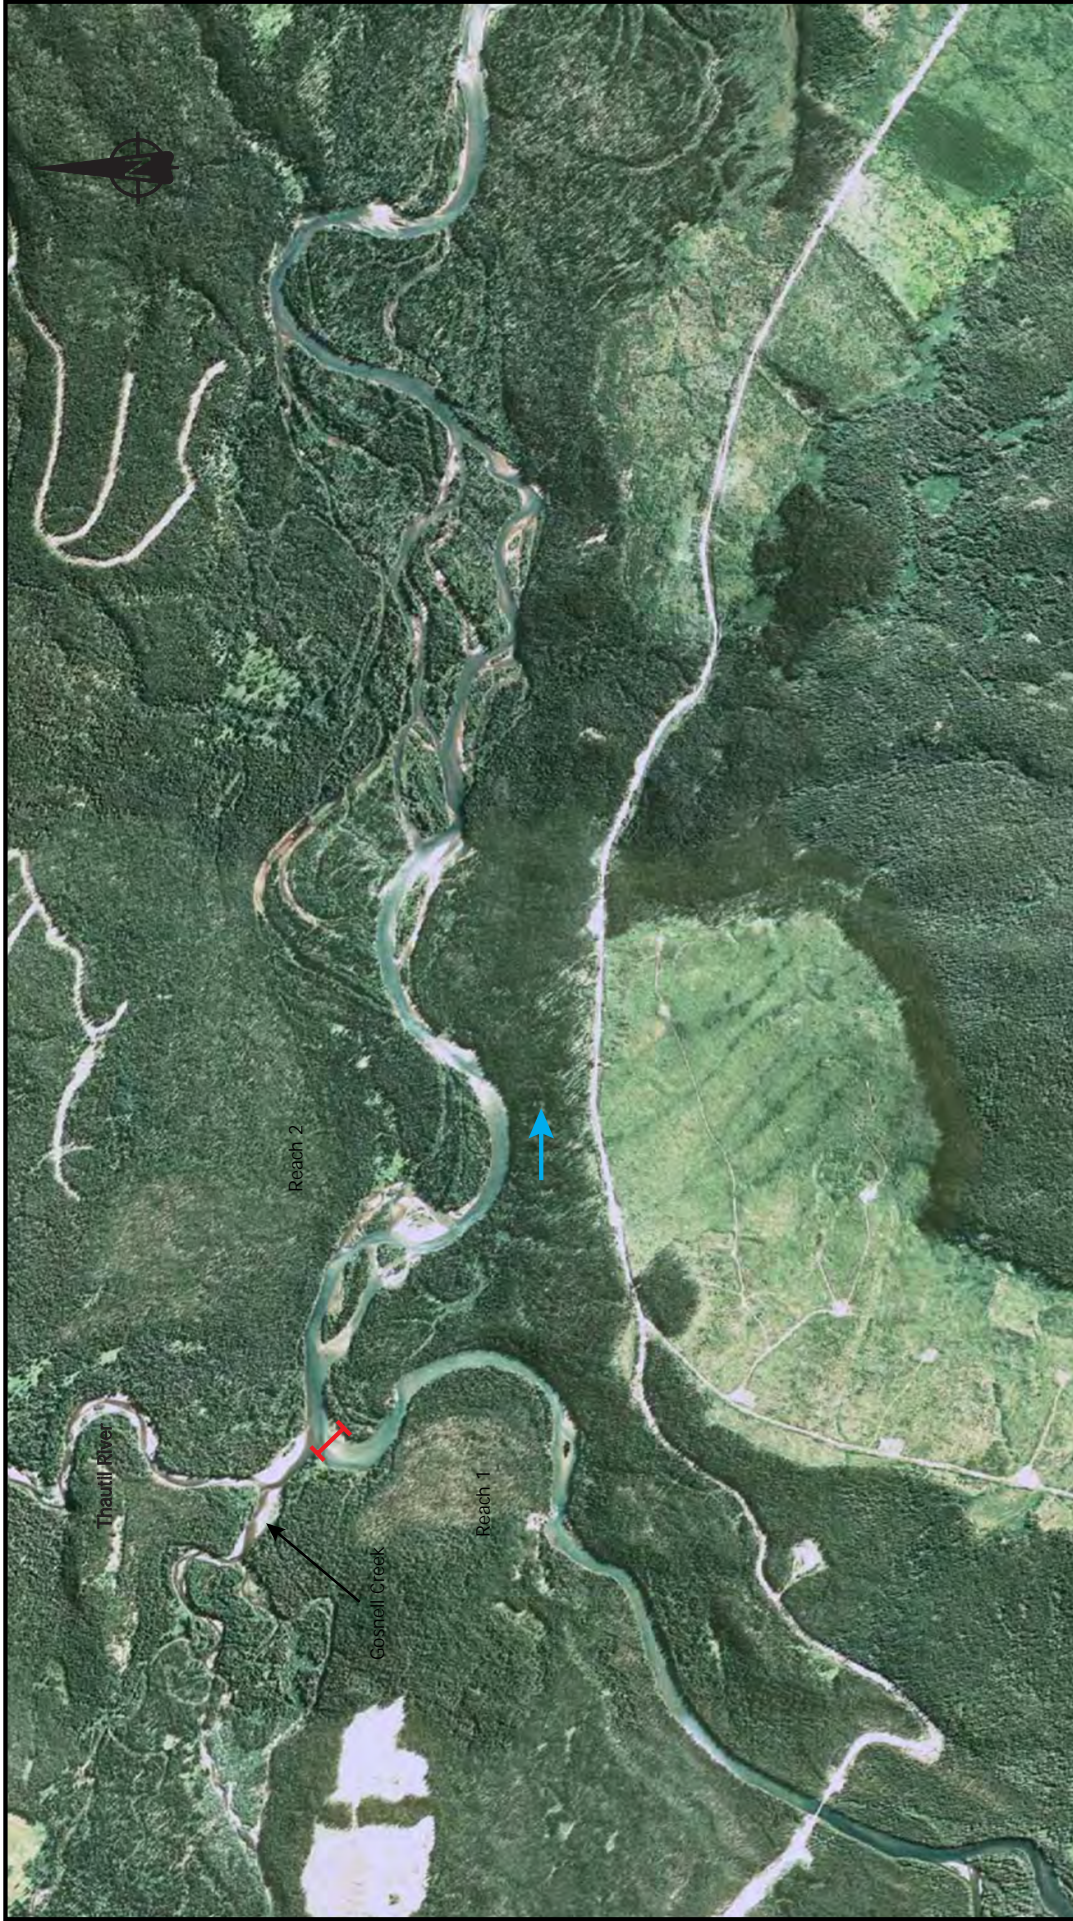
Figure 2.5.1: Recent Google Earth image showing channel conditions at the confluence of Reach 1 and Reach 2 on Morice River.

Figure 2.5.1 illustrates conditions at the upstream end of Reach 2 and Figure 2.5.2 documents how this site has changed over the period since 1955. The imagery illustrates the numerous channels in this area and how their location and relative importance varies with discharge and has changed over time. Similar channel processes occur in the downstream section of the study area. Weiland and Schwab (1992) further investigated rates of channel change and documented the mobile character of the multithread channels that occur within Reach 2. They compared river conditions based on air photos flown in 1949 and 1988. The results are presented on Figure 2.5.3 and indicate the extent of erosion and deposition over this 39-year period. They found that rapid changes may occur within a narrow corridor along the main channel but the rate of channel migration into the inactive floodplain occurred at a much slower rate of 1 to 1.5 m per year.

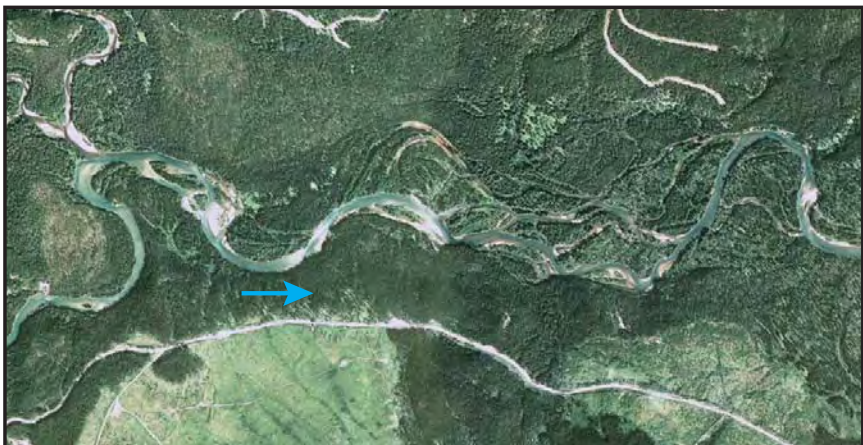
(i)  
Date: August 20, 1955  
BC1993 #61, 63 & 64

(ii)  
Date: July 19, 1960  
BC2777 #9 & 13

(iii)  
Date: July 27, 1971  
BC7362 #144-146

(iv)  
Date: 2011?  
Google Earth Imagery

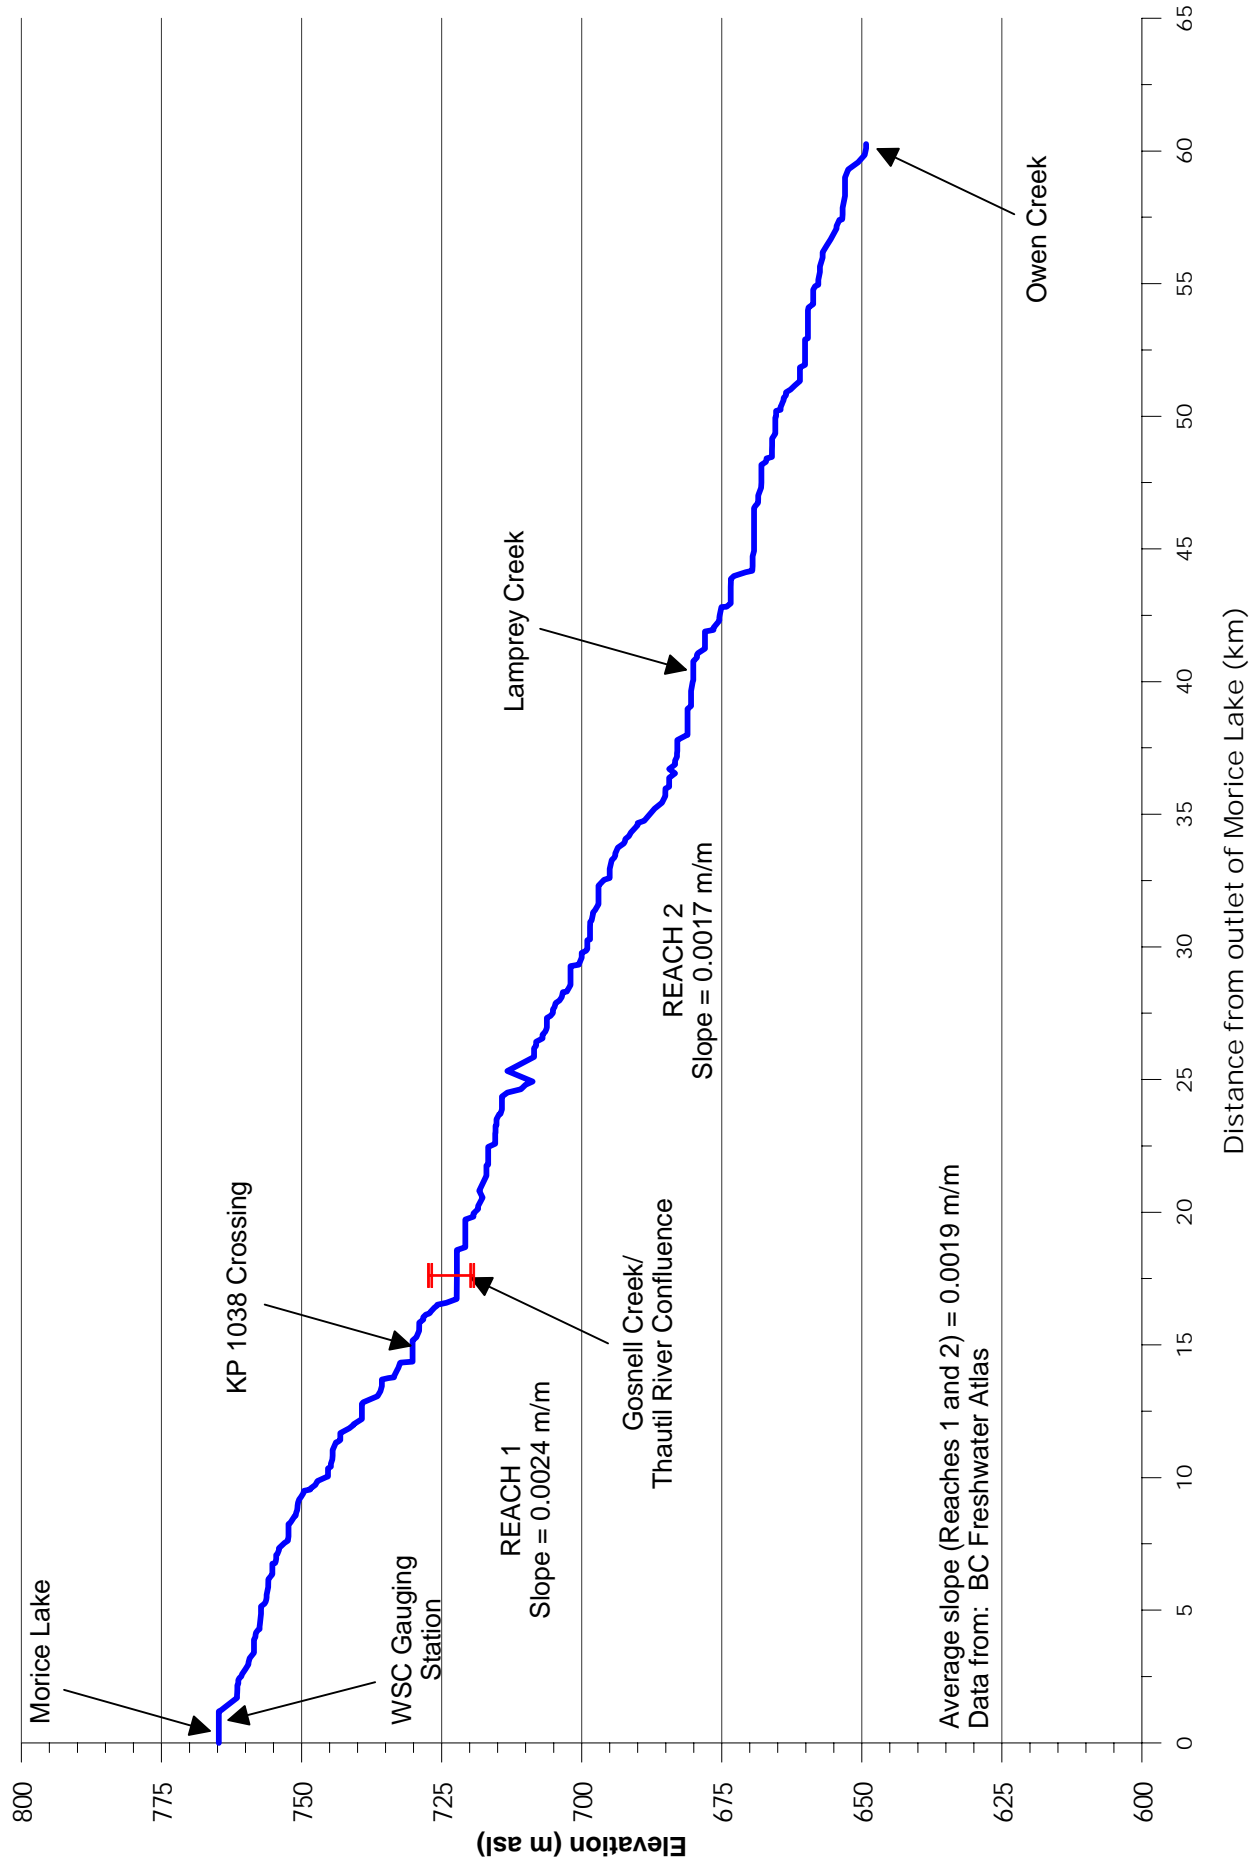
Figure 2.6.9: Long profile of Morice River from Morice Lake to Owen Creek.

Hydraulic geometry data similar to that collected at the WSC gauge is not available for Reach 2 of Morice River. However, as indicated on Figure 2.6.9, the average river slope in Reach 1 (0.0024 m/m) is similar to that in Reach 2 (0.0017 m/m).<sup>\*1</sup> River widths and upstream basin areas increase downstream of the Gosnell Creek/Thautil River confluence and consequently hydraulic geometry values will not necessarily be the same as those observed at the WSC gauge. Nevertheless, these data provide an initial (and

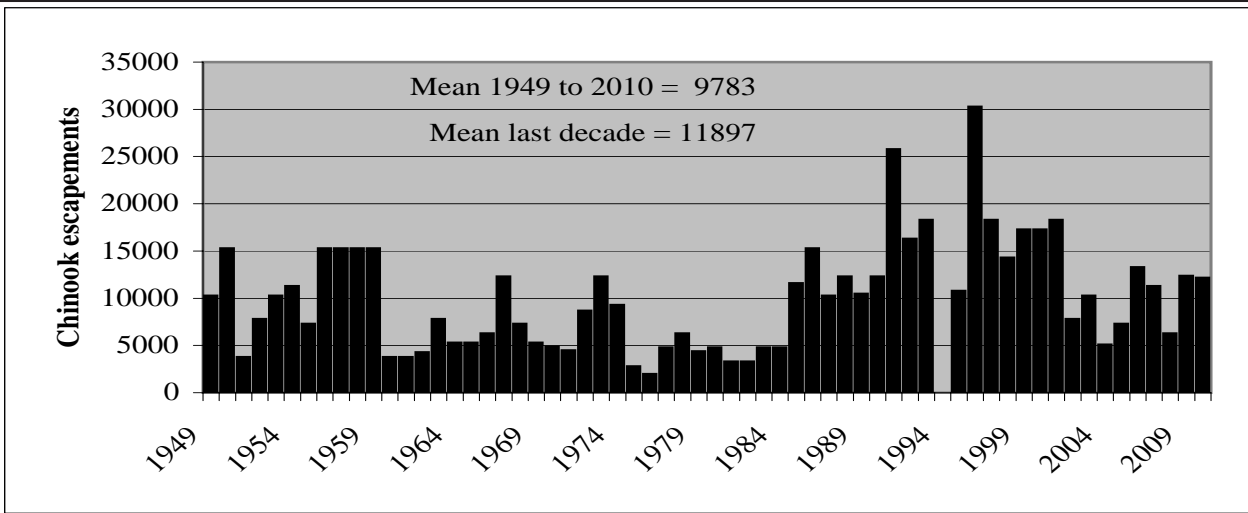
Figure 3.2.1.1: Escapement summaries for Morice chinook, sockeye and pink salmon.

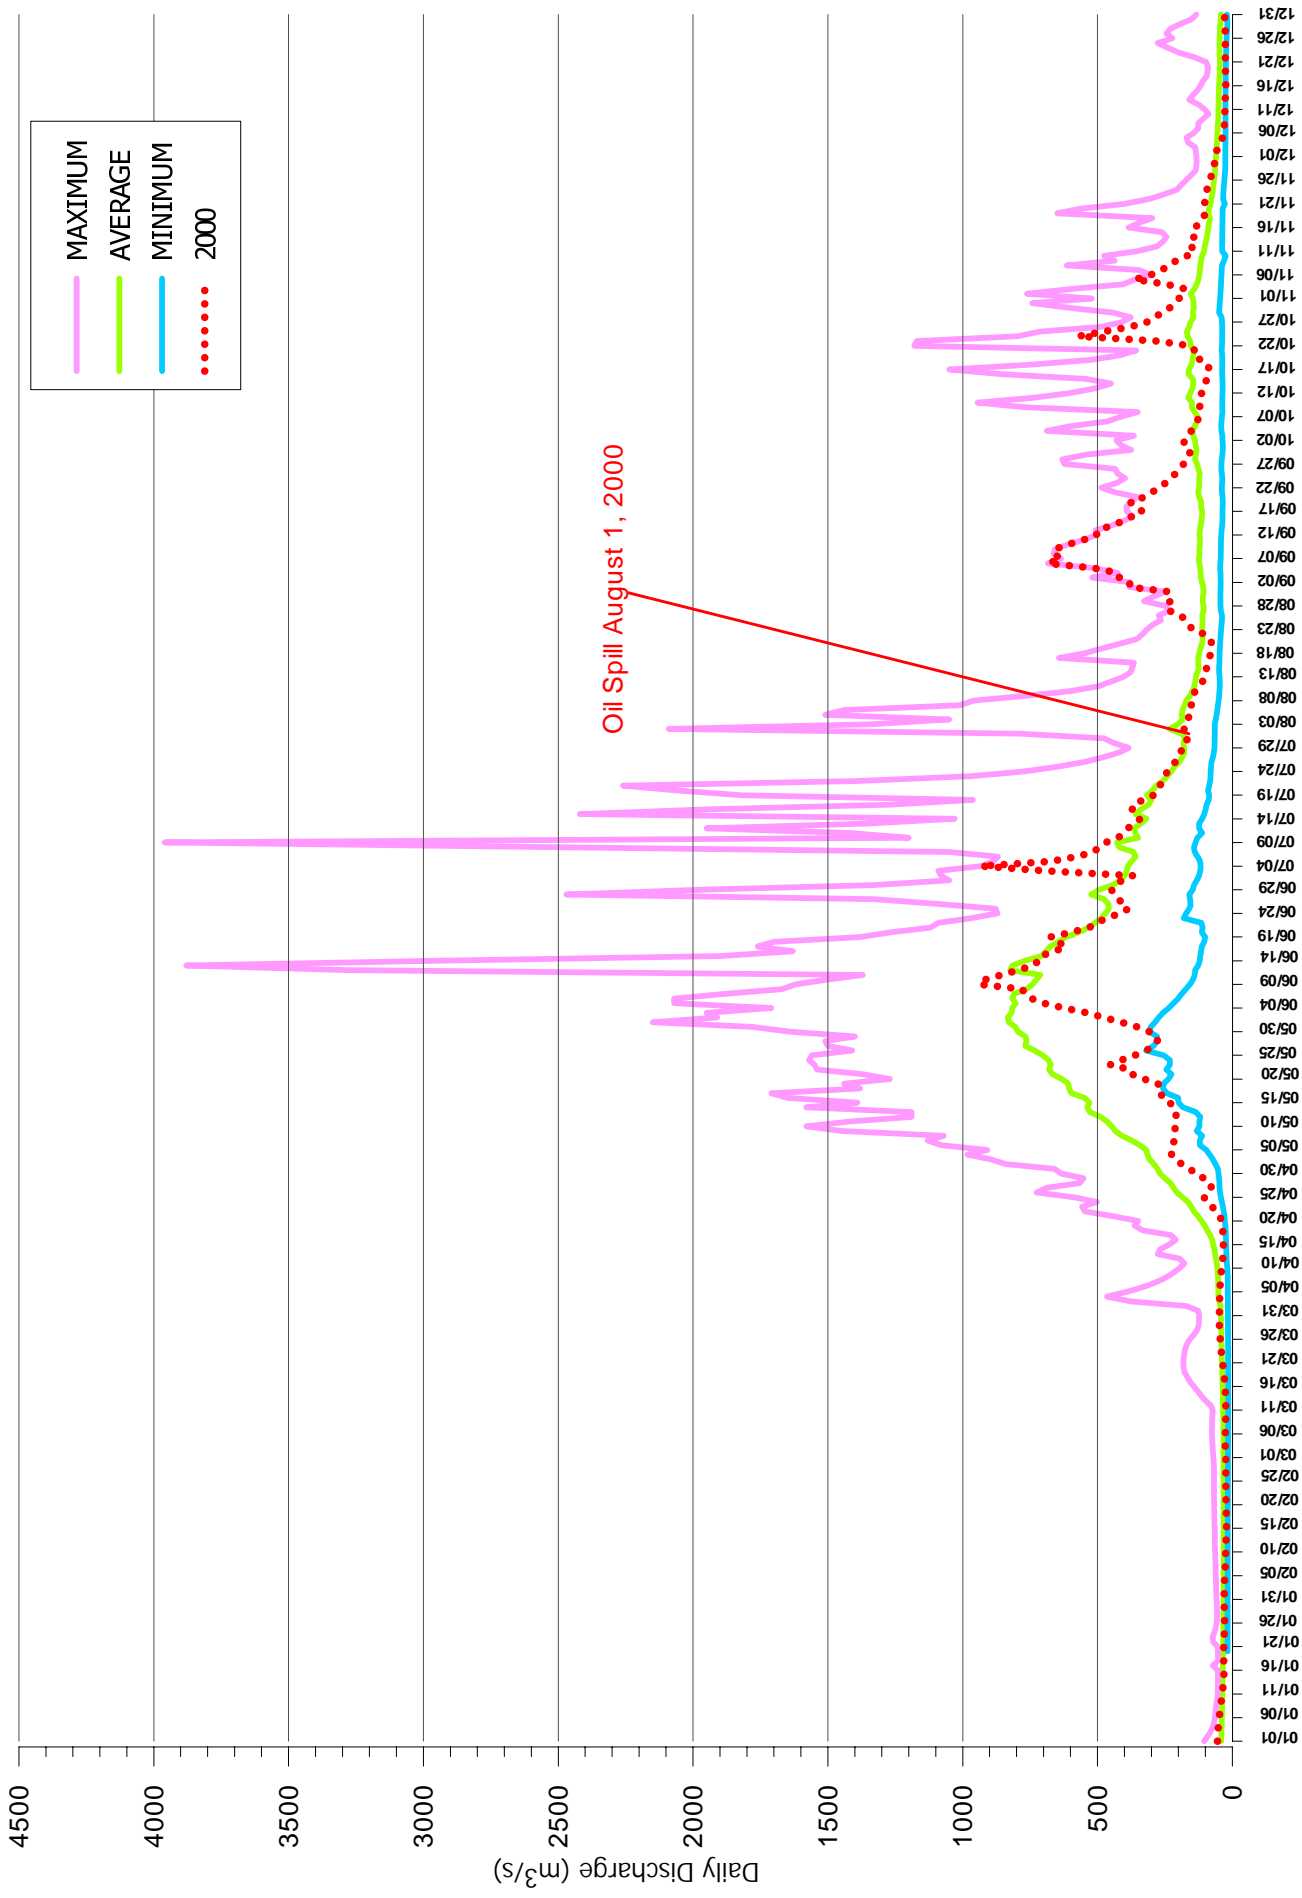
Figure 4.3.2: Seasonal variation in discharge, Pine River at East Pine, 1961 to 2010, plus 2000.

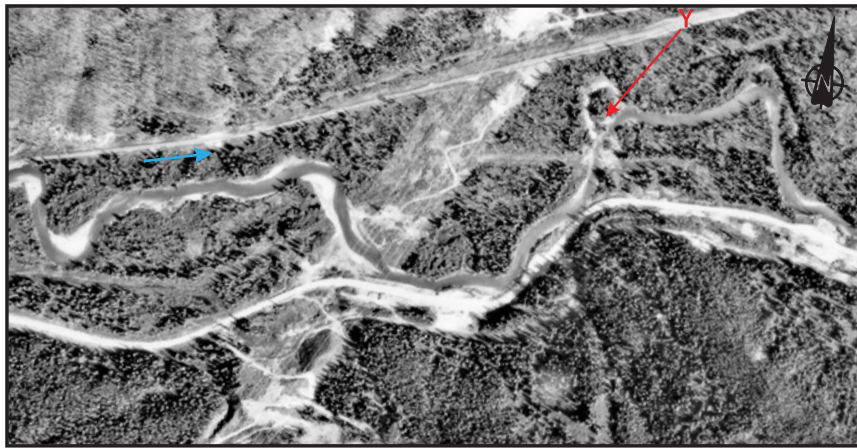
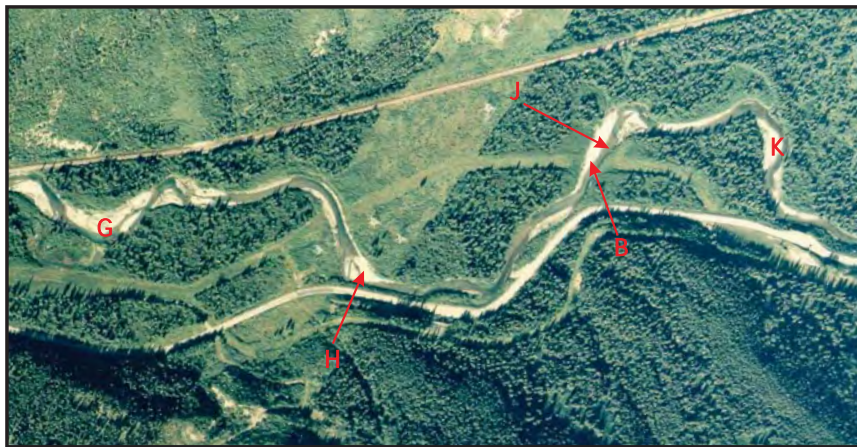
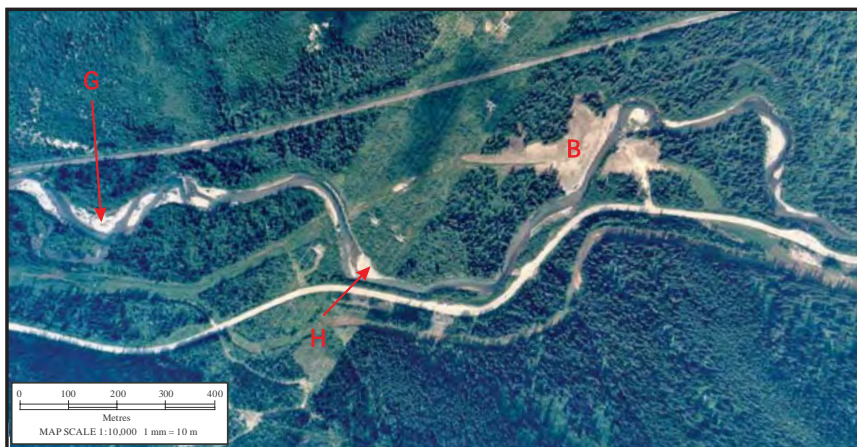
(i)  
 Date: May 17, 1953  
 BC1650 #59  
 NOTE:  
 ■ Extent of inundation during high water conditions.  
 ■ Location of John Hart Highway and apparent instream encroachments (P).

(ii)  
 Date: September 11, 1955  
 BC2136 #65  
 NOTE:  
 ■ Low water channel conditions.  
 ■ Size and extent of unvegetated instream gravel accumulations (e.g. Q and R) and vegetation development on formerly unvegetated bars (e.g. S).

(iii)  
 Date: July 20, 1960  
 BC2770 #10  
 NOTE:  
 ■ Clearing of left bank valley wall (T) and portions of the valley flat (e.g. U and V).  
 ■ Construction of the BC Railway (W) and pipeline ROW (X).  
 ■ Incipient cut-off channel (Y).

Figure 4.3.5A: Historical changes in channel morphology on Pine River in the vicinity of the August 1, 2000 oil spill (from EDI & MMA, 2002).

(v)  
 Date: June 15, 1969  
 BC7177 #175  
 NOTE:  
 ■ Channel cut-off at **Y**.

(vi)  
 Date: August 31, 1989  
 30BC89064 #72  
 NOTE:  
 ■ Increased size of pipeline ROW (**A** and **B**).  
 ■ Channel cut-off at **E** and **F**.  
 ■ Extensive sediment accumulations (e.g. **G**, **H**, **I**, **J** and **K**) following upstream channel avulsion.

(vii)  
 Date: September 1, 1997  
 30BCC97182 #131  
 NOTE:  
 ■ Further sediment accumulations (e.g. in the vicinity of **G**, **H**, **J** and **K**).  
 ■ Straightened channel at pipeline crossing **B**, likely resulting in channel downcutting and erosion of the right bank.

(viii)  
 Date: August 9, 2001  
 IAS (01) 54434 #33  
 NOTE:  
 ■ Replacement pipeline crossing **B** following rupture in August 2000. The pipeline failure occurred on the left bank outside of the main river channel.  
 ■ Reworking of sediment accumulations (e.g. **G** and **H**) indicating the channel is still readjusting to the post-1960 influx of coarse sediment.

Figure 4.3.5B: Historical changes in channel morphology on Pine River in the vicinity of the August 1, 2000 oil spill (from EDI & MMA, 2002).

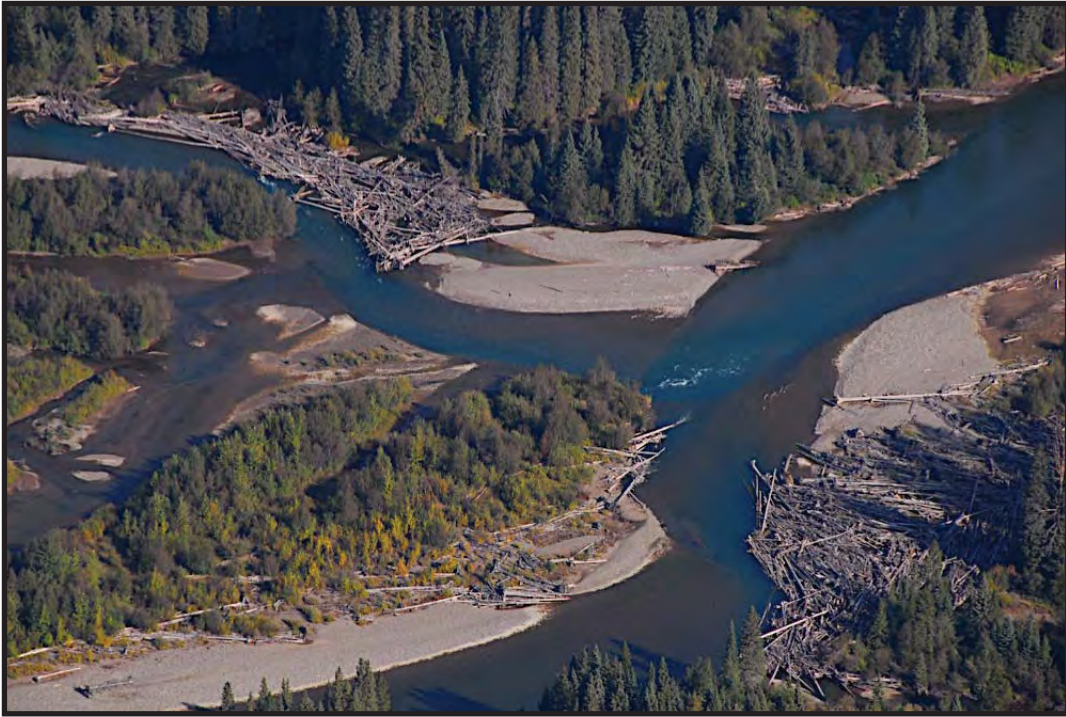
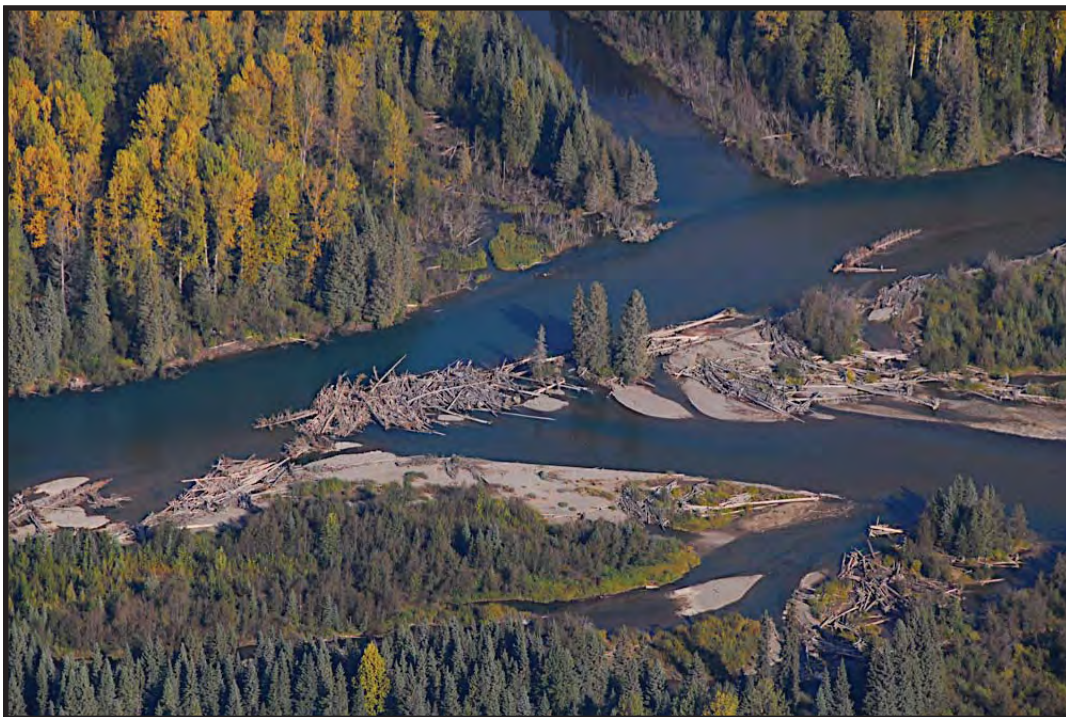
Photograph of log jams on the channel edge and at the inlet to a secondary channel.

Plate 2.5.1: Photographs of log jams on Reach 2 of Morice River.

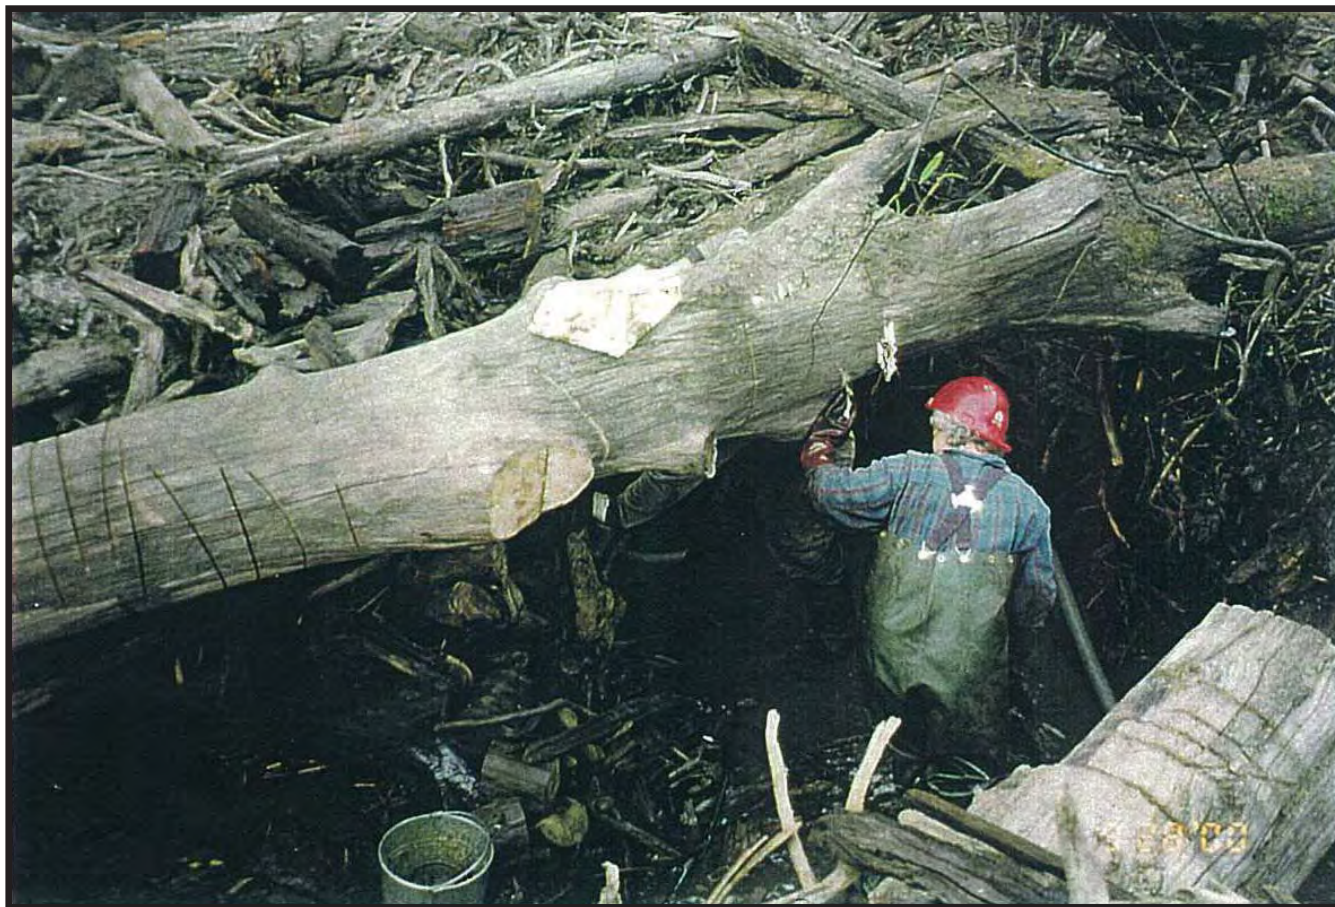
Plate 4.3.1: Crew working to clean oil out from under a log jam on Pine River. [From nhc, 2001.]

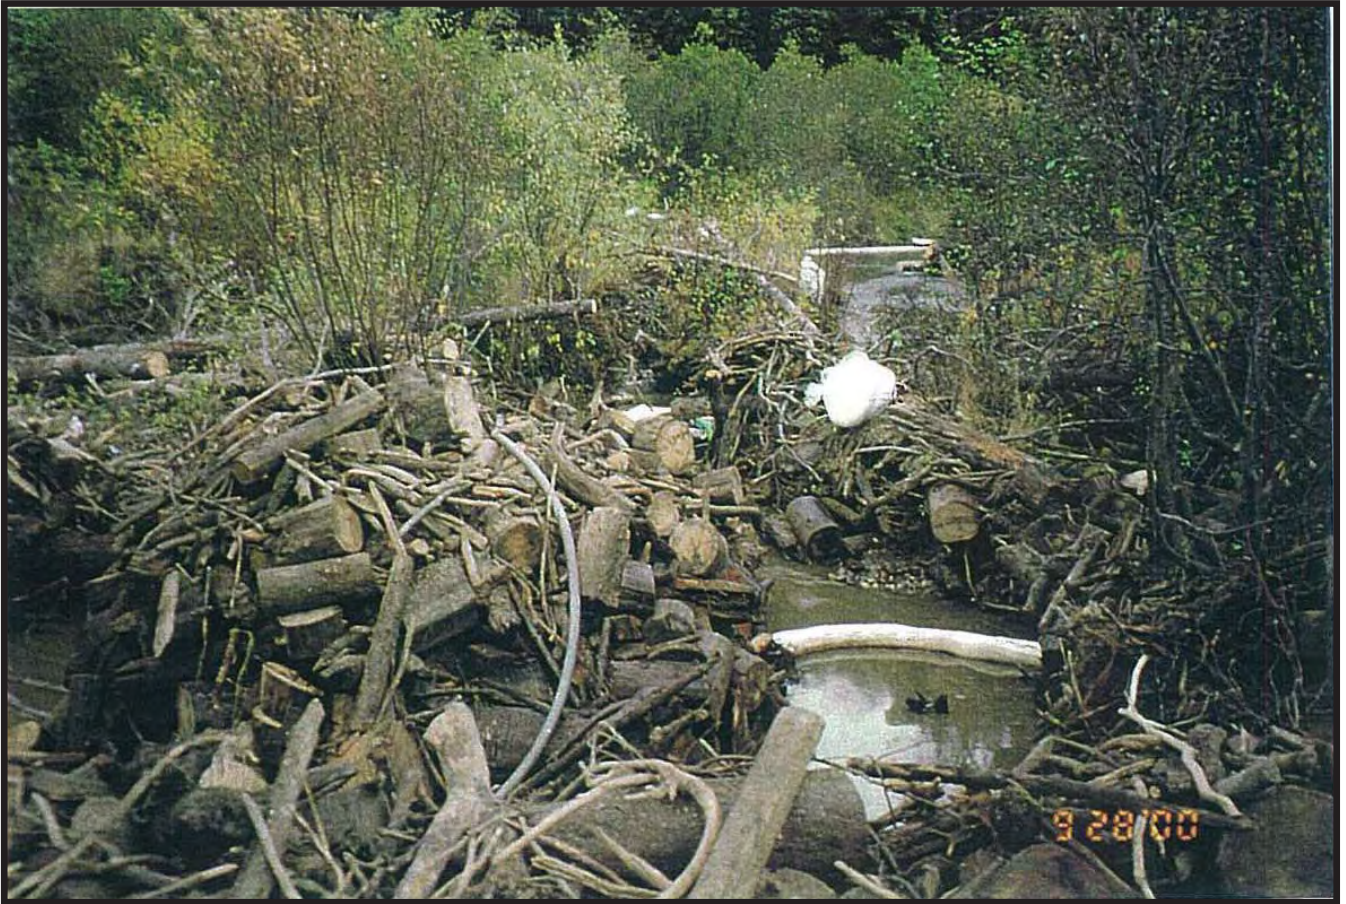
Plate 4.3.2: Oil coated log jams on Pine River were removed and burned. [From nhc, 2001.]

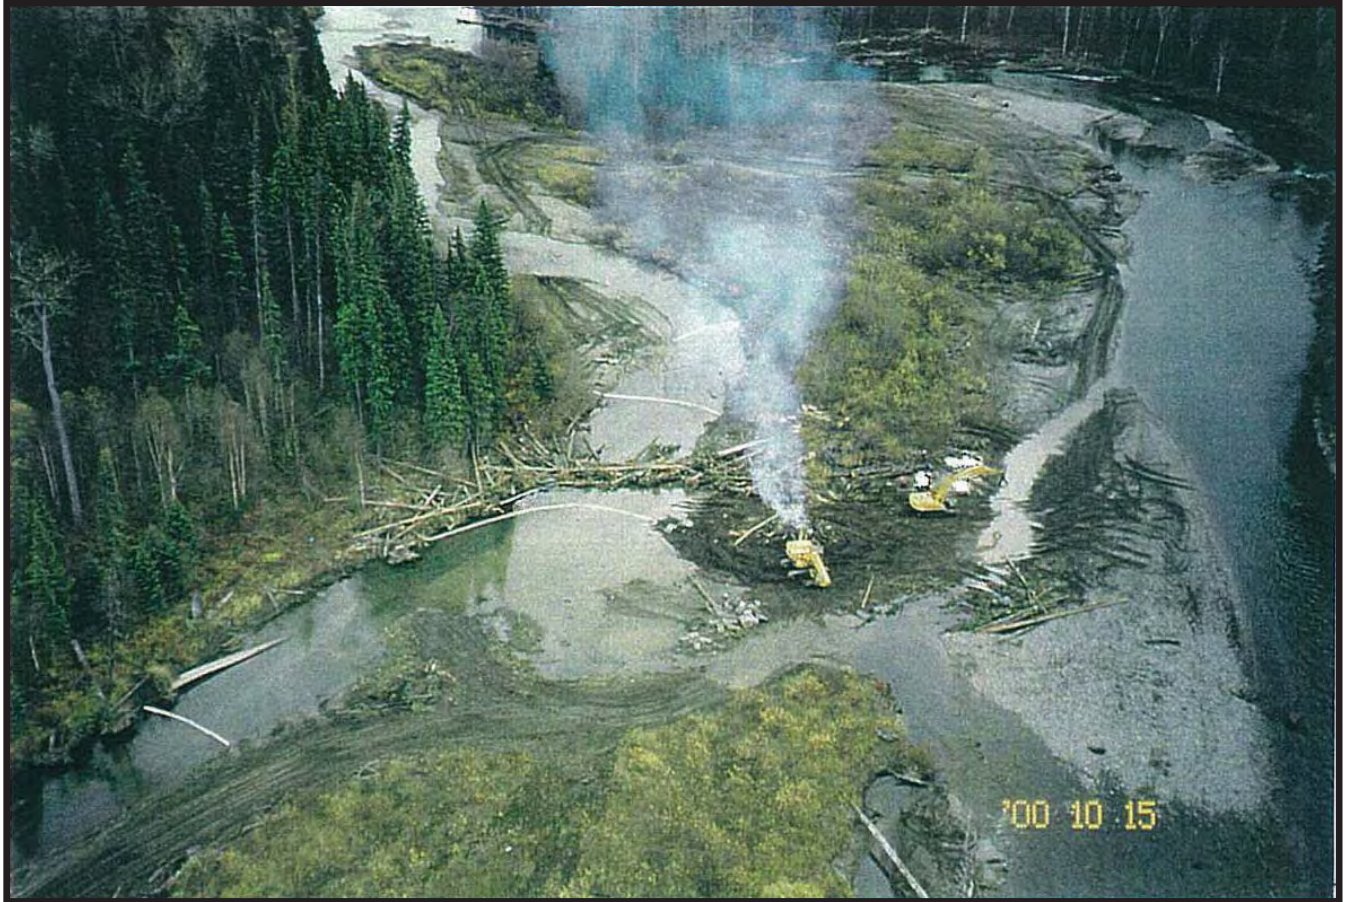
Plate 4.3.3: Log jam removal and reconstruction on Pine River. [From nhc, 2001.]

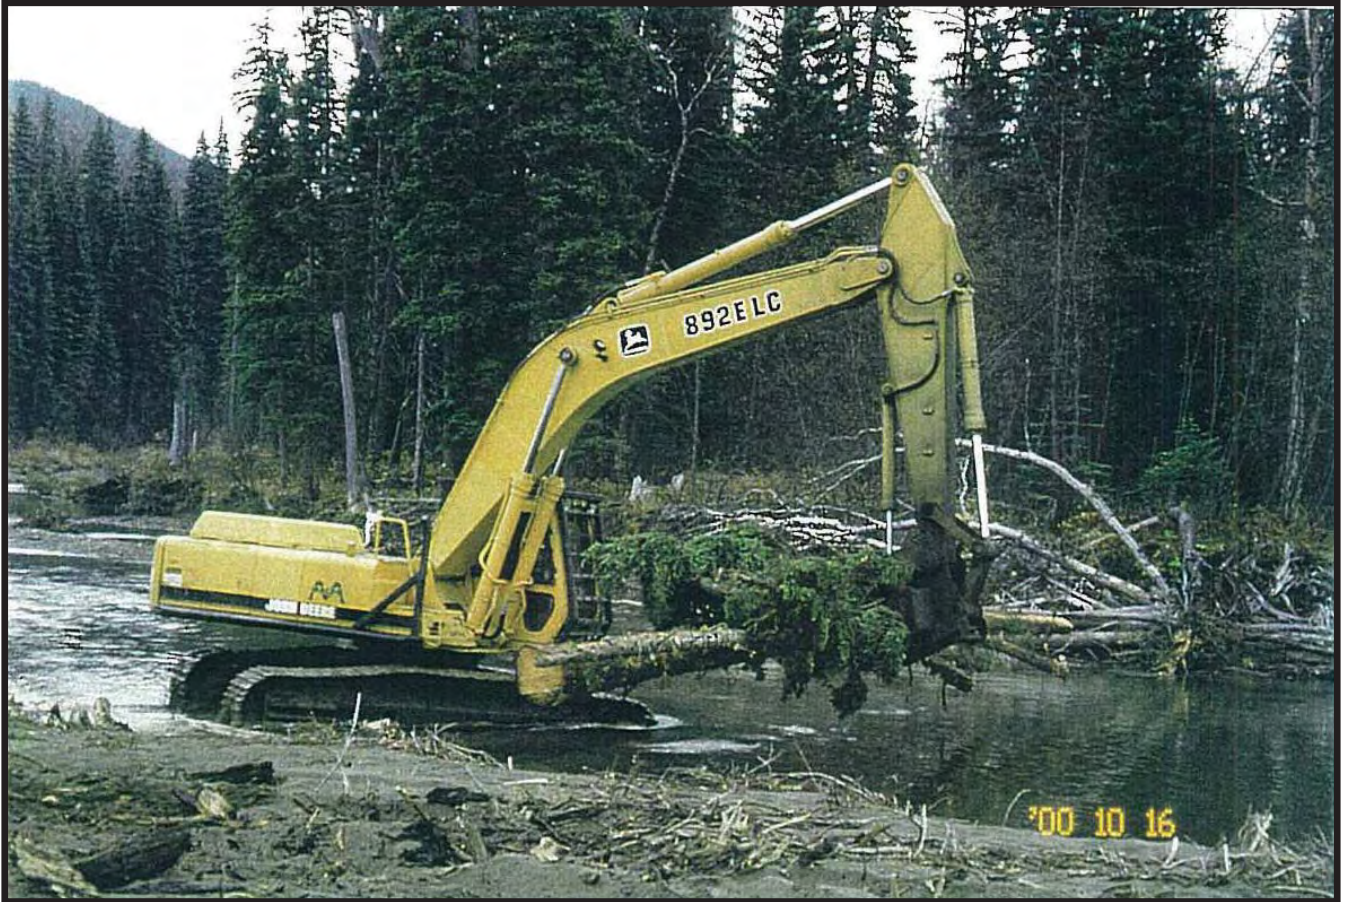
Plate 4.3.4: Log jam construction on Pine River. [From nhc, 2001.]

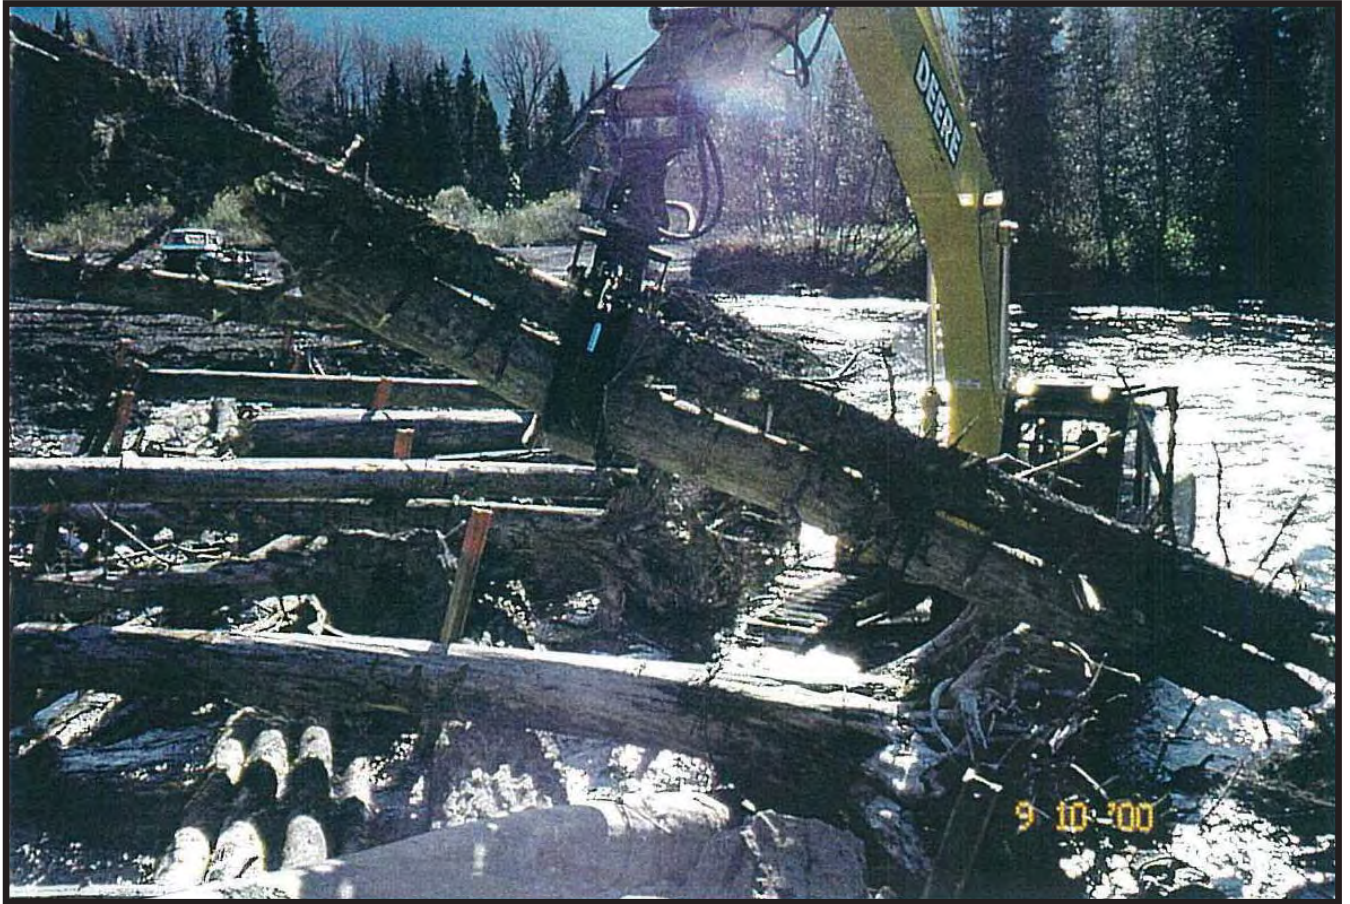
Plate 4.3.5: Logs placed in log jam reconstruction on Pine River. [From nhc, 2001.]
