SEYMOUR LAKE

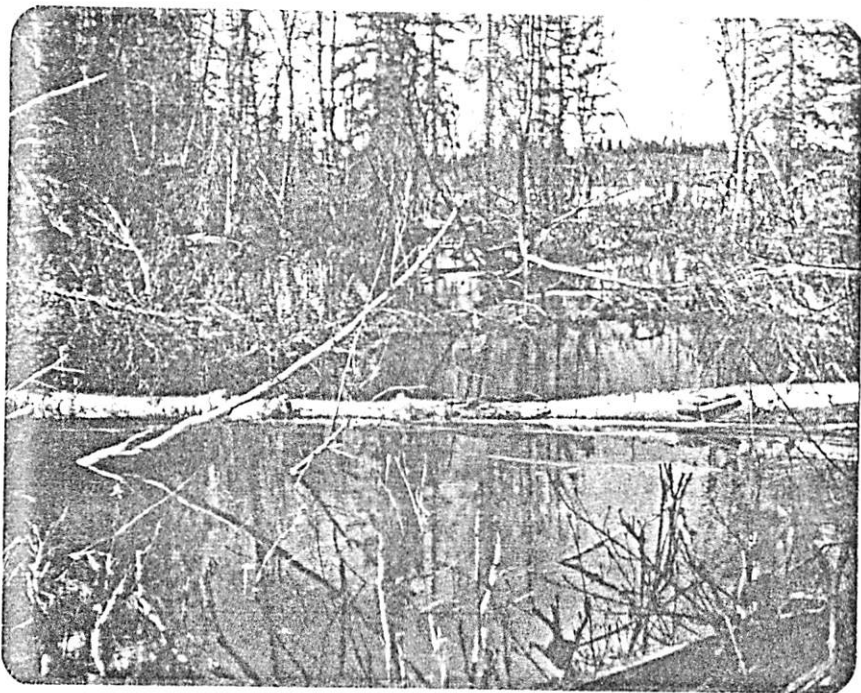
Photo 1 - Inlet #1, looking towards the lake.

Description - the stream was riddled with beaver dams in the lower section and was flooded to 200 ft. wide or more (see photo #1). The substrate was predominately fine, organic debris.

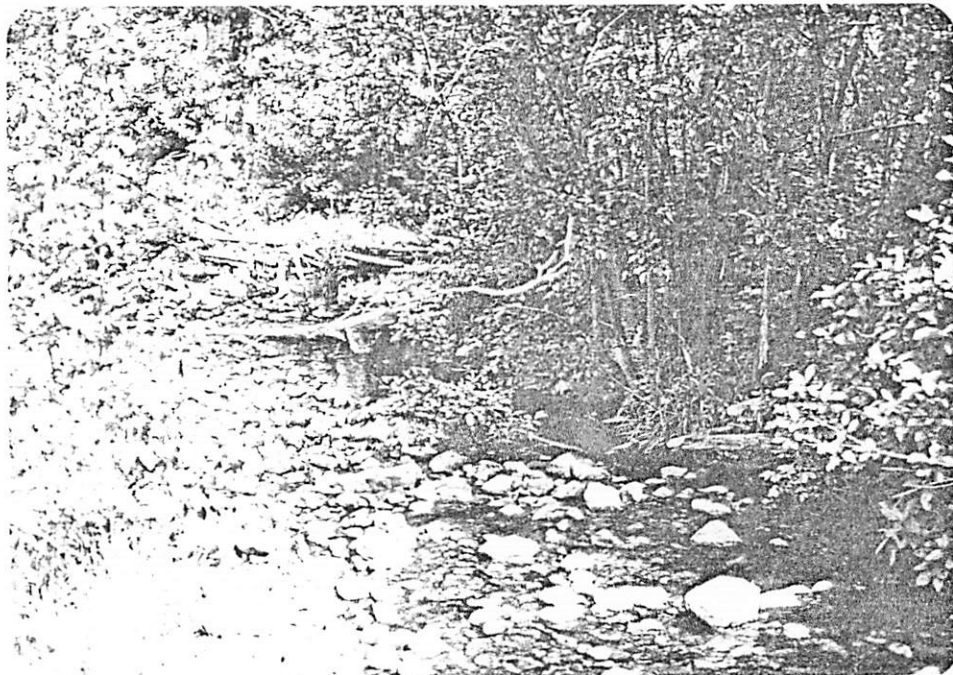
Photo 6 - The outlet in the ravine.

Above the field the stream runs through a ravine. Streamside vegetation here is thick. Where the creek could be observed it was 3 to 10 feet wide over a substrate of gravel, cobble and stone (see photos 6 & 7). The habitat is similar until the outflow is reached where extensive beaver activity has caused flooding. There are three major dams within the first 100 yds. downstream and several more below this. (see photo 8) On May 14 the stream was flooded to approximately 100 ft. in places.

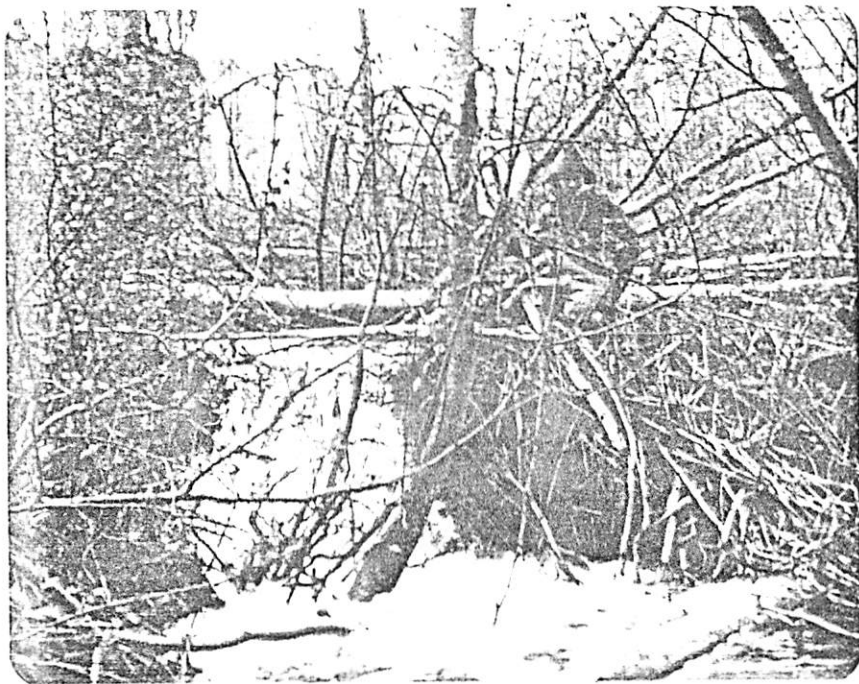
Photo 8 - One of the beaver dams near the outflow.

Barriers - Beaver activity near the Telkwa Coal Road and near the outflow have resulted in several partial and/or complete barriers.

The ideal situation in this lake would be the establishment of a self-sustaining trout population. The outlet has sufficient flow during the summer to serve as a good spawning and rearing habitat, although a resident reported that the stream does dry up intermittently some summers. The beaver dams near the outflow present a major problem as they form impassable barriers to the upstream movement of fish. Removal of the dams could result in an excellent spawning and rearing stream.
