**FISHERIES ASSESSMENT OF  
PROPOSED RIP RAP SITES FROM KM 17  
TO KM 25 MORICE RIVER 1998**

**DAVID BUSTARD AND ASSOCIATES LTD.**

**BC MINISTRY OF FORESTS**

May 1998

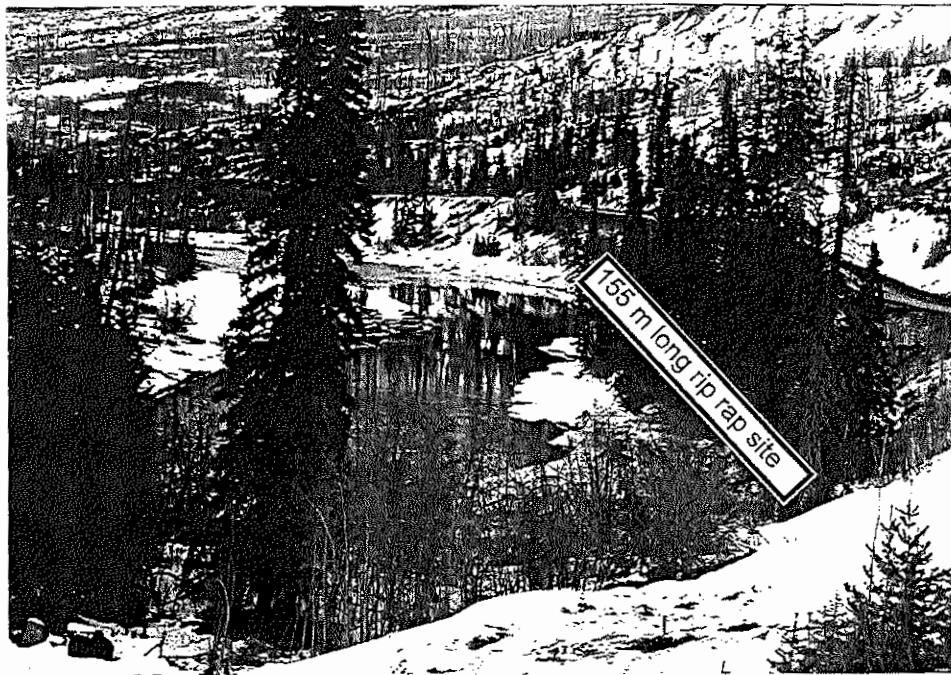
**Photo 1. Proposed rip rap site at Km 25 of the Morice River. The conifer riparian zone on the river's right side is located on the section where rip rap is to be placed.**

- Km 25 - Riparian vegetation removal and rip rap placement along a 155 m length<sup>1</sup> of bank that would extend upstream from existing rip rap (Photo 1).
- Km 23 - Lengthen an existing rip rap placement along this section to protect the base of a 30-m long slide on the Morice River (Photo 2).
- Km 17.5 - Complete a rip rap blanket at the toe of a slide along the river at this location<sup>2</sup>.

Aesthetics and recreation are important considerations on the mainstem Morice River. The Km 25 site is characterized by a short section of mature conifer forest along the edge (Photo 1). Much of the forested edge of the river has been lost in this section of the Morice River. The removal of the riparian edge at Km 25 will result in a decline in the aesthetic/recreation features along this section of river until a well-developed riparian edge can be re-established.

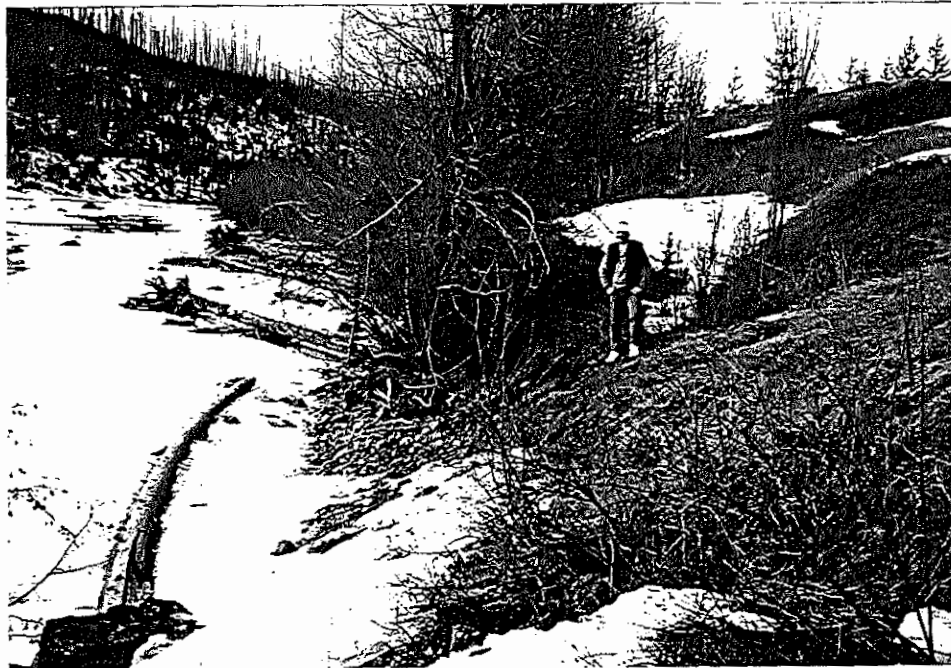
**Photo 2. This small rotational failure is located at Km 23 of the Morice River. Rip rap is proposed for approximately 60 m along this section. The adjacent channel is dry during the low flow March period.**

<sup>4</sup> The immediate shoreline in the vicinity of the proposed rip rap placement at Km 23 was dry during the spring assessments (Photo 2).

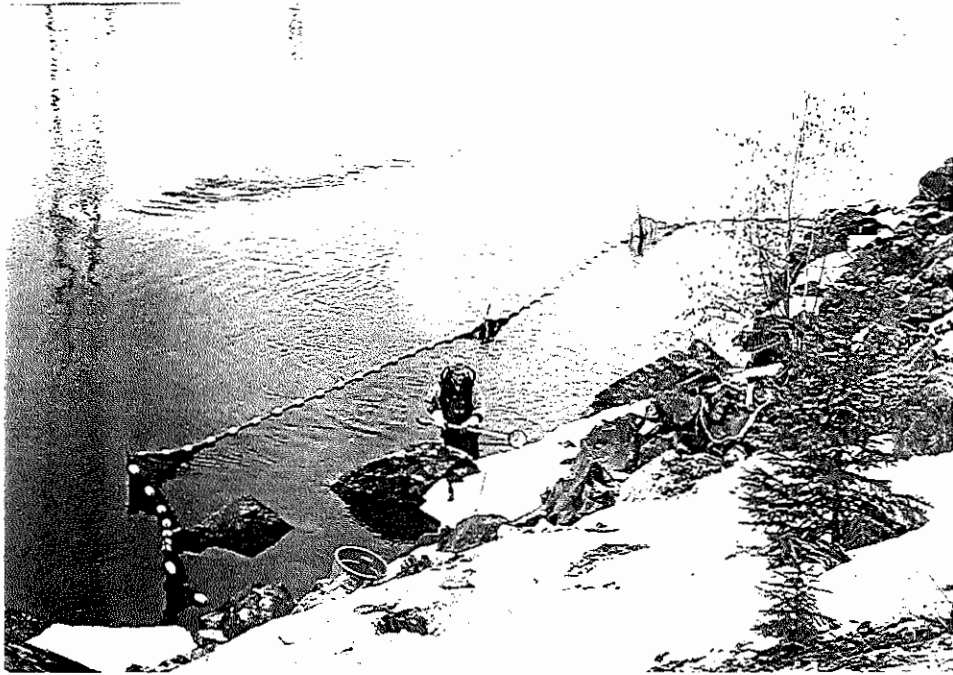
**Photo 3. Enclosed electrofishing site along existing rip rap section at Km 25 of the Morice River.**

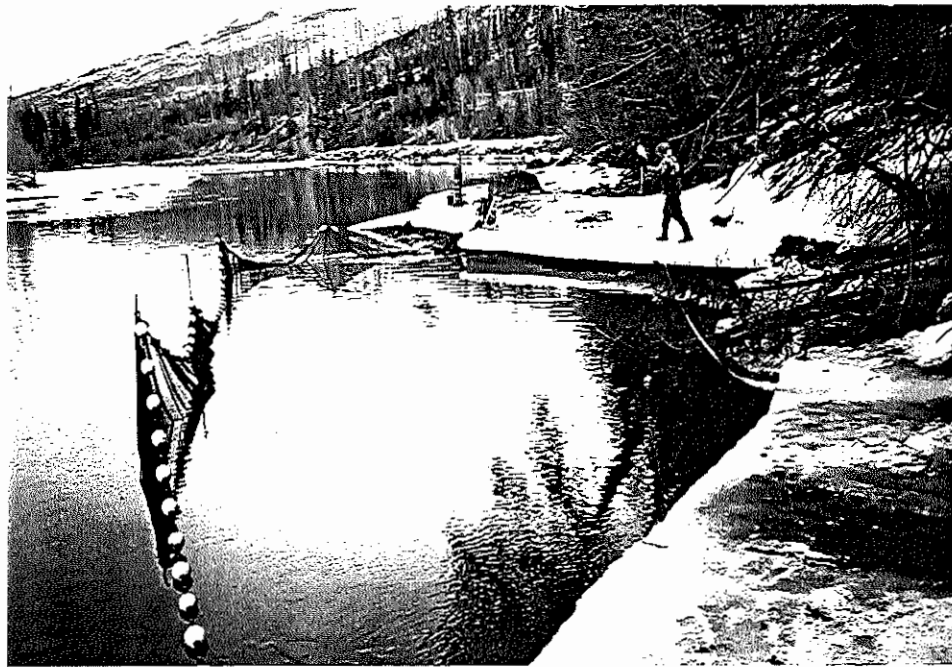
**Photo 4. Enclosed margin site along Km 25 section of Morice River proposed for rip rap placement.**
