Reconnaissance Level Fish and Fish Habitat Inventory in the Bulkley T.S.A.

(Working Unit #9- Fulton)

April 1998

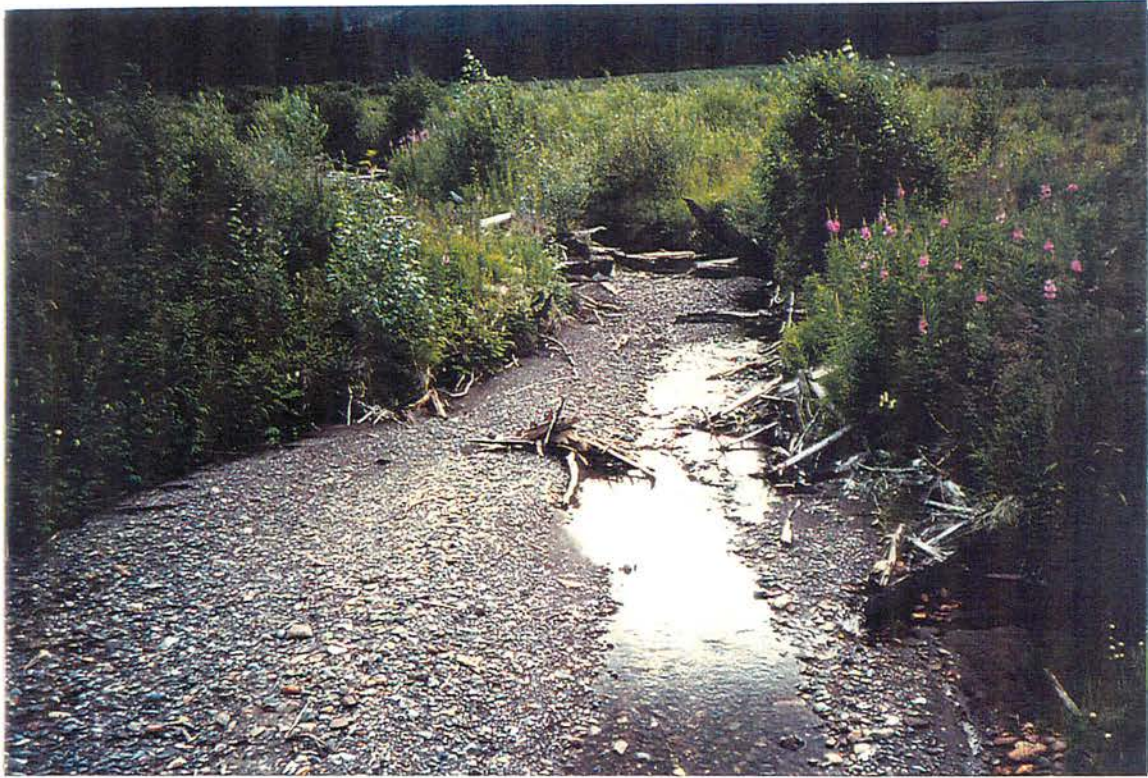
- Comments**
- C1: S3
 - C2: LS = 2%, RS = 2%
 - C3: No fisheries sensitive zones noted.
 - C4: The electroshocking effort, using a 12 B POW model was 287 seconds over 100m. In addition to the fish listed in the fish summary 14 juvenile Dolly Varden, ranging in size from 40 to 120 mm, were caught at this site.
 - C5: Lat N 54 50' 21.1", Long W 126 39' 04.4"
 - C6: No additional bank texture information.
 - C7: No pH, DO or conductivity measurements were made at the site. The mean air temperature on this day was 11.5°C
 - C8: Good spawning and rearing habitat present on site. The large amount of LOD in the channel creates a number of pools.

Photo #: J-6-6, 1996/08/16
Site #: J103, Looking upstream from bridge.

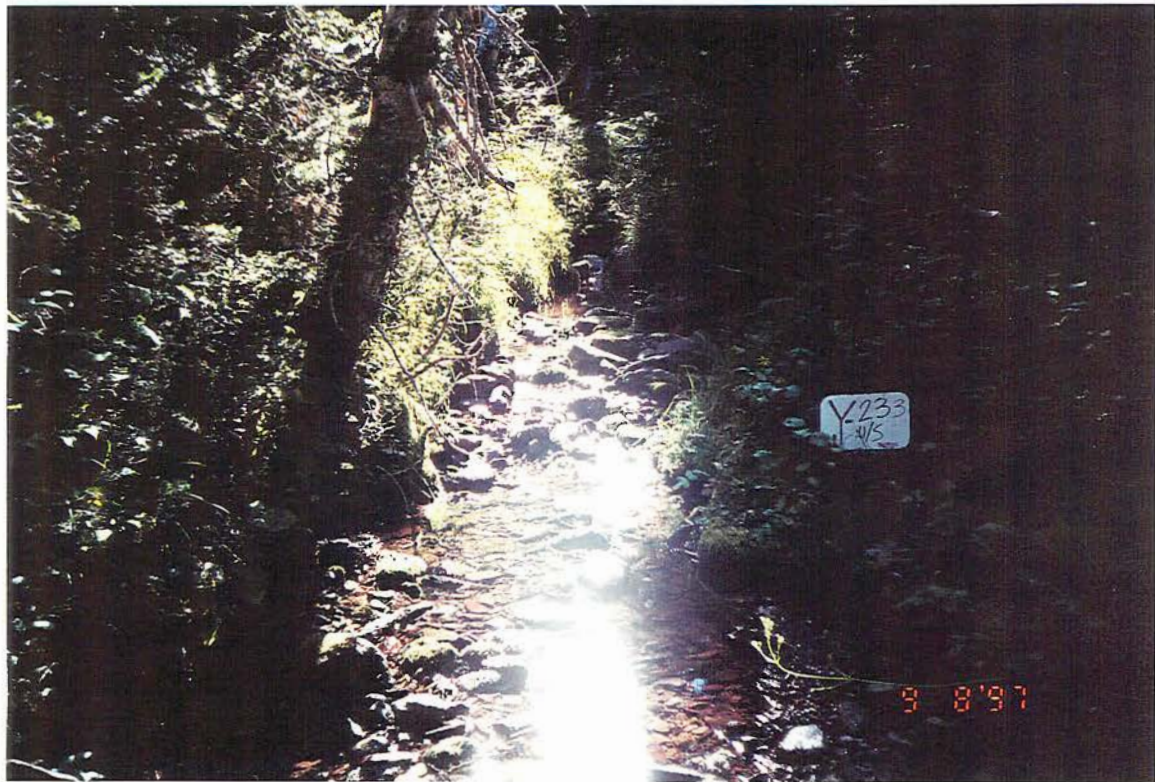
Photo #: Y-28-5, 08/09/97
Site #: Y233, Looking upstream at the channel

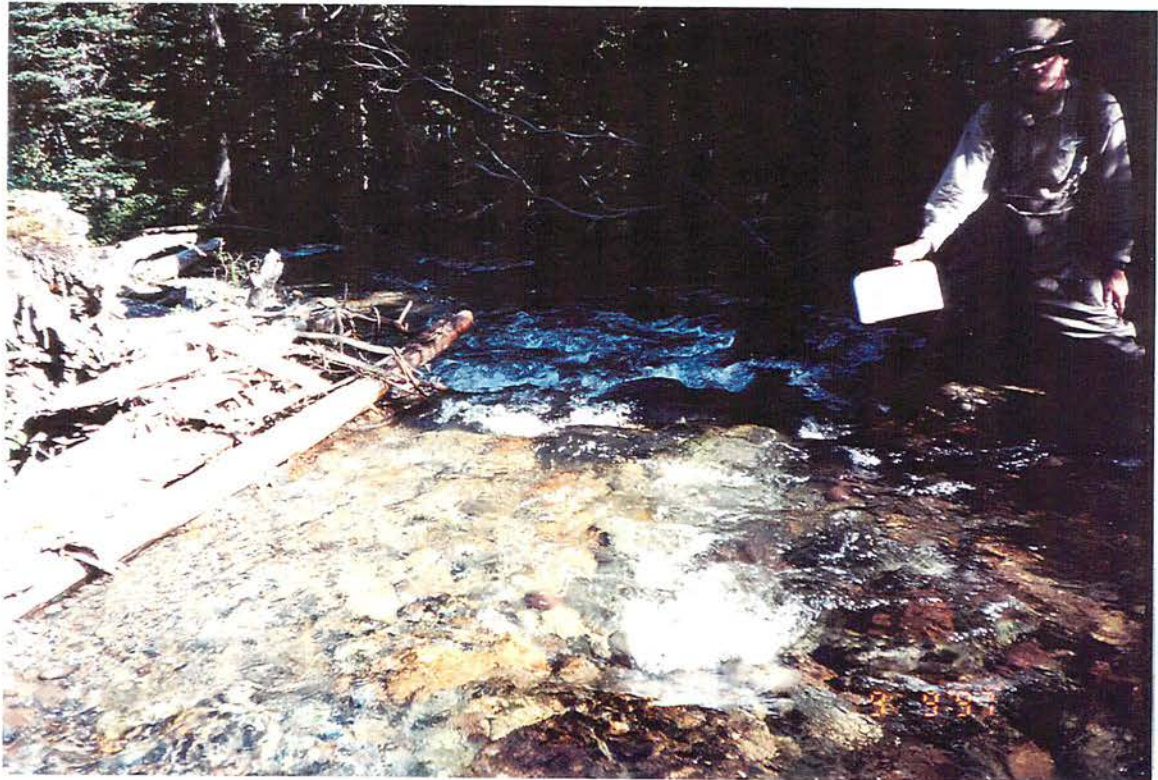
Photo #: E-27-2, 09-Sep-97
Site #: E279, Looking downstream at the channel, note the woody debris

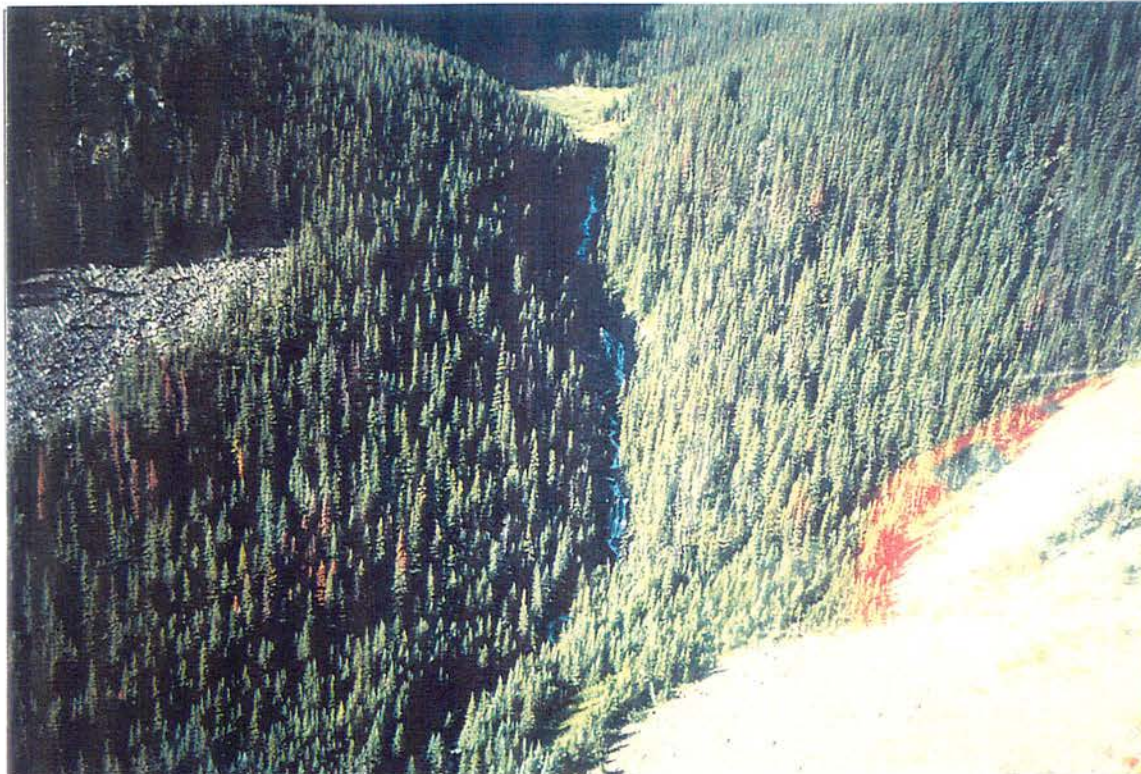
- C1: S3
- C2: LS = 10%, RS = 13%
- C3: No fisheries sensitive zones noted.
- C4: The electroshocking effort, using a 15 a Smithroot model, was 539 seconds over 100 meters. Future sampling is recommended to confirm the presence of a resident fish population.
- C5: Lat N 54 54 07, Long W 126 47 07
- C6: No additional bank texture information.
- C7: DO, pH and conductivity measurements were not taken at this site. The mean air temperature on this day was 14.5°C
- C8: No additional fish habitat information.
- C9: This creek runs through an avalanche zone and contains woody debris derived from an avalanche.

Photo #: B-6-16, 1996/08/25
Site #: B94, 100m cascade downstream of site B94.

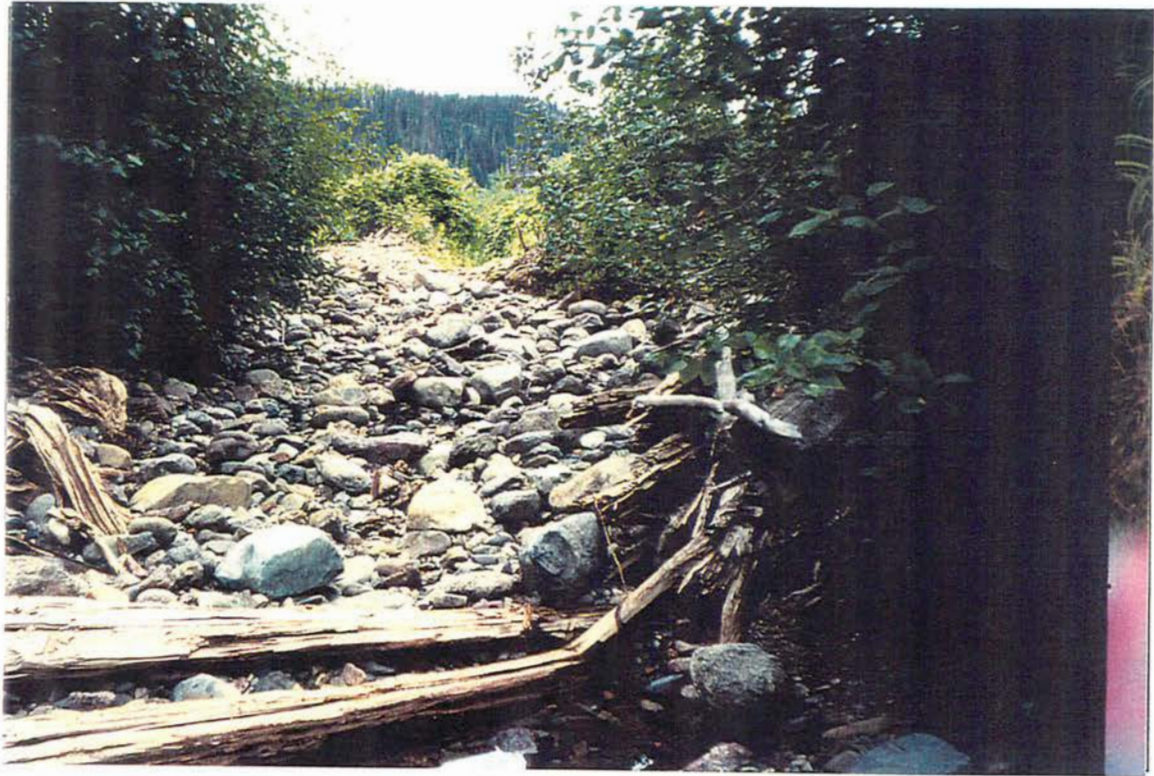
- C8: No spawning, rearing or overwintering habitat is present on site.
- C9: The channel has been severely impacted by logging. Slumping banks, log jams, debris flooding and loose substrate are present in this area. Approximately 40 meters below the road the creek disappears underground. There is no downstream surface flow and no channel. The water disappears underground in the section of the creek with a channel. Otherwise it runs as a trickle through the rocks.

Photo #: J-5-21, 1996/08/16
Site #: J100, Looking upstream, Fink C.

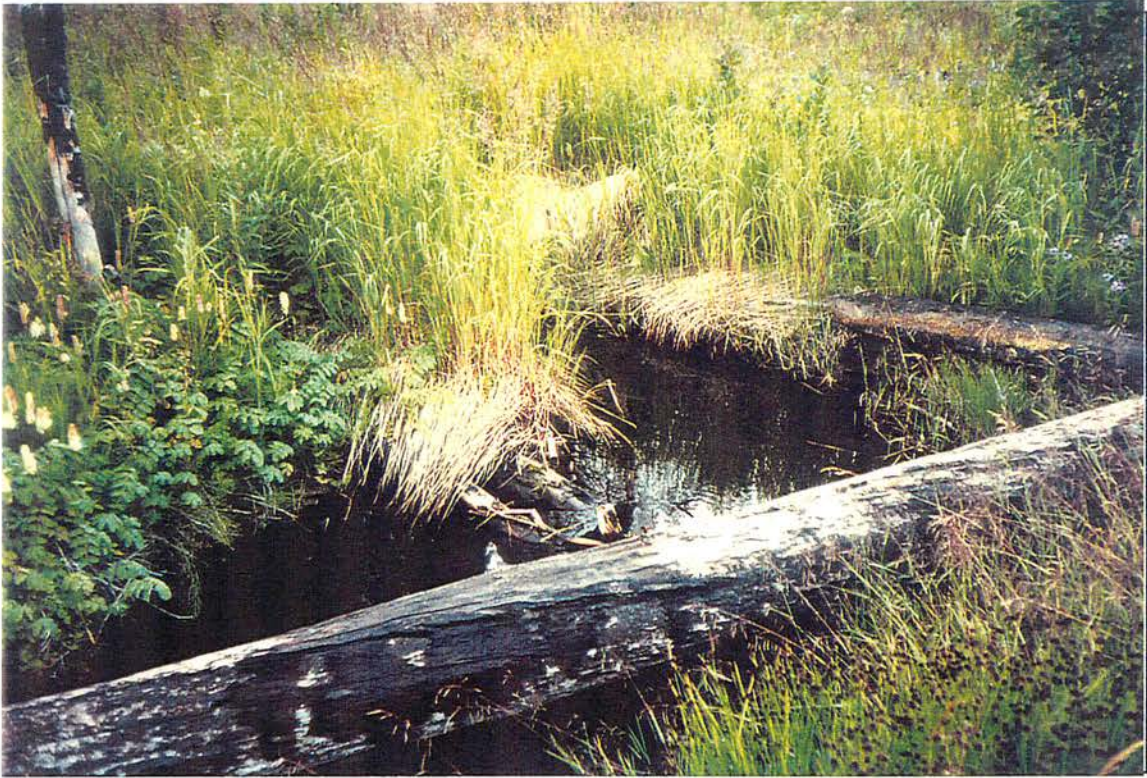
- C1: S3
- C2: LS = 4%, RS = 4%
- C3: No fisheries sensitive zones noted at this site.
- C4: The electroshocking effort, using a 12 B POW model, was 505 seconds over 150 meters.
- C5: Lat N 54 51' 26.3", Long W 126 40' 46.7"
- C6: No additional bank texture information.
- C7: No pH, DO or conductivity measurements were made at this site. The mean air temperature on this day was 11.5°C
- C8: Potential rearing habitat exists at this site. The channel is filled with spawning sized gravels, however, the slow flow and shallow water result in marginal spawning habitat.
- C9: This creek flows through a cutblock. No buffer zone was left to protect the creek. Currently burned logs are present in the channel.
- I: A small tributary, class S4, was seen upstream of the road. A small bridge over the stream does not encroach on the creek.

Photo #: J-5-19, 1996/08/16
Site #: J99, Looking upstream, LOD and pools.

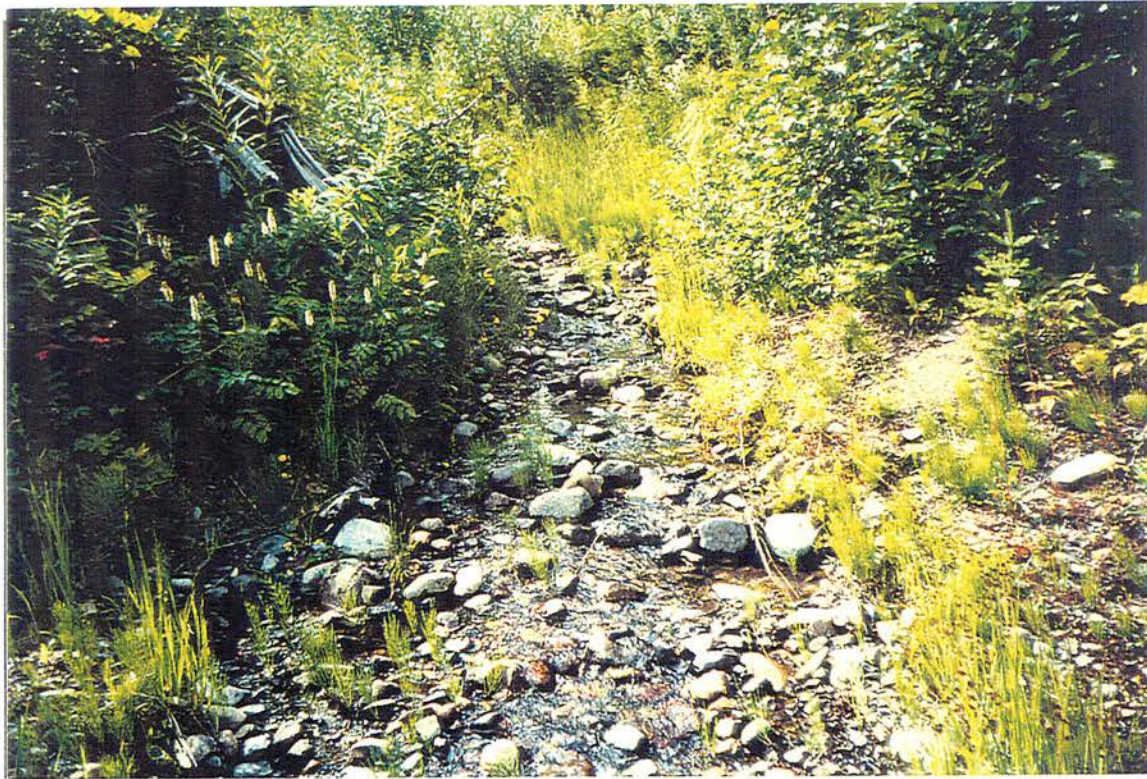
C1: S6
 C2: LS = 10%, RS = 3%
 C3: No fisheries sensitive zones noted on site.
 C4: The electroshocking effort, using a 12 B POW model, was 68 seconds over 220 meters.
 C5: Lat N. 54 50' 59.5", Long W 126 40' 29.4"
 C6: No additional bank texture information.
 C7: No pH, DO, conductivity measurements were made on site. The mean air temperature on this day was 11.5°C
 C8: The creek disappears underground 150 meters downstream of the road. The culvert at this location is not a barrier. A small pond, .2m deep and 20m squared, is located upstream of the road.

Photo #: J-6-2, 1996/08/16
Site #: J101, Looking upstream, grass in channel.

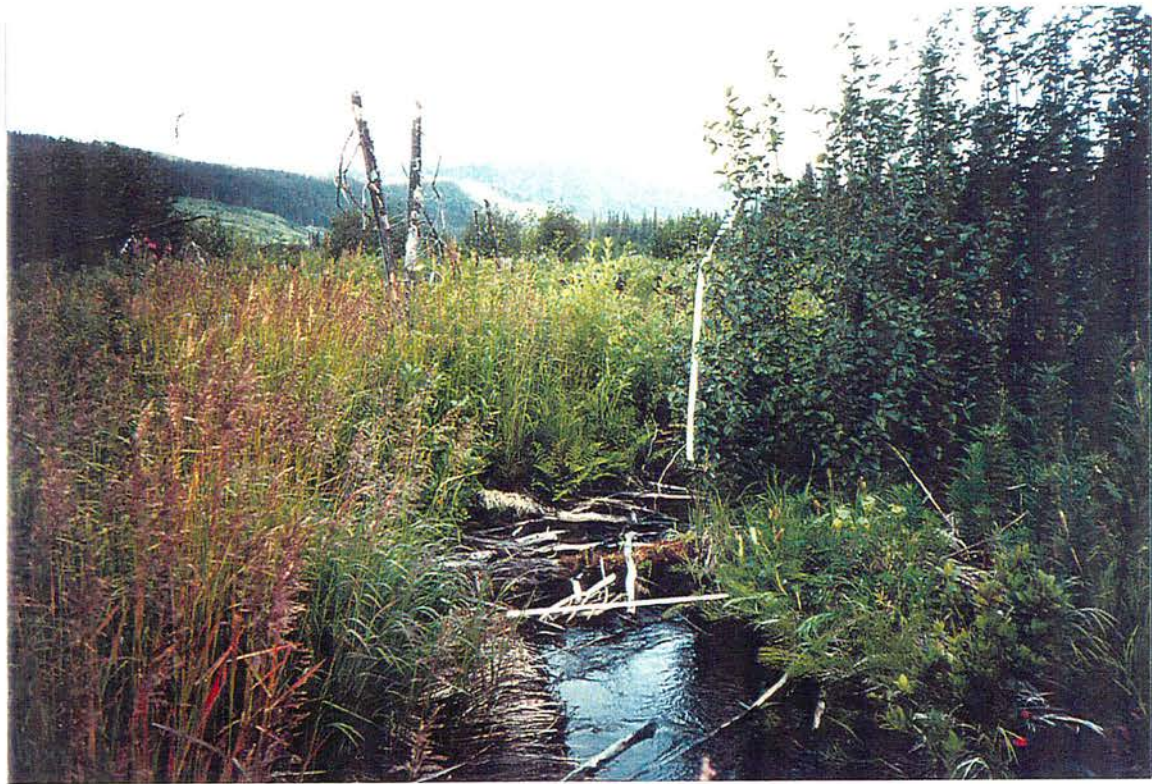
- C1: S3
- C2: LS=2%, RS=2%
- C4: An electroshocker was not available for sampling. This creek drains into a swamp which was minnow trapped. No fish were caught.
- C5: Lat N 54 50 18.6, Long W 126 39 10.9
- C6: No additional bank texture information.
- C7: DO, pH and conductivity were not measured at this site. The water was clear to the bottom. The mean air temperature on this day was 11.6°C
- C8: This site contains marginal rearing habitat. No spawning or overwintering habitat was observed in the sampling area. In general this creek has been severely impacted by logging, which was carried down right down to the stream banks. The creek runs along side the road like a ditch in the sampling area.

Photo #: J-7-11, 1996/08/19
Site #: J117, Looking downstream, LOD in channel.

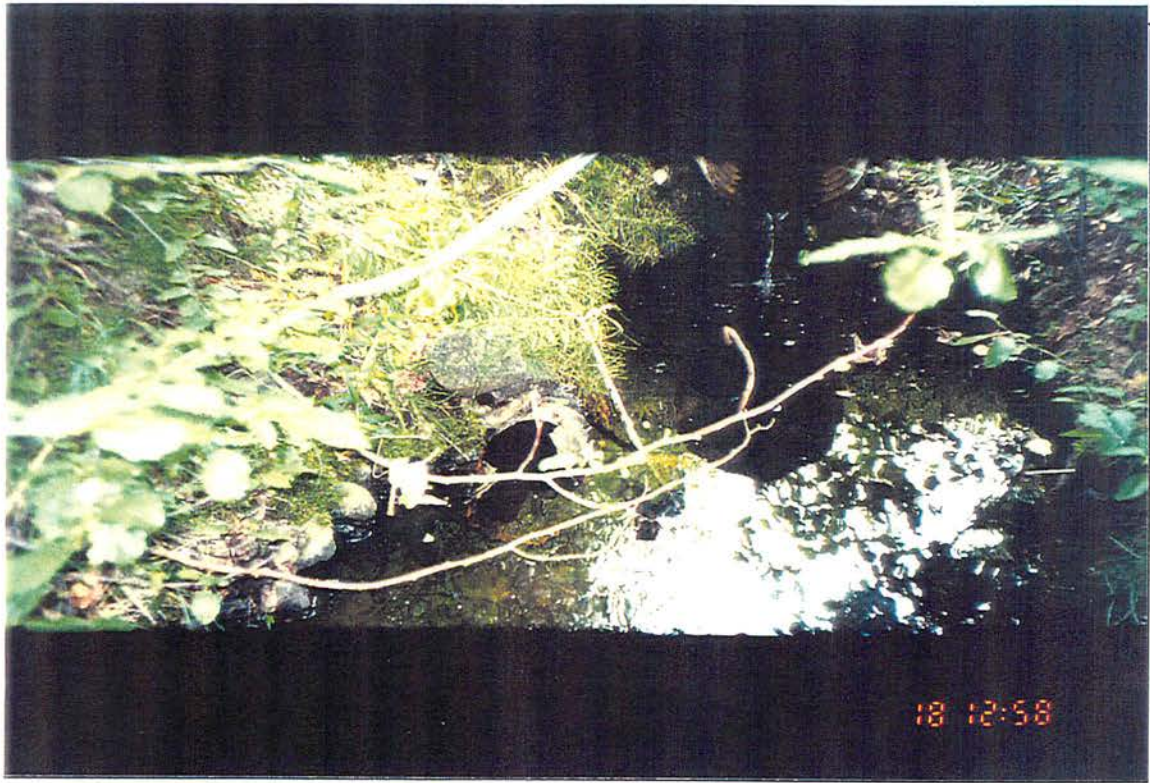
Photo #: T-7-4, 1996/08/18
Site #: T119, Upstream view with two culverts.

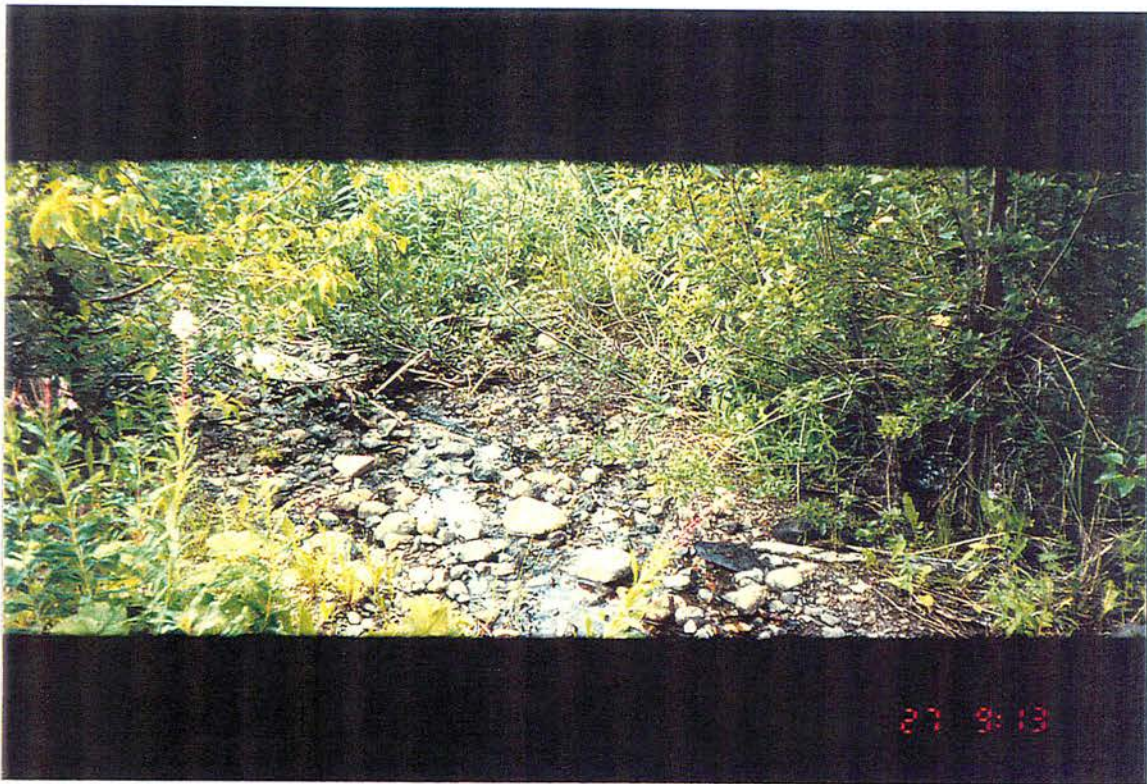
- C1 S3
 C2 LS = 9%, RS = 15%
 C3 No fisheries sensitive zones were noted at this site.
 C4 The electroshocking effort, using a Smithroot 15 A model was 120 seconds over 100 square meters.
 C5 Lat N 54 56' 54.01", Long w 126 44' 30.6"
 C6 No additional bank texture information.
 C7 DO and conductivity were not measured at this site. The water was clear to the bottom. The mean air temperature on this day was 13.7°C
 C8 Some good rearing and potential spawning habitat was noted at this stie.
 C9 This creek was re routed by the road crossing, at which no culvert was installed. The creek follows the road and disappears underground. This is a barrier that might be passable during freshet.

Photo #: T-10-20, 1996/08/27
Site #: T179, Downstream view taken from road.

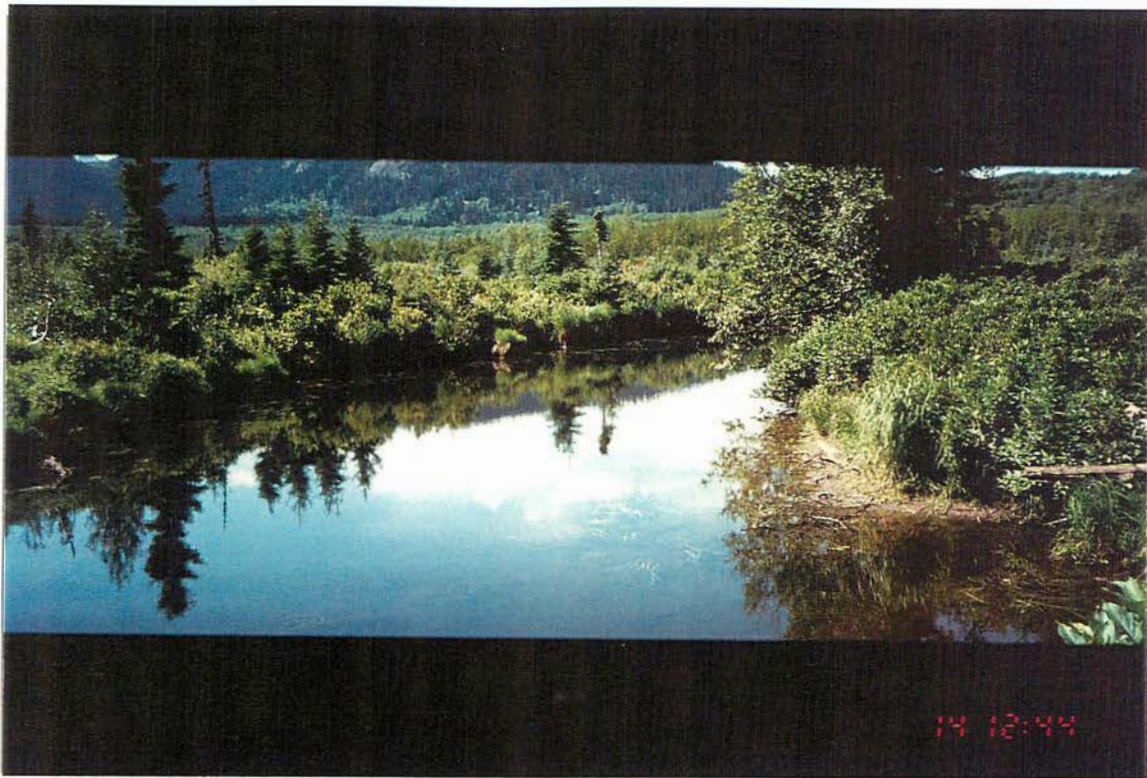
- Comments**
- C1 S2
 - C2 LS - 12% RS - 9%
 - C3 No fisheries sensitive zones noted.
 - C4 The electroshocking effort was not recorded. A minnow trap was also set at this site. Five prickly sculpin and one burbot were caught.
 - C5 Lat N 55 01' 48", Long W 126 43' 41".
 - C6 No additional bank texture information.
 - C7 No pH, DO, or conductivity tests were carried out at this site. The mean air temperature on this day was 11.5°C
 - C8 A log jam was observed downstream of the sampling area. In between dams the water depth was 80 cm and the sediment contained some algae covered boulders.
 - C9 Discharge could not be measured at this site because the water was too deep and the channel was too wide for the crew to obtain any measurements.

Photo #: T-5-20, 1996/08\14
Site #: T99, Upstream view; large, willow-lined stream.

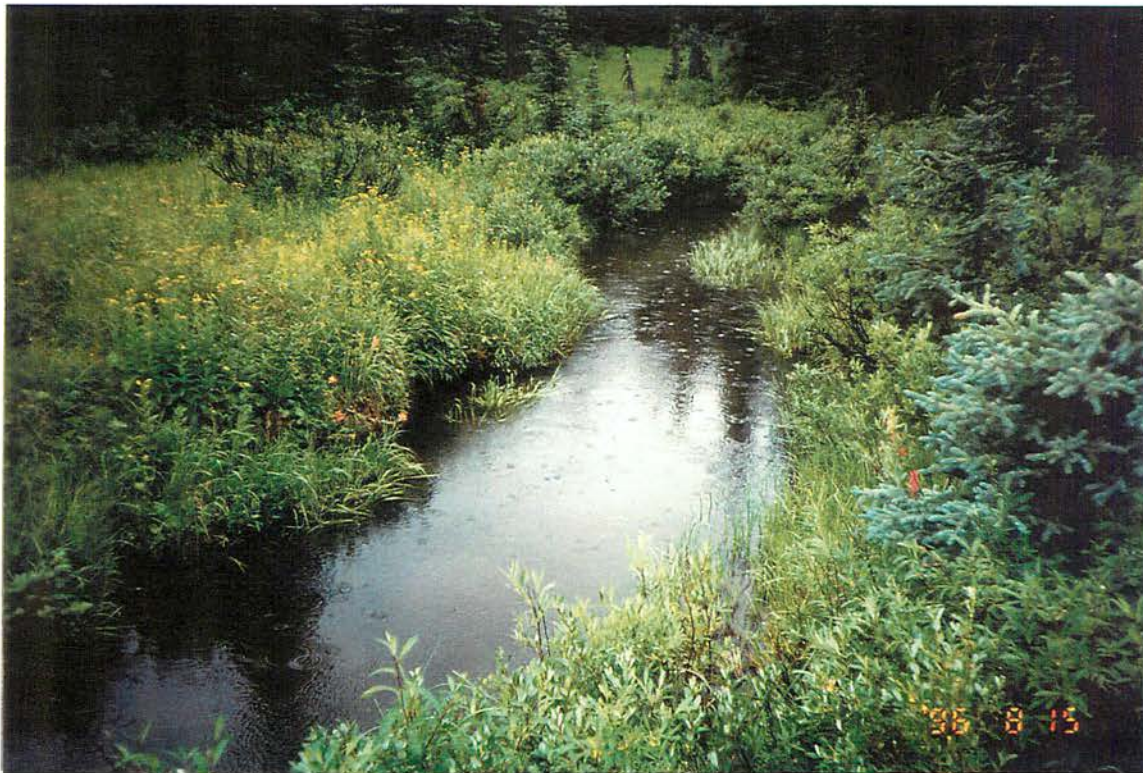
- Comments**
- C1: S3.
 - C2: The side slopes were not measured at this site.
 - C3: No fisheries sensitive zones were noted at this site.
 - C4: The electroshocker was not functioning properly on the sampling day. Future sampling is recommended to determine the presence or absence of fish at this site.
 - C5: N 51 05' 03", W 126 56' 22".
 - C6: No additional bank texture information.
 - C7: DO, pH and conductivity measurements were not taken at this site. The mean air temperature on this day was 12.8°C
 - C8: A lot of deep pool cover was observed at this site. This site would provide rearing habitat for cutthroat trout, rainbow trout and Dolly Varden.
 - C9: The channel widths at this site were estimated because the water became quite deep as the crew moved downstream. Future sampling is recommended, the channel grew wider as the crew moved downstream toward the helicopter landing site.

Photo #: H-4-14, 1996/08/15
Site #: H79, Looking upstream, channel through grassy area.

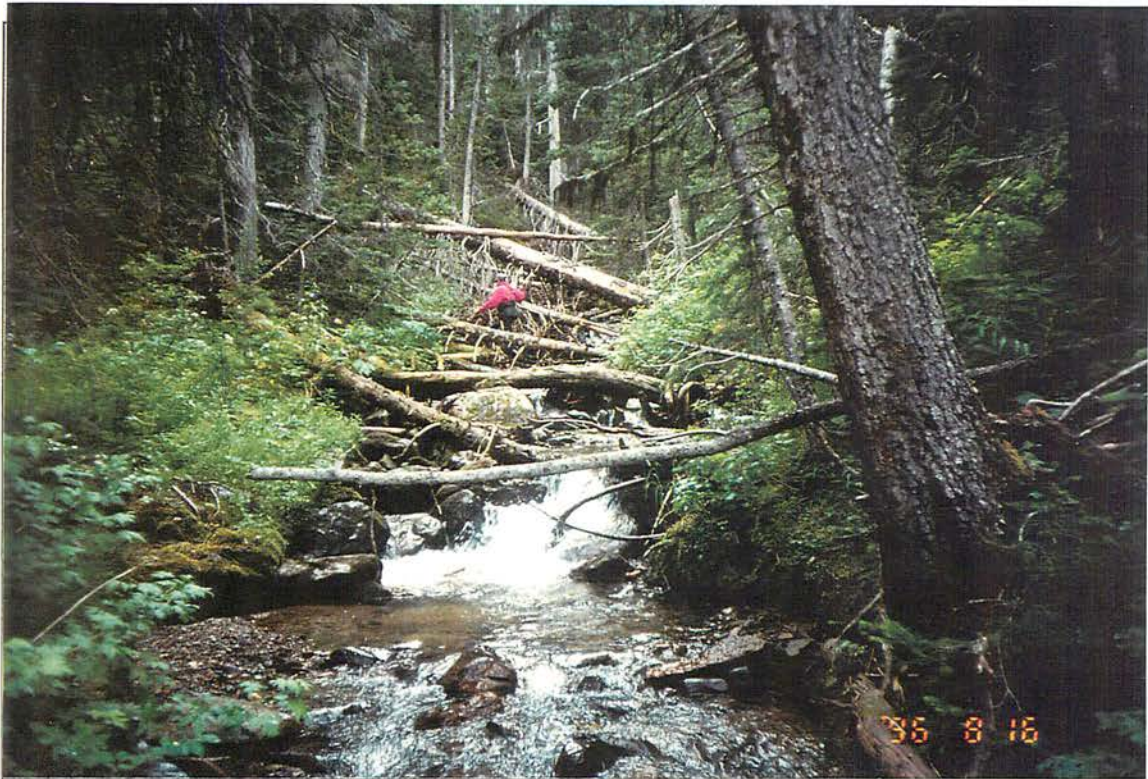
- C1: S3
- C2: The side slopes could not be measured at this site.
- C3: No fisheries sensitive zones were noted at this site.
- C4: This site was not electrofished because the shocker was not working at the time of sampling.
- C5: Lat N 55 00' 30", Long W 126 52' 45". The GPS unit could not get a reading at this site.
- C6: No additional bank texture information.
- C7: DO, pH and conductivity were not measured at this site. The water was clear to the bottom. The mean air temperature on this day was 11.5°C
- C8: This site has some good fish habitat, particularly at lower water velocities. Some deep pools but somewhat steep gradient was noted in the sampling area. The clinometer was too wet to read.

Photo #: H-4-22, 1996/08/16
Site #: H82, Looking upstream, cascade not a barrier.

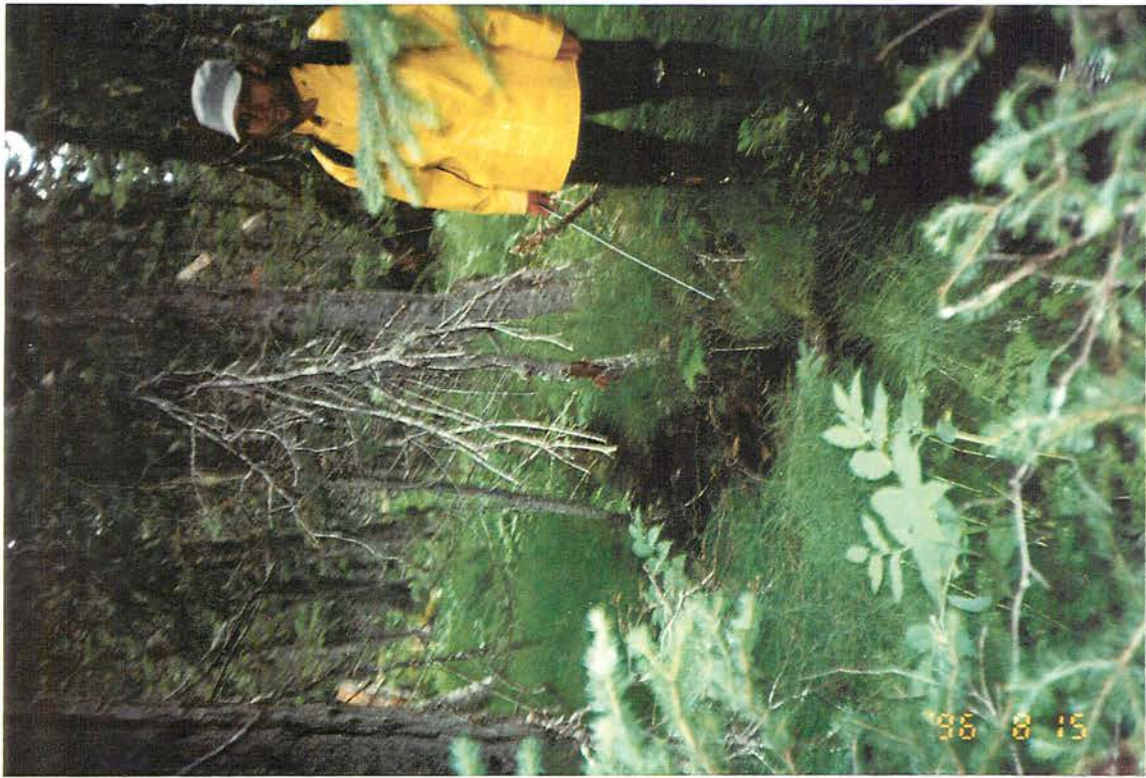
- C1 S4
- C2 LS = 5%, RS = 3%.
- C3 No fisheries sensitive zones were noted at this site.
- C4 The electroshocking effort, using a type VII model, was 221 seconds over 100 meters. The water level was too low at the time of sampling to effectively electrofish the stream.
- C5 Lat N 55 01' 24.6", Long W 126 54' 13.1".
- C6 No additional bank texture information.
- C7 No DO, pH, conductivity measurements were made at this site. The mean air temperature on this day was 12.8°C
- C8 This creek is definitely accessible to fish and contains marginal to good fish habitat. Some underground flow was observed in the sampling area. Future sampling at high flow is recommended.

Photo #: H-4-9, 1996/08/15
Site #: H76, Looking upstream.

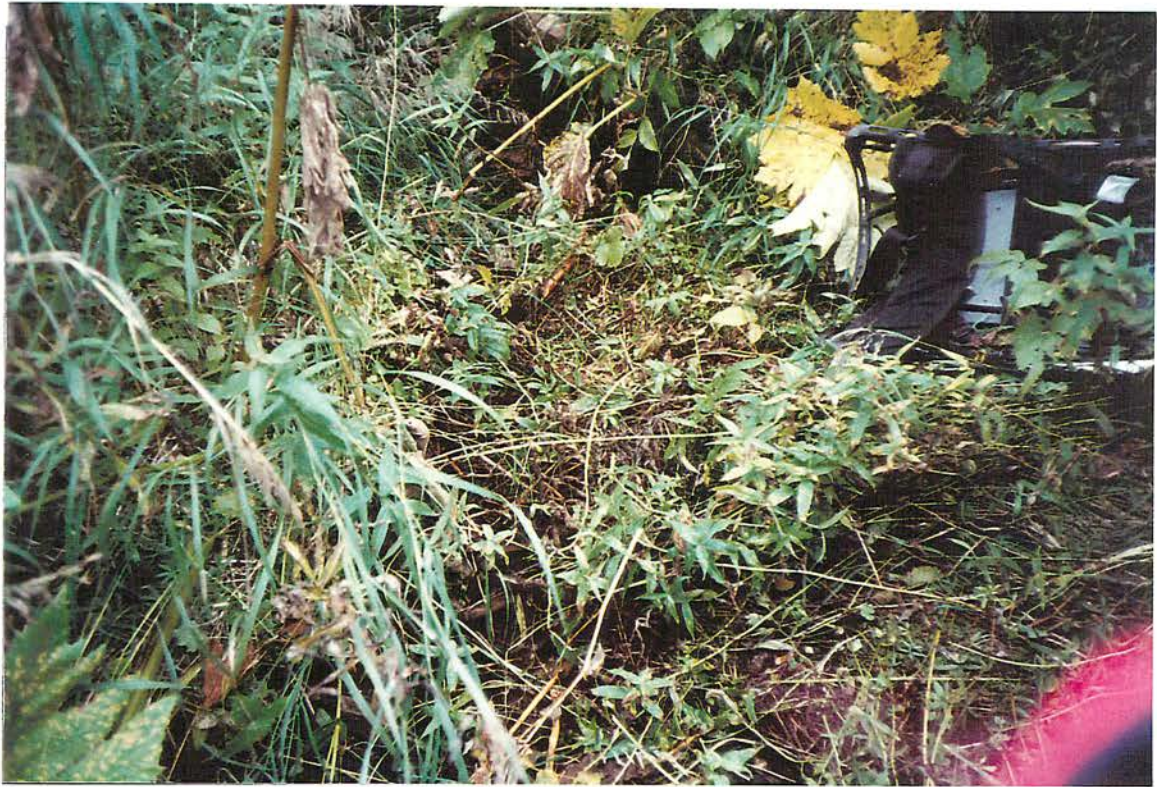
- C1: S4.
- C2: LS=15%, RS=15%
- C3: No fisheries sensitive zones noted.
- C4: This site was not electrofished as the channel was dry.
- C5: No additional bank texture information.
- C6: Water quality was not evaluated at this site. The air temperature at this site was 15.0 C.
- C7: This dry stream has been impacted heavily by past logging, it was previously looged to the banks. At higher flows this reach would offer a small amount of rearing habitat. Sections of this reach are well shaded by alder and willow, and contain small sections of gravel and large cobble.
- C8: There is a large amount of moose and bear activity in the area.

Photo #: W-P-2, 10-Sep-97
Site #: W257, Looking downstream at the channel

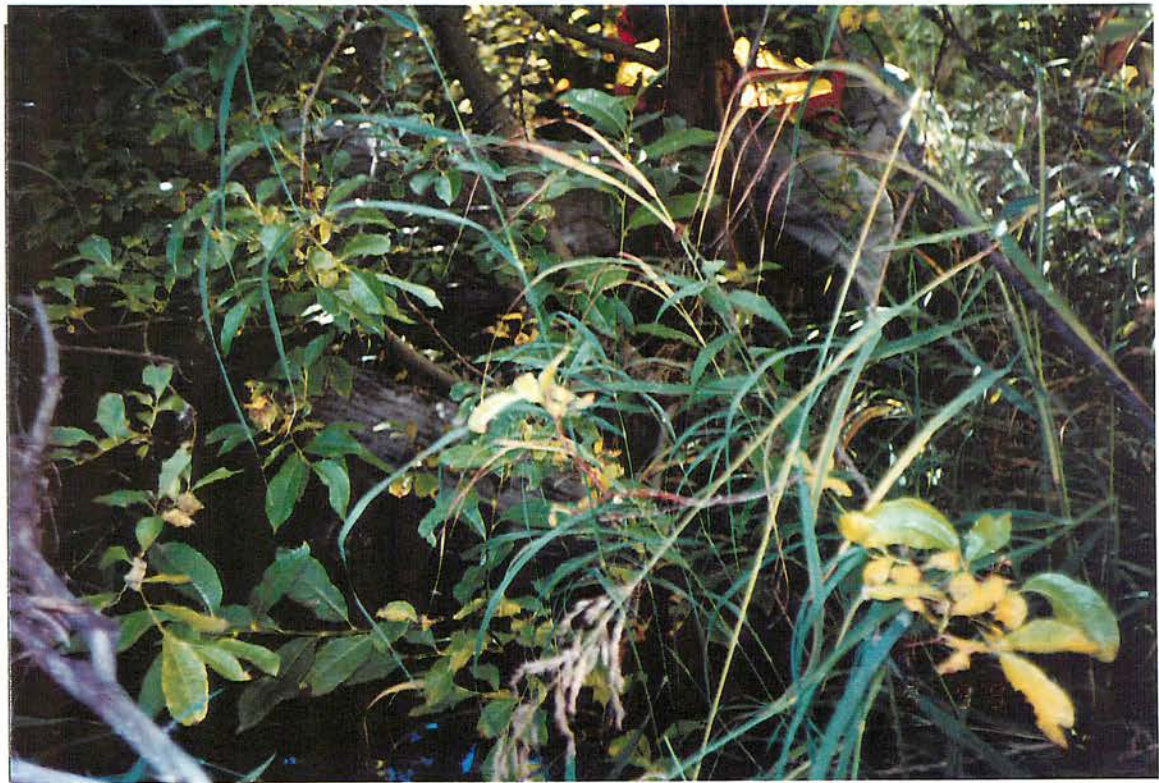
Photo #: W-O-22, 09-Sep-97

Site #: W254, Looking upstream at the channel, note the dense shrub cover

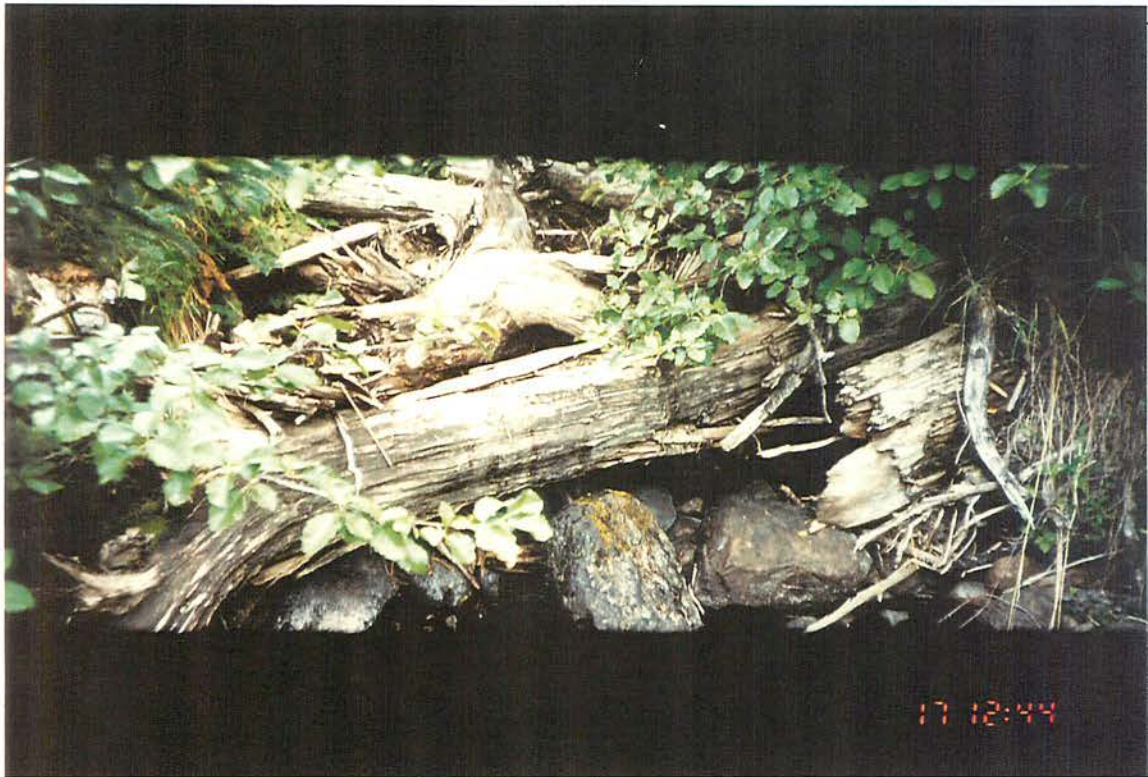
Photo #: T-6-15, 1996/08/17
Site #: T113, Channel, LOD over large cobble.
