# Reconnaissance Level Fish and Fish Habitat Inventory in the Bulkley T.S.A.

*(Working Unit #4 - Boucher)*

**Pacific Inland Resources (FRBC)**

April 1998

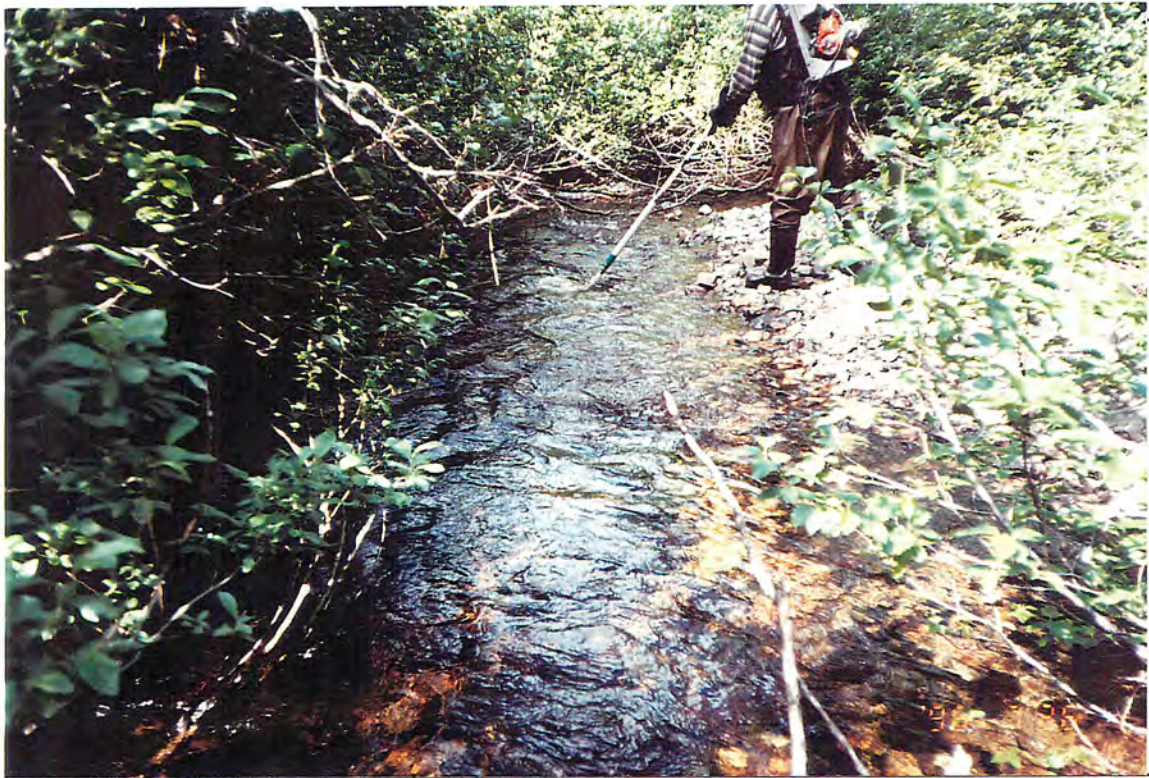
Photo #: H-1-5, 1996/07/26  
Site #: H4, Looking downstream.

- C1 S3  
C2 LS = 3%, RS = 12%  
C3 No fisheries sensitive zones noted.  
C4 The electroshocking effort, using a Smithroot 15 A model was, 305 seconds over 150 meters.  
C6 No additional bank texture information.  
C7 DO, pH and conductivity were not measured at this site. The mean air temperature on this day was 18.8°C  
C8 This site has some good rearing habitat. LOD cover is particularly important.  
C5 Lat N 55 24.119°, Long W 126 44.337°

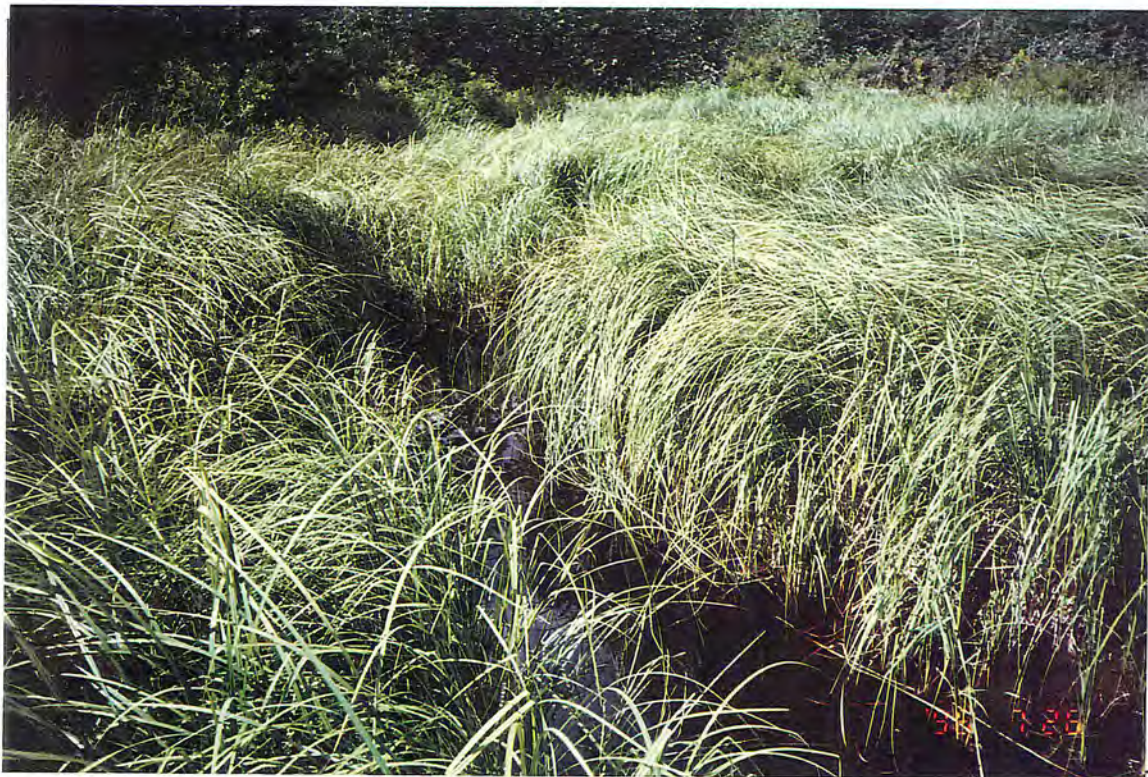
Photo #: H-1-4, 1996/07/26

- C1 S3  
 C2 LS= 5%, RS= 3%  
 C3 No fisheries sensitive zones noted.  
 C4 The electroshocking effort, using a Smithroot 12 B POW model, was 500 seconds over 70 meters.  
 C5 Lat N 55 24' 164", Long W 126 44' 390"  
 C6 No additional bank texture information.  
 C7 DO, pH and conductivity were not measured at this site. The mean air temperature on this day was 18.8°C  
 C8 This site has some good rearing habitat. Heavy siltation was noted at the road crossing.

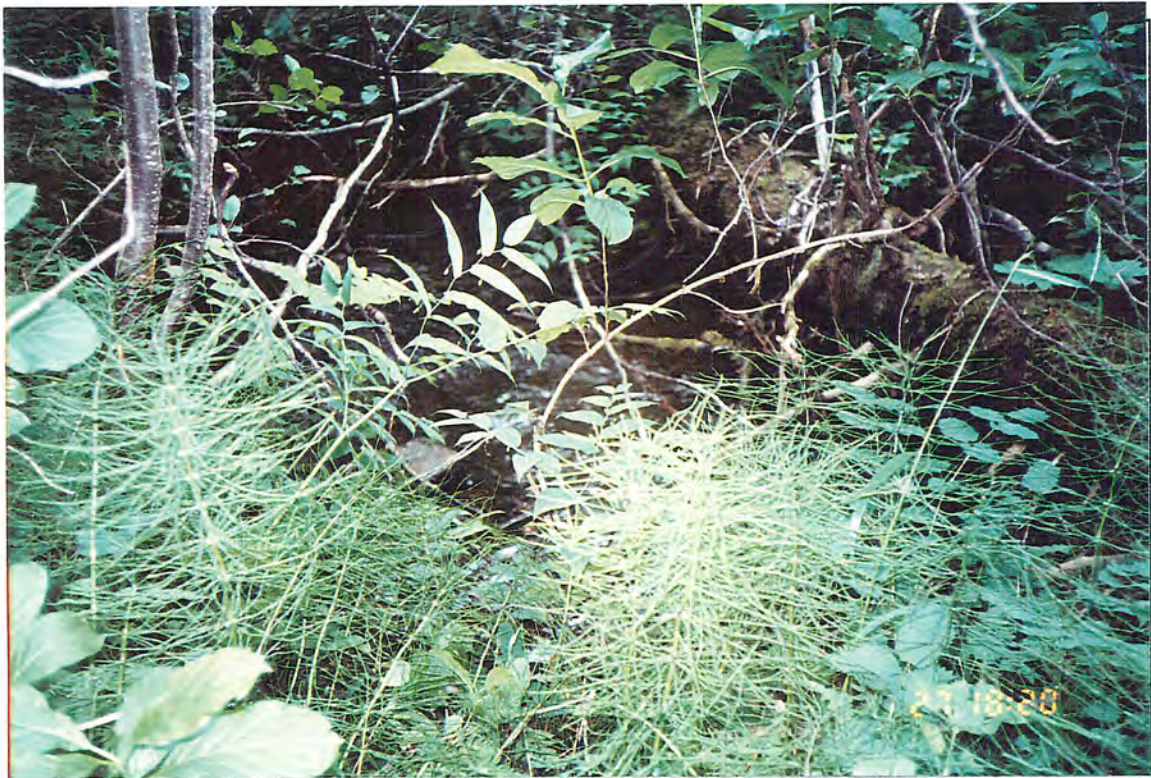
Photo #: T-1-21, 1996/07/27  
Site #: T18, Channel.

- C1: S3
- C2: The side slopes were not measured at this site.
- C3: No fisheries sensitive zones noted.
- C4: The electroshocking effort, using a Honda Mark 10 model, was 108 seconds over 50 meters.
- C5: N 55 23' 53.4" W 125 44' 55"
- C6: No additional bank texture information.
- C7: DO, pH and conductivity were not measured at this site. The mean air temperature on this day was 19.8°C
- C8: This site provides rearing habitat. LOD and cutbanks are particularly prominent

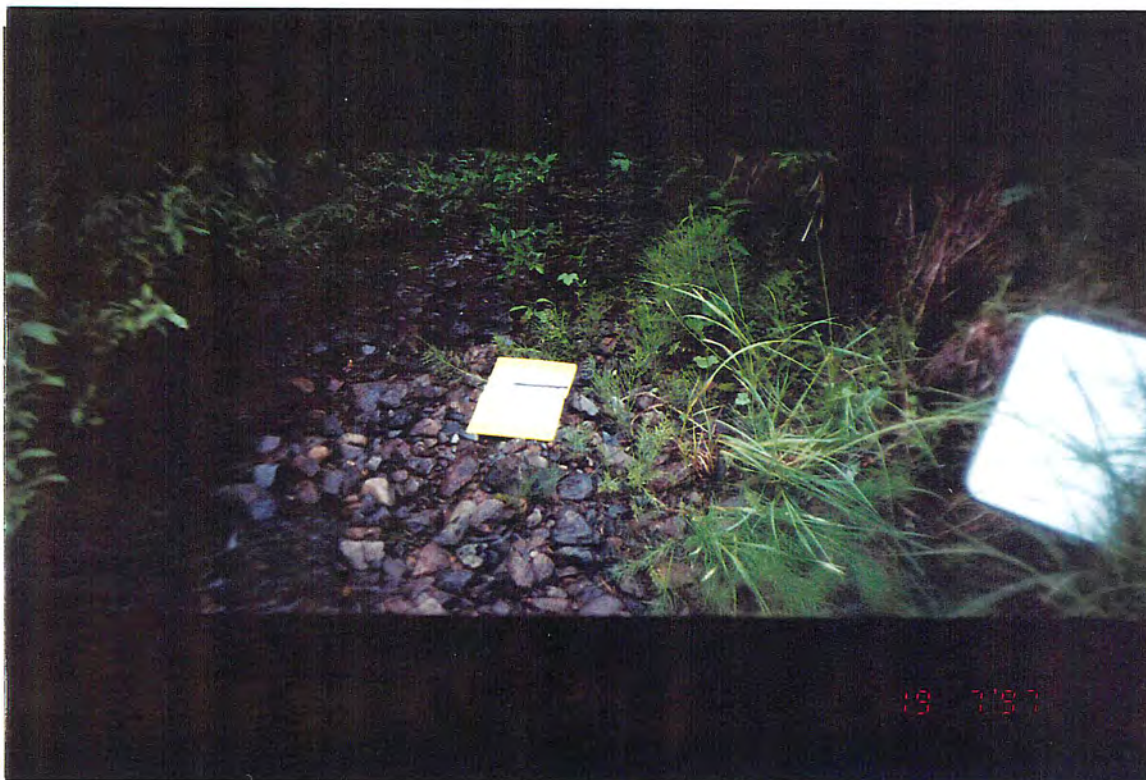
Photo #: Z-7-19, 19-Jul-97  
Site #: Z57, Looking downstream at the channel

- C1: S3  
 C2: LS=0%, RS=0%  
 C3: No fisheries sensitive zones noted.  
 C4: The electroshocking effort, using a Smithroot Type 12 B POW model set at J, 5, 300V, was 233 seconds over 100 meters.  
 C5: No additional bank texture information.  
 C6: DO was not measured at this site, the water was clear to bottom. The air temperature at this site was 13 C.  
 C7: There is some nice spawning sized substrate here, although the area does not have abundant rearing cover.

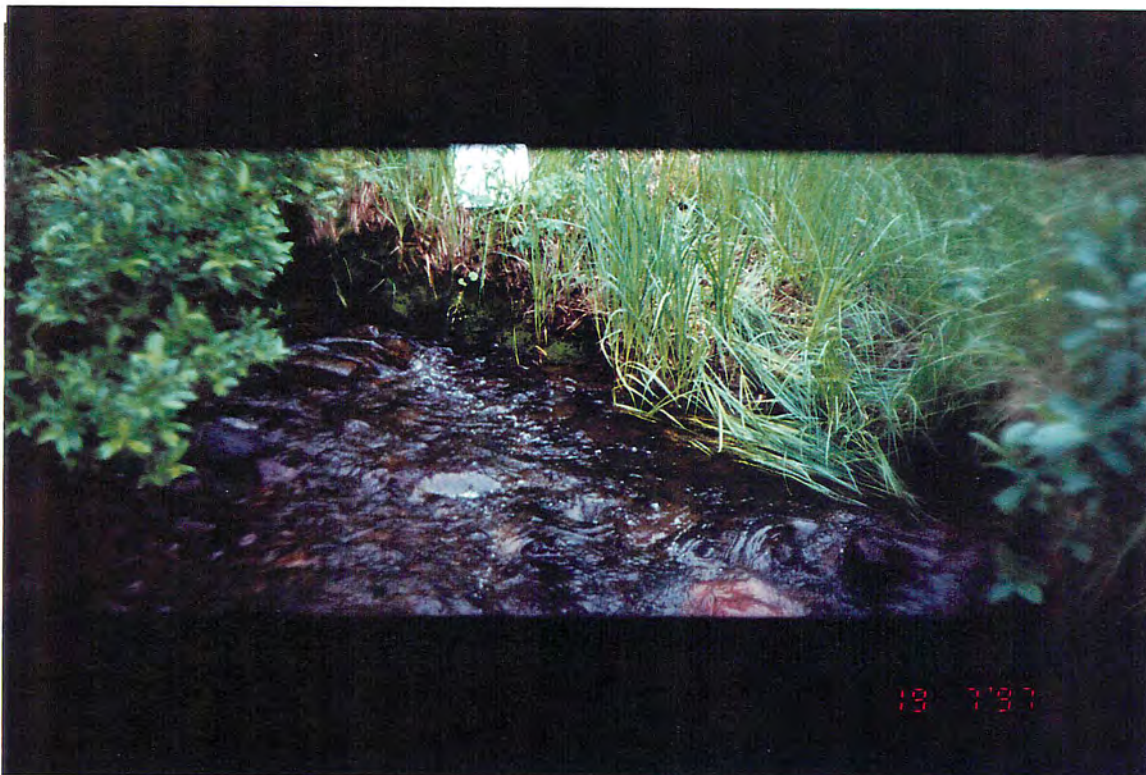
Photo #: Z-7-20, 19-Jul-97  
Site #: Z57, Looking upstream at the channel

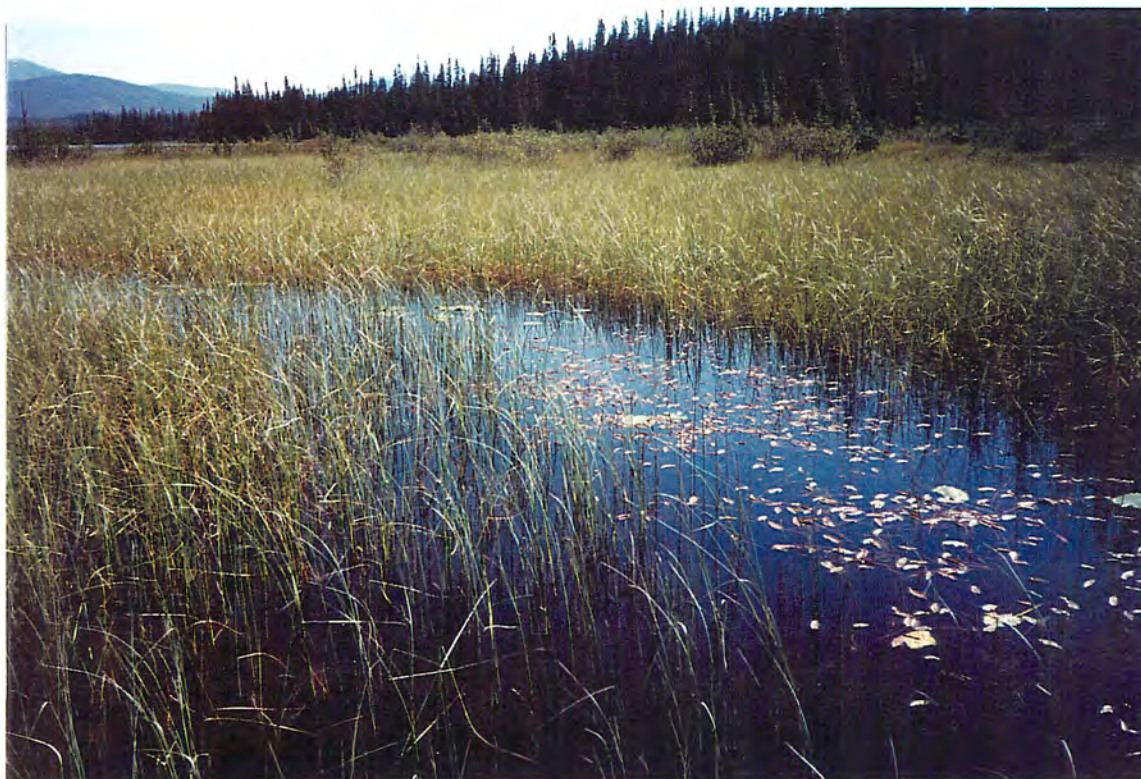
Photo #: J-2-3, 1996/07/27

- C1: S3  
C2: LS=2 RS=2  
C3: A large swamp is associated with this site.  
C4: The electroshocking effort, using a Smithroot 12 B POW model was 635 seconds over 80 meters.  
C5: Lat N 55 23' 37", Long W 126 32' 39"  
C6: No additional bank texture information.  
C7: DO, pH, conductivity were not measured at this site. the water was clear to the bottom. The mean air temperature on this day was 19.8°C  
C8: This is a small tributary that was sampled very close to mouth. It is attached to a sizeable lake. A lot of instream vegetation cover, including lily pads, was noted. Tadpoles and 2 osprey were also observed at this site.

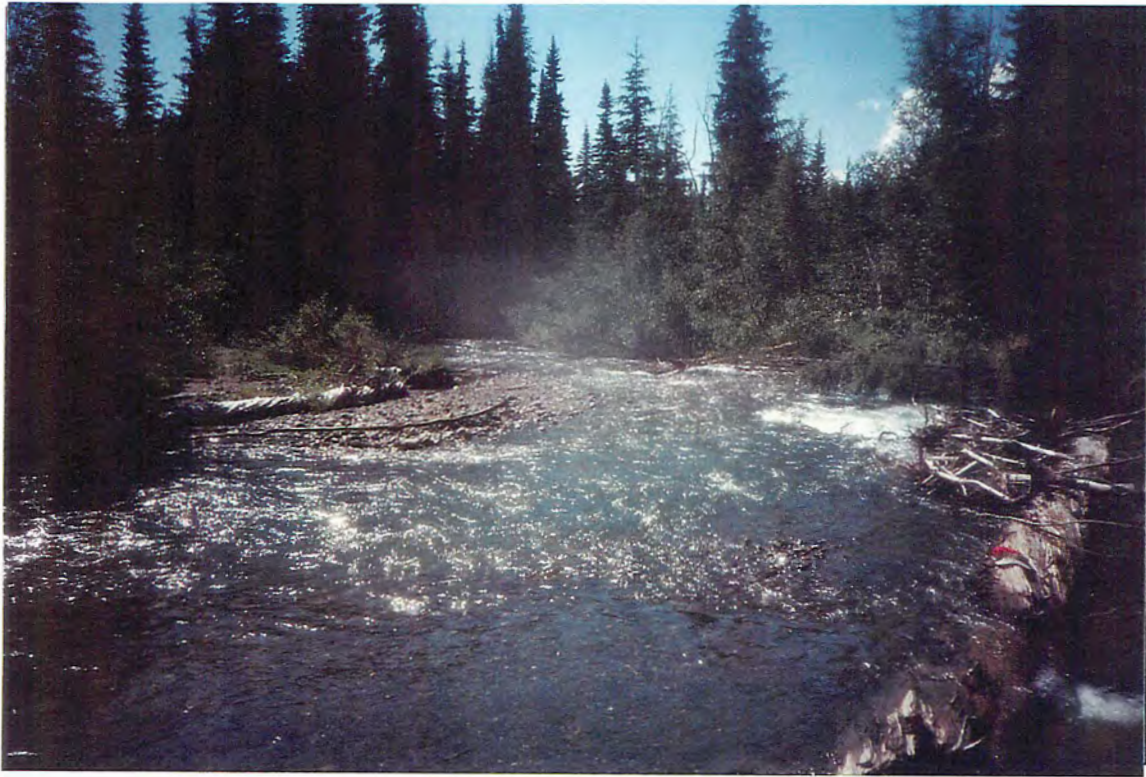
Photo #: J-1-20, 1996/07/26

- C1: S2  
C2: LS=1%, RS=1%  
C3: No fisheries sensitive zones were noted at this site.  
C4: The electrofishing effort, using a 12BPOW model, was not recorded at this site.  
C5: Lat N 55 29' 59", Long W 126 31' 27"  
C6: No additional bank texture information.  
C7: DO, pH, conductivity were not measured at this site. The mean air temperature on this day was 19.2°C  
C8: This site provides rearing habitat for Dolly Varden. LOD cover is particularly important at this site.

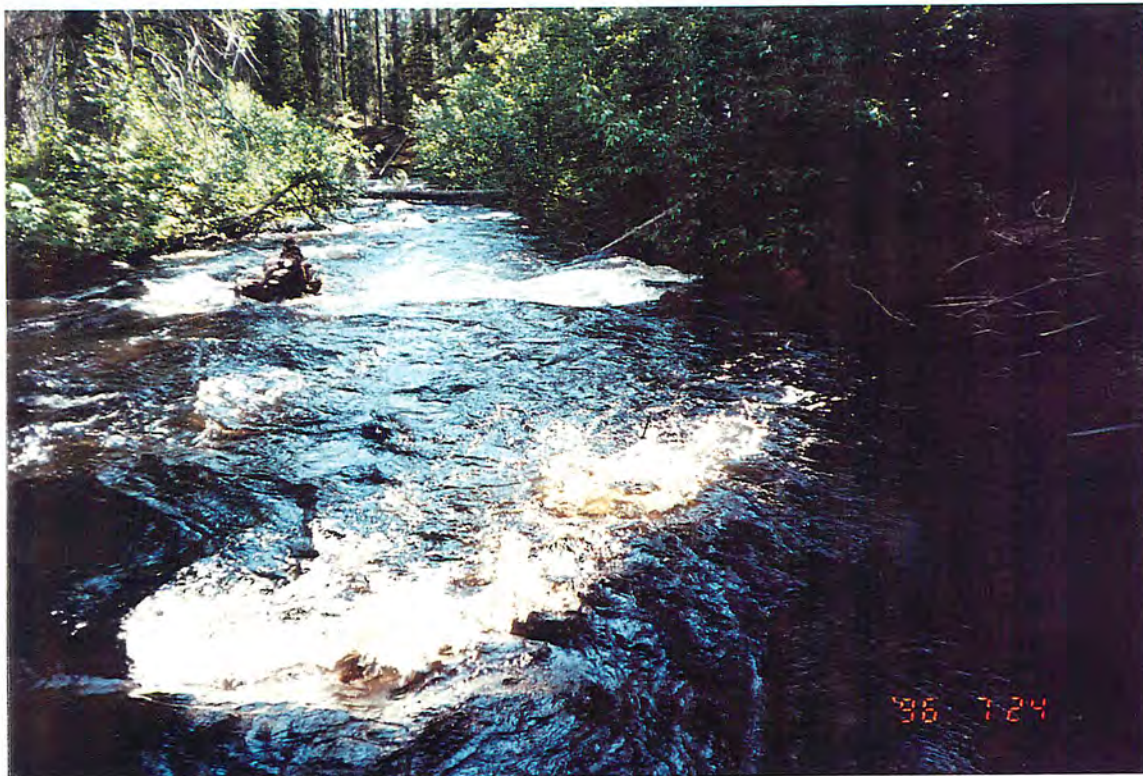
Photo #: R-1-1, 1996/07/24

Site #: J2, Looking downstream from bridge on Rd. 459.

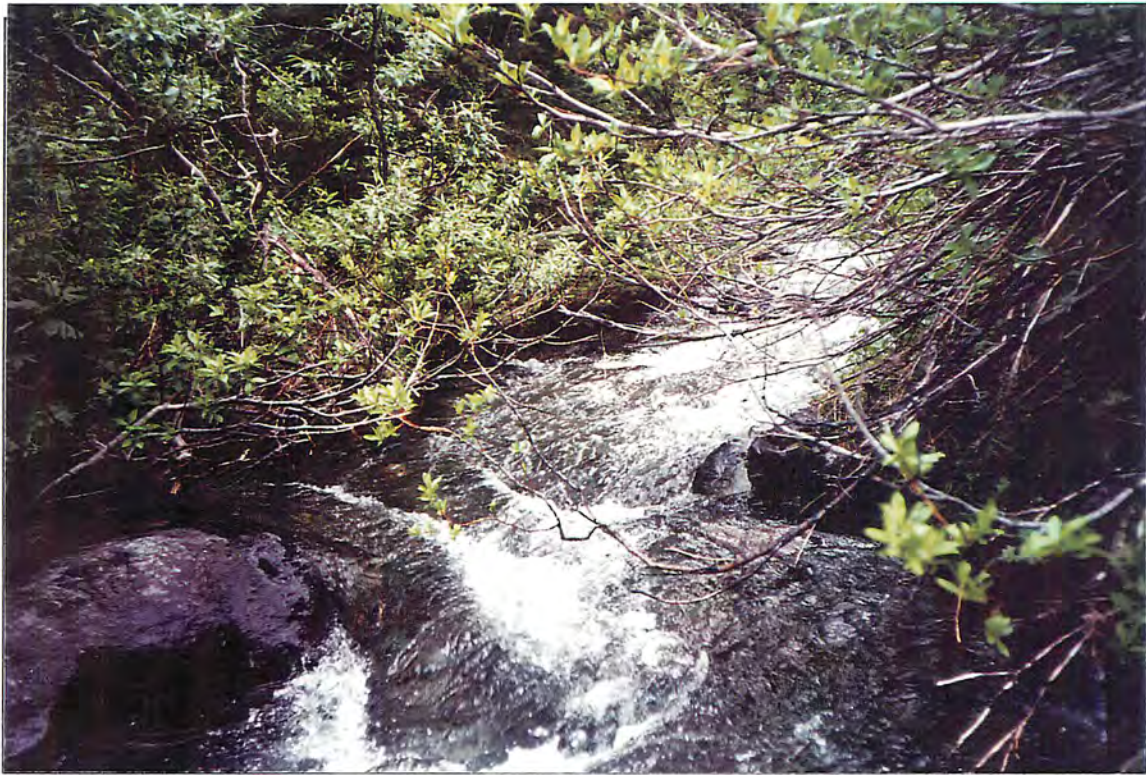
C7 Some potential spawning habitat occurs at this site. The mean air temperature on this day was 19.2°C

Photo #: J-1-14, 1996/07/25  
Site #: J9, Looking upstream.

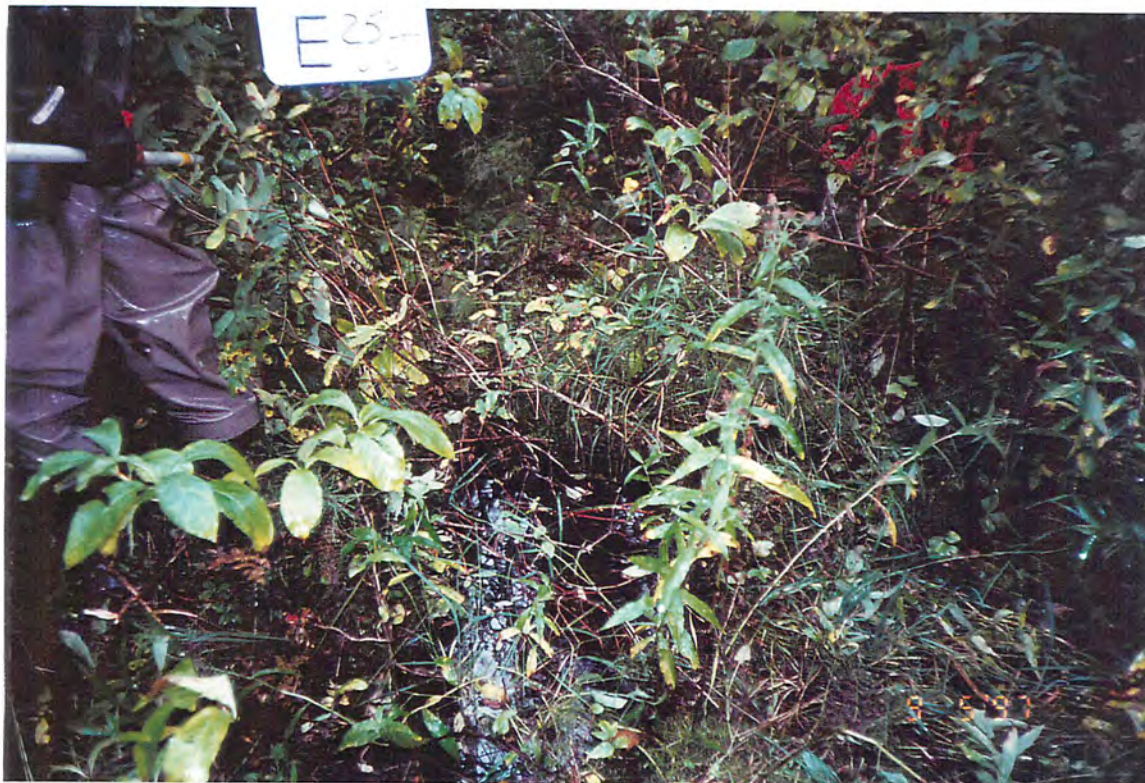
Photo #: E-24B-7, 05-Sep-97  
 Site #: E254, Looking upstream at the channel

- C1: S4  
C2: LS = 2%, RS = 3%  
C3: No fisheries sensitive zones noted.  
C4: The electroshocking effort, using a Smithroot 12 B POW model set at 1-5-600V, was 199 seconds over 125 meters.  
C5: No additional bank texture information.  
C6: DO was not measured, the water was clear to the bottom.  
C7: This reach is has no real spawning habitat, but does provide rearing cover in the form of pools, cutbank and overstream vegetation. Subterranean flow and periodic undefined sections of channel were also noted.

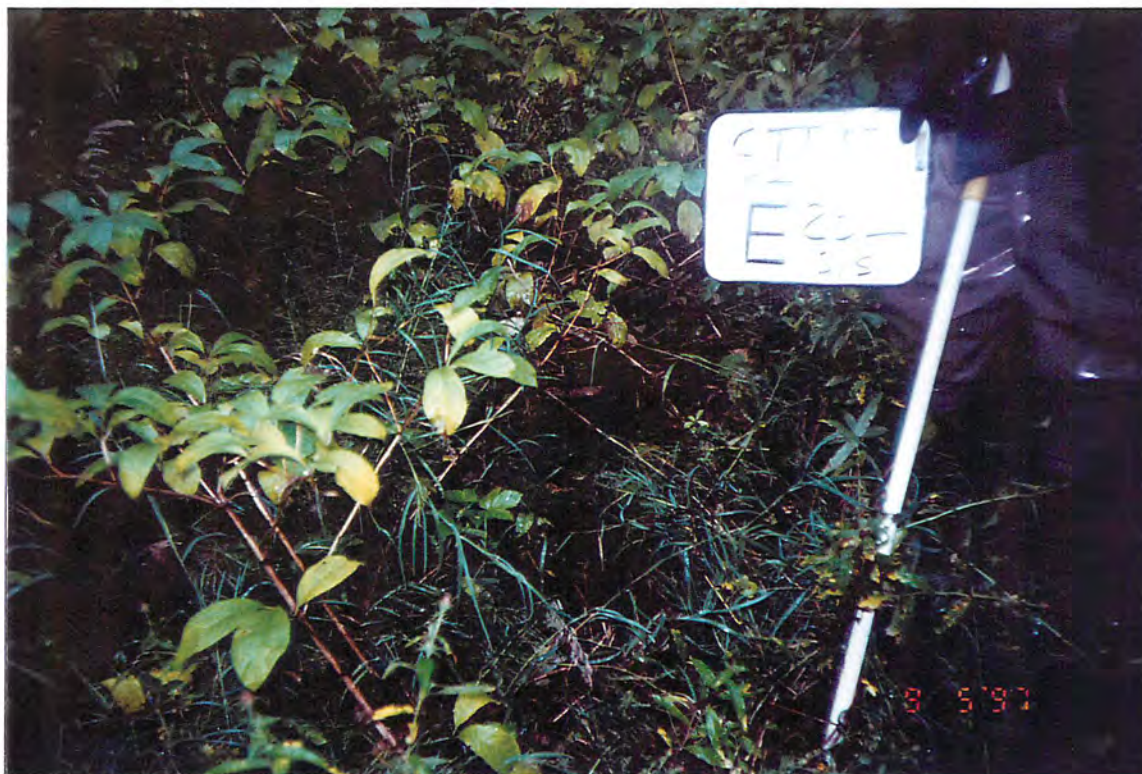
Photo #: E-24B-8, 05-Sep-97  
 Site #: E254, Looking downstream at the channel

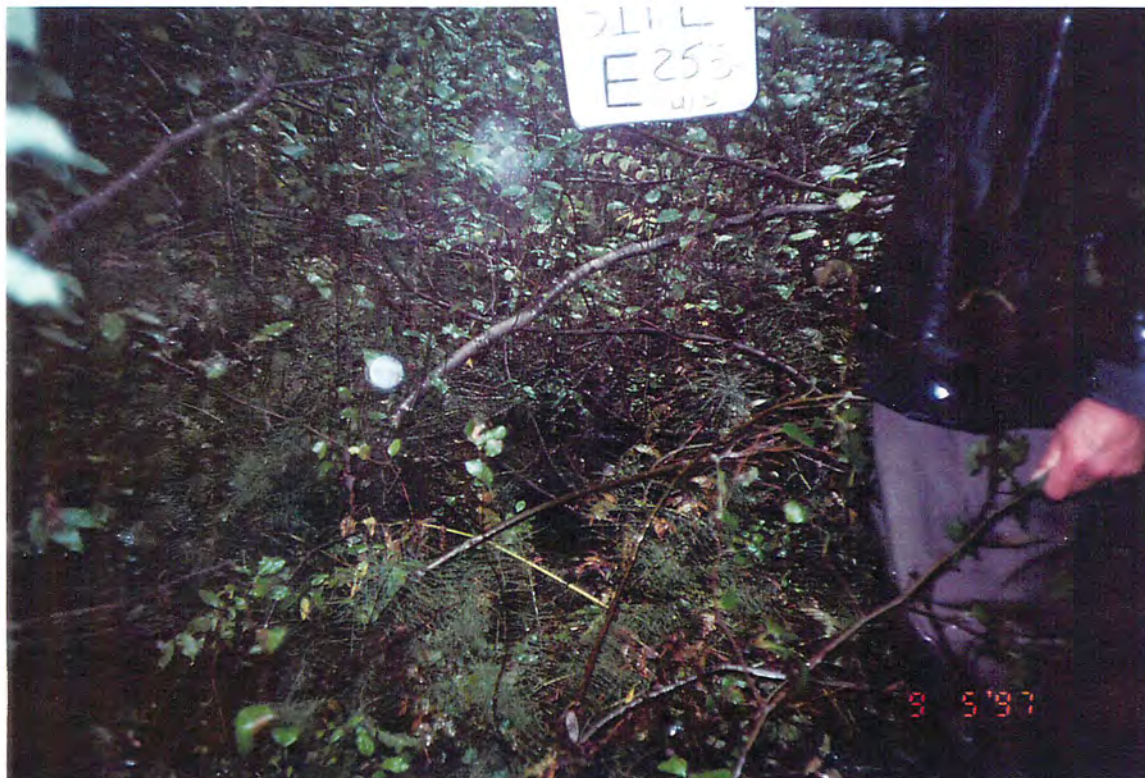
Photo #: E-24B-9, 05-Sep-97  
Site #: E255, Looking upstream at the channel

- C1 S4  
C2 LS = 8%, RS = 10%  
C3 No fisheries sensitive zones noted.  
C4 This dry site was not electrofished.  
C5 No additional bank texture information.  
C6 Water quality was not evaluated.  
C7 When water is present, cutbank and pool cover is available for rearing fish. LOD cover was also noted. Spawning habitat was not observed in the sampling area. This appears to be a seasonally wet creek.

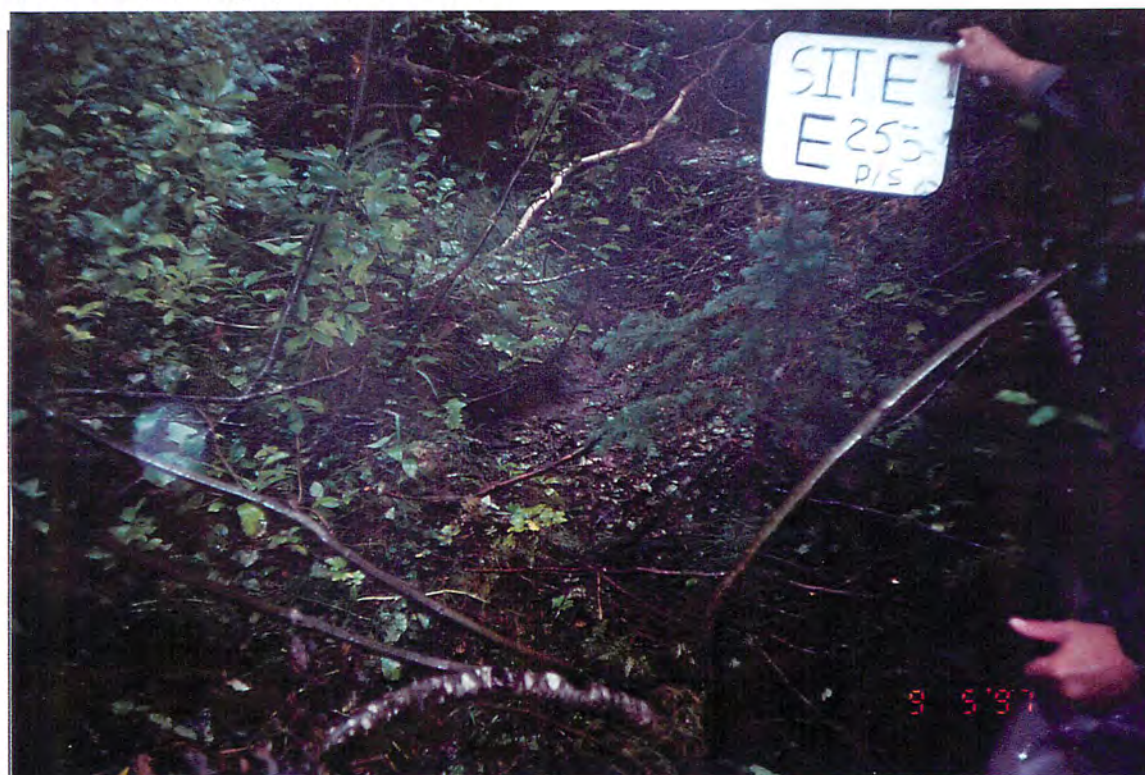
Photo #: E-24B-10, 05-Sep-97  
Site #: E255, Looking downstream at the channel

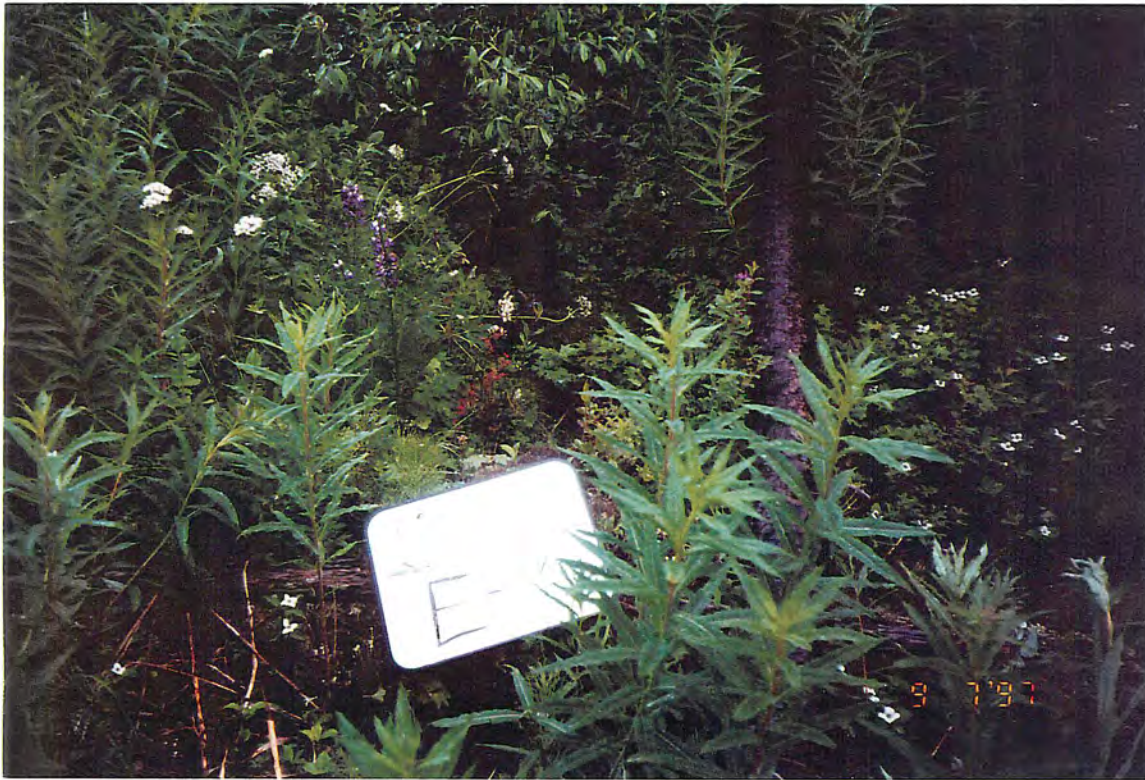
Photo #: E-1-3, 09-Jul-97

C4 The electroshocking effort, using a Smithroot 12 B POW model set at I, 5, was 150 seconds over 150 meters. No fish were caught.

Site #: E3, Looking upstream with fireweed and dogwood

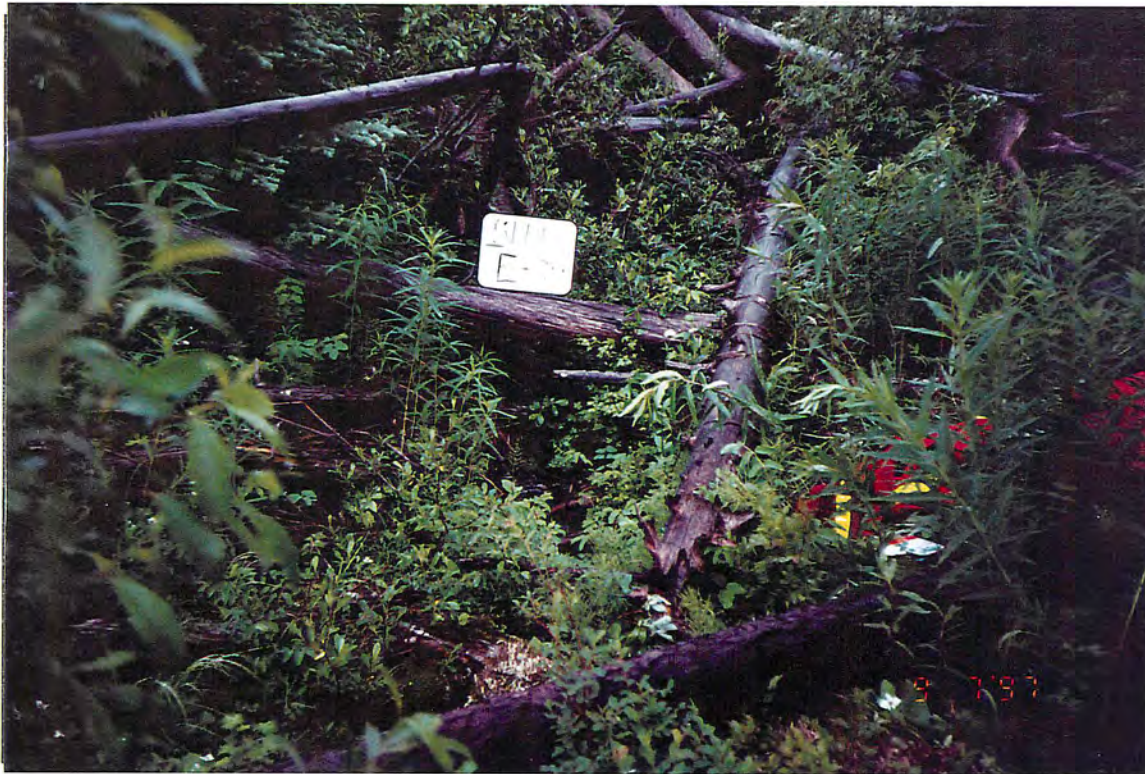
Photo #: E-1-4, 09-Jul-97

Site #: E3, Looking downstream with LOD, instream veg.

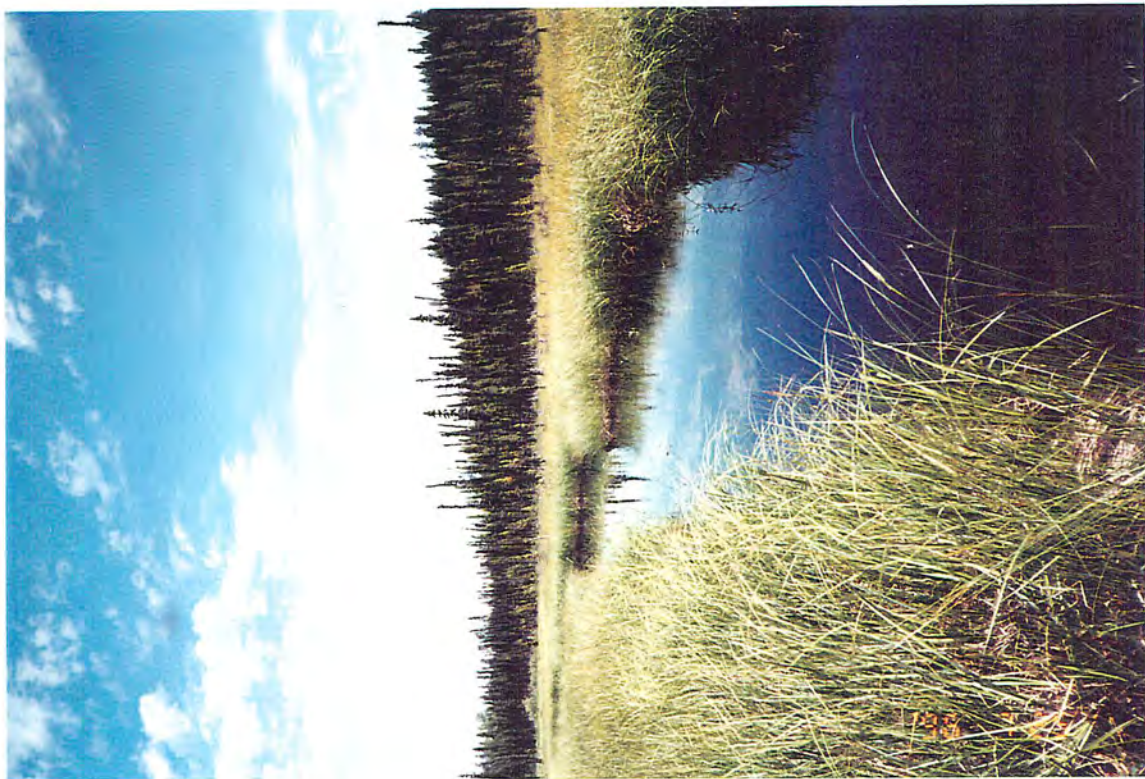
Photo #: H-1-2, 1996/07/25

C8: RB were observed surfacing in the attached lake.

Site #: H1, Looking upstream, through marsh.

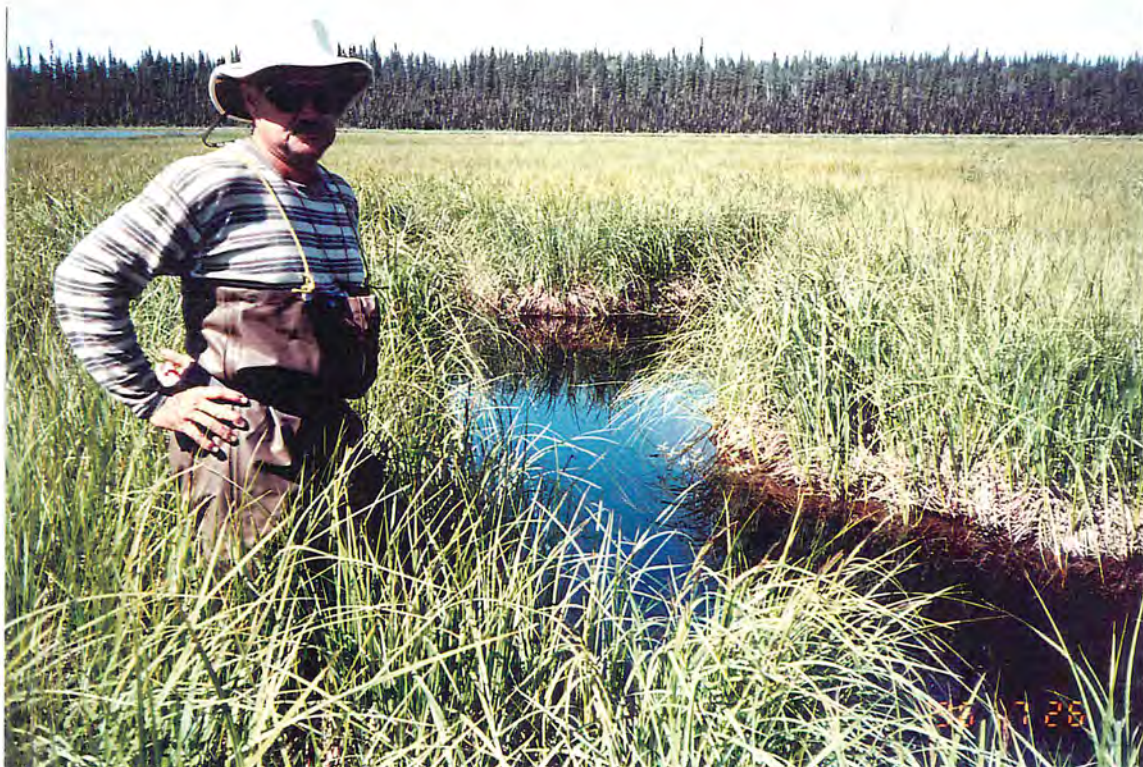
Photo #: H-1-3, 1996/07/26

Site #: H2, Looking upstream, through marsh.

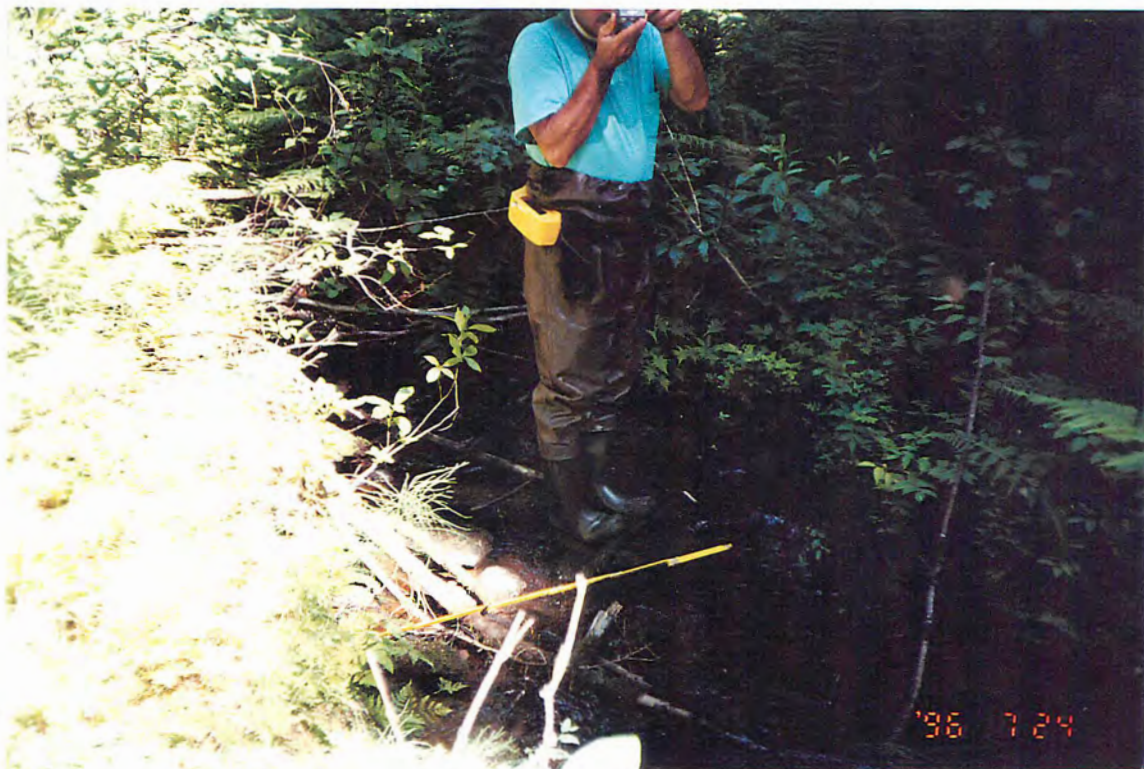
- C1 S3. This reach has been upgraded to an S3 from an S4. Two of the four measured channel widths and the average wetted width, meet the S3 width requirement.
- C2 RS = 38%, LS = 24%
- C3 No fisheries sensitive zones noted.
- C4 The electroshocking effort, using a Smithroot 12 B POW model was 500 seconds over 100 meters.
- C5 Lat N 55 26 16.8", Long W 126 38 29.2"
- C6 Fines and gravels make up the bank texture at this site.
- C7 DO, pH and conductivity were not measured at this site. The mean air temperature on this day was 17.5°C
- C8 This site has some excellent rearing cover.

Photo #: J-1-1, 1996/07/24  
Site #: J1, Looking upstream.

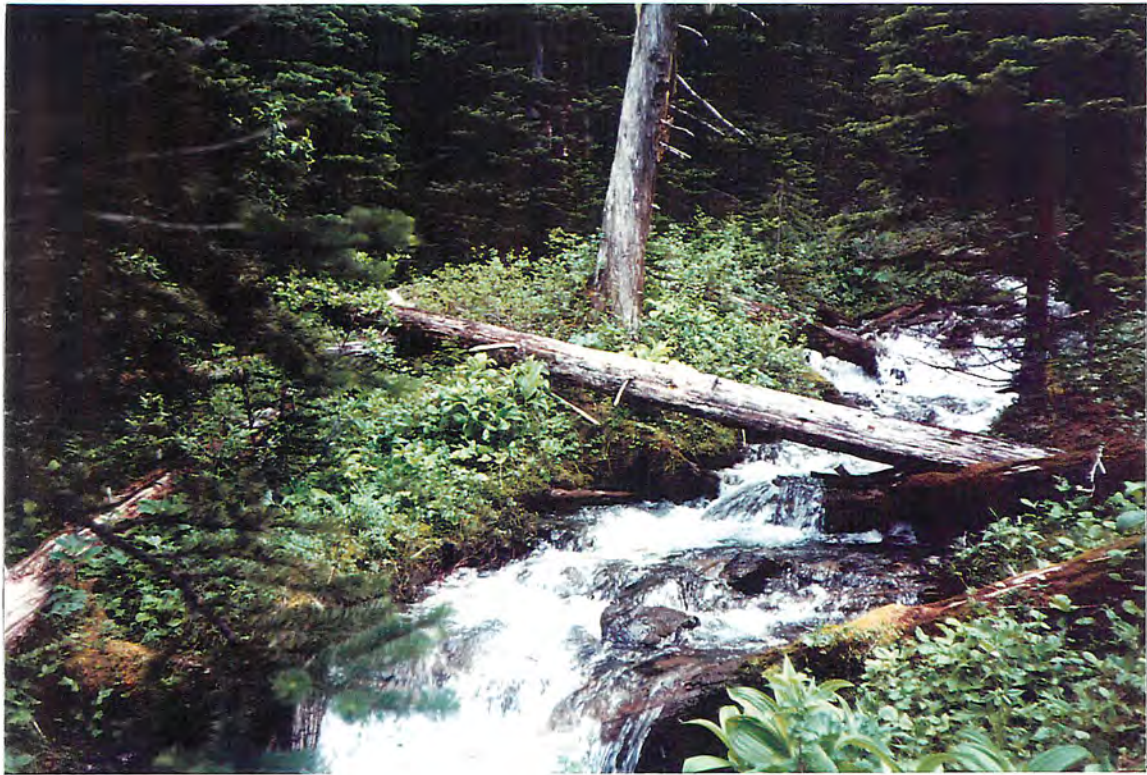
Photo #: J-1-15, 1996/07/25  
Site #: J10, Looking upstream.

C4: This site was not electrofished as a fish was caught 400 meters downstream near the confluence of this tributary with Boucher Creek. The only possible limiting factor to fish distribution in this case is gradient, which exceeds 20% upstream of the sampling area. However, step pool habitat was observed.

C8: Cascades ranging from .5 -.7 meters in height, were observed throughout the site.

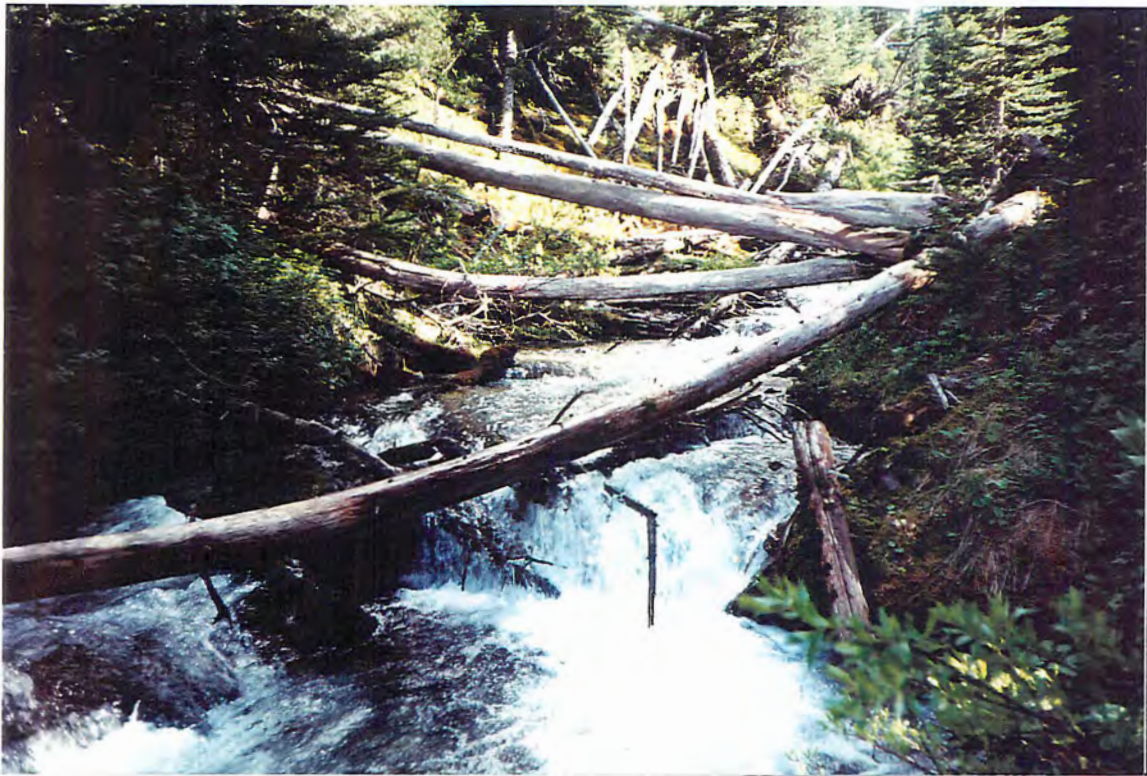
Photo #: J-1-16, 1996/07/25

C8 The gradient of this creek is steep. White water was observed. This site could provide Dolly Varden habitat. A lot of LOD cover and some spawning gravels were noted in the area.

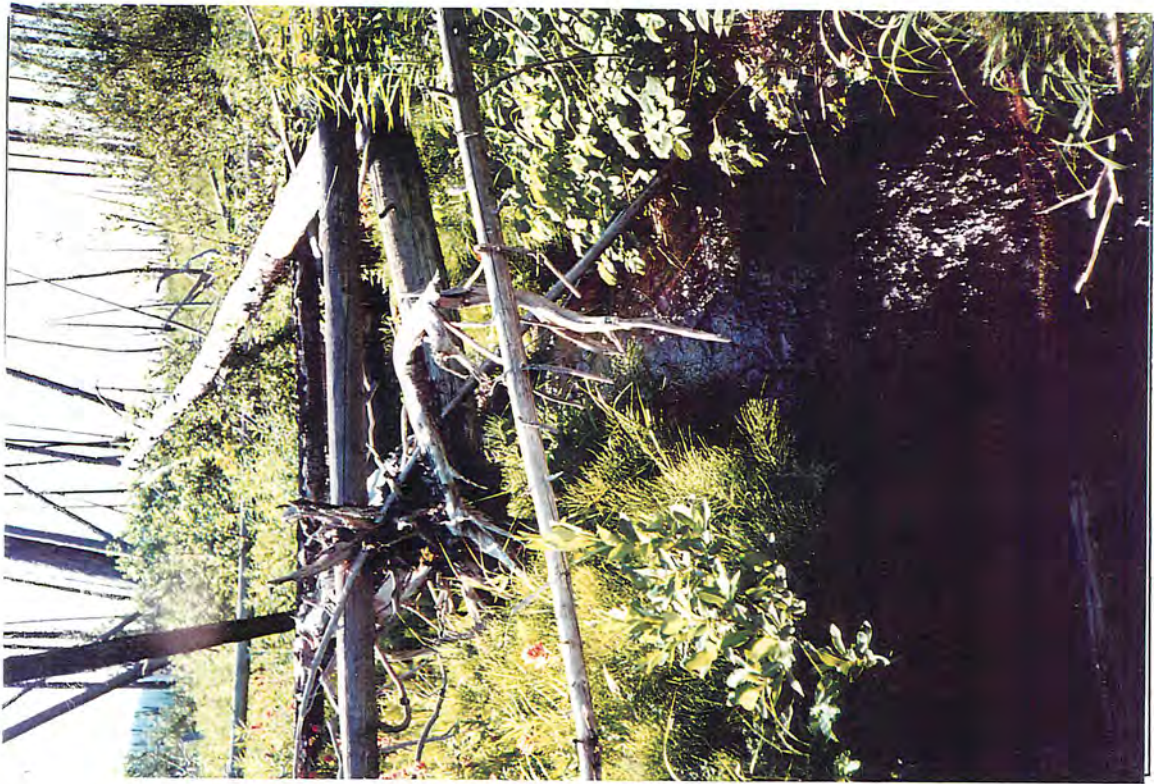
Photo #: J-1-18, 1996/07/26  
Site #: J13, Looking upstream.

C8: The culvert at this site could use some more armouring at the outlet.

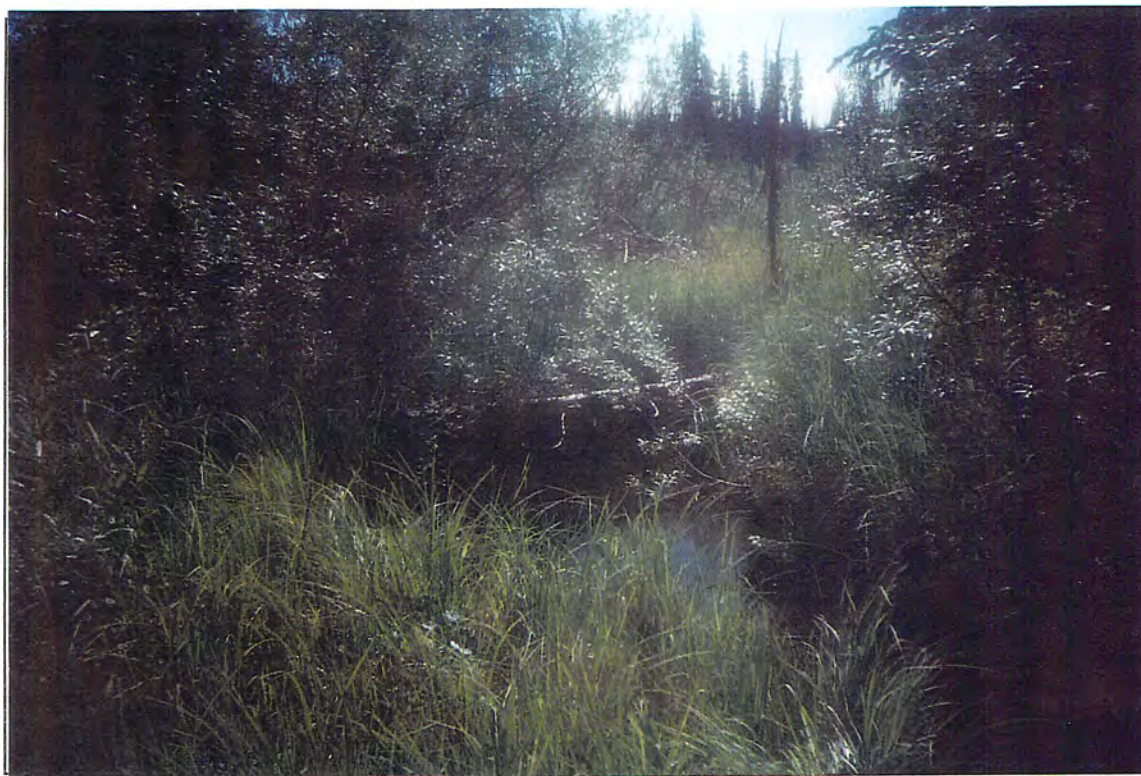
- C1: S3  
 C2: LS = 0%, RS = 0%  
 C3: No fisheries sensitive zones were noted at this site.  
 C4: The electroshocking effort, using a 12 BPOW model, was 381 seconds over 97 meters.  
 C5: Lat N 55 30' 52" , Long W 126 32' 05"  
 C6: No additional bank texture information.  
 C7: DO, pH, conductivity were not measured at this site. The mean air temperature on this day was 18.8°C  
 C8: No observable flow occurred at this site at the time of sampling. A series of beaver dams that were not obstructions was observed. A strong sulphur smell, and a lot of organic matter instream, were noted. The only possible habitat at this site occurs in the beaver pond, which contains plenty of insect food. All channels were checked for rearing fish, but none were seen.

Photo #: J-1-19, 1996/07/26  
Site #: J14, Channel through grass and alder.

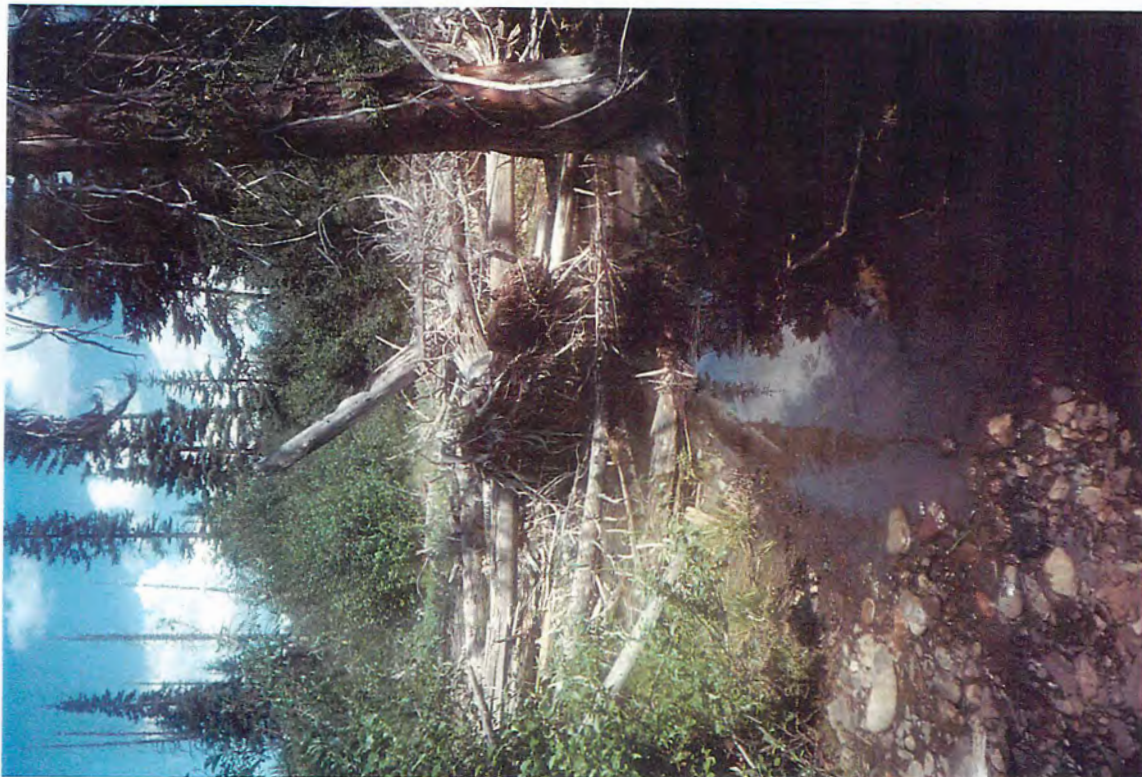
Photo #: J-1-22, 1996/07/26  
Site #: J16, Algae bloom.

C8 This site connects with J14. No barriers to fish passage were observed. Algae was seen in the stream.
